REPORT ON

LEAK AT FONTENELLE DAM  
SEEDSKADEE PROJECT, WYOMING

September 1965

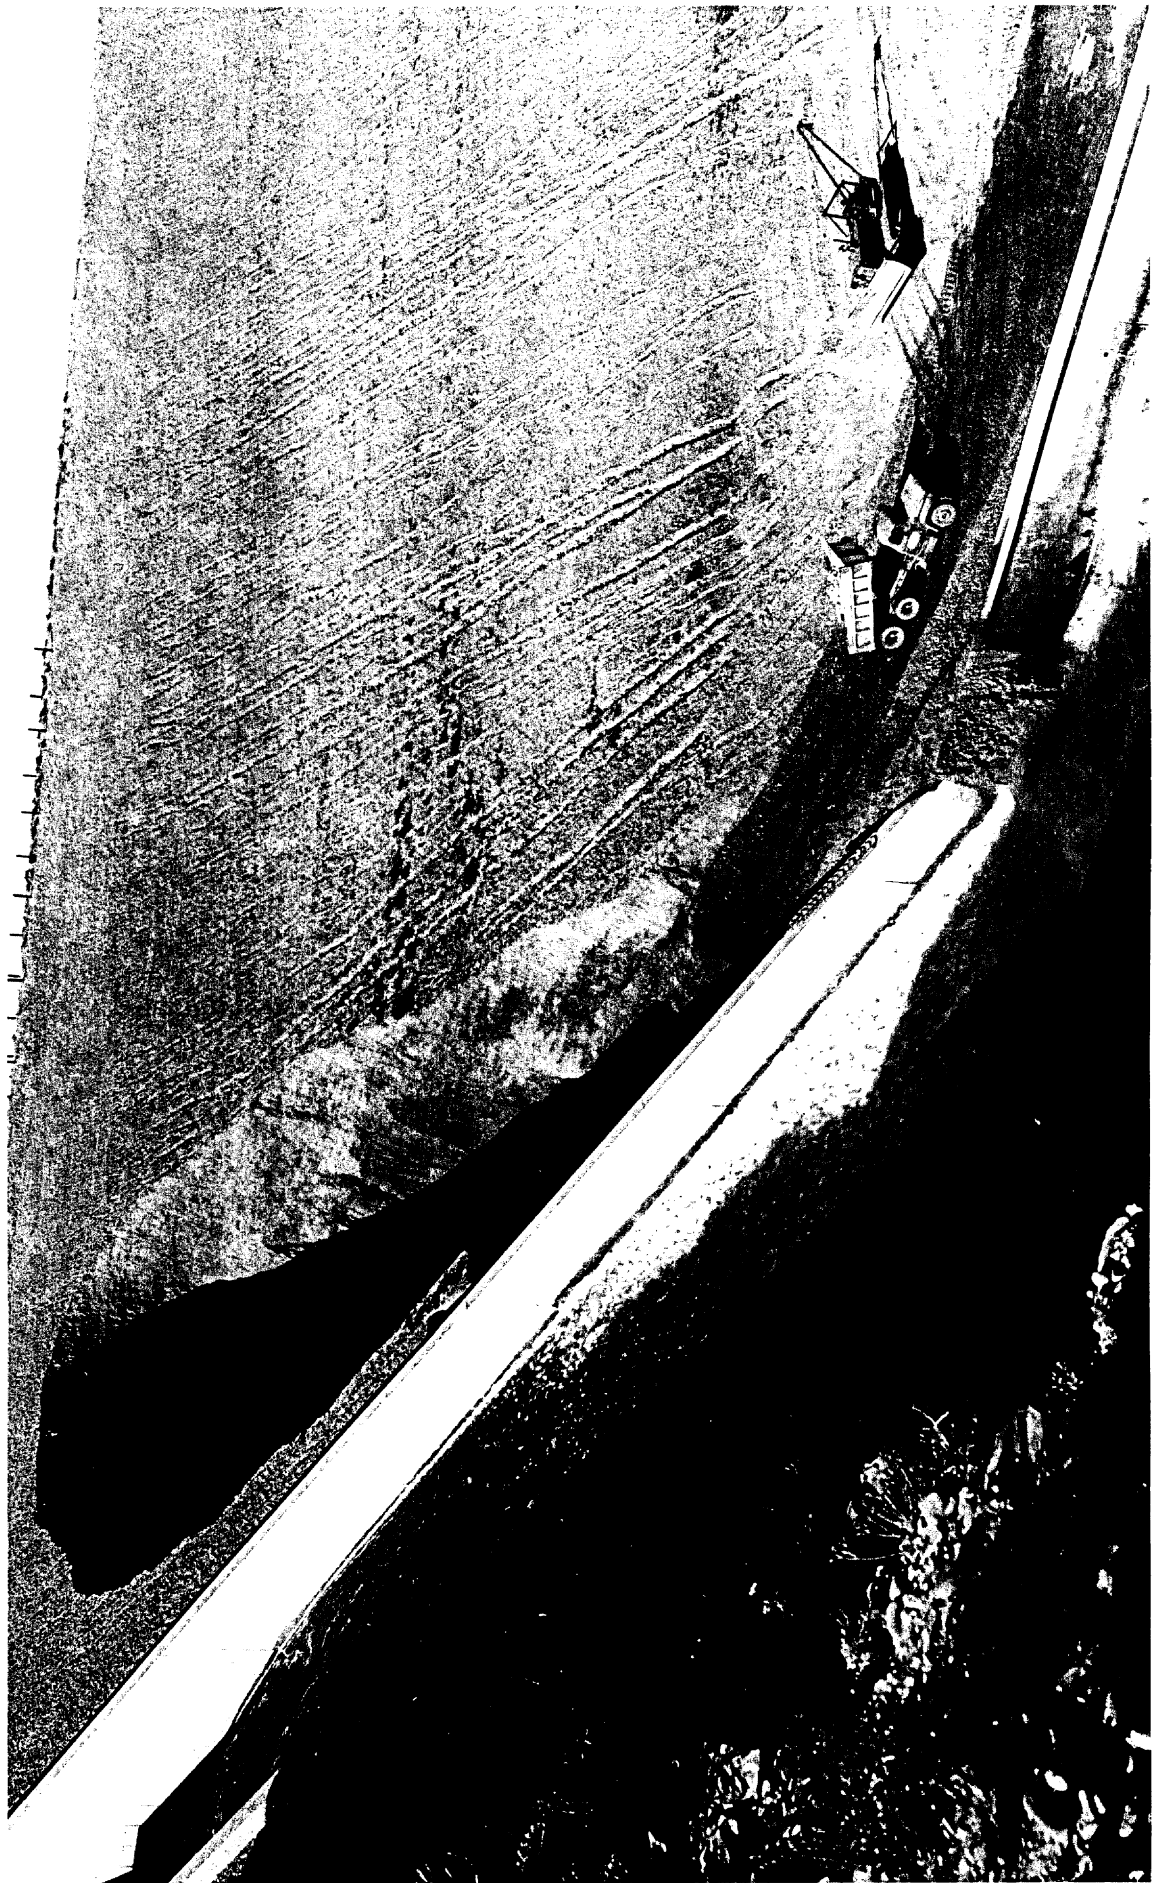
PHOTOGRAPH 3

unchanged in volume, and the placement of rock in the eroded area continued. No further erosion was taking place. At 8 a.m. the outlet gates were opened to full capacity of 17,000 c.f.s. (See Figure 2 and Photograph 3.) The 14,500-c.f.s. releases had prevailed for about 15 hours so that the channel downstream should have been conditioned and the residents downstream prepared for higher flows. It was realized that higher releases would result in some overbank flooding, but this was considered a circumstance necessary to accomplish the most rapid evacuation of the reservoir.

17,000 c.f.s. discharge from outlet works when opened fully at 8:00 a.m. Sunday, September 5, with reservoir water surface at 6,505 feet. Note backfill along wall had been removed by contractor prior to the leak.

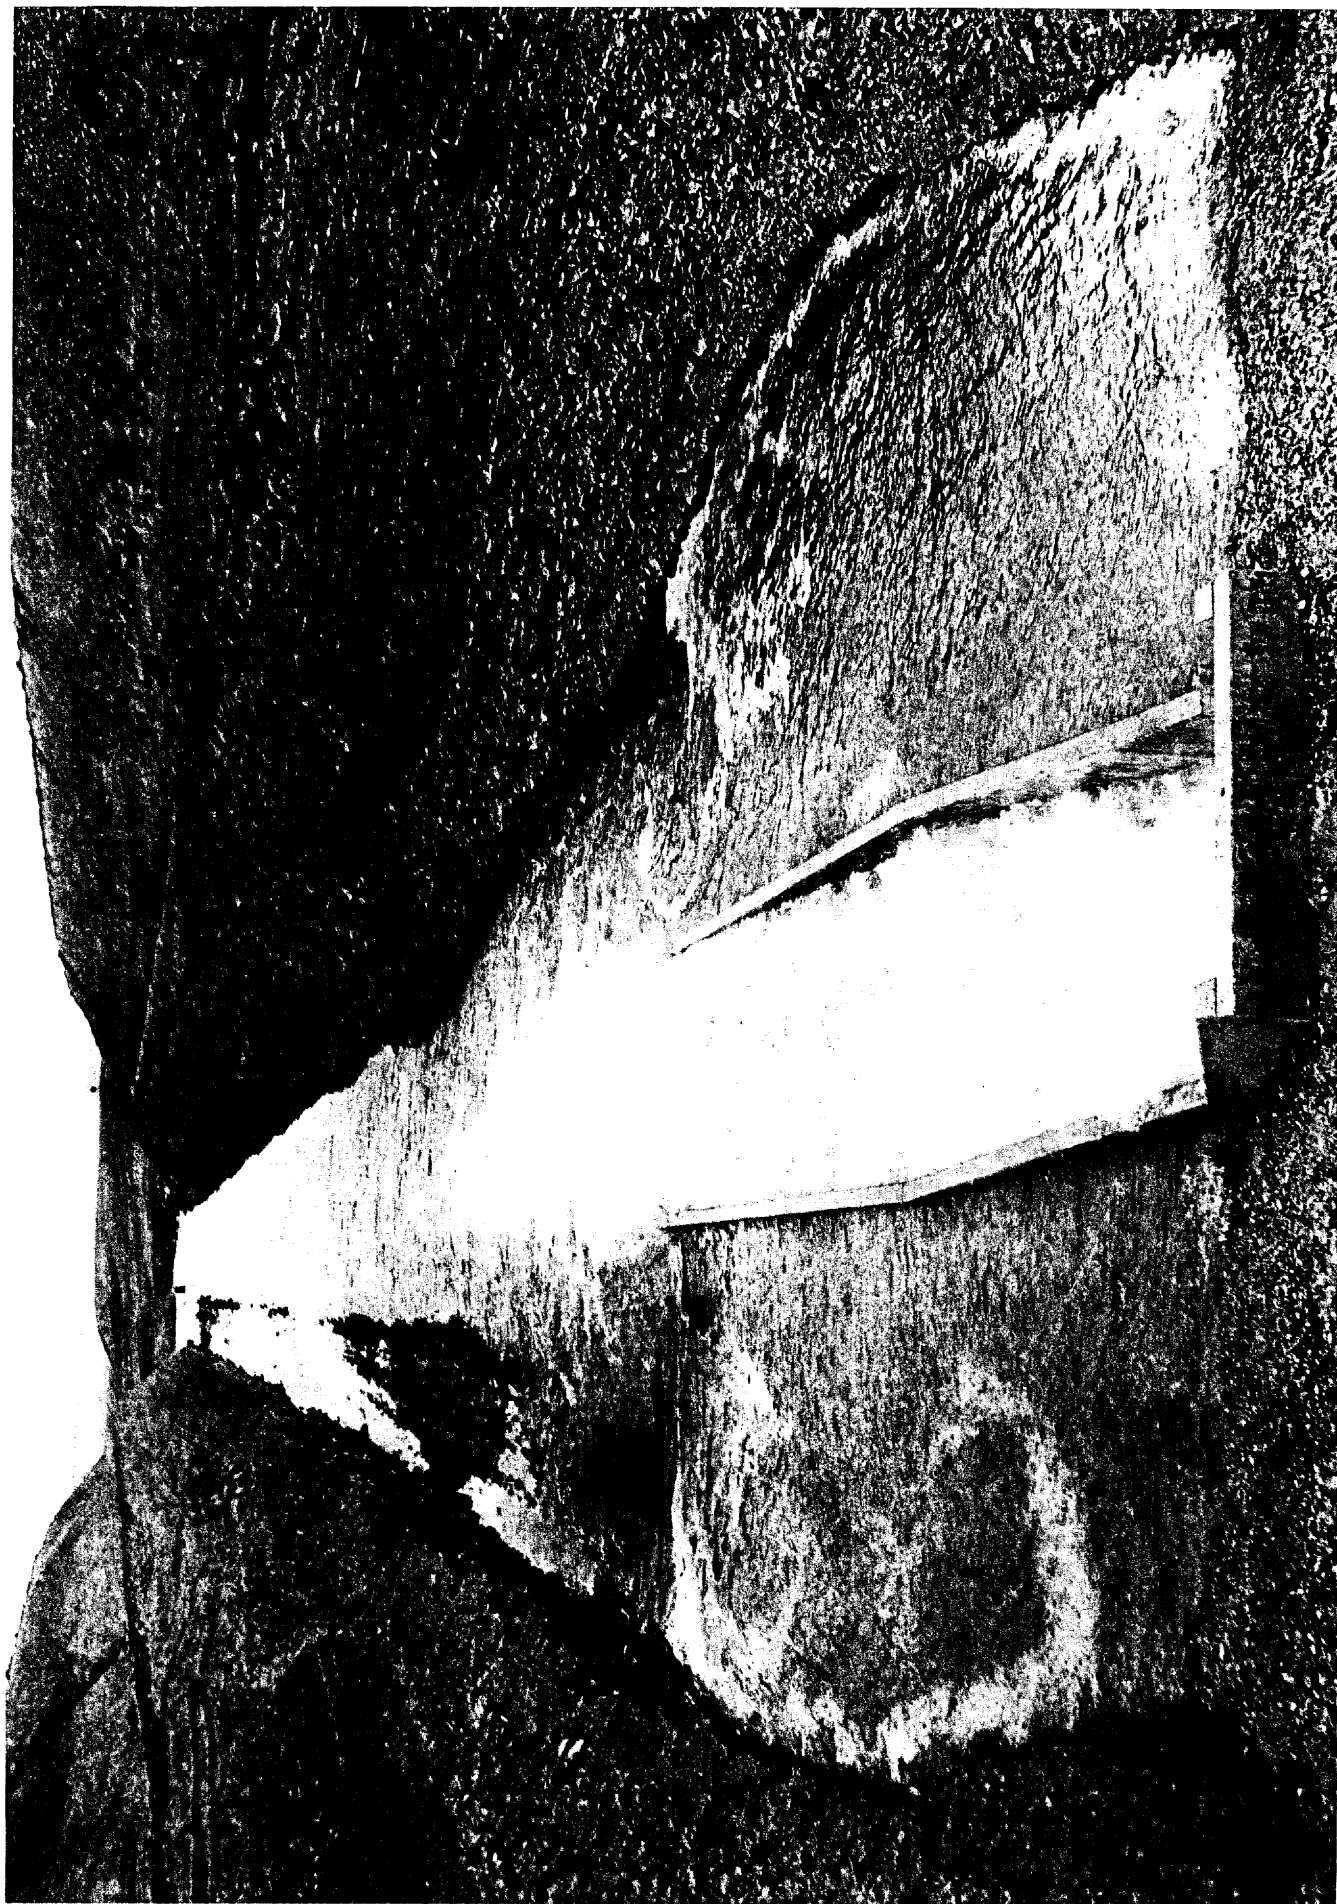
Rock dumped on crest road was pushed over the side to drop into the path of the leak flow. - The leak water tumbles down rocky materials and erosion is arrested below point of emergence.

Sunday September 5.

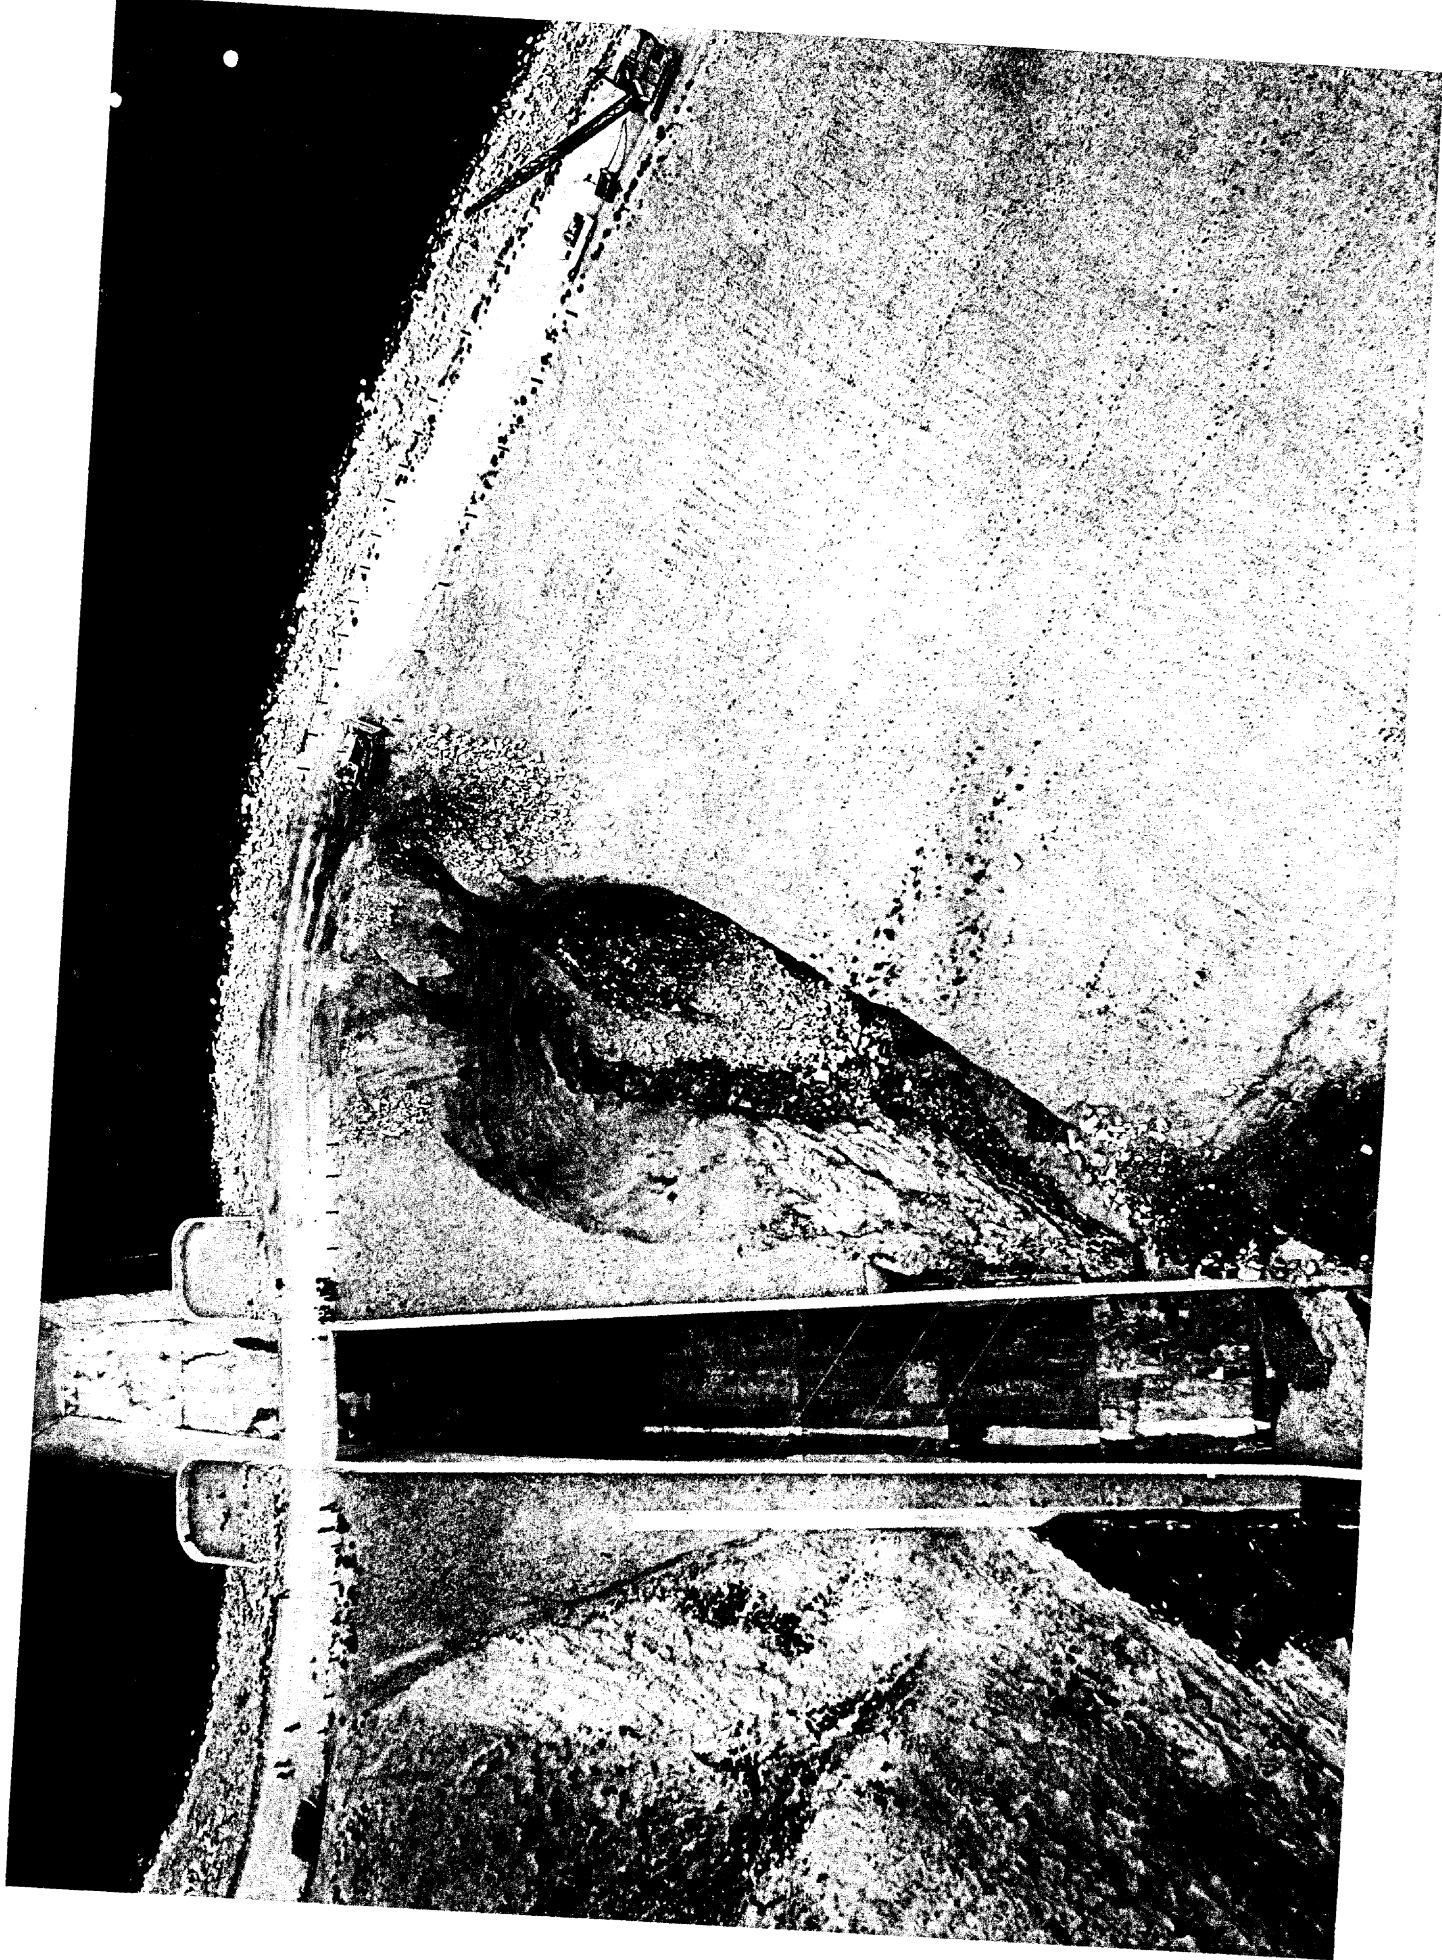
PHOTOGRAPH 6

The rock pushed into the cavity piled up in front of the leak opening in the embankment and caused the leak outflow to rise vertically somewhat as the opening became choked. Sunday, September 5.

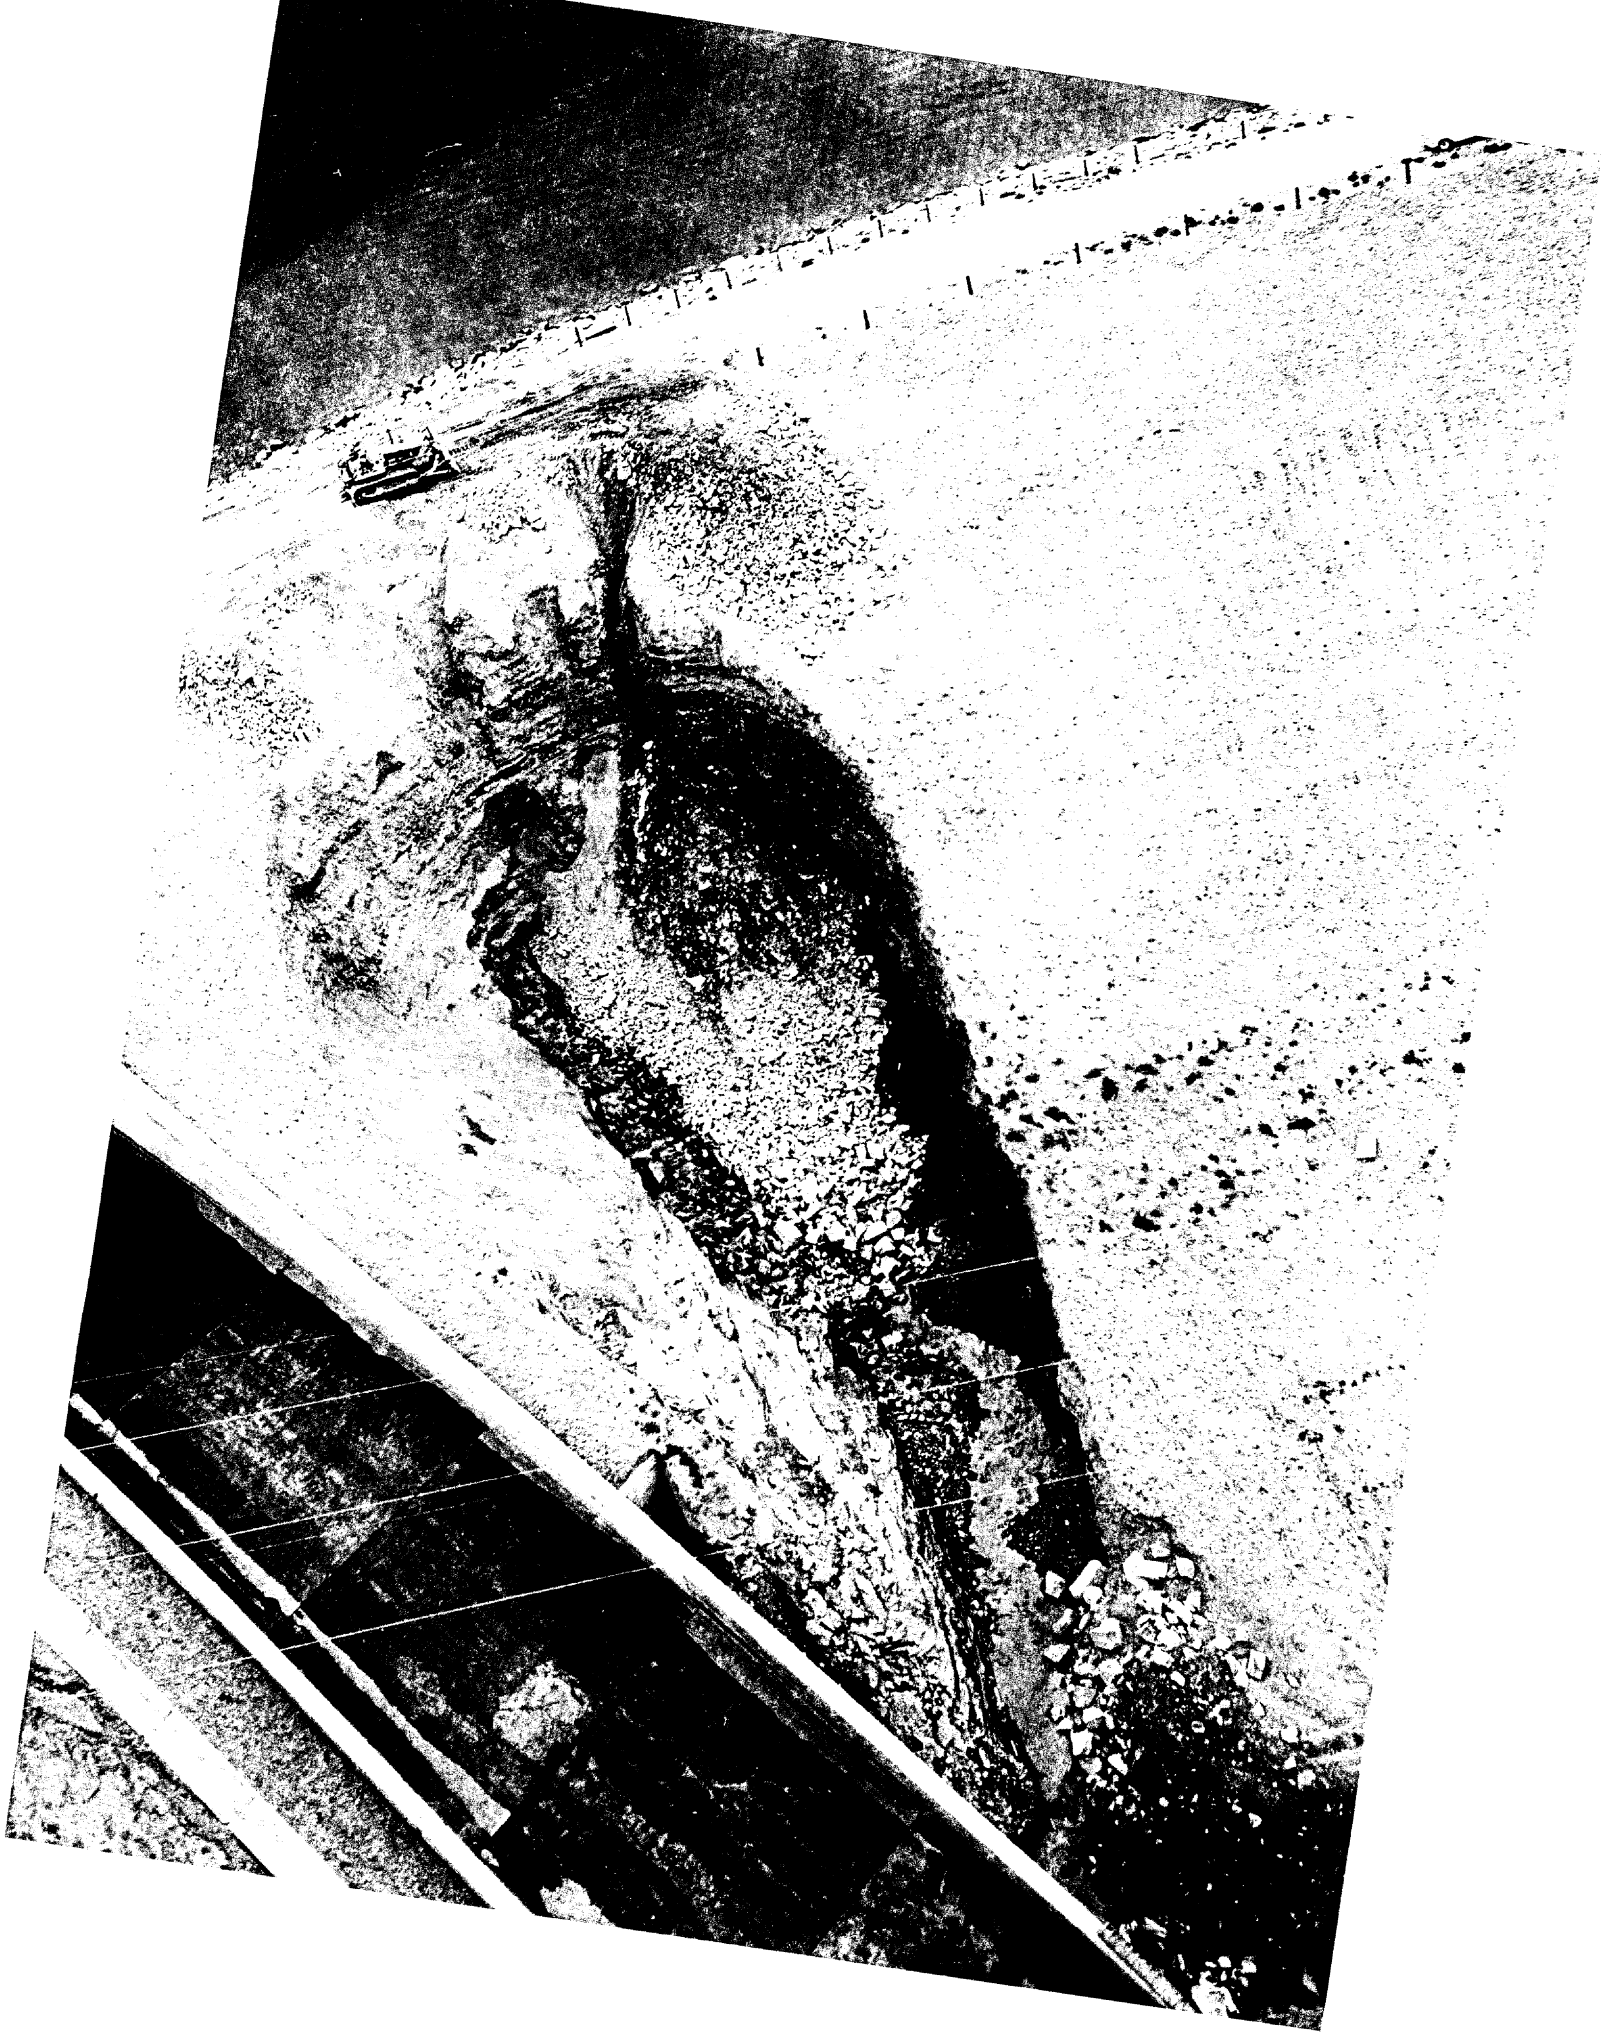
PHOTOGRAPH 7

At about 3 p.m. the flow of water from the leak began a series of rather violent surges. During each surge of flow, the volume of discharge increased significantly and the emerging flow was much more heavily laden with suspended materials. (See Photograph 7.) Following each surge, the leak flow dropped off to a very small amount, giving the appearance that the flows were momentarily stopped. It was the consensus that the rockfill was damming the emerging leak flows, causing and accelerating the erosion and internal caving of the embankment.

At the peak of each surge in leak flow, muddy water gushed from opening in notably increased volume. Surges began before 3 p.m., Sunday, September 5.

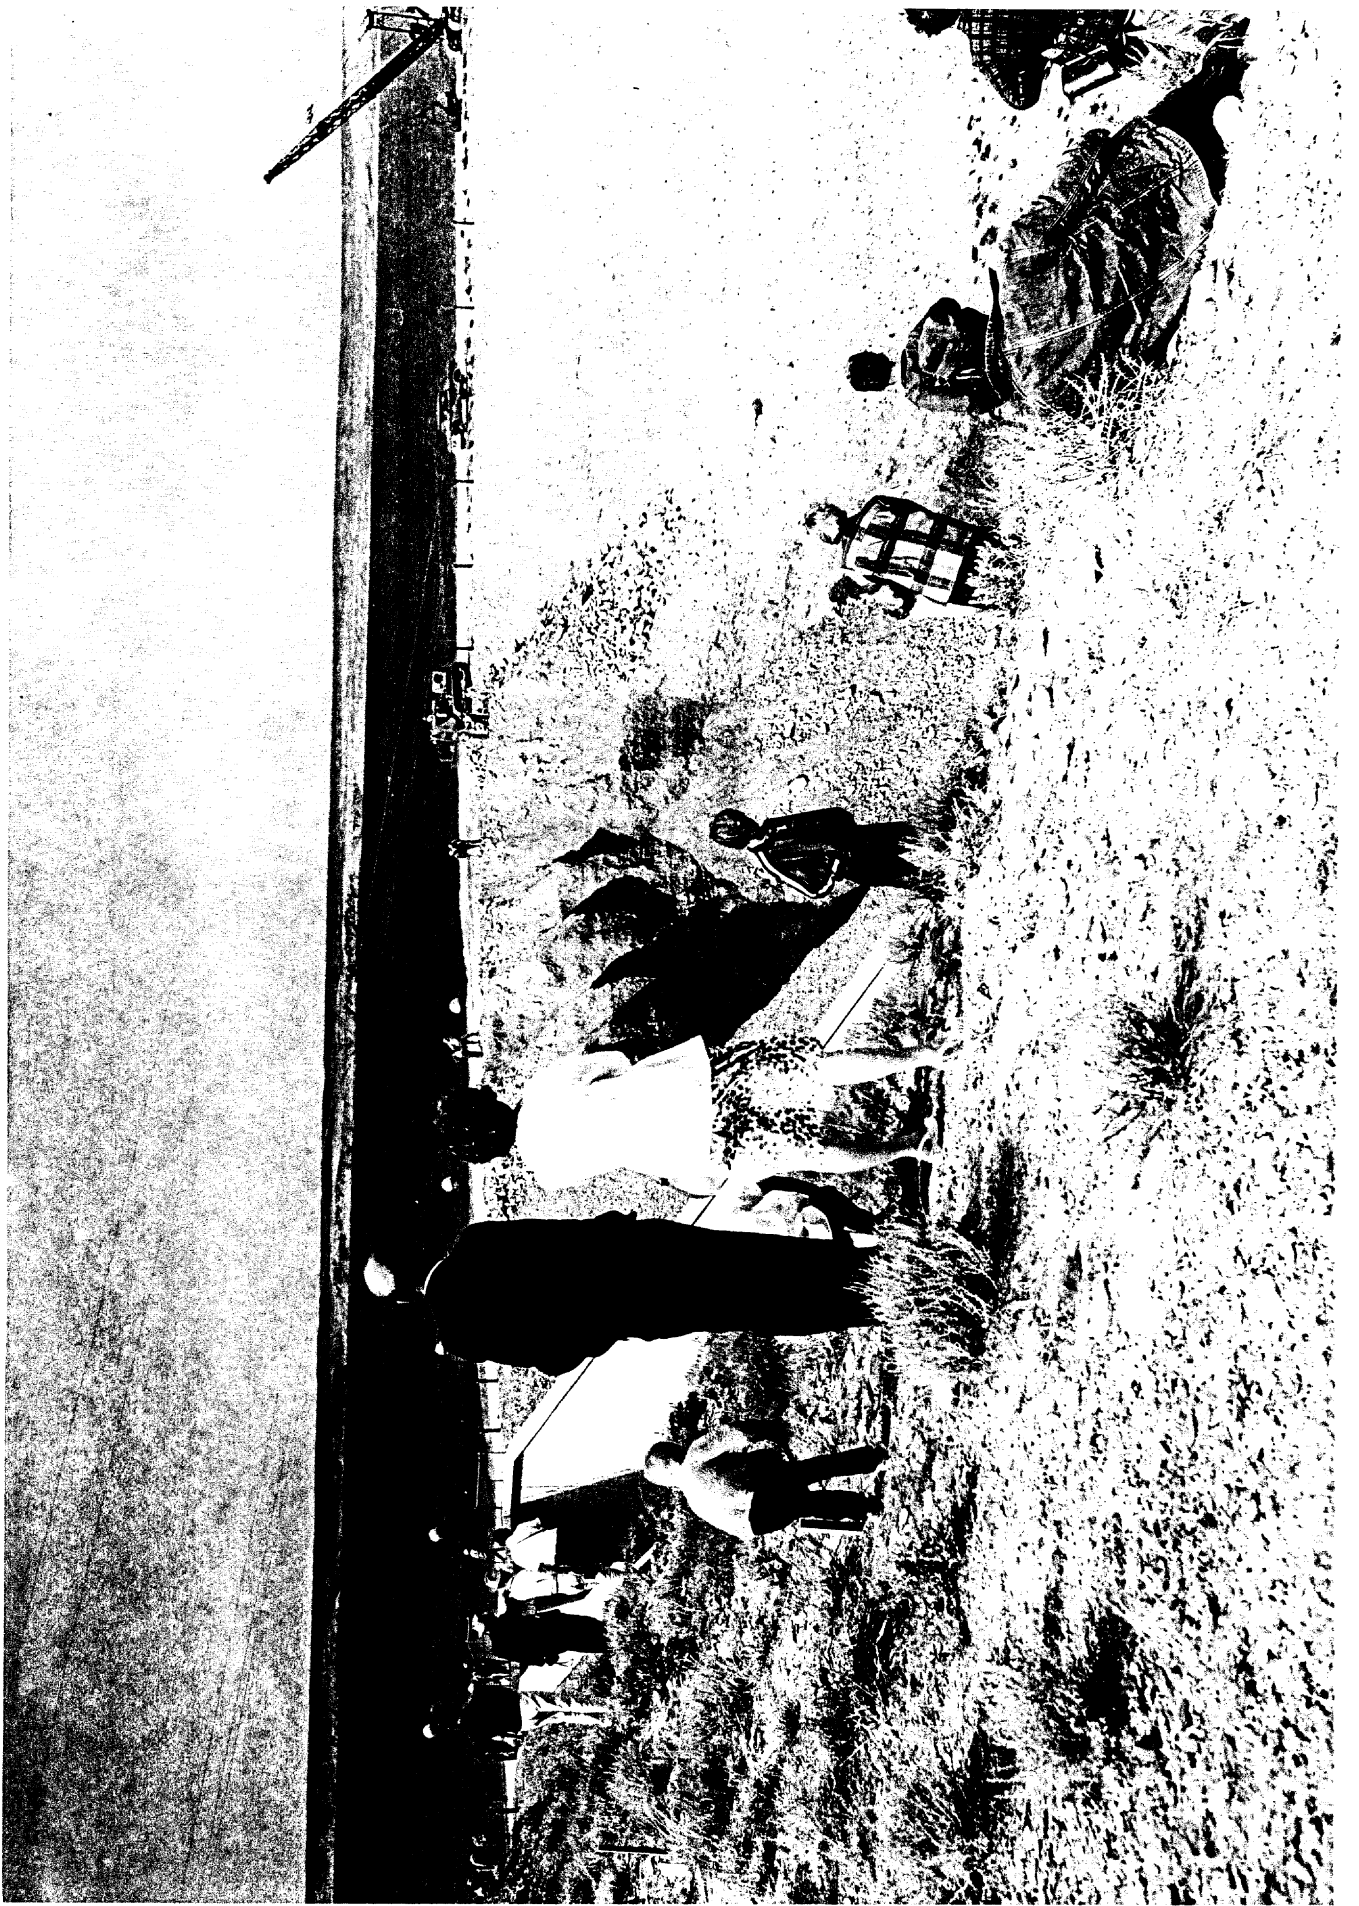
PHOTOGRAPH 9

As shown in the photographs taken prior to this time (see Photograph 9), the leak flows were entirely or partially discharging over the east spillway wall into the toe of the spillway chute. On the morning of September 6, equipment was moved into the area below the leak and the leak flows channelled parallel to the east wall of the spillway. A 4-foot weir was installed adjacent to the lower end of the spillway wall with the leak flows directed over the weir. The first measurement of the leak flow was made by the United States Geological Survey early on the afternoon of September 6. They measured the flow as 5.7 c.f.s. (See Figure 5 for subsequent leak flow measurements as the reservoir was drawn down.)

Most of the leak flow plunged over the spillway wall into the stilling basin. It was necessary to excavate a channel parallel to the wall and install a weir before the leak flow could be measured. Photograph taken Sunday, September 5; first weir measurement made early afternoon, Monday, September 6.

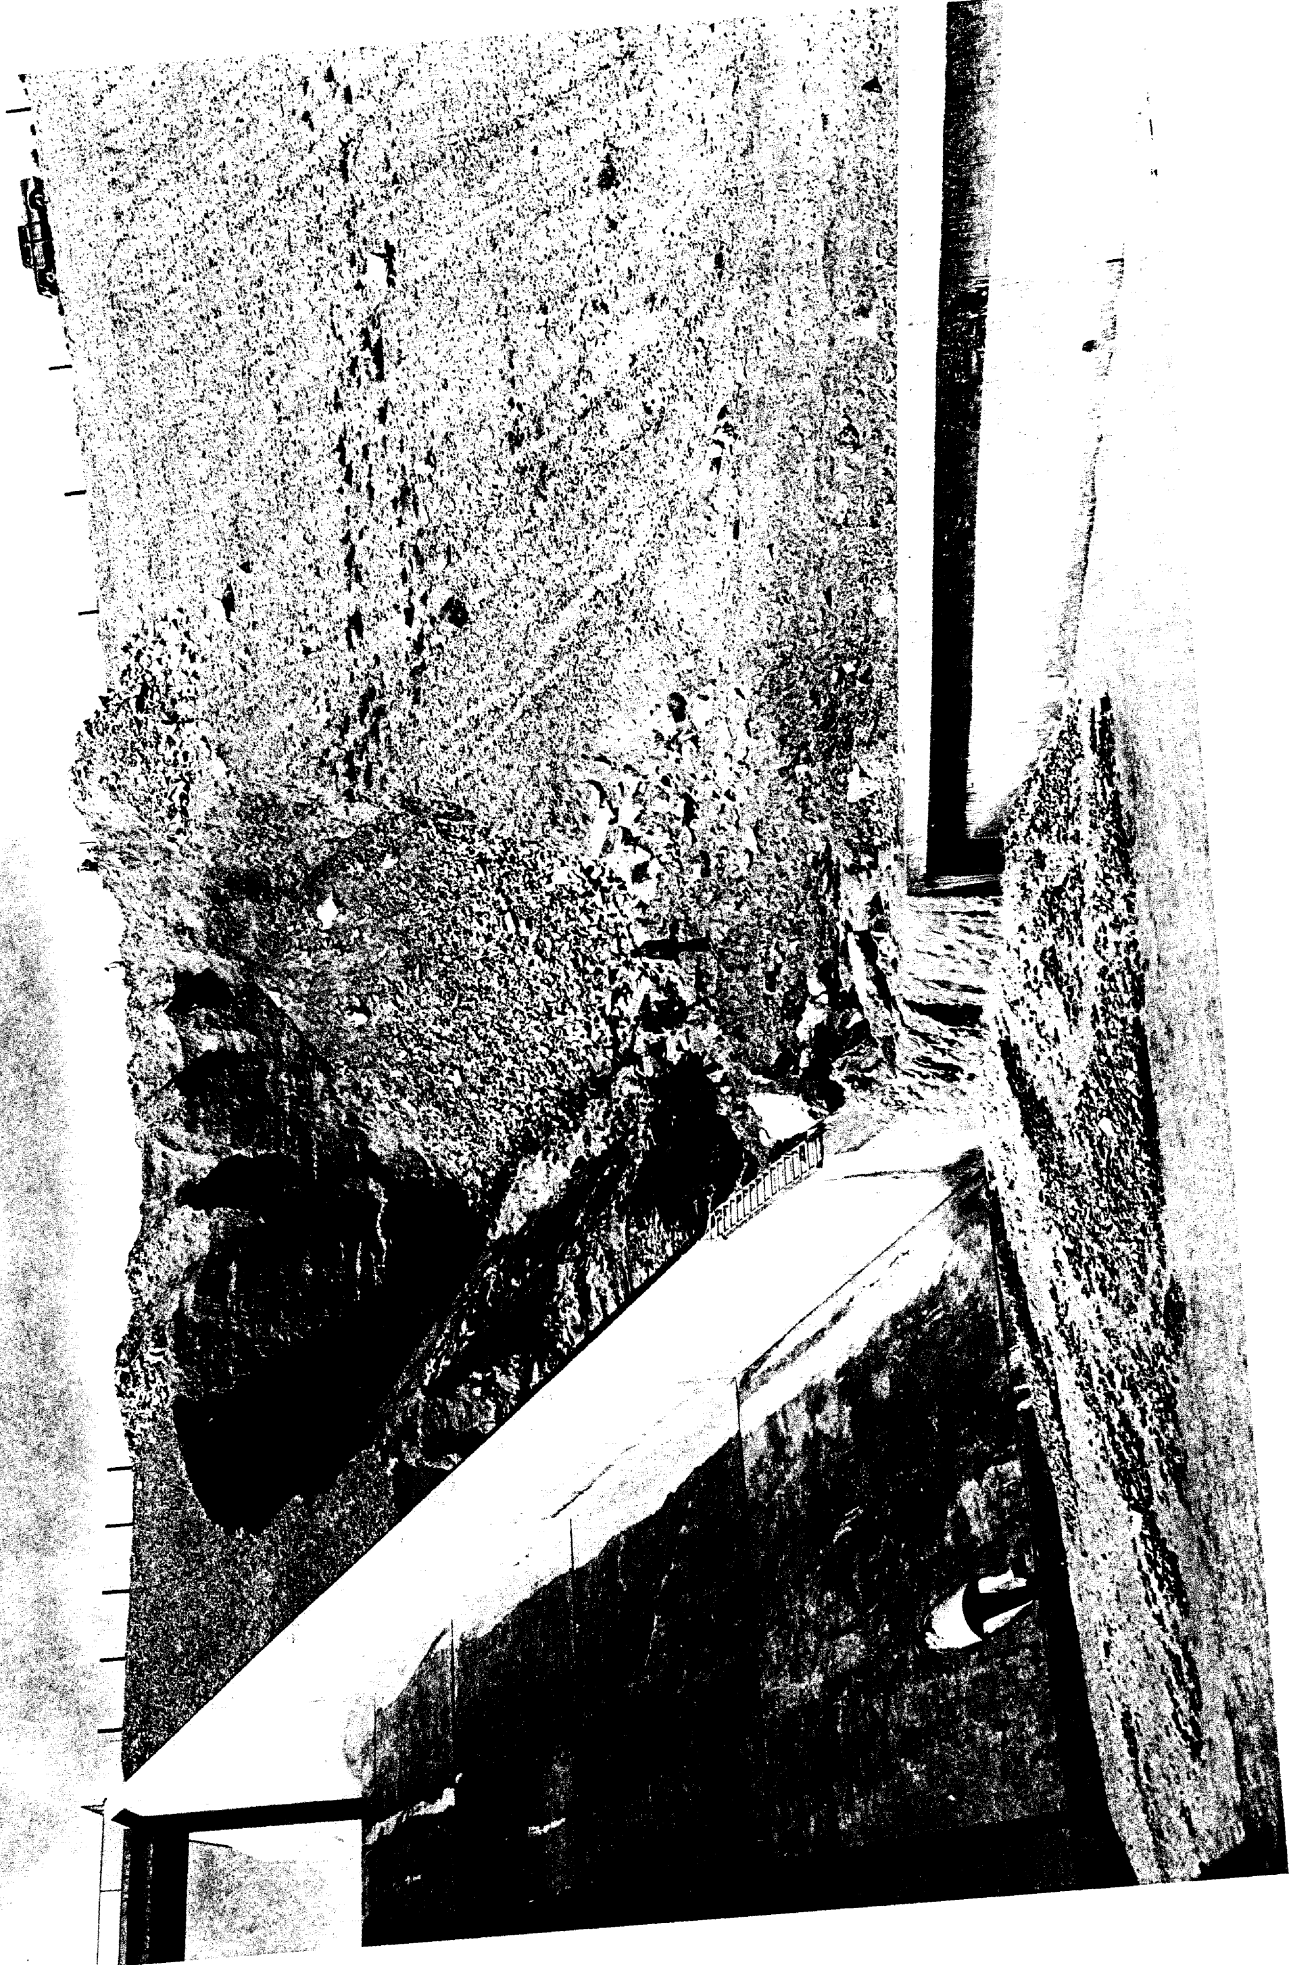
PHOTOGRAPH 10

At about 4:45 p.m. a sudden and alarming incident occurred. A 15' x 20' area on the upstream half of the crest road on the dam adjacent to the spillway bridge suddenly and completely collapsed. (See Photograph 10.) This collapsed area was referred to as the "sink hole." Immediate inspection of the sink hole was made by Project Construction Engineer Hatch and his men. (See Photograph 11.) By measurement it was determined to be 30 feet deep and was observed to bell out or widen to the east and to the south. The widening to the south was in

The "sink hole" formed by sudden collapse of the upstream half of crest road at 4:45 p.m., Monday, September 6, was critically near the upstream face of leak area cavity.

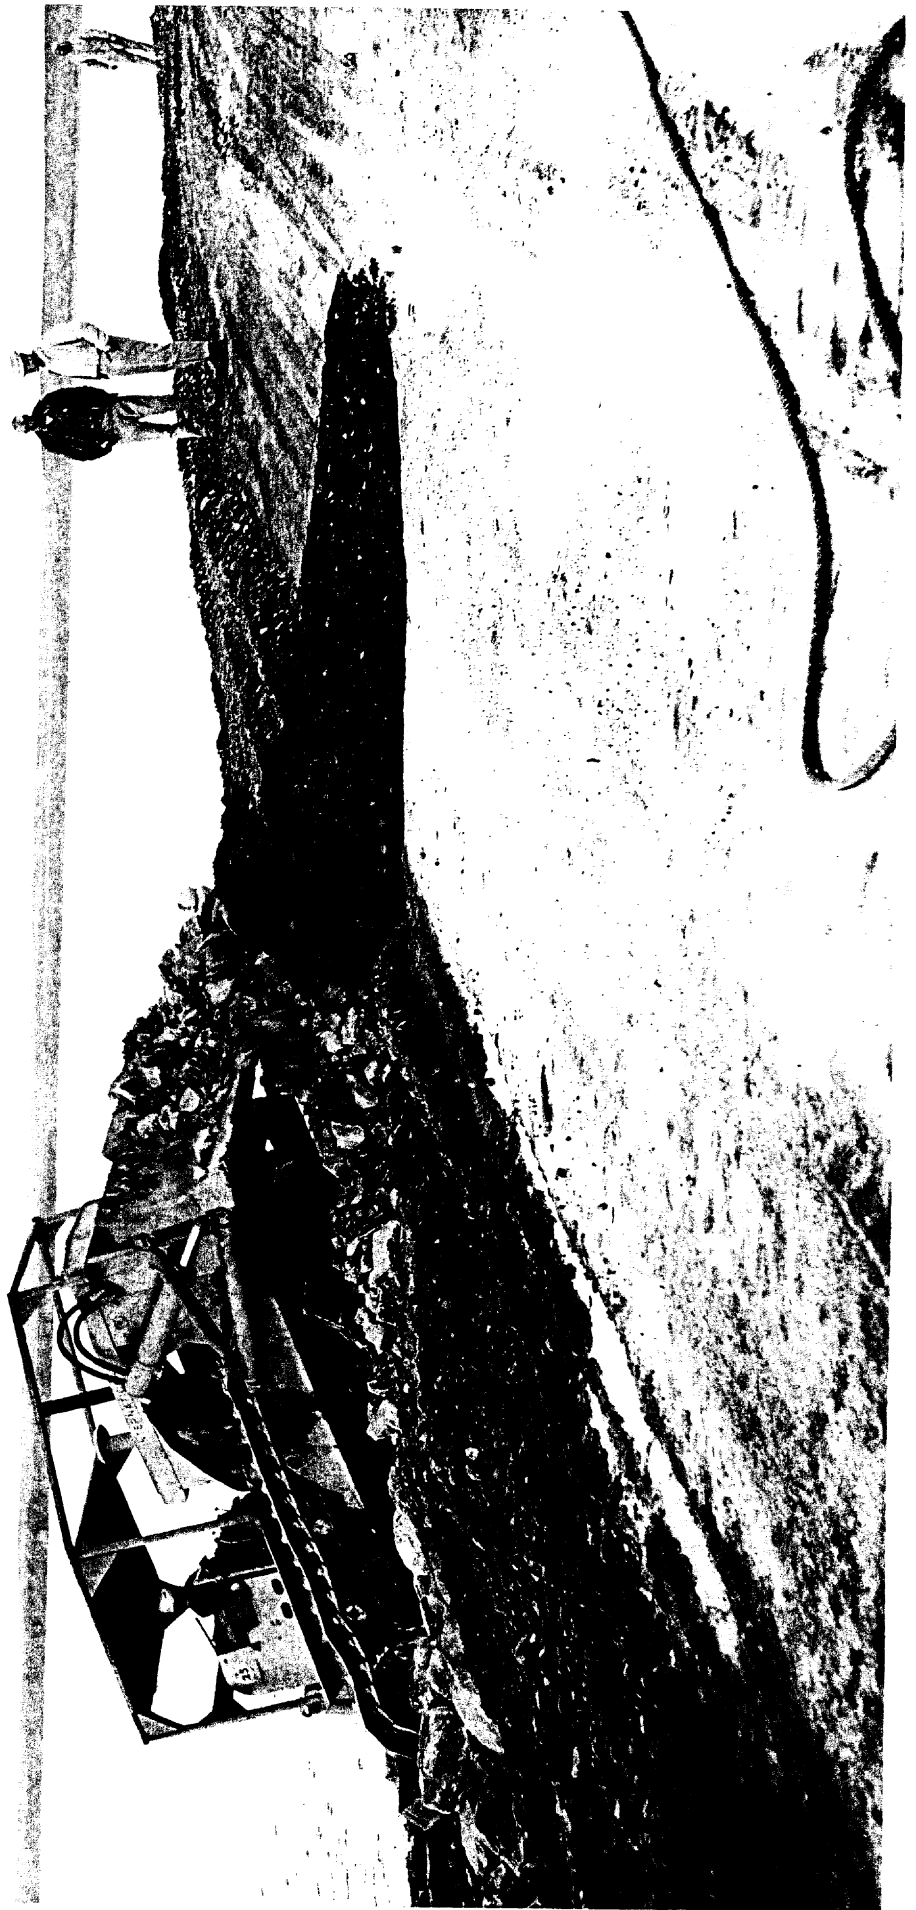
PHOTOGRAPH 11

Project Construction Engineer John Hatch and his men immediately measured the depth of sink hole at about 30 feet; observed water flowing from exposed bedrock on the west side of sink hole (nearest camera); and noted that the bottom of the hole belled out to the east and south (toward leak cavity).  
Monday afternoon, September 6.

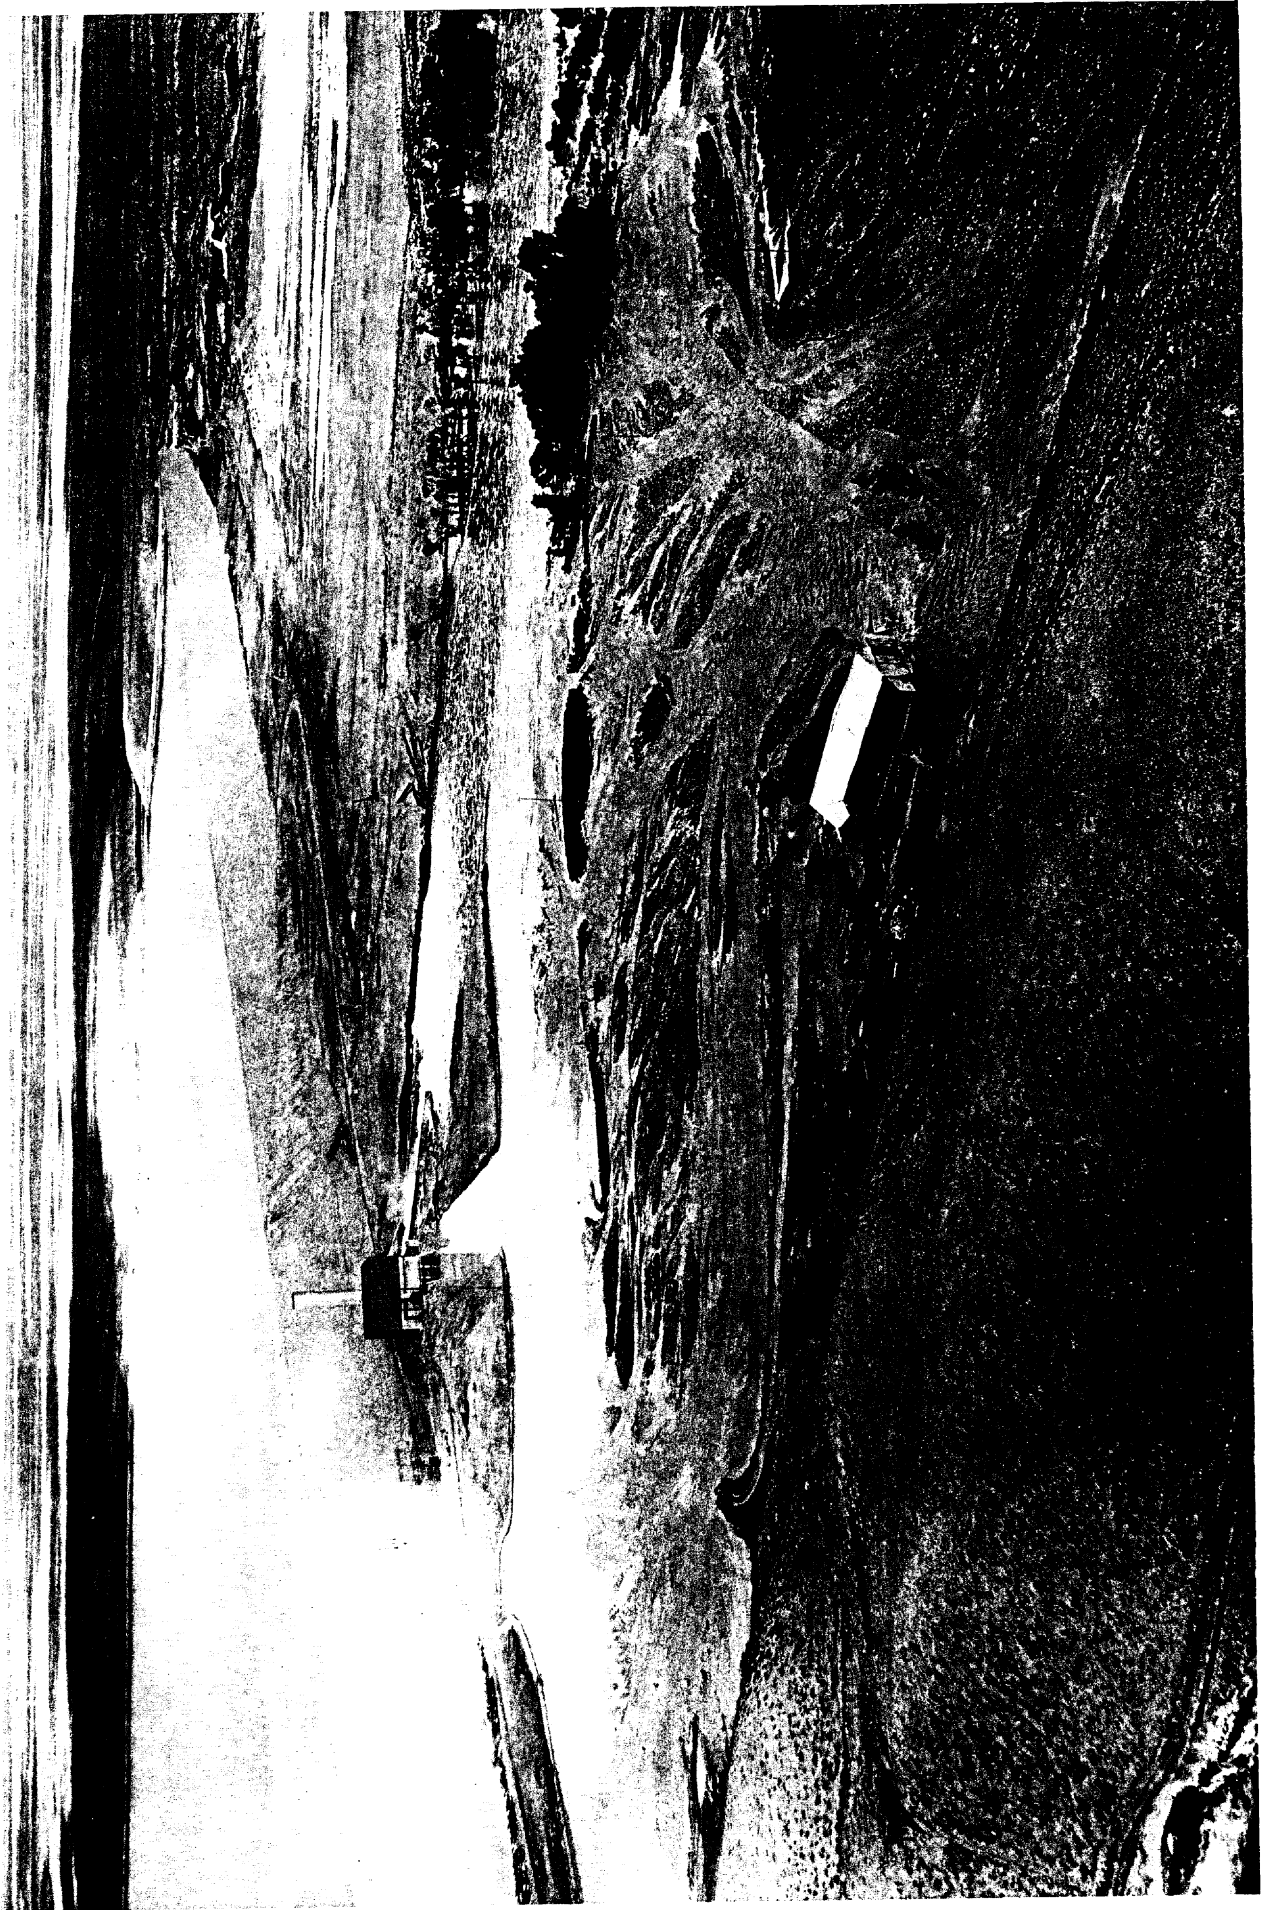
PHOTOGRAPH 16

Erosion by leak flow, measured at about 4 c.f.s. on Thursday, September 9, has been stabilized. Reservoir level had been lowered to about elevation 6,490 feet, with effective thickness of undisturbed embankment at 100 feet in minimum critical dimension.
