REPORT ON

LEAK AT FONTENELLE DAM  
SEEDSKADEE PROJECT, WYOMING

September 1965

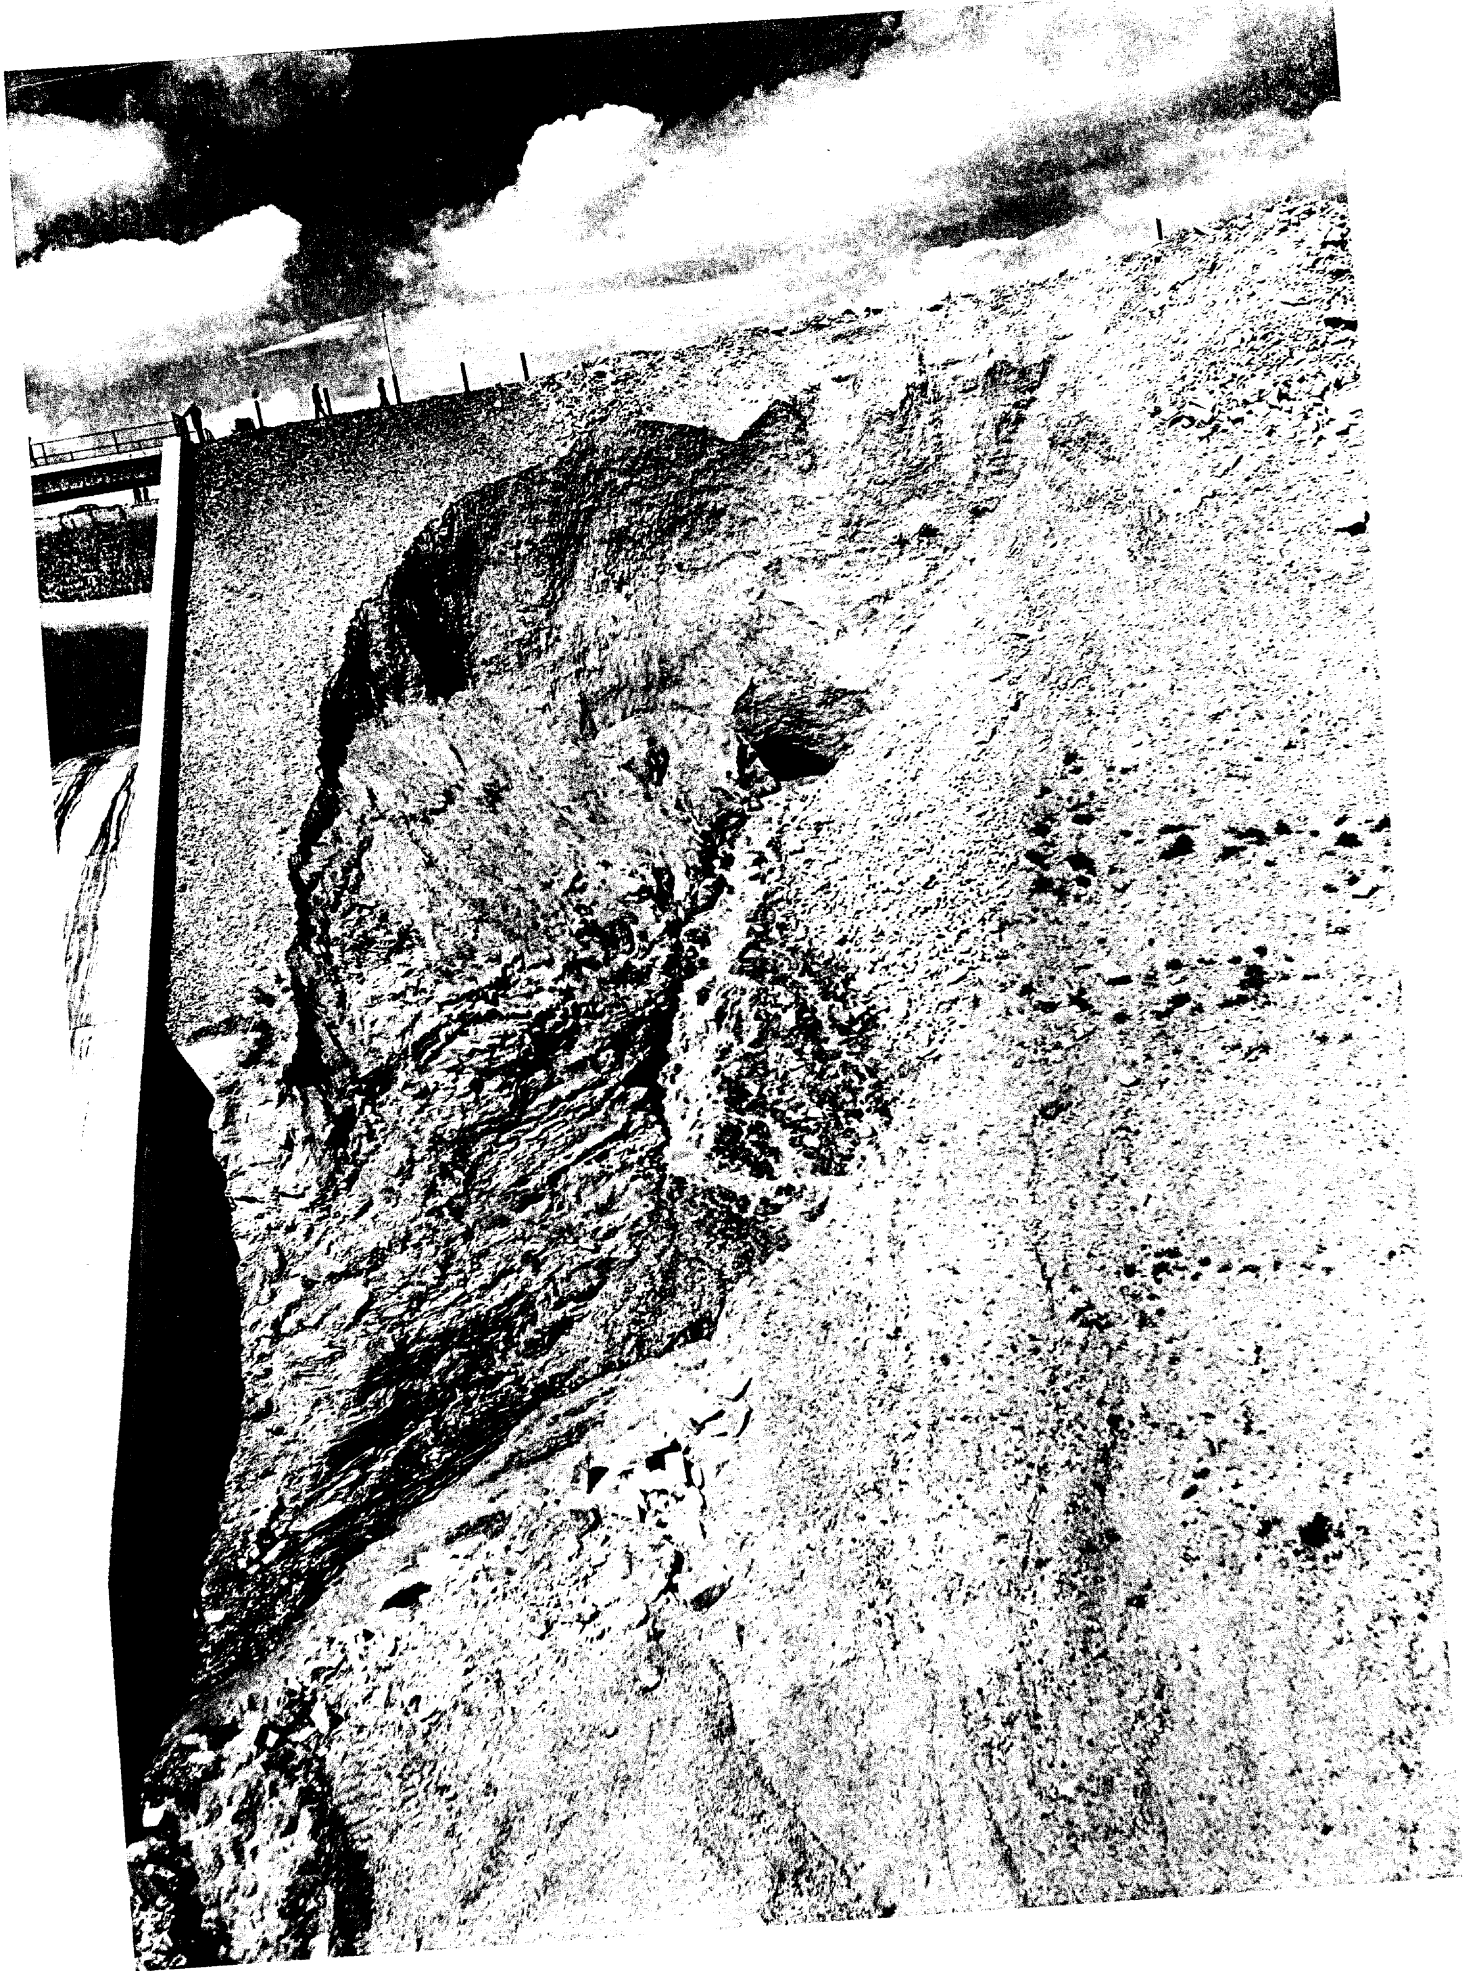
PHOTOGRAPH 17

Fontenelle Dam on Thursday, September 9, with reservoir level at about elevation 6,490 feet--drawn down about 17.5 feet from 6,507.40 level at start of evacuation, but still 32 feet above level of emerging leak flow. Rate of drawdown, about 4 feet per day at this time. Each 1 foot of drawdown added 3 feet to width of embankment between waterline and leak cavity.

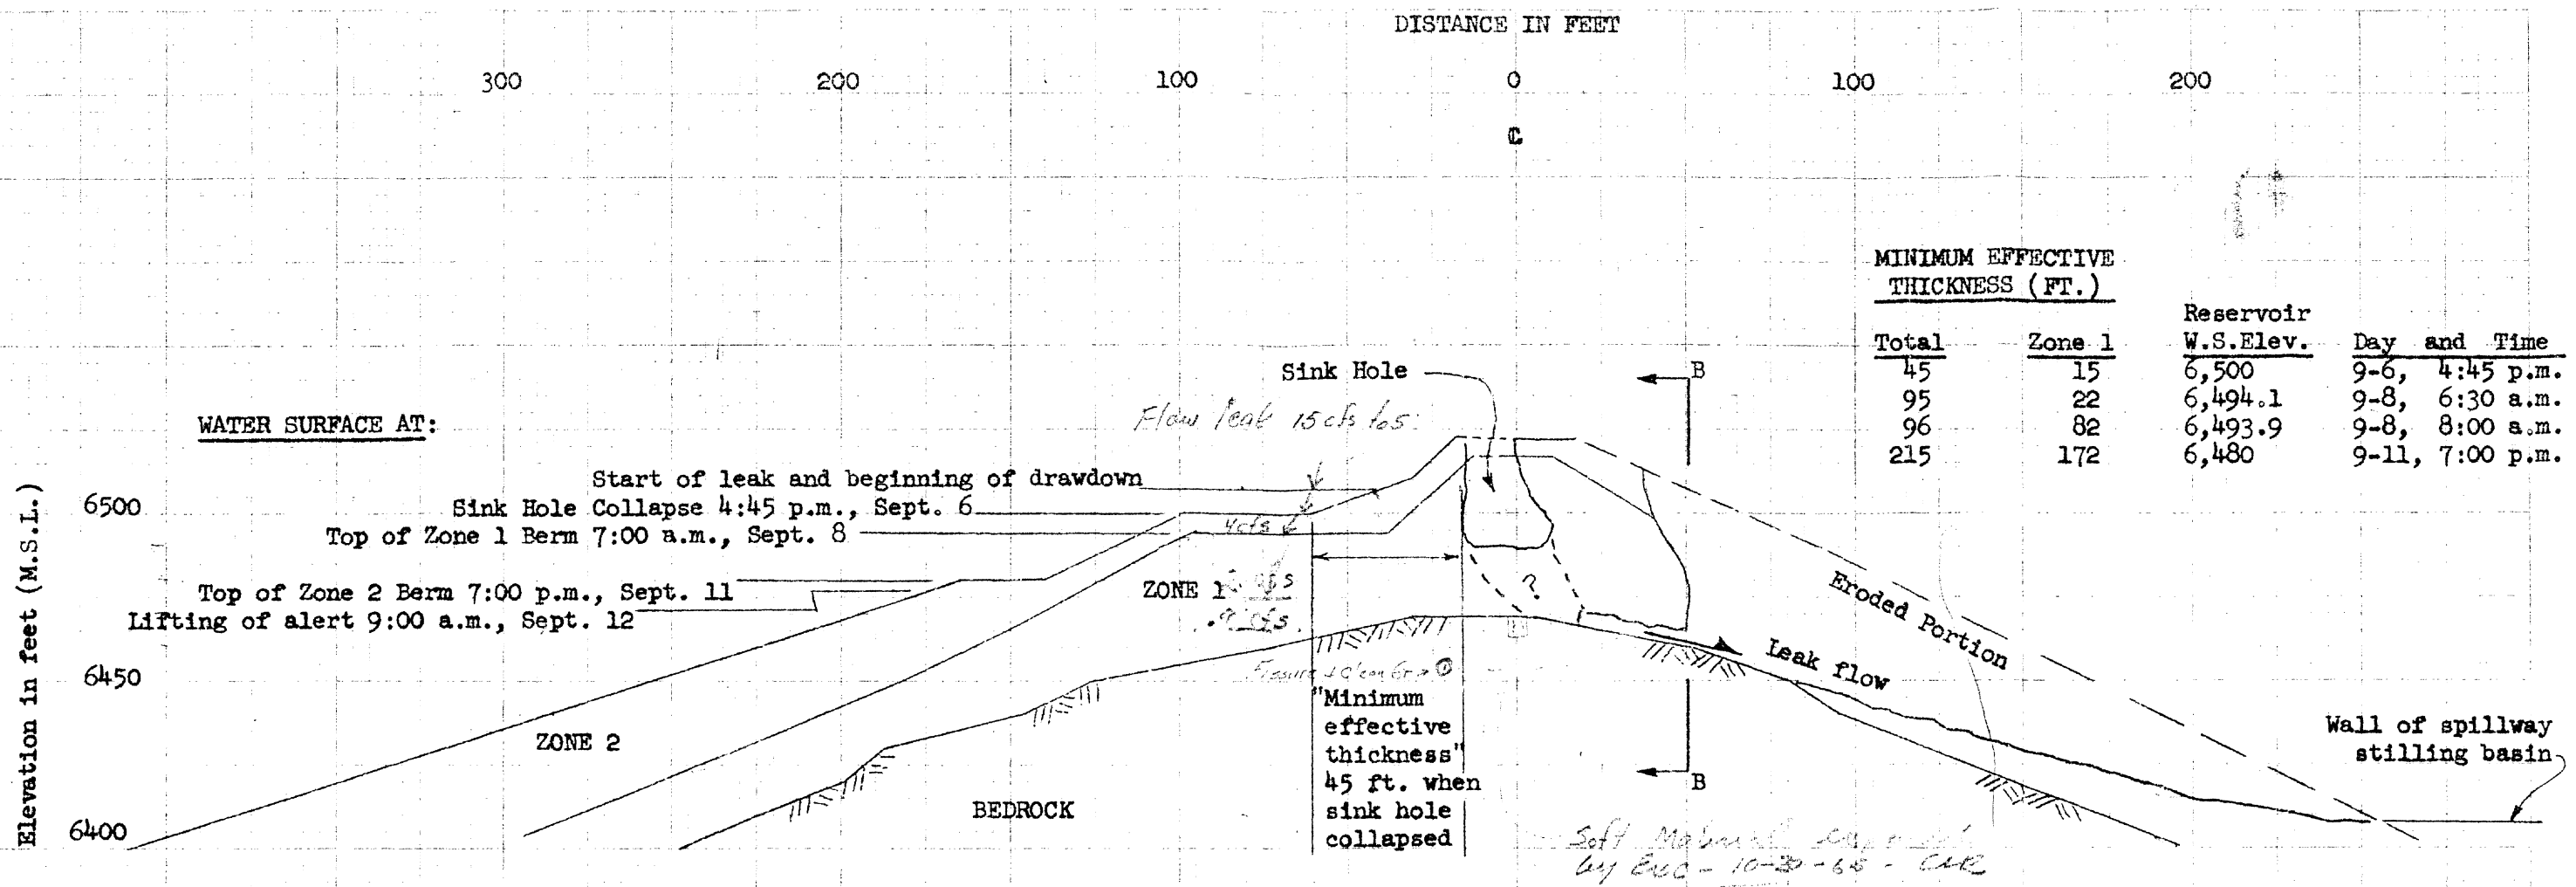
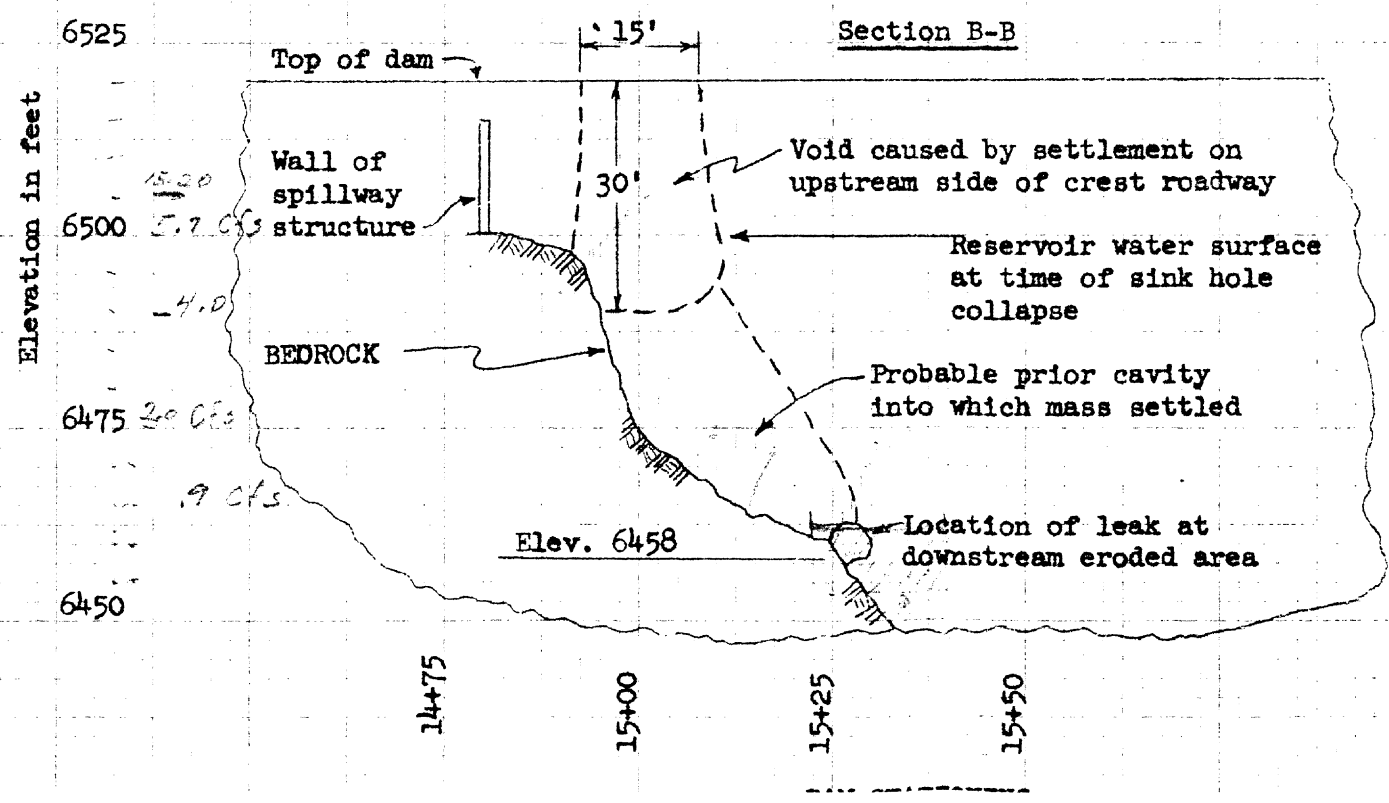
**FIGURE 4**

**FONTENELLE DAM**  
 Cross Section "A"  
 showing effective thickness  
 of embankment during  
 emergency drawdown
