INVESTIGATION OF FAILURES OF EDENVILLE AND SANFORD DAMS

SEPTEMBER 13, 2021

Executive Summary

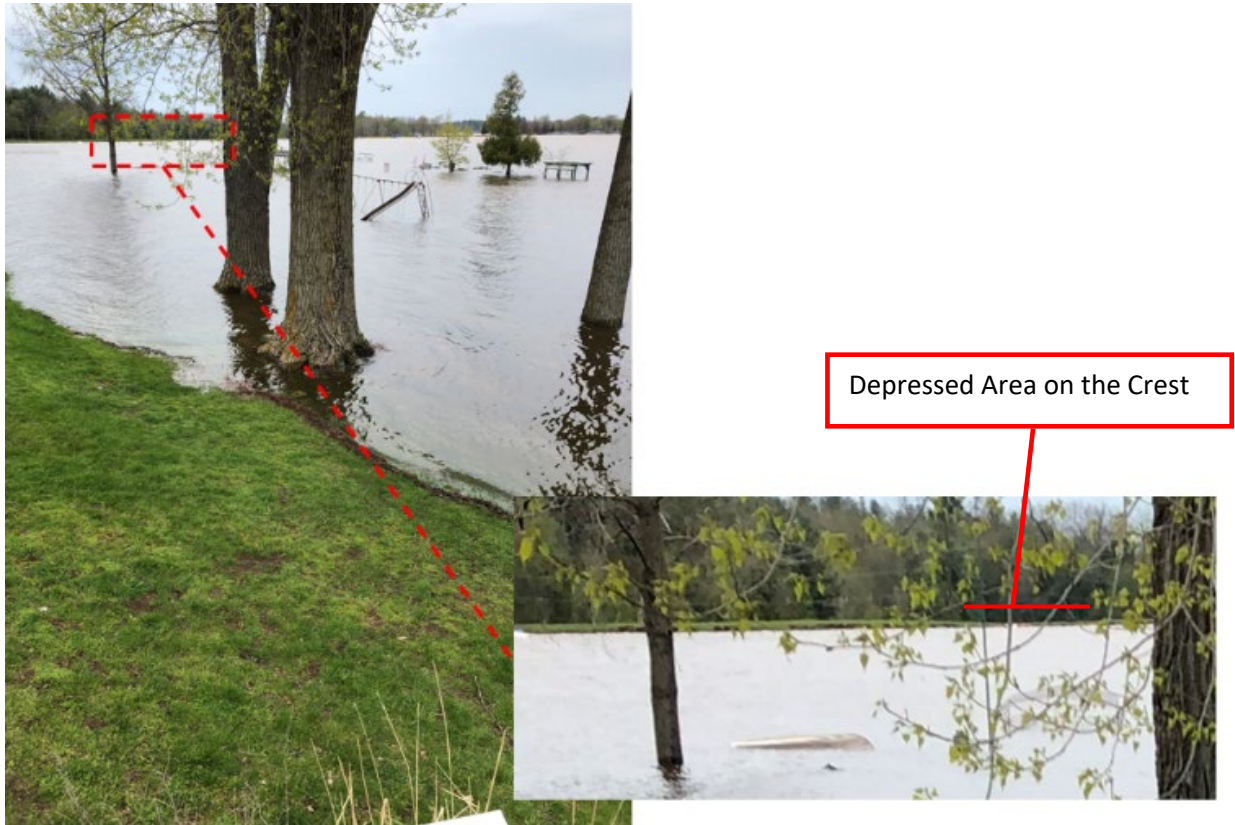
Other than the upstream erosion, the IFT was not able to find any reports of distress in the Edenville left embankment on Tuesday, May 19, prior to about 5:00 p.m. Eyewitnesses report observing a depression or subsidence in a section of the Edenville left embankment crest at about 5:00 p.m., about a half hour before the failure, and this observation is supported by photographic evidence as shown in Figures 4 and 5. Another photograph taken at 2:52 p.m. that afternoon does not show a depression in the crest (Figure 6). The photographs in Figure 4 through Figure 6 were taken by local residents who were observing the lake and the dam from the upstream left (east) bank of the lake.

Figure 4: Photograph showing depression in the crest of the Edenville left embankment at 5:03 p.m., Tuesday, May 19, 2020

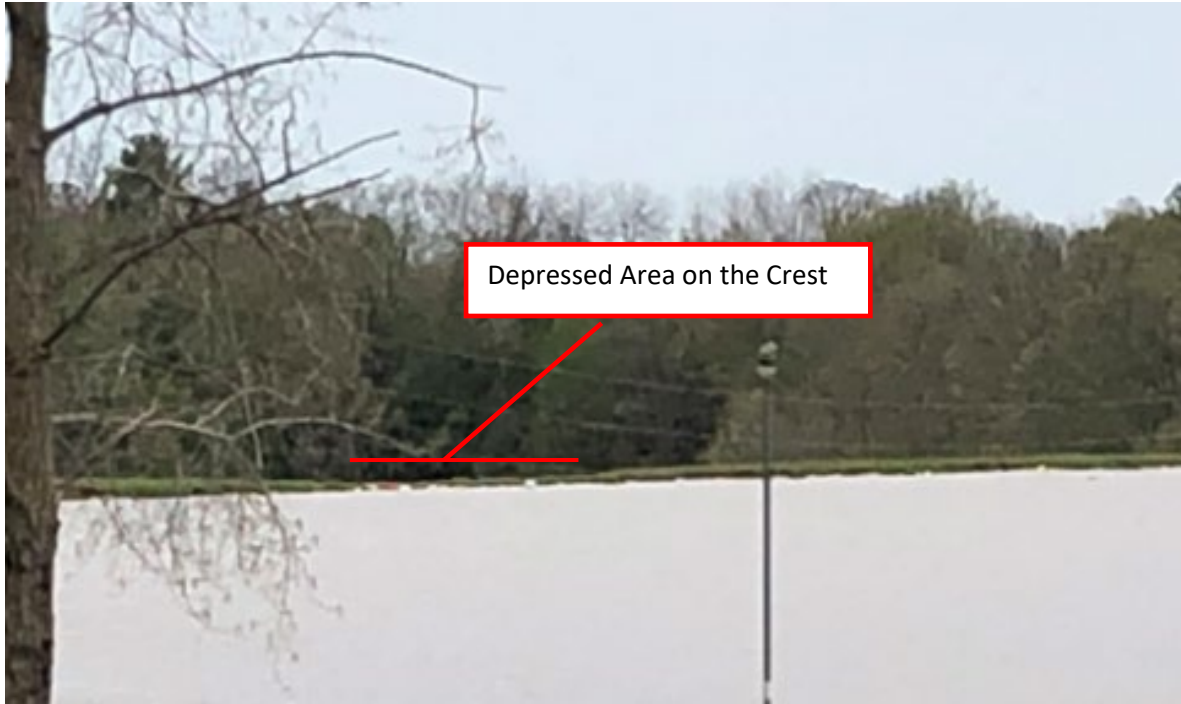
Figure 5: Photograph showing depression in the crest of the Edenville left embankment at 5:20 p.m., Tuesday, May 19, 2020

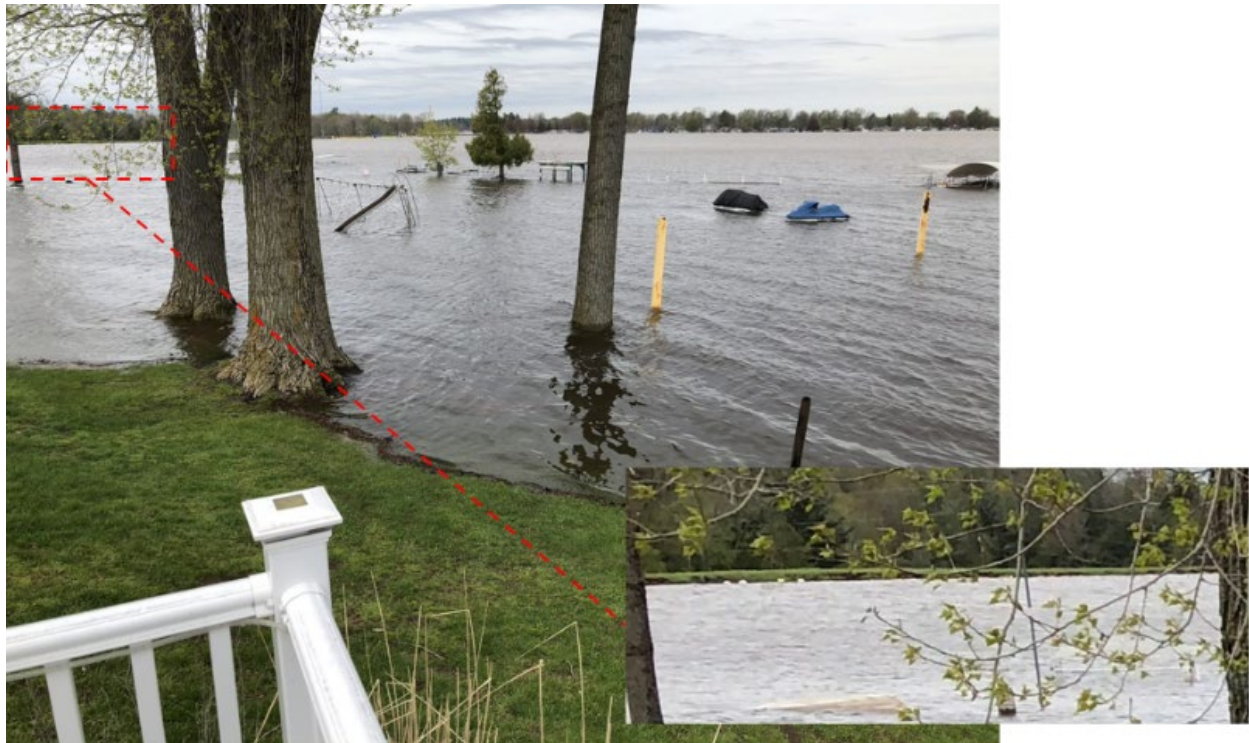
Figure 6: Photograph showing the crest of the Edenville left embankment at 2:52 p.m., Tuesday, May 19, 2020

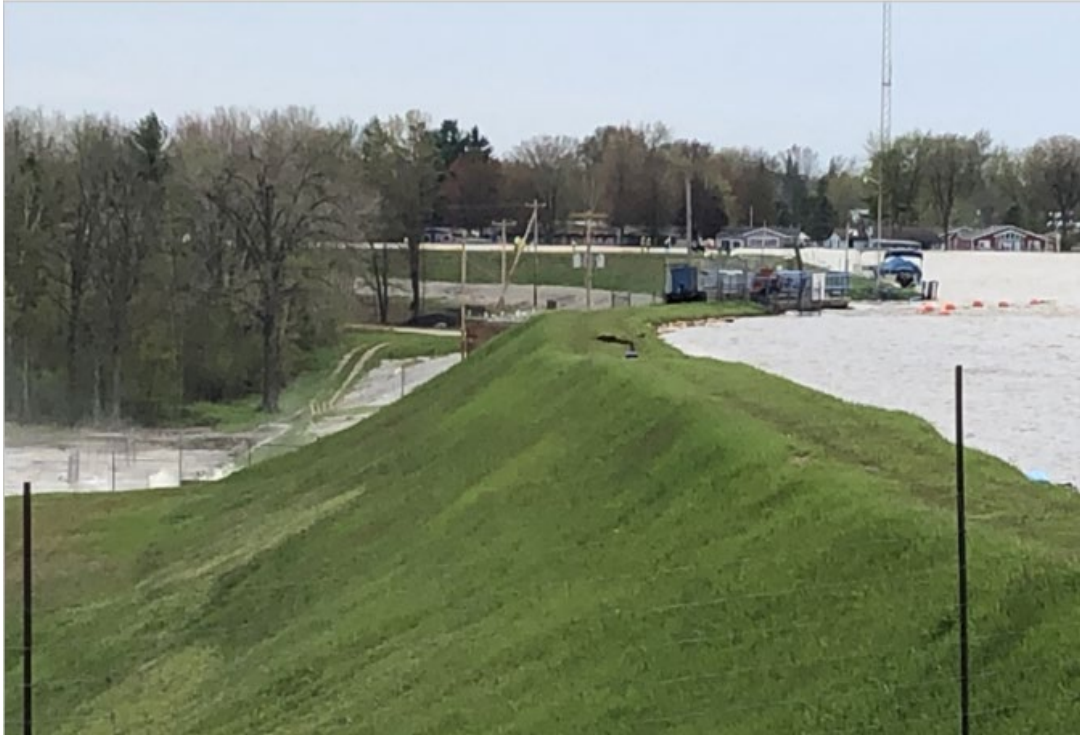
After observing the depression in the crest, several residents walked to the Consumers Energy substation located downstream of the Edenville left embankment. The photograph of the downstream side of the embankment in Figure 7 was taken at 5:31 p.m. that day. The photograph shows the depression in the crest, but otherwise does not show any significant signs of distress in the embankment. Figure 7 shows a lighter colored area near the toe of the embankment at the ultimate failure location. The IFT considered the possibility that this light color might indicate seepage, but after reviewing other photographs and talking with eyewitnesses, the IFT concluded that it does not appear to be seepage. Historical photographs showed significant variability of color on the face of the embankment. However, because Figure 7 is a distant view of the embankment, the possibility that the color difference represents seepage cannot be totally ruled out.

Figure 7: Photograph showing the downstream side of the Edenville left embankment at 5:31 p.m., Tuesday, May 19, 2020

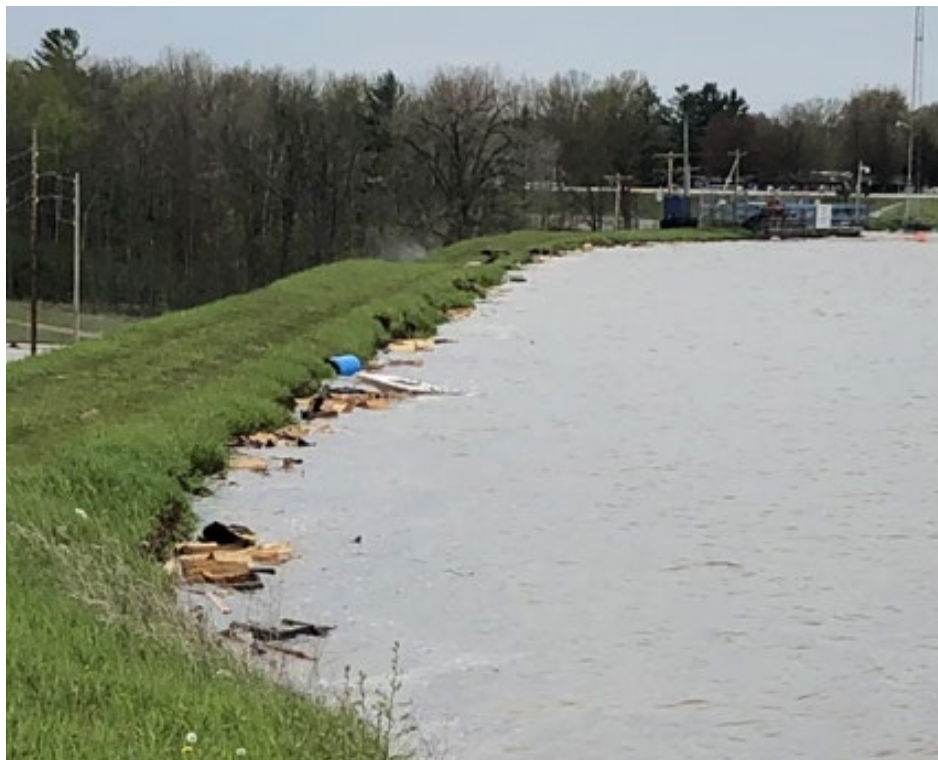
Figure 8 shows a view of the depression in the crest from upstream at 5:33 p.m. The photograph in Figure 8 also shows the erosion that had occurred on the upstream slope of the embankment.

Figure 8: Enlarged photograph showing the upstream side of the Edenville left embankment at 5:31 p.m., Tuesday, May 19, 2020

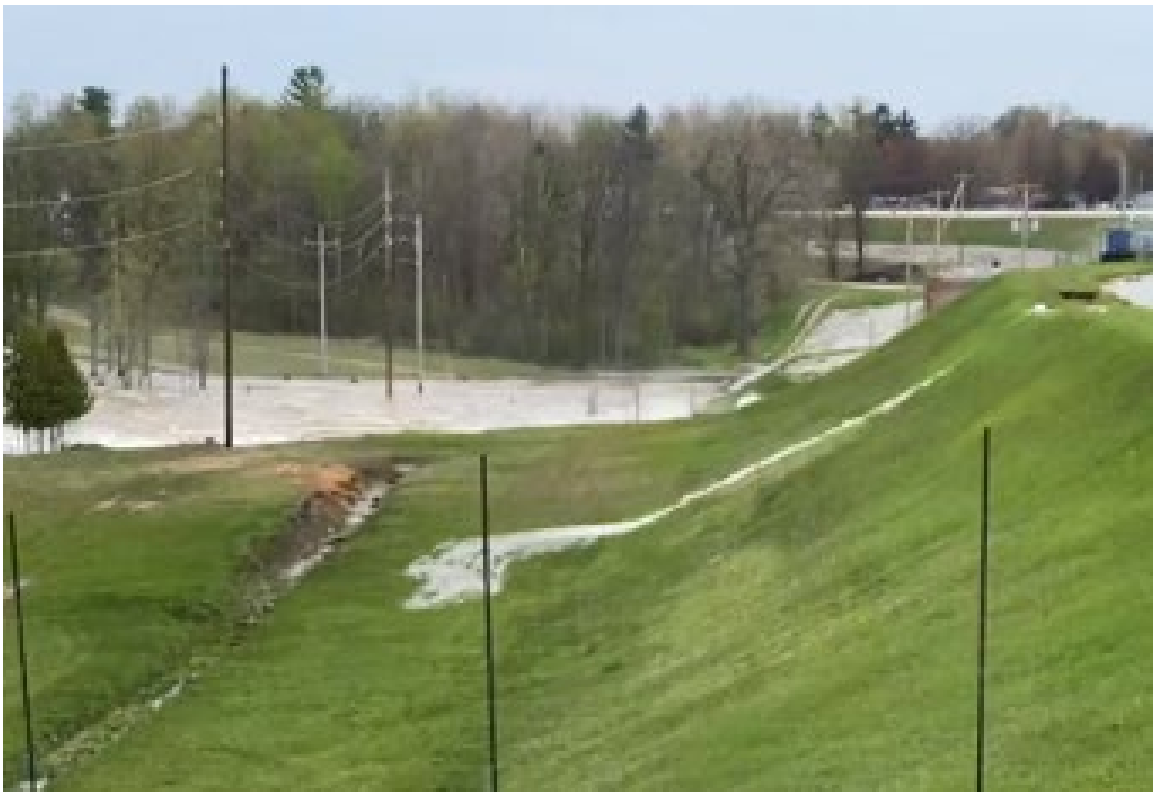
Figure 9 is at the beginning of the video (0 seconds, 5:35 p.m.) and shows the depression in the crest and the stream of water on the downstream face, but no other obvious signs of distress. Figure 10, at 4 seconds, shows a slight bulge in the downstream toe and possibly an increase in the depression at the crest. Figure 11, at 6 seconds, shows a significant increase in the toe bulge and the depression in the crest. Figure 12 through Figure 15 show the progression of the embankment failure over the subsequent 8 seconds, from 7 seconds to 15 seconds in the video, concluding with a large mass of soil deposited downstream of the toe of the dam. Figure 16, at 28 seconds, shows increasing water flow through the failed embankment location. By 36 seconds, Figure 17, a breach through the embankment has formed. From the dam failure video, it can be concluded that the failure of the embankment occurred in no more than about 10 seconds and the breach developed between about 10 and 20 seconds later. It is also noted that the failure of the embankment was initially limited to a length estimated to be between 40 and 80 feet along the axis of the dam.

Figure 9: Enlarged still image from dam failure video at 0 seconds

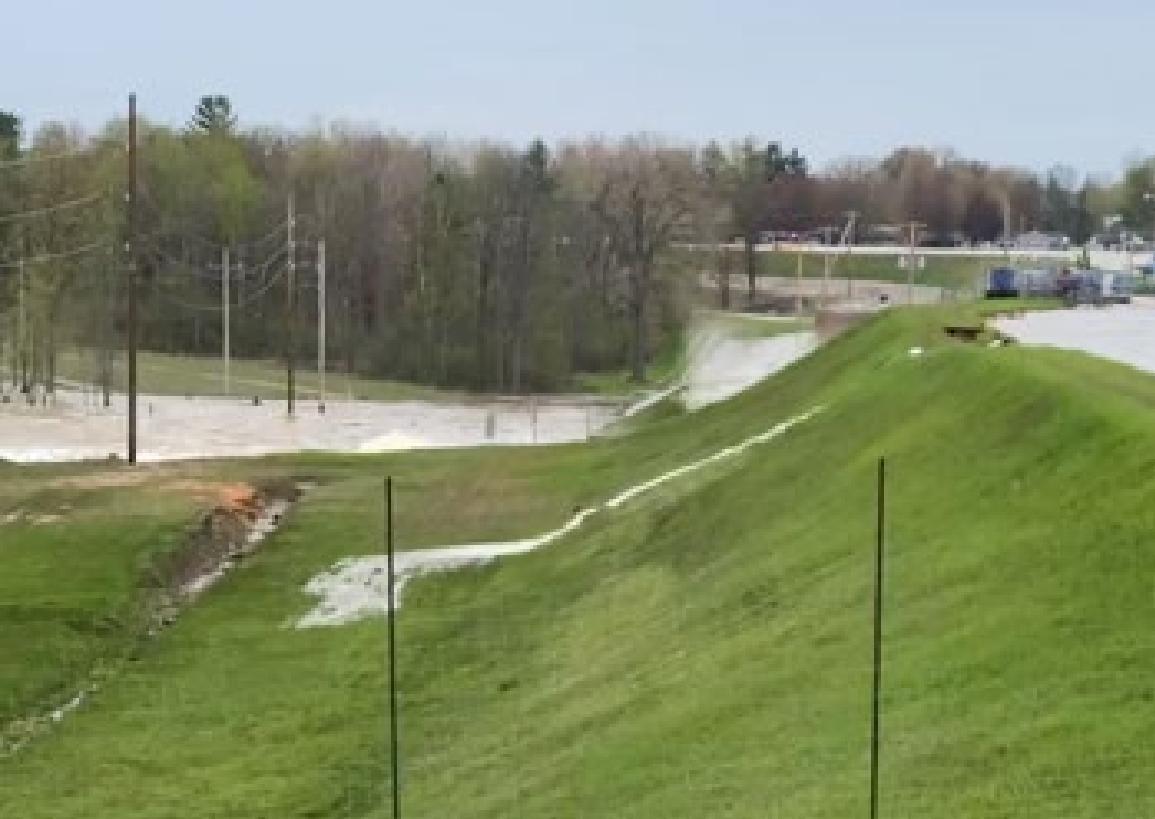
Figure 10: Enlarged still image from dam failure video at 4 seconds

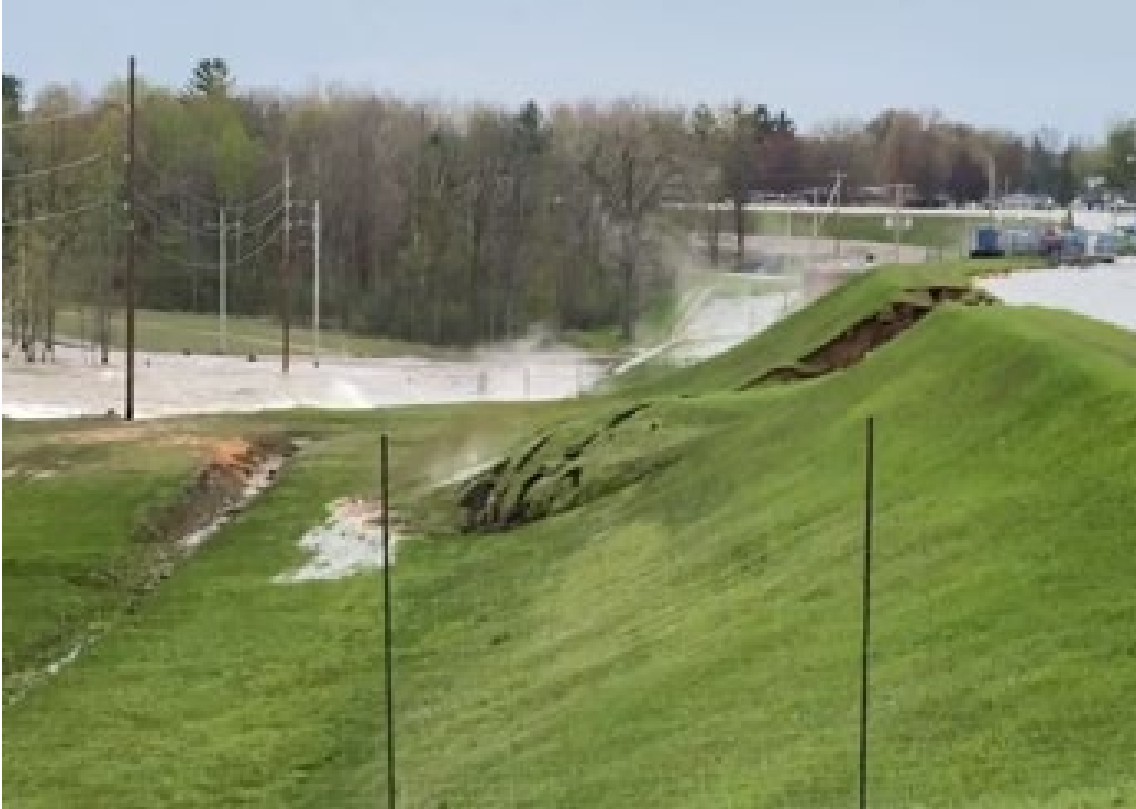
Figure 12: Enlarged still image from dam failure video at 7 seconds

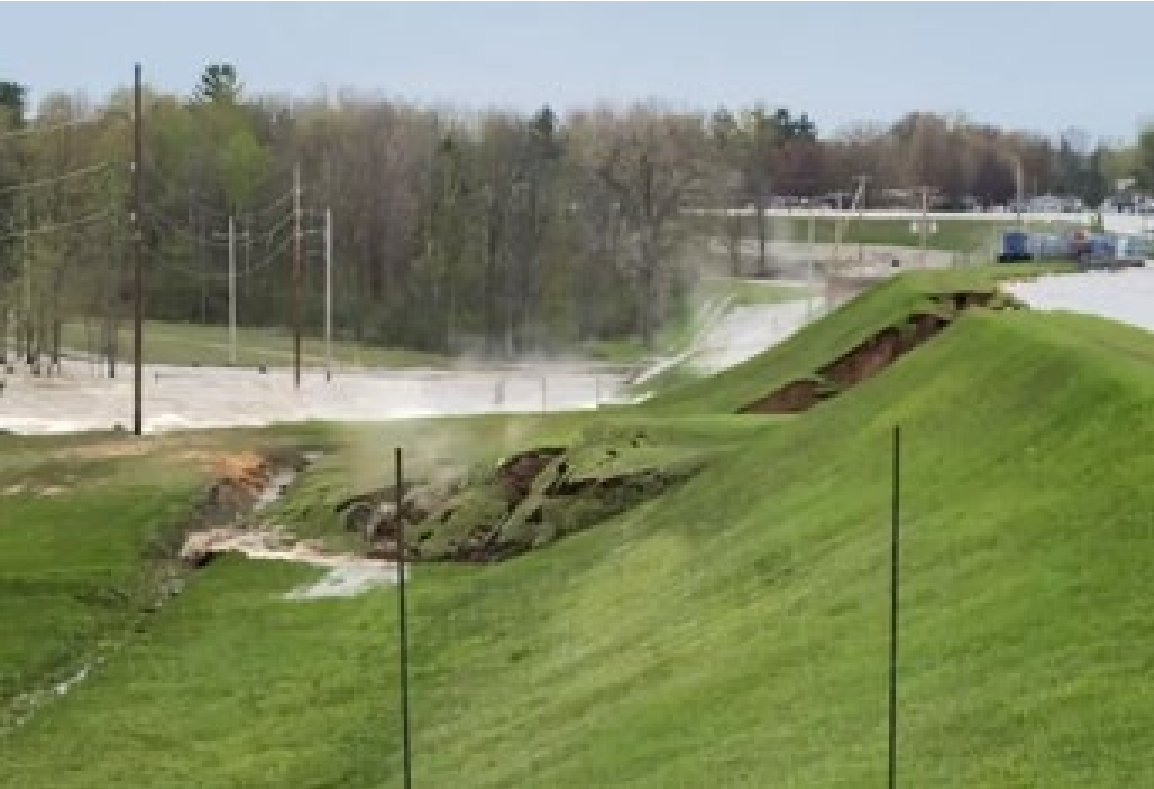
Figure 13: Enlarged still image from dam failure video at 8 seconds

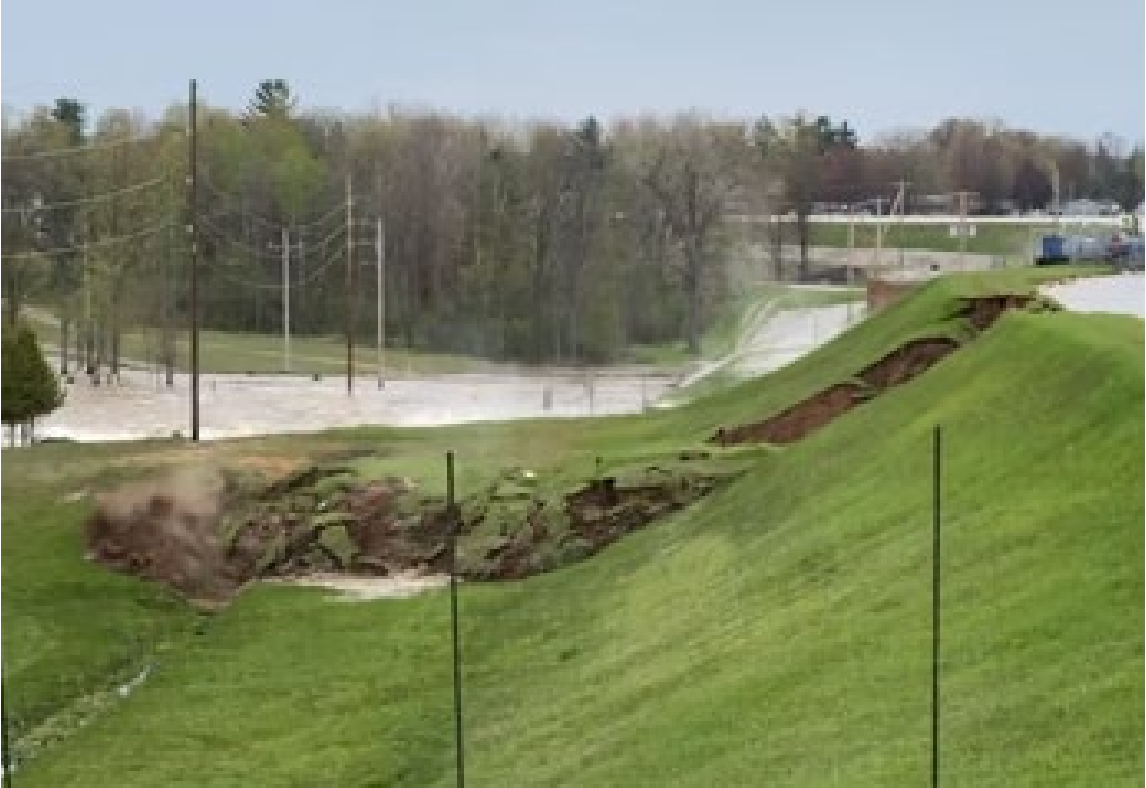
Figure 14: Enlarged still image from dam failure video at 10 seconds

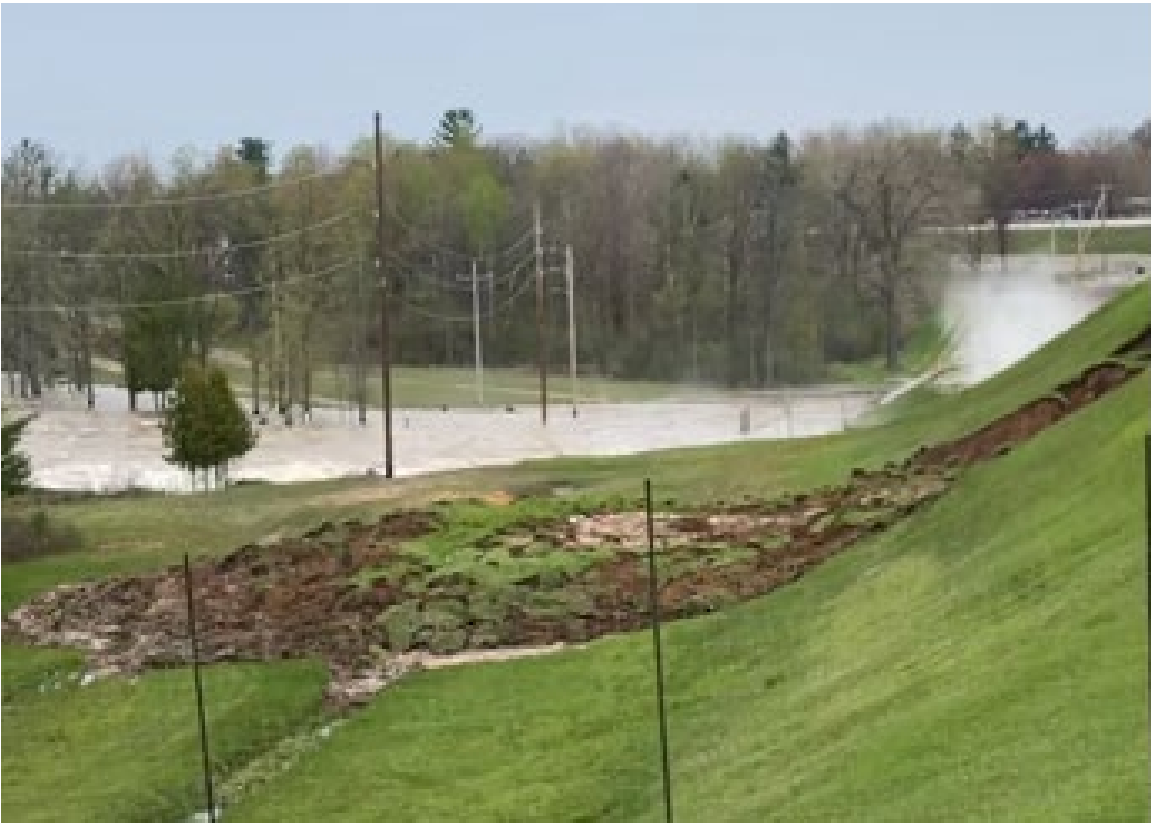
Figure 15: Enlarged still image from dam failure video at 15 seconds

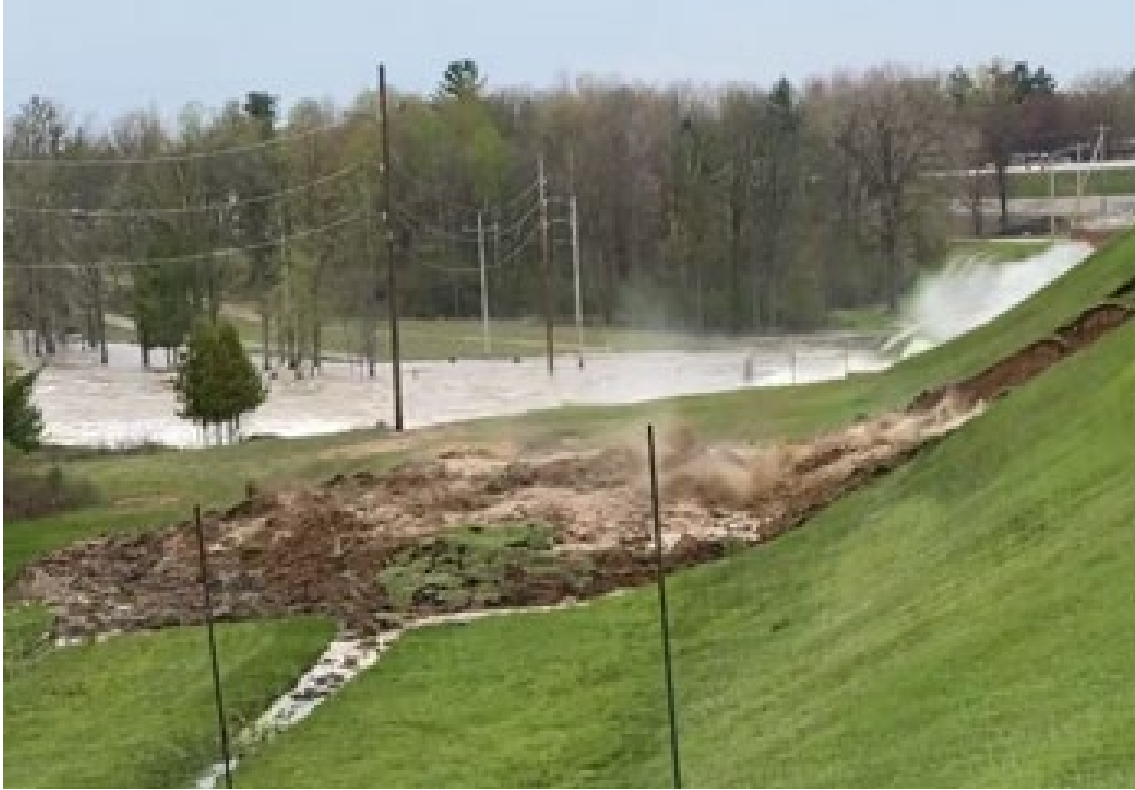
Figure 16: Enlarged still image from dam failure video at 28 seconds

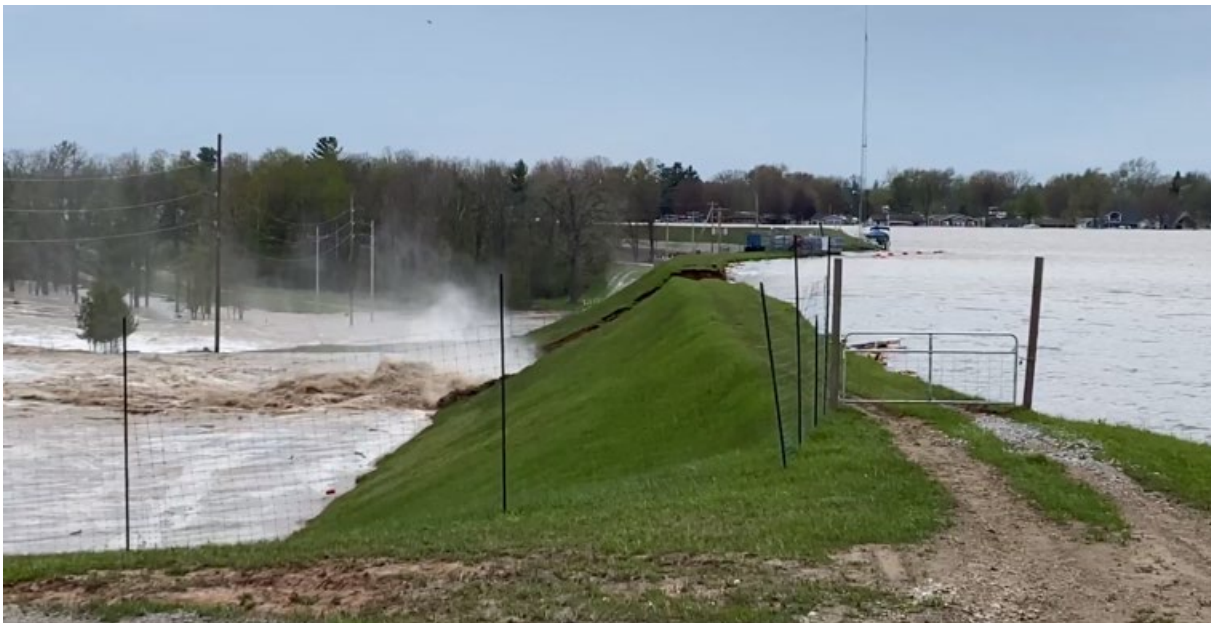
Figure 17: Enlarged still image from dam failure video at 36 seconds

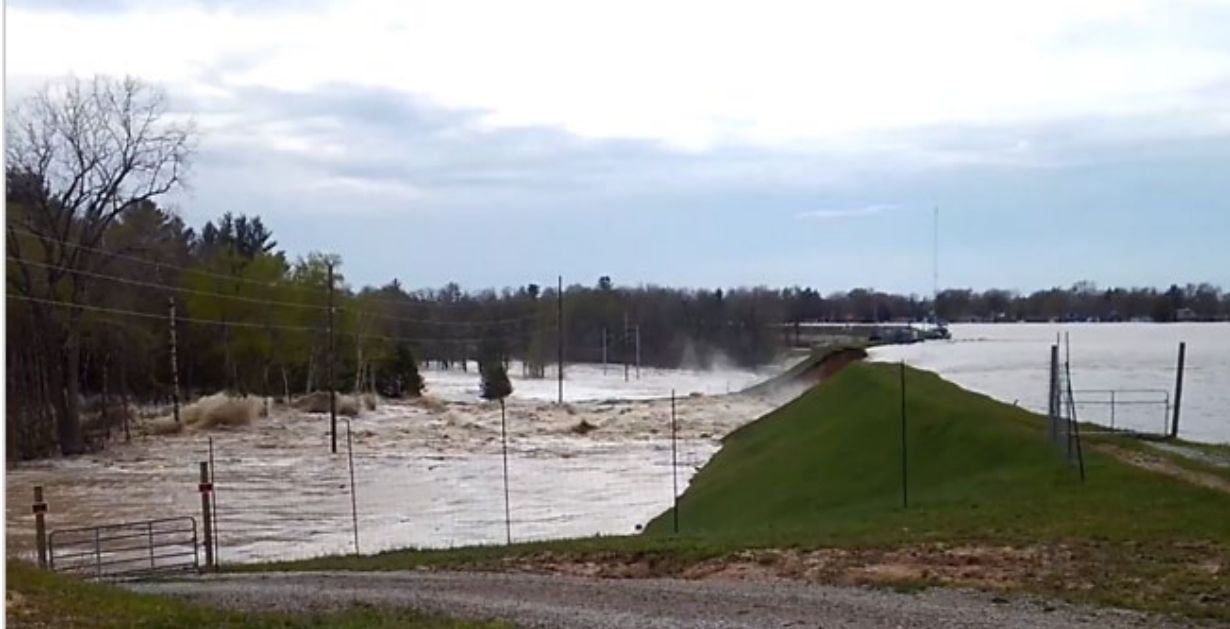
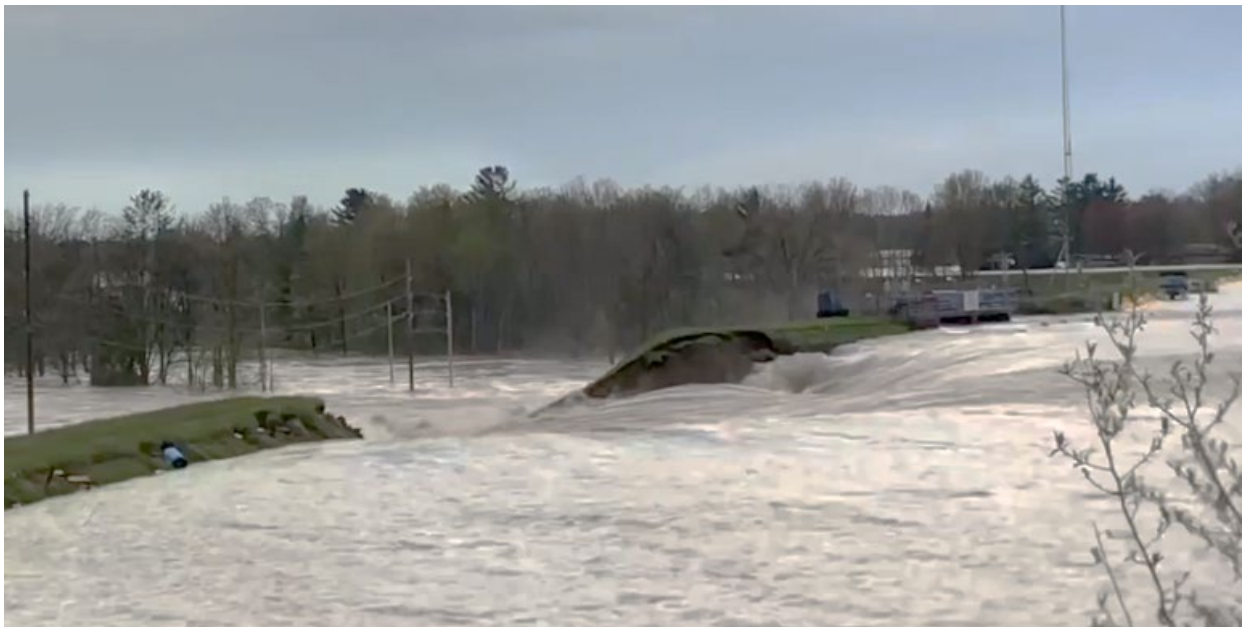
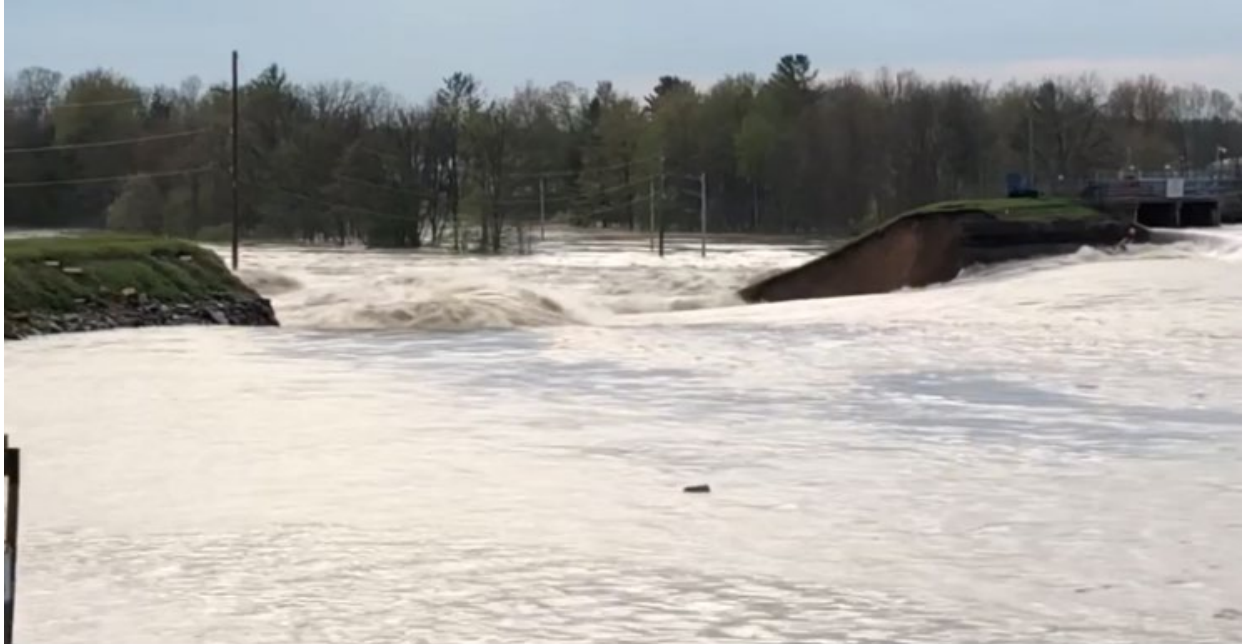
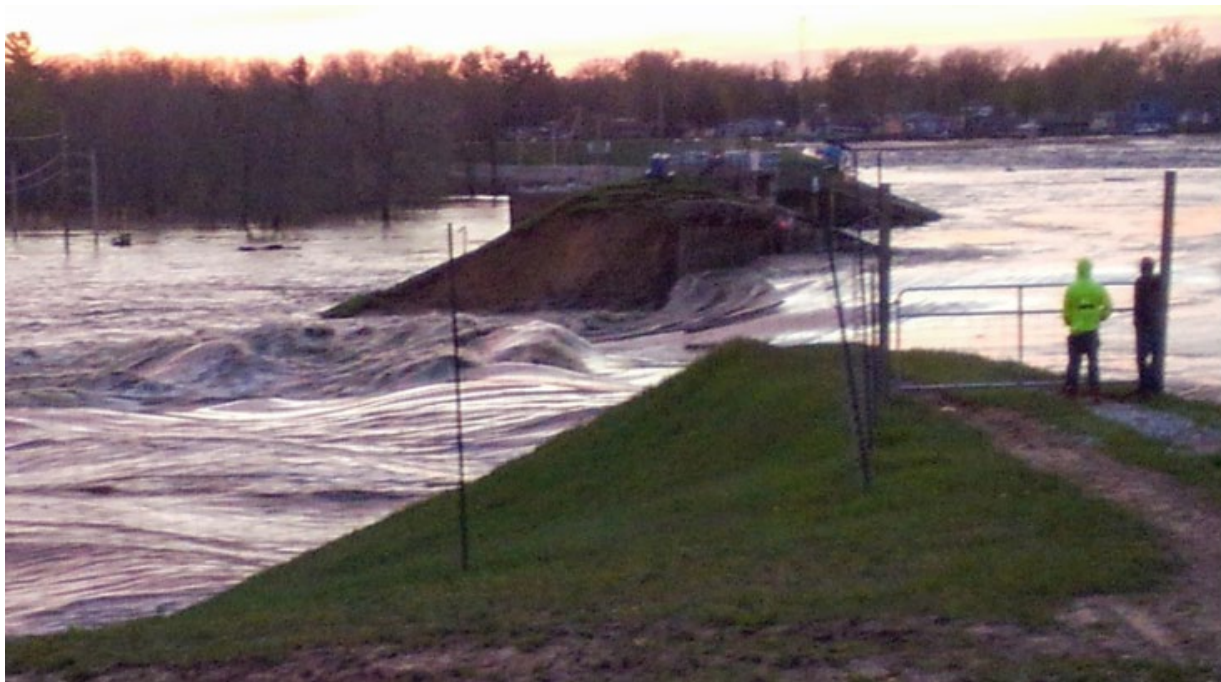
Over the next several hours the breach widened, and Wixom Lake was drained. Four images of the widening of the breach are shown in Figures 18 through 21.

Figure 18: Edenville left embankment breach at 6:00 p.m. on Tuesday, May 19, 2020

Figure 19: Edenville left embankment breach at 6:24 p.m. on Tuesday, May 19, 2020

Figure 20: Edenville left embankment breach at 7:13 p.m. on Tuesday, May 19, 2020

Figure 21: Edenville left embankment breach at 9:04 p.m. on Tuesday, May 19, 2020

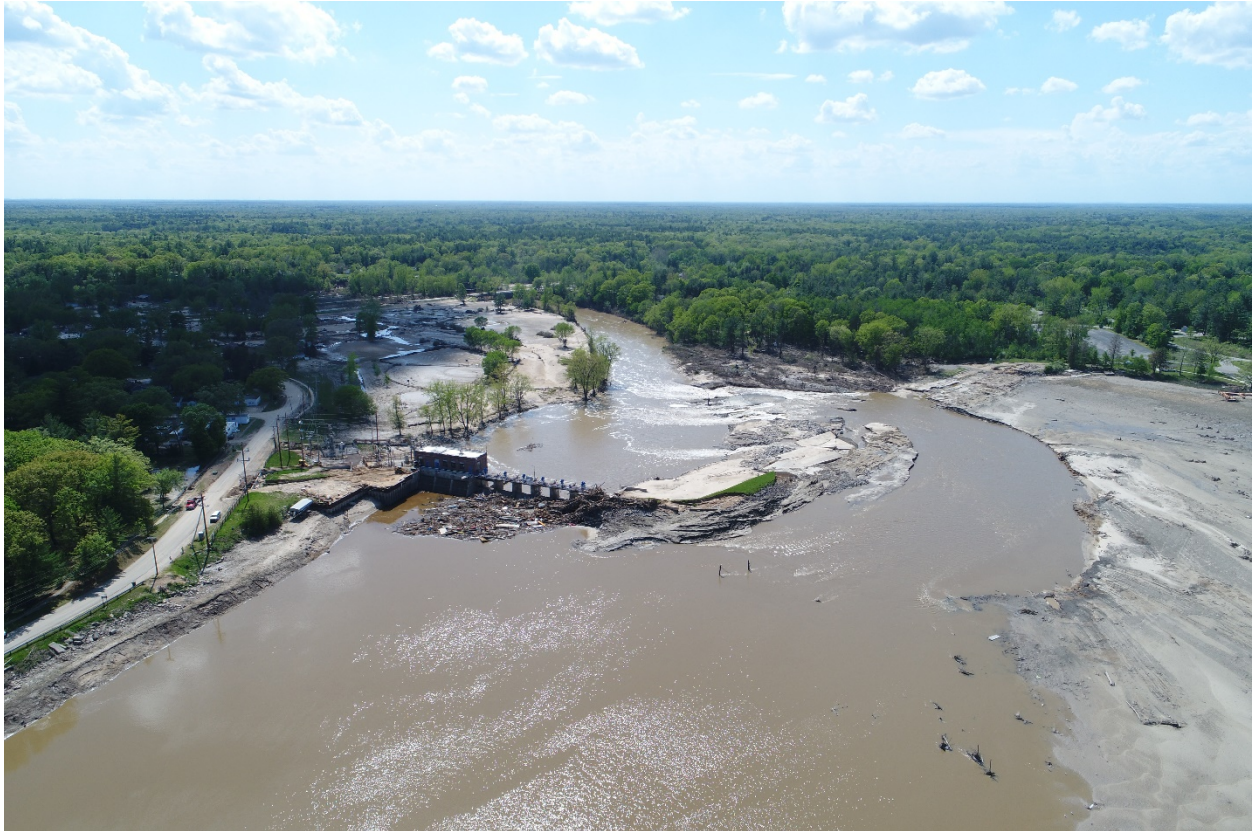
reached El. 636.8, the low spot on the embankment crest, and continued to rise. Shortly afterward, an overtopping failure of Sanford Dam occurred, and the failure flood from Edenville Dam plus the contents of Sanford Lake were released, inundating the areas downstream. A view of the failed Sanford Dam is shown in Figure 22.

Given the failure of Edenville Dam, the failure of Sanford Dam was not unexpected. As noted in the Boyce Hydro incident report, “It was always understood by the regulators and engineers involved that should a breach occur at Edenville, Sanford would necessarily fail.”

Figure 22: Sanford Dam failure, viewed from upstream (photo courtesy of EGLE)

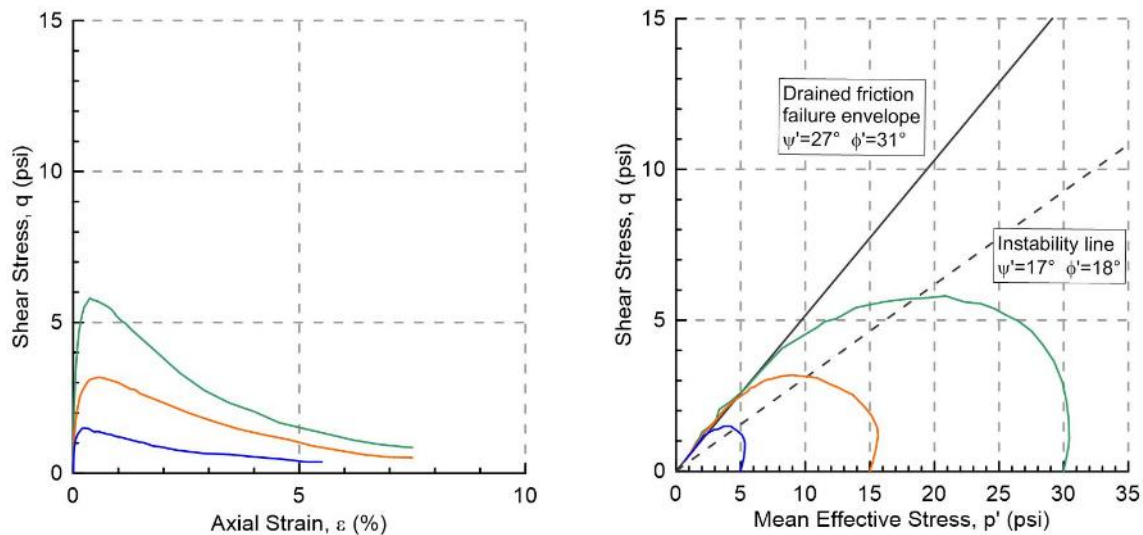
Laboratory tests on specimens from a bulk uniform fine sand sample collected from the left breach face show dramatic brittle, strain-softening collapse behavior when the sand is loose. Figure 26 shows the results of undrained triaxial strength tests on three specimens of the sand compacted to 30 percent relative density and consolidated to different confining pressures. The left side of the figure shows stress-strain curves for the three specimens. All three curves show brittle stress-strain behavior like that shown in Figure 23. The right side of Figure 26 shows stress paths for the three specimens. All three specimens show peak undrained shear strengths at stress states well below the drained frictional envelope of 31 degrees, followed by large increases in pore water pressure and dramatic decreases in strength, similar to the behavior illustrated in Figure 24. Consequently, these test results show that a sand sample taken from the left embankment, when it is loose, exhibits the stress-strain characteristics necessary for static liquefaction.

Figure 26: Laboratory undrained triaxial test results for Edenville Dam uniform fine sand sample at 30 percent relative density⁸

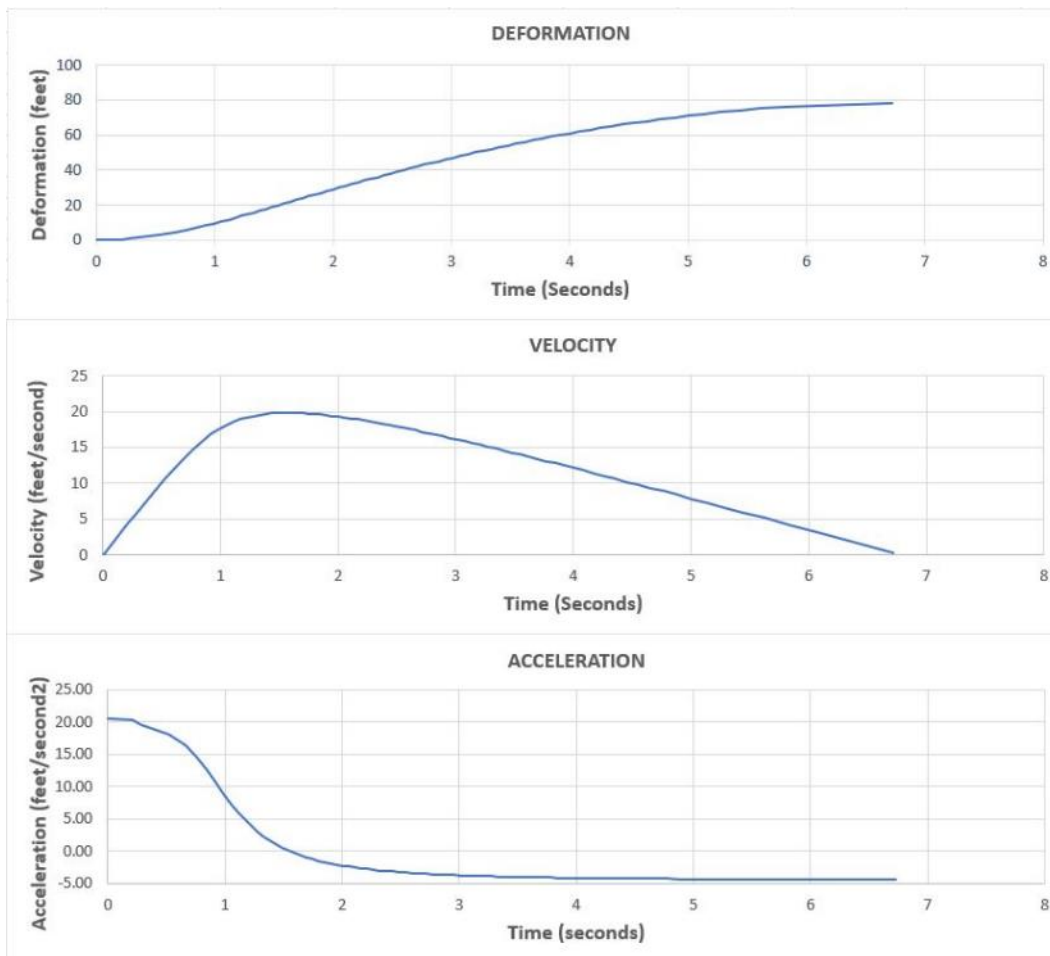
or residual strength. The changes in accelerations, velocities, and deformations are calculated incrementally in time steps. The results are shown in Figure 27 as plots of deformation, velocity, and acceleration versus time. An American Society of Civil Engineers investigation team completed pixel tracing analysis on the failure video and concluded that the failure mass reached a velocity of about 5 meters per second or 16.4 feet per second (ft/sec), which is reasonably close to the 19.8 ft/sec resulting from the simplified kinetic analysis. In addition, the displacement time of about 6.7 seconds from the kinetic analysis is similar to the failure time interpreted from the dam failure video. Consequently, the results of the kinetic analysis support the plausibility of a static liquefaction failure.

Figure 27: Results of kinetic calculations for possible static liquefaction failure of Edenville left embankment

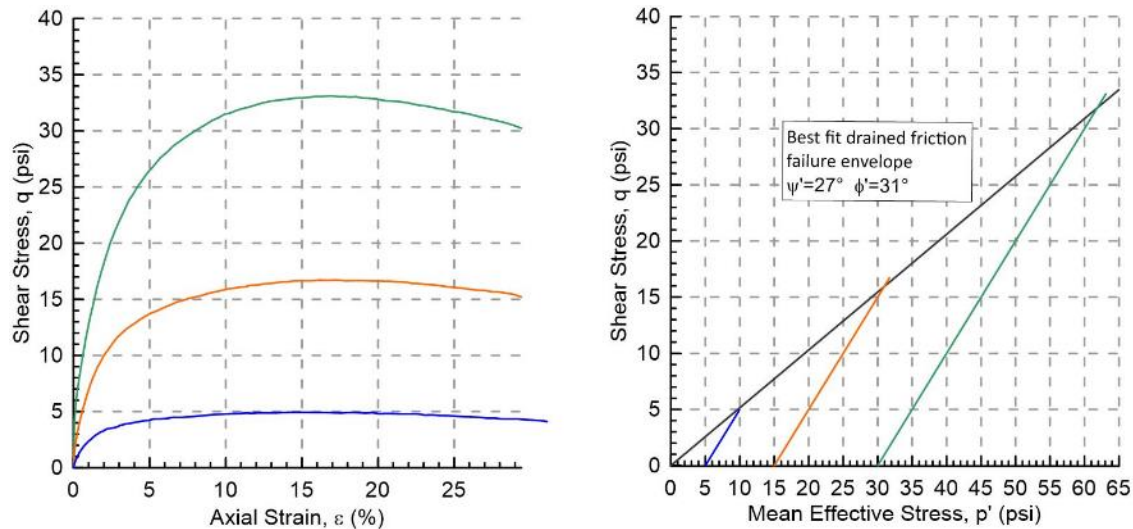
With ductile stress-strain behavior, it would be expected that the instability failure would be progressive—a rise in pore water pressure dropping the factor of safety below 1.0 and causing enough deformation to restore stability, followed by further rise in pore water pressure causing further slumping, with this process continuing and ultimately leading to enough deformation to cause failure through overtopping or internal erosion. The observed characteristics of the failure are not consistent with this mechanism, and the IFT judged this mechanism to be implausible as the primary cause of the failure, although it may have contributed to the observed crest subsidence noted above and may have been a contributing trigger for static liquefaction.

Figure 28: Laboratory drained triaxial test results for Edenville Dam uniform fine sand sample at 30 percent relative density

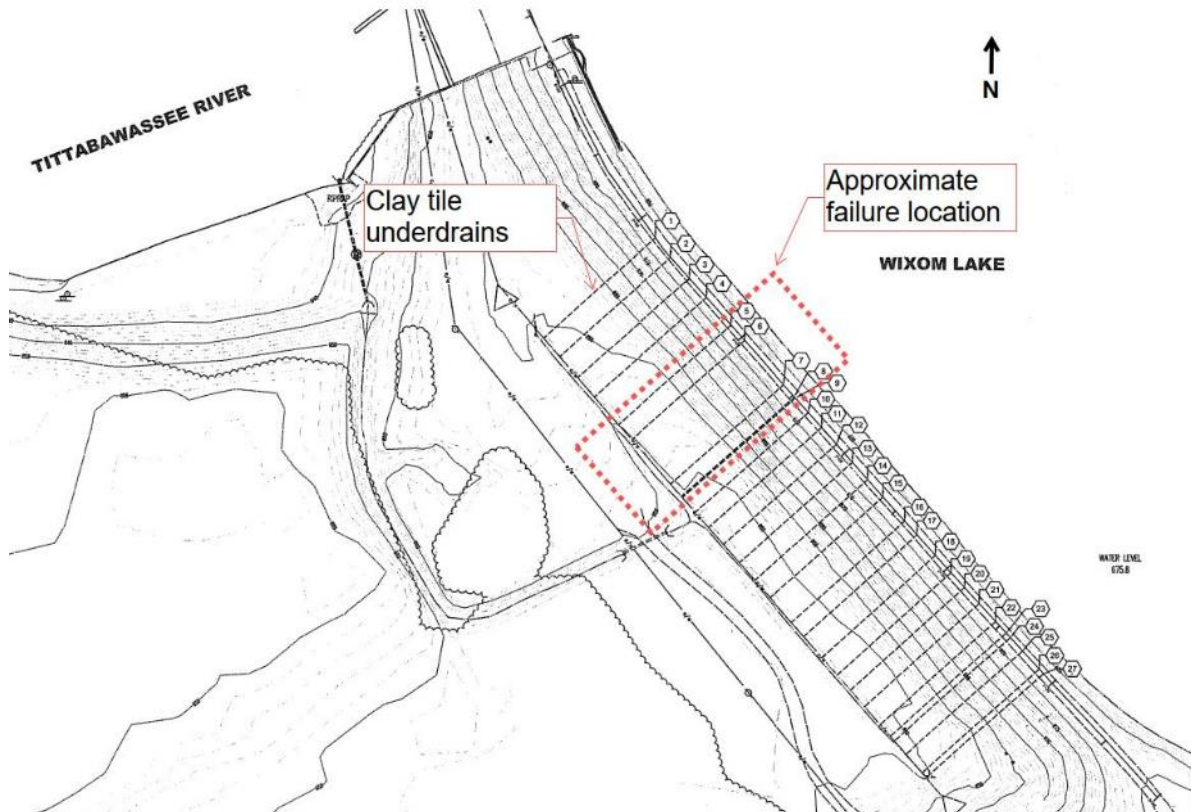
One question that arose during the IFT's investigation is: Why was the failure limited to a 40- to 80-foot length of the embankment? One possible explanation is that the failure section included the loosest sands within the embankment. Another possible, and perhaps more plausible, explanation is that the clay tile underdrains beneath the embankment were missing in the failure section. A 2012 investigation of the drains did not identify drains beneath the failure location, as shown in Figure 29, suggesting that the drains at that location either were never installed or subsequently had become buried and ineffective. Since the remainder of the drains along the Edenville left embankment have been observed to consistently flow, they appear to provide some degree of drainage for the embankment. The lack of drains in the failure location could have resulted in a higher phreatic surface at that location than elsewhere along the embankment.

Figure 29: Plan from 2012 underdrain survey, showing lack of underdrains in the failure location
