AN INVESTIGATION OF
THE
FAILURE OF LAWN LAKE DAM
LARIMER COUNTY, COLORADO

Conducted by The
Office Of The State Engineer

February 14, 1983

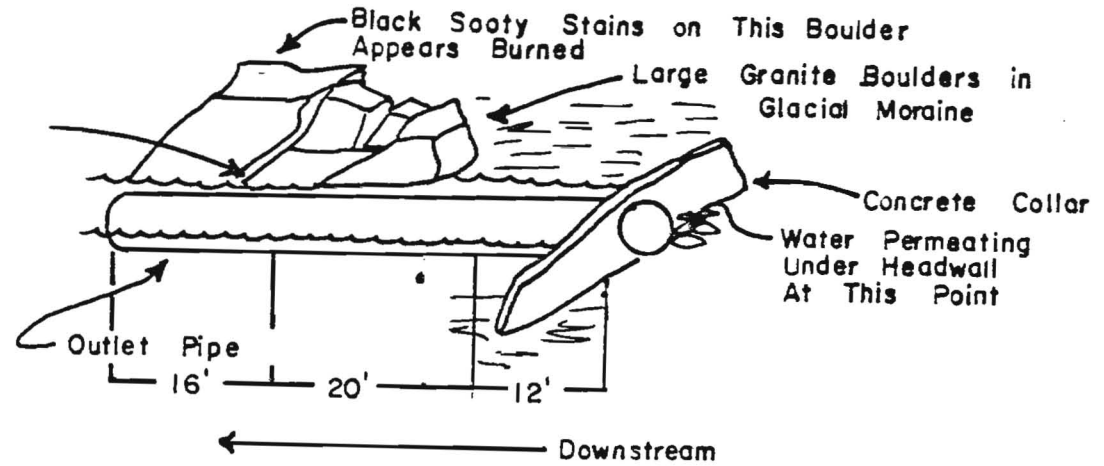
SKETCH OF OUTLET AREA
LOOKING SOUTH 7-22-82
NOT TO SCALE

Black Sandy
Material Found
Here

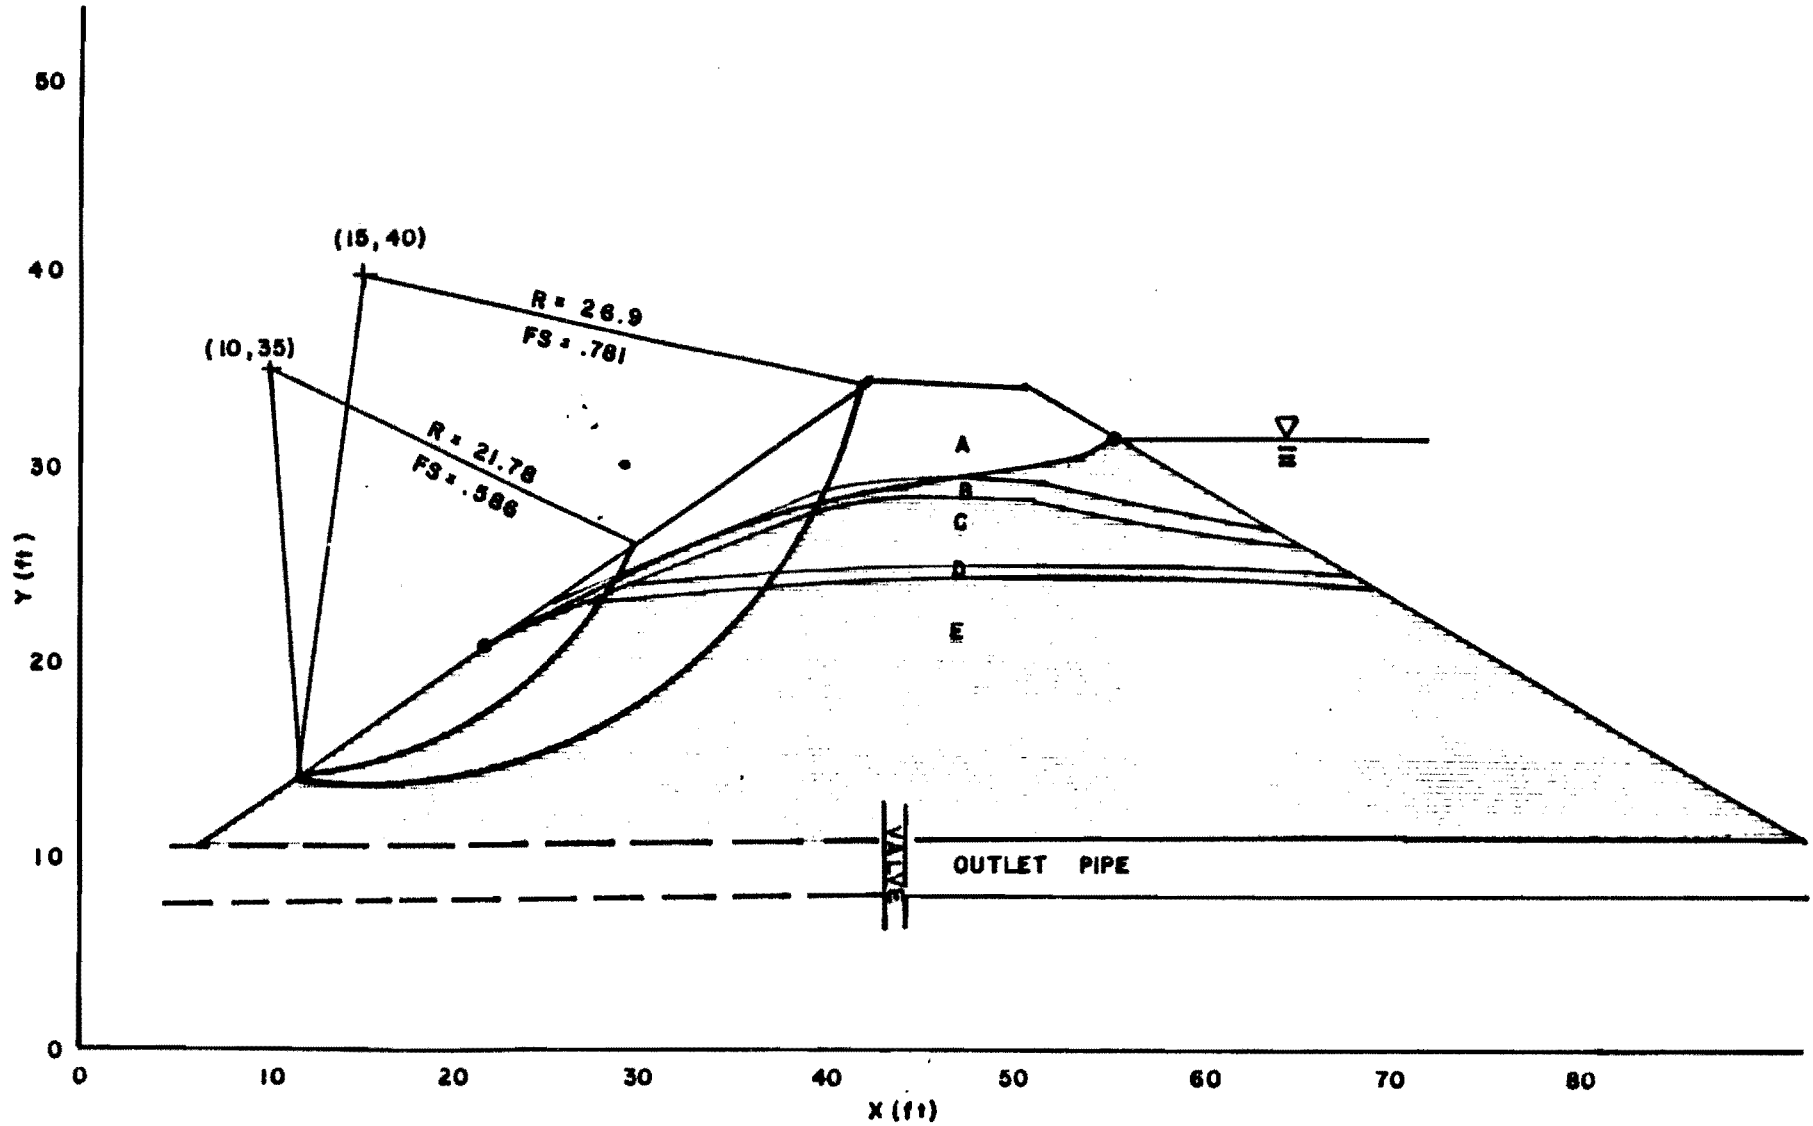
FIGURE C-4

The initial analysis assumed that the embankment section through the outlet (maximum section) was undrained, similar to a homogeneous dam, which resulted in a factor of safety of less than one. This condition would cause an unstable slope and probable slip failure. It was concluded from the evaluation of the records of storage and the permeabilities obtained from the laboratory testing, however, that steady-state seepage must have existed at

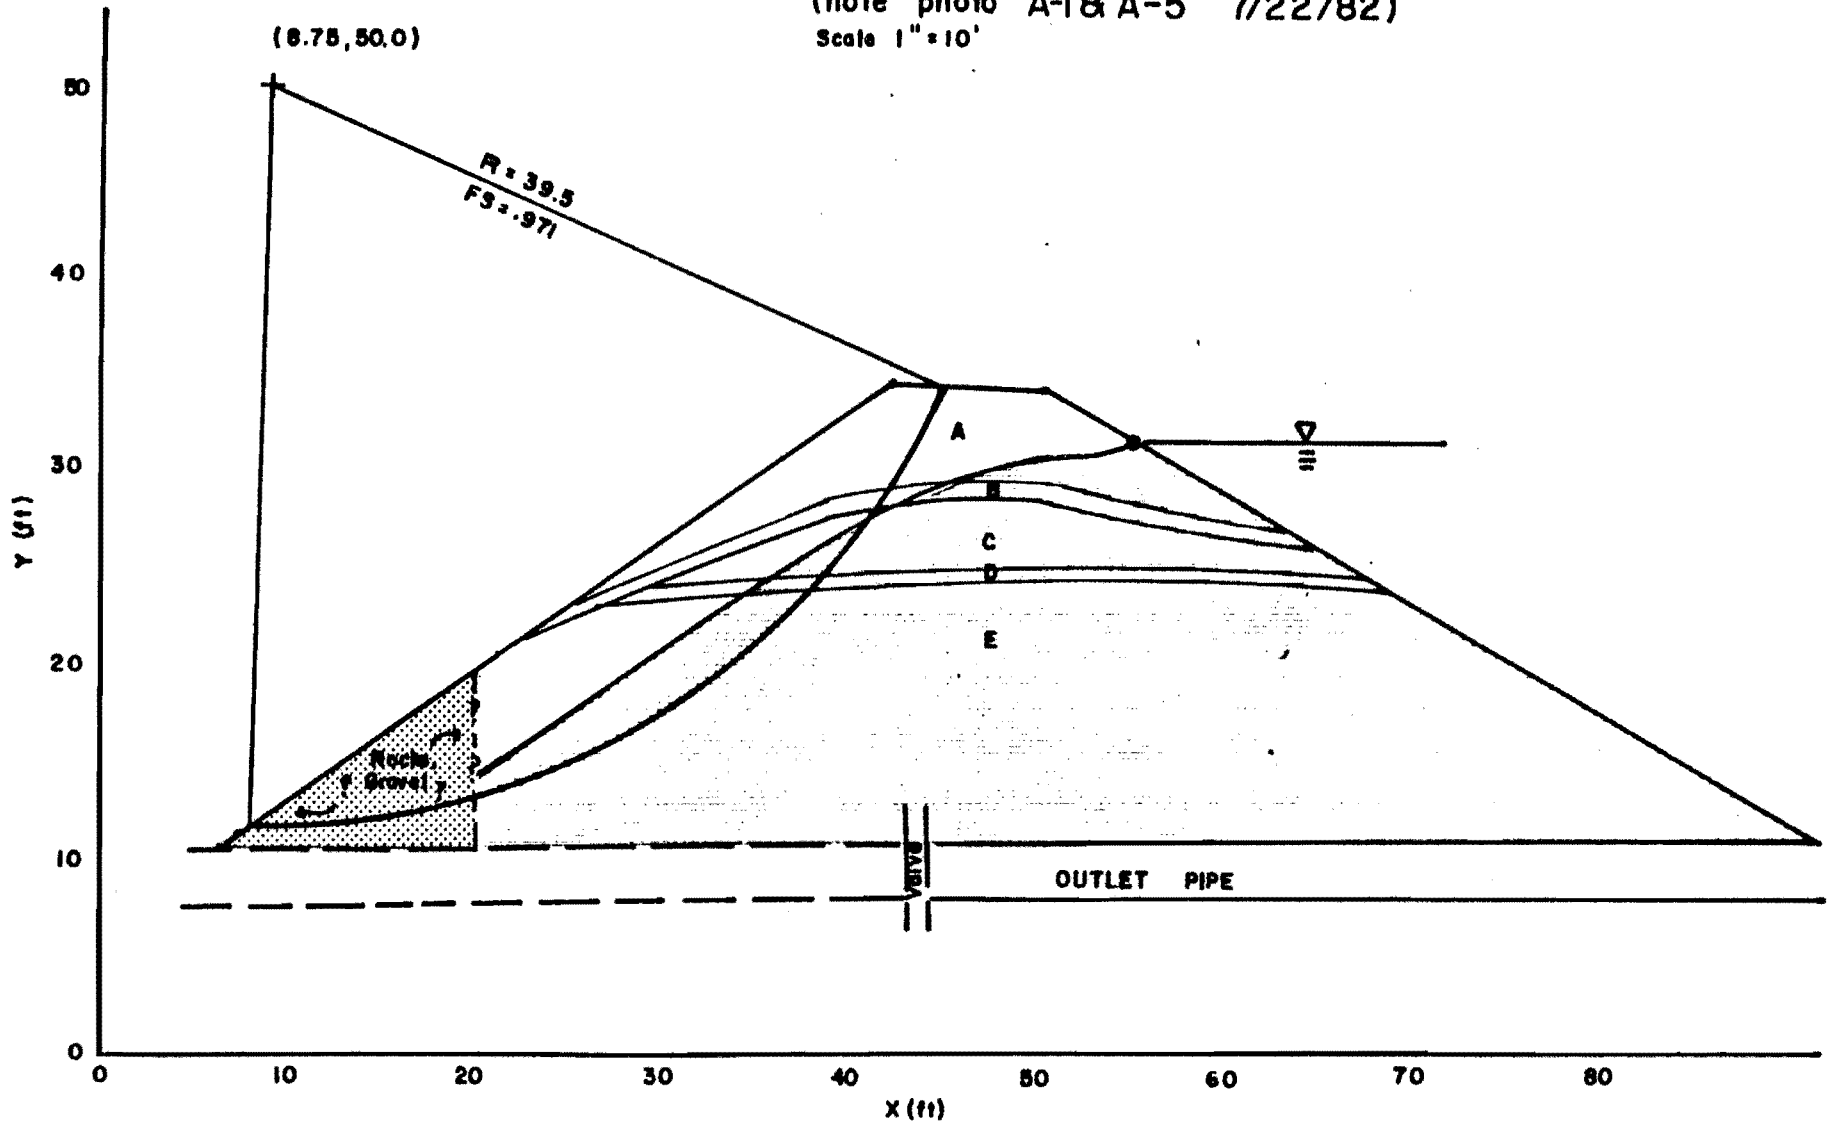
FIGURE C-5

the time of failure and the assumption of no drainage was not likely. Some type of drainage probably existed within the dam section which kept the seepage from reducing the strength of the materials to a state of stress which would cause the materials to fail under normal conditions. Some other abnormal condition existed which caused the failure.
