## Reconnaissance Report on the Failure of Kelly Barnes Lake Dam, Toccoa Falls, Georgia (1978)

RECONNAISSANCE REPORT ON THE FAILURE  
OF  
KELLY BARNES LAKE DAM, TOCCOA FALLS, GEORGIA

George F. Sowers  
Senior Geotechnical Consultant  
Law Engineering Testing Company  
Regents Professor of Civil Engineering  
Georgia Institute of Technology

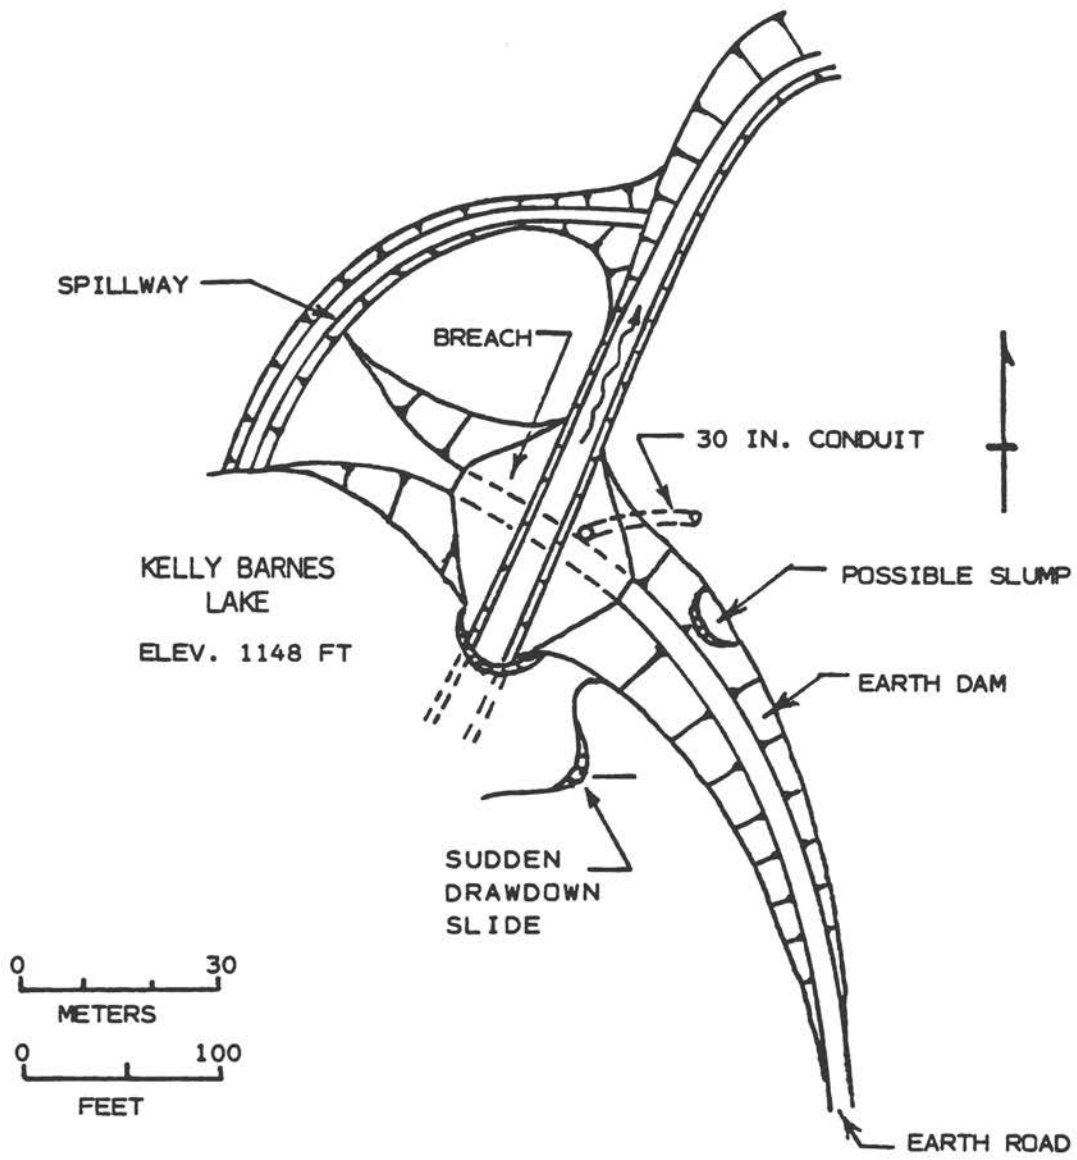
FIGURE 2 Kelly Barnes Lake Dam, Toccoa Falls, Georgia.  
Estimated plan of dam before failure (Field  
Notes, George F. Sowers, 9 November 1977)

No plans or cross sections of the dam have been discovered so far. Figures 2 and 3 show a plan and cross section based on field observations which include estimated dimensions. More accurate plans and cross sections must await ground surveys. Because the maximum section of the dam was completely obliterated by the failure, it can only be presumed that the cross section of the dam seen on the abutments continued across the creek. If anything, the maximum cross section of the dam might have been steeper, as suggested by the scour and rock staining. The dam was generally crescent-shaped in plan, concave upstream, following a low ridge. The dam height above the present eroded stream

channel was approximately 40 feet. The upstream slope is relatively flat, approximately 25 degrees with respect to the horizontal. The downstream slope is very steep, averaging 40 degrees for the upper 15 feet and 35 degrees below. Crude leveling with the Brunton compass indicates that the south end of the failure area is 1 to 2 feet higher than the northwest.

There was a side channel spillway on the northwest abutment. The channel was approximately 5 to 6 feet deep and 6 feet wide at the base, with approximately 1.5 (H) to 1 (V) side slopes. Swish marks and leaves accumulated in the side of this channel indicate that the water was 3.8 feet deep before the dam failed.

The spillway channel above a depth of 2 feet was partially obstructed by brush and small trees of the type that can grow in and adjacent to running water. There was no evidence of large debris jamming the spillway channel. The size of the brush and trees in the channel indicates that it might have been cleaned out 4 or 5 years ago. They also indicate that the continuous overflow was about 2 feet deep.

NOTE: DOWNSTREAM FACE OF DAM COVERED WITH TREES 6 TO 8 INCHES IN DIAMETER AND SMALL SHRUBS. UP-STREAM FACE COVERED WITH SMALL SHRUBBY TREES.

NOTE: SHRUBS AND 1 TO 2 INCH DIAMETER TREES IN SPILLWAY, LITTLE TRASH.

CROSS SECTION OF SIDE CHANNEL SPILLWAY  
(WATER DEPTH BEFORE FAILURE FROM SWISH LINES)

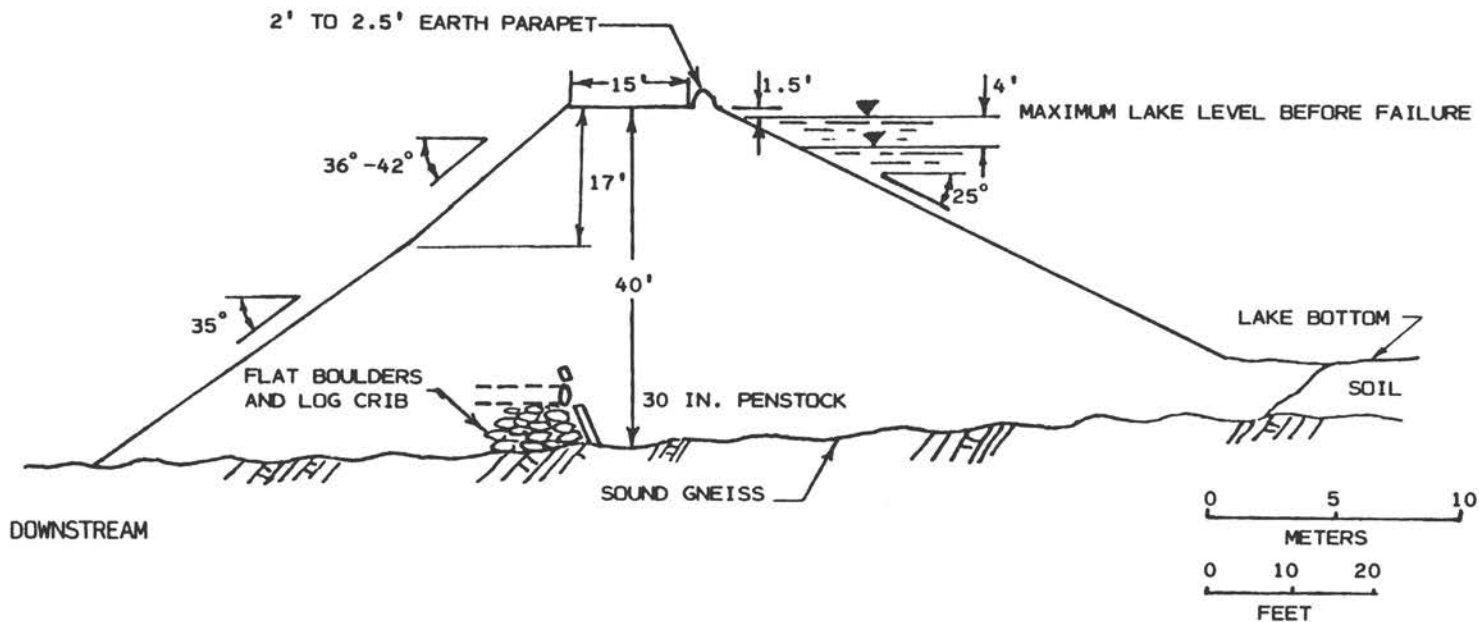
FIGURE 3 Kelly Barnes Lake Dam, Toccoa Falls, Georgia. Maximum cross section, center of Toccoa Creek, looking east-southeast, based on adjacent intact remains of dam (Field Notes, George F. Sowers, 9 November 1977)

More than one occurrence of earth-fill dam placement is suggested by (1) an abrupt change in downstream slope 20 to 25 feet above the stream bottom and (2) a 4-foot layer of different-colored soil in the upper 4 feet of dam fill. Therefore it is concluded that the earth-fill dam was superimposed on the old stone-filled timber crib in 2 or more stages, producing an eventual height of 40 feet.

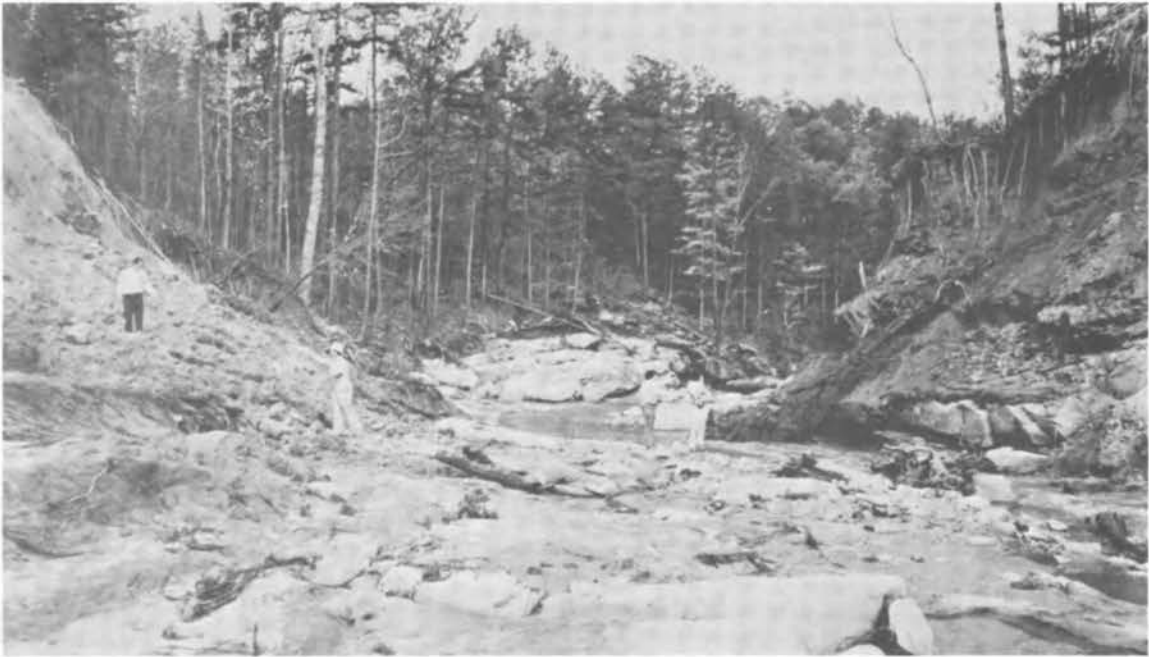
FIGURE 4a Dam looking downstream through breach

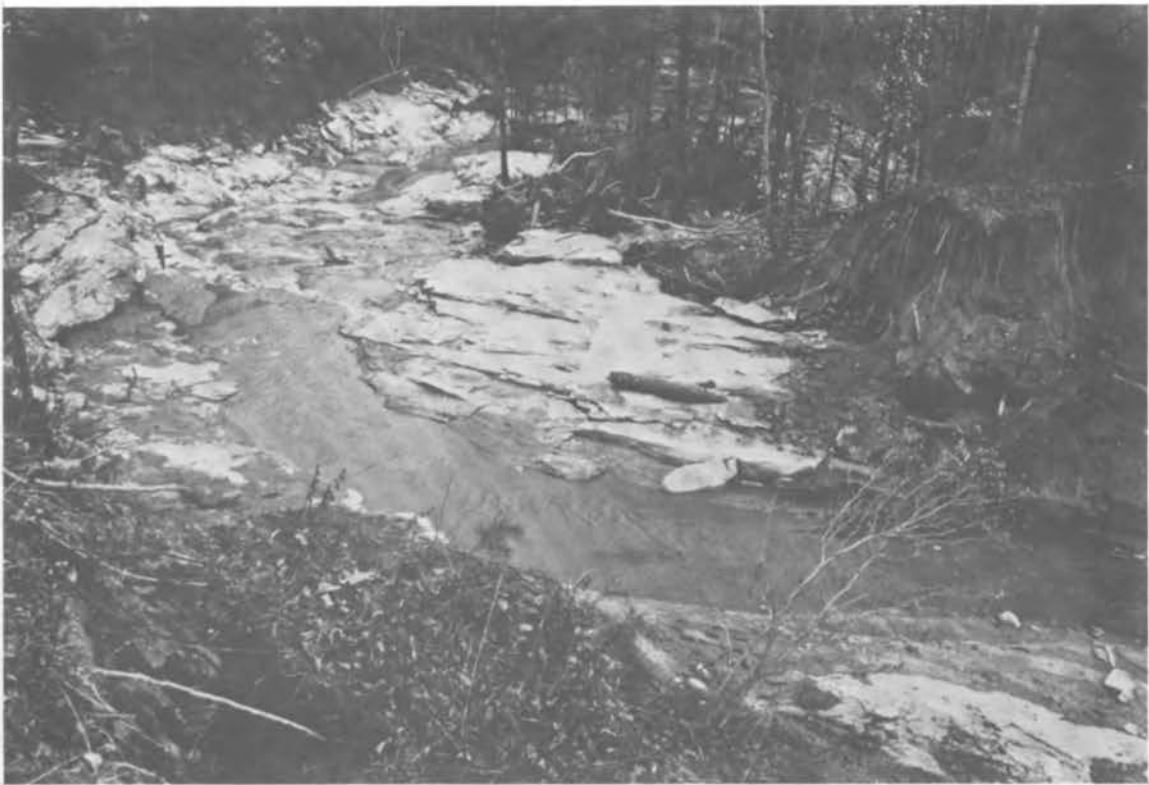
FIGURE 4b Scoured creek immediately downstream from dam looking downstream

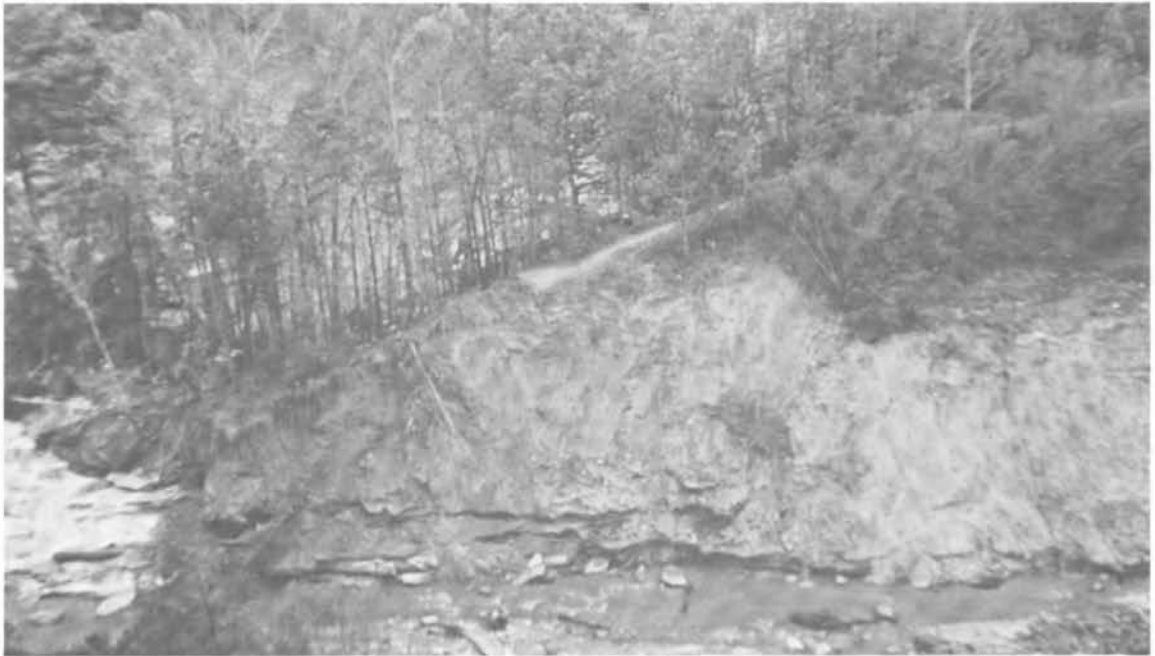
FIGURE 5 Face of breach on right abutment looking downstream

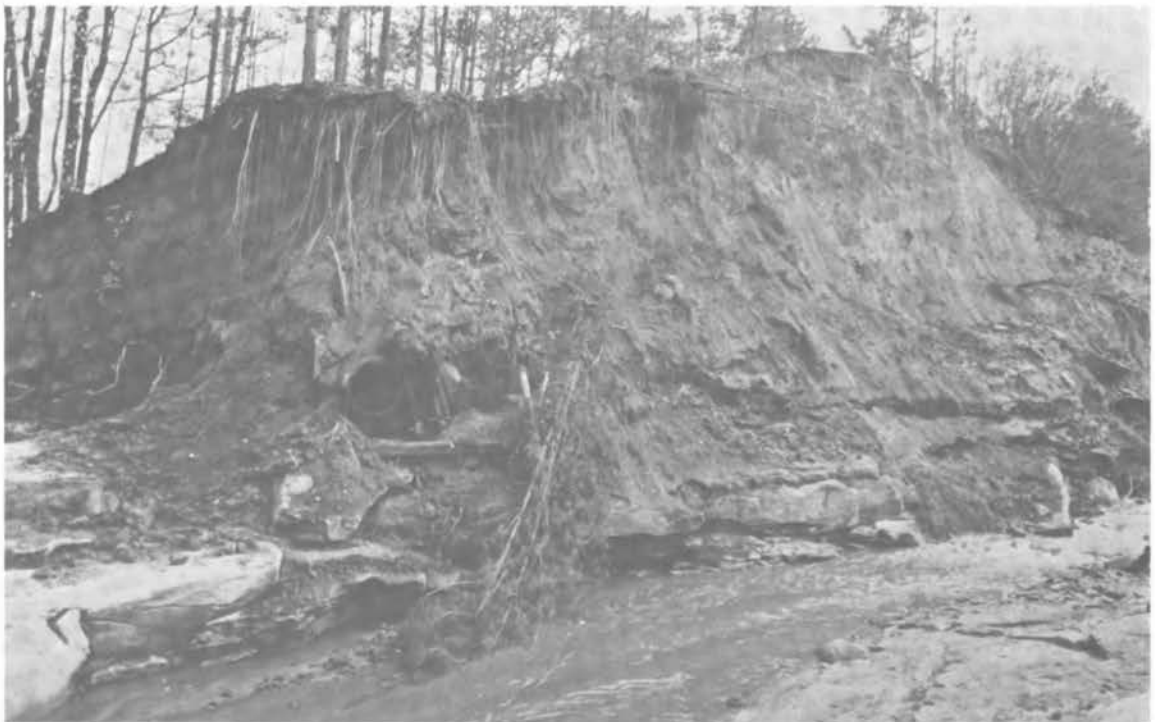
An old 30-inch conduit or penstock leading to the abandoned power plant is exposed in the southeast face of the breach (Figure 6). The steel appears to be in good condition. Further down the stream near the toe of the dam the pipe had been cut. It appears to be in good condition considering its age.

FIGURE 6 Face of breach on right side looking southwest, showing old penstock and remains of 1899 crib dam at downstream toe on left

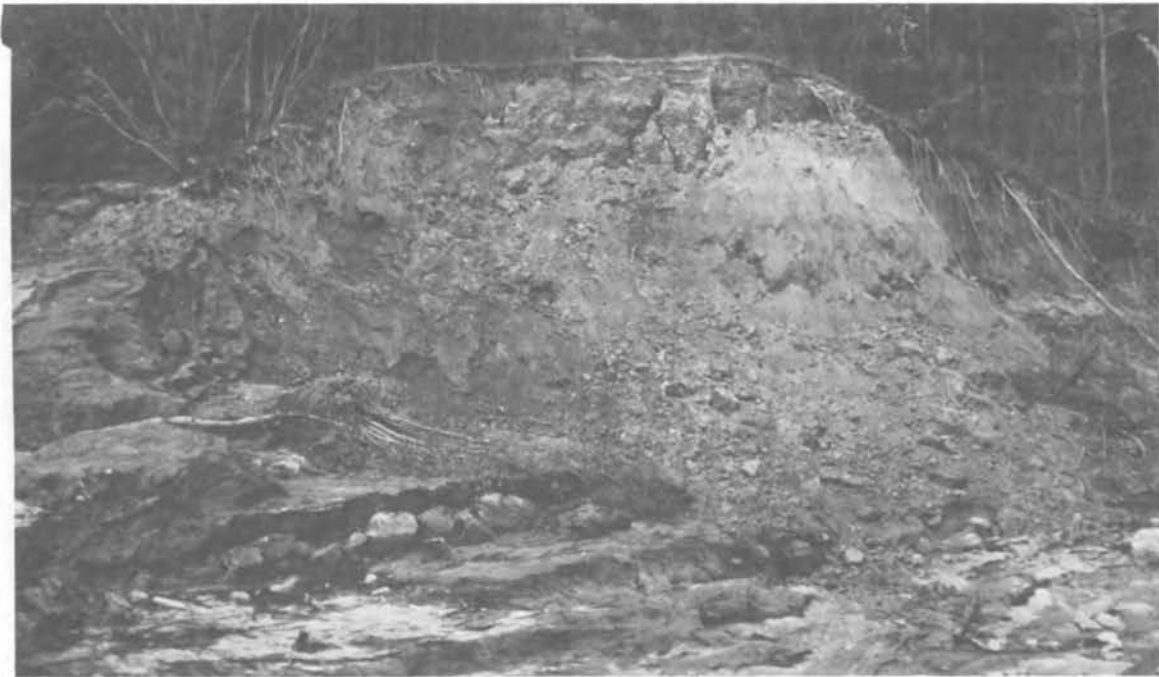
FIGURE 7 Face of breach on left side, looking north, upstream to left

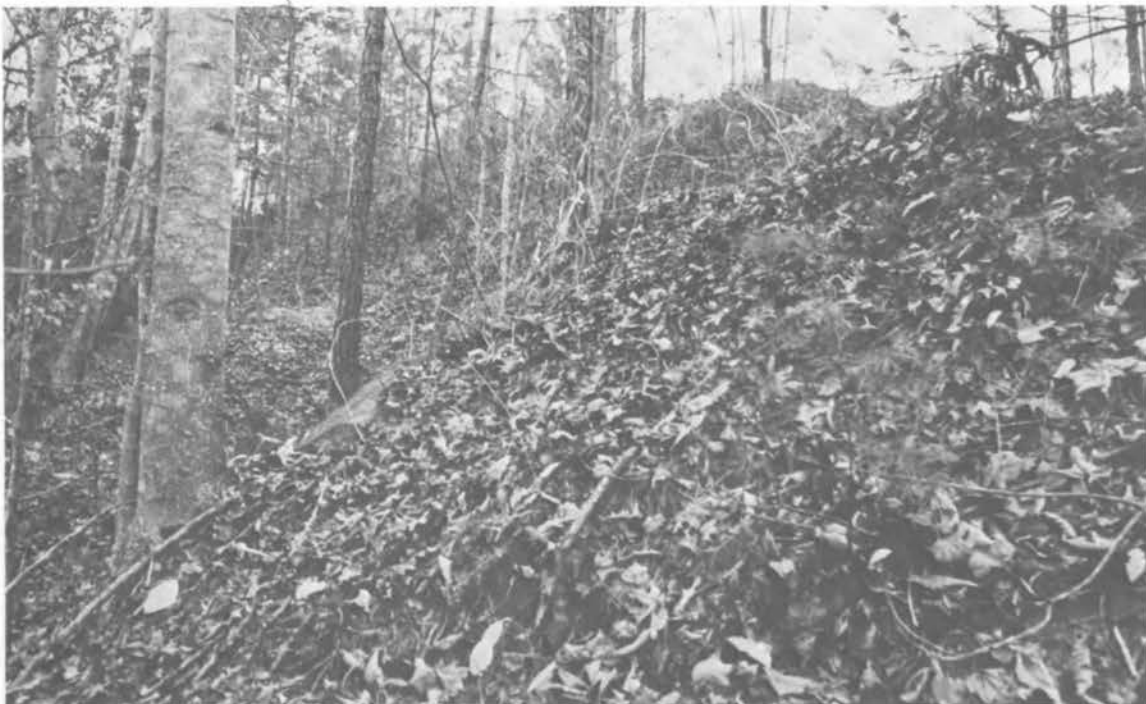
The downstream face of the intact portions of the dam are covered with brush and trees up to 8 inches in diameter (Figure 8). The size and species of the largest trees suggest that they are 20 to 25 years old. The upstream face of the dam was covered by small trees and brush. The absence of stumps and large trees suggests that the dam face had been well maintained until about 20 years ago. This coincides with the abandonment of power generation in 1955 or 1957.

There is a sharp irregularity on the downstream face of the southeast end of the dam near the creek. The topography and the attitude of the trees suggest that this irregularity was caused by a small slump or landslide in the steep downstream face of the dam. If so, the vegetation surrounding it suggests that it is several years to tens of years old.

The steep slope of the dam and the suggestion of an earlier slide on the southeast downstream face support the concept of a slide in the downstream face initiating failure. The micaceous soils of which the dam is built are susceptible to weakening upon saturation from rain. The 5 days of continuous rain would have saturated the somewhat porous micaceous soils, and the final intense rain the night of failure would have provided a trigger. Saturation could have been aggravated by leakage of the old penstock or by piping along it.

FIGURE 8 Right downstream face, 10-in. tulip poplar,  
6 to 8-in. pines, old slide scar

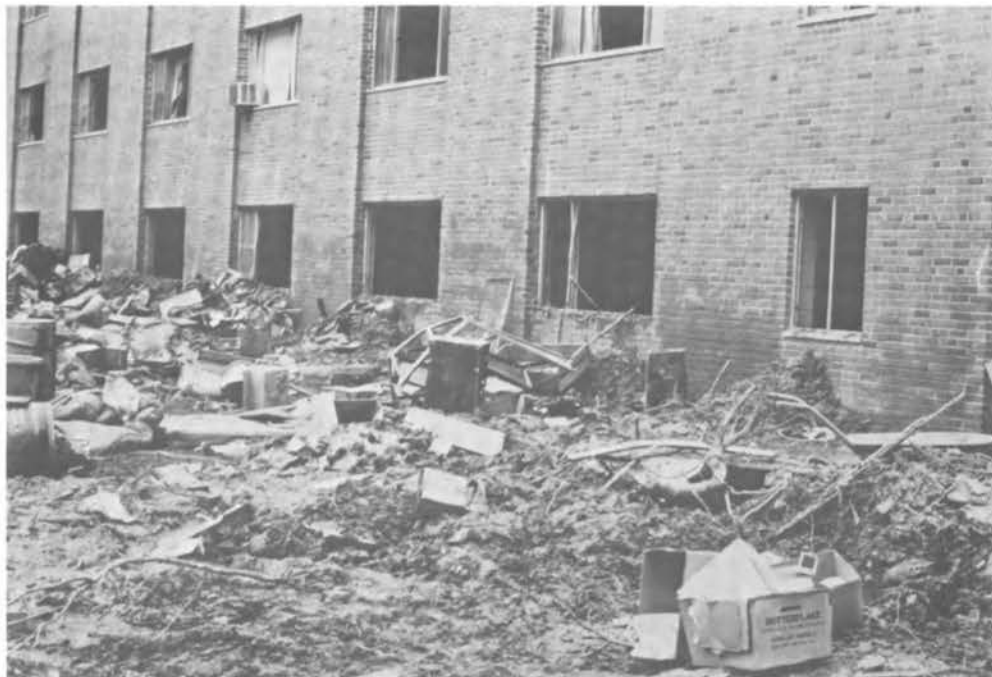
A few hundred feet further downstream is a college dormitory building, partially in the floodplain. The flood wave reached a height of about 8 feet in the ground floor. Three of the students occupying this floor were drowned; others were able to swim or scramble to safety. The upper floors were not damaged.

FIGURE 9b Dormitory looking at riverside face. High water line about top of windows, debris and mud shoveled from rooms looking for bodies

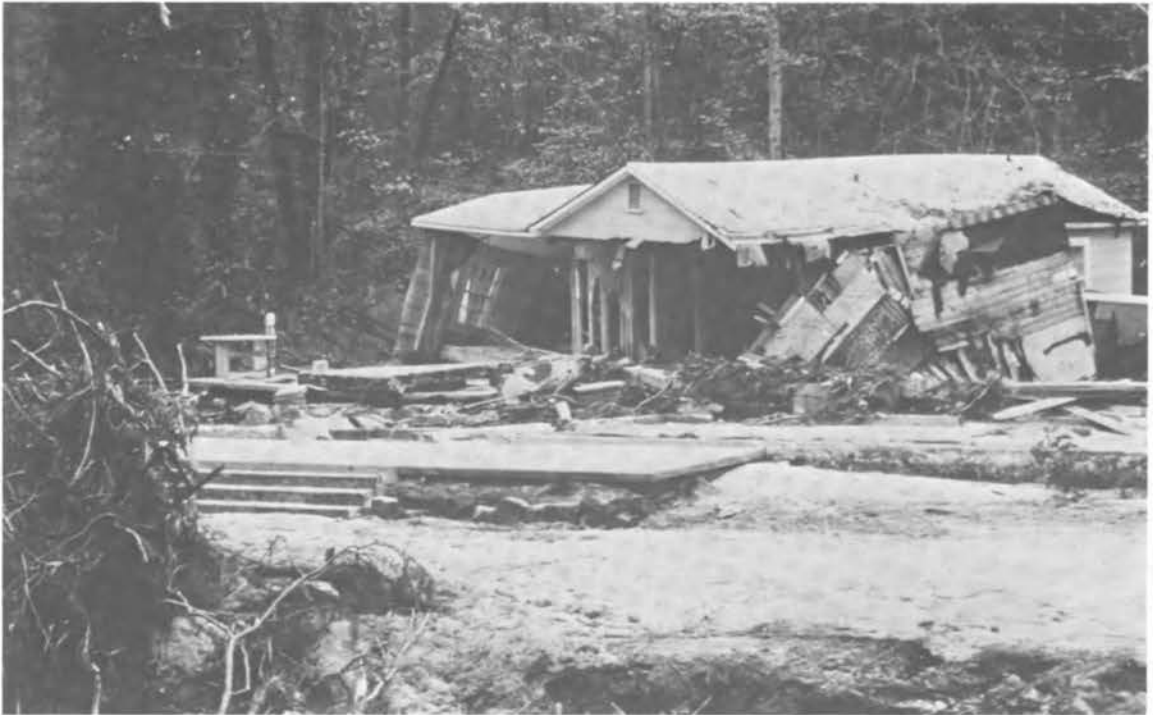
FIGURE 11 Damaged faculty home on right bank across from dormitory

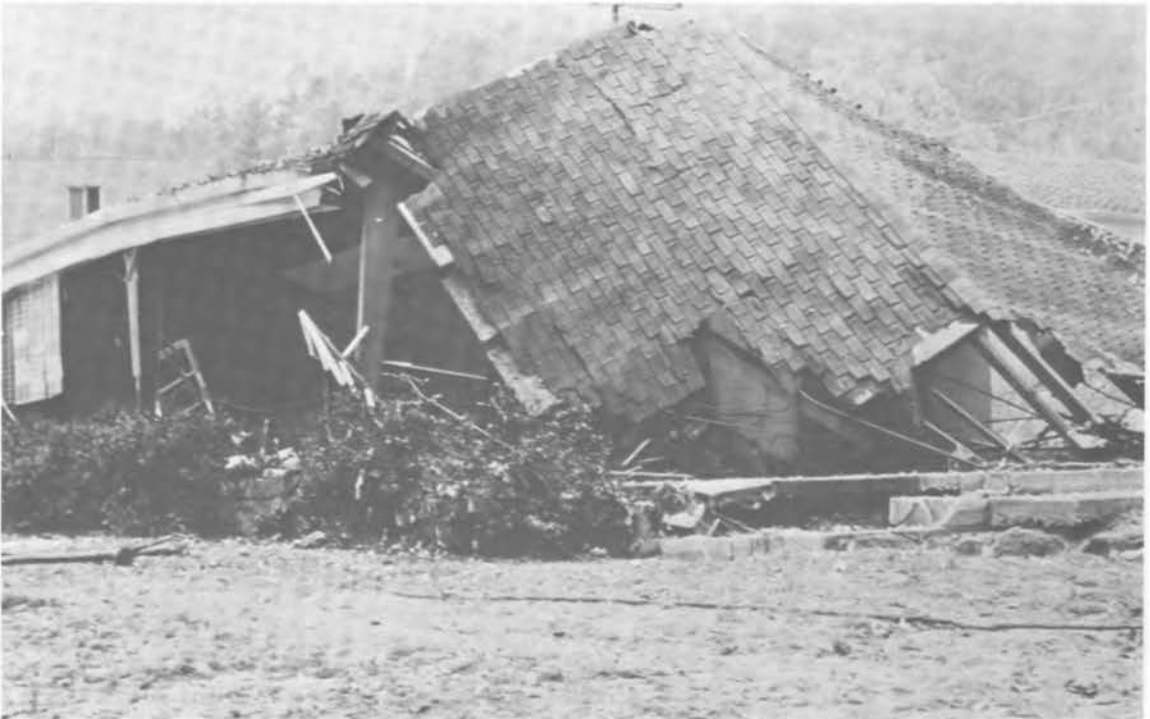
FIGURE 12 Damaged cottage downstream from dormitory

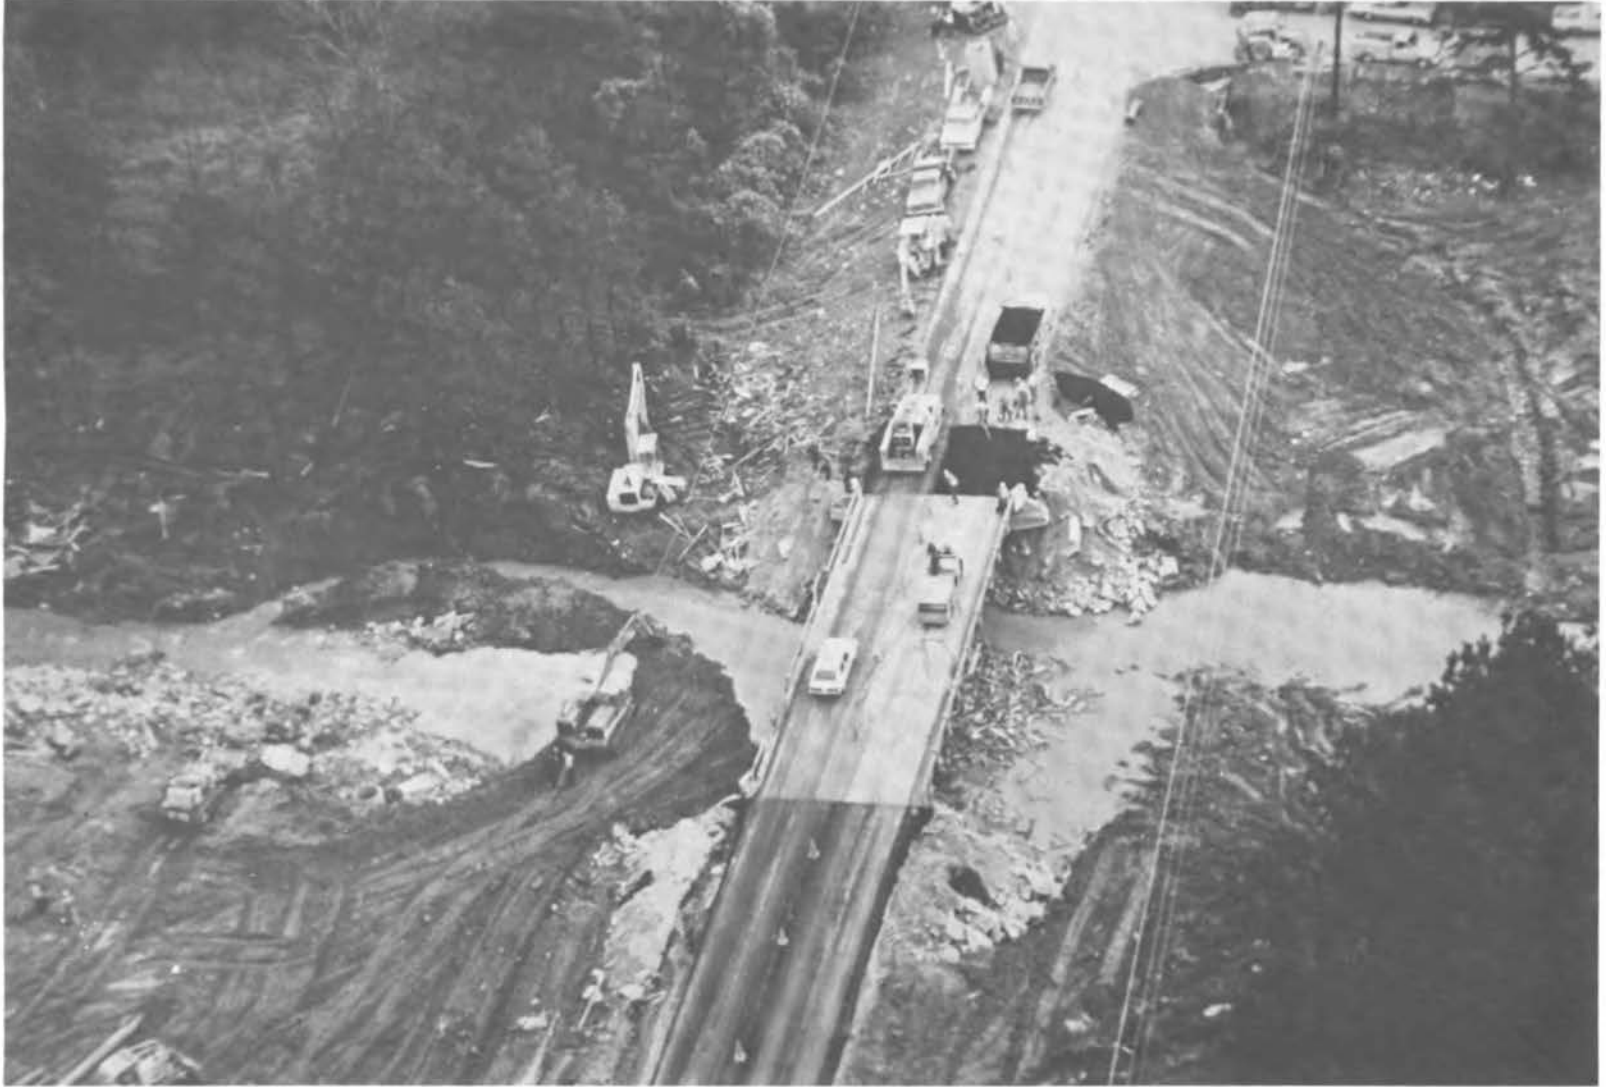
One-half mile downstream the creek passes under Georgia Highway 17. The concrete bridge, supported by spread footings on weathered rock, remained intact. The debris lodging against it produced a crude dam. The water rose, flowed across the approach fills, and washed out the highway on both sides of the abutments. The bridge partially dampened the flood wave. The velocities downstream were somewhat lower and the flood heights above the floodplain appeared to be 5 to 7 feet. Although there was some bridge damage downstream from Highway 17, most of the damage was between Highway 17 and the falls.

FIGURE 13 Highway 17 with new asphalt paving on new approach fills

By late Sunday, traffic had been restored to Highway 17. By November 9, the highway repairs were nearly complete. The Highway Department maintenance crews rebuilt the 16-inch water main and had it in operation by Thursday, November 10. Meanwhile, some water service was reestablished using an abandoned 10-inch water main that had not been destroyed.
