INVESTIGATION OF THE CAUSE OF QUAIL CREEK DIKE FAILURE

Report of Independent Review Team

March 7, 1989

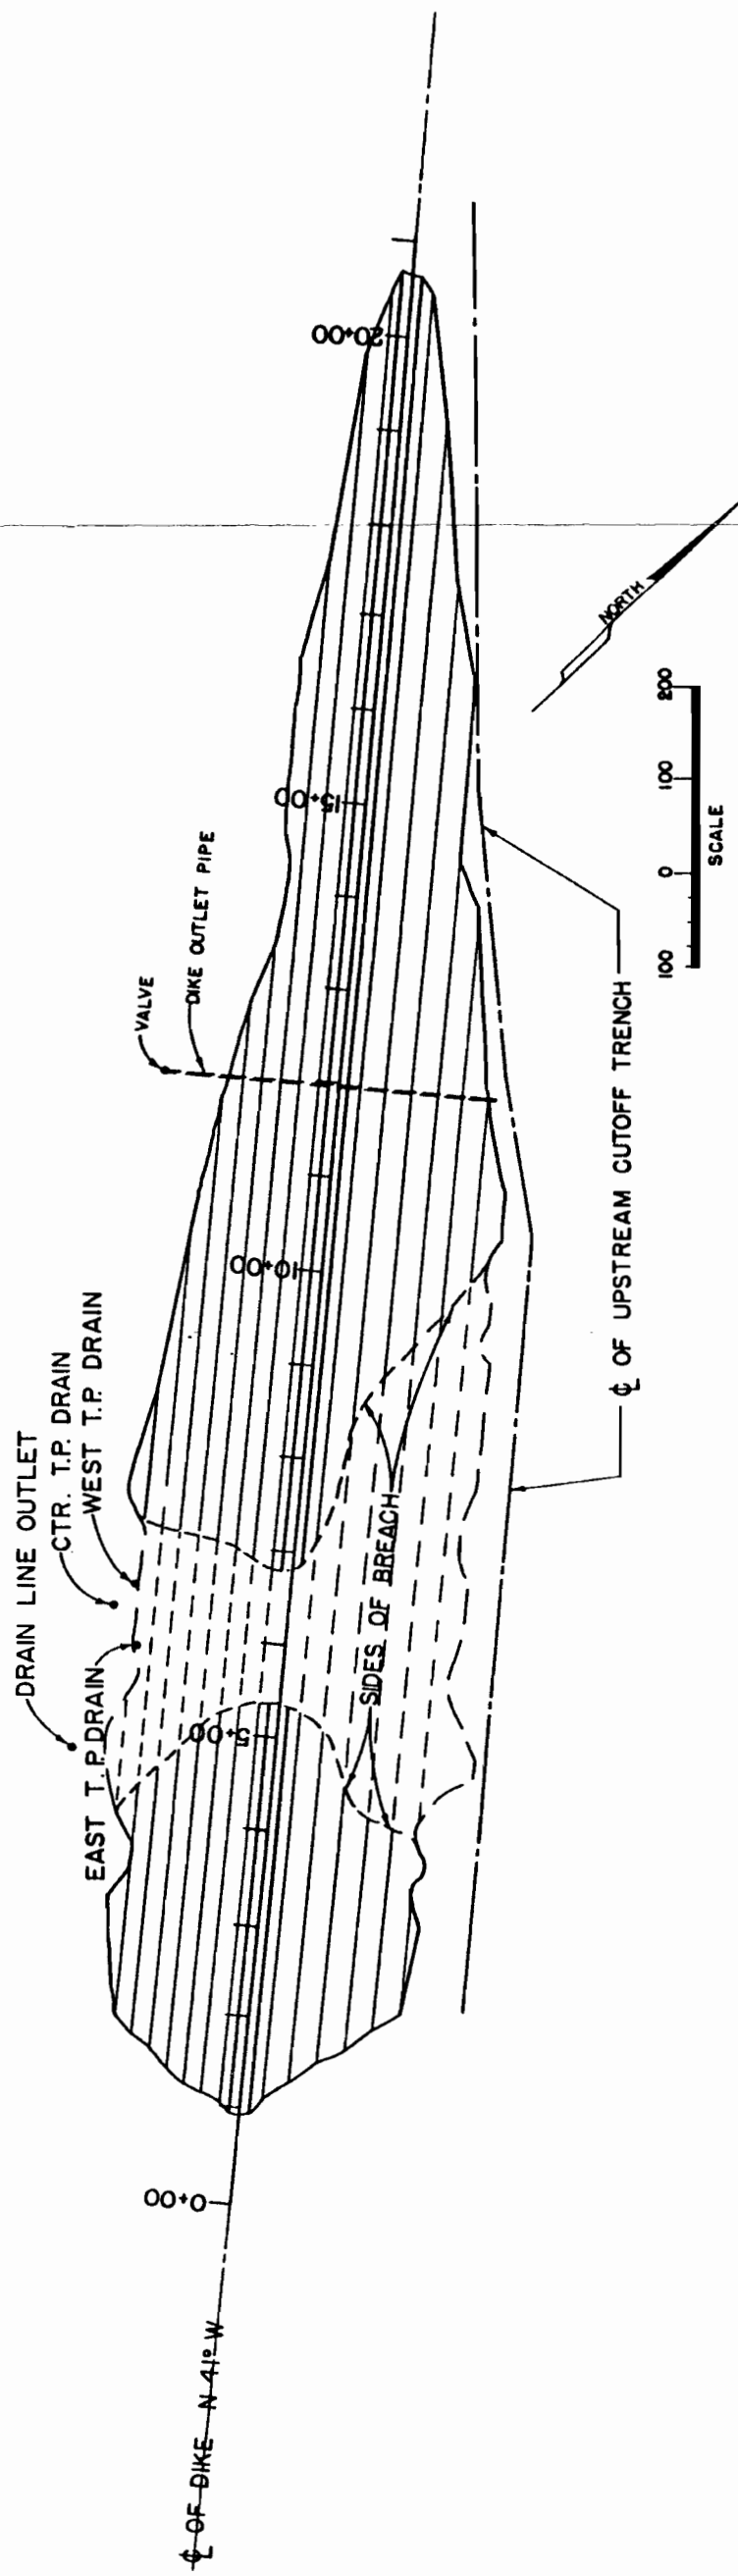
Figure 2-6
Upstream Cutoff Trench and
Plan View of Area of Failure

Based on eyewitness accounts, the first indication of the potential failure was on December 31, 1988, with the observed upward flow of discolored water around an observation pipe located at about Sta. 5+90 (see Figure 2-6). Equipment and materials were mobilized to place a gravel filter over the seep area. Despite continued efforts to control the flow, the volume increased to an estimated 70 cfs at about 10:30 p.m. when the flow changed from vertical to horizontal from a rapidly growing cavity at the toe. At this point, personnel and equipment were removed and an emergency downstream evacuation ordered. At about 11:30 p.m., a wedge of the downstream slope about 50 feet wide and extending about one-third of the way up the slope dropped down. Continuing embankment caving toward the reservoir crossed the dike crest and breached the dike, releasing the reservoir at about 12:30 a.m. on January 1, 1989. By 1:00 p.m. on January 1, about 25,000 acre-feet of water had drained from the reservoir, resulting in a breach about 300 feet wide and 80 to 90 feet deep.

NOTE: East T.P. Drain Is At Location Of Concentrated Seep Prior To Failure.

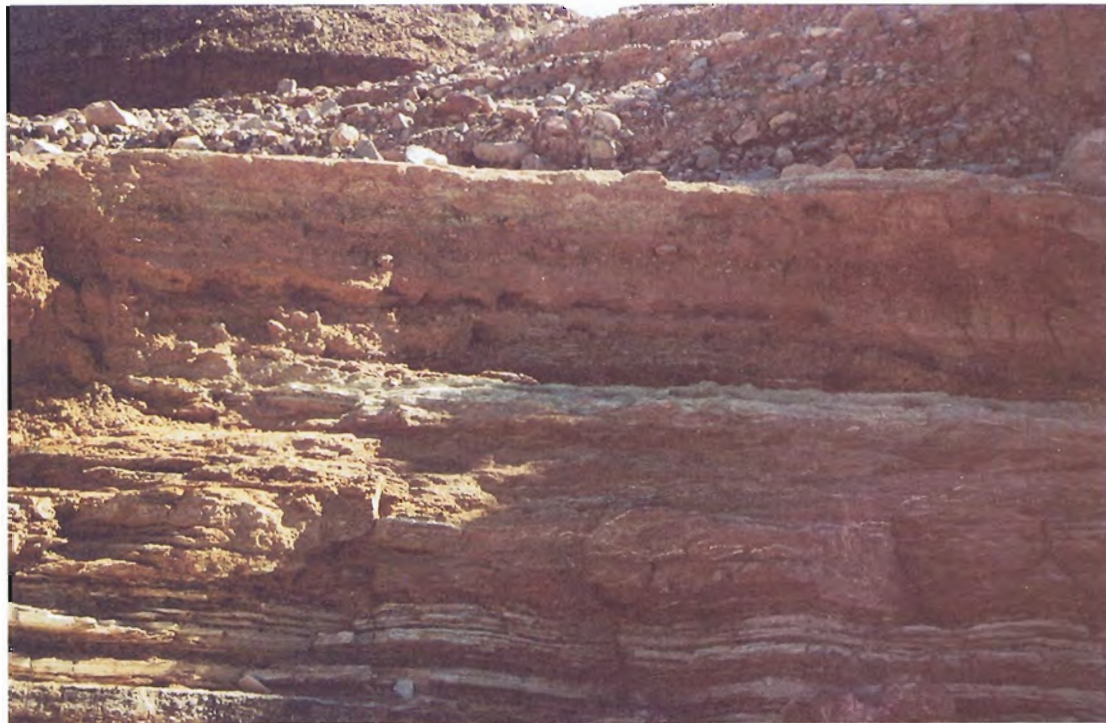
34. View of erosion channel near contact of dam and foundation downstream near station 4 + 50.

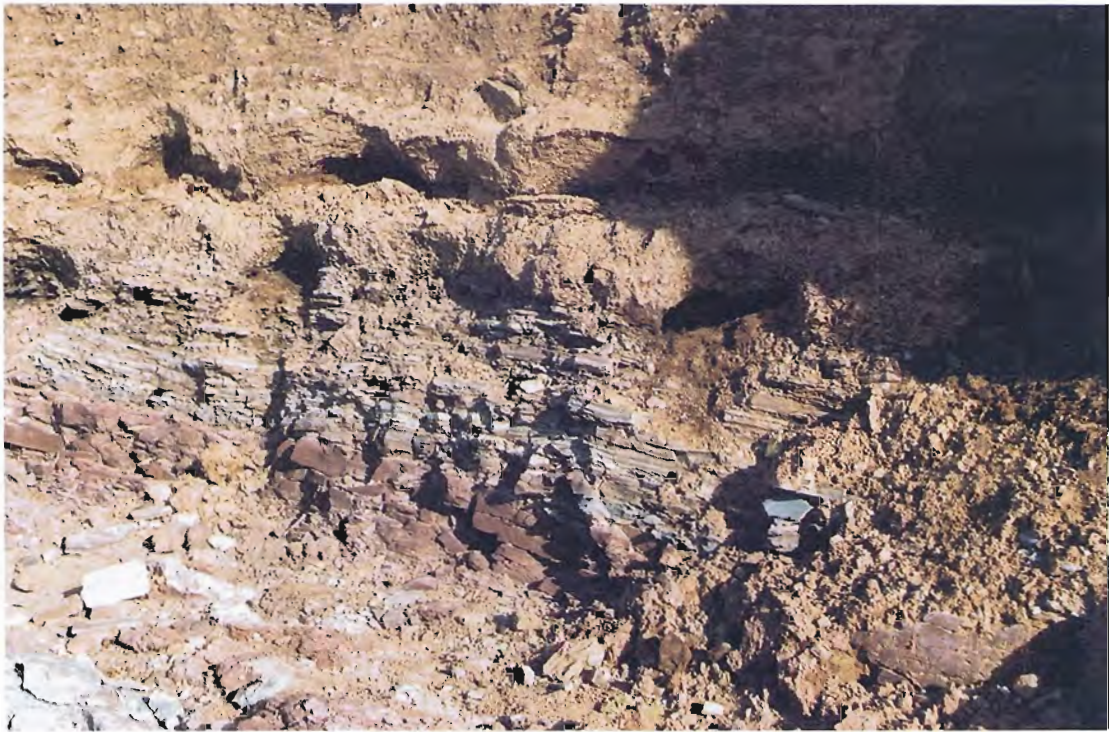
35. Close-up of downstream channels.

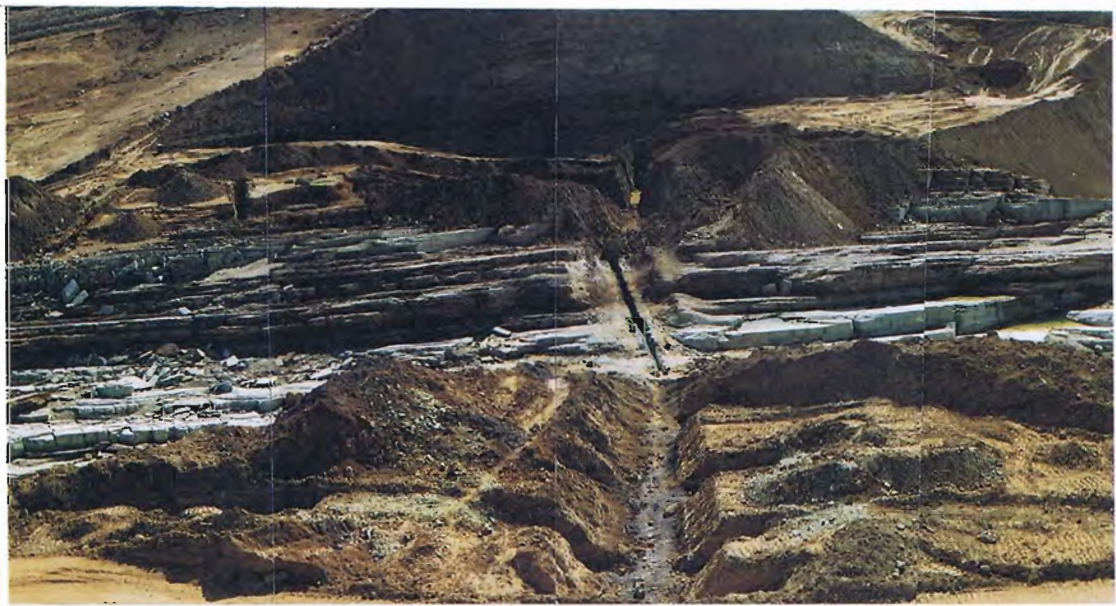
44. View from top of remaining right embankment showing post failure exploratory trenches.

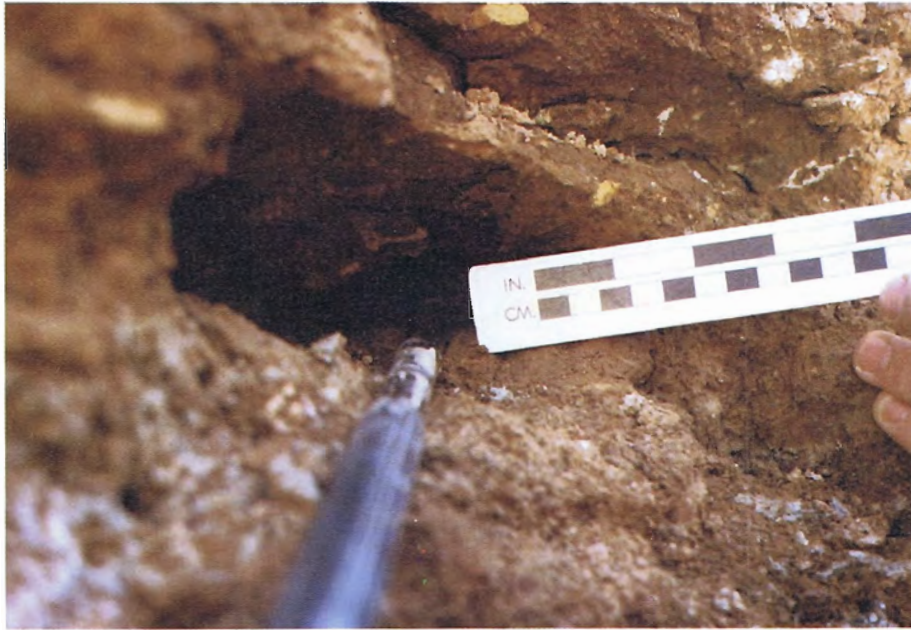
45. Piping channel found in exploratory trench upstream of dike centerline on left side of breach.

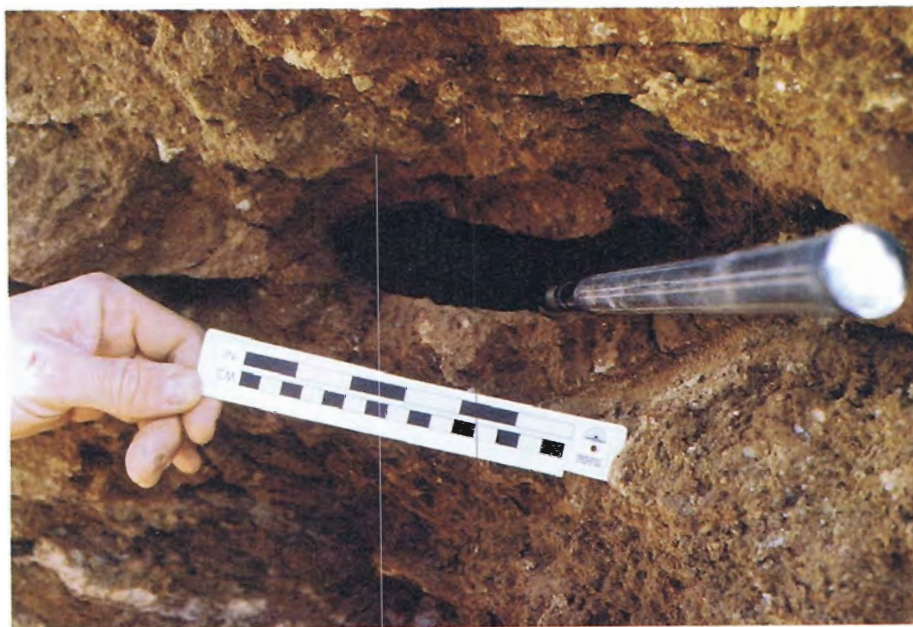
46. Piping channel found in exploratory trench upstream of dike centerline on left side of breach.

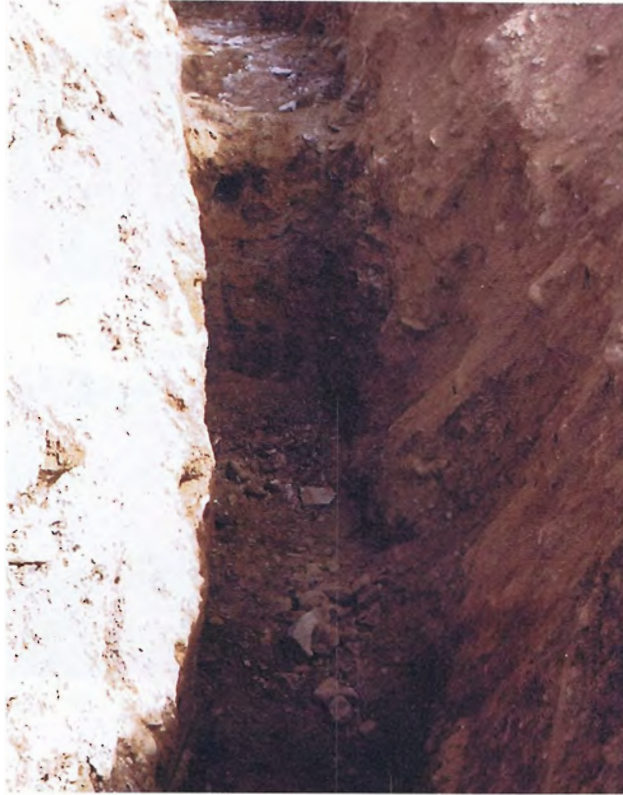
47. Drain pipe encountered in exploratory trench at original downstream toe of dam.

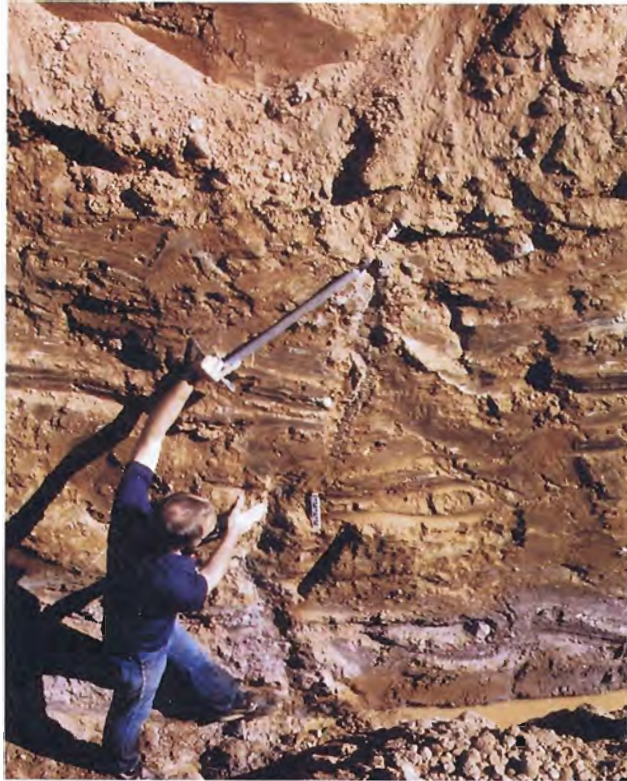
49. Grout filling crack noted in exploratory trench on centerline of cutoff on left side of breach.

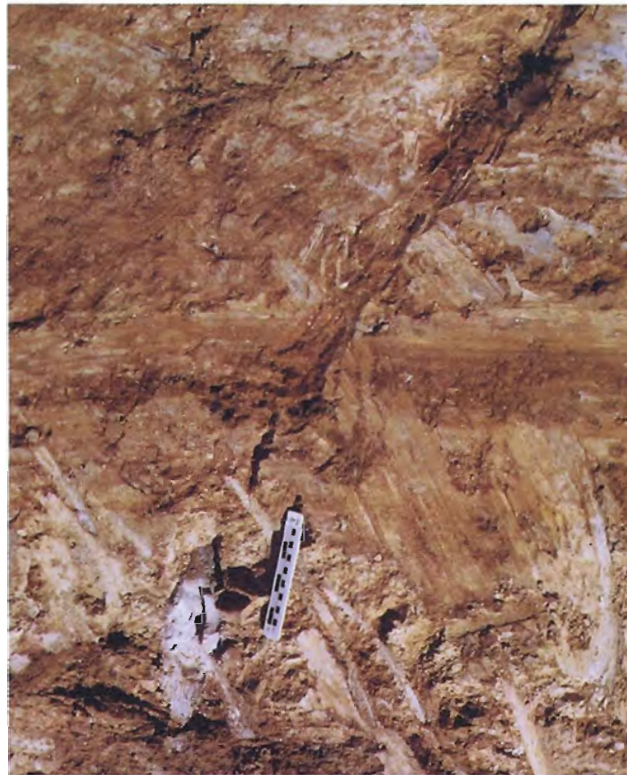
50. Grout contamination in Zone I materials on right side of breach.
