# South Carolina Dam Failure Assessment and Advisement

DR-SC-4241

FEMA P-1801 / December 2016

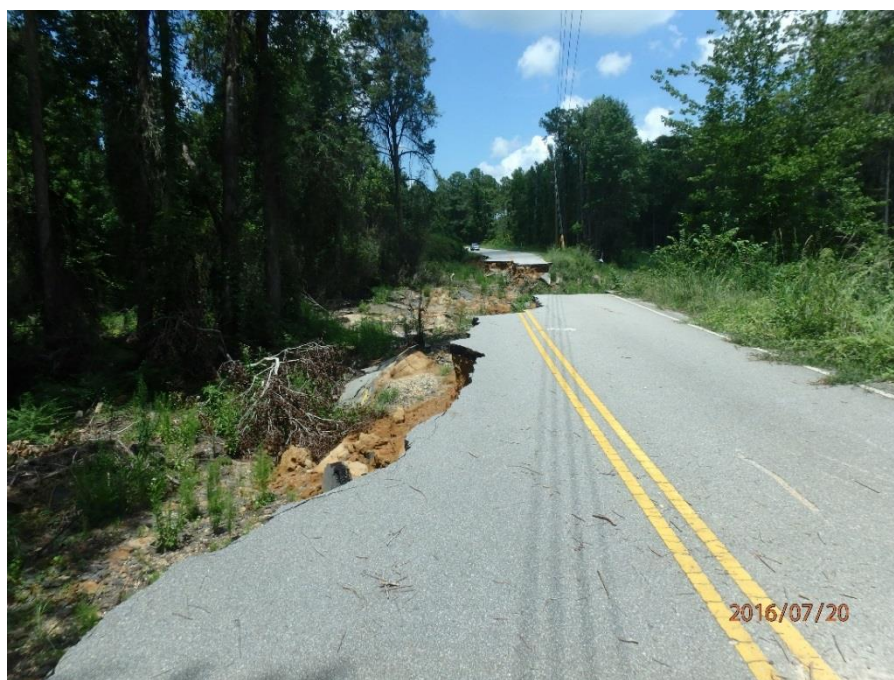
Figure 12 shows an example of overtopping failure at dam SCNONAME 14008. The foreground of the photo shows head cutting at the downstream toe and the background shows a complete failure where the head-cutting has propagated upstream through the road/dam embankment.

Figure 12: Head-Cutting of the Embankment at SCNONAME 14008 (Source: FEMA 2016)

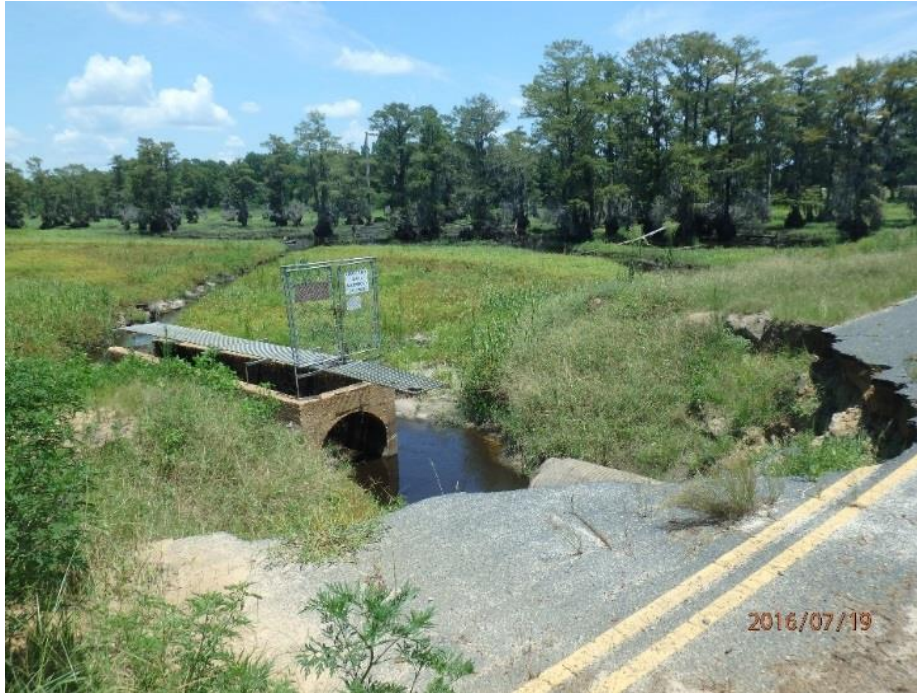
Potential piping failure and internal erosion was observed at 6 dams. Figure 14 shows dam SCNONAME 14005 where internal erosion was one of the causes of failure. The outlet pipe at this dam was completely rusted and caved in. The most common form of internal erosion is piping, which is caused by seepage of water through the soil, causing some of the soil particles to wash away from the embankment. It can also be caused by leaking or failing pipes through the dam. Internal erosion is partly a function of the type of soil used to construct the embankment and the degree of compaction achieved when placing the soil; fine-grained, well-compacted, cohesive soils (e.g., clays) are less likely to experience internal erosion than large-grained, poorly compacted, non-cohesive soils (e.g., sands). Internal erosion is dangerous because it may not be readily evident to an untrained observer, and failure can occur without much warning.

Figure 14: Piping Failure at SCNONAME 14005 (Source: FEMA 2016)

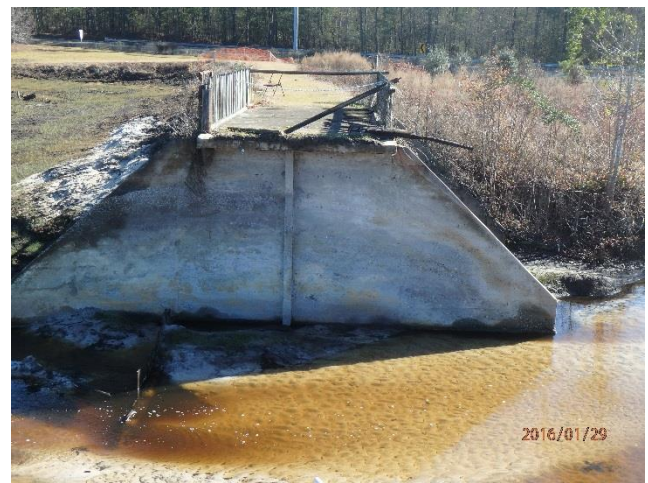
Structural failure was observed to contribute to the failure of 12 dams. Structural failures of earth dams can occur in the embankment itself or in its associated structures. The most apparent signs of embankment failure are cracking, settlement, and sliding. Sloughs, bulges, and cracks are indications of potential failure. Failures of spillways and drains can also cause an embankment to fail. Spillways, which are often constructed of concrete or stones and mortar, can fail when soils supporting their foundations erode, resulting in settlement and cracking of the spillway. Processes such as freezing and thawing, chemical reactions, and erosion can weaken the spillway materials, which also could lead to failure. An example of a structural failure where the connection between the concrete spillway and earthen embankment deteriorated can be seen at JW Smoaks Pond in Figure 15. This dam did not exhibit any significant signs of overtopping and had an open channel emergency spillway that was engaged and functioned properly. Another example of a structural failure can be seen on the next page in Figure 16 from Duffies Pond Dam. While this dam exhibited signs of overtopping, it was deemed a structural failure after discussion with the owner indicated that the dam was manually breached for a repair in that same location years ago, indicating the repair was likely the cause of failure.

Figure 15. Example of Structural Failure at JW Smoaks Pond (Source: FEMA 2016)

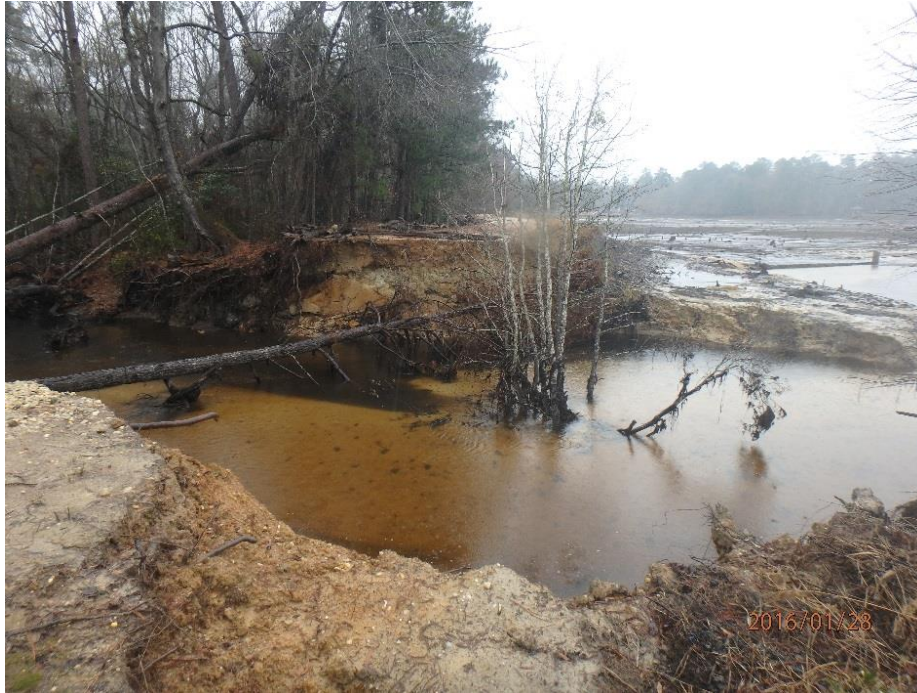
Figure 16: Structural Failure at Duffies Pond Dam (Source: FEMA 2016)

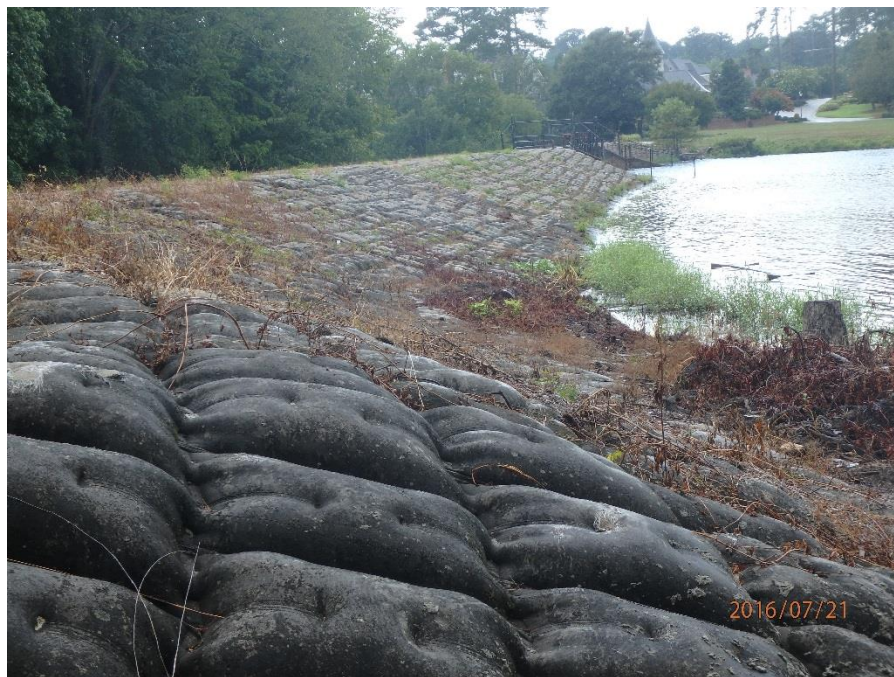
Figure 24: Concrete Armoring at Forest Lake Dam (Source: FEMA)

Structural approaches to mitigating overtopping of the dams are technically feasible and vary in cost. It is recommended that any designs completed to mitigate future overtopping incorporate planned land use changes so that designs account for future conditions both upstream of downstream of the dam over the life of the dam and not just current conditions. A licensed engineer should review the projected future flows and make design recommendations. FEMA 1015 “*Overtopping Protection for Dams*”, (which can be found online at <https://www.fema.gov/media-library/assets/documents/97888>) provides extensive, detailed information about the approaches that can be used. The most common structural approaches to mitigating dam failure from overtopping includes armoring of the downstream dam face and increasing the spillway capacity. Additional information about armoring is available in the associated FEMA Recovery Advisory “*Embankment Armoring*”. Forest Lake Dam, which is located in Columbia, is an example of concrete armoring to mitigate overtopping failure and can be seen below in Figure 24.

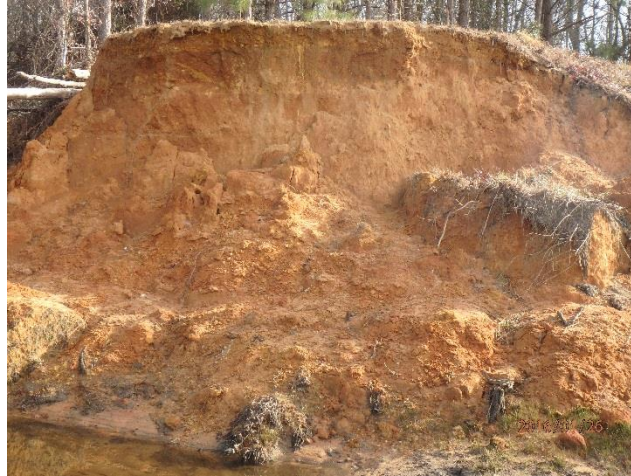
Figure 25: Typical Soil Profile of Failed Dam. Able/Corbett Pond Dam shown (Source: FEMA)

- **Ensure proper compaction** – Foundation soils should be well-compacted and able to support the weight of the dam as well as the water being retained behind the dam. The soils that comprise the dam also should be well-compacted in accordance with the recommendations of the design engineer. Achieving the proper compaction at or slightly above the optimum moisture content is critical to ensuring the stability and proper performance of the dam.
