**DEPARTMENT OF THE ARMY**  
U.S. ARMY CORPS OF ENGINEERS  
RISK MANAGEMENT CENTER  
12596 WEST BAYAUD AVE., SUITE 400  
LAKEWOOD, CO 80228

SUBJECT: 3 September 2015 Gold King Mine, CO Travel Report

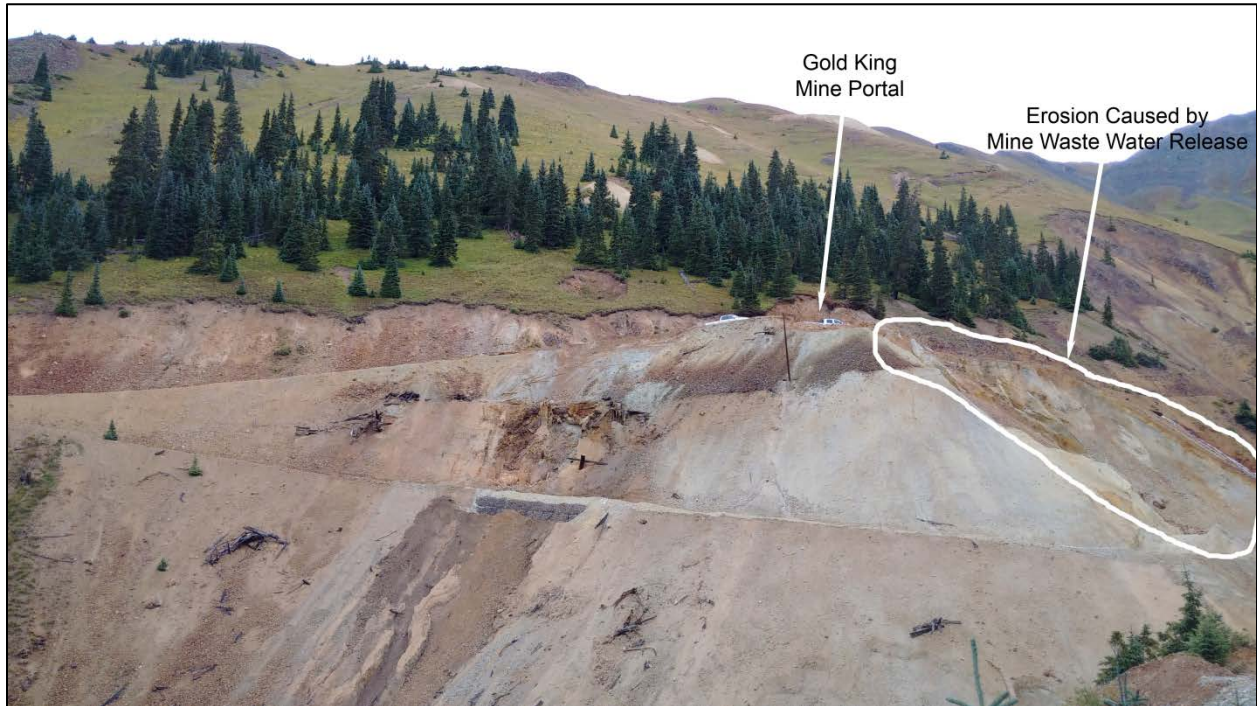
c. The EPA was preparing to investigate the Gold King Mine on August 5, 2015 by removing the fill placed above the mine entrance. They excavated to the top of the mine entrance denoted by the mine timbers that used to form the roof of the entrance. Once they were done excavating, a small amount of seepage was noticed near the top of the mine entrance. Soon, a small clear spring shot up approximately 2' from the pile of debris near the mine entrance. This spring soon changed to a steady flow, which increased dramatically over the next few minutes. The entire seepage change happened within 5 minutes. EPA has a series of time/date stamped photos that documents this sequence of events.

Figure 3 - Photo of the mine portal and the erosion caused by the mine waste water release

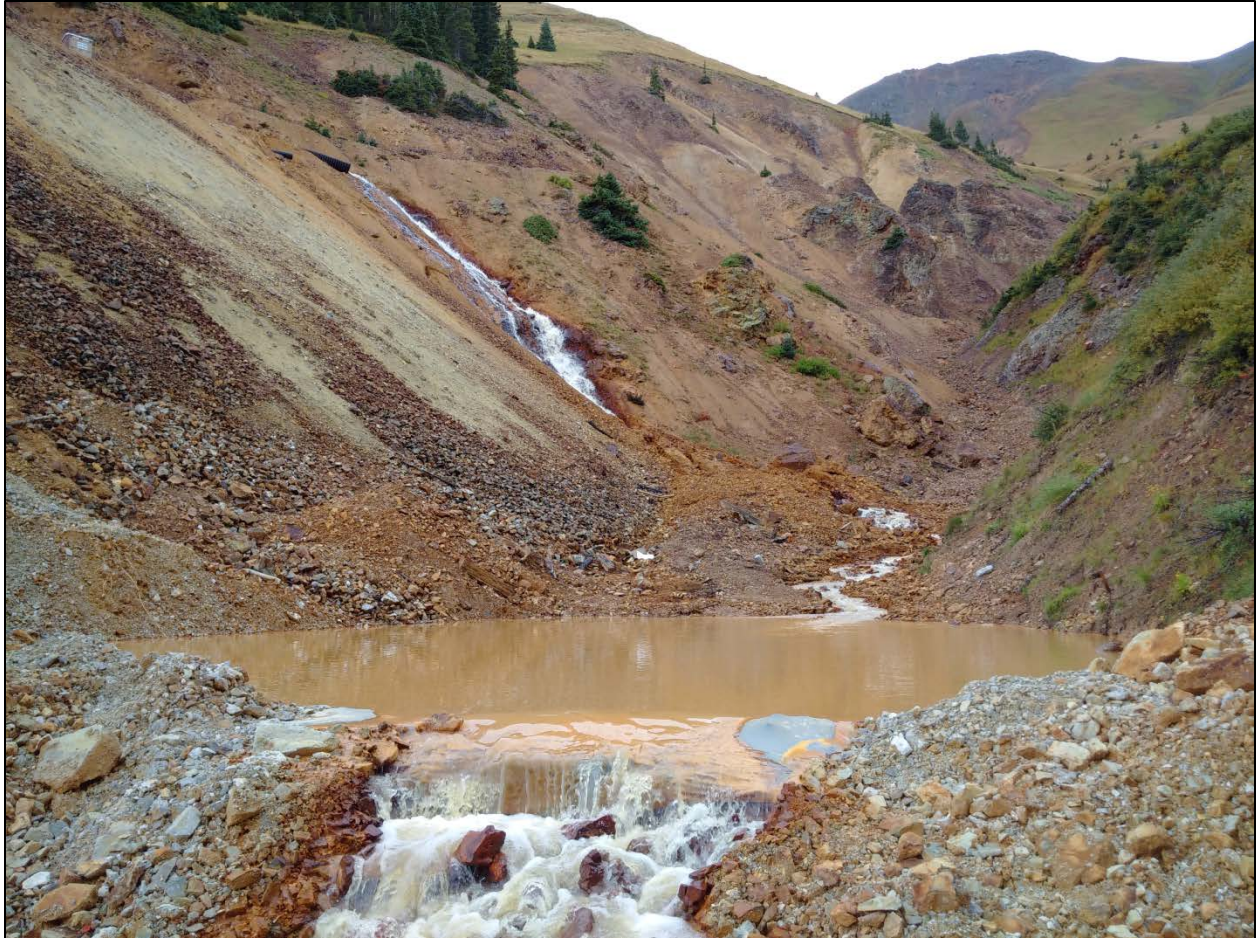
Figure 4 - Photo looking up near the Gold King Mine portal (off screen left), showing the discharge from the mine as of 3 September and a new settling pond.

e. The EPA constructed several new settling ponds to handle the discharge from Gold King. Some water is being pumped to settling ponds downslope from the Red and Bonita Mine. The EPA is currently working to construct a more robust settling pond near the American portal before winter sets in. Most of the existing settling pond system would be destroyed by Spring runoff.

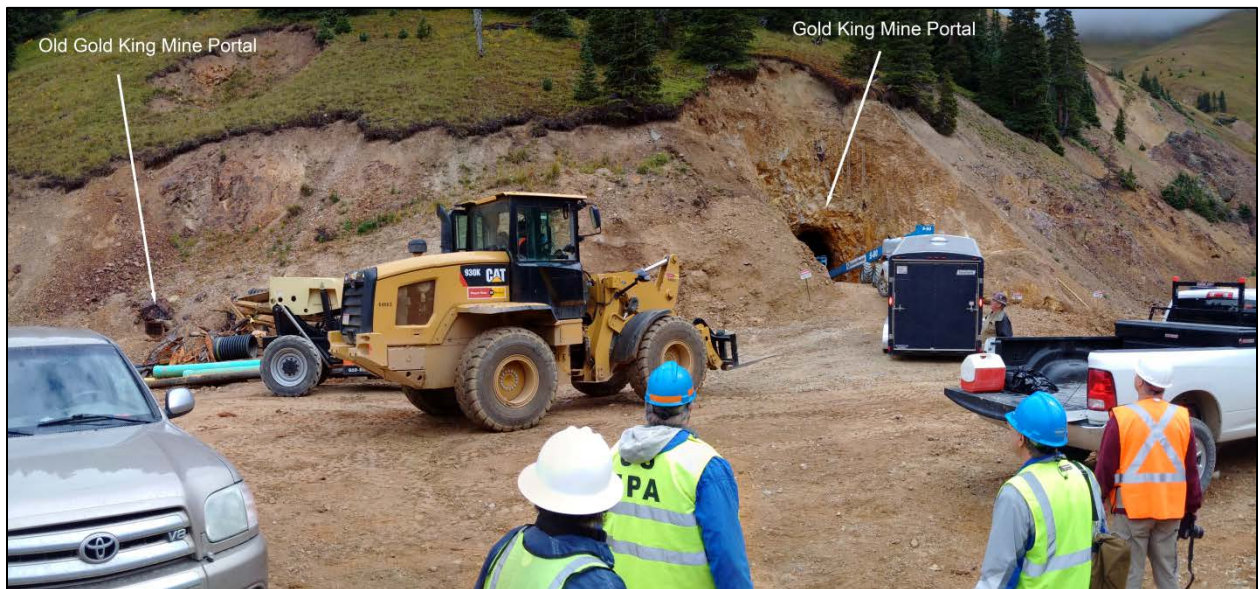
Figure 5 - Photo of the old and new Gold King Mine portals

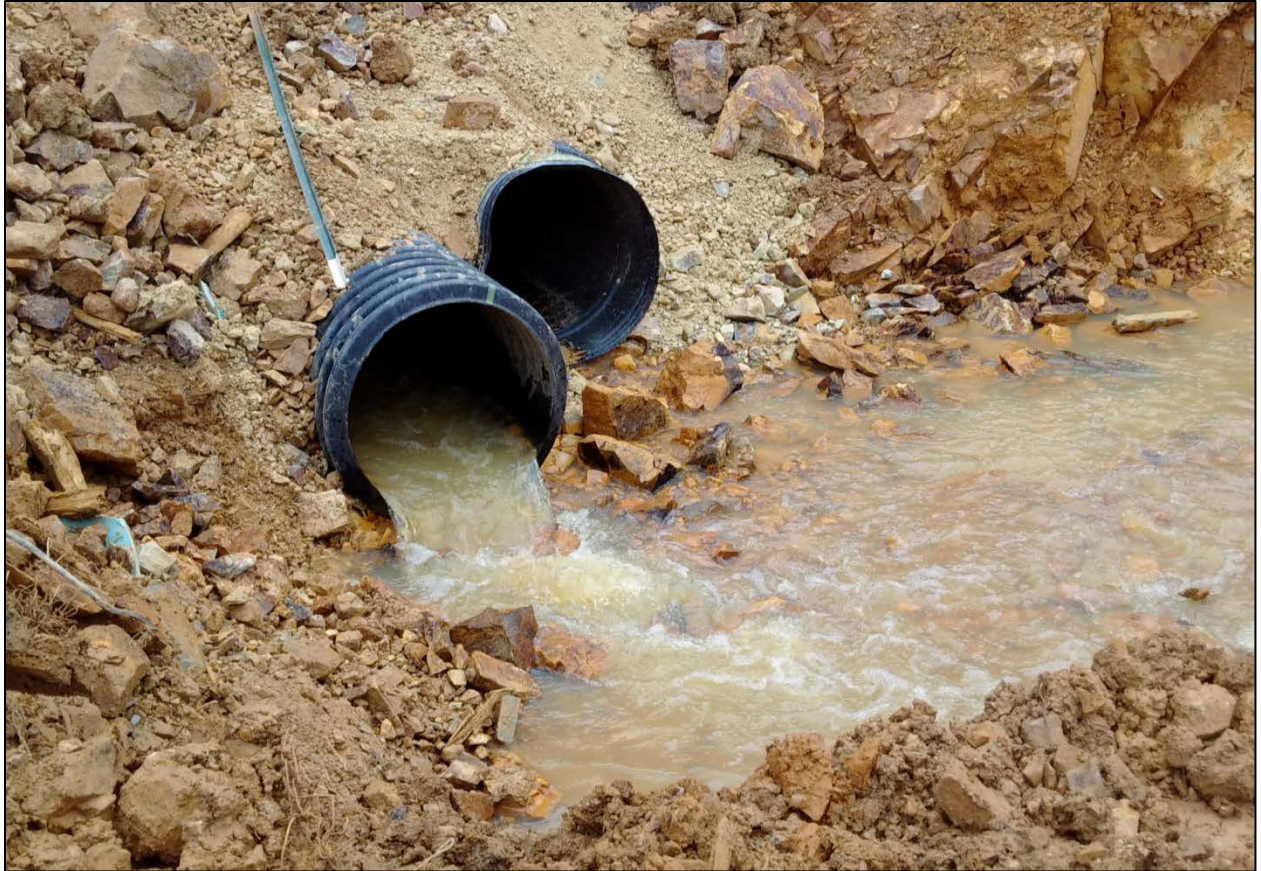
d. Discharge from the mine continues to flow at approximately 600 gallons per minute, which is more than three times higher than before the portal collapse. It is not yet safe to enter the portal, but it appears that several areas behind the face of the portal collapsed.

Figure 6 - Current discharge from Gold King Mine

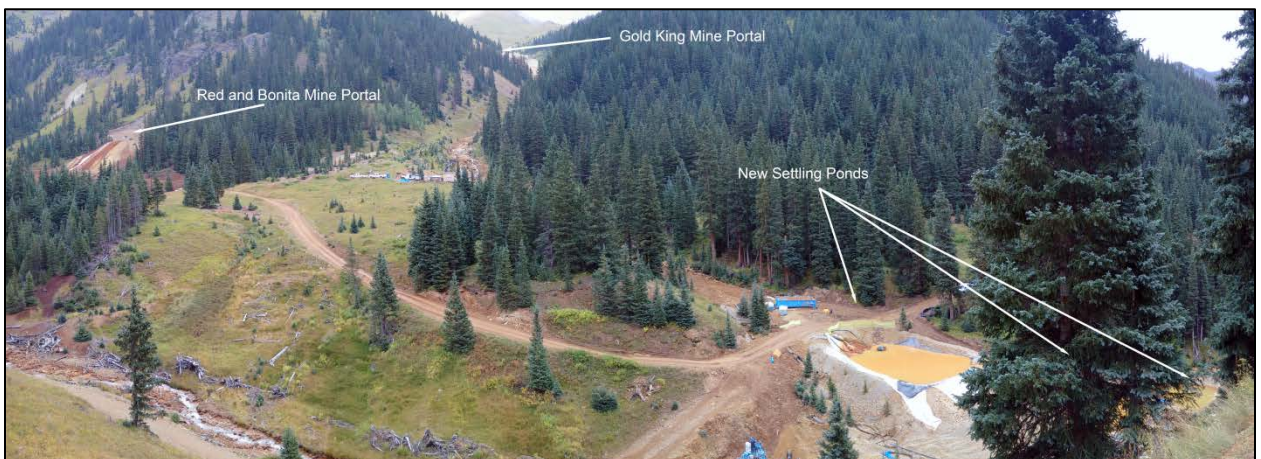
Figure 7 - Photo showing Cement Creek and the new settling pond complex

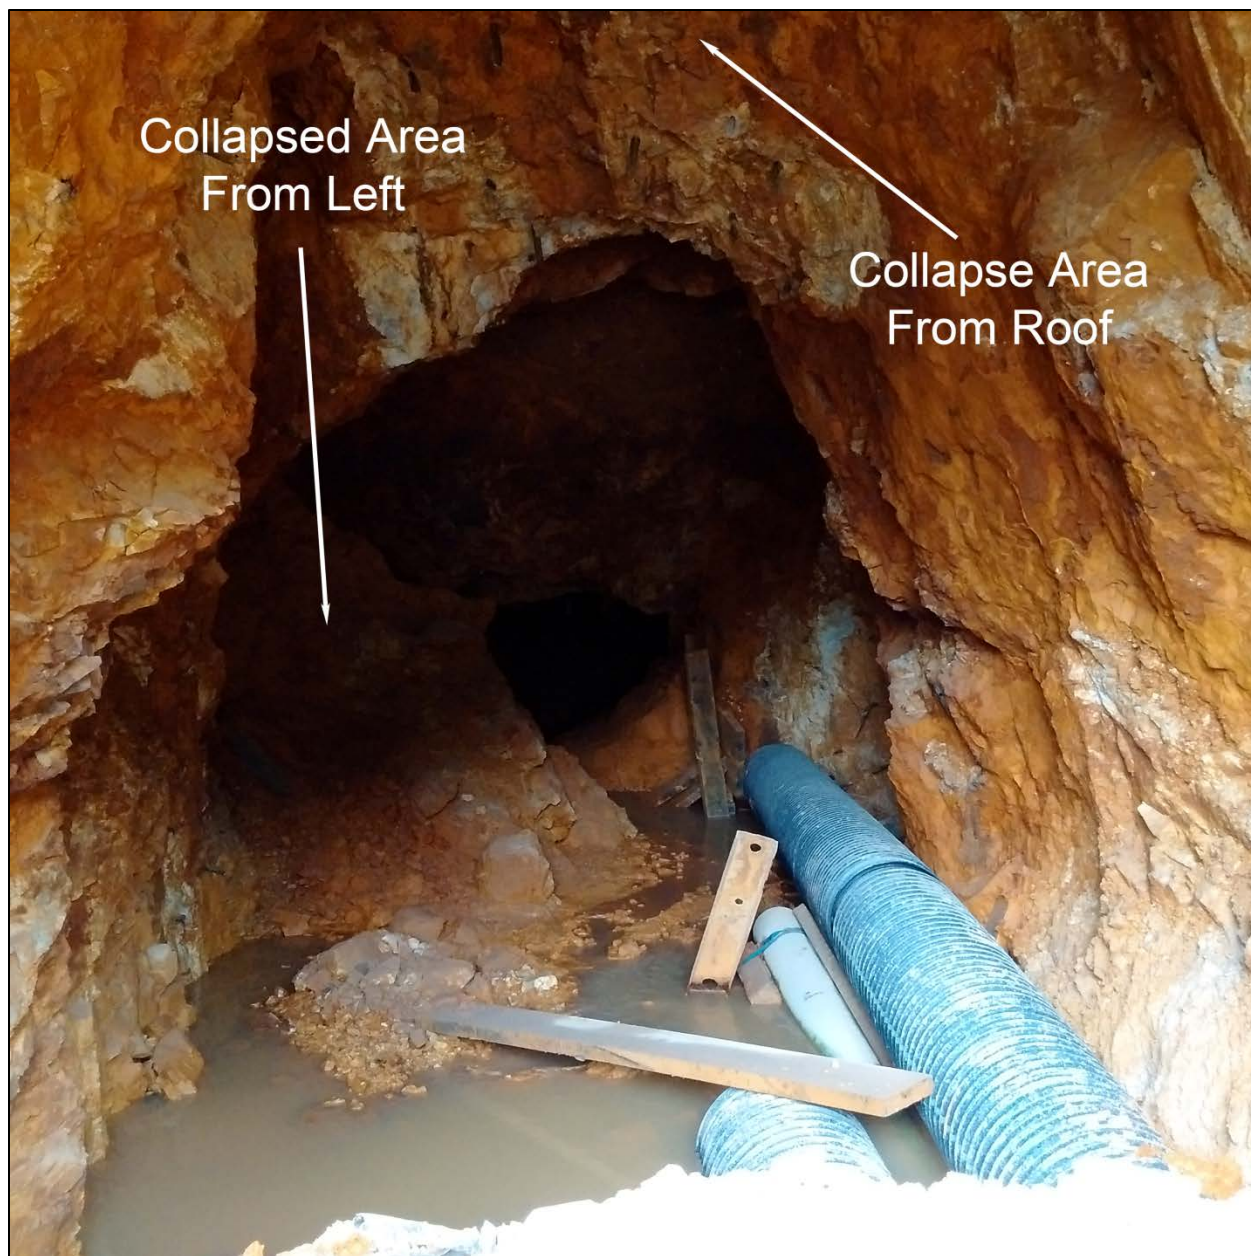
Figure 8 - Photo looking into Gold King Mine. Note portions of the tunnel have collapsed from the left and from the roof

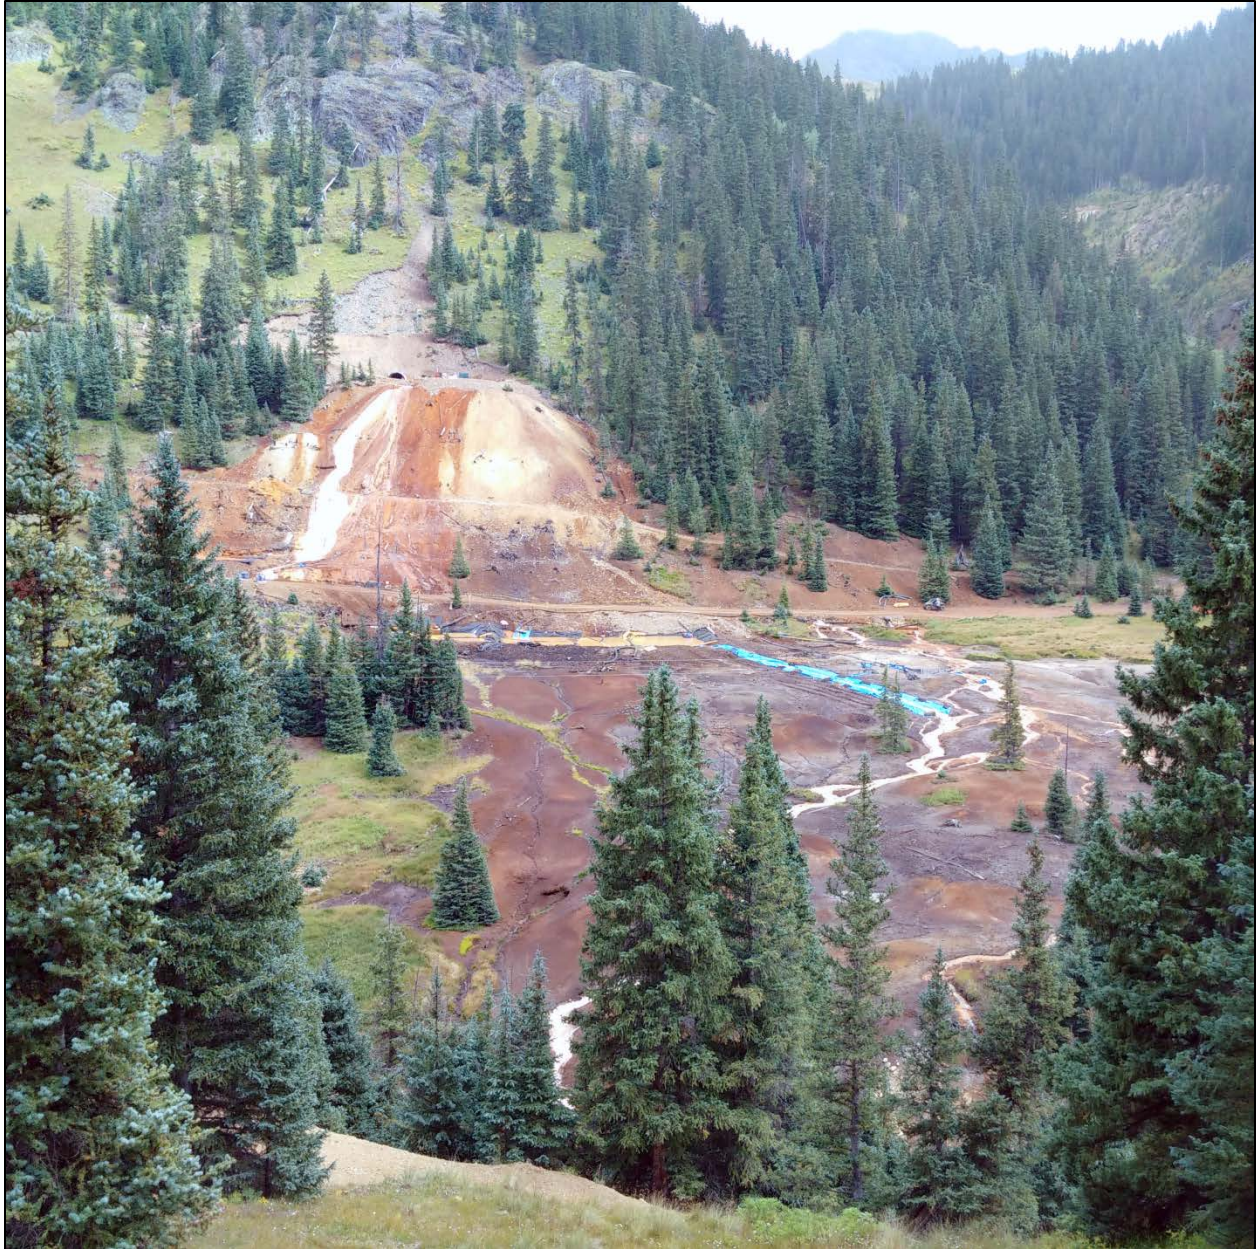
**Figure 9 - Photo showing the Red and Bonita Mine portal. Some discharge from Gold King is now being piped over to the settling ponds beneath Red and Bonita.**

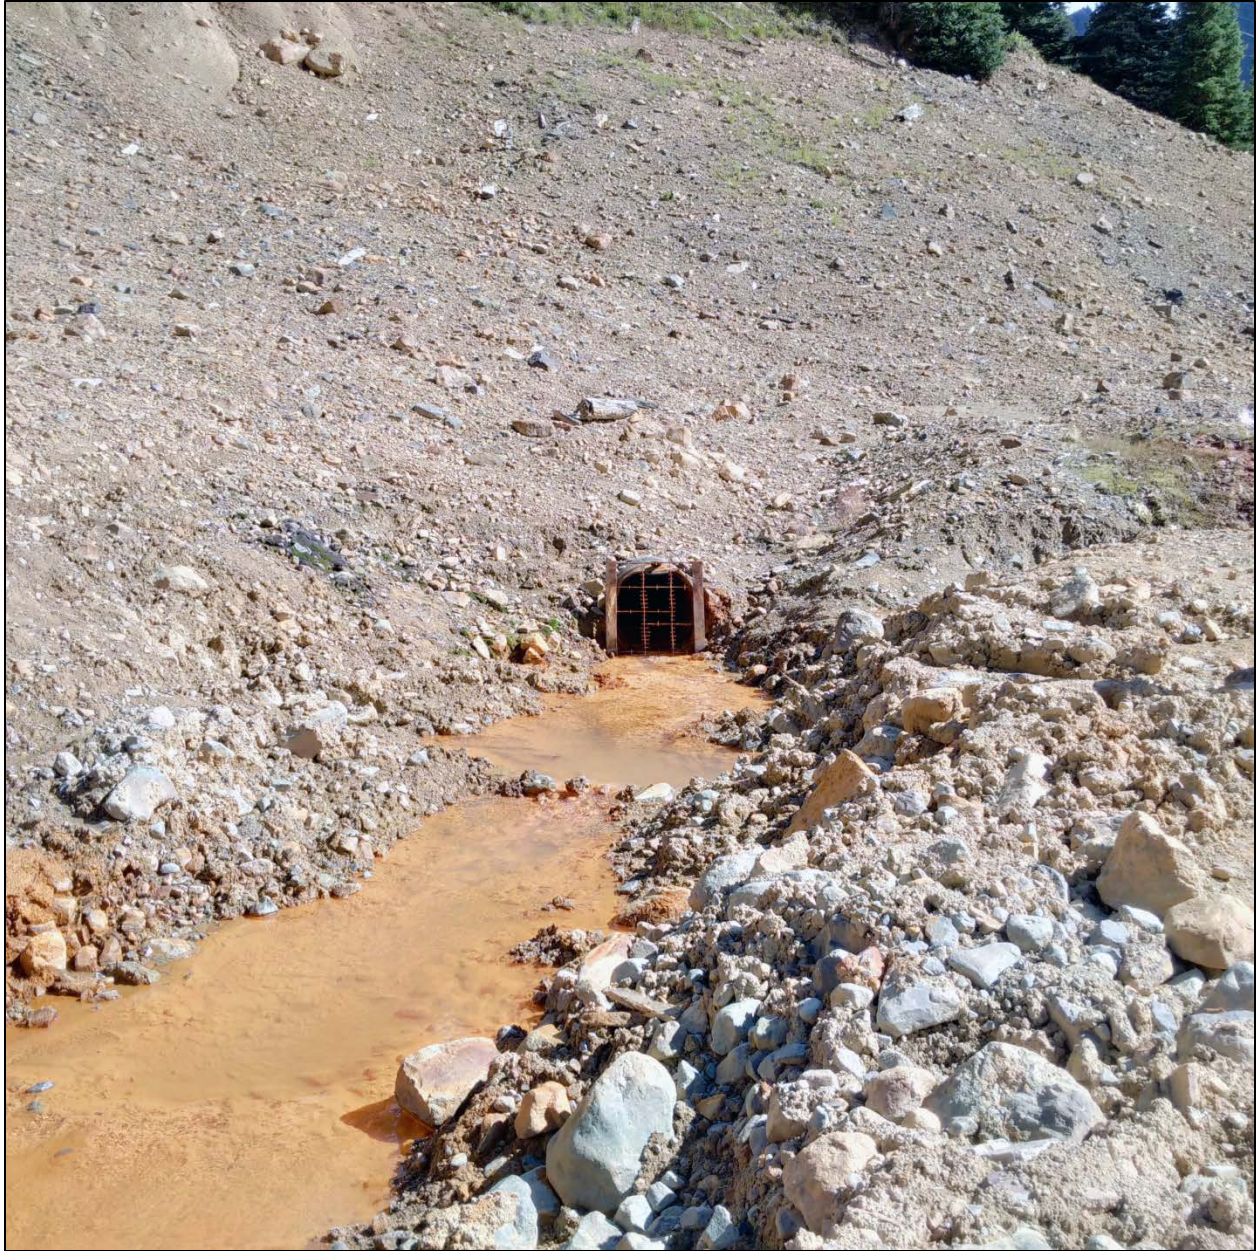
**Figure 10 - Photo of the discharge coming out of the American portal of the Sunnyside Mine**
