**ANALYSIS OF
COAL REFUSE DAM FAILURE**

**MIDDLE FORK BUFFALO CREEK
SAUNDERS, WEST VIRGINIA**

**UNITED STATES
DEPARTMENT OF THE INTERIOR
BUREAU OF MINES
WASHINGTON, D.C.**

VOLUME 1 OF 2 - TEXT

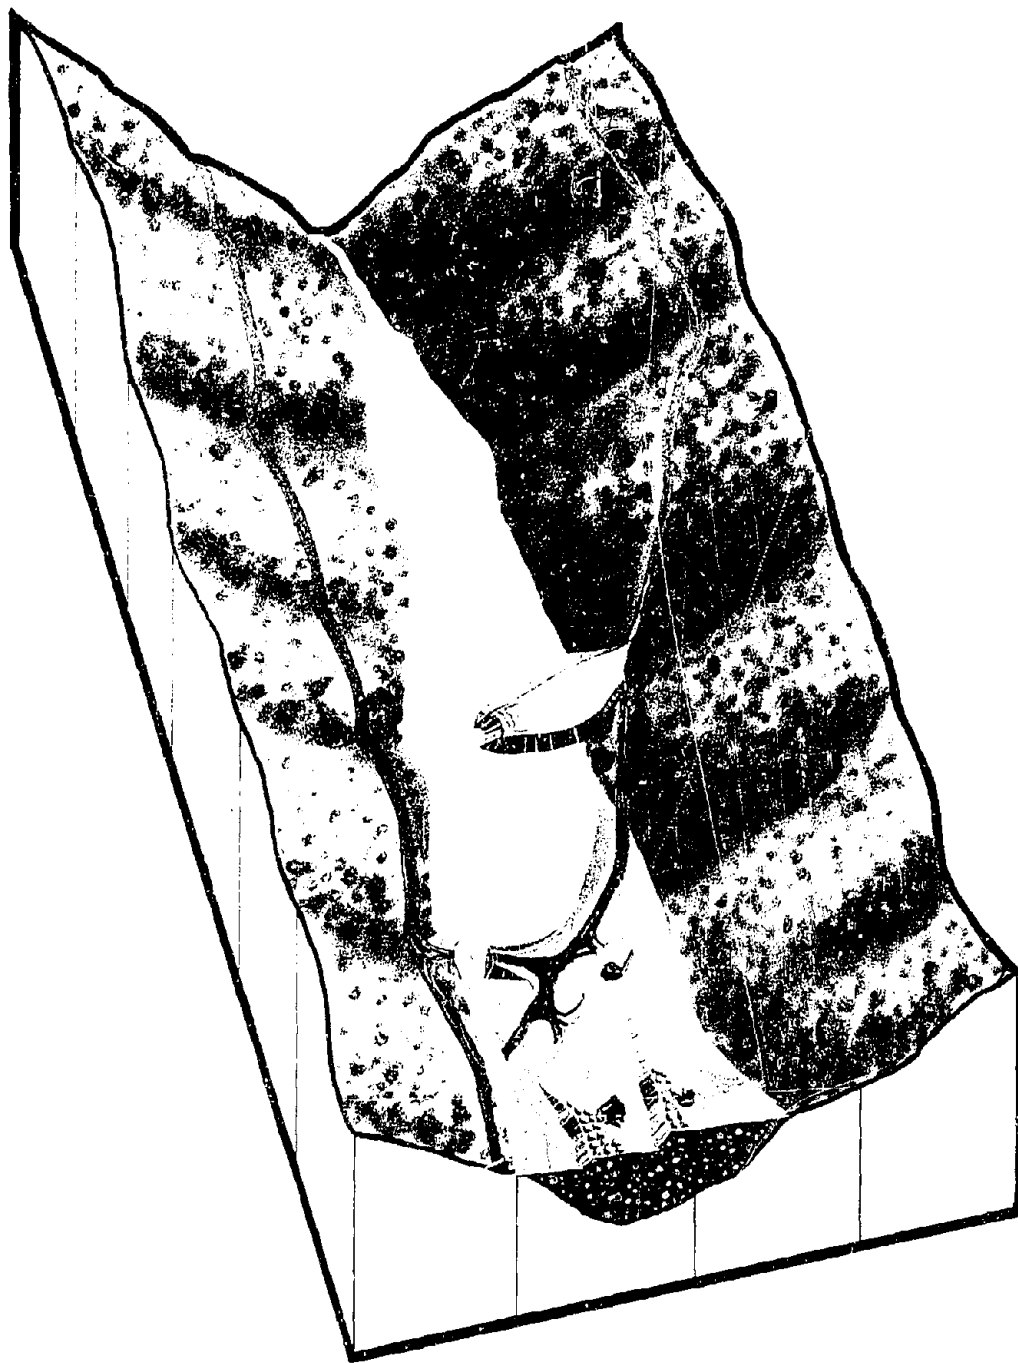
MIDDLE FORK VALLEY, MARCH 1967, LOOKING UPSTREAM. DAM NO. 1 HAS FAILED BY OVERTOPPING. DAM NO. 2 SUFFERS EROSION AND SLUMPING THROUGH INCOMPLETE AT THIS TIME.

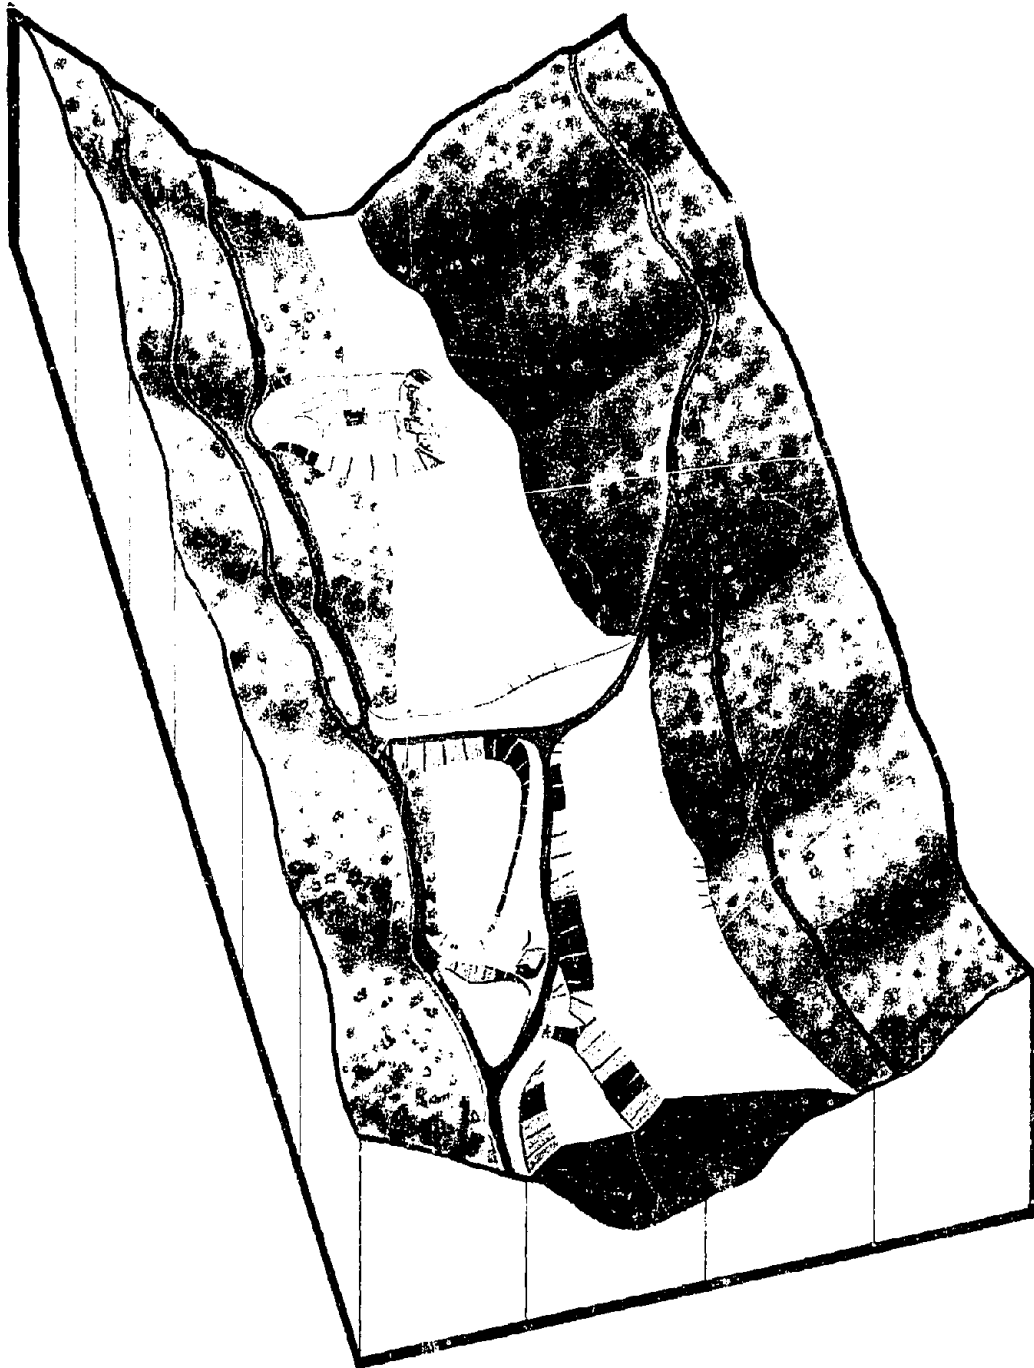
FIGURE V-14C

In February 1969, a large slump occurred on the advancing face of the embankment (Figure V-14C). This failure is described as "that whole end of the dam, 100 feet of it, disappeared" (U.S. Congress, 1972b, p. 318). This failure was not directly related to seepage forces in

MIDDLE FORK VALLEY, FEBRUARY 1969, LOOKING UPSTREAM. THE ADVANCING FACE OF THE DAM NO. 3 EMBANKMENT HAS FAILED.

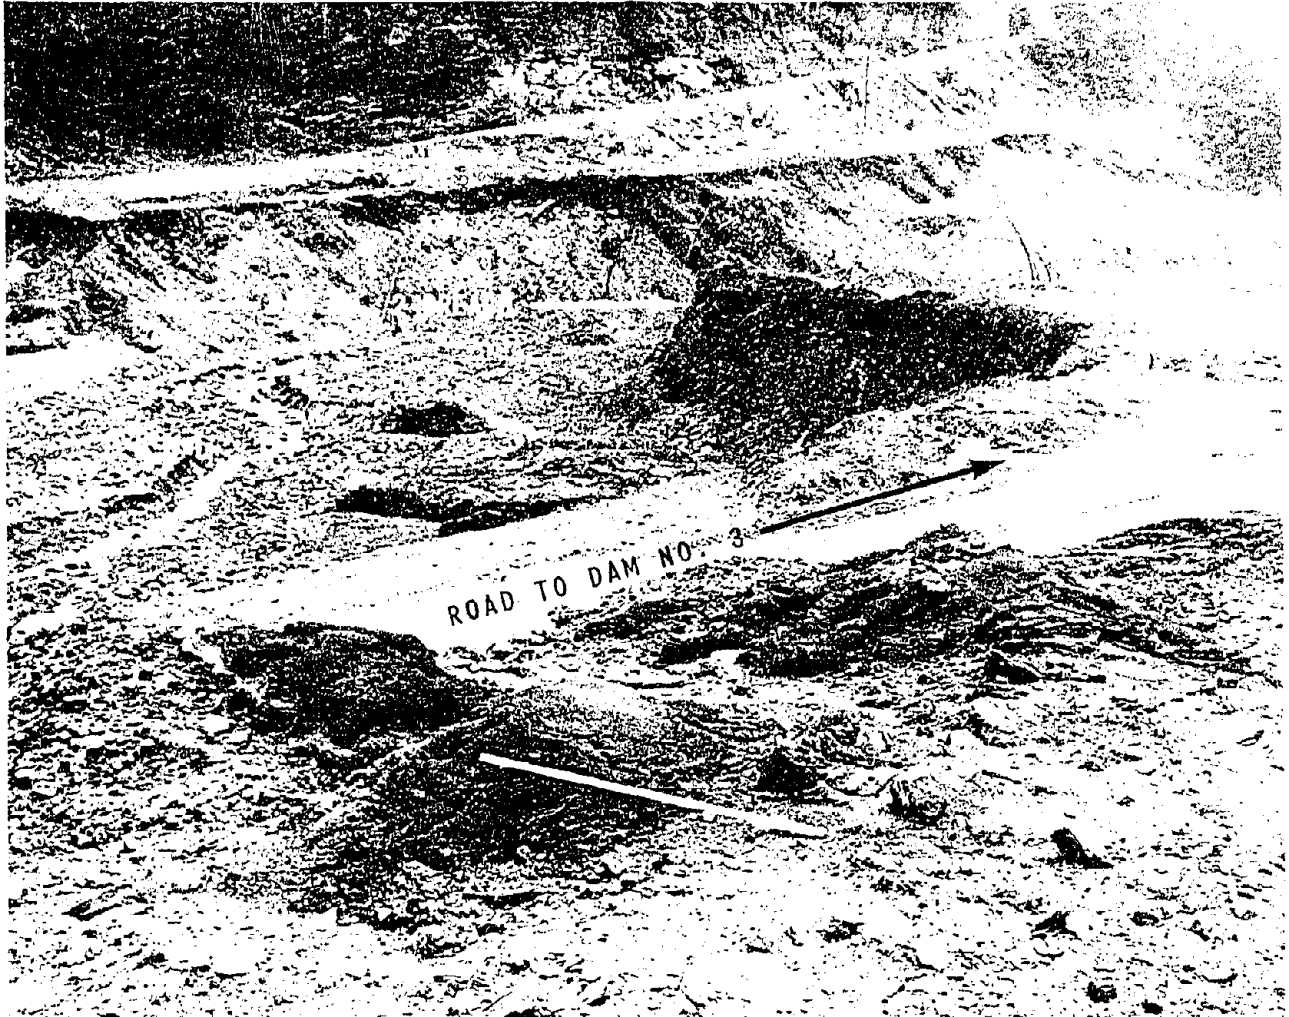
PATCHES OF POOL 2 SLUDGE AT APPROXIMATE ELEVATION 1702 ON REFUSE BANK (SEE ALSO FIGURE VI-4).

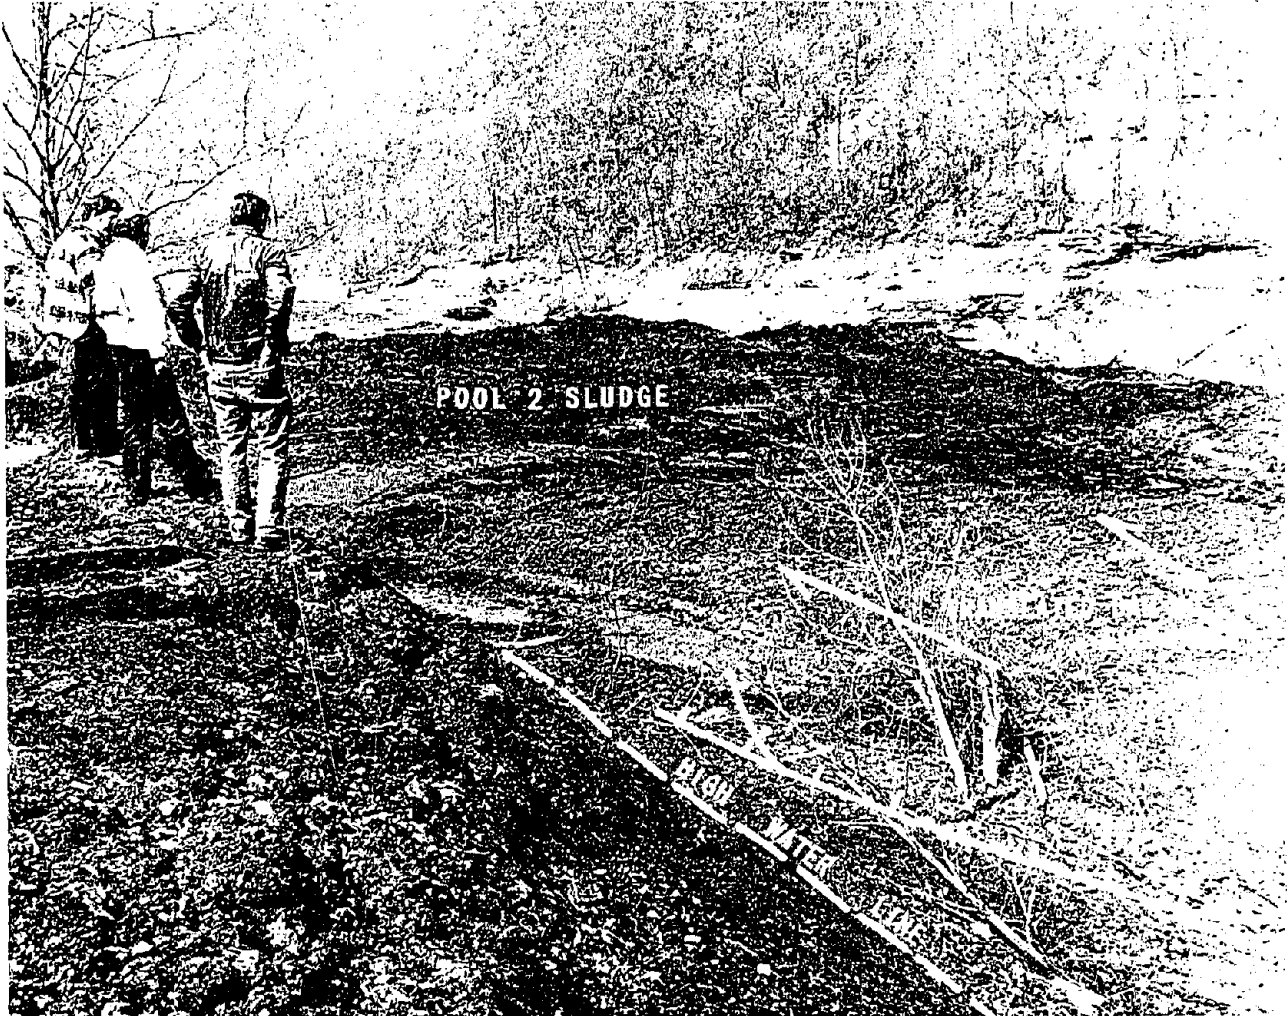
POOL 2 SLUDGE (DARK AREA IN MIDDLEGROUND) AND TRANSLATED DAM NO. 3 EMBANKMENT GRAVELS AT RIGHT, BELOW SLOPE. VIEW FROM ROAD ABOVE POOL 2 AT LEFT SIDE OF VALLEY. THE HIGH WATER LINE IS SHOWN HERE AT APPROXIMATE ELEVATION 1712. SYMBOLS SHOW LOCATIONS OF SECONDARY LANDSLIDE CRACKS IN TRANSLATED DAM NO. 3 EMBANKMENT GRAVEL. THE MAIN SLIDE MASS MOVED DOWNSTREAM (DIAGONALLY TO THE UPPER LEFT IN THE PHOTO), PUSHING THE DARK POOL 2 SLUDGE IN FRONT OF IT. HIGHER PORTIONS OF THE TRANSLATED EMBANKMENT ON THE LEFT SIDE OF POOL 2, JUST BELOW THE HIGH WATER LINE IN THE PHOTO, THEN SLID TOWARDS THE CENTER OF MIDDLE FORK VALLEY. FIGURES VI-9 THROUGH VI-14 WERE TAKEN IN THE POOL 2 SLUDGE OR "ROILED AREA", SHOWN ABOVE. FOR ANOTHER VIEW OF THE HIGH WATER LINE SHOWN HERE, SEE FIGURE VI-25A.

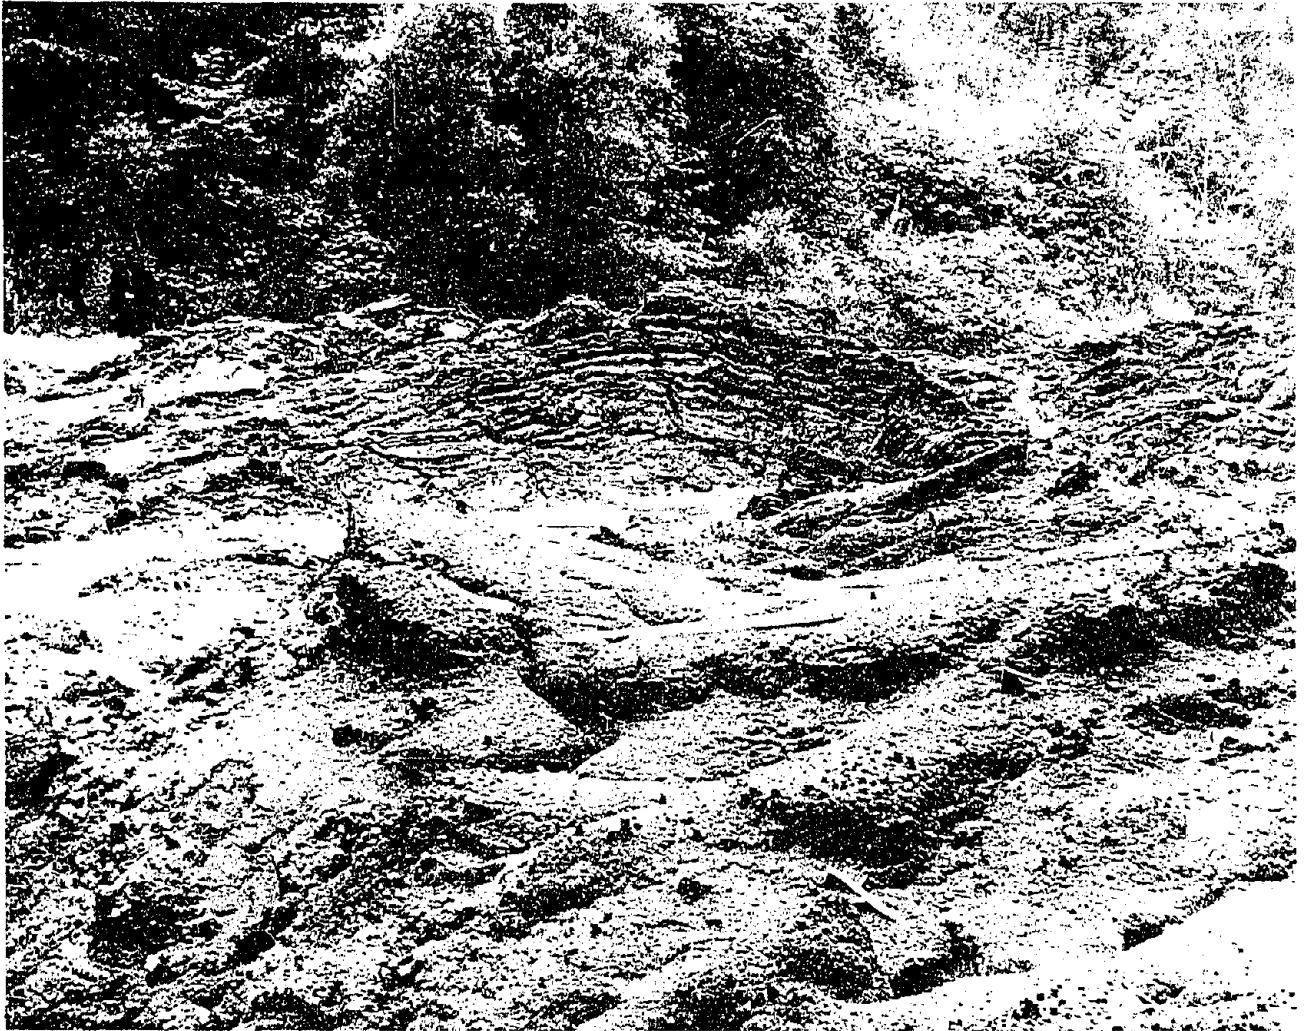
GENTLE FOLDS IN THE "ROILED AREA" OF POOL 2 SLUDGE. DETAILS OF THE BEDDING ARE WELL PRESERVED IN THE ANTICLINE IN THE BACKGROUND

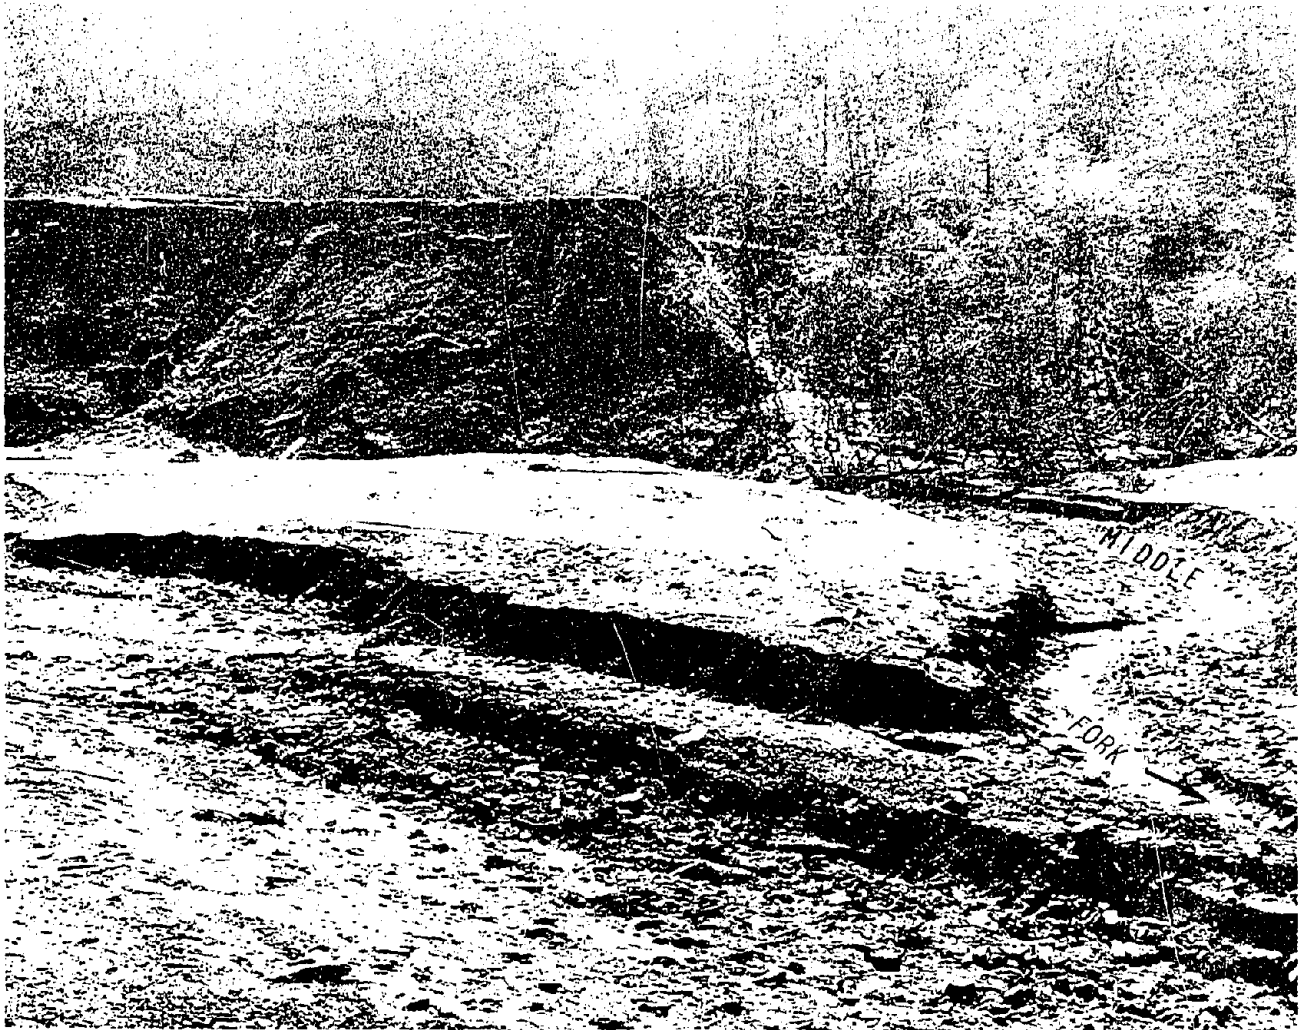
DOWNSTREAM PORTION OF LEFT ABUTMENT REMNANT OF DAM NO. 3, FEBRUARY 29, 1972. THE LOW, SCoured MOUND IN THE CENTER EXTENDED TO THE RIGHT DURING THE FIRST STAGES OF THE FAILURE. IN THE FINAL EMPTYING OF POOL 3, THE MOUND WAS DISSECTED BY MIDDLE FORK AS SEEN HERE.

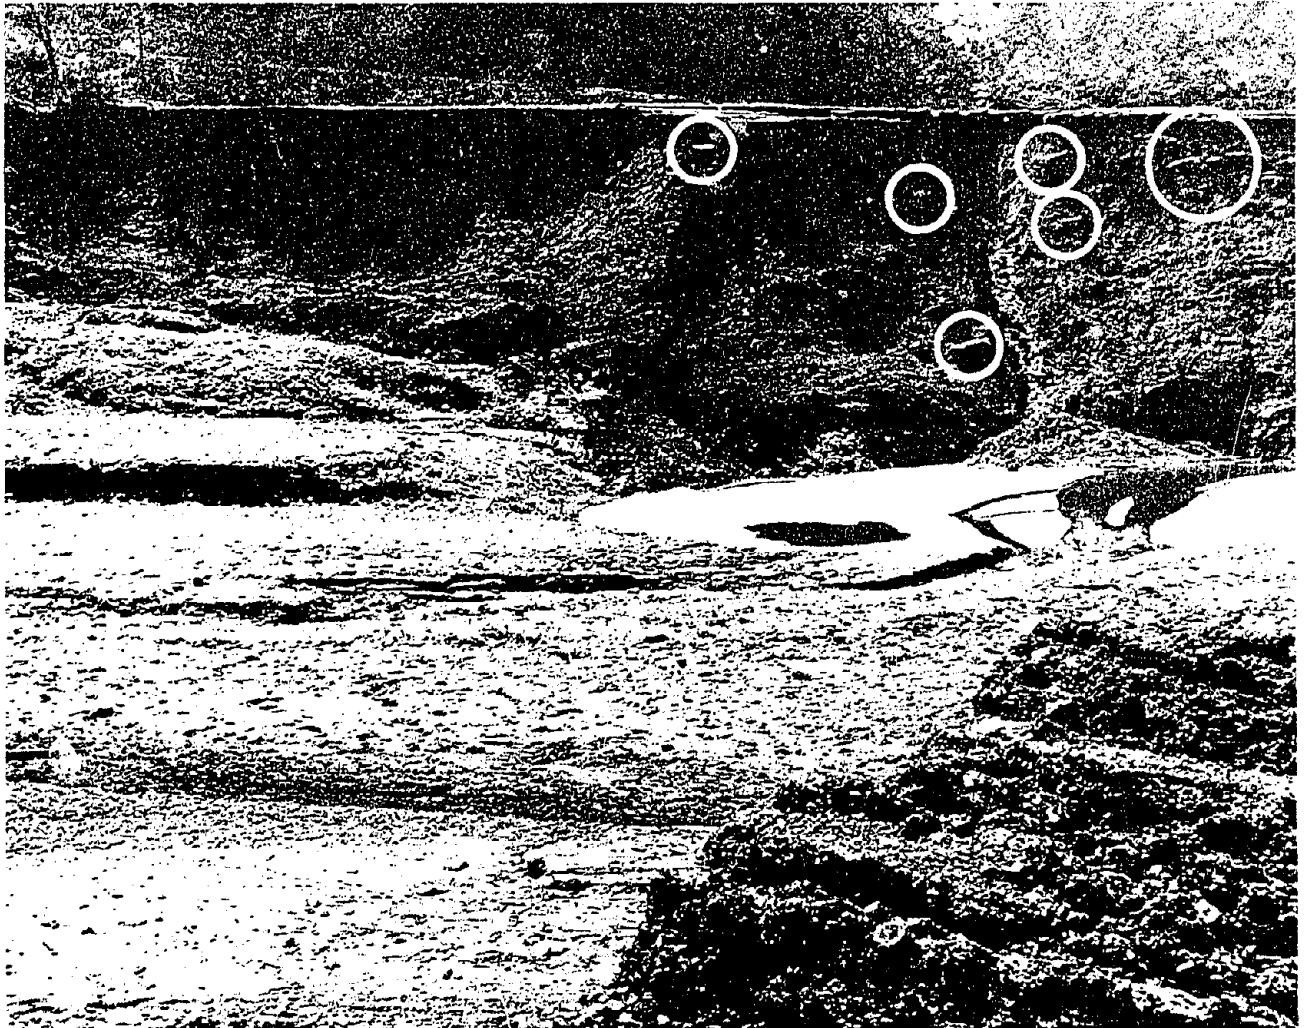
CENTRAL AND UPSTREAM PORTIONS OF THE LEFT ABUTMENT REMNANT OF DAM NO. 3, FEBRUARY 29, 1972.
NOTE THE CONTRAST BETWEEN THE LIGHT, RELATIVELY SAND-FREE STREAM TERRACES AND THE DARK
EMBANKMENT MATERIAL. PORTIONS OF THE SURFACE OF DAM NO. 3 WHICH HAVE SLID TOWARD THE
VIEWER ARE READILY IDENTIFIABLE BY THE HIGHLIGHTS ON THEM (CIRCLED). THE LARGE CIRCULAR
FEATURE AT THE BASE OF THE ABUTMENT REMNANT (RIGHT CENTER) CONTAINED SINKHOLE-LIKE
CAVITIES, ONE TO FOUR FEET IN DIAMETER, SINCE FILLED IN

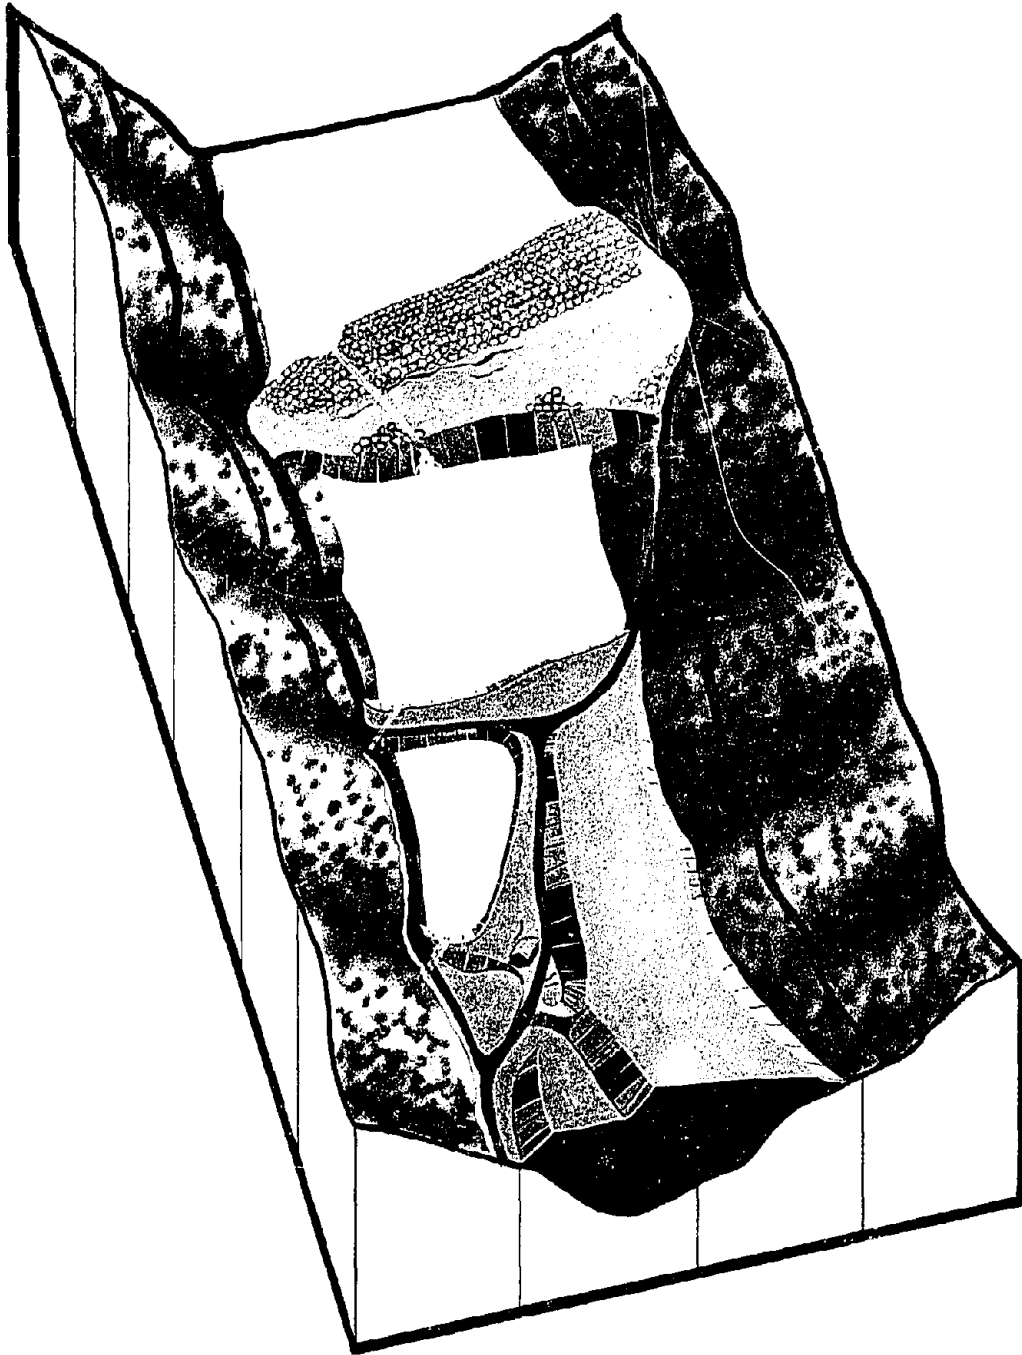
MIDDLE FORK VALLEY, FEBRUARY 26, 1972 SHOWING POOL 3 AT HIGH WATER ELEVATION OF 1753;
EARLY SIGNS OF DISTRESS OF DAM NO. 3 ARE INDICATED BY CRACKS PARALLEL TO CREST.

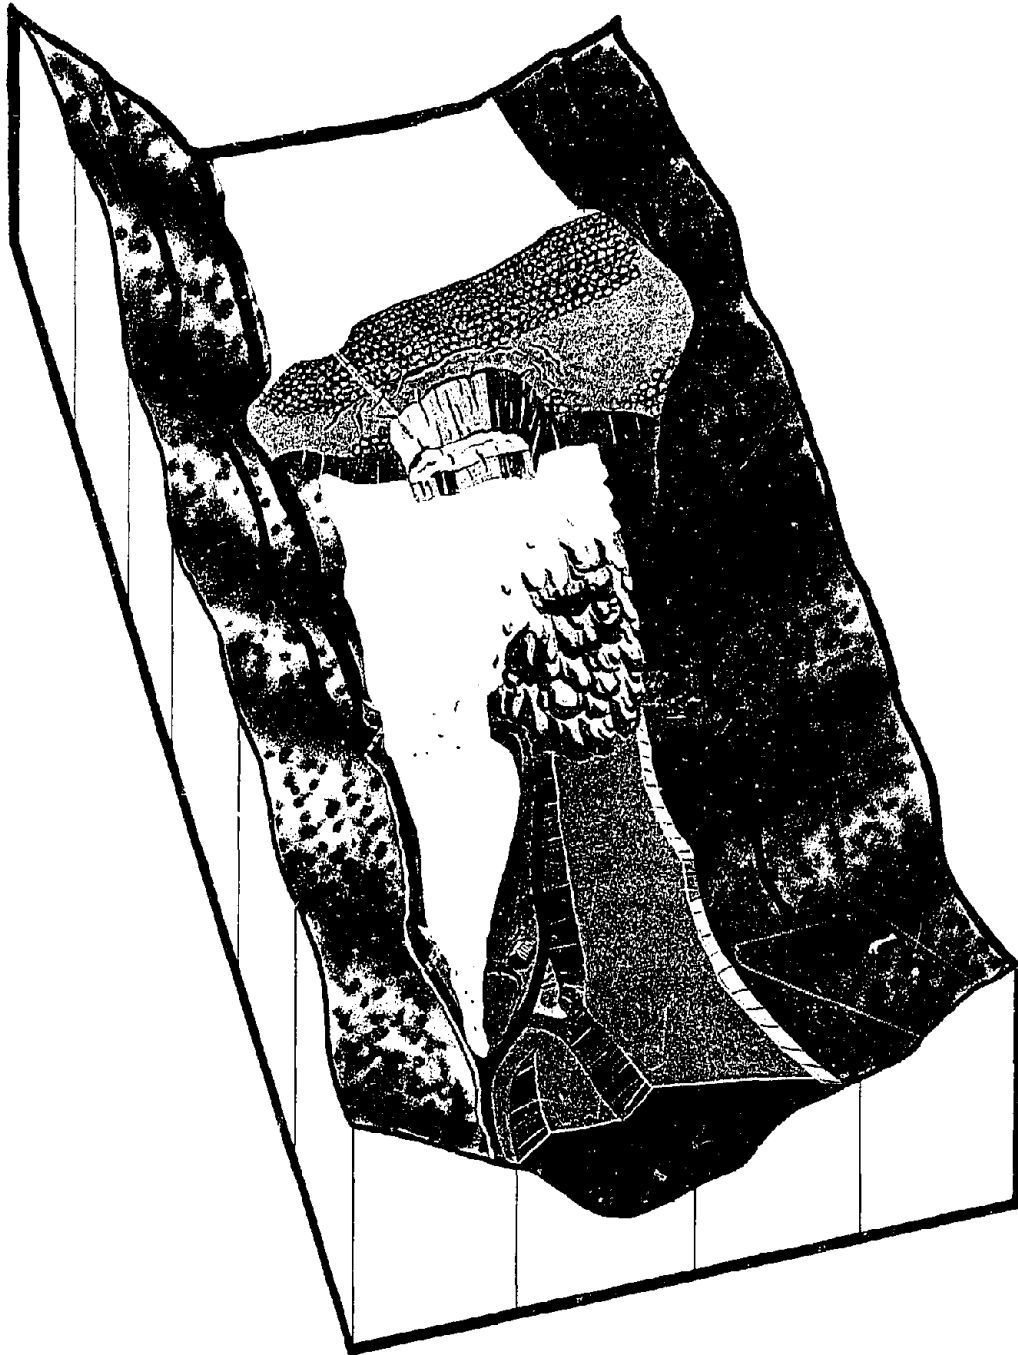
MIDDLE FORK VALLEY, FEBRUARY 26, 1972; INITIAL MASSIVE SHEAR FAILURE OF DAM NO. 3 CAUSING OVERTOPPING OF DAMS 2 AND 1. THE FOUNDATION SLUDGE FROM POOL 2 IS SHOWN TRANSLATED TO LEFT ABUTMENT AREA OF DAM NO. 2.

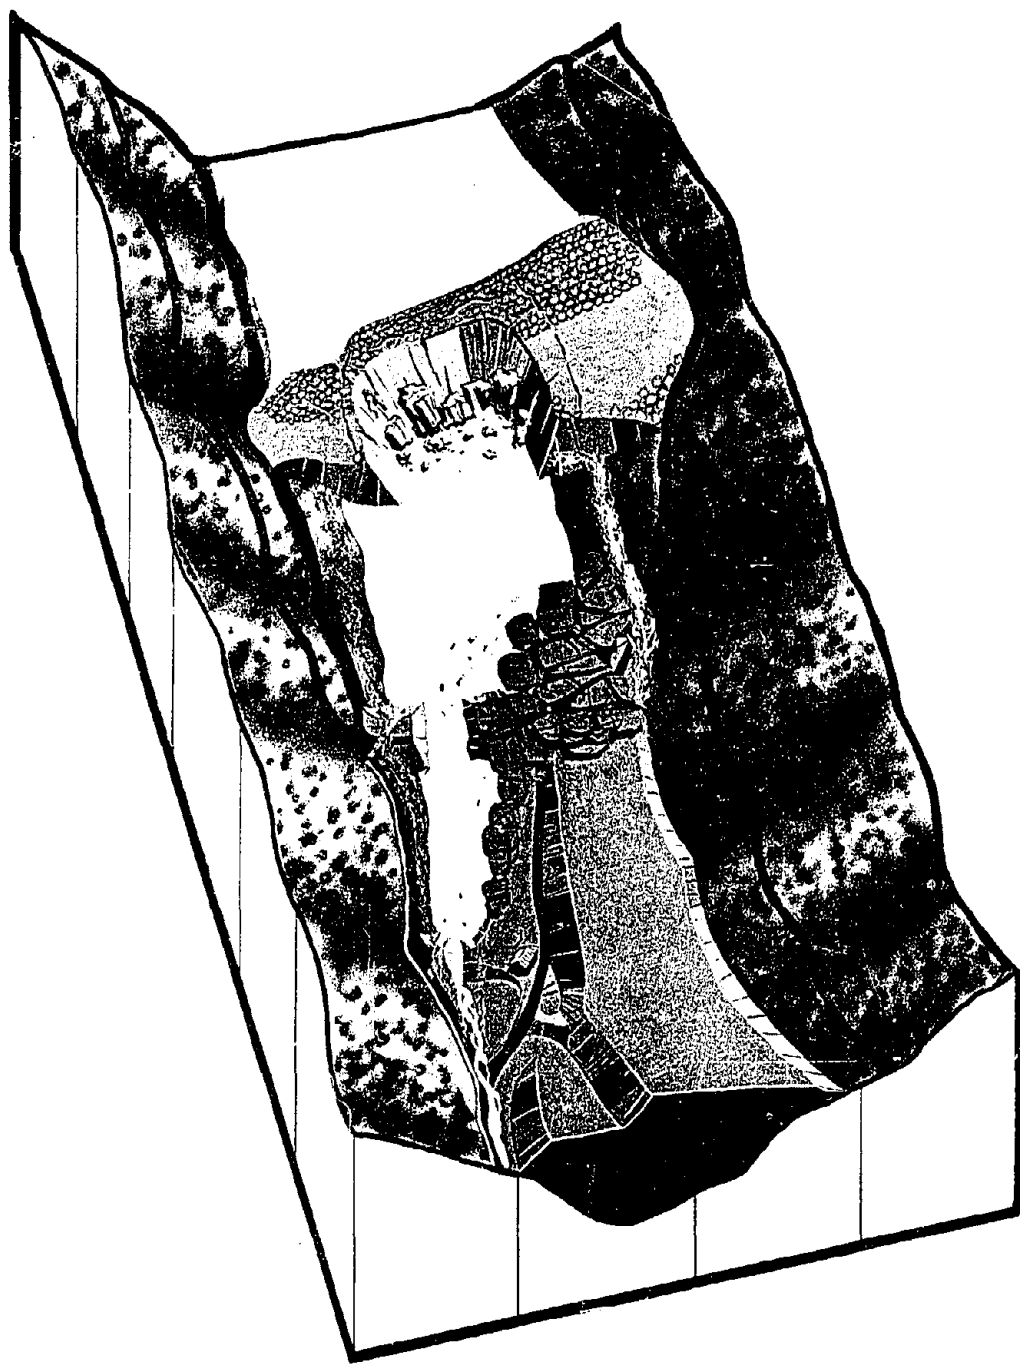
MIDDLE FORK VALLEY, FEBRUARY 26, 1972; PROGRESSIVE FAILURE CONTINUES TO DESTROY REMAINING SECTIONS OF DAM NO. 3; THE INITIAL FLOOD WATER FROM POOL 2 ASSOCIATED WITH SHEAR FAILURE BEGINS TO SUBSIDE EXPOSING THE INITIAL BREACH IN DAM NO. 2.

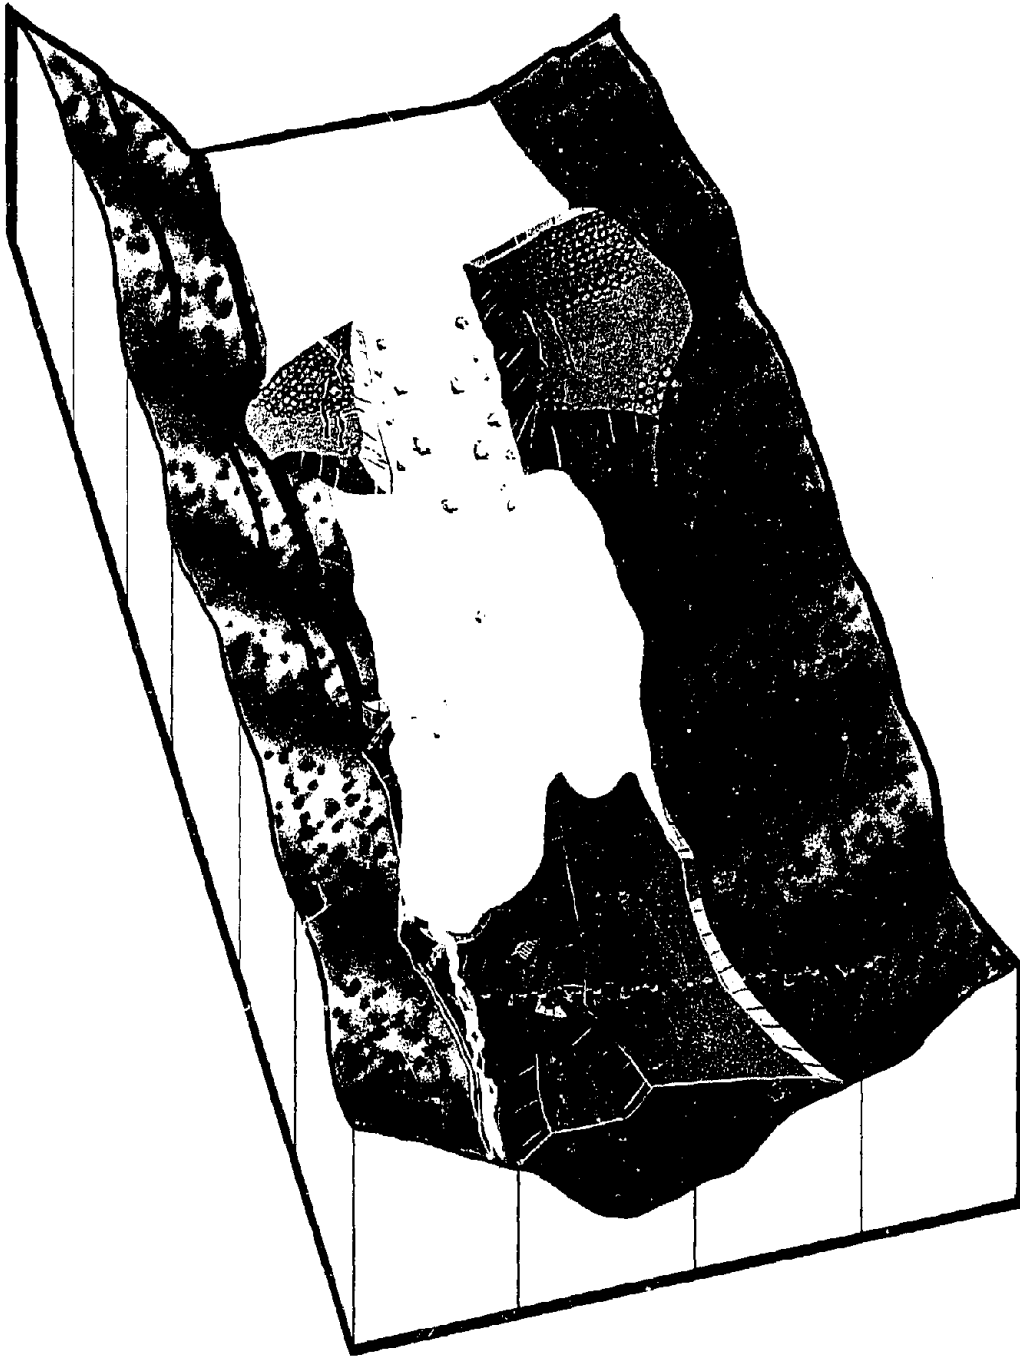
MIDDLE FOKK VALLEY, FEBRUARY 26, 1972; CATASTROPHIC FAILURE OF DAM NO. 3 WHICH RELEASES
THE MAJOR FLOOD WAVE.

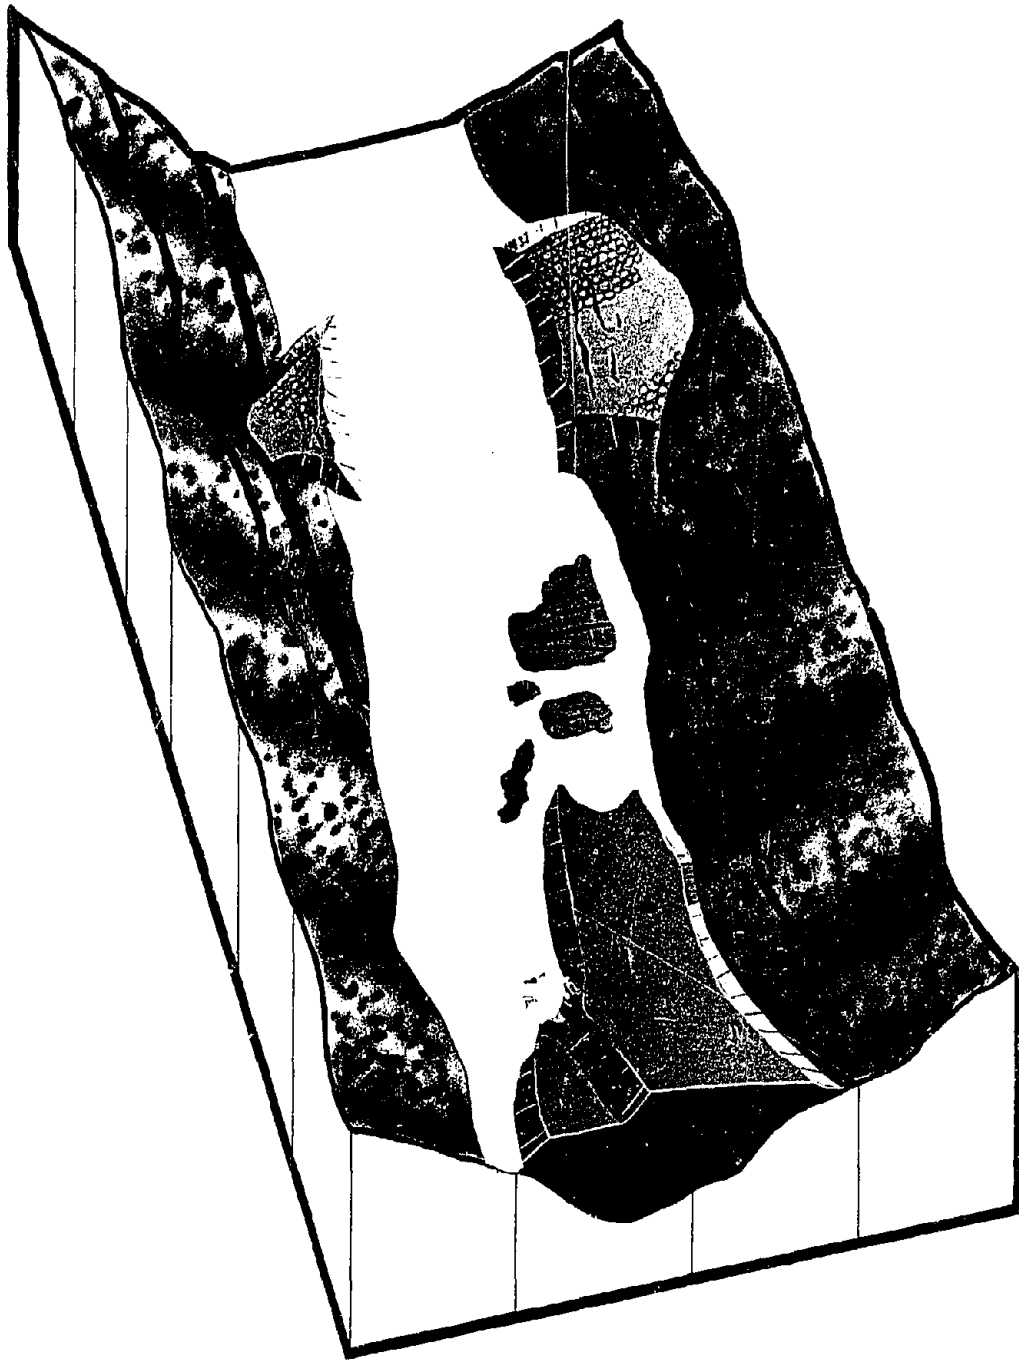
MIDDLE FORK VALLEY, FEBRUARY 26, 1972; FLOOD WAVE OVERTOPS DAM NO. 2 AND DESTROYS DAM NO. 1. BOTH REMNANTS OF DAM NO. 3 CONTINUE TO FAIL BY UNDERCUTTING ACTION OF FLOOD FLOW.

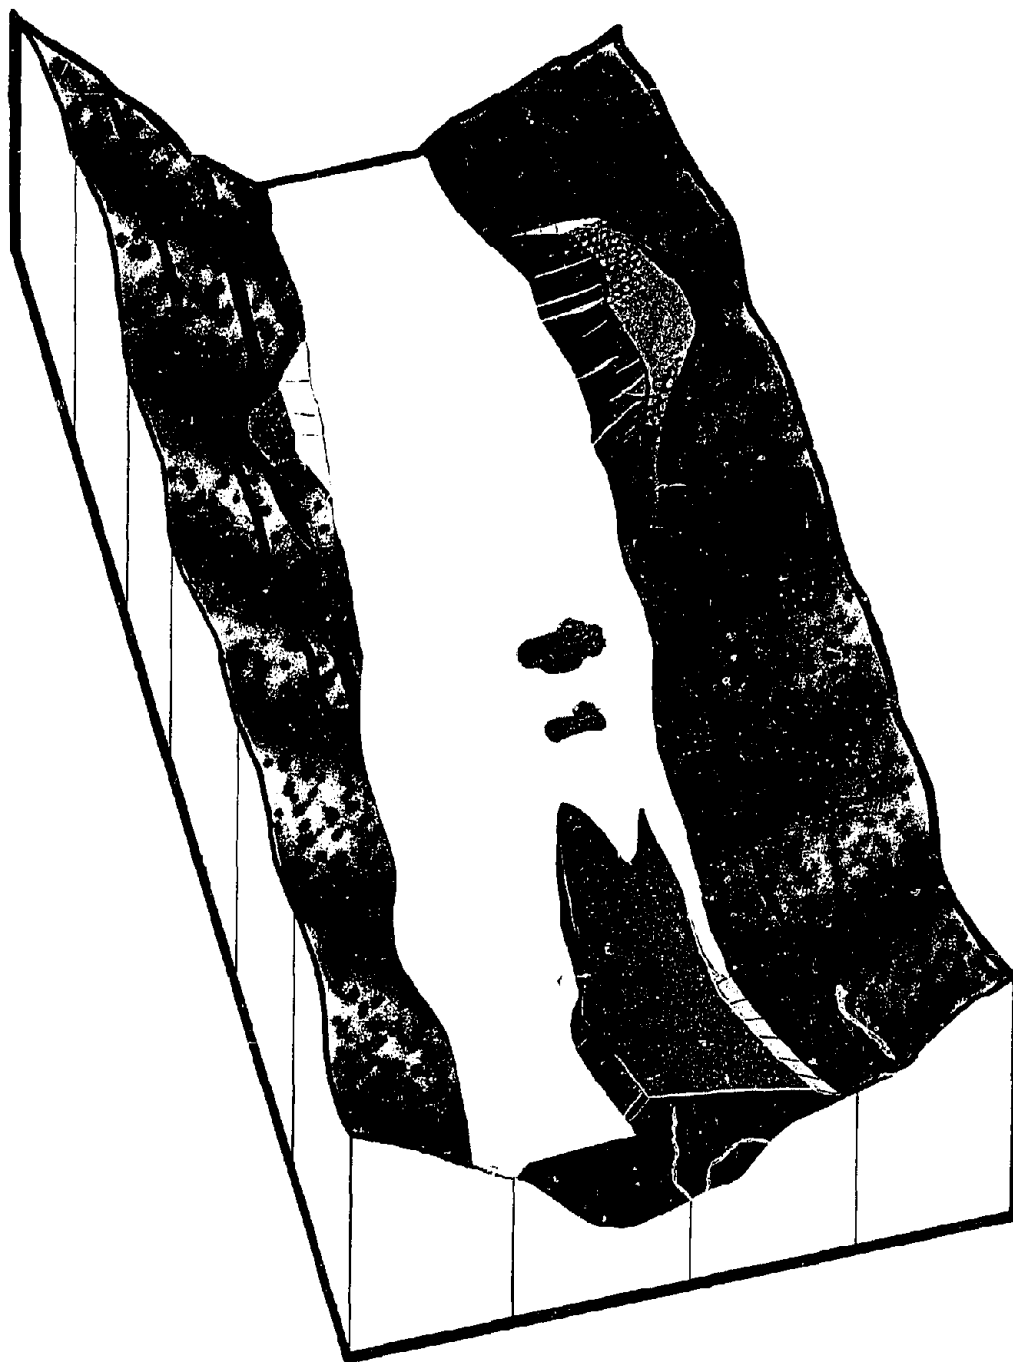
MIDDLE FORK VALLEY, FEBRUARY 26, 1972; HIGH WATER LINE ADJACENT TO REFUSE BANK IS DEVELOPED BY CONSTRICTION OF THE NARROW VALLEY DOWNSTREAM OF DAM NO. 1.
