SUBJECT: Failure of Two Medicine Dam

Two Medicine Dam is located in the northwestern part of Montana on Two Medicine River just outside the southeast boundary of Glacier National Park. Storage created by the dam backs water into Lower Two Medicine Lake. The road to the town of Two Medicine in the park passes the damsite. The dam was designed by the Bureau of Reclamation for the Bureau of Indian Affairs. Construction of the dam was started in July 1911 and was completed in August 1913. Indian and white labor were used in its construction. The storage capacity created by the dam was 13,500 acre-feet at spillway crest elevation 4874.

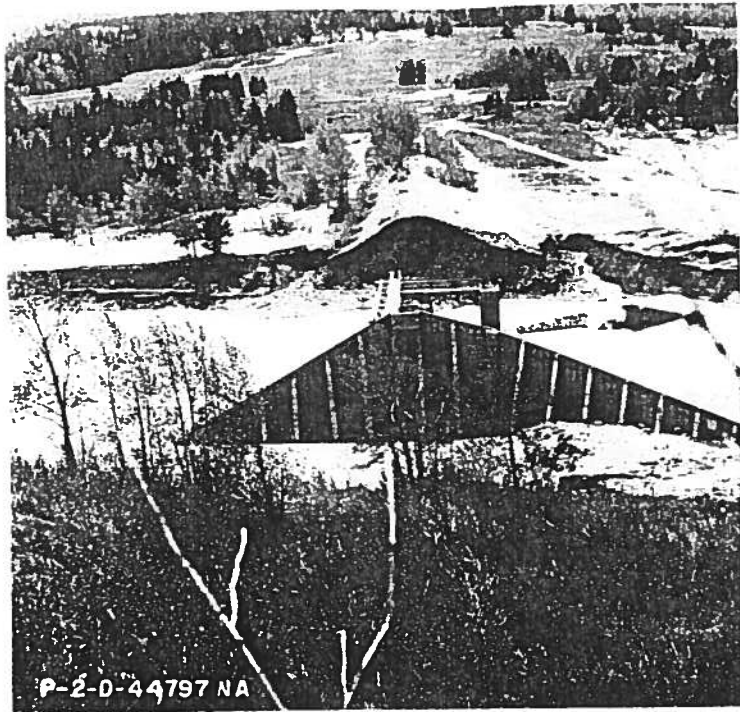
As a result of heavy rains in the area around June 7 and 8 of this year, which created above normal discharge, the dam failed, see Photographs No. 1, 2, 3, and 4. The failure occurred by overtopping of the embankments at about 3:30 p.m. on June 8. On June 11, accompanied by Mr. G. R. Hanson, Chief, Field Engineering Branch, Projects Office, Great Falls, I visited the site of the dam and examined the portions of the structure still standing. The request to make this inspection was made by the Regional Director, Region 6. Before going to the site, we stopped at the Office of the Project Engineer, Bureau of Indian Affairs, Blackfeet Indian Reservation, Browning, Montana, where we reviewed drawings, examined recent pictures and discussed the failure of the dam. The Bureau of Indian Affairs calculated that the peak discharge during the flood was 9,600 cfs and the Geological Survey in their letter of July 15, 1964 stated the maximum water surface elevation to be 4883.3. Since all the stop logs were in place and since the calculated capacity of the spillway and outlet was much less than the estimated discharge, the dam failed because of inadequate spillway capacity being available.

Photograph No. 1
Two Medicine Dam - View from left abutment. 6-11-64

No thought should be given to rehabilitating the present structure. If the dam is to be replaced, a new structure should be built using modern day concepts of design.

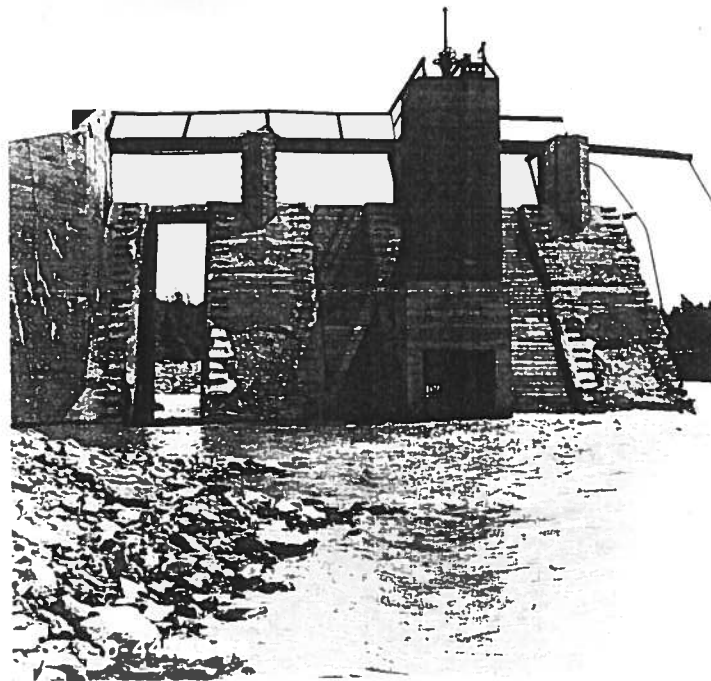
Photograph No. 2
Two Medicine Dam - Spillway section, looking downstream. 6-11-64

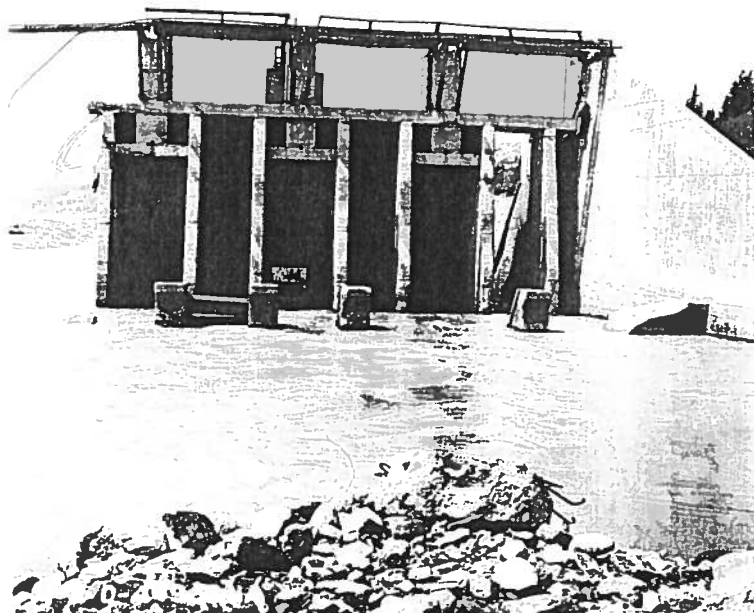
Photograph No. 3
Two Medicine Dam - Spillway section, looking upstream. 6-11-64

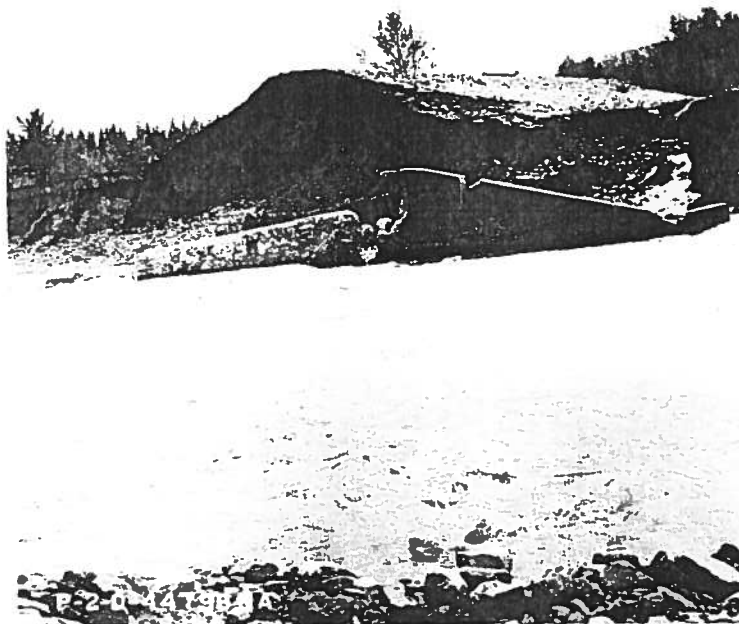
side of the spillway has been washed away except for a part of the upstream section. As the flood flow cut through the embankment, it evidently undermined the footing of the counterforted retaining wall and the wall toppled into the newly created river channel, see Photograph No. 4. Similar action took place on the left side of the spillway, but the flood receded before this wall completely failed. This wall had tilted sufficiently towards the abutment to allow the stop logs in the first spillway opening to be unseated and washed away, see Photographs No. 2 and 3. It is not known how much of the timber cribbing which served as a spillway apron has been washed away. The row of timber sheet piling at the heel of the spillway structure and at the end of the apron can still be seen in place.

Photograph No. 4
Two Medicine Dam - View of right embankment showing remains of
spillway retaining wall. 6-11-64

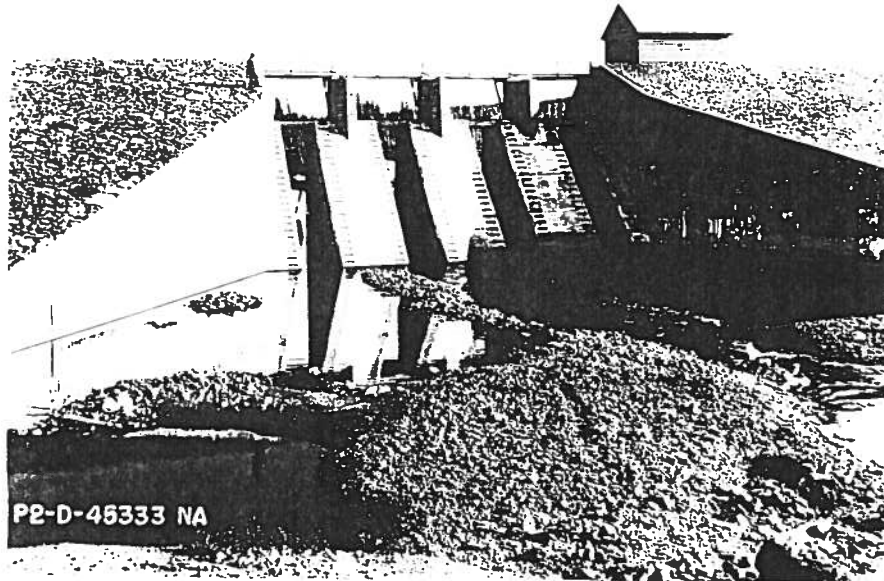
The failure of the dam, in all likelihood, started at the contact between the earth embankments and the retaining walls as the freeboard on the embankment decreased with the rising reservoir. In these areas there was a definite indication of settlement in the embankments. Photograph No. 5, taken in 1913, and Photograph No. 6, taken at a more recent date, show perhaps as much as 3 feet of settlement at the counterforted retaining walls. This area would form the shortest and easiest path for discharge over the embankments. Insufficient compaction of material in this area or shrinkage of the material from the wall due to drying would increase this weakness. Once the water could find a path through the embankment, the dam was doomed.

Photograph No. 5
Two Medicine Dam - View of dam taken upon
completion of construction, 6-1913

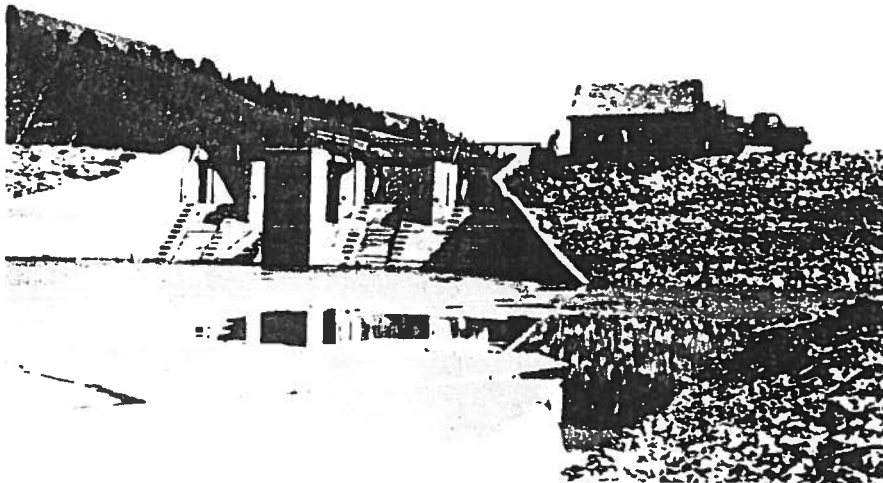
Photograph No. 6
Two Medicine Dam - View showing embankment settlement
at spillway counterforted retaining walls.
