TENNESSEE VALLEY AUTHORITY

SUBJECT: REPORT ON FAILURE OF WHEELER LOCK

REPORT ON FAILURE OF WHEELER LOCK

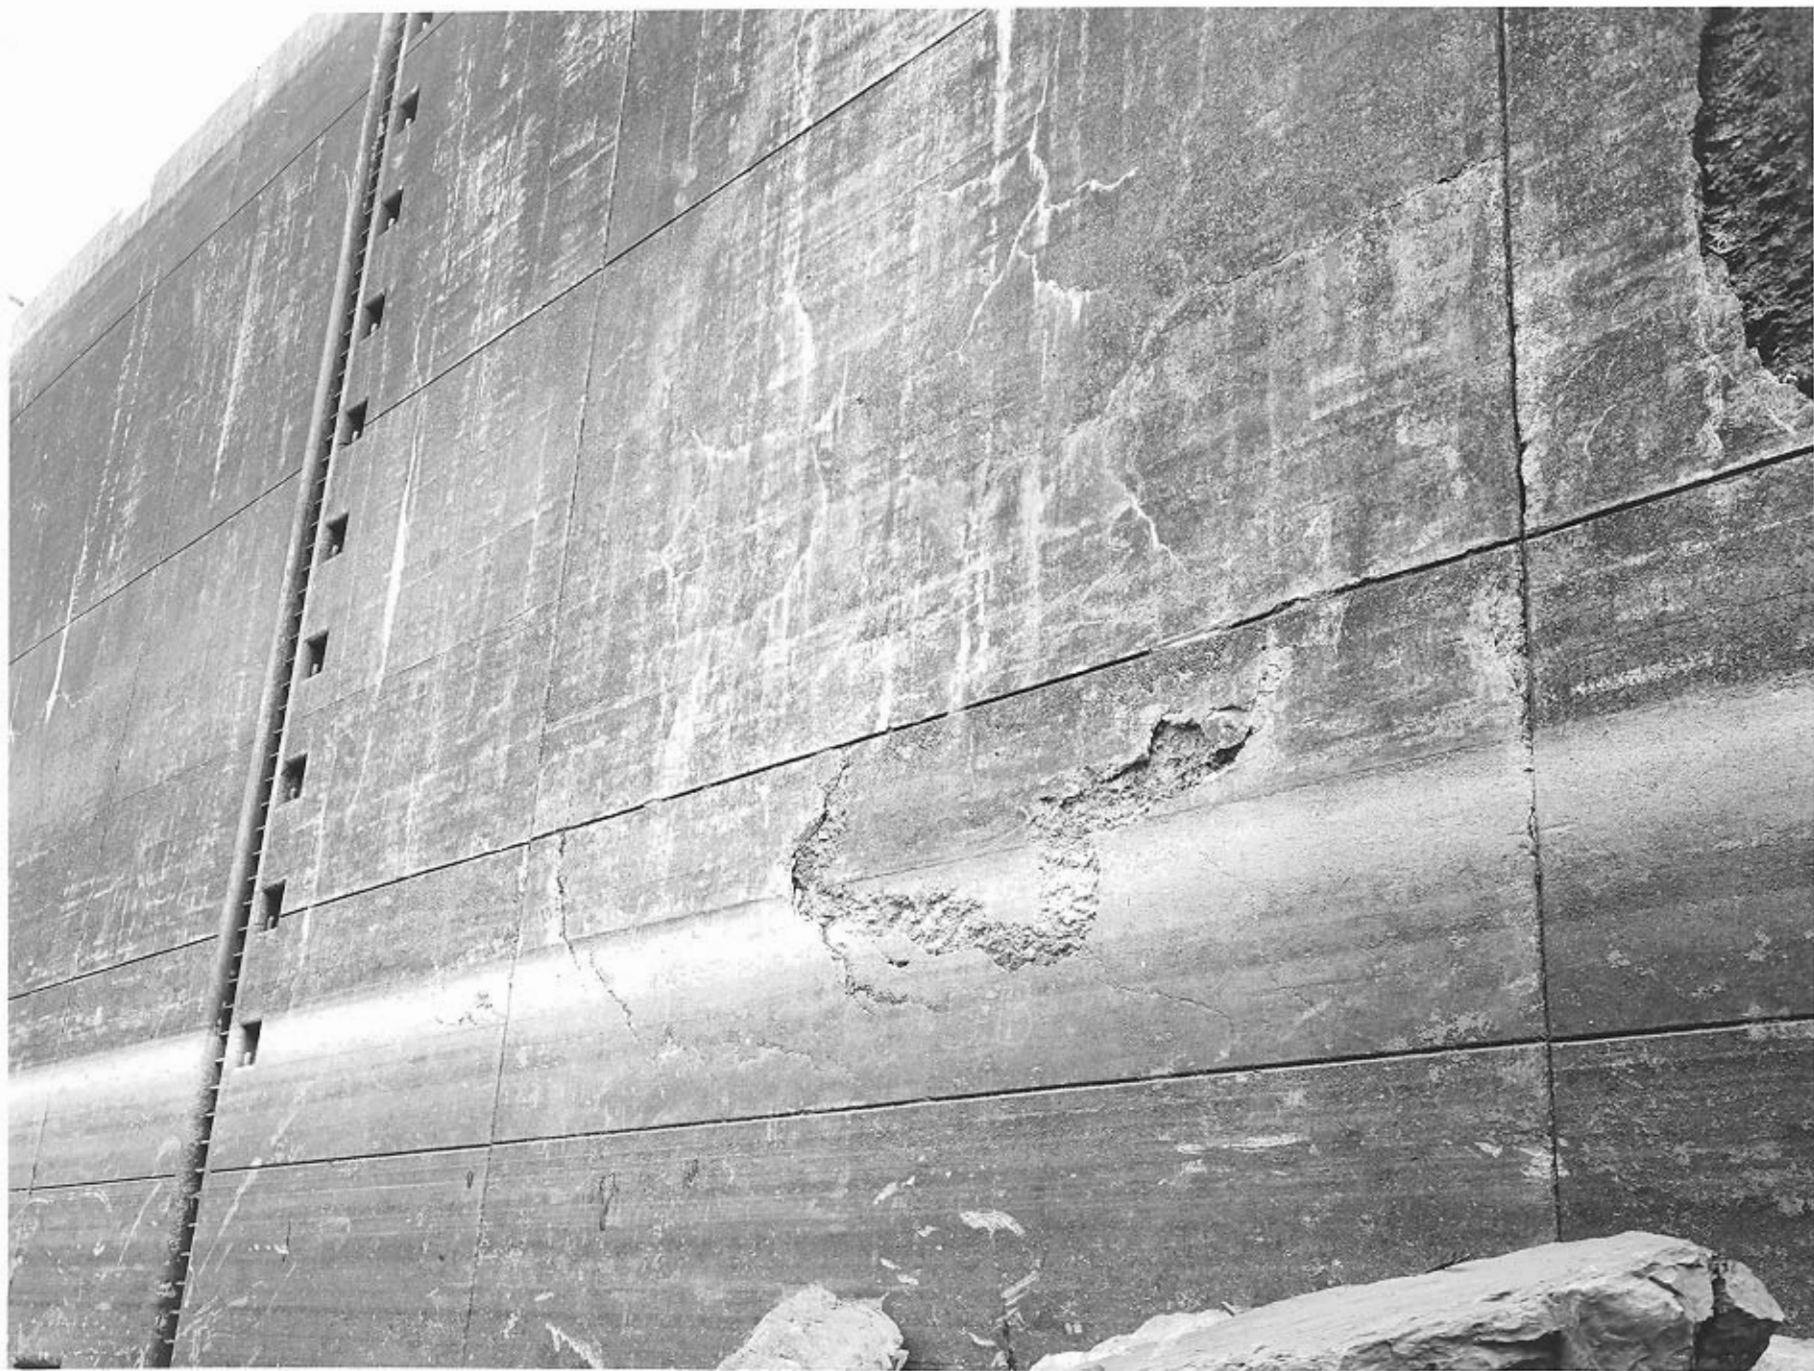
Auxiliary lock downstream face and culvert in block 12.

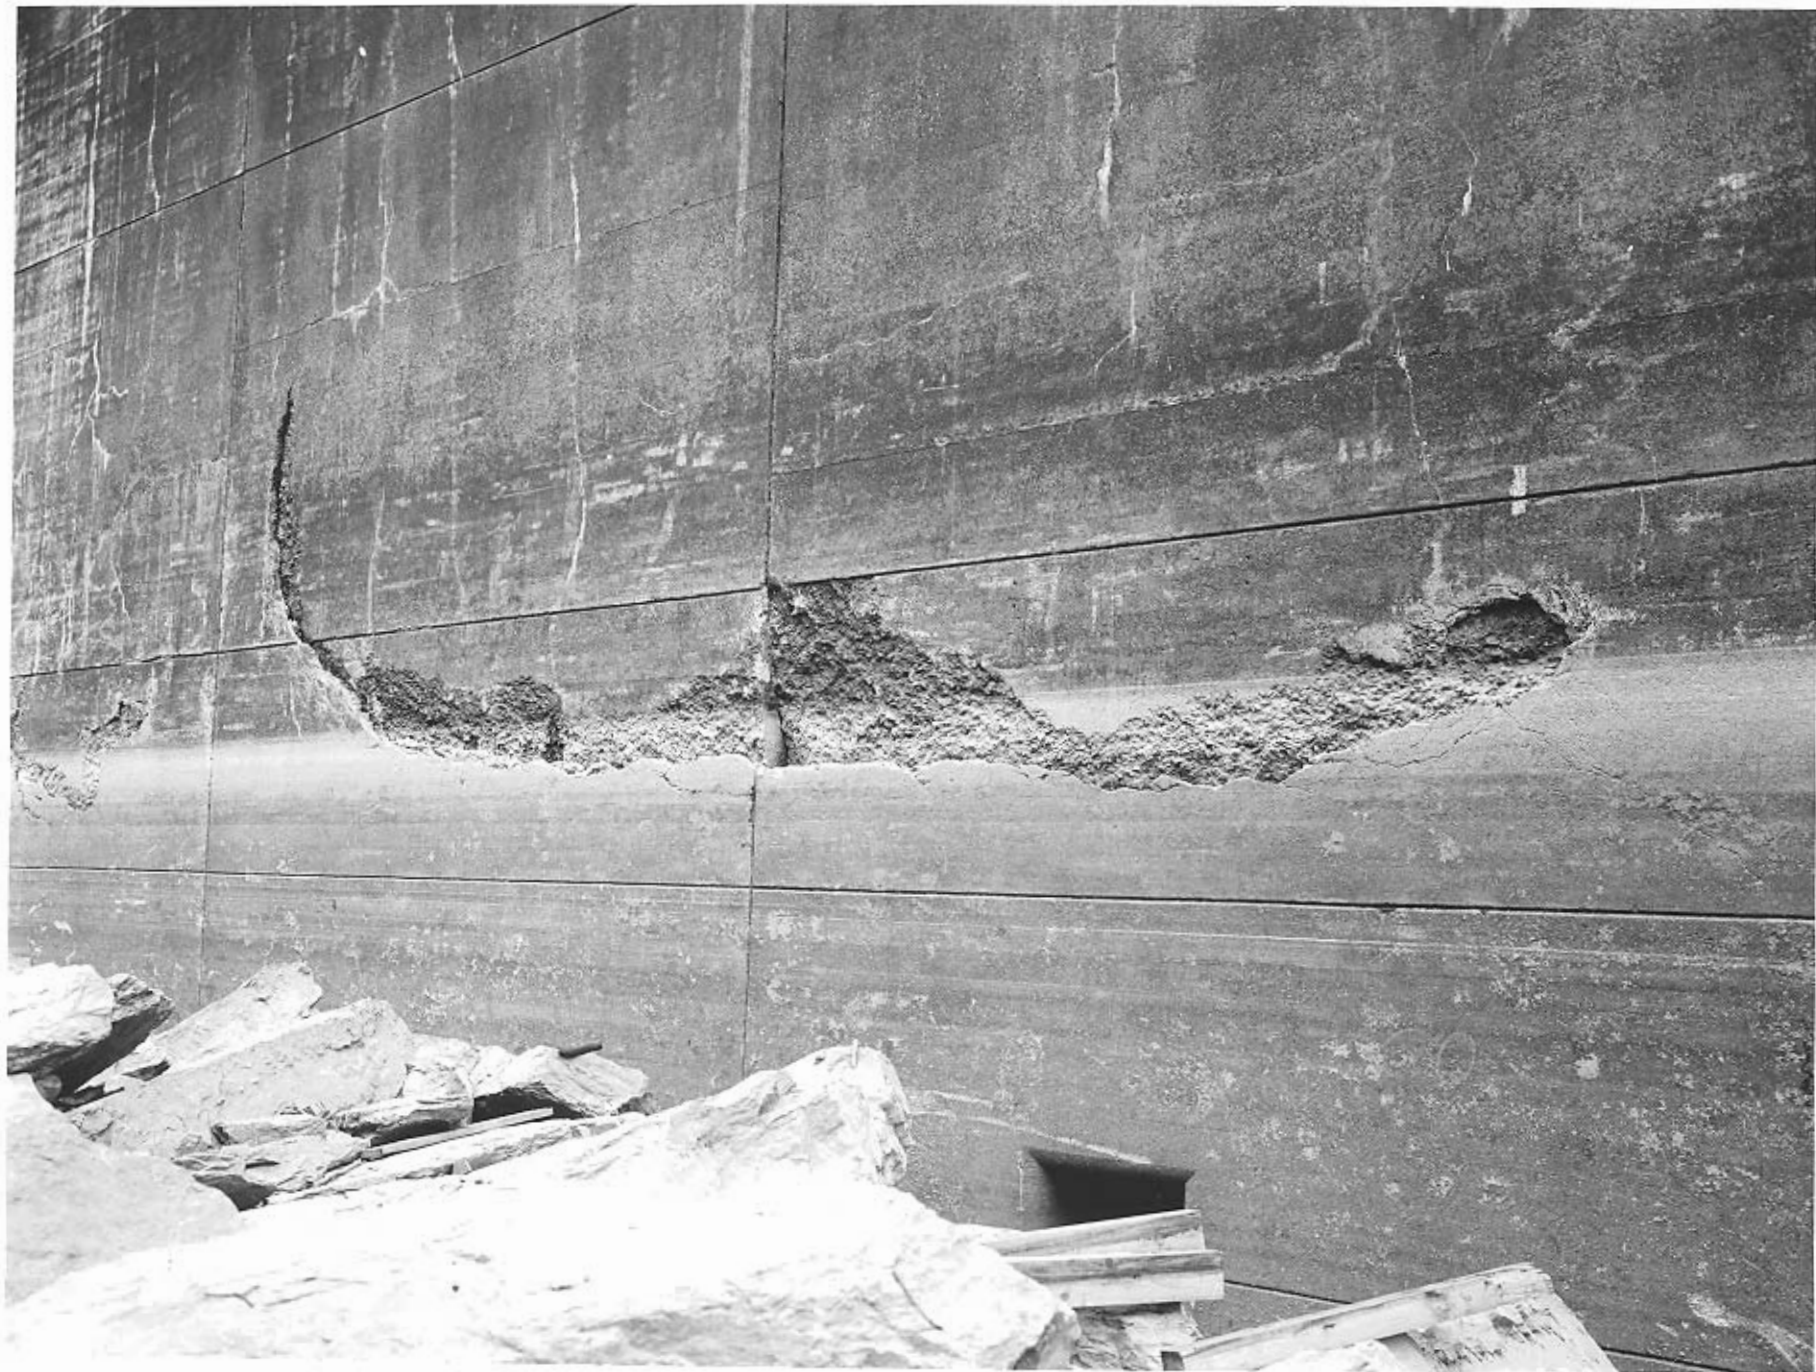
Auxiliary lock, crack in block 58.

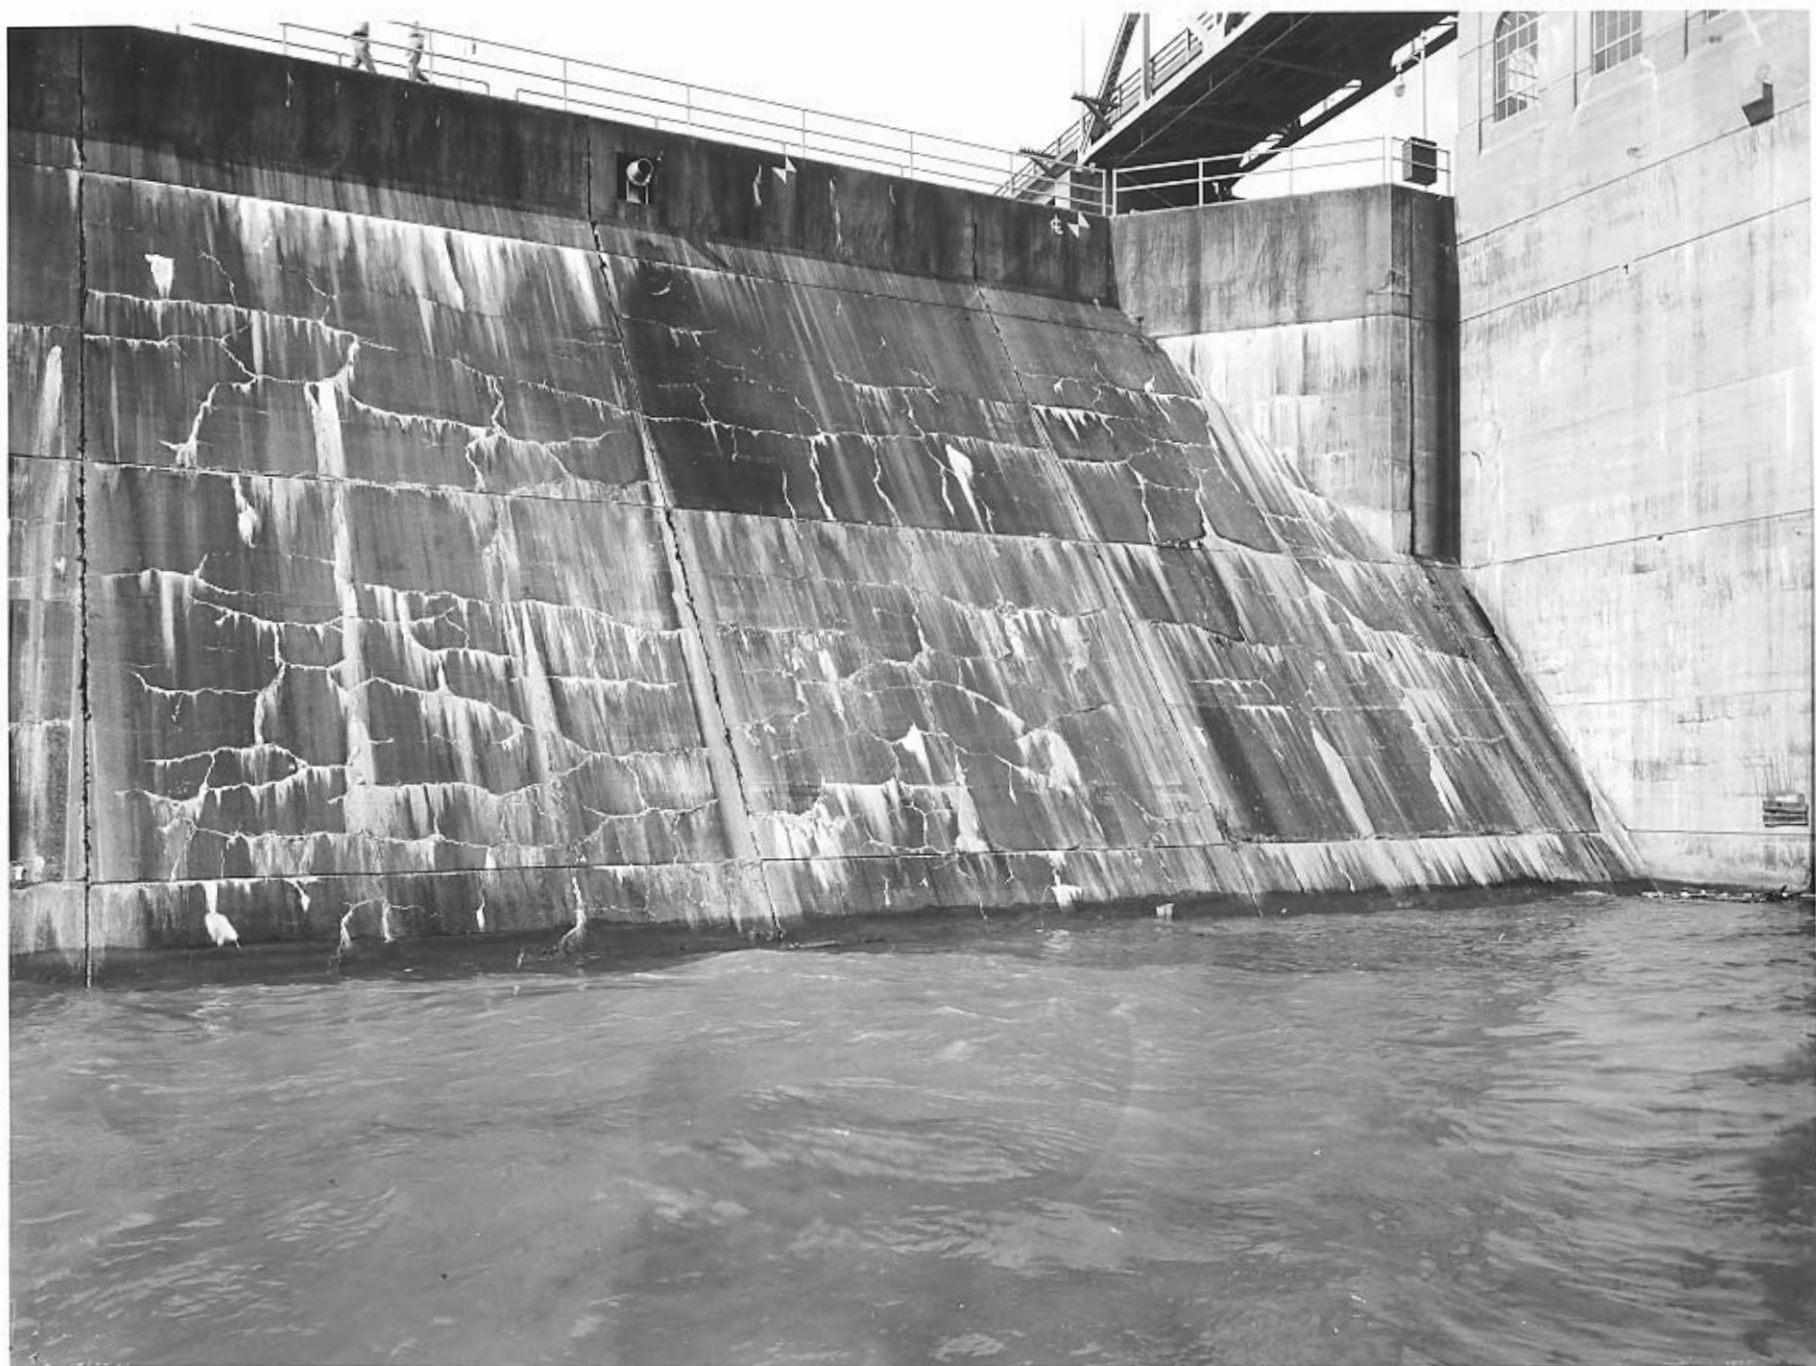
Auxiliary lock, crack in blocks 59 and 60 (river wall).

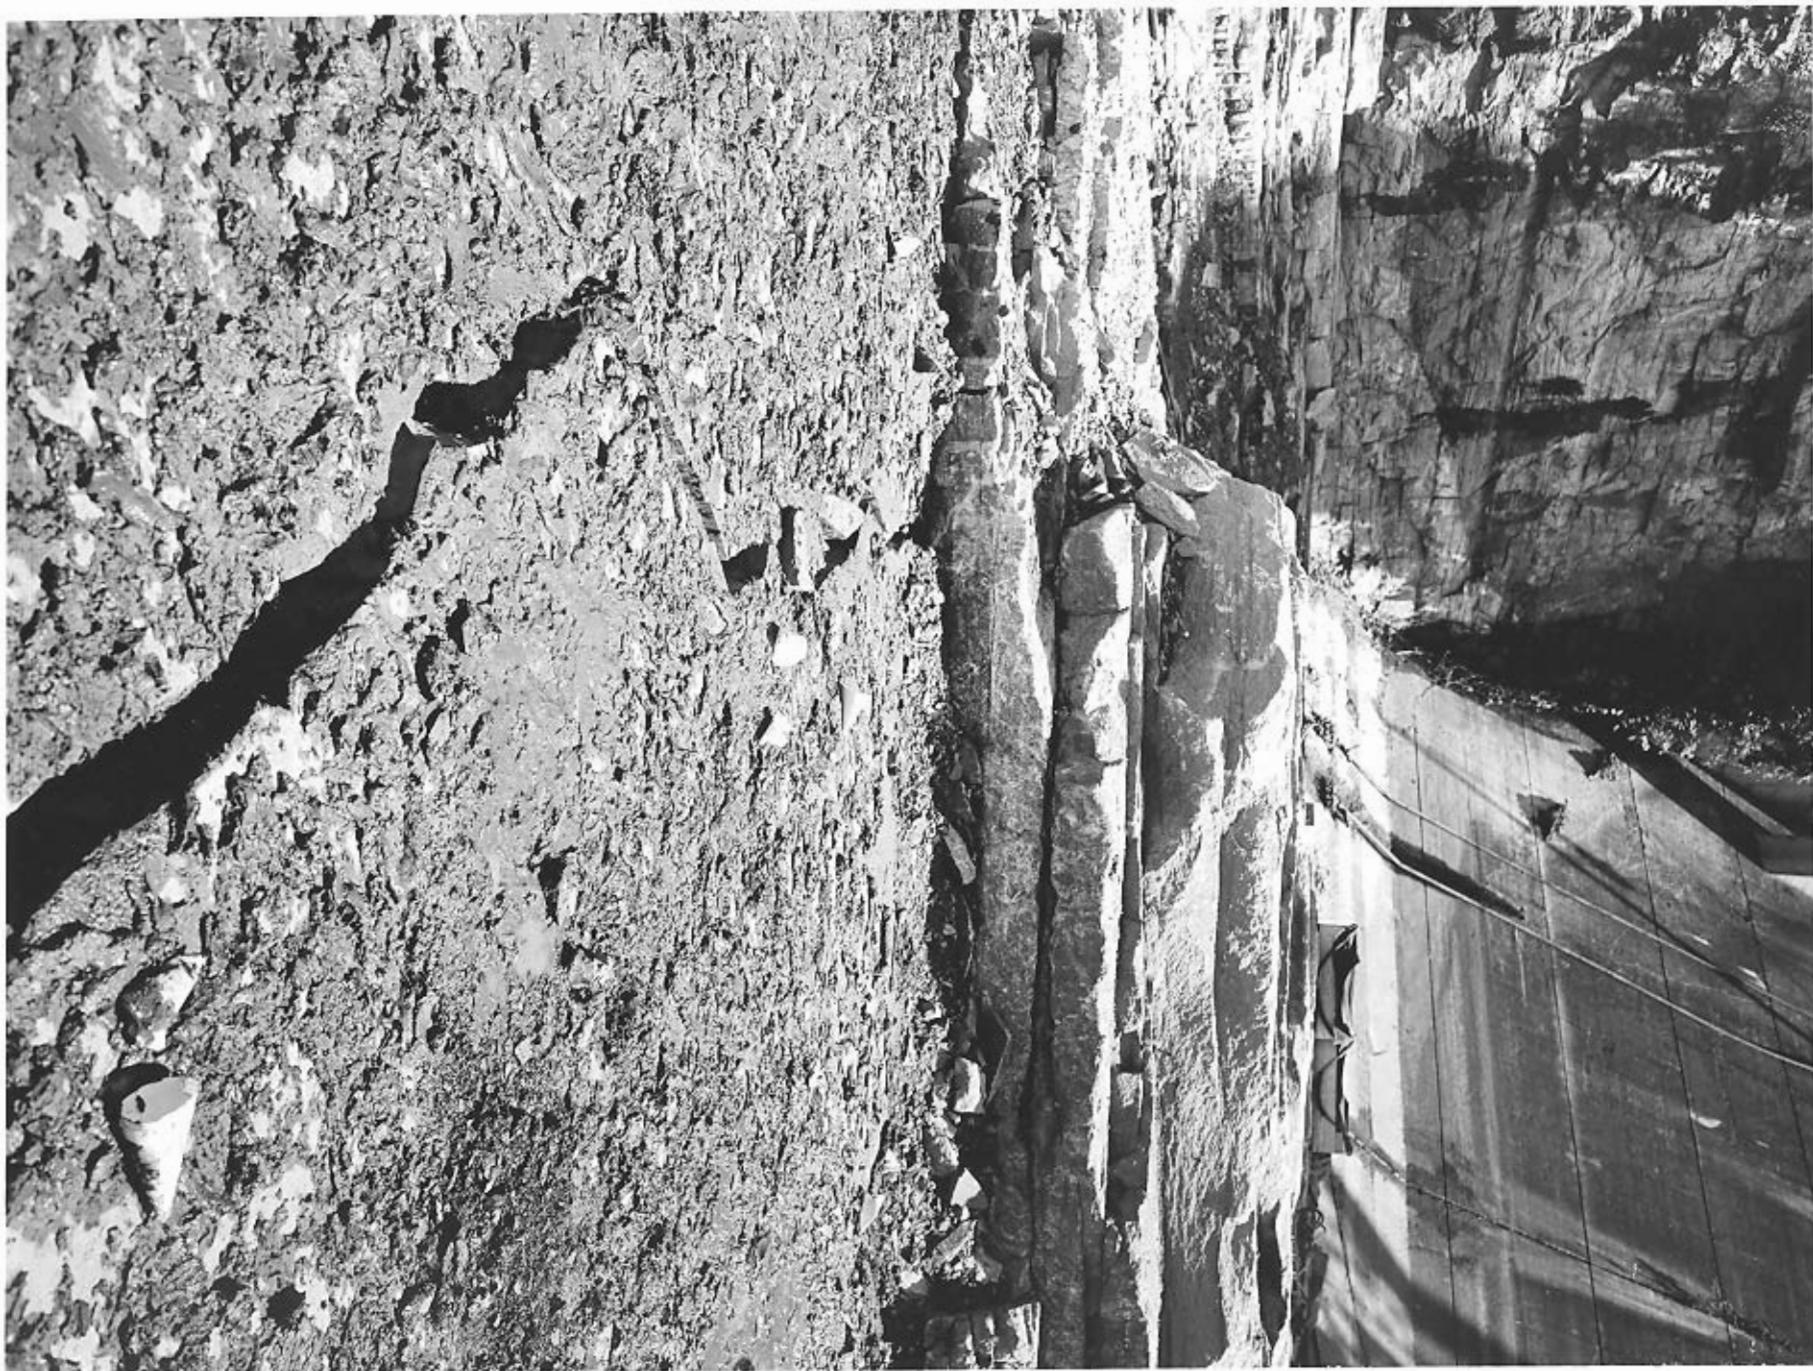
Looking upstream at crack in rock.

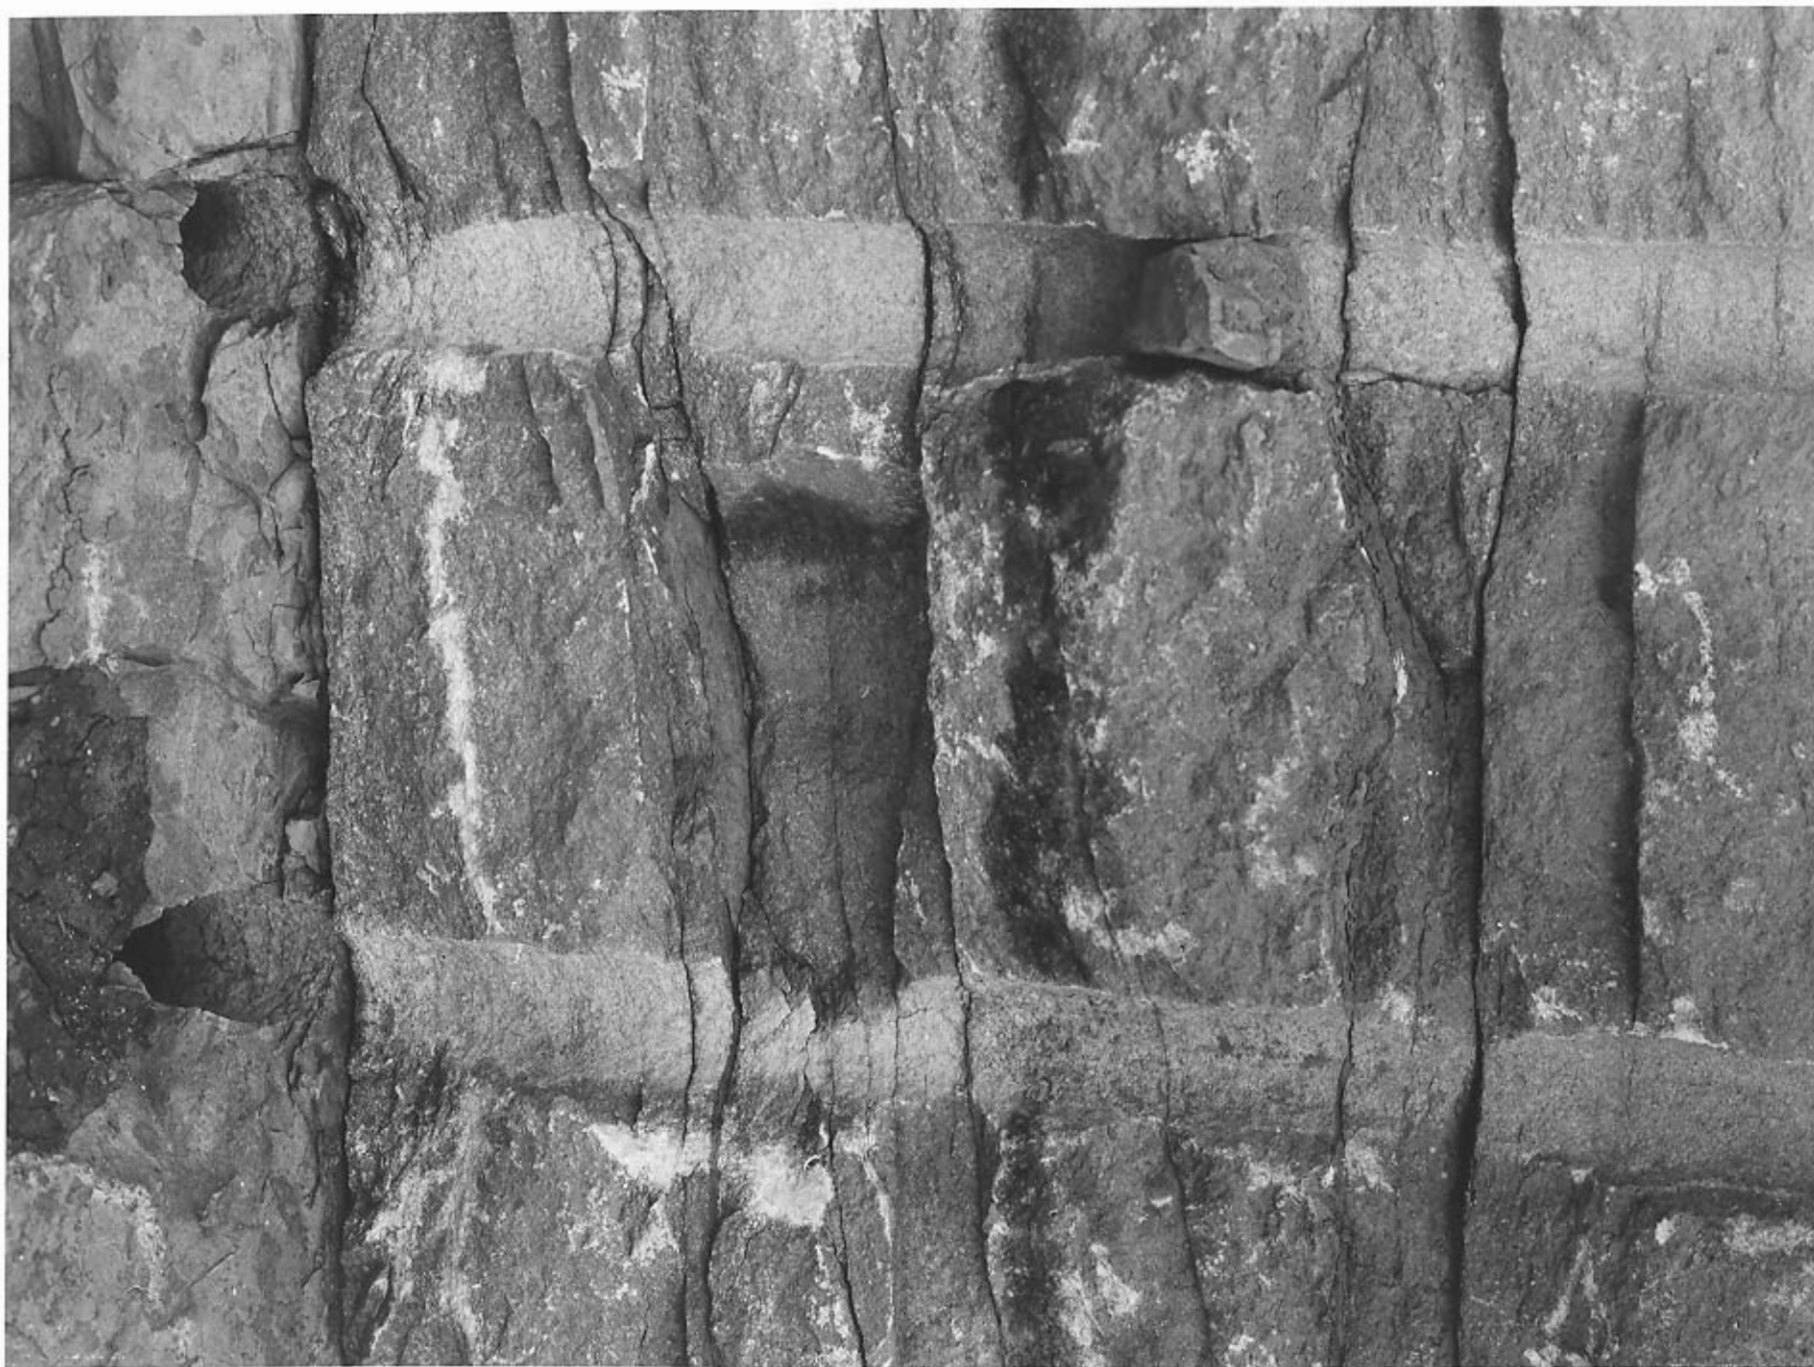
Looking east at line drill holes at southwest corner of upper miter sill ledge.

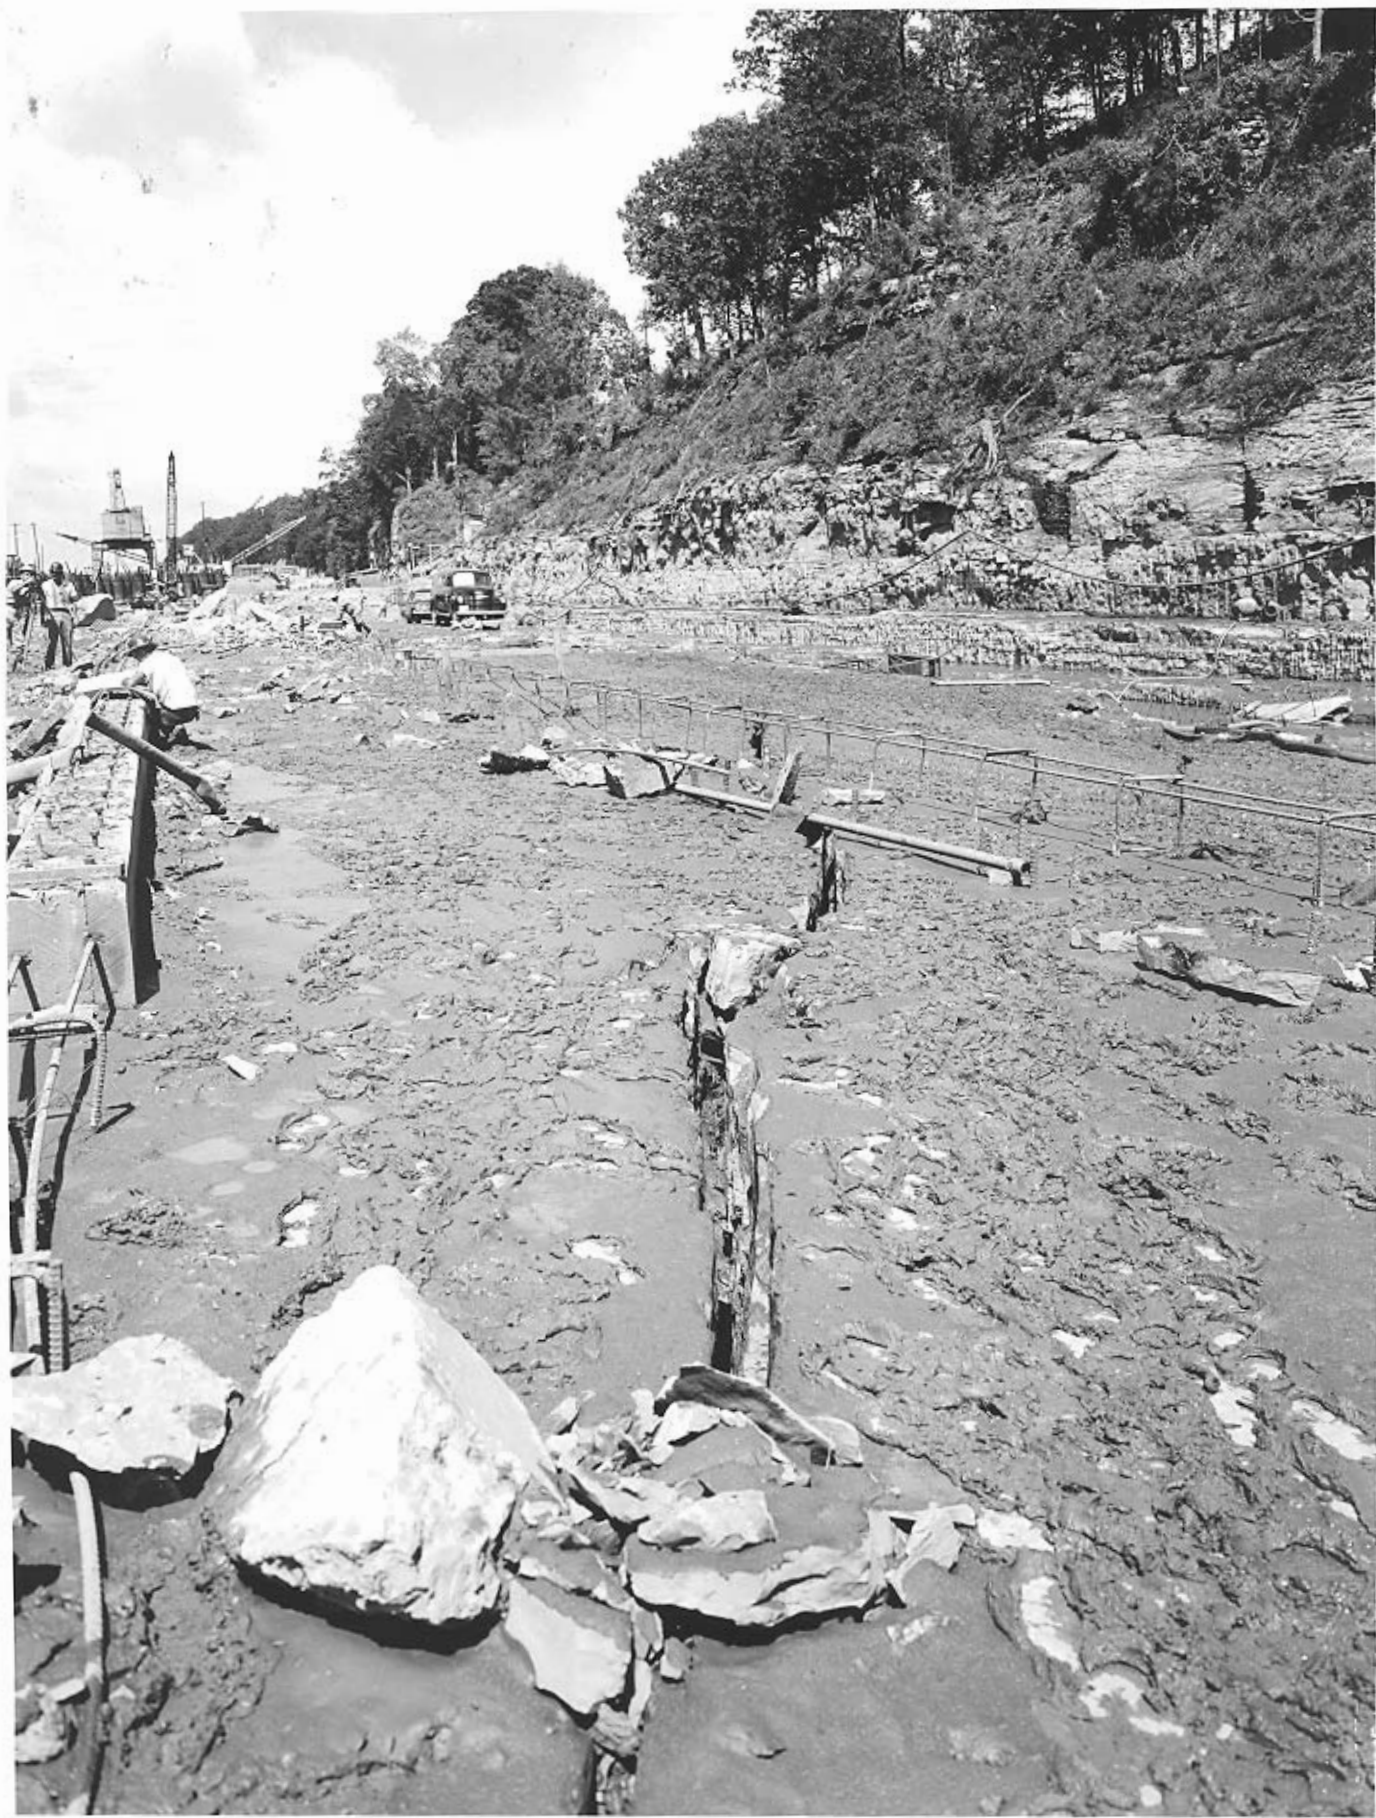
Looking downstream at crack in rock.

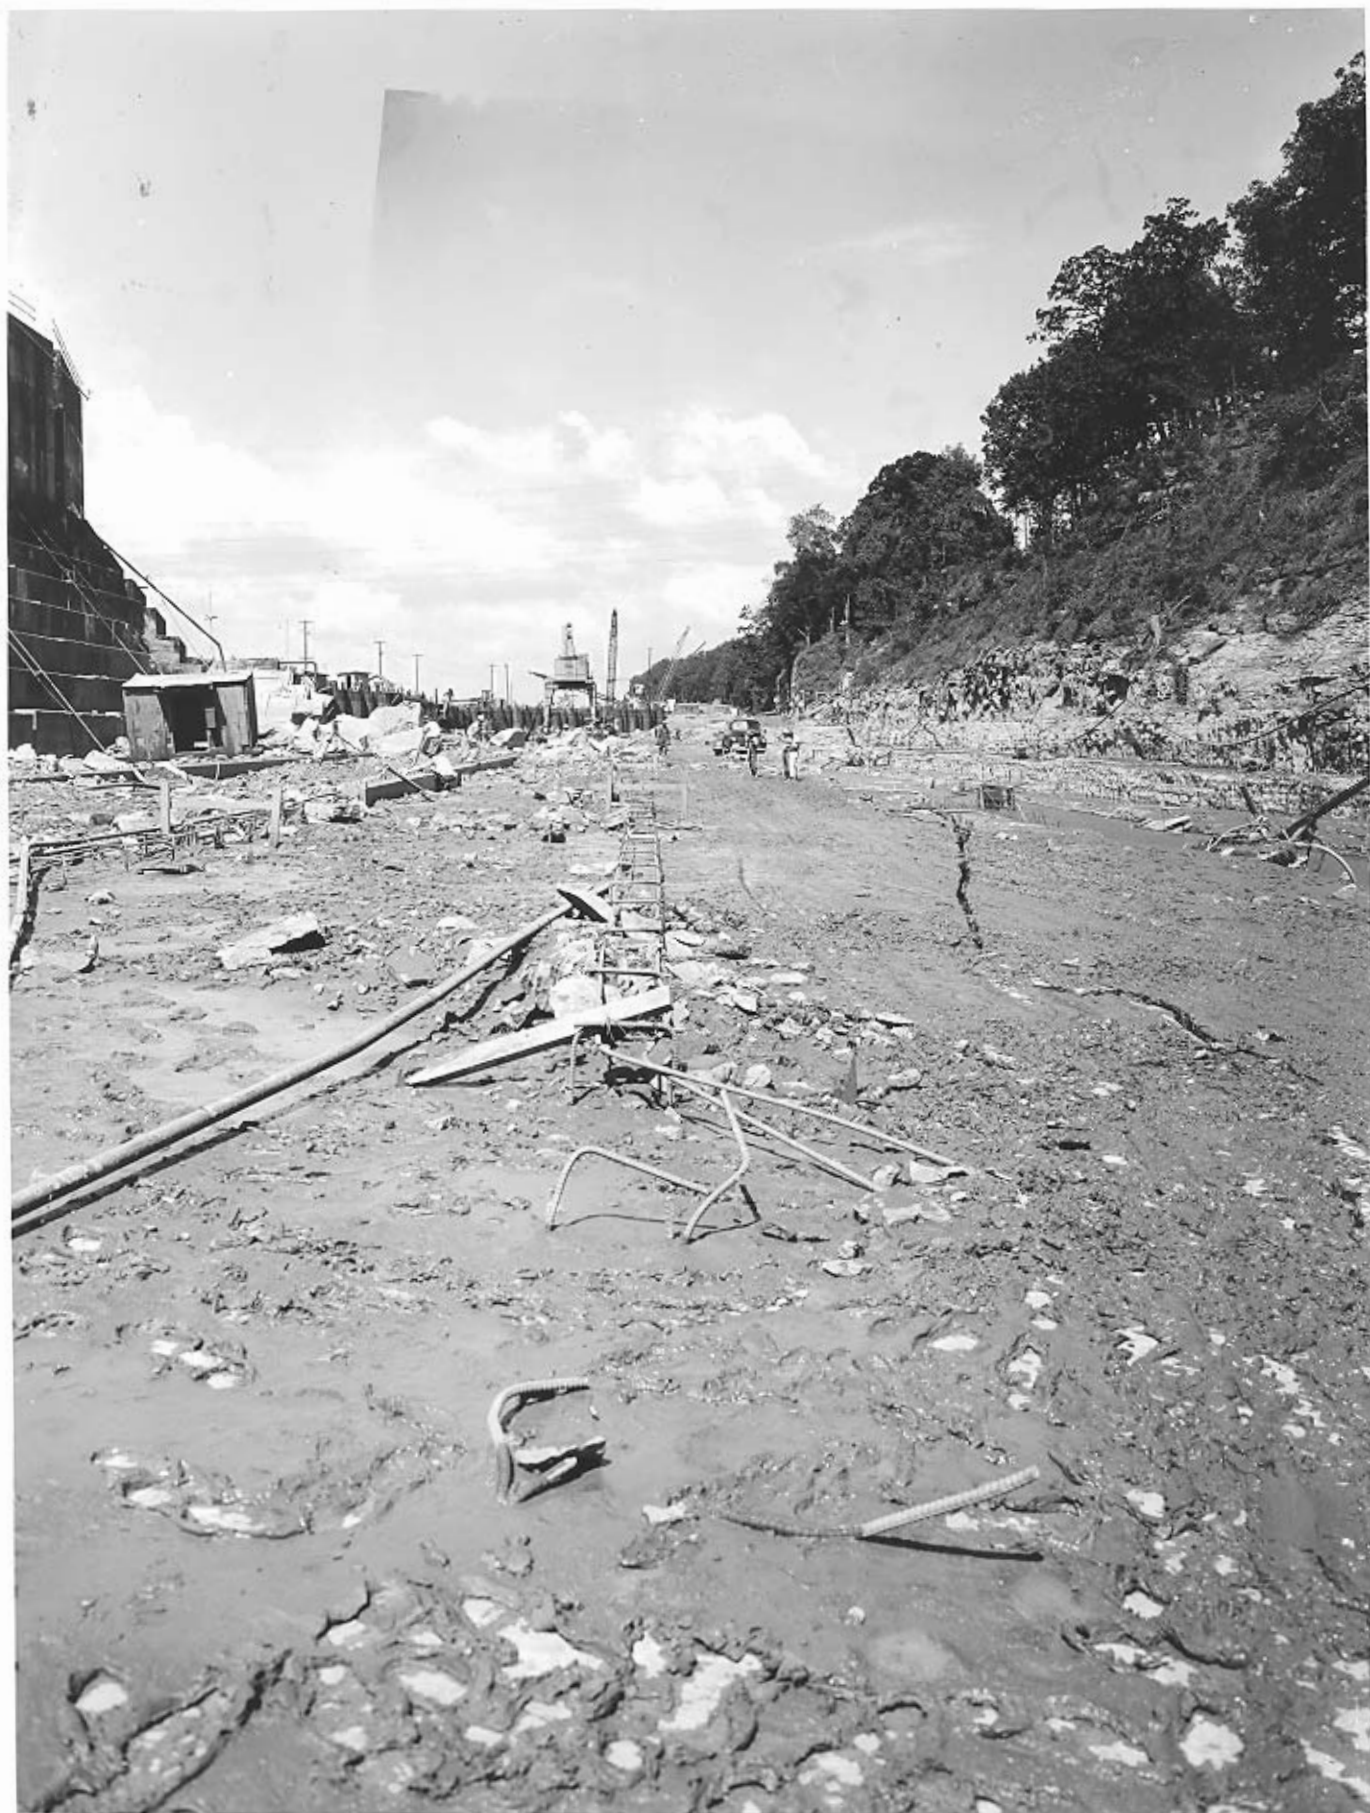
Looking downstream at crack in rock. Note crane runway reinforcing.

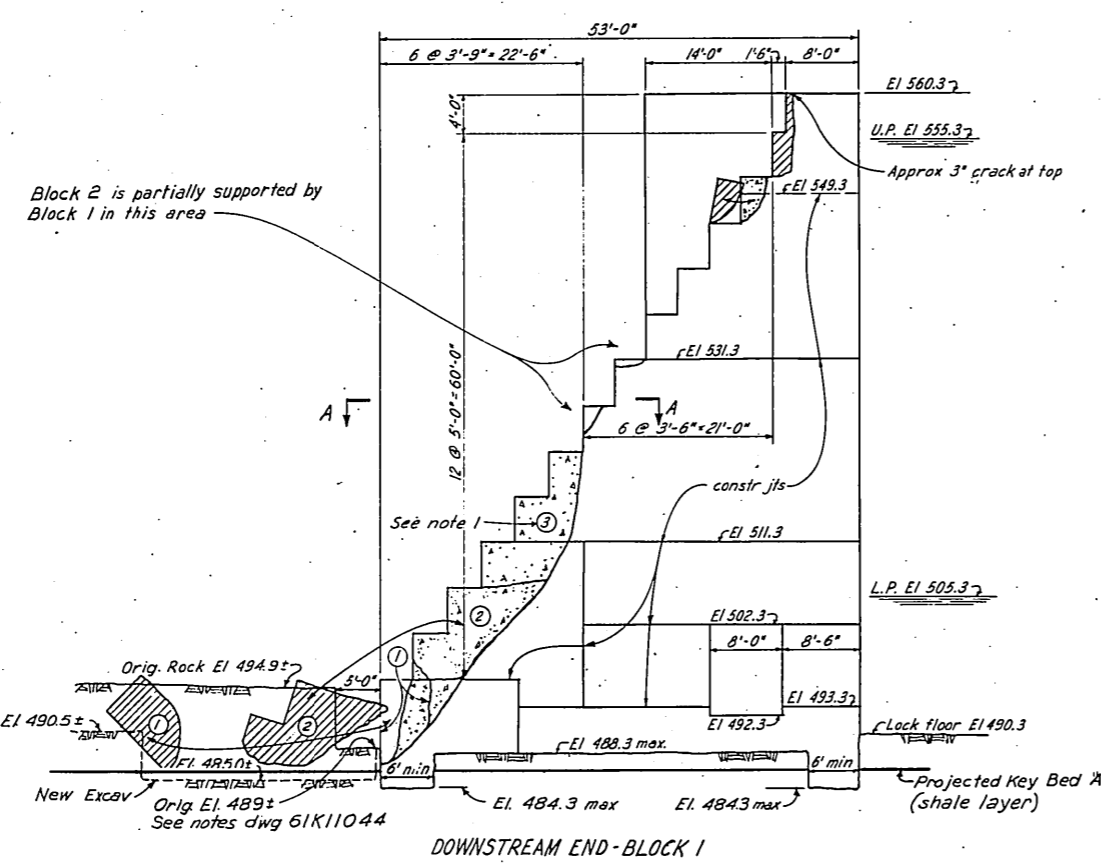
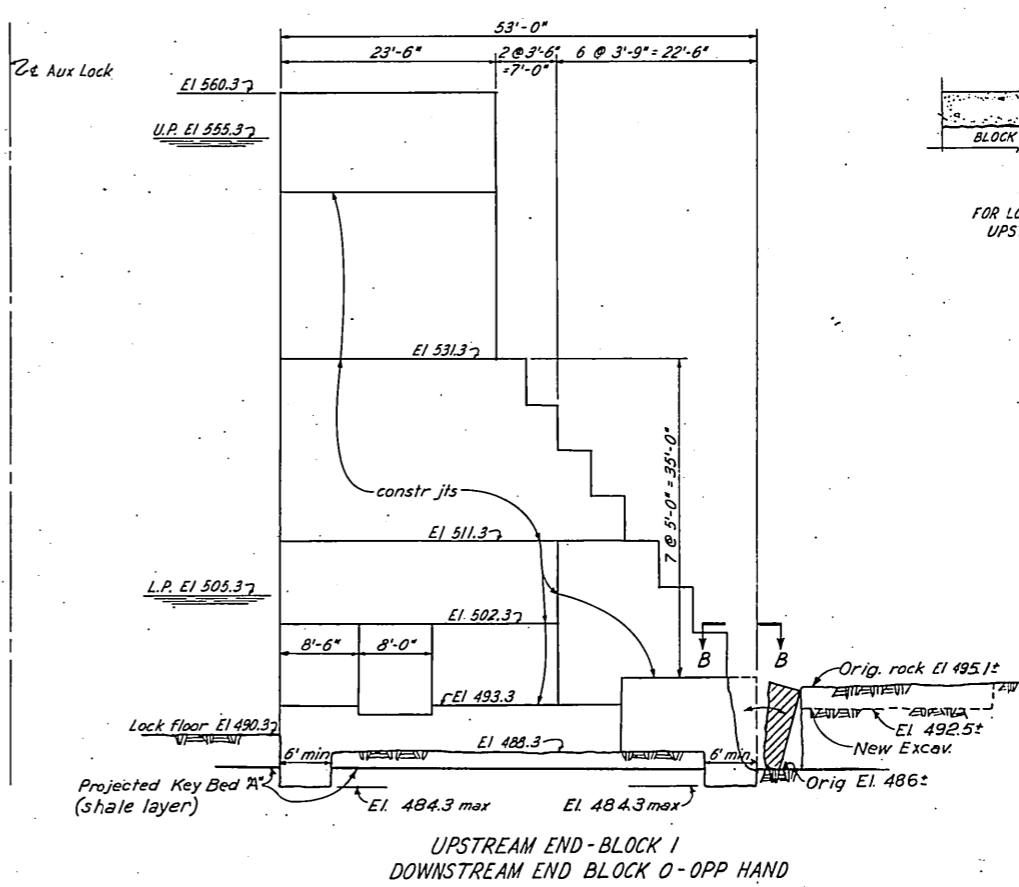
AUXILIARY LOCK			
EXISTING CONDITIONS NORTH WALL BLOCKS 0 AND 1			
WHEELER PROJECT TENNESSEE VALLEY AUTHORITY DIVISION OF CONSTRUCTION			
SUBMITTED	RECOMMENDED	APPROVED	
W.T.W. Webb	H. H. ...	W. ...	
FIELD OFFICE	7-12-61	3	PC 4 61K11054 R2
RECORD DRAWING AS CONSTRUCTED

Notes:
Hatched areas show location of concrete broken from the block.
A control point on block 1 moved 3/8" North.
No movement occurred in block 0.
Dimensions and Design El. shown are typical for blocks 0 thru 12.
All elevations shown are Design elevations except those pertaining to "New Excav" or indicated as "Orig".

NOTE 1:
Piece ③ shattered.

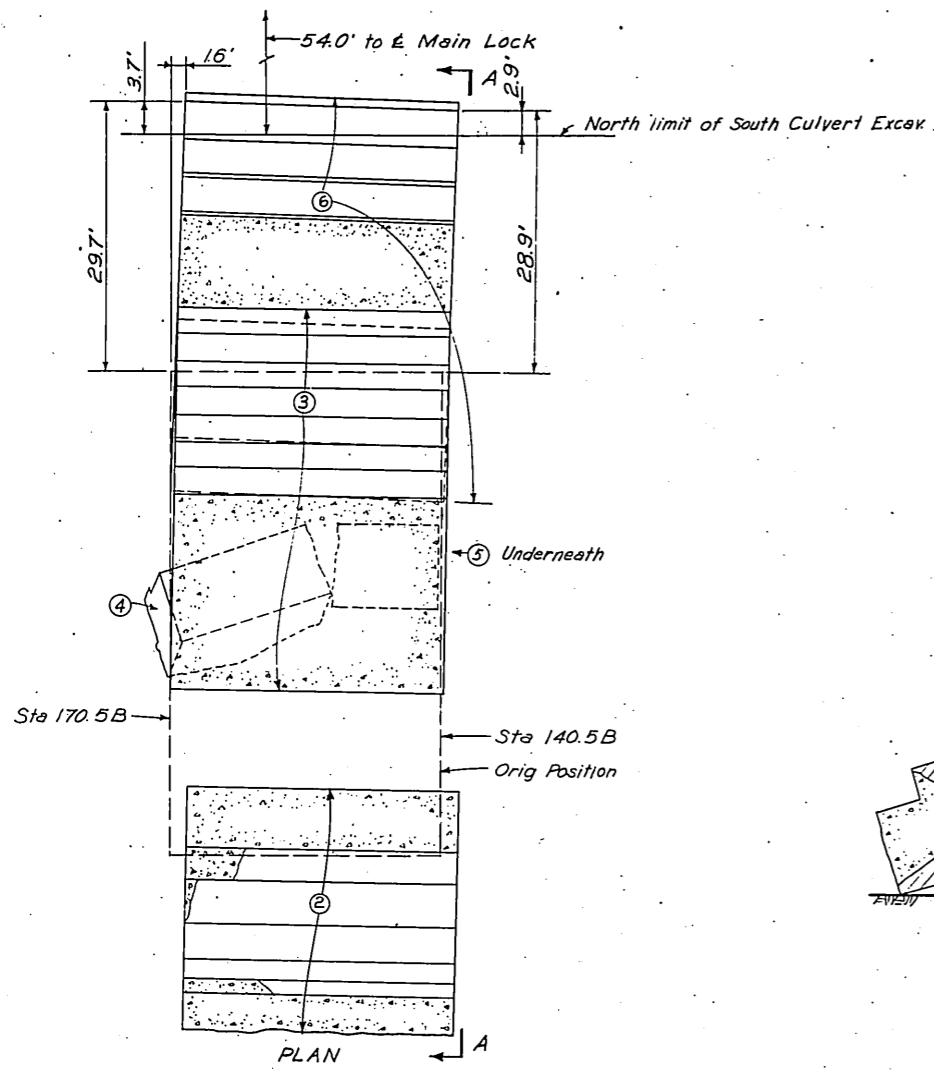
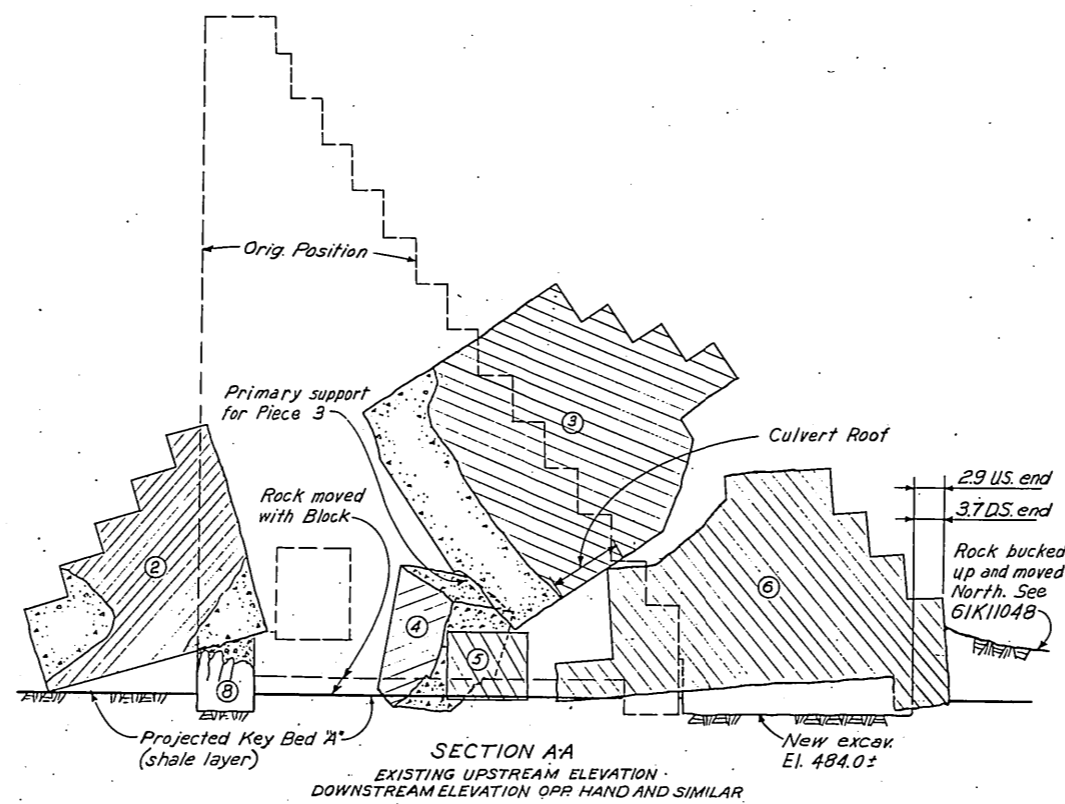
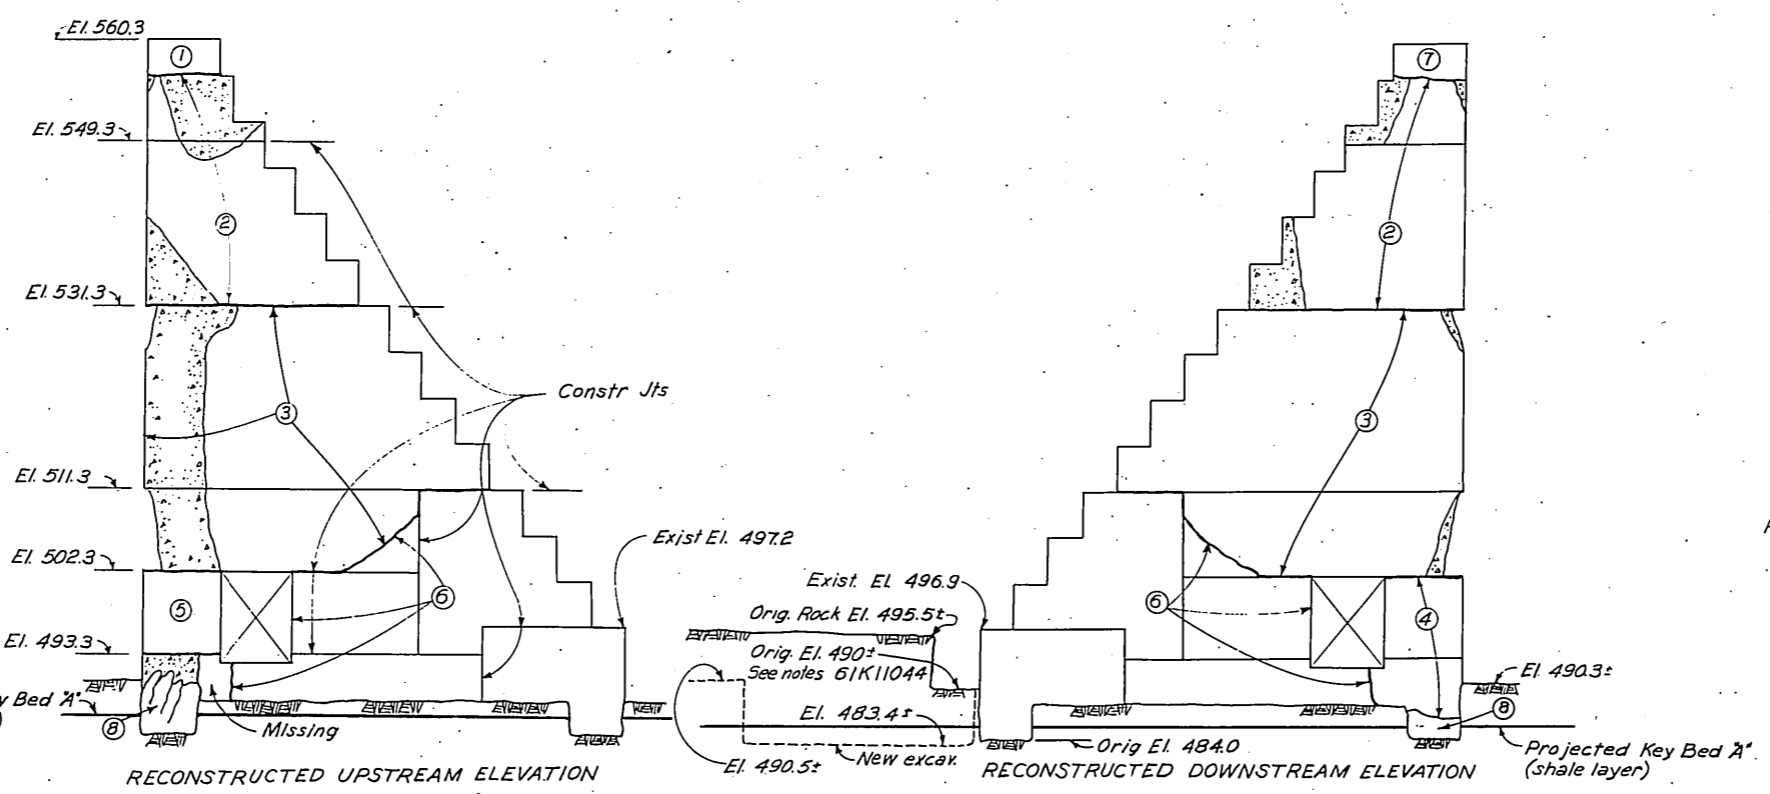
AUXILIARY LOCK		
EXISTING CONDITION		
BLOCK 4		
NORTH WALL		
WHEELER PROJECT		
TENNESSEE VALLEY AUTHORITY		
DIVISION OF CONSTRUCTION		
SUBMITTED	RECOMMENDED	APPROVED
W.T. Webb	H.A. Beckwith	[Signature]
FIELD OFFICE	7-14-61	3/ PC 4
61K11057 RP		
RECORD DRAWING AS CONSTRUCTED

Notes:
 The entire Block moved except a portion of the front Key.
 A majority of the spalled pieces are laying underneath the Block.
 All Elevations shown are Design Elevations except those indicated as 'Orig.', 'Exist.', or pertaining to new excav.
 (1) (7) and (9) are laying toward the South Wall of Aux. Lock and D.S. 15' to 30' from E of Block.
 (8) In original position, and severely cracked.
 The lower limits of piece (4) and (8) are approximate only, and could vary from those limits shown.
 This Block fell into the Lock Chamber 45 hours after initial movement
