TENNESSEE VALLEY AUTHORITY

SUBJECT: REPORT ON FAILURE OF WHEELER LOCK

REPORT ON FAILURE OF WHEELER LOCK

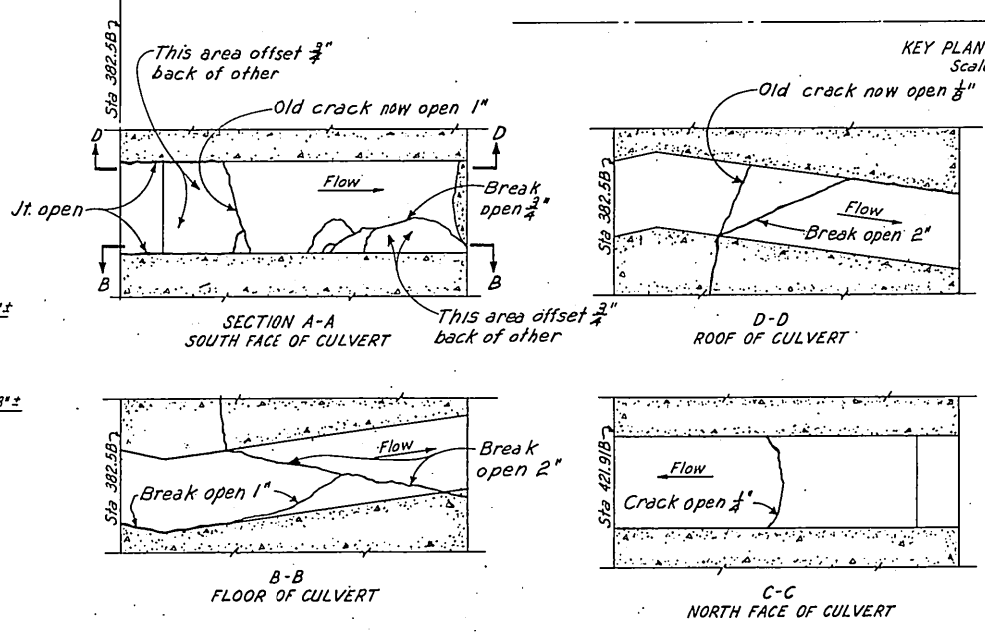
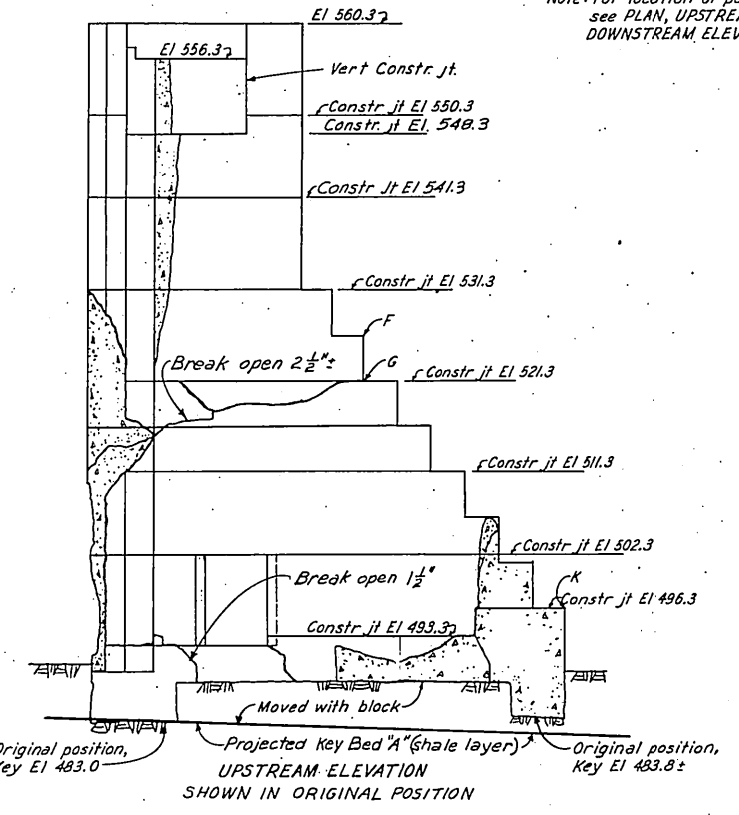
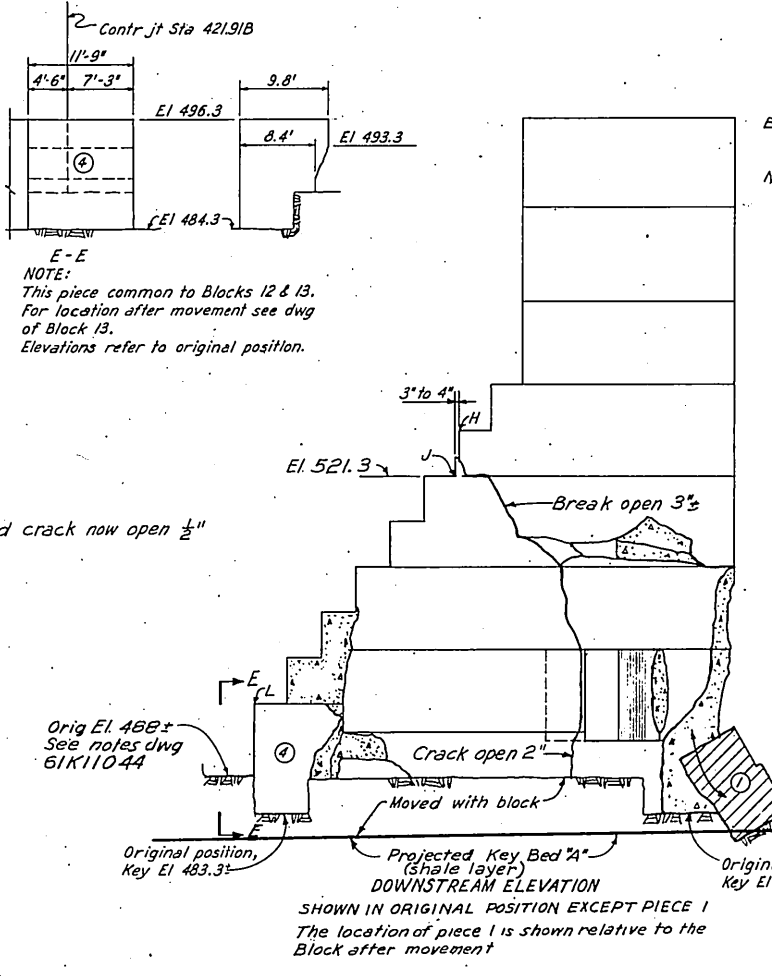
AUXILIARY LOCK		
EXISTING CONDITIONS		
NORTH WALL		
BLOCK 12		
WHEELER PROJECT		
TENNESSEE VALLEY AUTHORITY		
DIVISION OF CONSTRUCTION		
SUBMITTED	RECOMMENDED	APPROVED
W. T. Webb	H. S.
FIELD OFFICE	7-12-61	3 PC 4 61K11064 02
RECORD DRAWING AS CONSTRUCTED

NOTES:
 This block is shown in its present position in the plan view. The breaks in the block and the position of the various pieces are shown in the elevations except Piece 1.
 Hatched area shows the location of Piece 1 after movement. Piece 2, common to Blocks 12 & 13, is so numbered to coincide with the piece number in Block 13 and may be located in its present position on the dwg for Block 13. See E-E also.
 All other concrete shown spalled from the block was shattered in small pieces.
 All elevations are Design elevations except those indicated as "Orig." or pertaining to new excav.

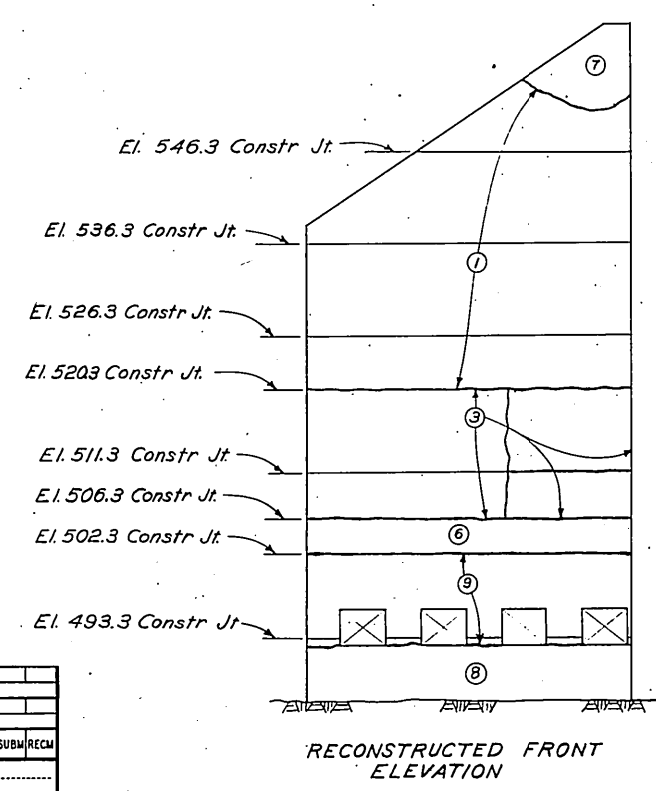
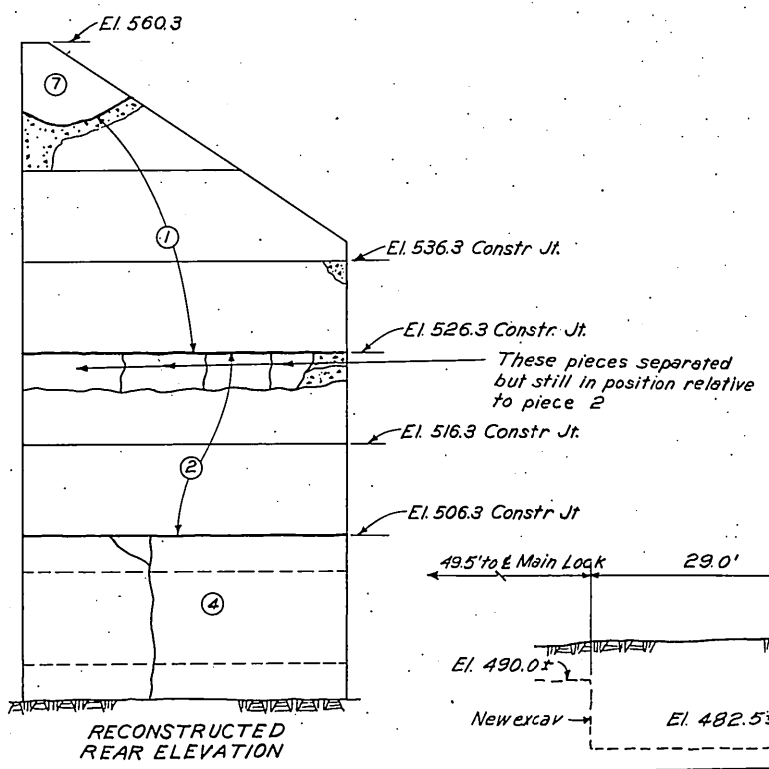
- Notes:
- ② Has multitude of cracks, and completely separated into at least 6 pieces, but pieces are still in position relative to one another.
 - ⑧ In original position.
 - ⑨ Shattered into small pieces which are laying under 1.

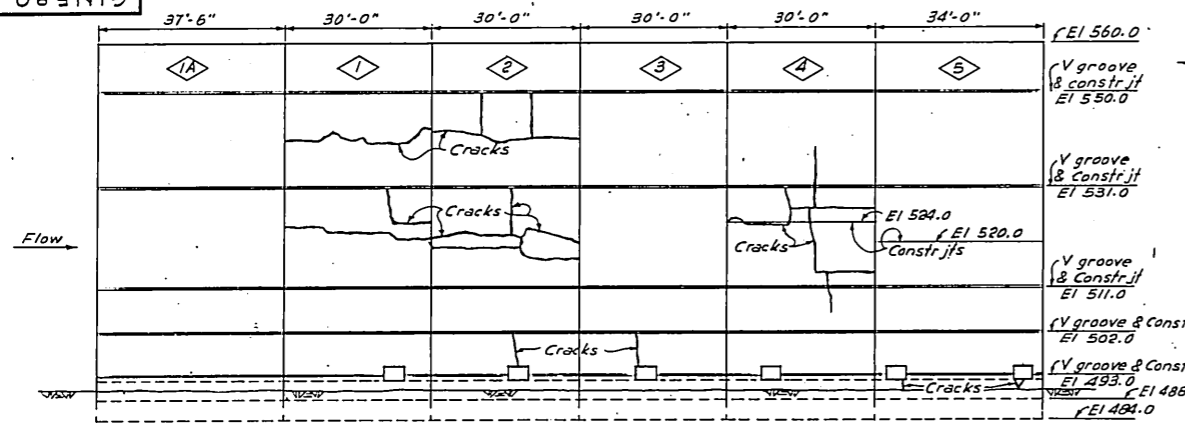
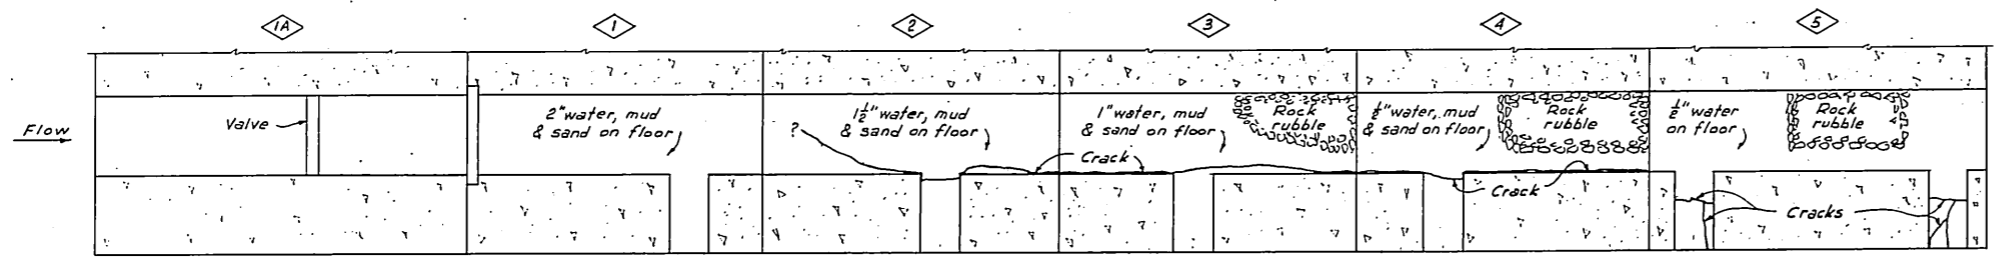
- NOTES:
- Cracks shown on Front Elevation are only the major cracks which cross the block or travel some distance vertically and are evident from a distance of 50 feet. There are many finer and shorter cracks, many of which show calcium stains indicating leakage. See photographs.

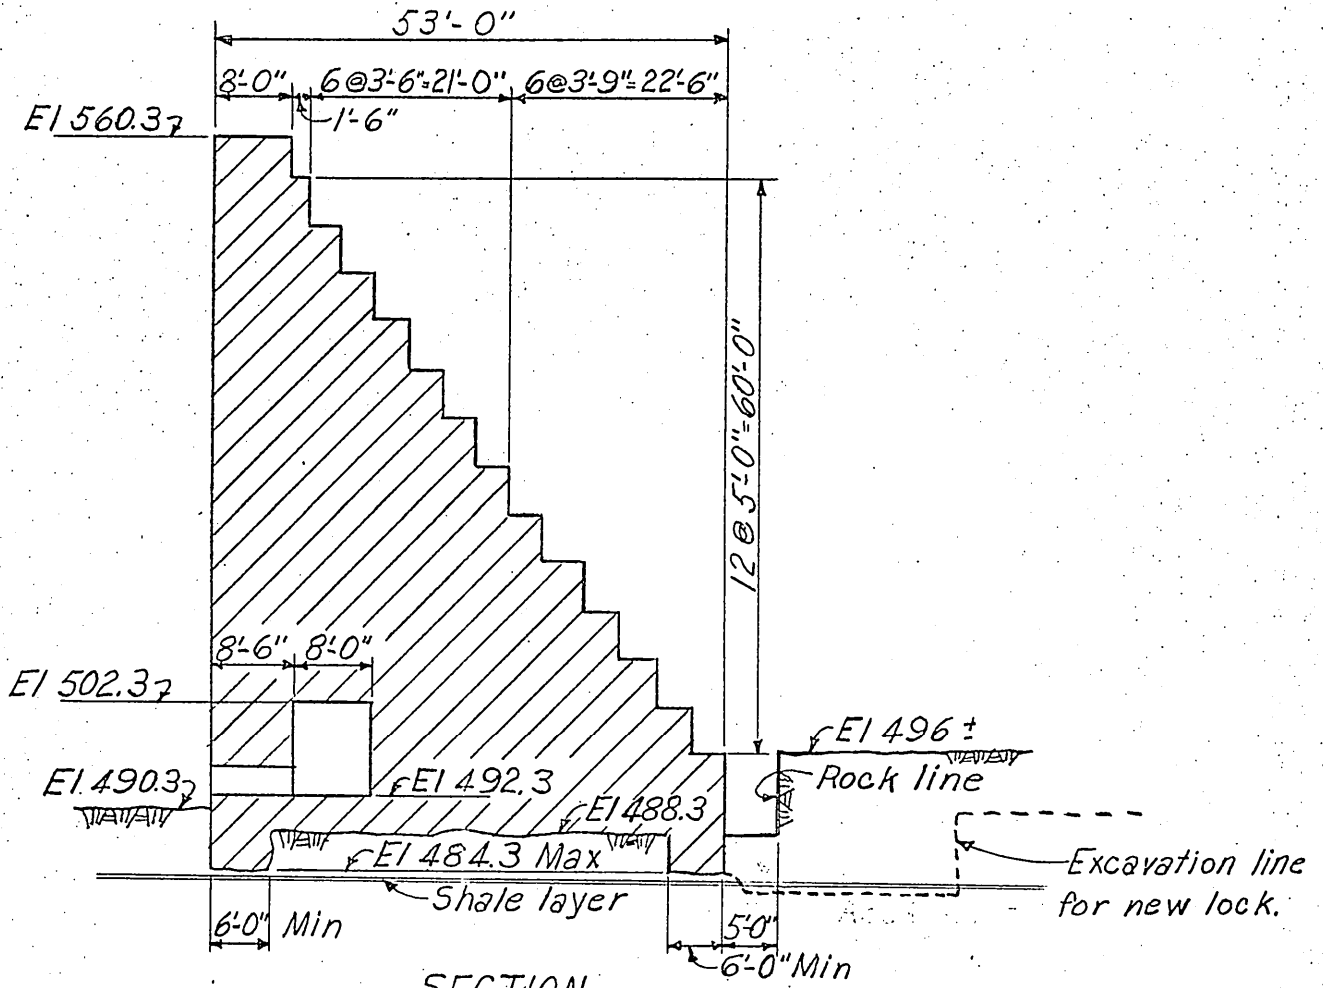
FIGURE 2

SECTION
LAND WALL THAT FAILED
