CITY OF TEMPE (STANTEC) / BRIDGESTONE

TEMPE TOWN LAKE DOWNSTREAM DAM FAILURE

Date of Loss: July 20, 2010

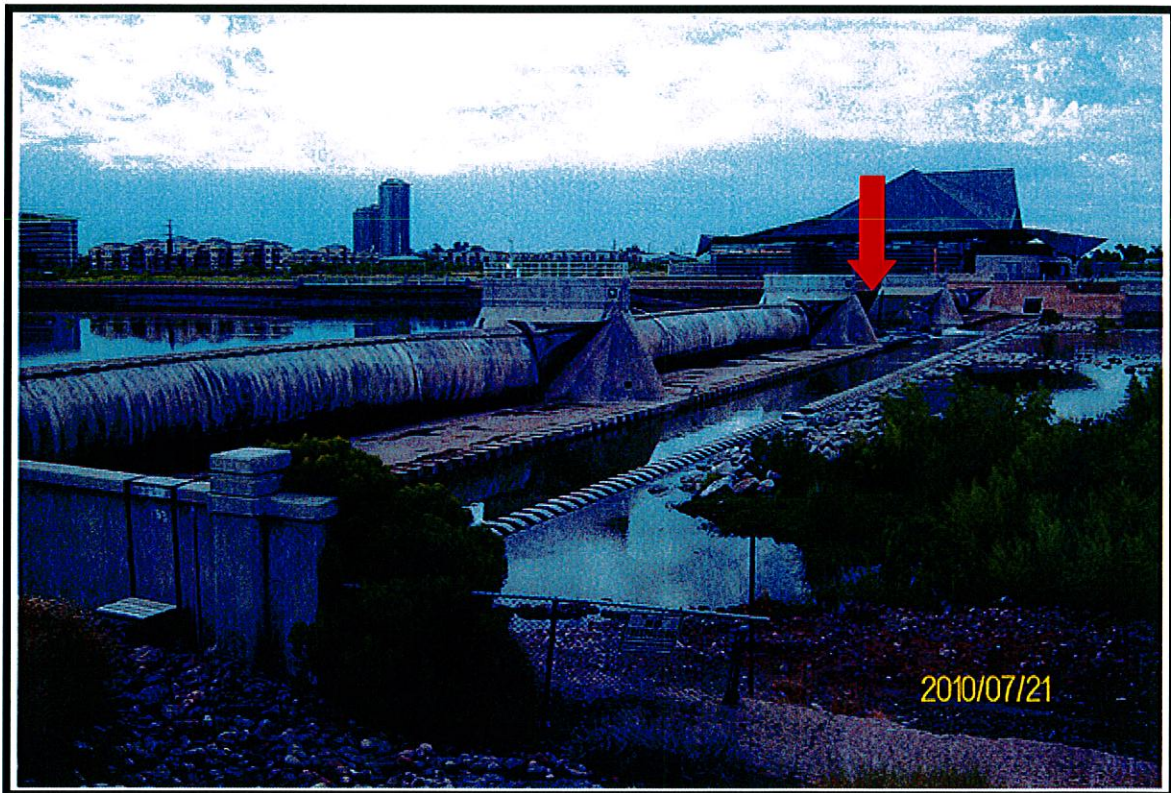
two bladders is ~201'. The diameter of each bladder is 16' when inflated. The bladders are designated as Number 1, 2, 3, and 4 with No. 1 on the south shore and No. 4 on the north shore. The failure occurred in Bladder No. 2, the inner bladder nearer the south shore. **Figure 1** shows the dam following the failure, arrow indicates failed dam span.

FIGURE 1: The dam following the July 20, 2010 failure, looking southeast from downstream. Arrow indicates failed dam span.

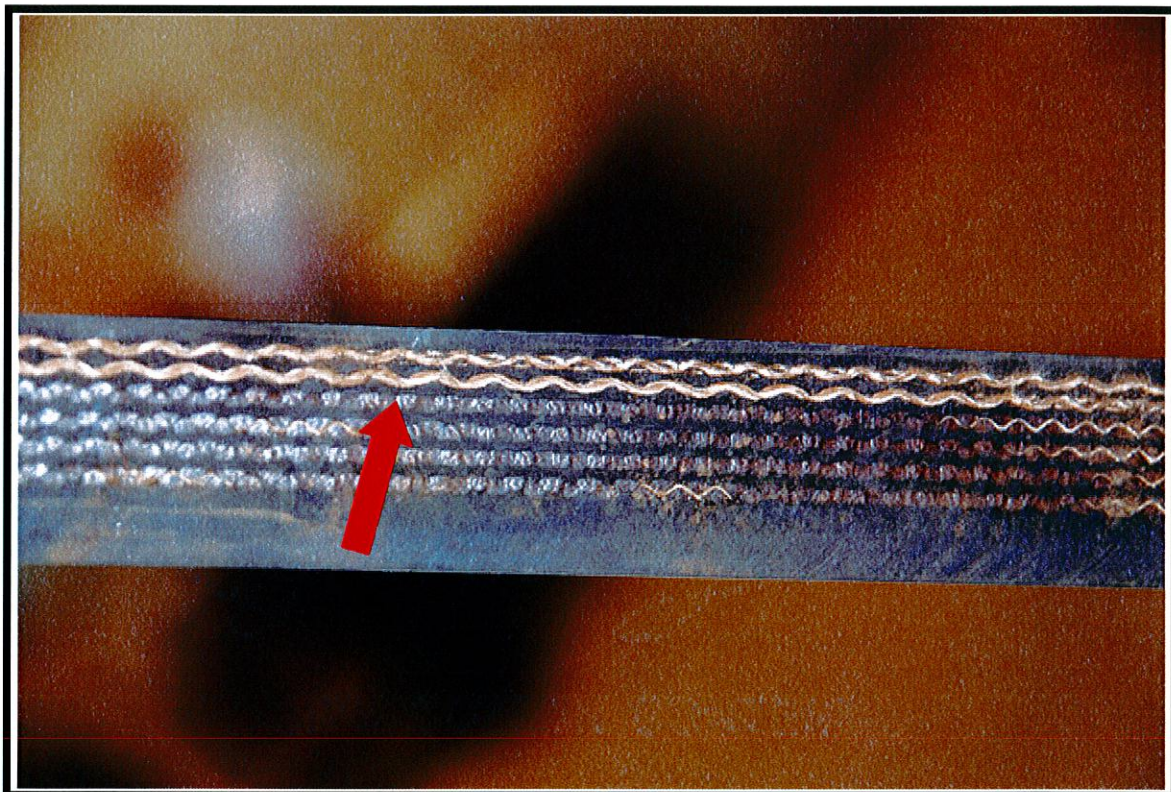
FIGURE 4: Cross-section of Bladder No. 2. Arrow indicates location of the delamination.

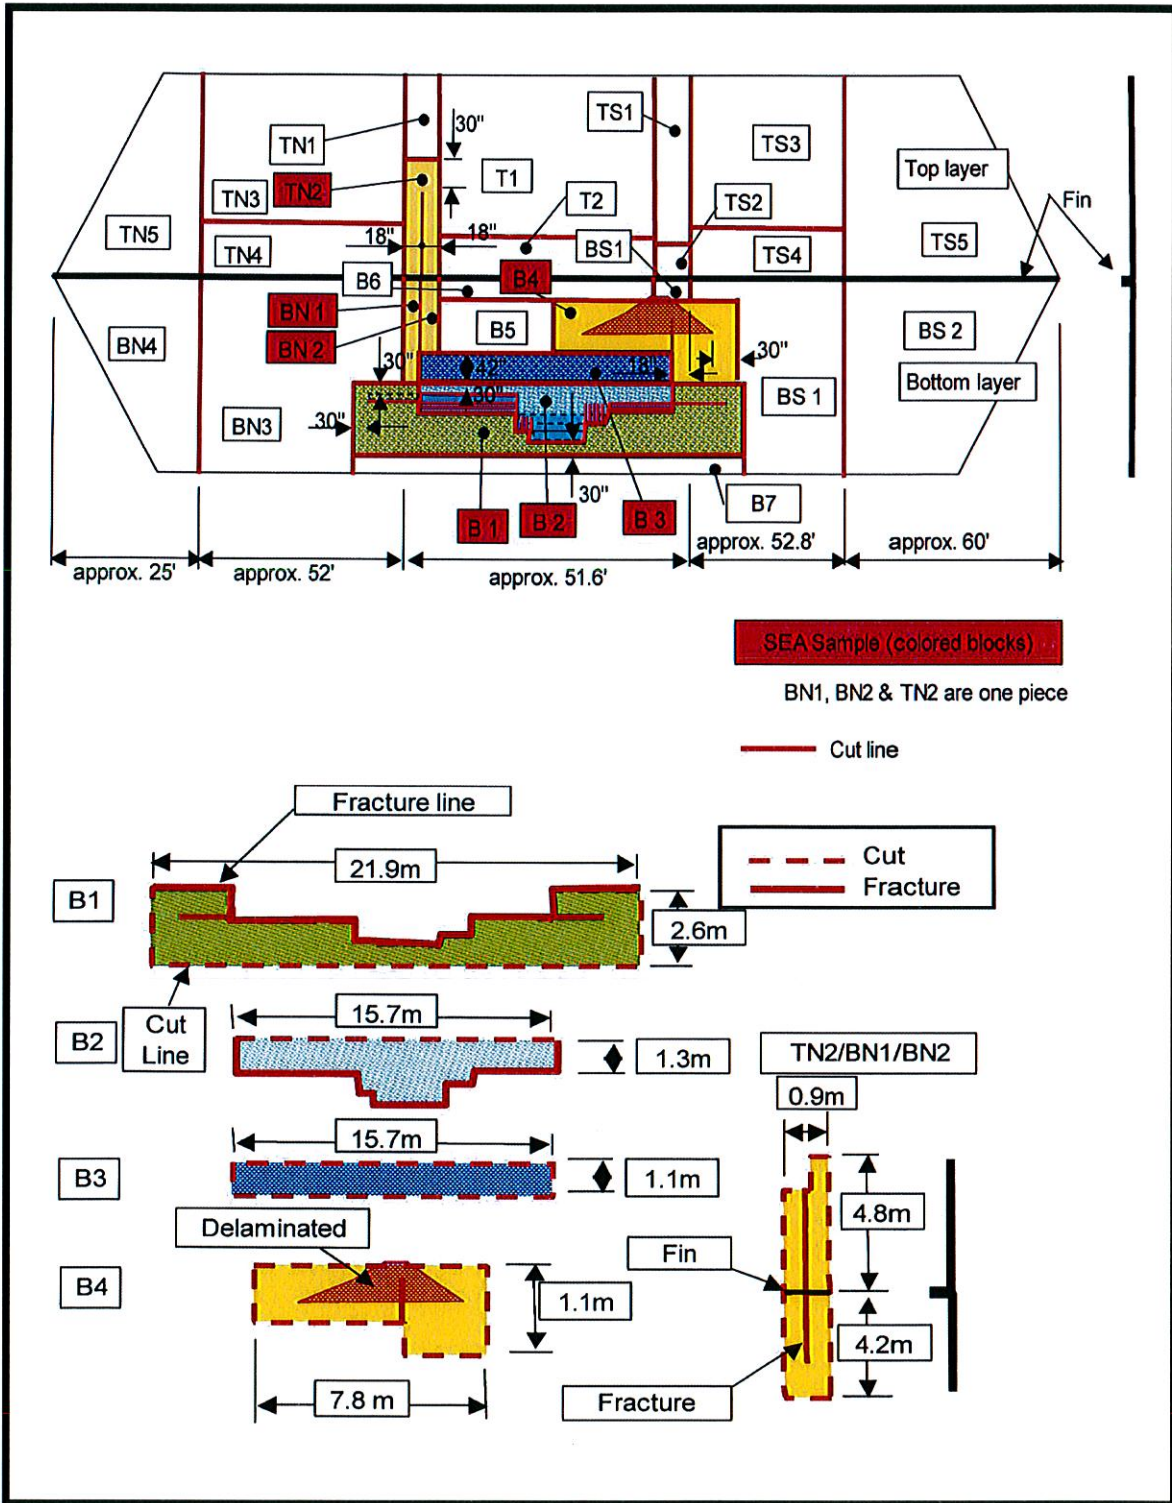
Portions of the failed Dam Span Bladder No. 2 were examined and photographed. **Figure 5** shows the location of the samples that were cut from the Bladder No. 2 and sent to SEA.

FIGURE 5: Location of bladder sections examined at SEA.

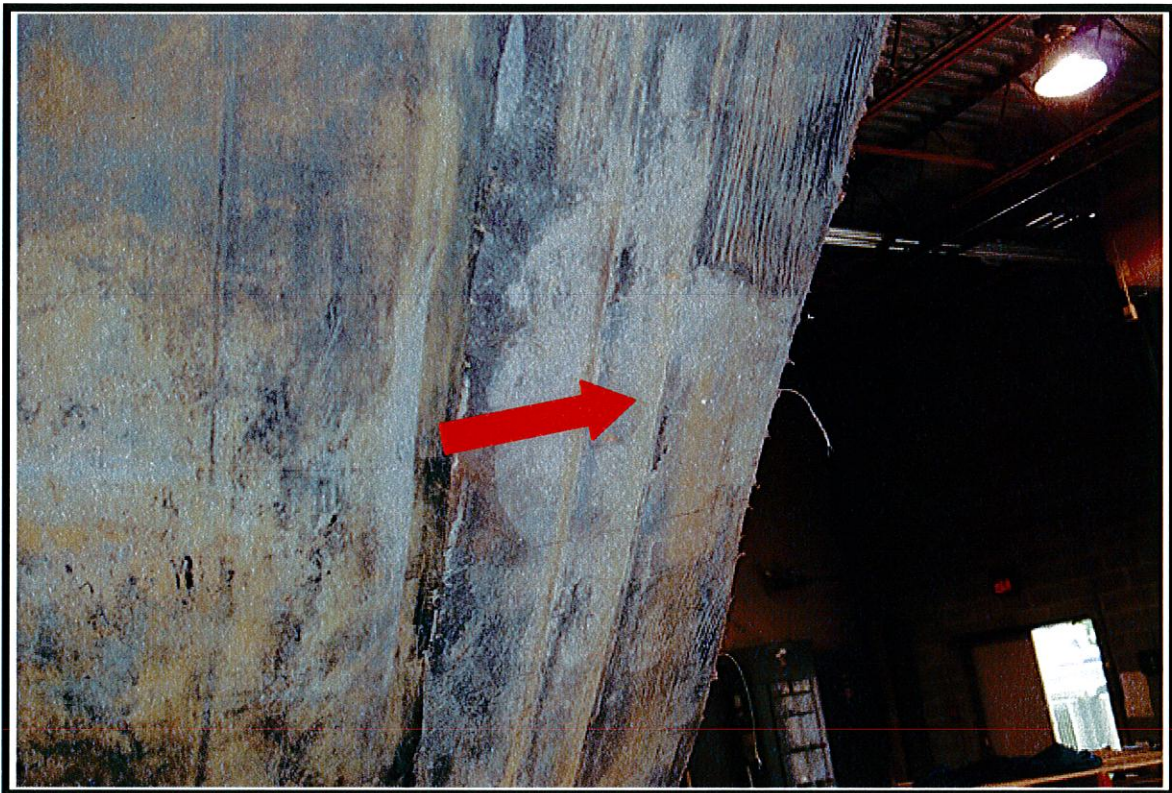
Analysis of the failed portions of the Dam's Span Bladder No. 2 showed a delamination or separation of the layers of the rubber sheets. The area showing delamination has been worn smooth from the separated layers rubbing against each other, see **Figure 6**. The separation occurred between the 2-ply and 4-ply layers as seen in Figure 3. This separation is characteristic of Intra Carcass Pressurization (ICP). ICP is normally the result of an interior breach in the layers of rubber that make-up the carcass. In this case, the bladder carcass breach occurred near where the bladder made contact with the concrete apron. This is the location where the bladder curvature deviates from its "cylindrical" profile and flattens out on the foundation. This change in curvature is where the bladder flexes, much like the sidewall on an automotive tire. This flexure causes a constant back and forth motion resulting from the movement of the bladder caused by the force of the water against the dam. The back and forth movement within the bladder carcass can cause small internal tears which then become the accumulation location for any air that penetrates the carcass. The penetration of the carcass is a diffusion process that is governed by an Arrhenius-type equation shown below and in **Figure 7**:

FIGURE 6: Delaminated area of bladder (arrow).

As the air penetrates the bladder rubber and accumulates at the internal tears, it builds up pressure, i.e., ICP. Over time, this accumulated pressure causes the separation or delamination of the layers of rubber that make-up the bladder wall.

The delaminated area no longer has the strength and structure of the other areas of the bladder and acts as a preferential site for failure, analogous to a stress riser. Although the pressure inside the bladder was only ~6 psi, the hoop stress in the bladder was ~600 psi. Once the accumulated air caused a large enough area of delamination of the layers, i.e., the effective stress riser, the hoop stress became larger than remaining strength of the bladder.

The failure was the result of the age of the dam (time) and the environmental conditions (temperature) in which the dam existed. The age of the dam was over 11 years and the temperatures in the Tempe area are extremely high, often exceeding 100°F.

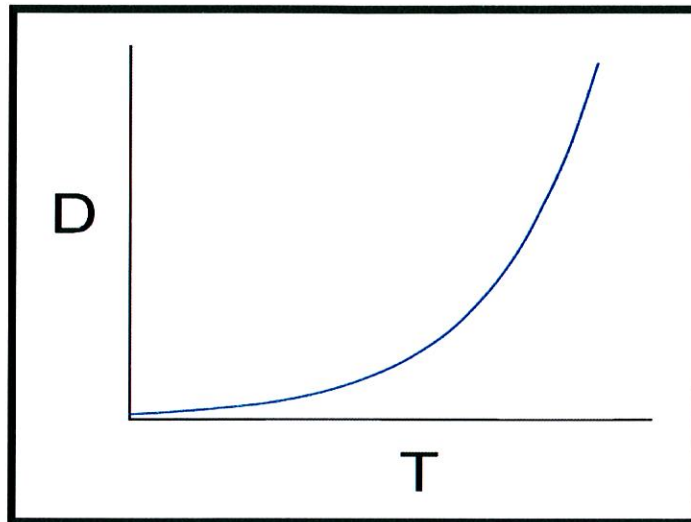
FIGURE 7: Arrhenius type curve showing exponential relationship between diffusivity (D) and temperature (T).

The penetration of air into the bladder rubber depends on both the carcass temperature and time. As the diffusion equation shows, the carcass temperature is the dominant factor since it has an exponential dependence, where, as noted above, time has a linear dependence.
