FAILURE OF DAM NO. 3
on the
Middle Fork of Buffalo Creek
near Saunders, West Virginia
on
February 26, 1972

Report prepared by
Roger K. Seals, W. Allen Marr, Jr., and T. William Lambe
for the
Committee on Natural Disasters
National Academy of Engineering

BUFFALO CREEK REPORT

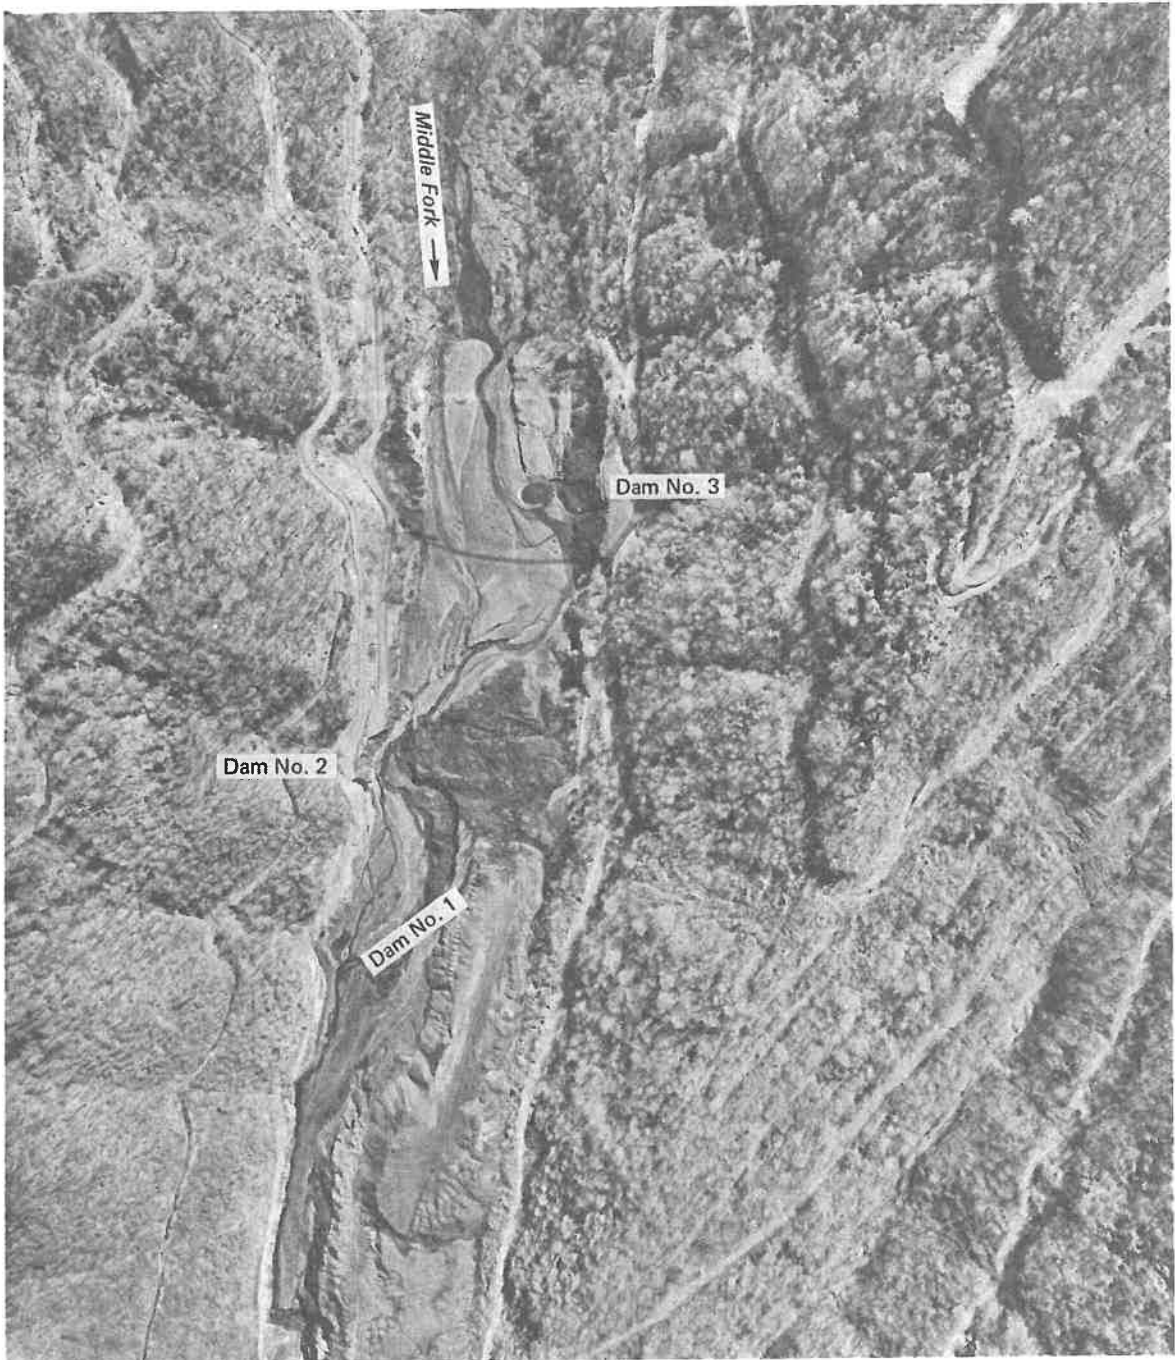
Figures 5 and 6 are aerial photographs made shortly after the failure (on February 27, 1972) and show the area near the mouth of Middle Fork (Saunders). The approximate locations of Dam Nos. 1, 2, and 3 are indicated on the photographs. Remnants of Dam No. 3 are seen, but no identifiable traces of Dam Nos. 1 and 2 remain. Dam No. 4 is

FIGURE 5 Aerial Photograph showing Approximate Locations of Dam Sites (2-27-72). Approximate Scale: 1" = 500'.

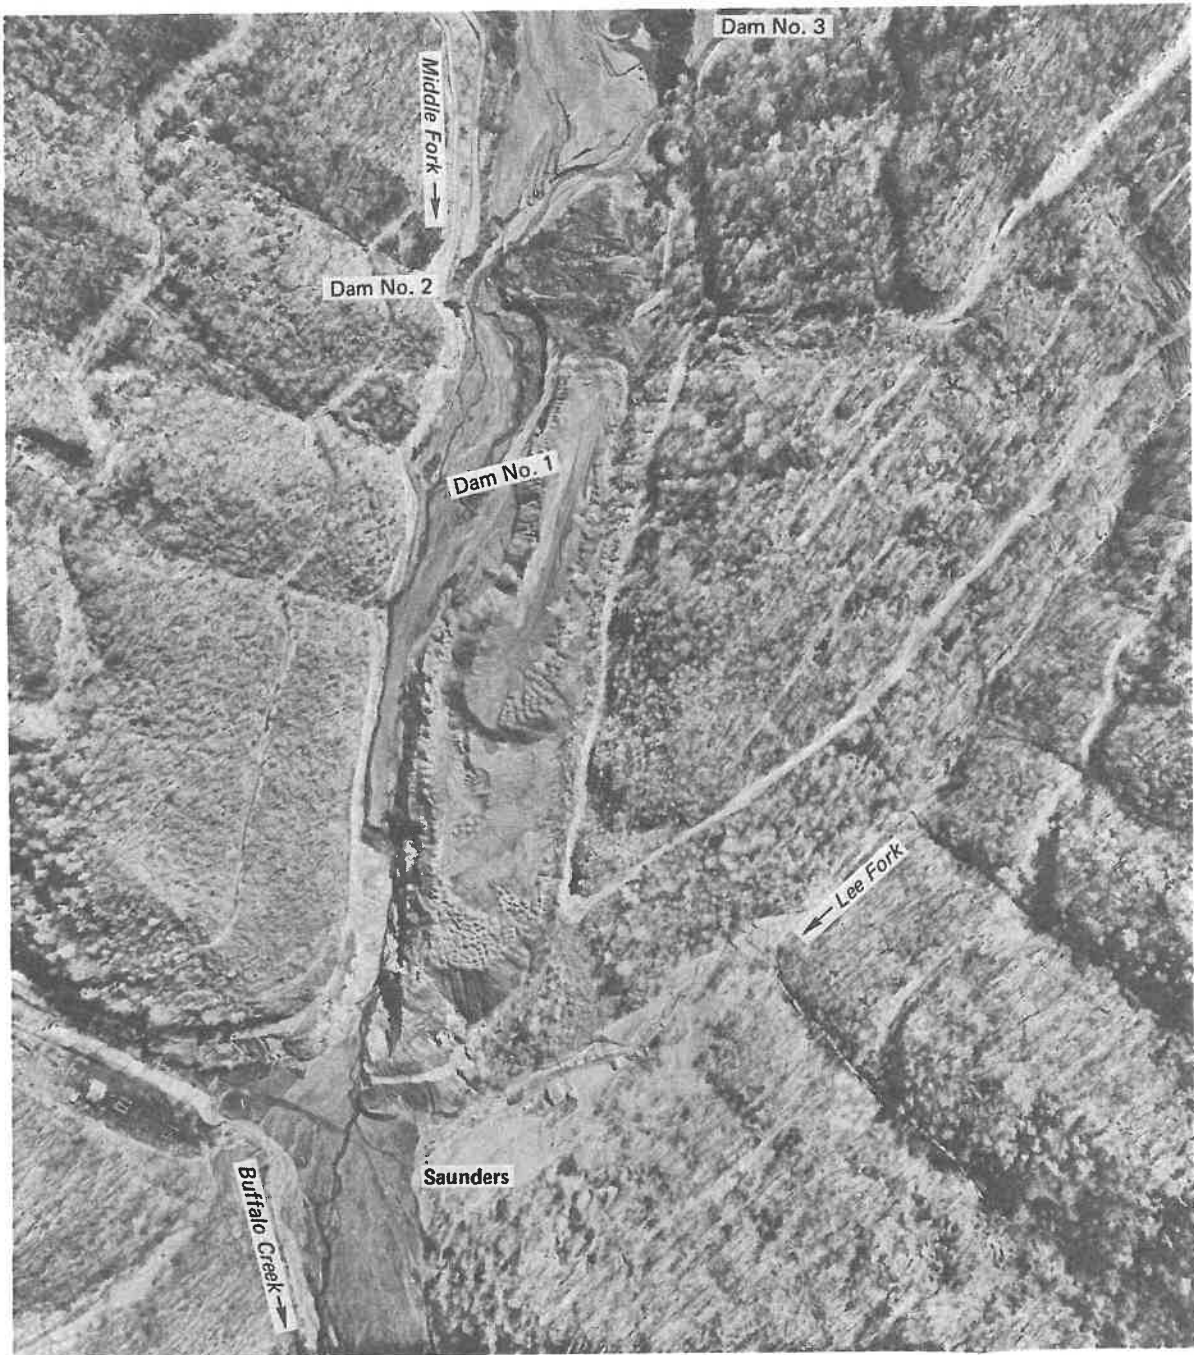
too far upstream on Middle Fork to appear in the photographs. Figure 6 clearly shows the gully eroded in the refuse bank as the flood waters entered the Buffalo Creek Valley.

FIGURE 6 Aerial Photograph of Saunders Area (2-27-72).
Approximate Scale: 1" = 500'.

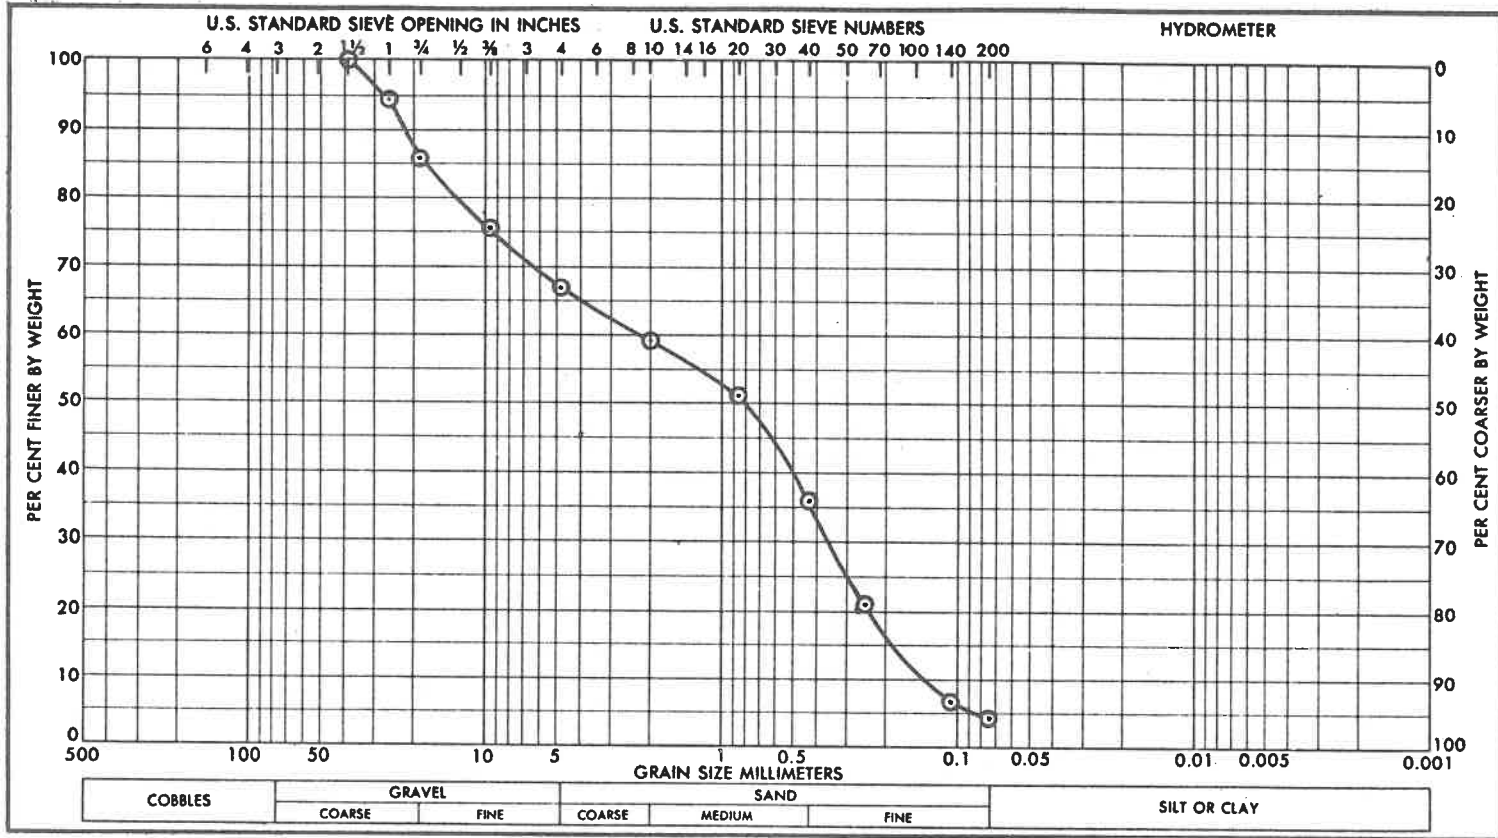
A sample of refuse was taken from the left abutment area at the time the inspection team made its visit. Specific gravity, grain size, and direct shear tests were conducted on the sample. Visually, the refuse was classified as a black granular material containing fragments of sandstone, shale, and low grade coal. Larger fragments vary from blocky to platy in shape. According to the Unified Soil Classification System, the refuse was classified as an SP material, i.e., poorly graded sand, gravelly sand, little or no fines. In the field, slabs of refuse were observed that were several feet wide and several inches thick. The grain size distribution curve for the laboratory sample is presented in Figure 7.

FIGURE 7 Grain Size Distribution Curve for Coal Refuse Sample Taken at Dam No. 3 Site.

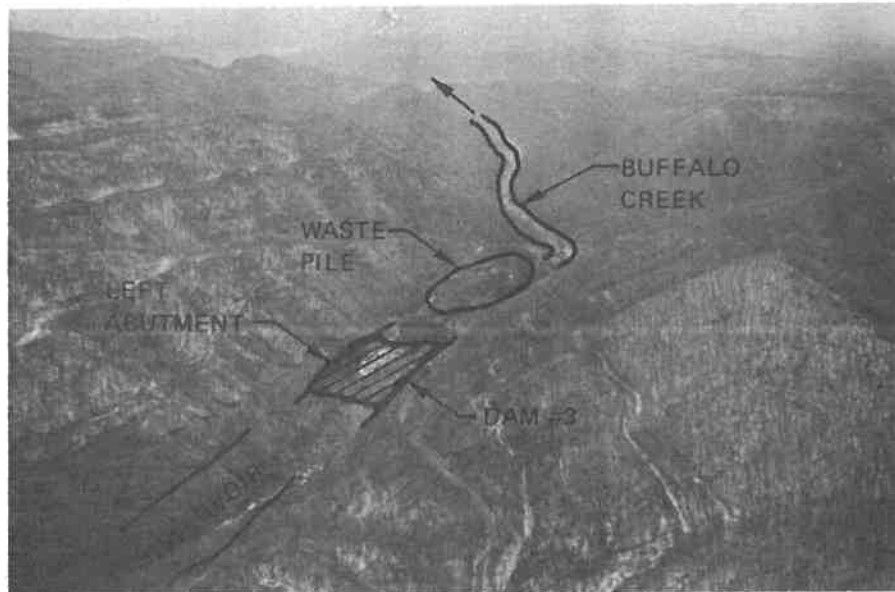
At 8:00 a.m. on February 26, 1972, Dam No. 3 failed. The released water over-topped the two small dams, No. 1 and No. 2, below Dam No. 3 and rushed down the right side of a large waste dump of coal refuse. An aerial view of the area taken seven days after the failure is shown in Figure 8.

FIGURE 8 Downstream View of Reservoir in Foreground, Left and Right Abutments of Dam No. 3 (at arrow), Waste Pile, and Buffalo Creek.

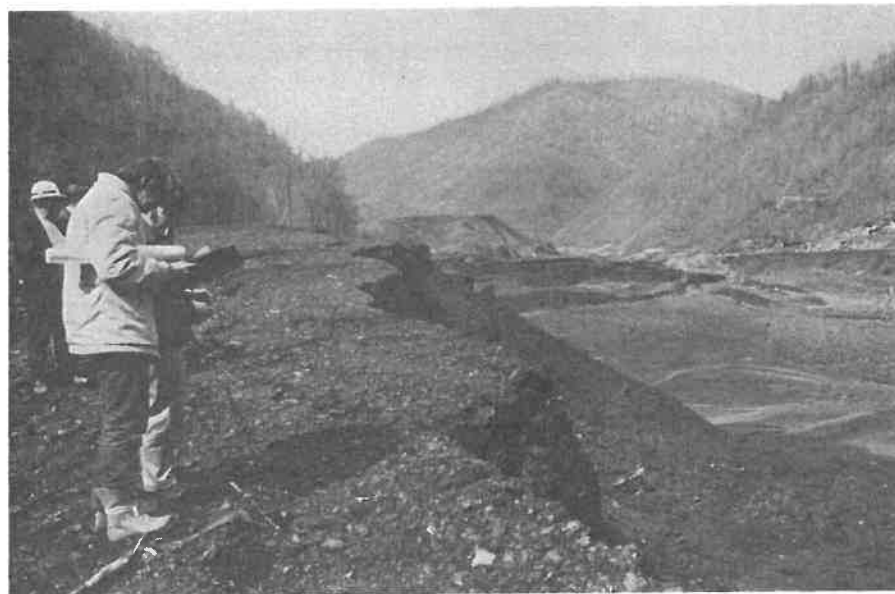
Only the abutments of Dam No. 3 remained. The left abutment shown in Figure 9 was estimated to be approximately 60 ft. high. At the time of failure the estimated crest width was 100-200 ft. and the base width was 400-500 ft. Trees, stumps, and natural soil present in the foundation can be seen in Figure 10. Figure 11 shows some of the coal silt and sludge which remained in the reservoir bottom.

FIGURE 9 Looking Downstream from Left Abutment.

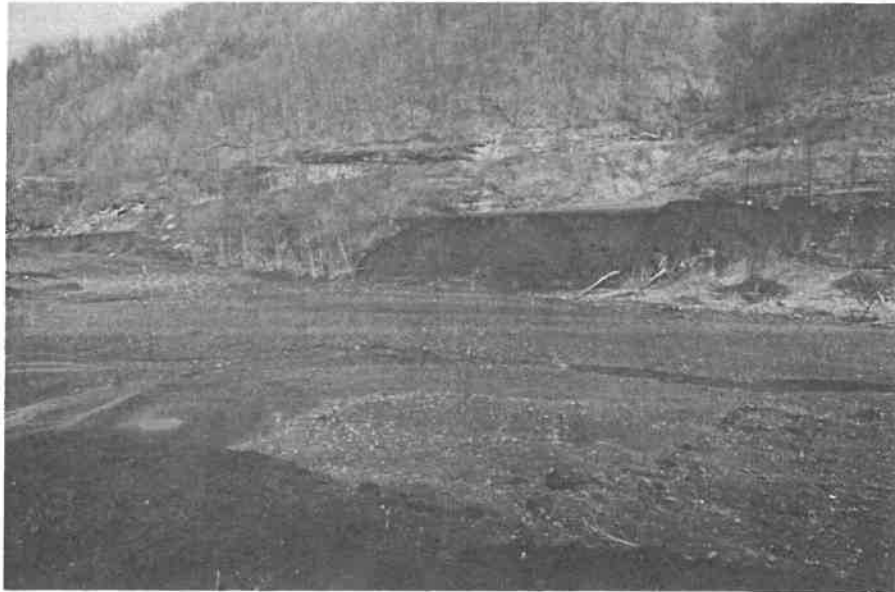
FIGURE 10 Looking at Right Abutment of Dam No. 3 from Left Abutment.

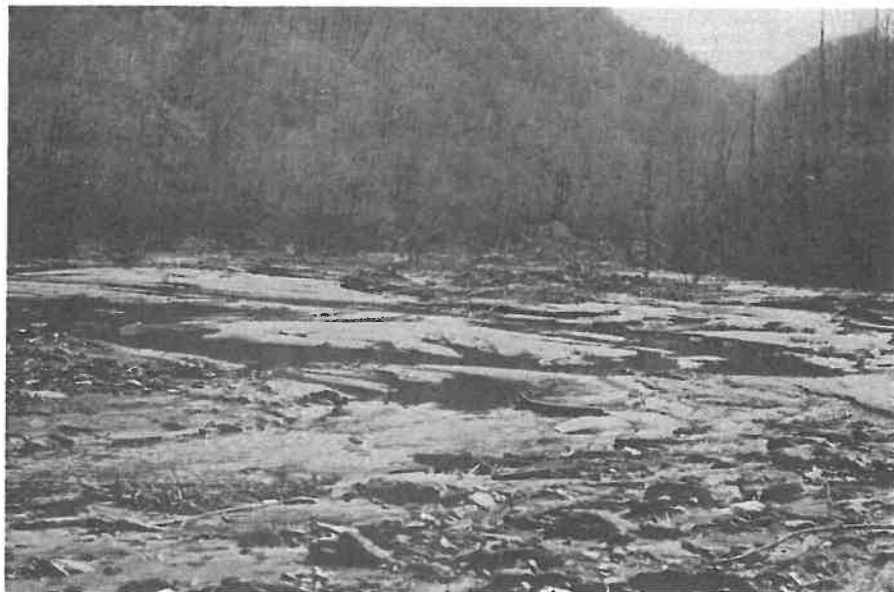
FIGURE 11 Looking Upstream at Reservoir Area from Center of Dam.

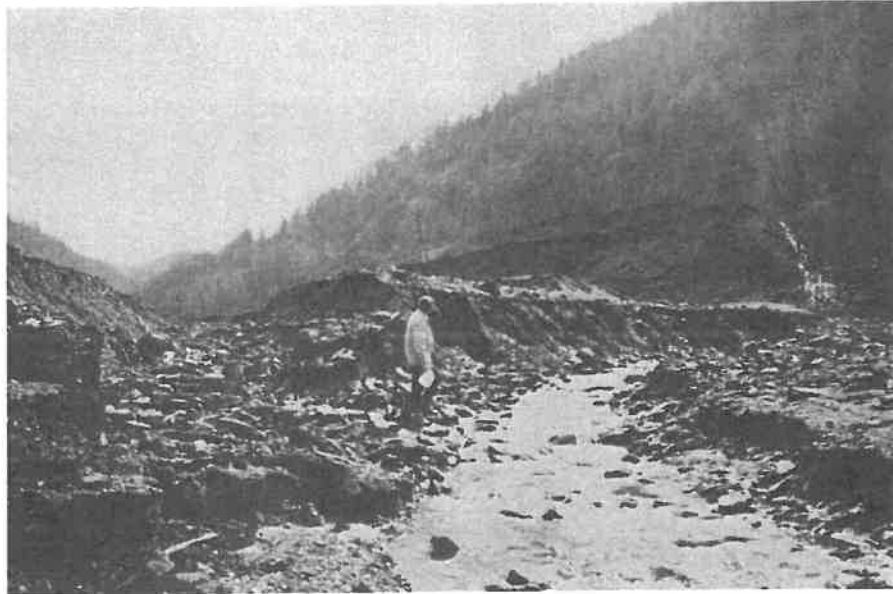
The two small dams were completely eroded away. Figure 12 is an upstream view of the location of Dam No. 2. The left abutment of Dam No. 3 is in the center background.

FIGURE 12 Looking up at Left Abutment. Dam No. 2
Formerly in Foreground.

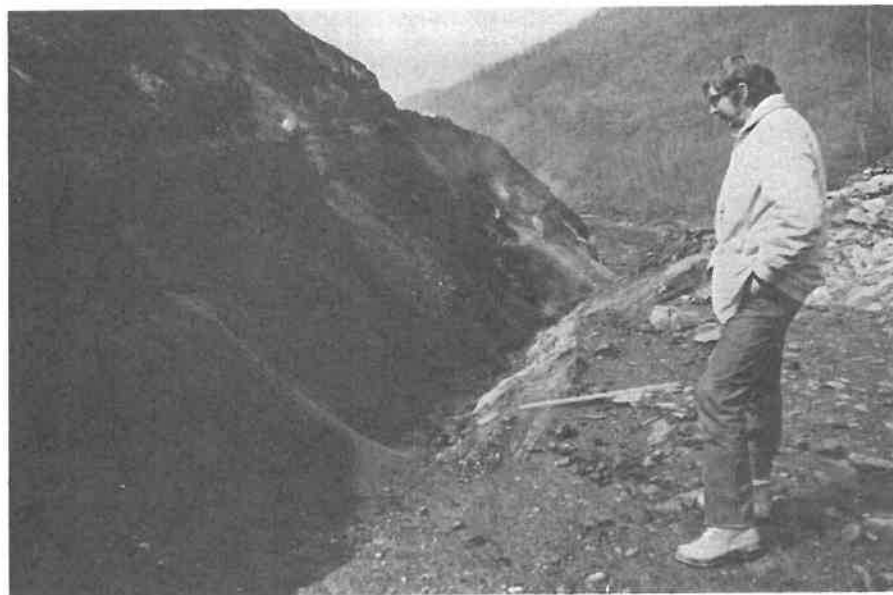
The water followed a haul road down the right side of the coal waste pile and eroded the 50-ft.-deep gulley shown in Figures 13 and 14. Steam explosions occurred when portions of the waste pile which were burning were flooded by the advancing water. The flood waters emptied out of the gulley into Buffalo Creek (Figure 15) and started their devastating way downstream. It was estimated by the U.S. Department of Interior Task Force that the entire quantity of impounded water was released within a 15-minute period.

FIGURE 13 Looking Downstream at Washed Out Gulley by
Waste Pile.

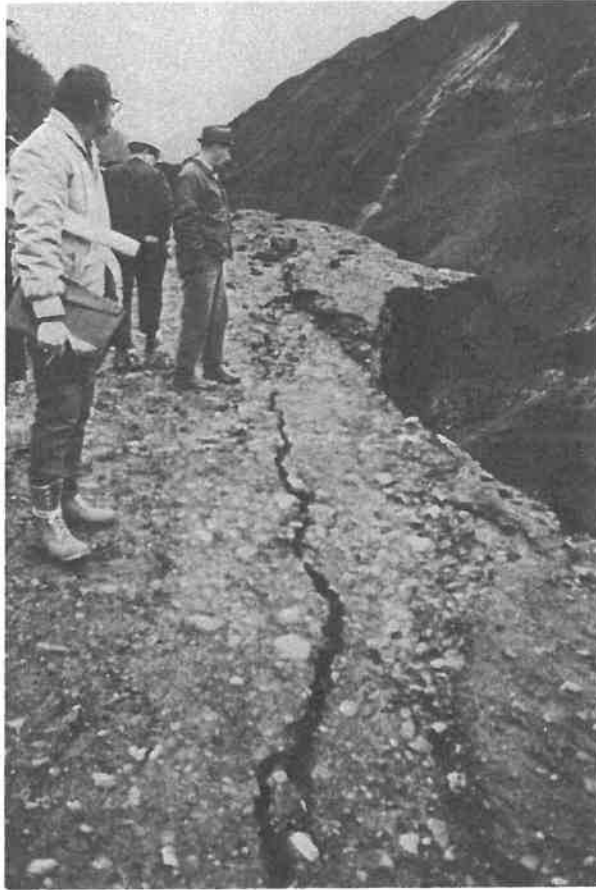
FIGURE 14 Looking Upstream at Edge of Waste Pile.

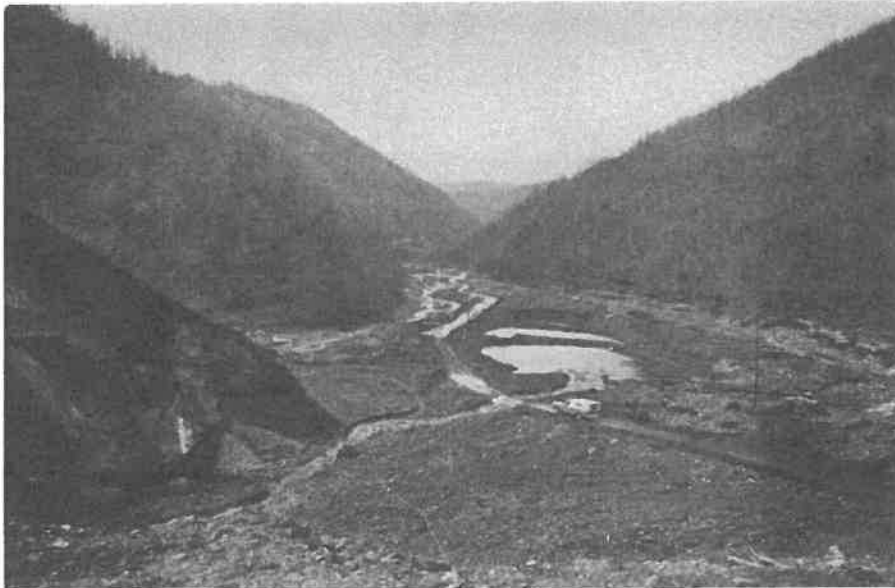
FIGURE 15 Looking Downstream at Buffalo Creek from Lower Right Edge of Waste Pile.

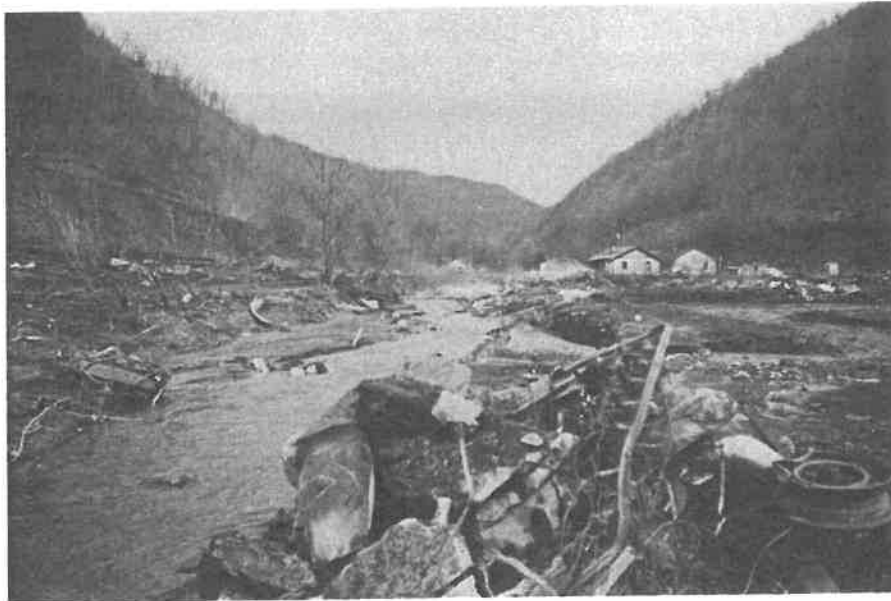
FIGURE 16 Looking Upstream at Buffalo Creek, 5 Miles Below Dam.

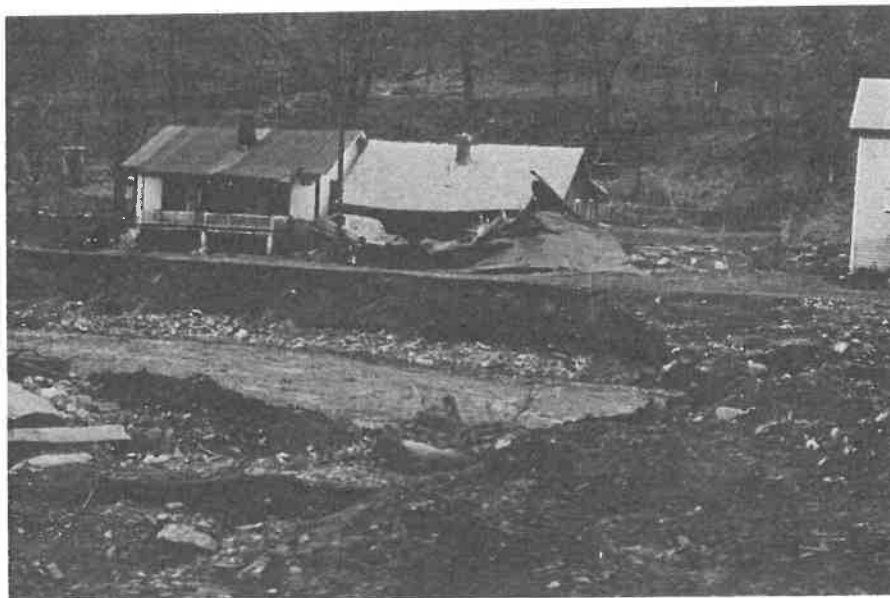
FIGURE 17 Home Removed from its Foundation and Damaged Automobile 5 Miles Below Dam.

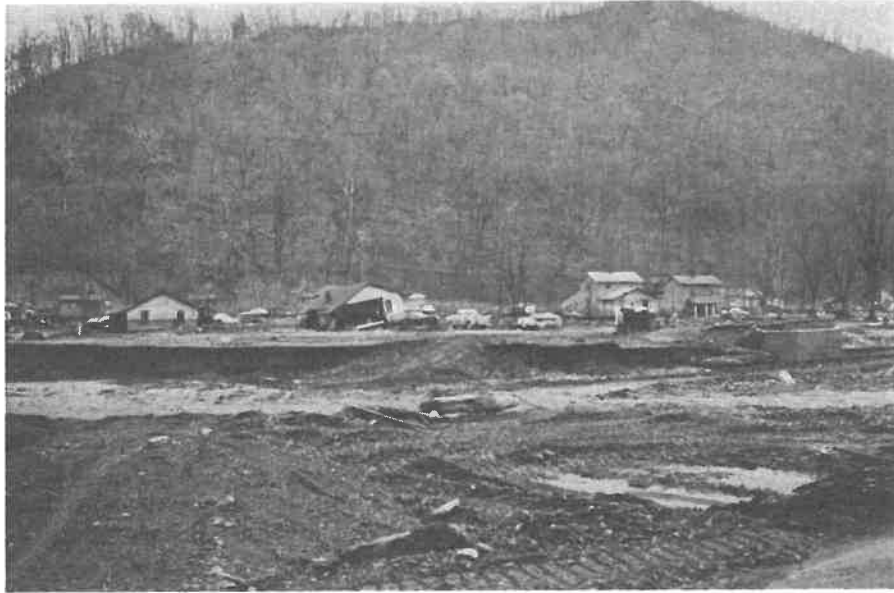
FIGURE 18 Town 8 Miles Below Dam.

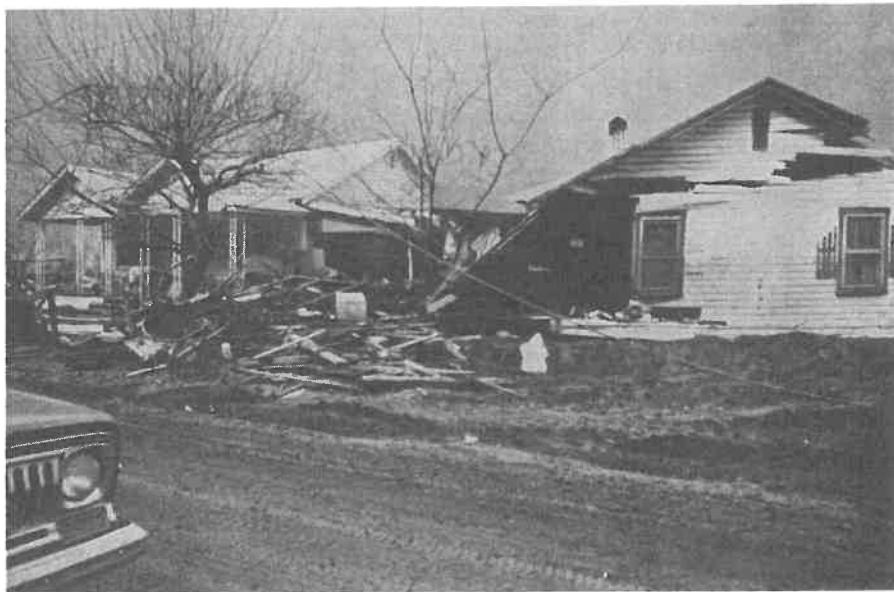
FIGURE 19 Homes 10 Miles Below Dam.

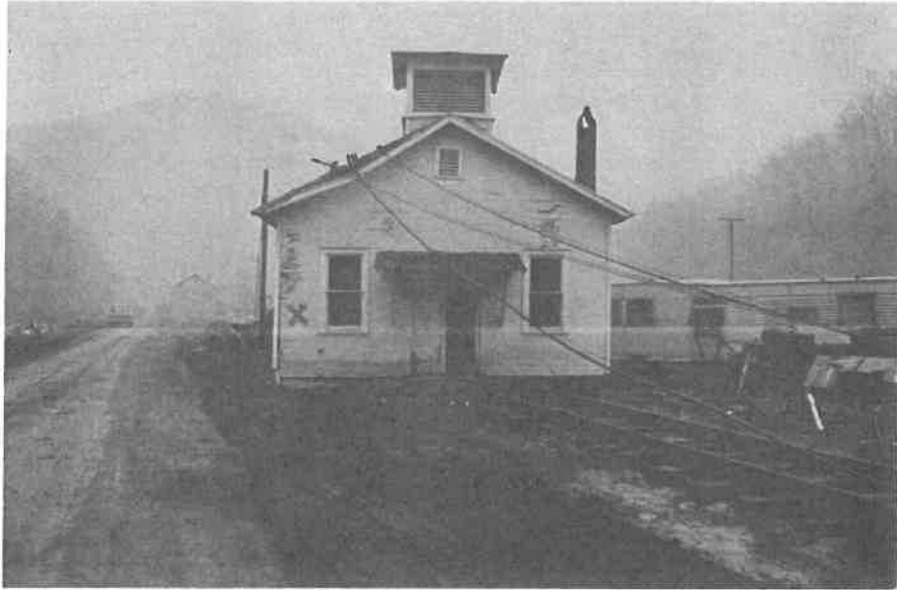
FIGURE 20 Church Removed from its Foundation. (X on Building indicates Condemned.)

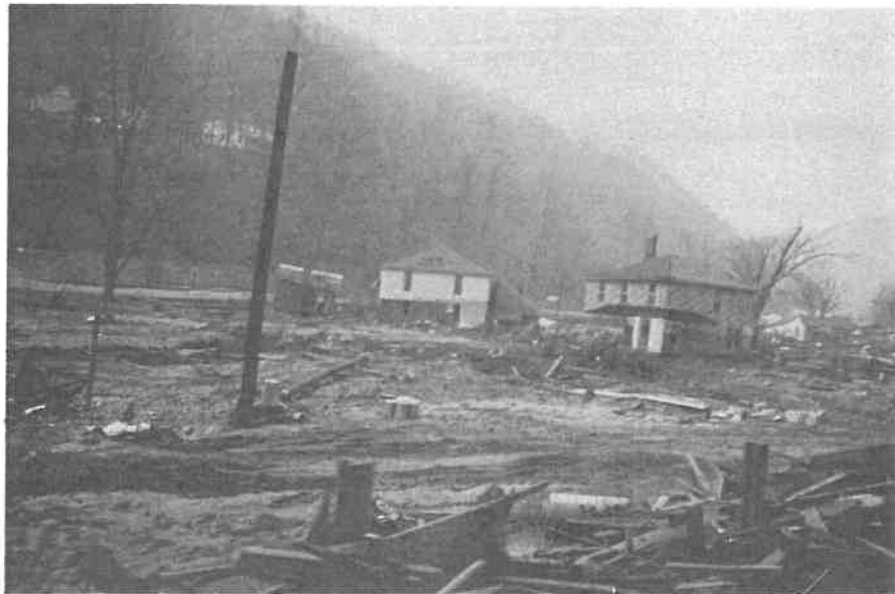
FIGURE 21 General Damage.

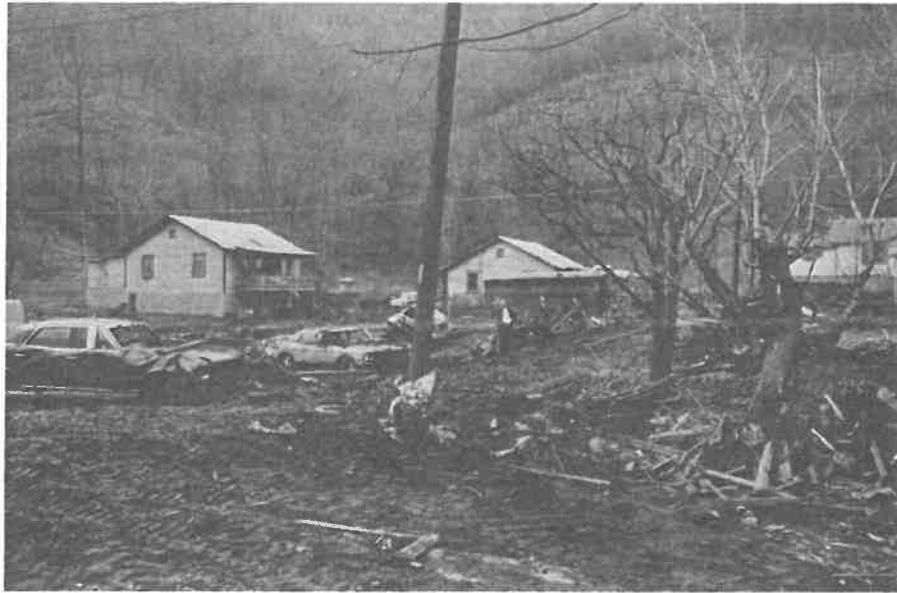
FIGURE 22 Debris 14 Miles Below Dam.

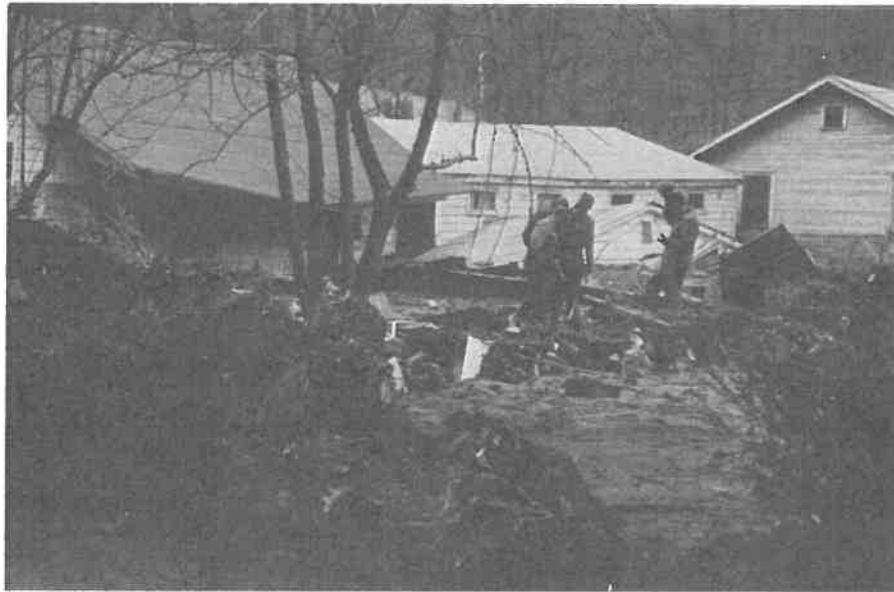
FIGURE 23 Guardsmen Searching Debris for Missing Bodies. Fourteen Miles Below Dam.

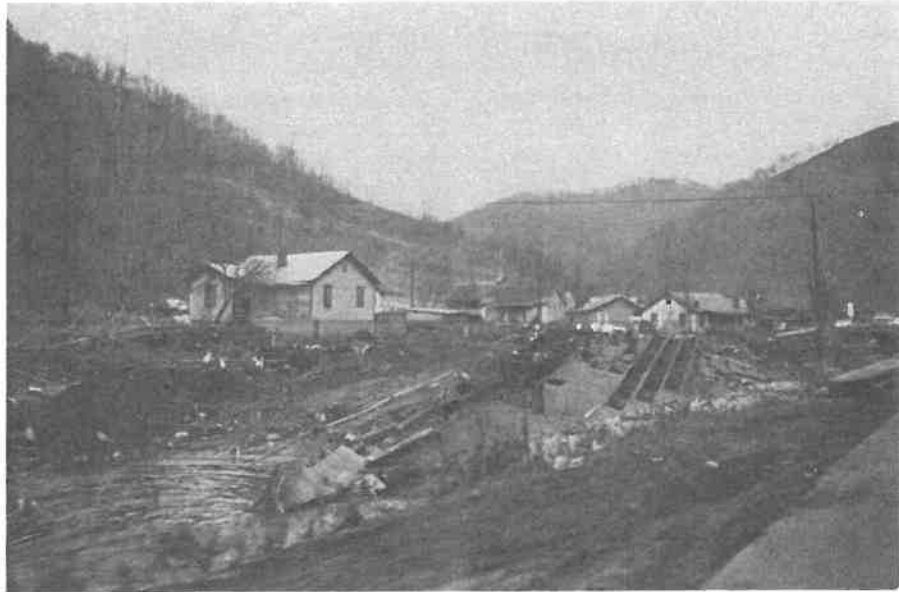
FIGURE 24 Destroyed Bridge.

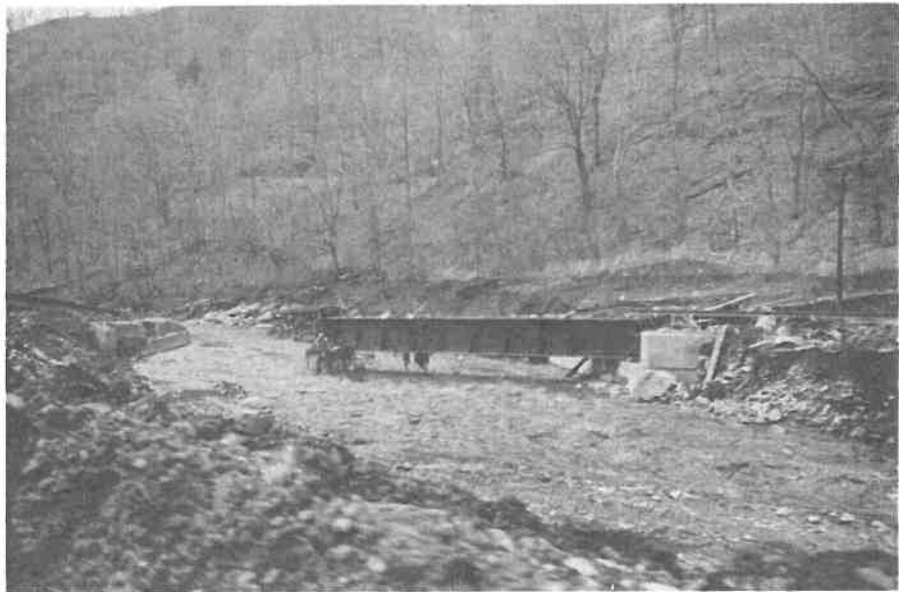
FIGURE 25 Destroyed Bridge.

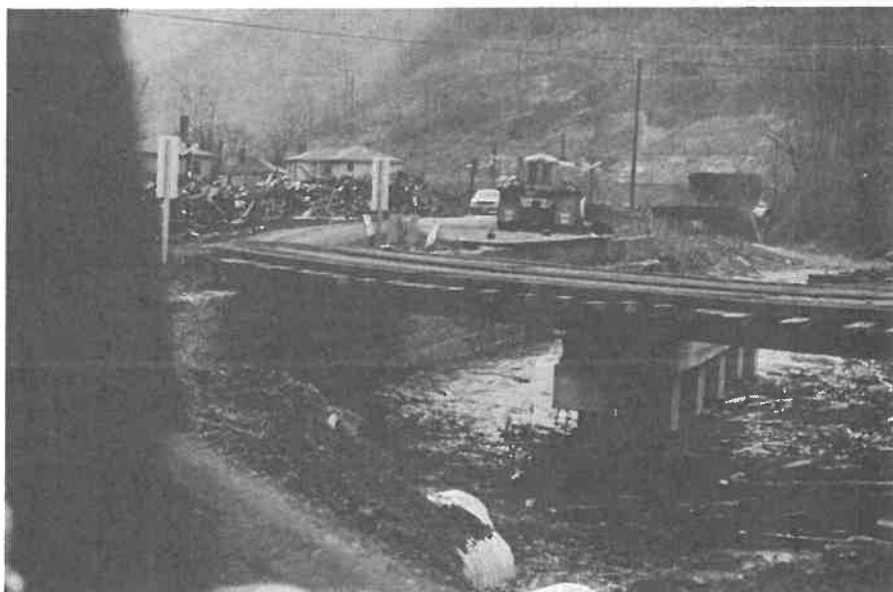
FIGURE 26 Temporary Bridge on Abutments of Destroyed Highway Bridge. Note Debris in Background.

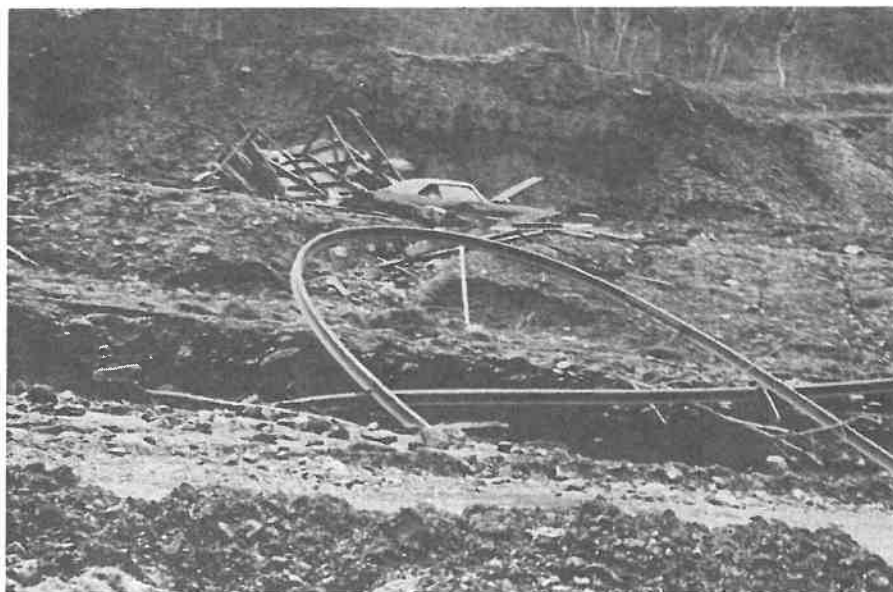
The flood water descended down the narrow Buffalo Creek Valley. Towns along the valley from Saunders to Man were flooded with as much as 20 to 30 ft. of water. Figures 16 through 23 show damage that resulted to homes, churches, and automobiles. A total of 118 people were killed. Debris and coal silt, many times including bodies, were spread along the valley. Several railroads and highway bridges were swept from their foundations, as shown in Figures 24 through 26. Large sections of the railroad, highway, and utilities were destroyed (Figure 27).

FIGURE 27 Bent Railroad Rails 5 Miles Below Dam.
