MADISON RIVER, MONTANA
REPORT ON
*FLOOD EMERGENCY
MADISON RIVER SLIDE*

*VOLUME I
MAIN REPORT*

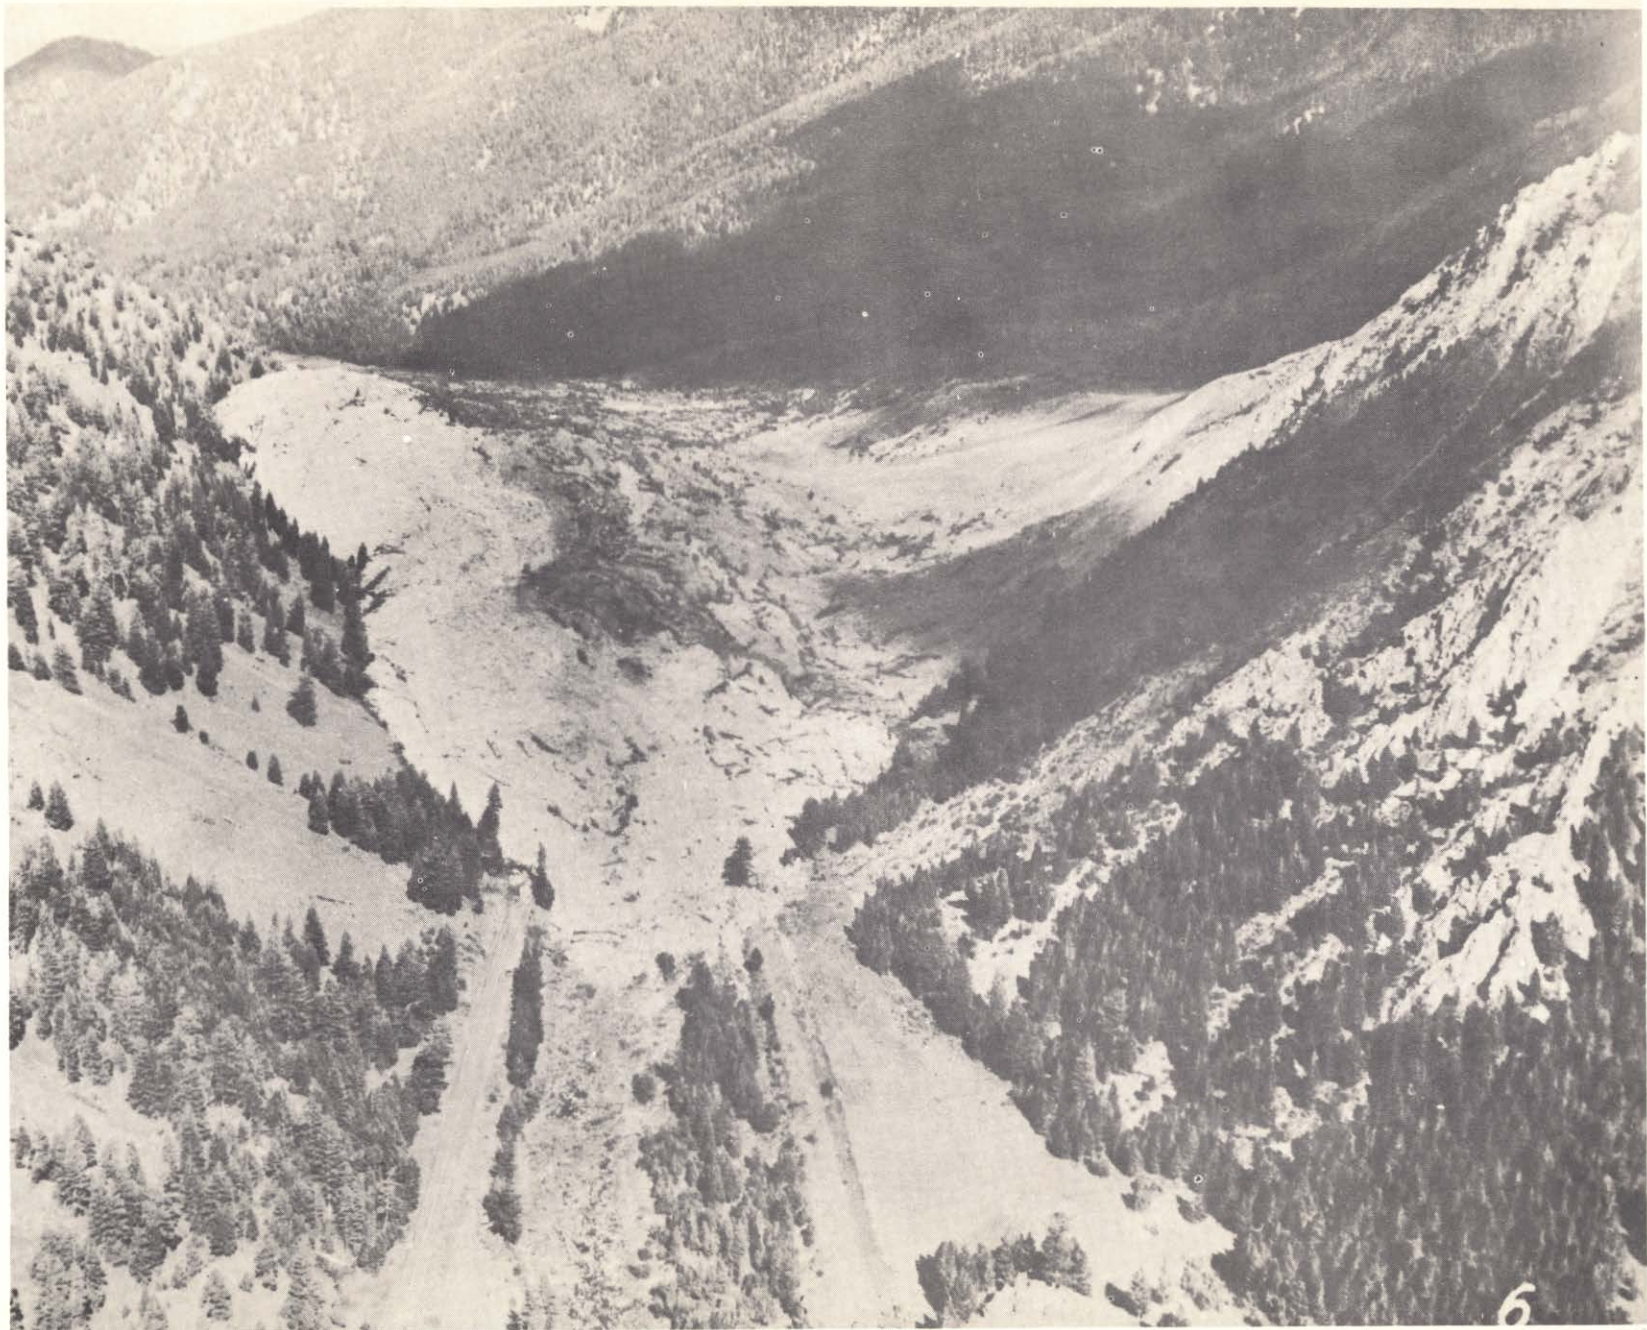
6
Photo 1. About 20 August 1959. Aerial view of Madison River slide about 2 days following earthquake. USDA - Forest Service photo.

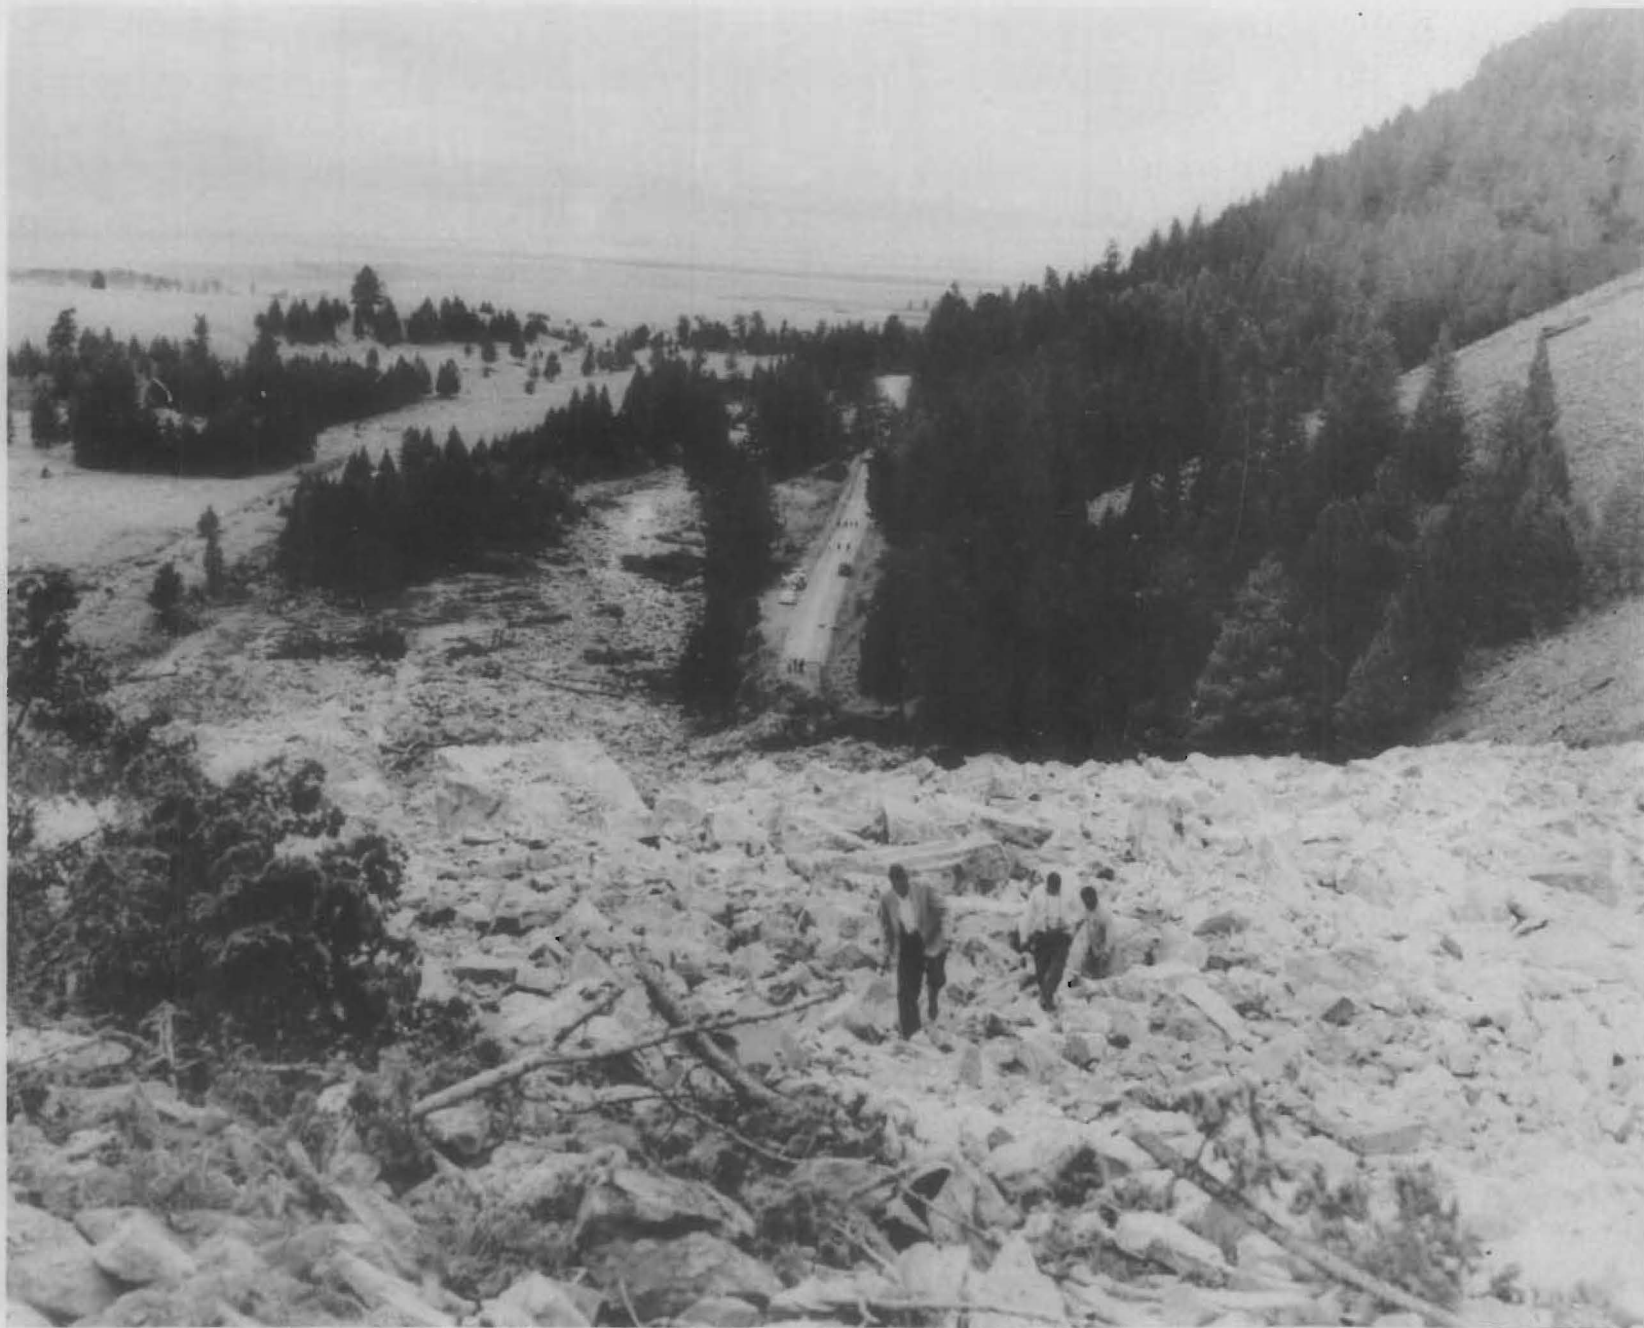
Photo 2. About 21 August 1959. A Forest Service photo, looking downstream at large rocks on downstream slope of slide and at the streambed below slide. (For later view, see Photo 27).

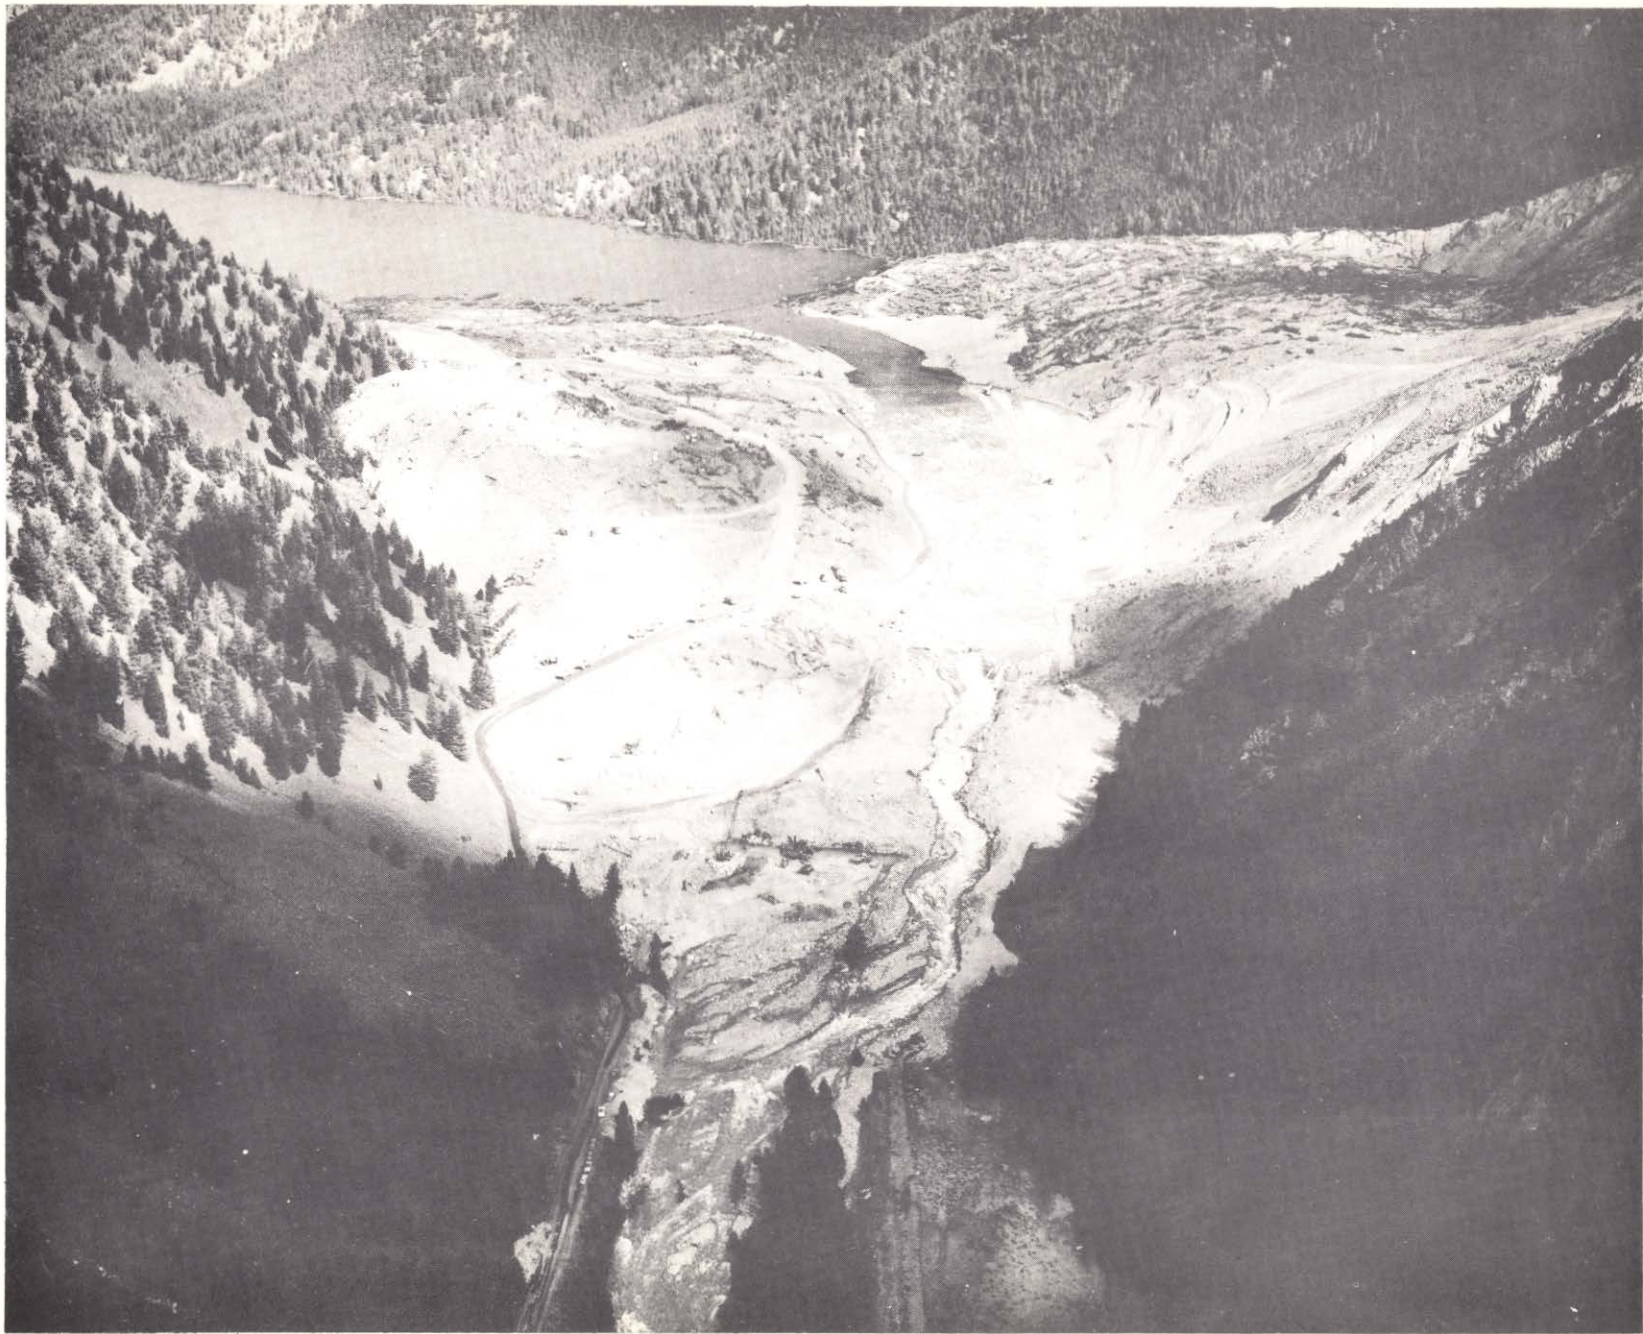
Photo 12. 16 September 1959. Aerial view of slide and spillway.

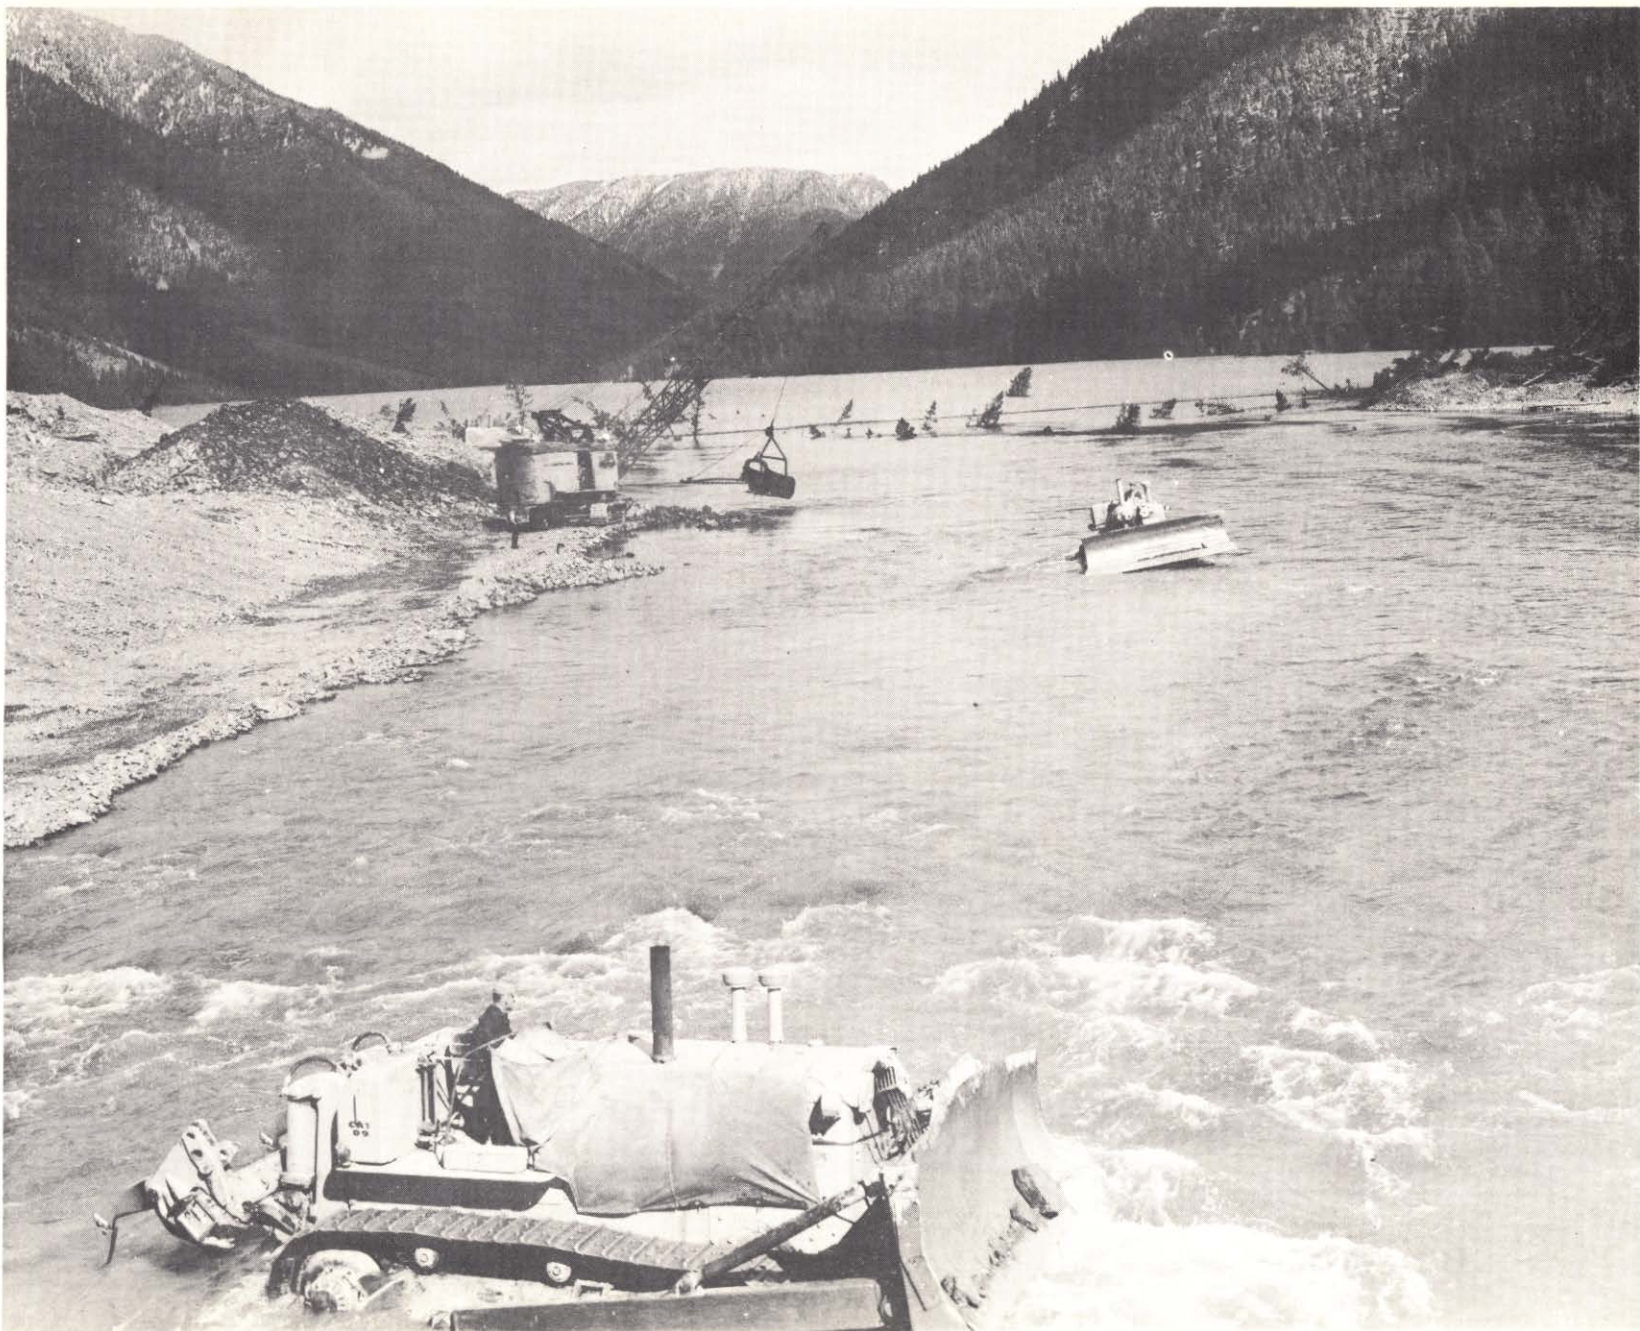
Photo 15. 29 September 1959. Starting to lower the spillway channel near the outlet of Earthquake Lake.

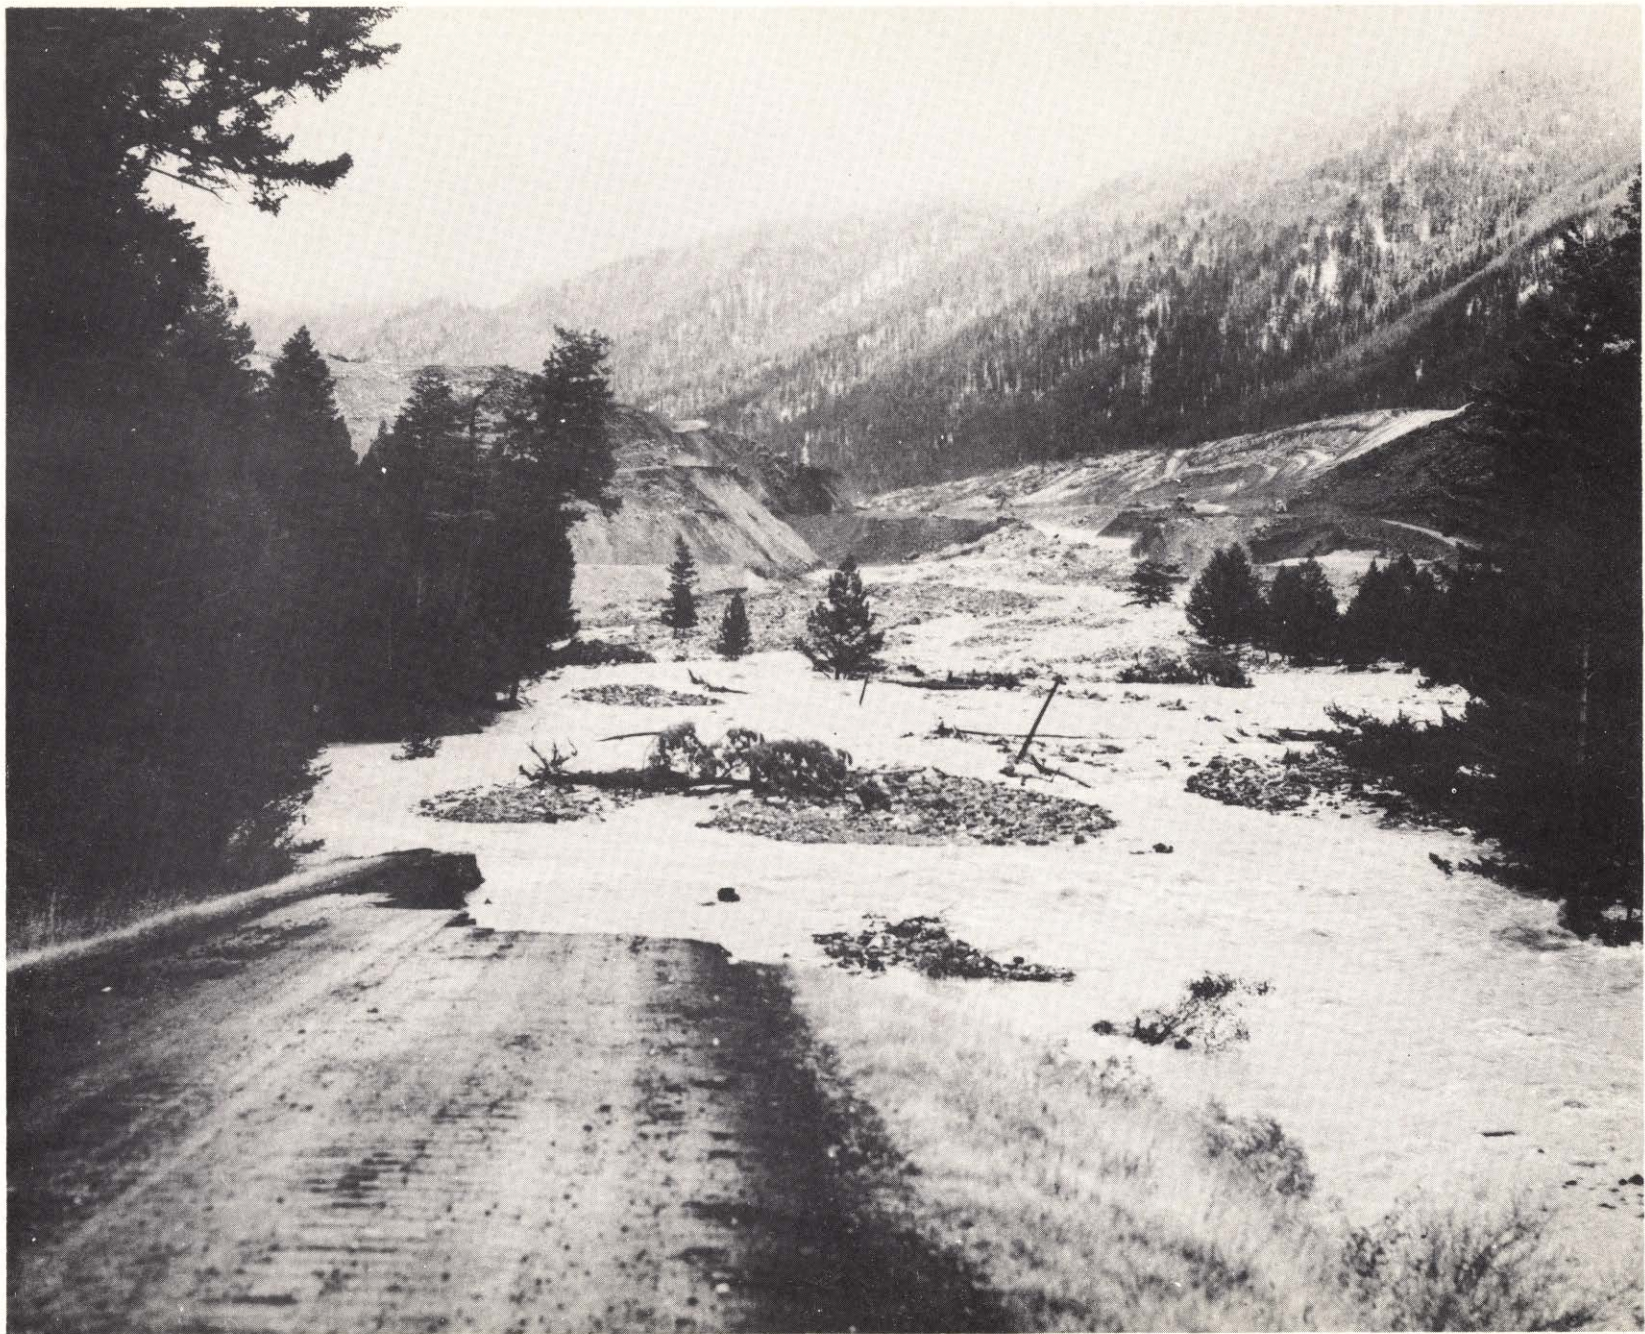
Photo 19. 9 October 1959. View showing rapid development of fan and damage to access road.

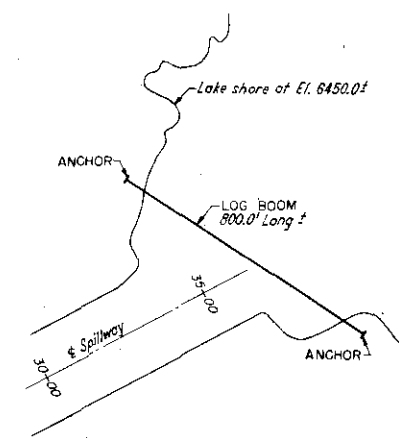
Note: When runners and body were through the body was replaced as originally constructed but 5 bars 3"x6" and 4 bars 3"x4" were used for runners, all spaced 6" between bars.

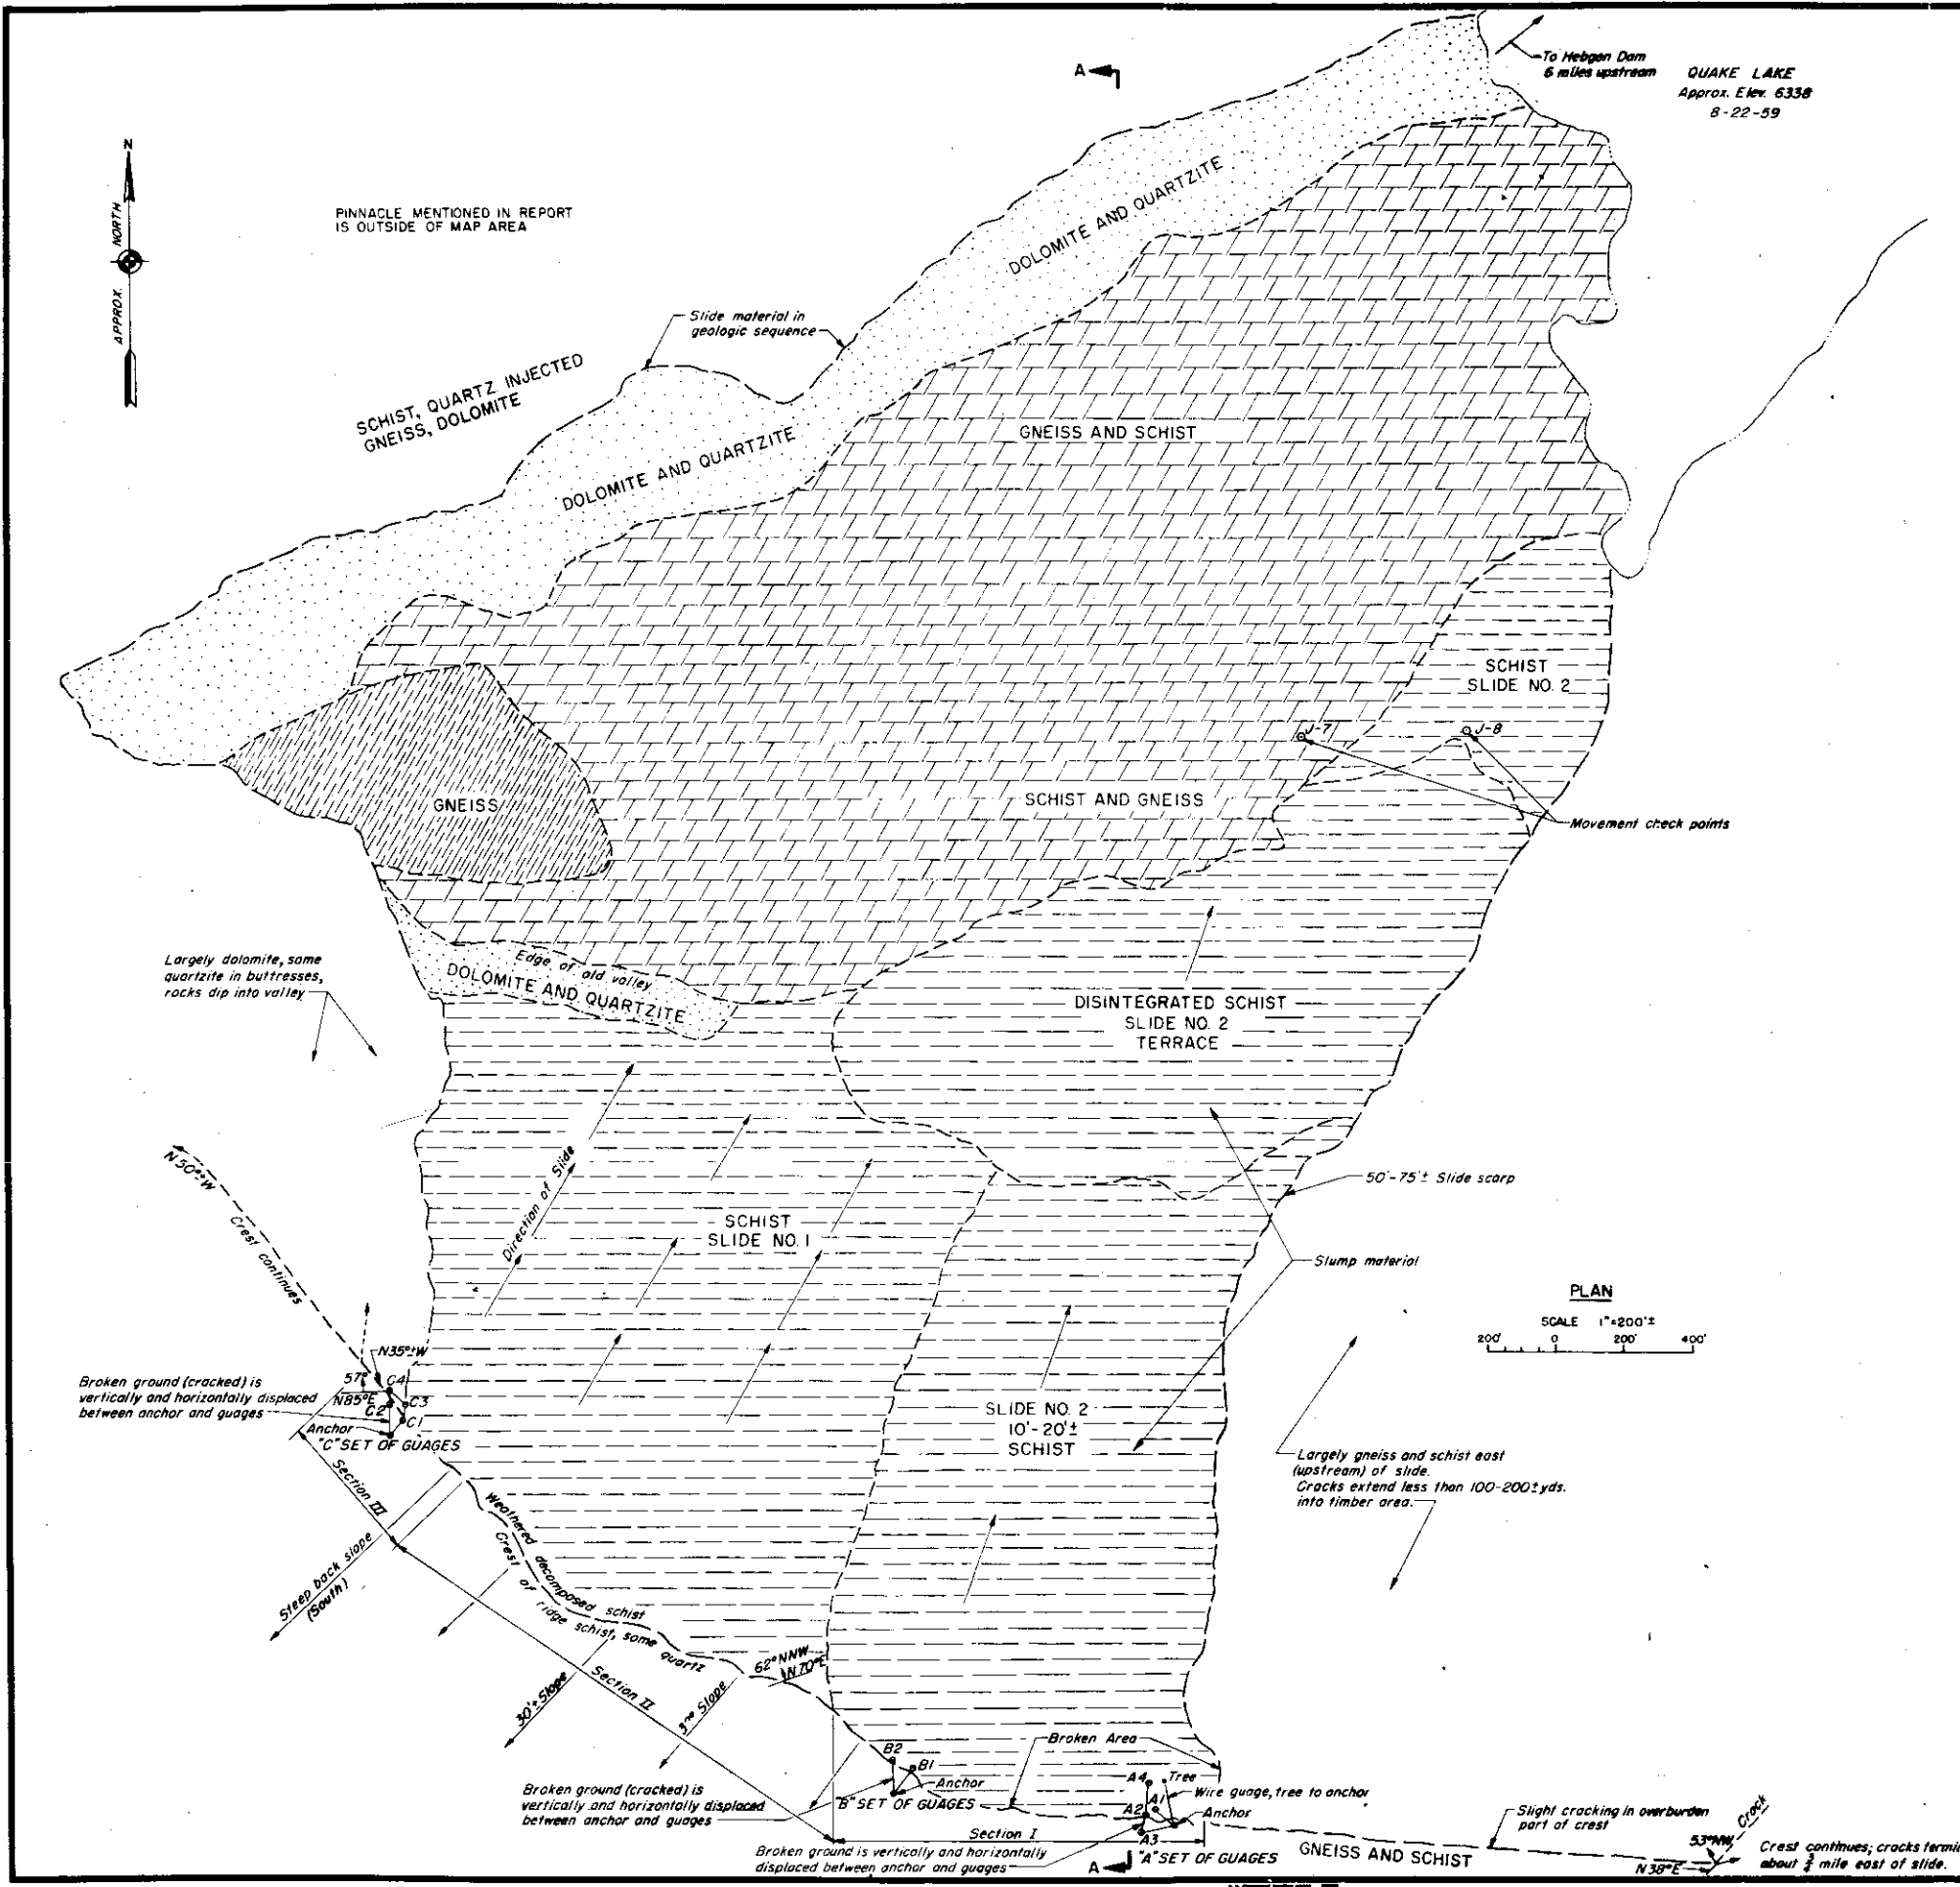
APPENDIX IX KNIGHT-CURTISS REPORT FIG. 1

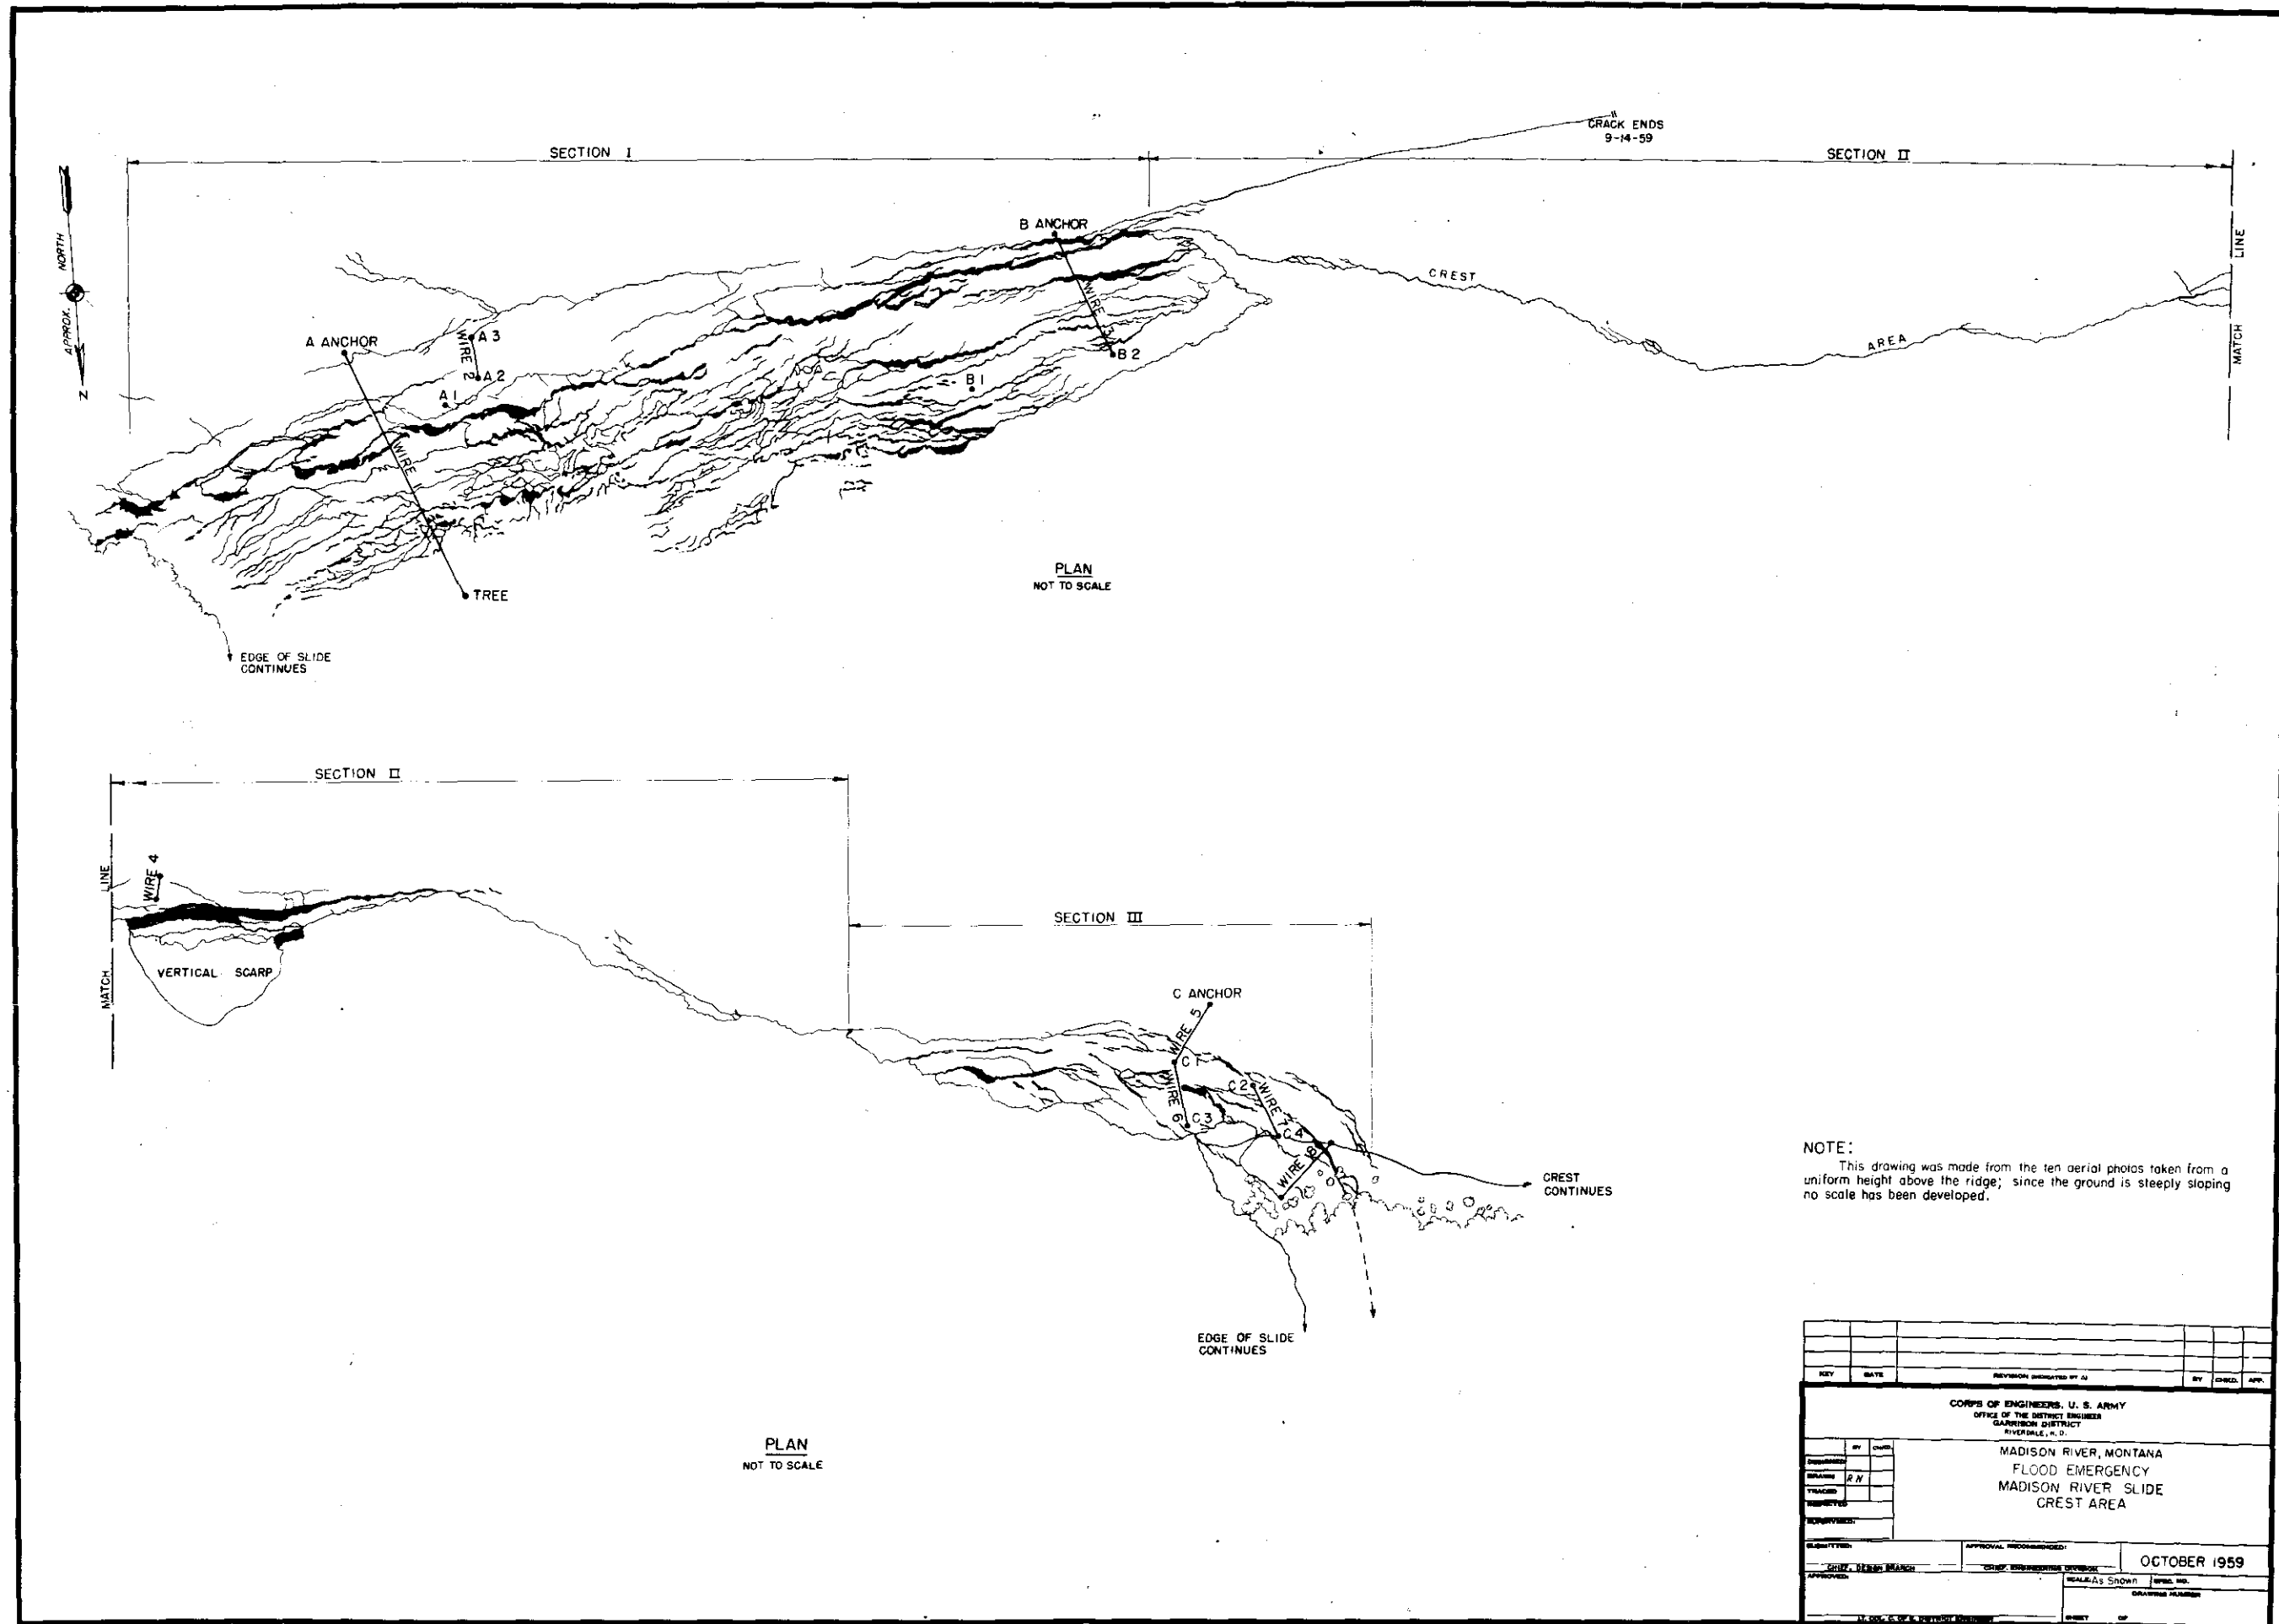
KEY	DATE	REVISION INDICATED BY	BY	CHECK	APP.
CORPS OF ENGINEERS, U. S. ARMY OFFICE OF THE DISTRICT ENGINEER GARRISON DISTRICT RIVERDALE, W. D.					
MADISON RIVER, MONTANA FLOOD EMERGENCY MADISON RIVER SLIDE CREST AREA					
DESIGNED BY	CHKD.	APPROVAL RECOMMENDED:		OCTOBER 1959	
DRAWN BY		CHIEF ENGINEER			
TRACED BY					
CHECKED BY

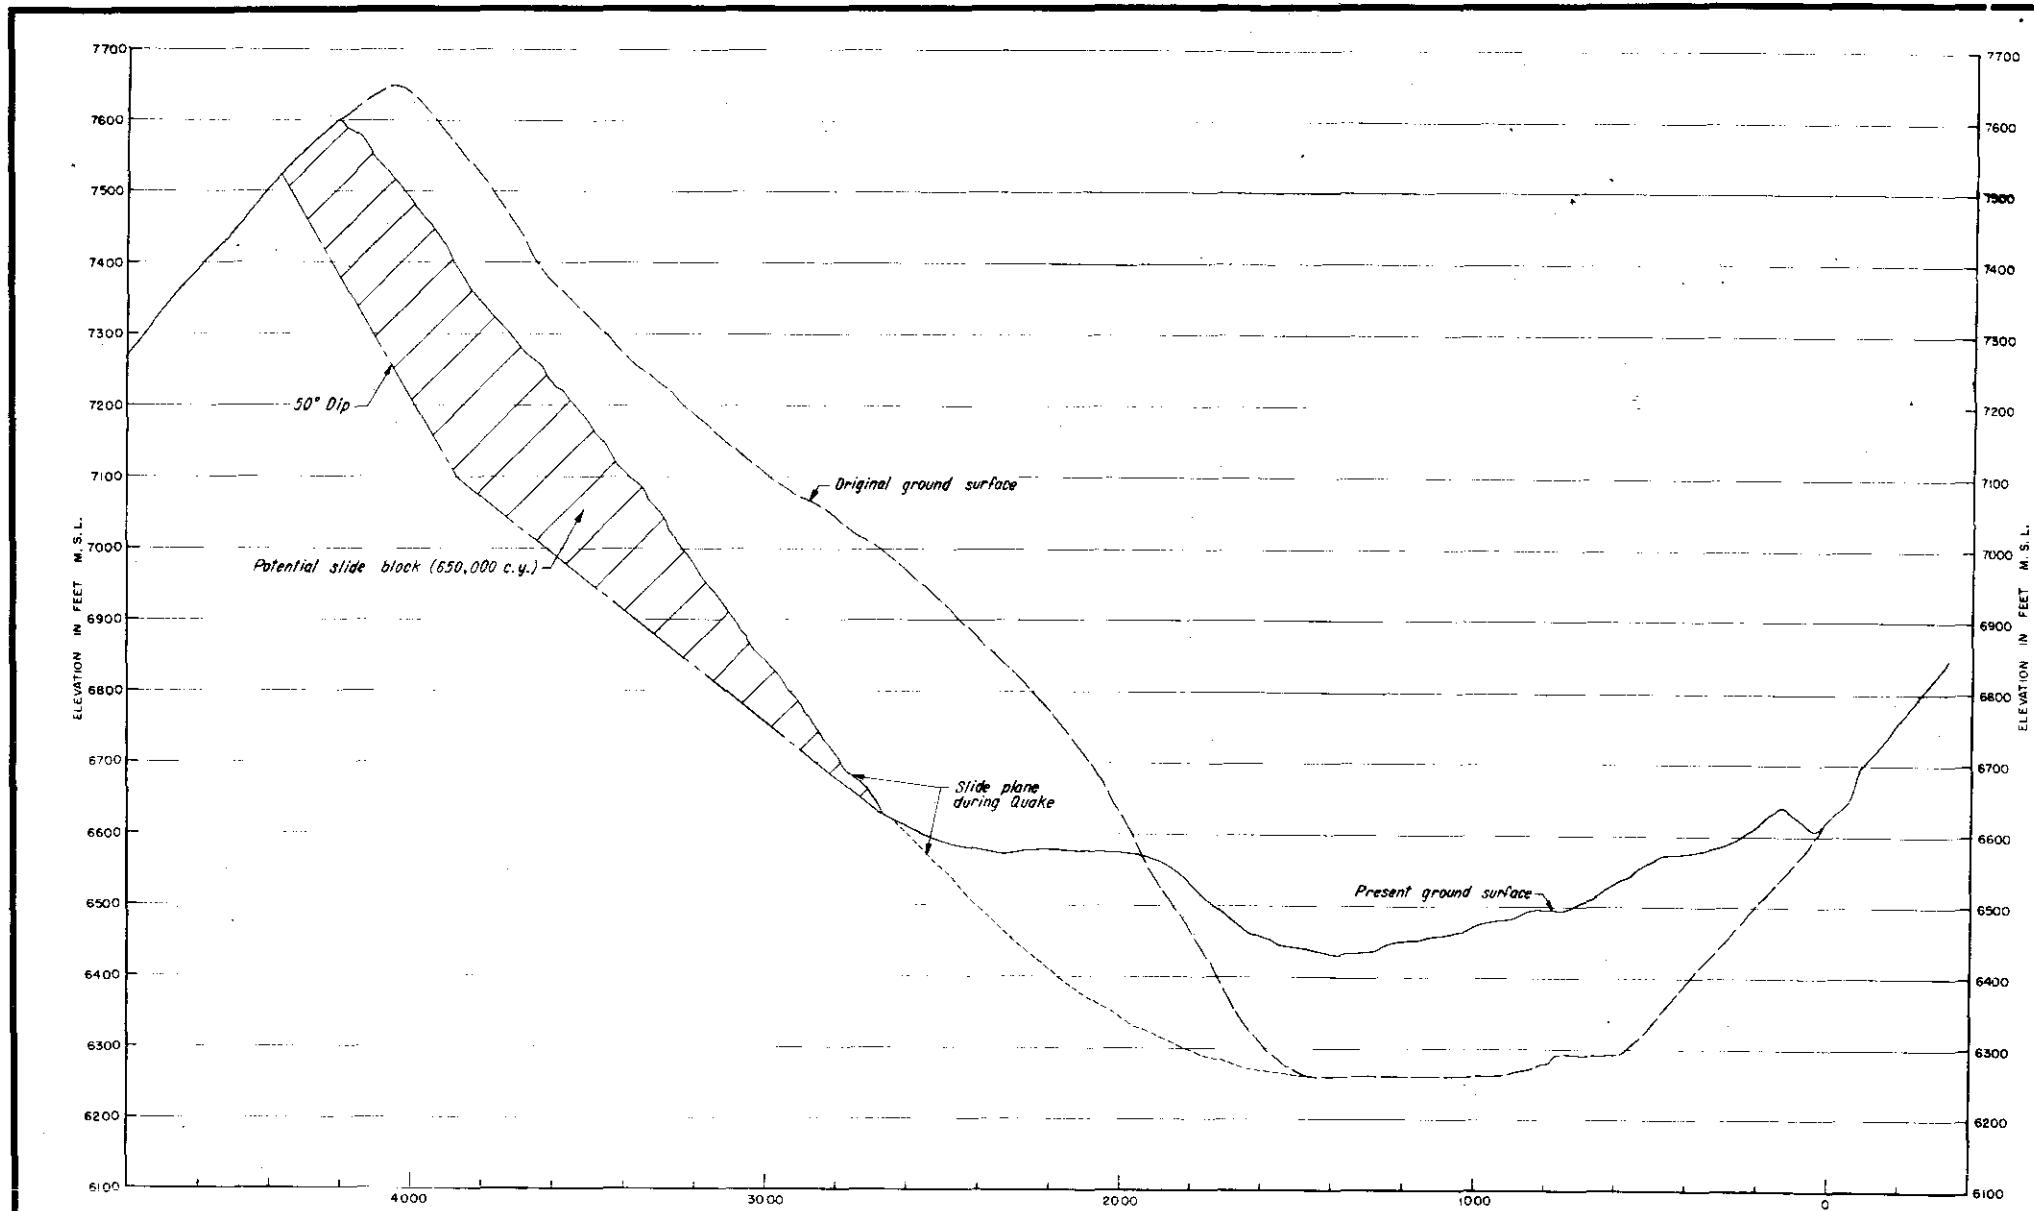
SECTION A-A
 SLIDE
 SCALE HOR. 1" = 200'
 VERT. 1" = 100'

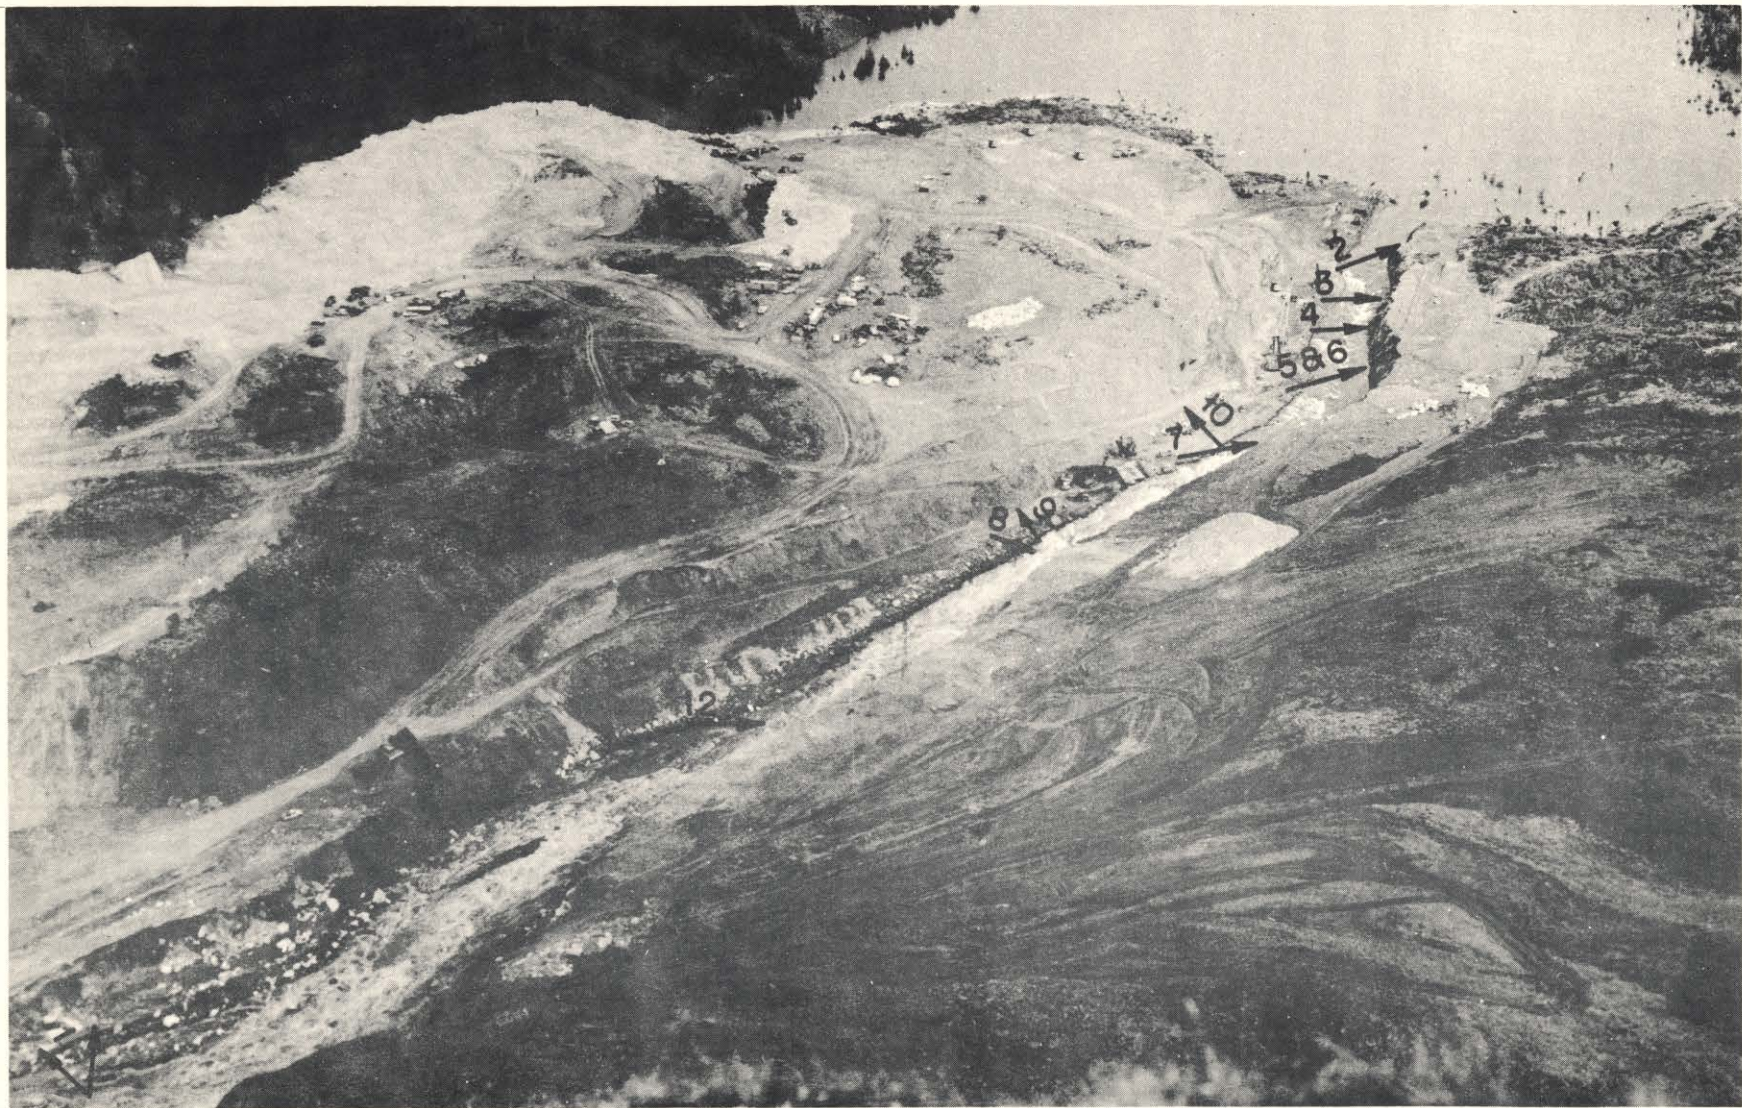
FLOOD EMERGENCY — MADISON RIVER SLIDE
