MADISON RIVER, MONTANA
REPORT ON
*FLOOD EMERGENCY
MADISON RIVER SLIDE*

*VOLUME I
MAIN REPORT*

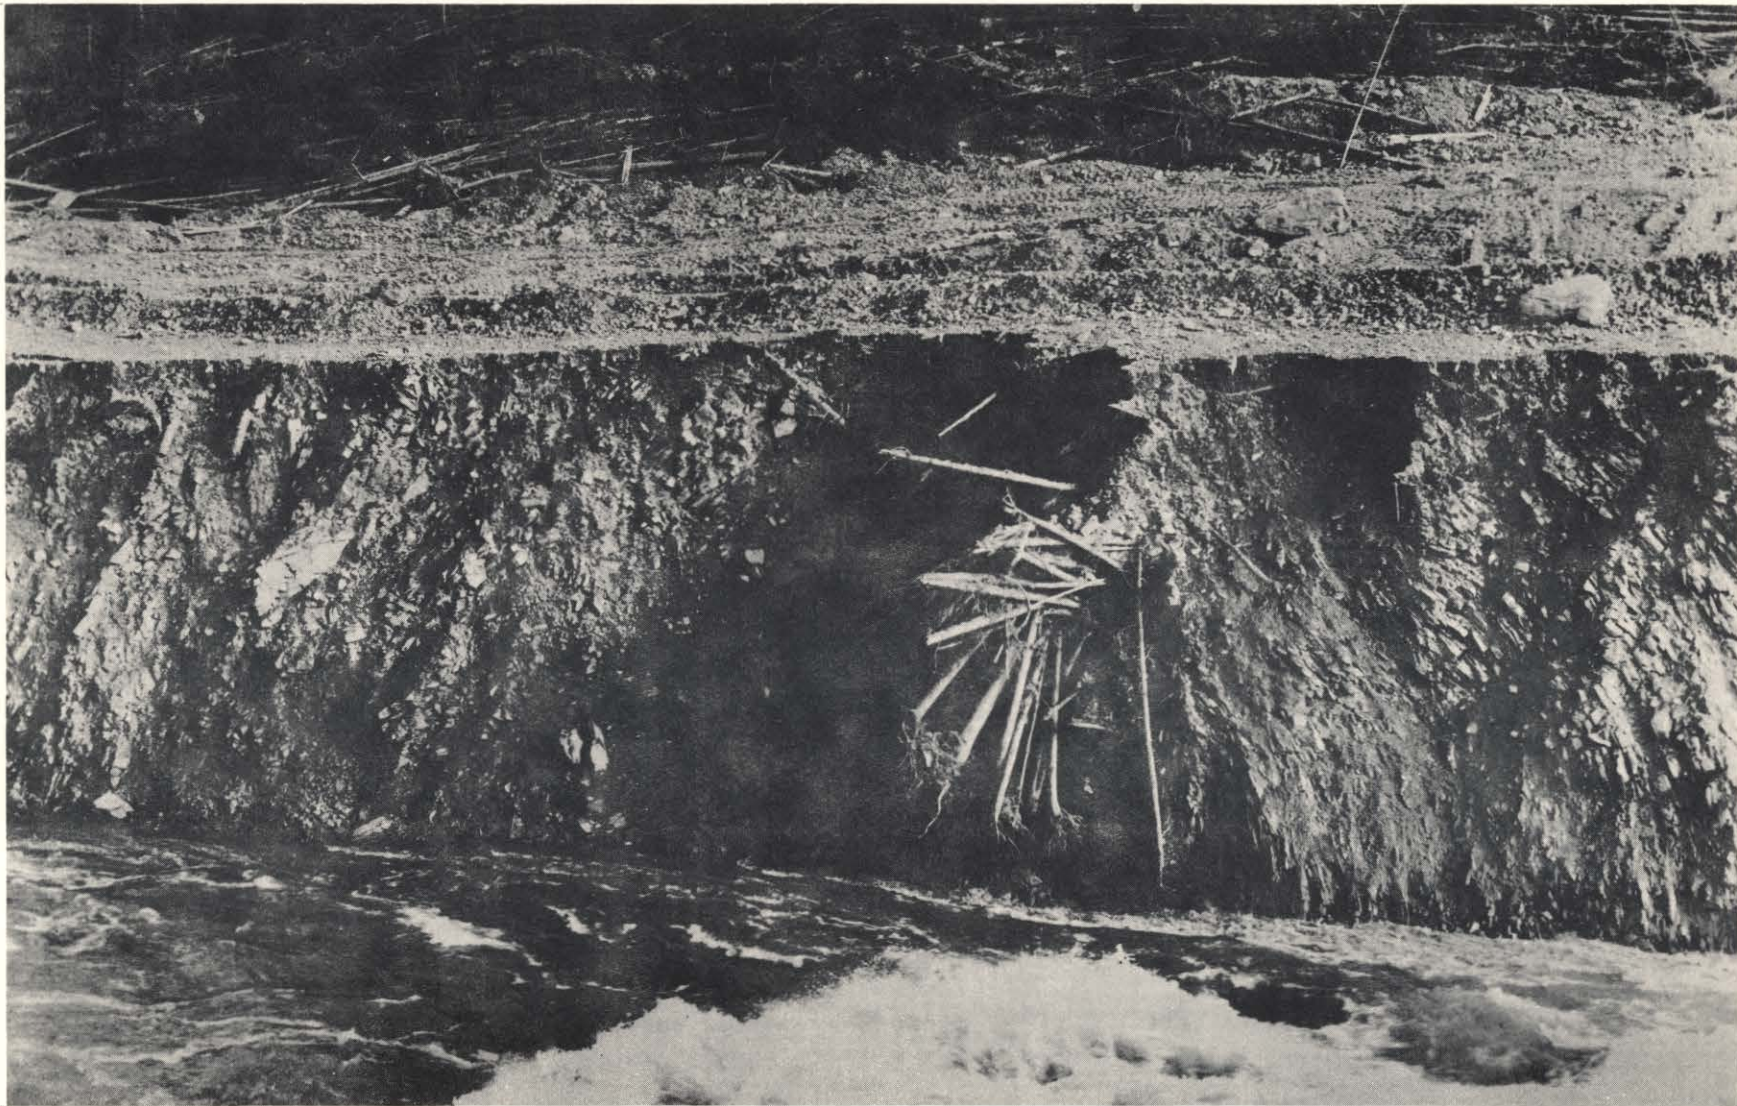
FLOOD EMERGENCY — MADISON RIVER SLIDE
U.S. ARMY ENGINEER DISTRICT, GARRISON, CORPS OF ENGINEERS, RIVERDALE, NORTH DAKOTA

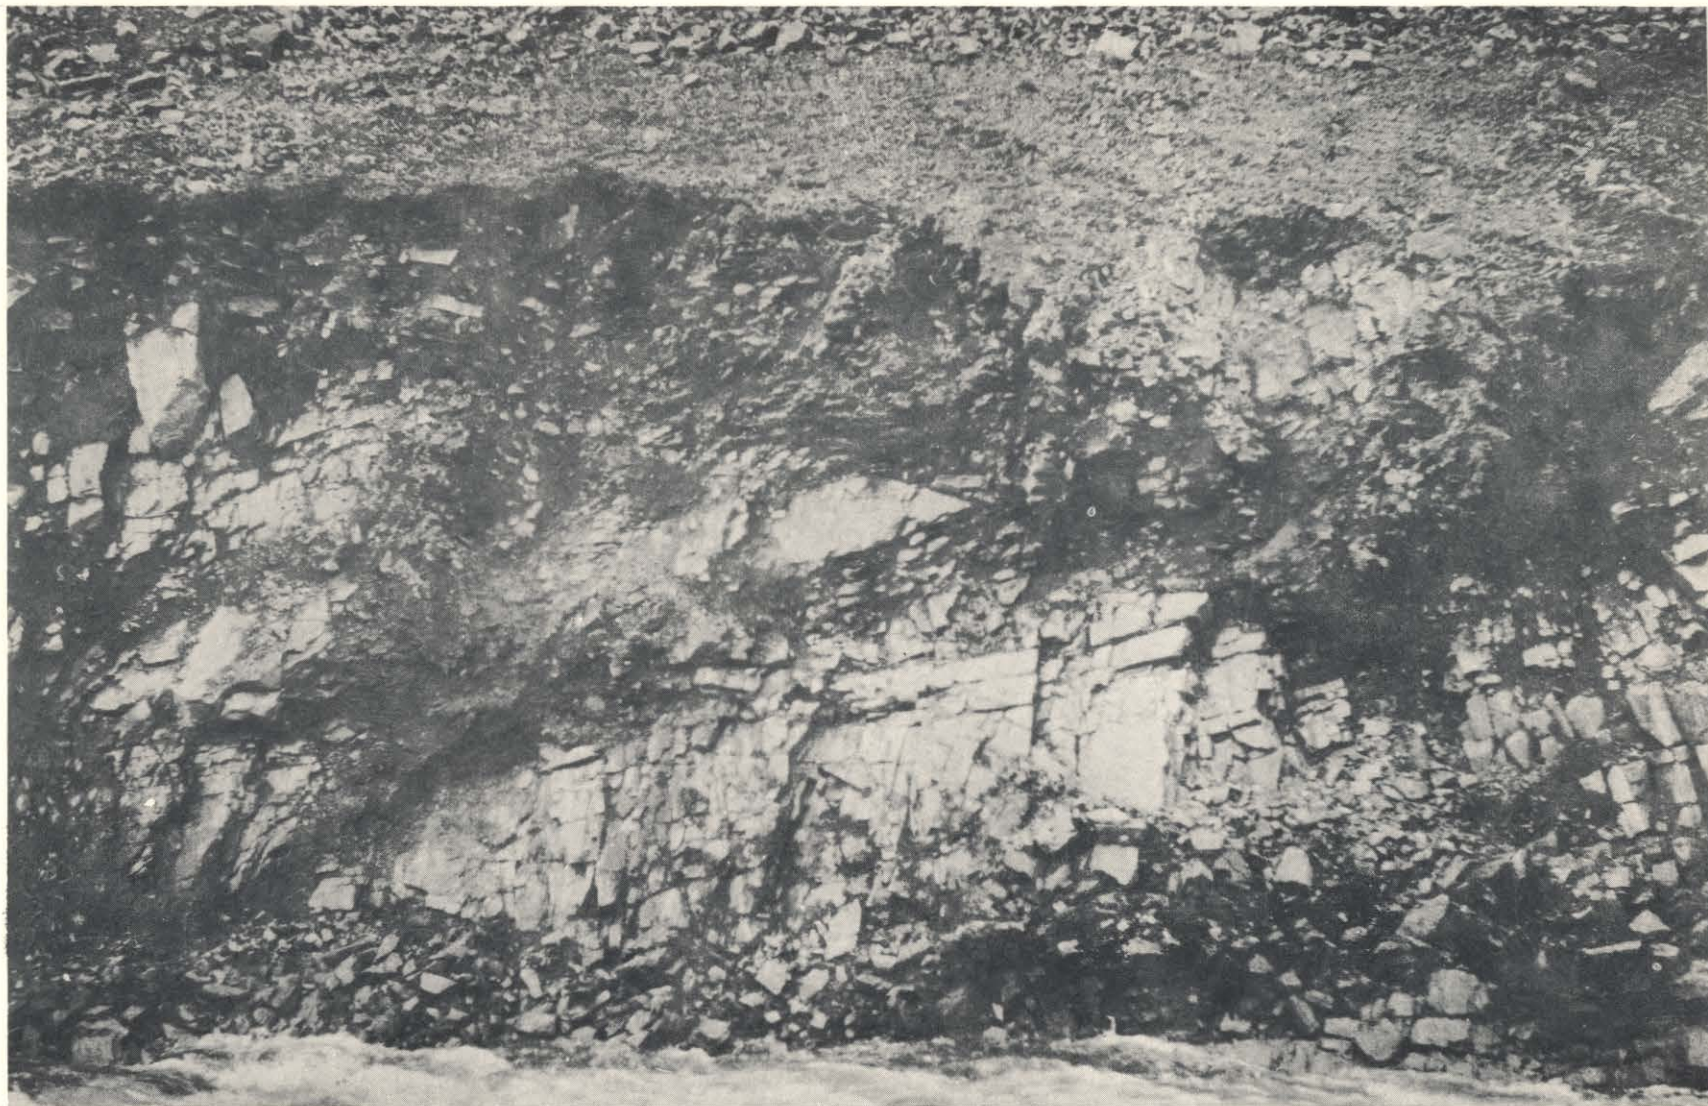
FLOOD EMERGENCY — MADISON RIVER SLIDE
U.S. ARMY ENGINEER DISTRICT, GARRISON, CORPS OF ENGINEERS, RIVERDALE, NORTH DAKOTA

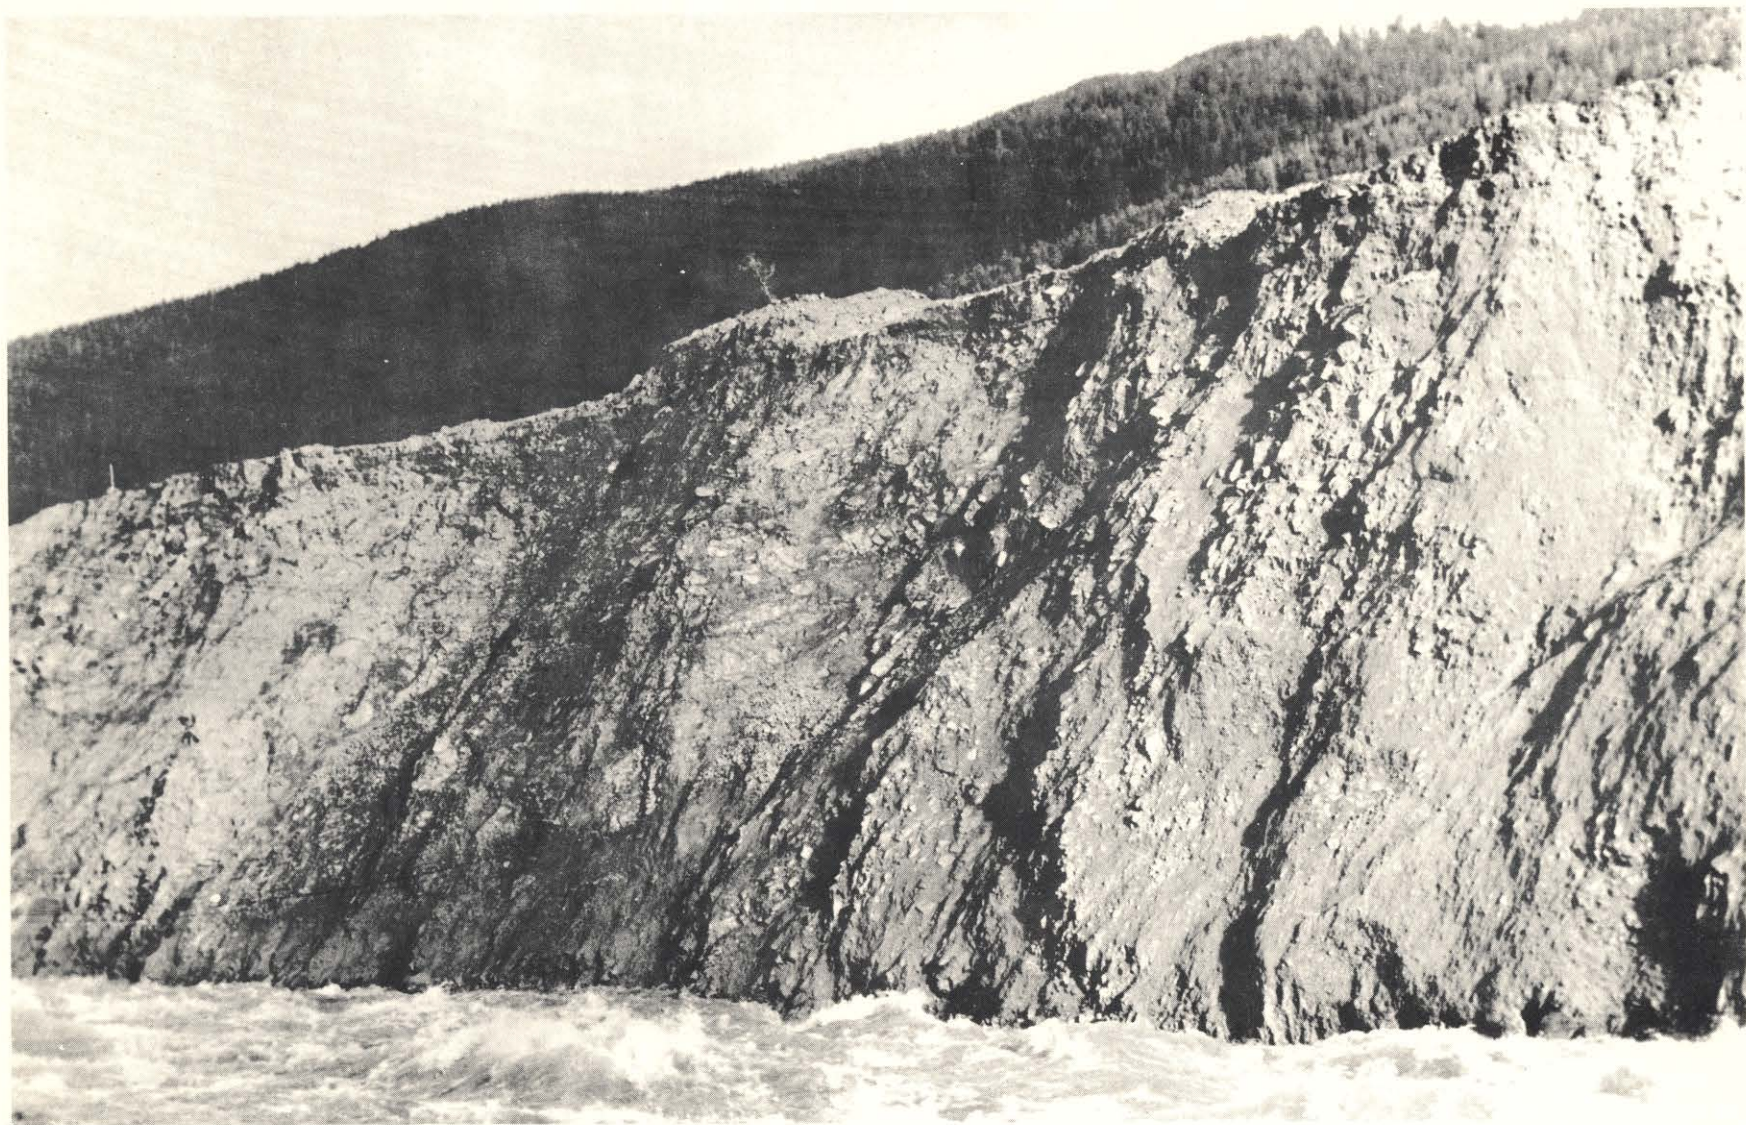
FLOOD EMERGENCY — MADISON RIVER SLIDE
U.S. ARMY ENGINEER DISTRICT, GARRISON, CORPS OF ENGINEERS, RIVERDALE, NORTH DAKOTA

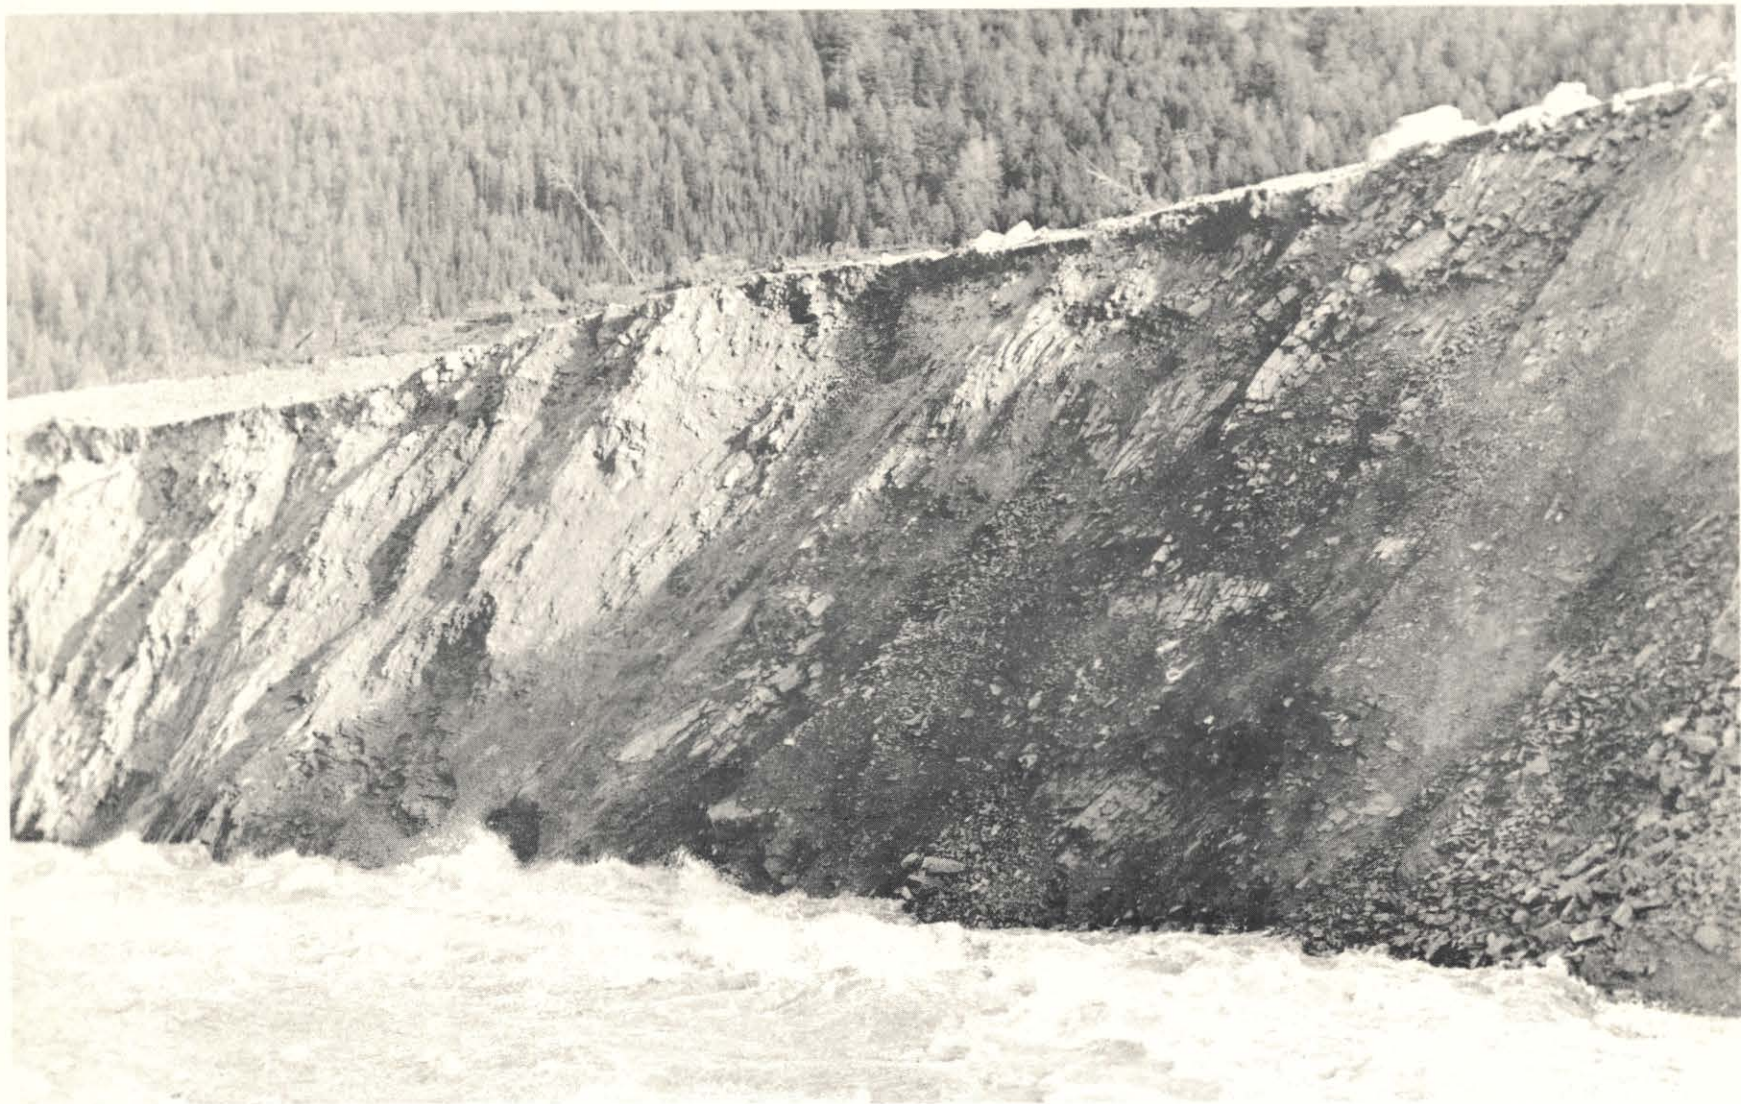
FLOOD EMERGENCY — MADISON RIVER SLIDE

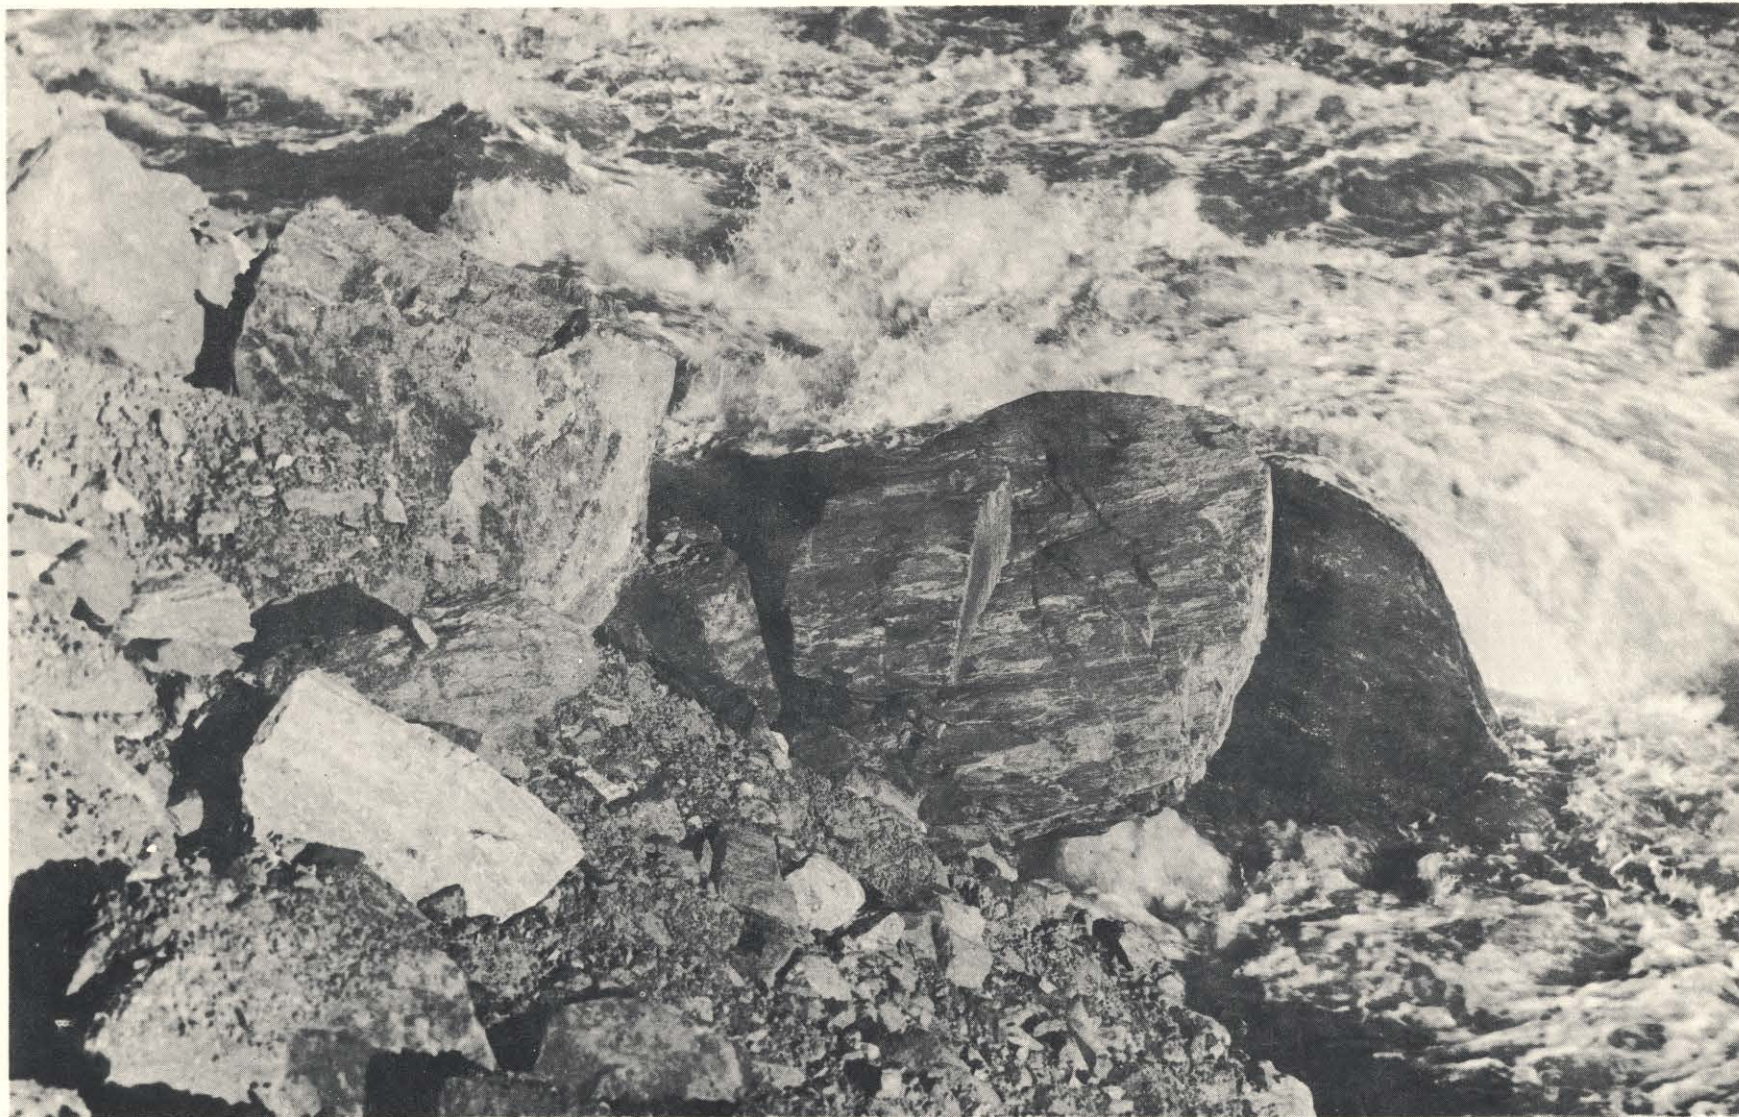
FLOOD EMERGENCY — MADISON RIVER SLIDE
U.S. ARMY ENGINEER DISTRICT, GARRISON, CORPS OF ENGINEERS, RIVERDALE, NORTH DAKOTA

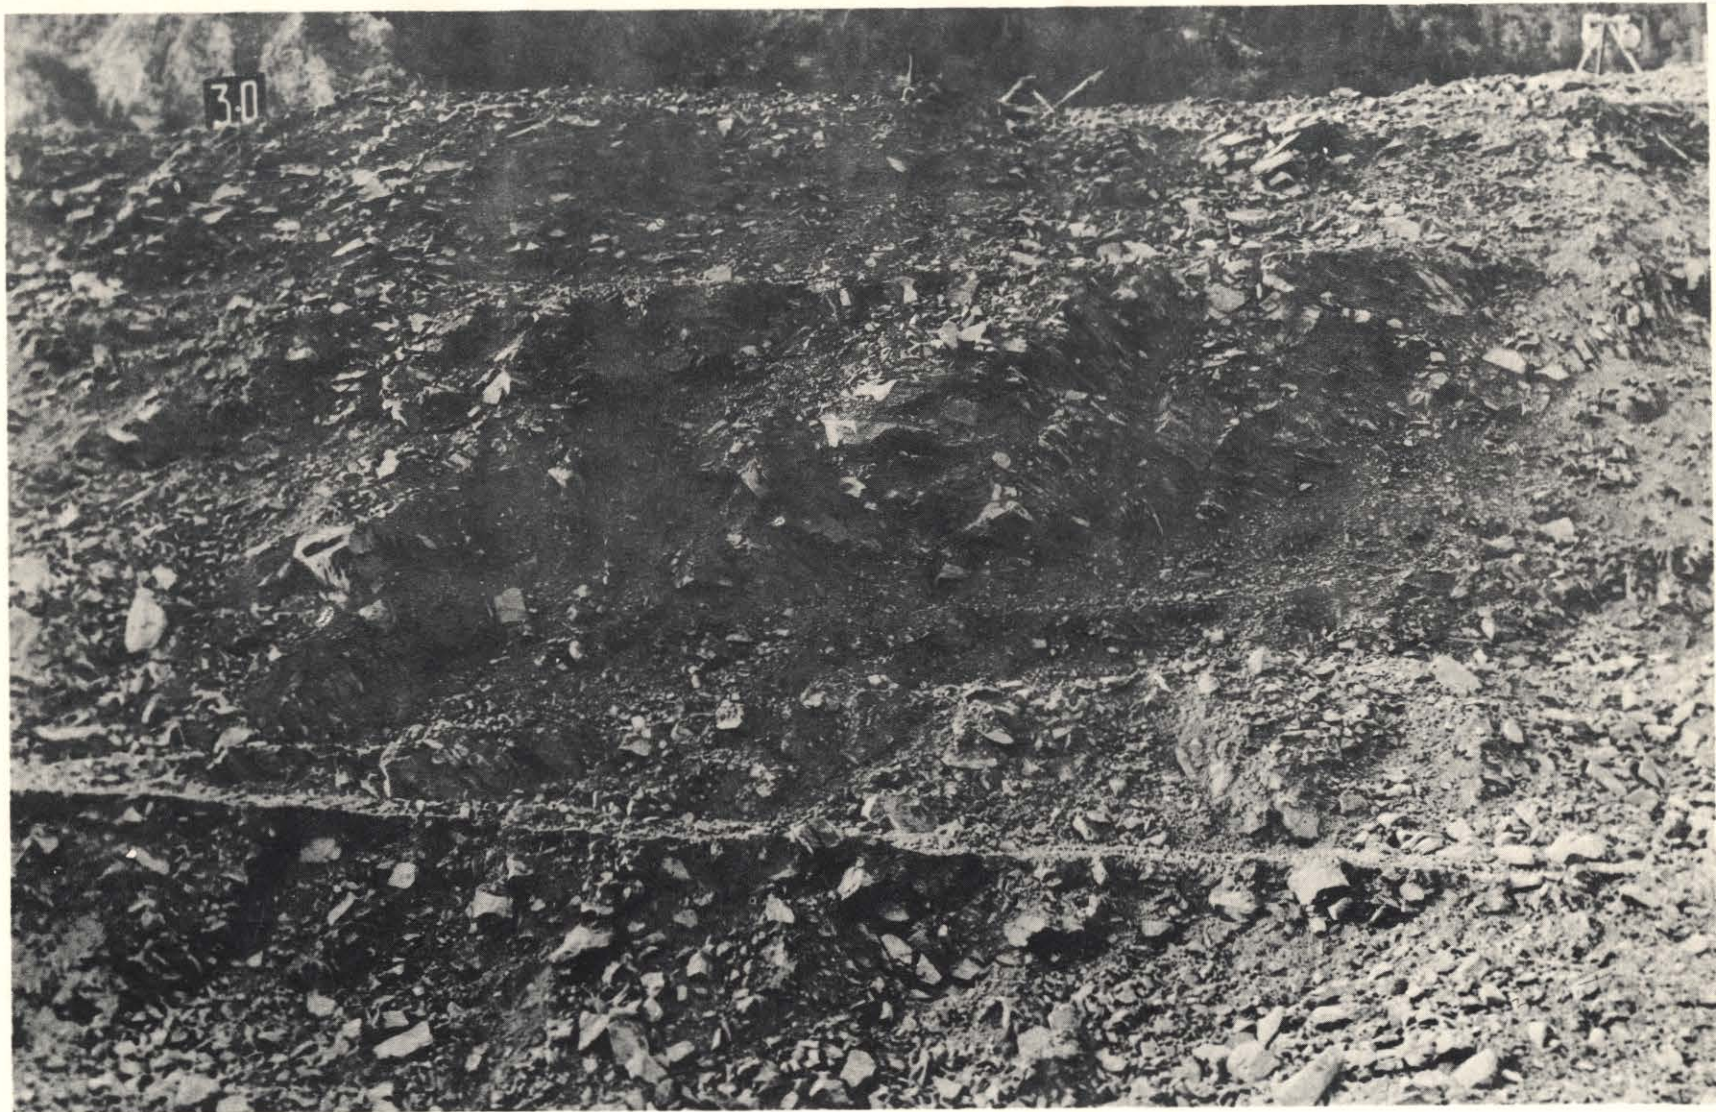
FLOOD EMERGENCY — MADISON RIVER SLIDE
U.S. ARMY ENGINEER DISTRICT, GARRISON, CORPS OF ENGINEERS, RIVERDALE, NORTH DAKOTA

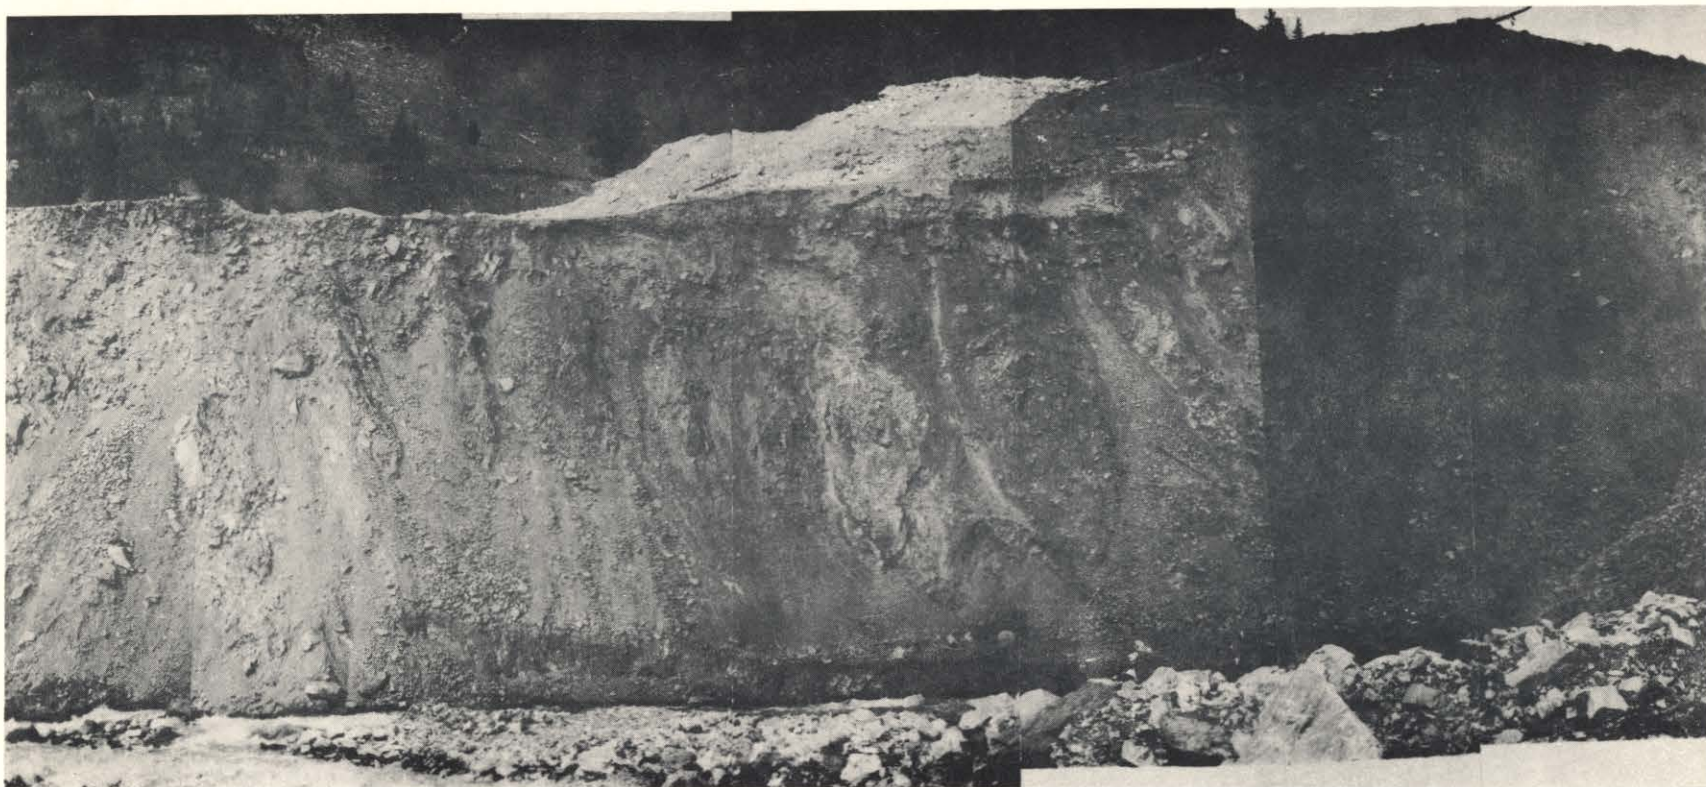
FLOOD EMERGENCY — MADISON RIVER SLIDE
U.S. ARMY ENGINEER DISTRICT, GARRISON, CORPS OF ENGINEERS, RIVERDALE, NORTH DAKOTA

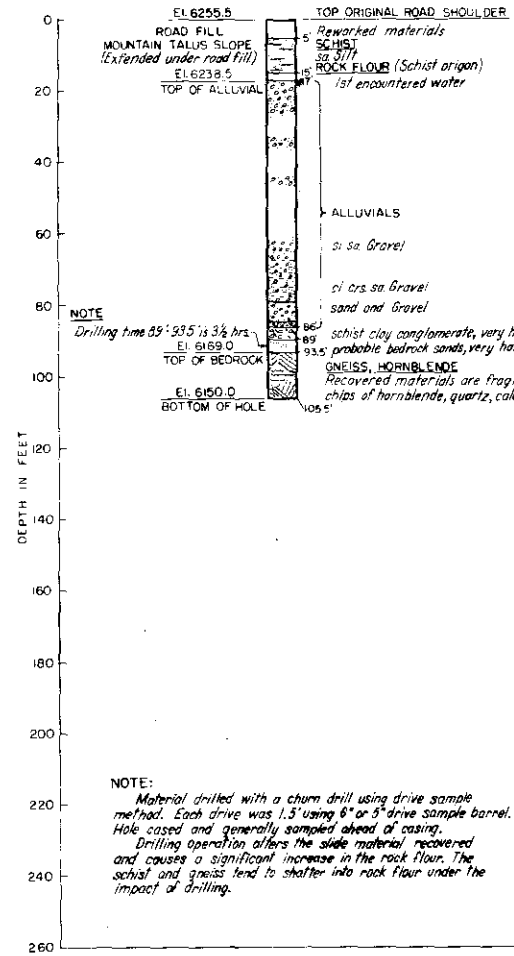
PIEZOMETER NO. 2
STA. 9+40
EL. 6342.8

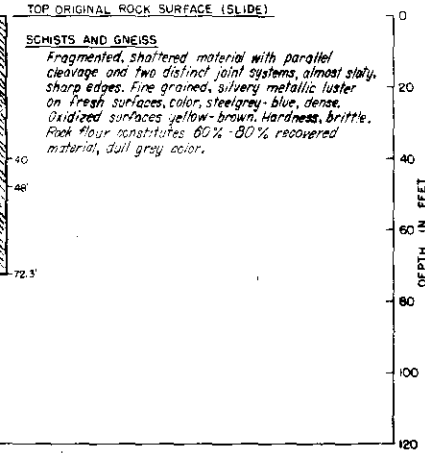
NOTE:
Drilling was terminated at 237.0'. This was below the surface elevation of the former valley alluviums. It is believed that the talc schist was part of the slide which had scoured out the valley alluvials and the base of slide was not reached.

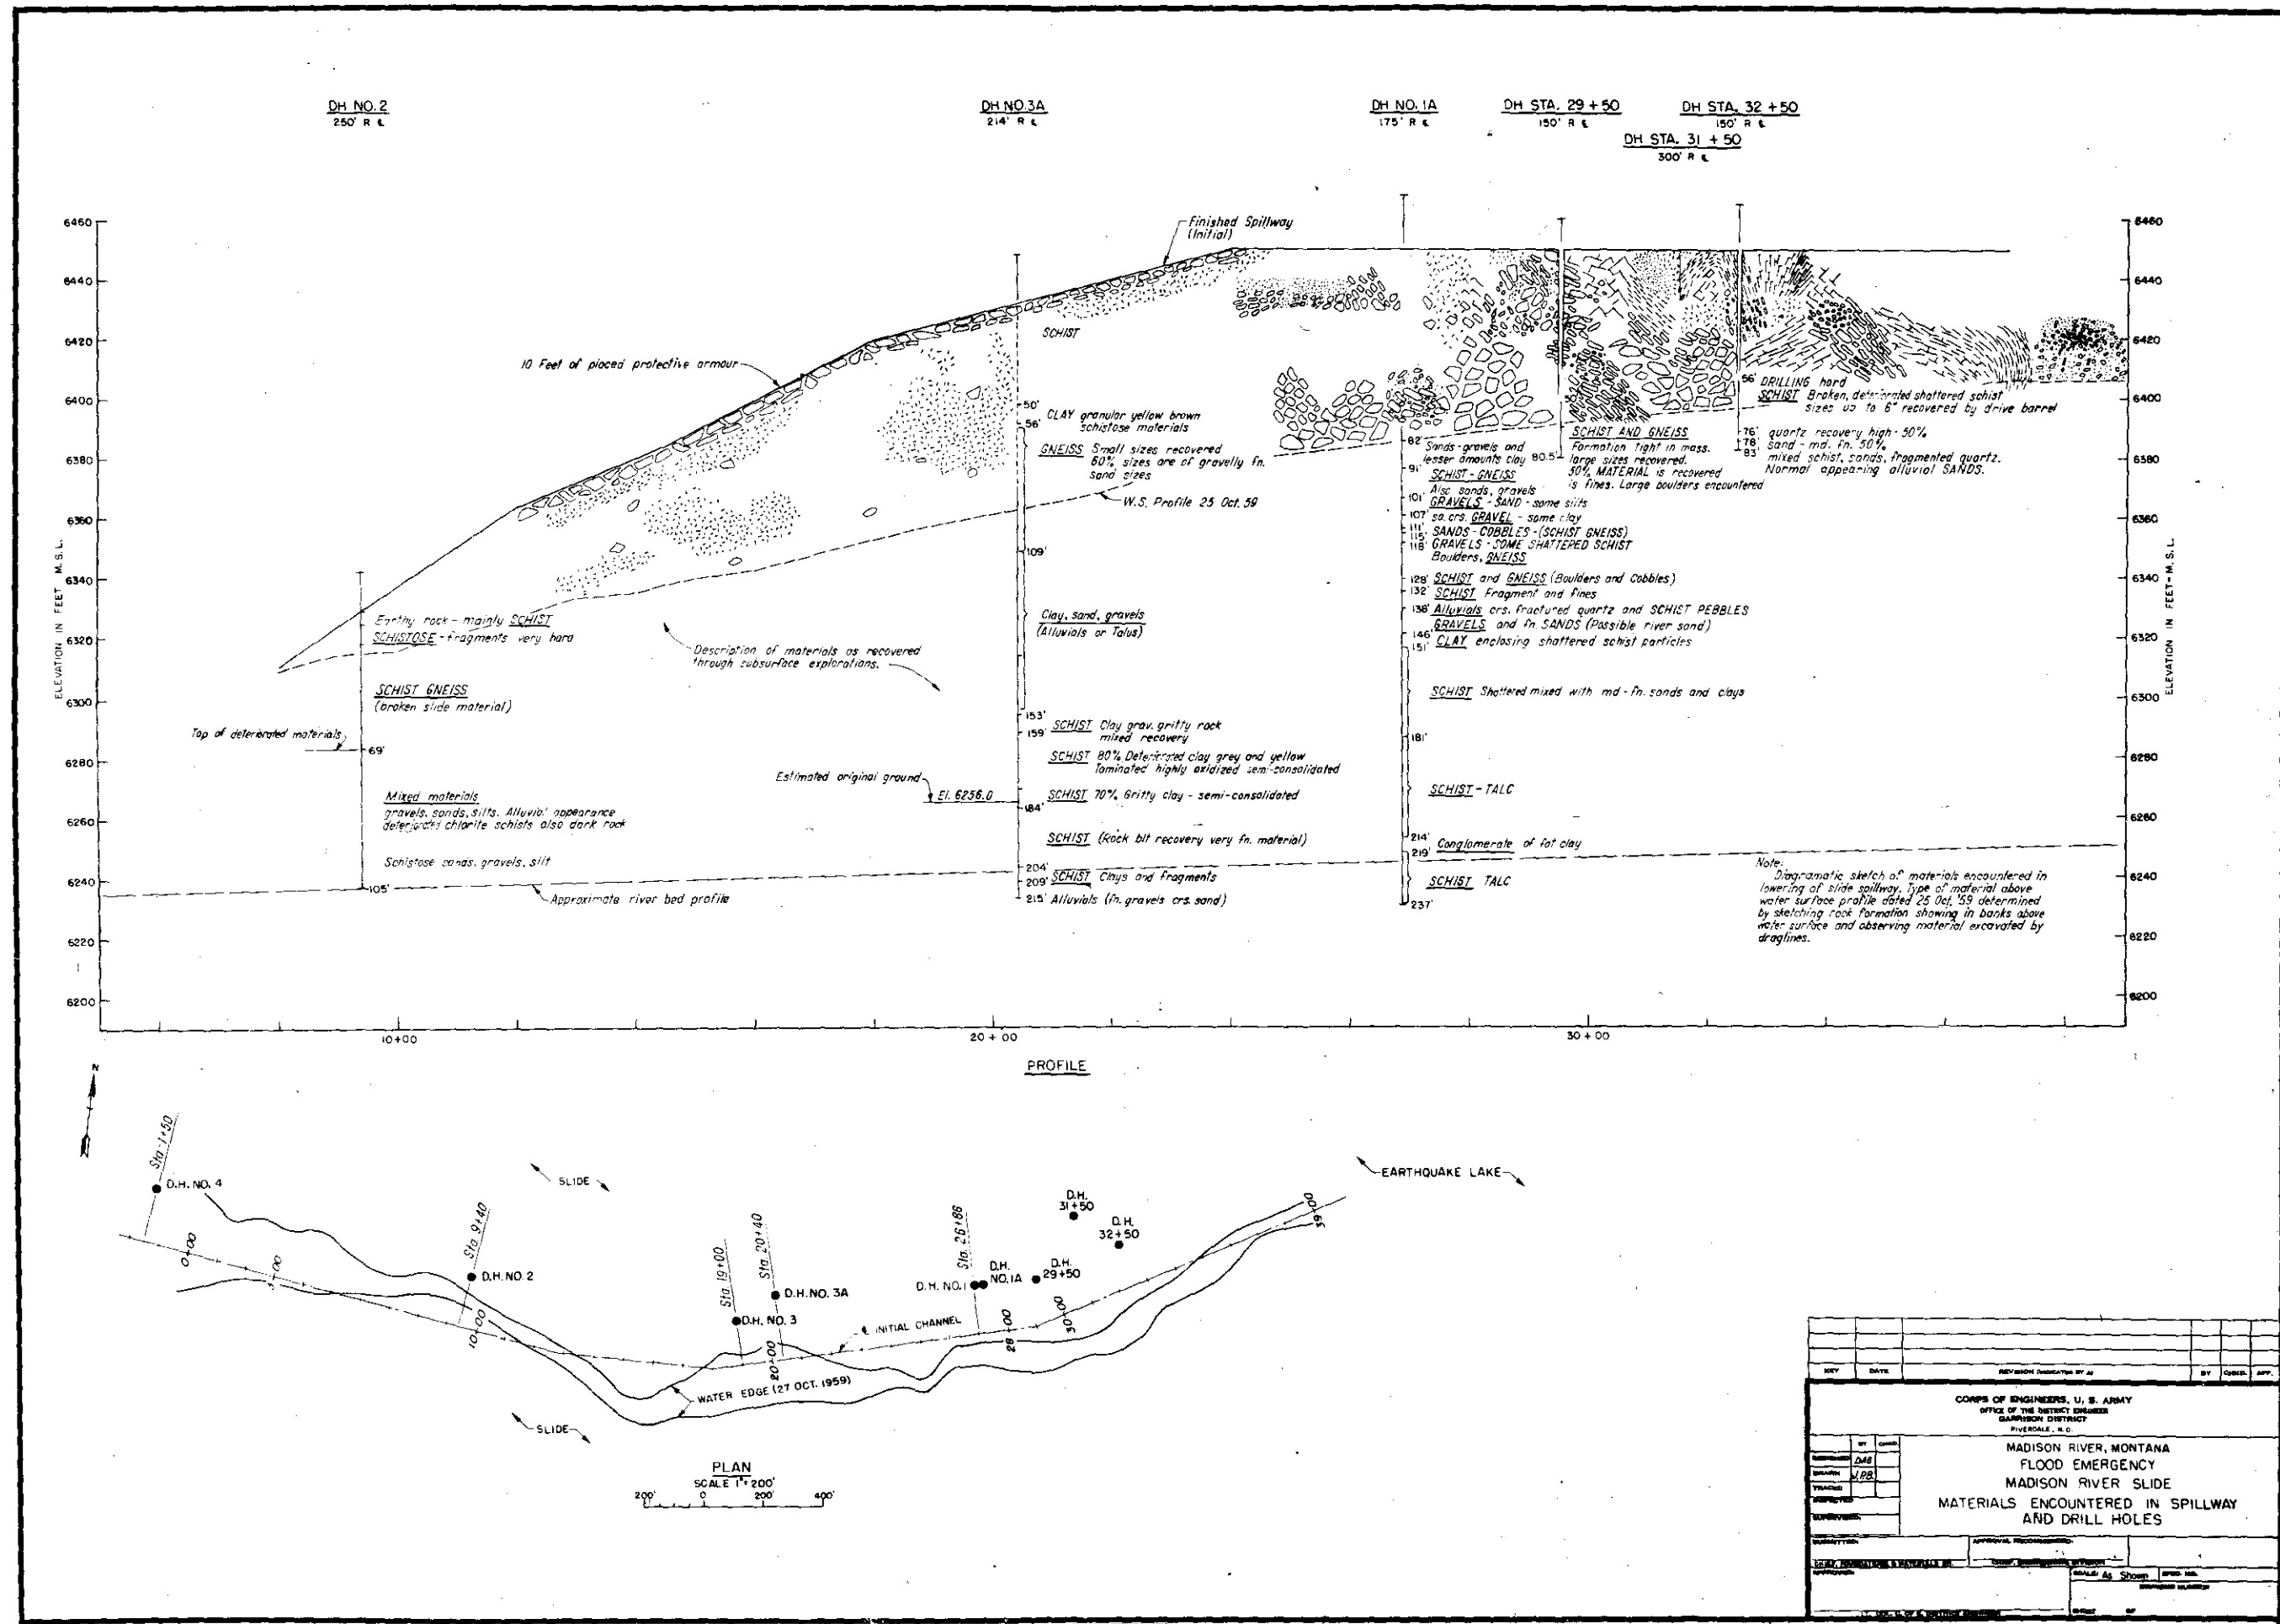
DH NO. 2 250' R L
 DH NO. 3A 214' R L
 DH NO. 1A 175' R L
 DH STA. 29 + 50 150' R L
 DH STA. 32 + 50 150' R L
 DH STA. 31 + 50 300' R L

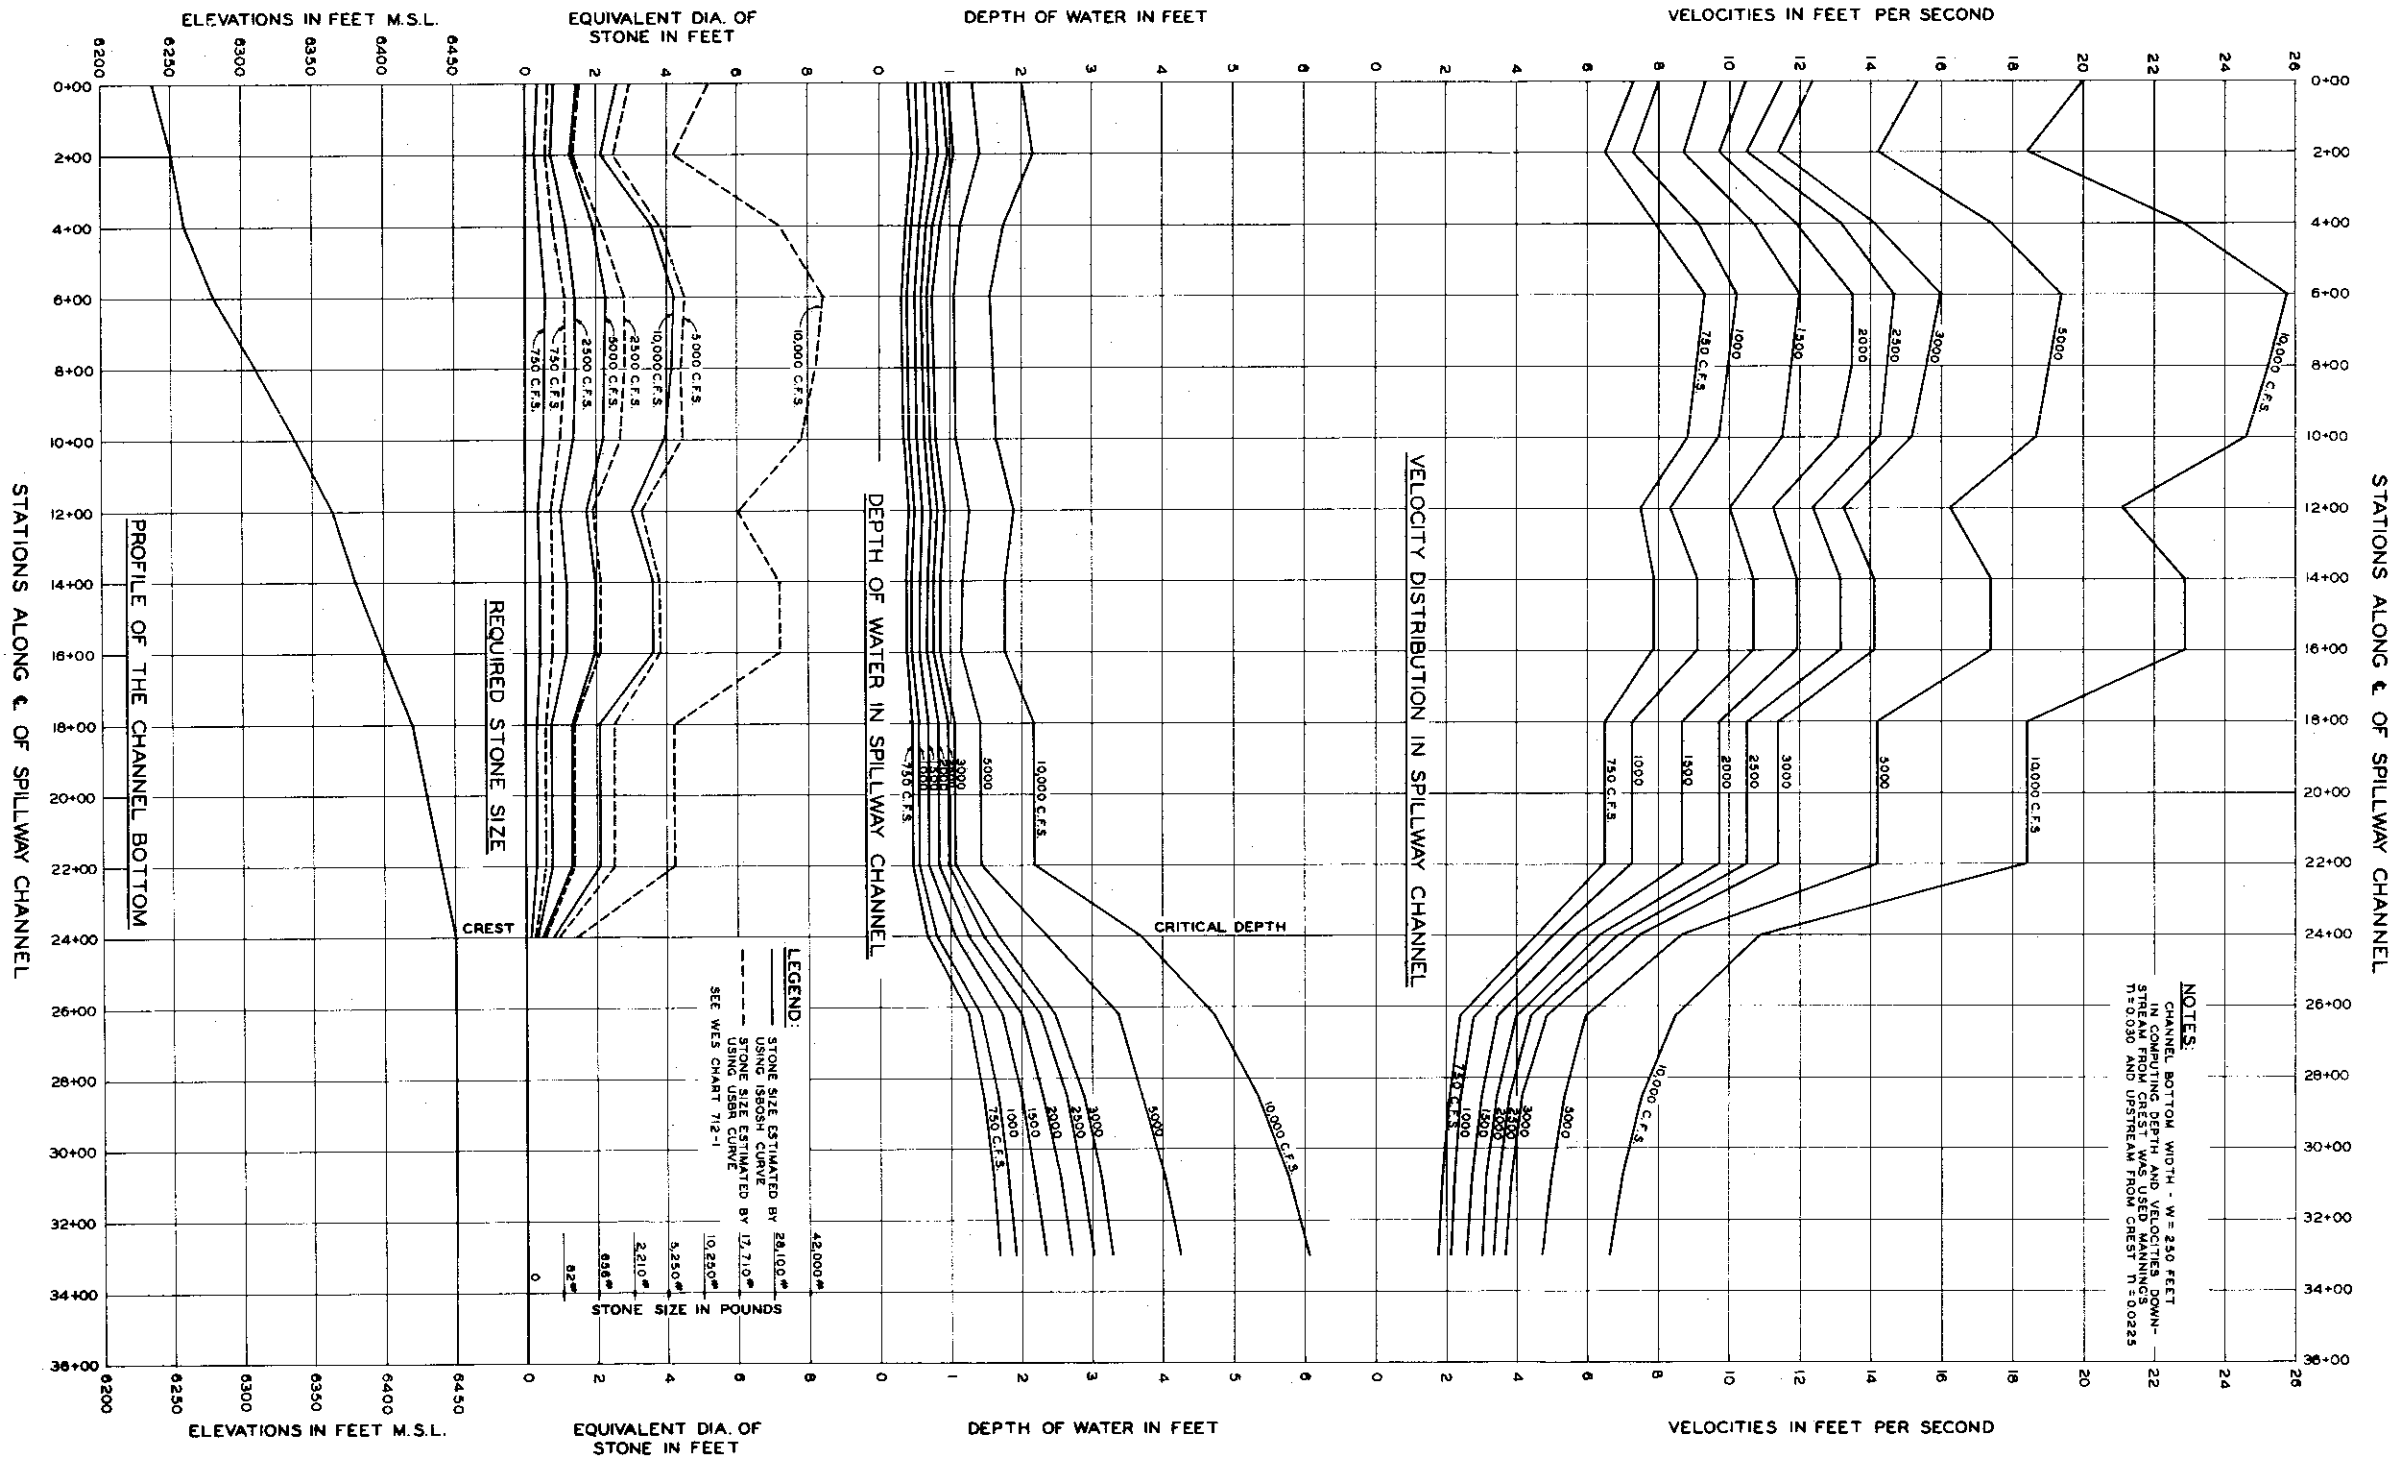
NOTES:
 CHANNEL BOTTOM WIDTH - W = 250 FEET
 IN COMPUTING DEPTH AND VELOCITIES DOWN-
 STREAM FROM CREST AND UPSTREAM FROM
 N+0030 AND UPSTREAM FROM CREST N+0225
