MADISON RIVER, MONTANA
REPORT ON
*FLOOD EMERGENCY
MADISON RIVER SLIDE*

*VOLUME I
MAIN REPORT*

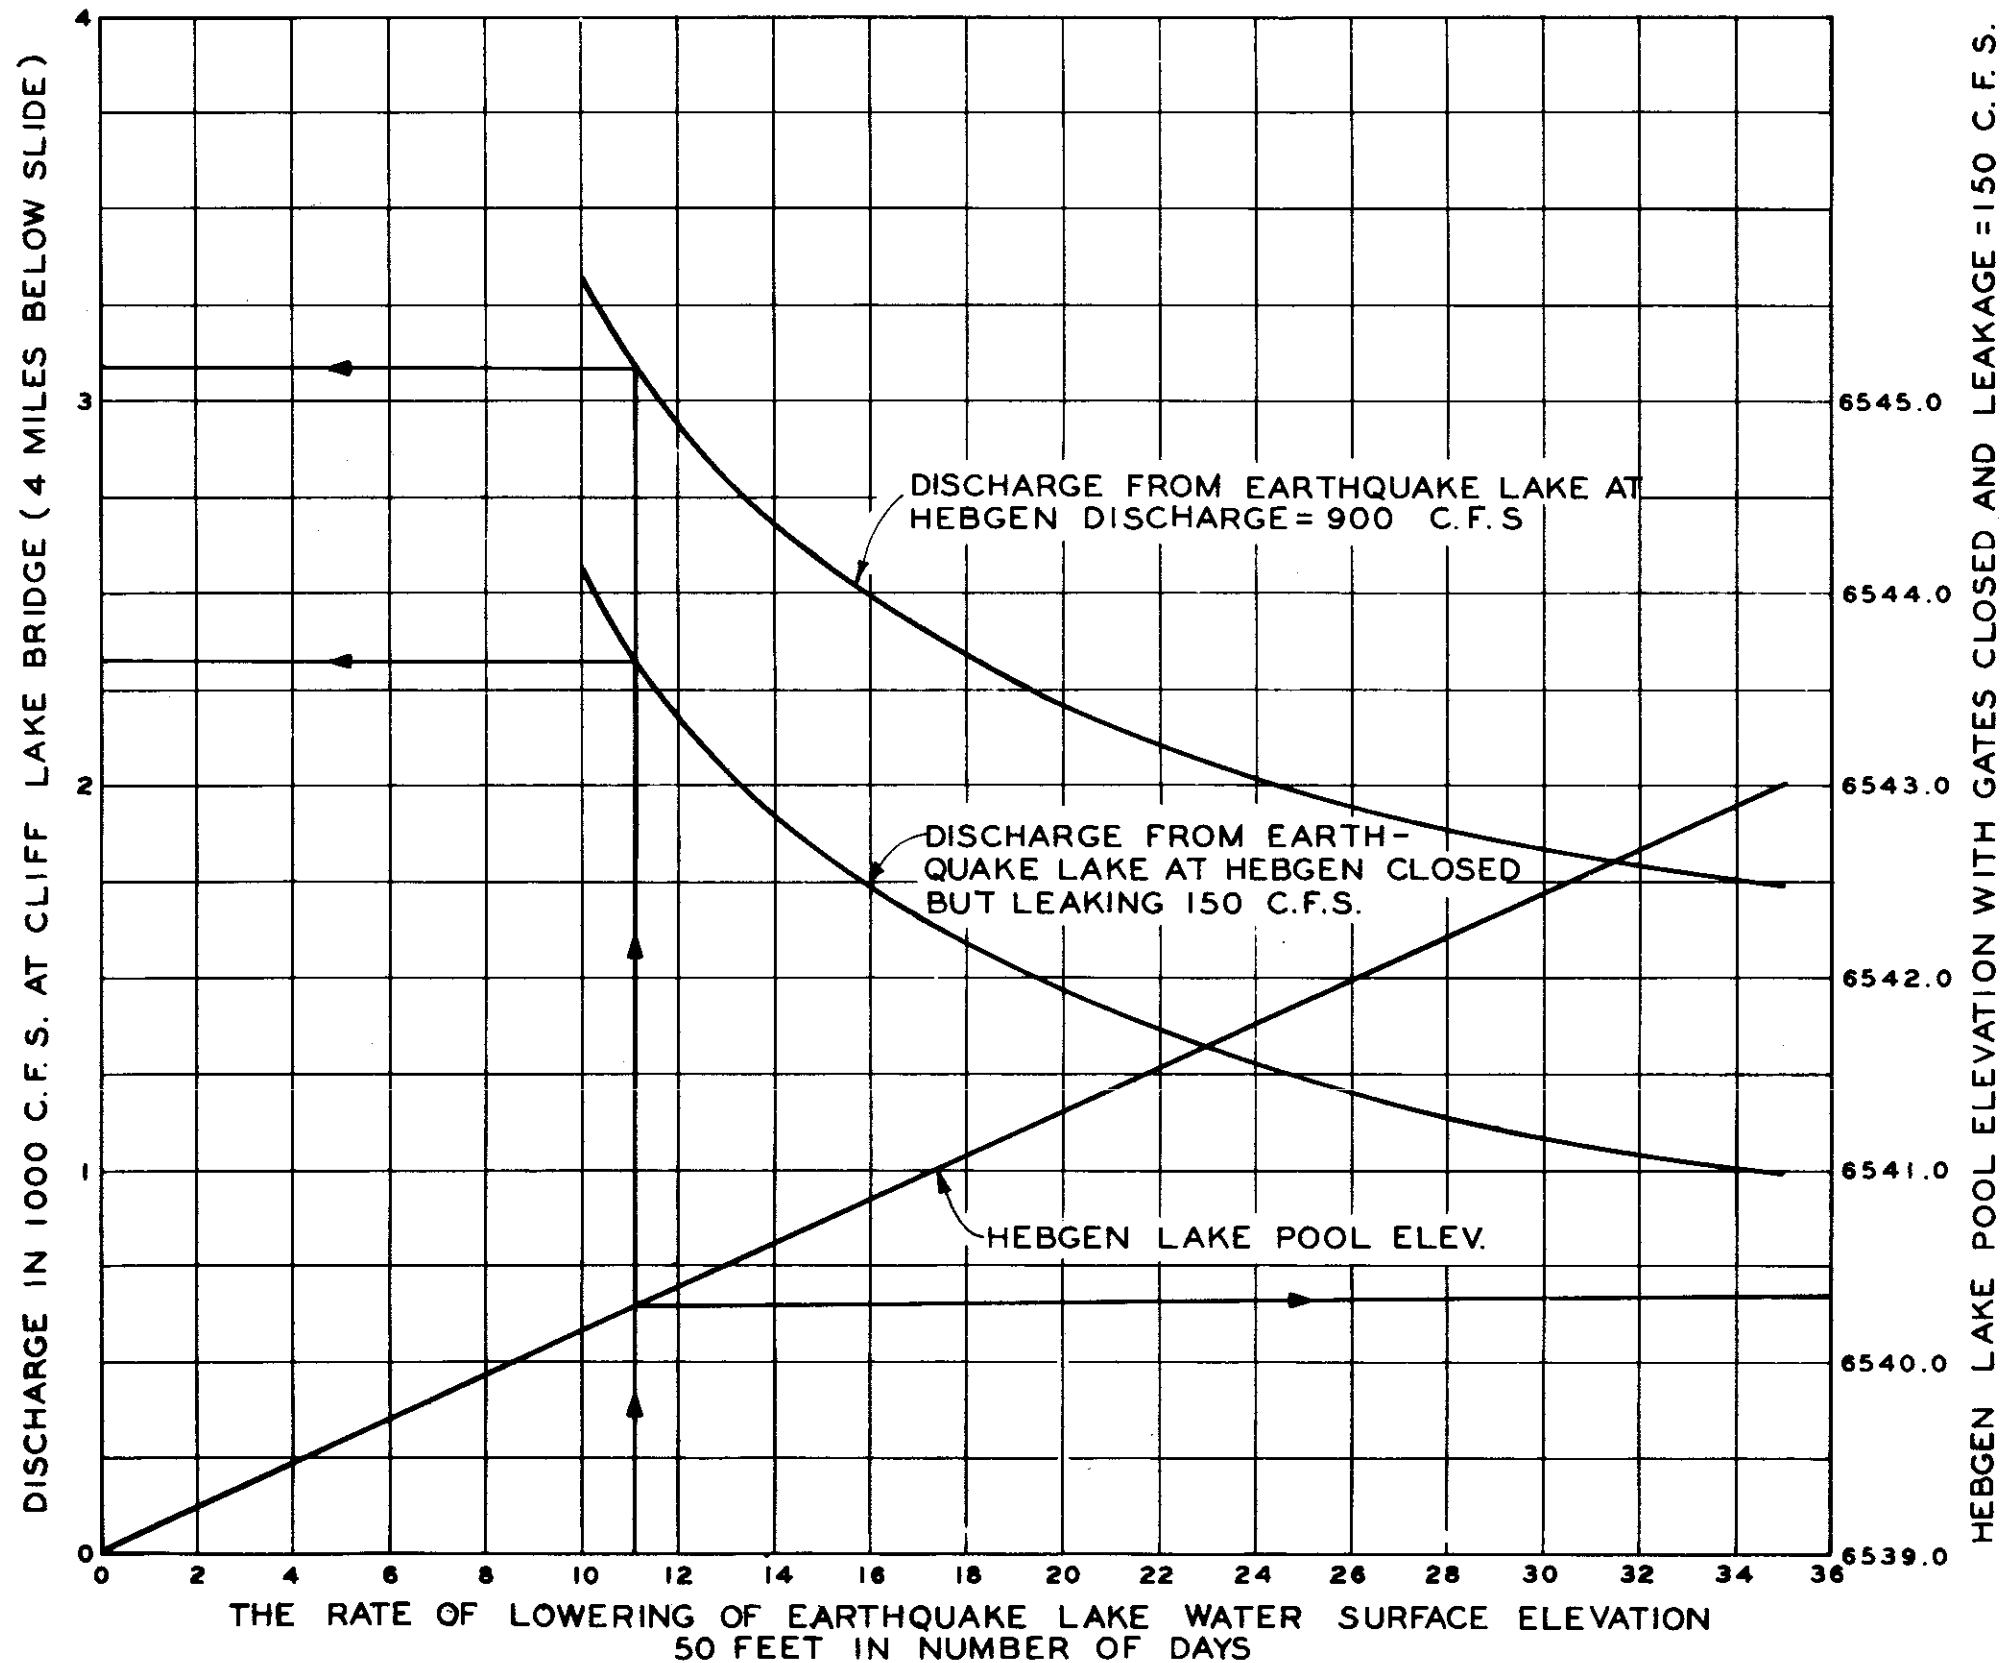
MADISON RIVER, MONTANA
 FLOOD EMERGENCY
 MADISON RIVER SLIDE
 VARIATION OF DEPTH, VELOCITIES AND
 STONE SIZE ALONG THE SPILLWAY CHANNEL
 AT DIFFERENT DISCHARGES
 SEPT. 1960
 THIS DRAWING HAS BEEN REDUCED TO
 THREE EIGHTHS THE ORIGINAL SCALE

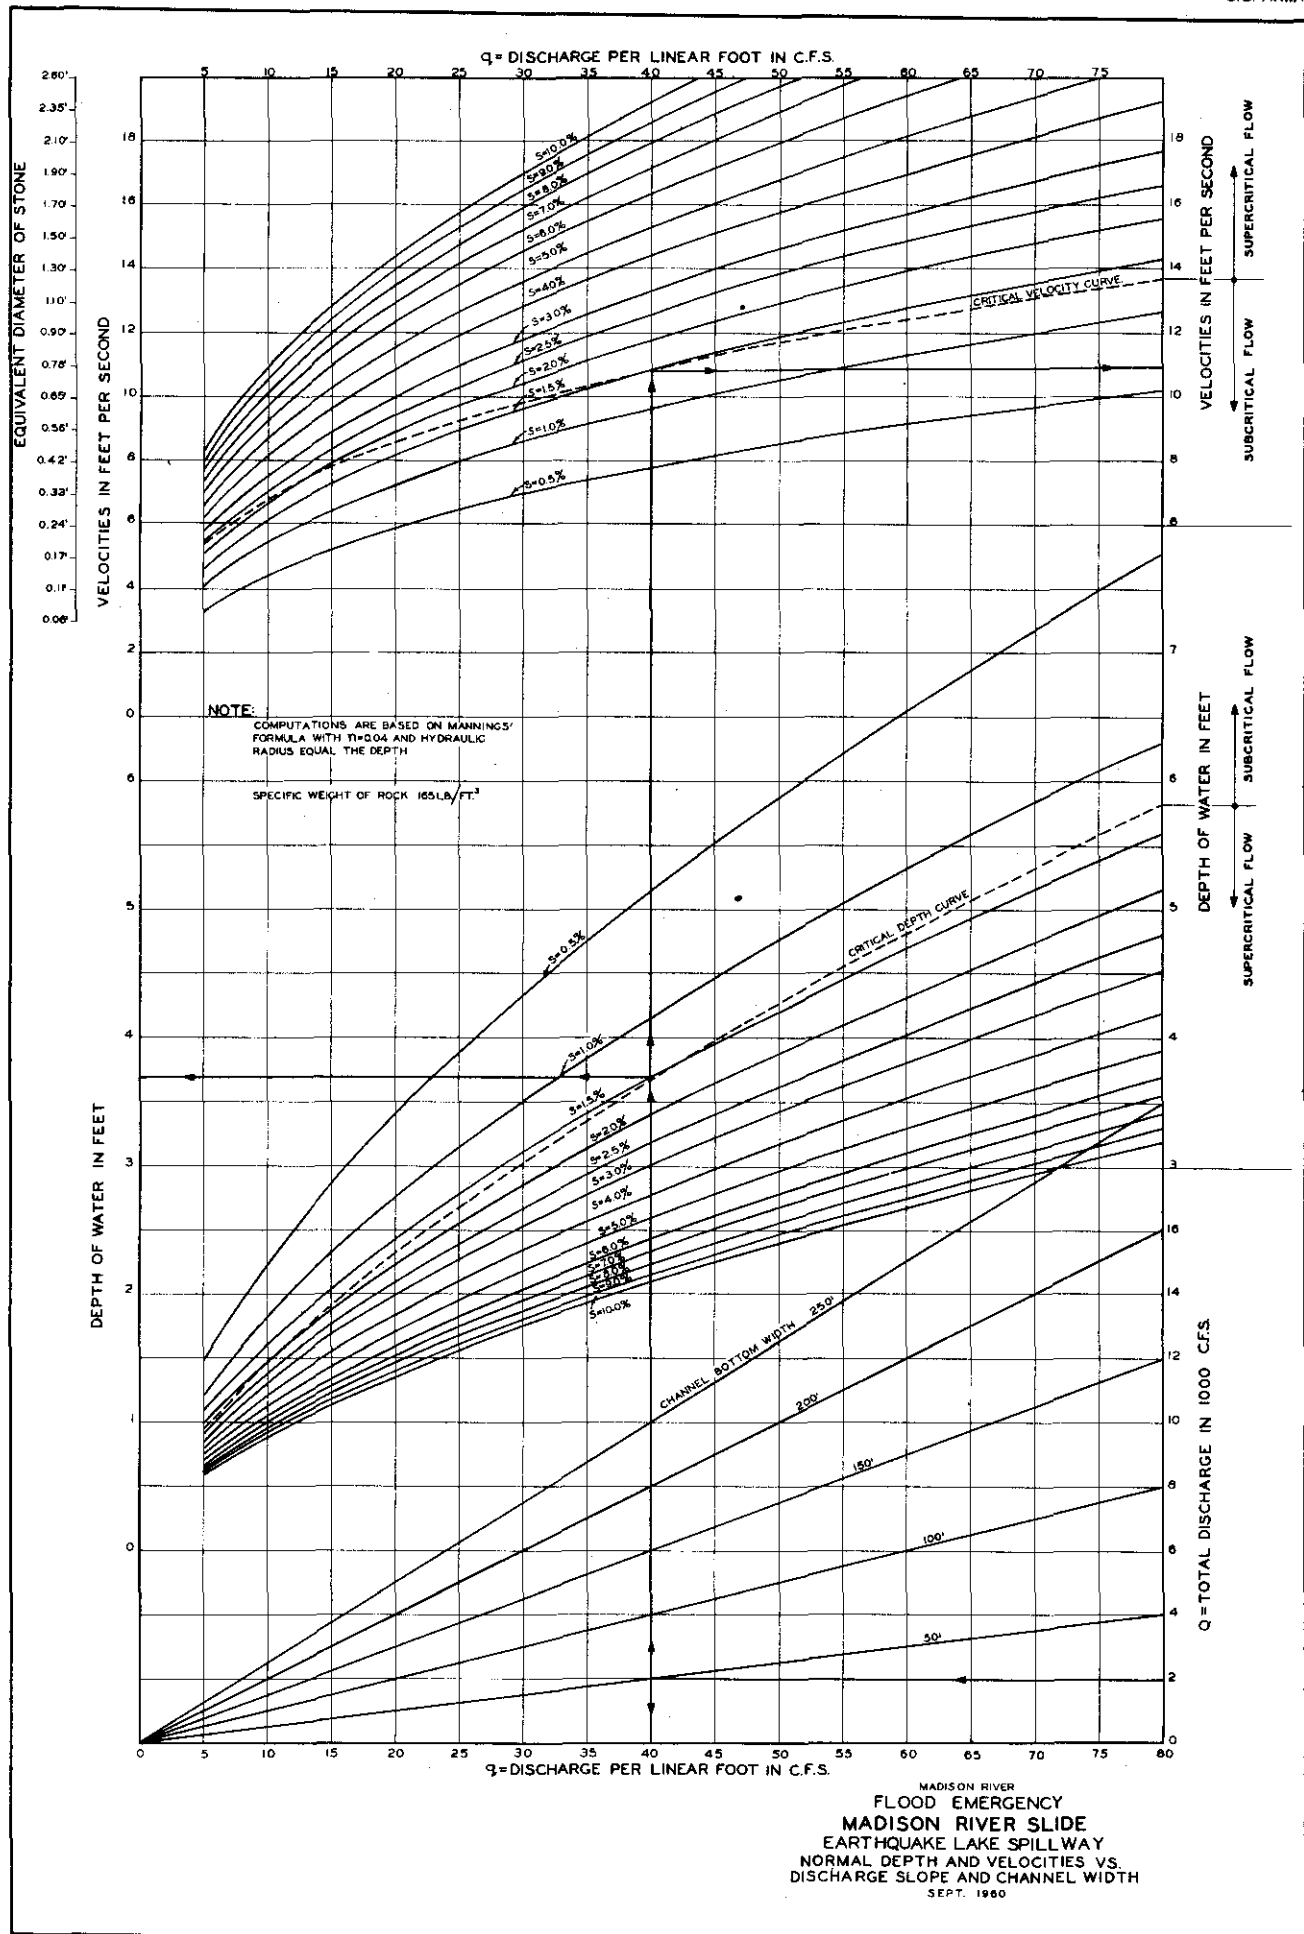
MADISON RIVER
 FLOOD EMERGENCY
 MADISON RIVER SLIDE
 EARTHQUAKE LAKE SPILLWAY
 NORMAL DEPTH AND VELOCITIES VS.
 DISCHARGE SLOPE AND CHANNEL WIDTH
 SEPT. 1960
