**Bechtel Corporation**

**HEBGEN DAM, MONTANA POWER COMPANY**

**Effects of August 1959 Earthquake**

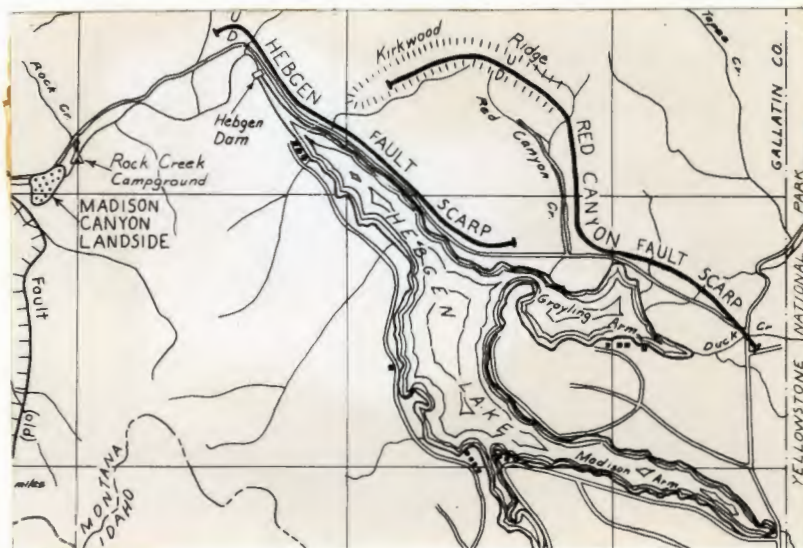
**Fig. 2**  
**MAP OF FAULTS**  
**(GeoTimes, Oct. 1959)**

Displacement occurred on two faults, tentatively designated the Hebgen and the Red Canyon faults, which run in a northwesterly-southeasterly direction north of Hebgen Lake.

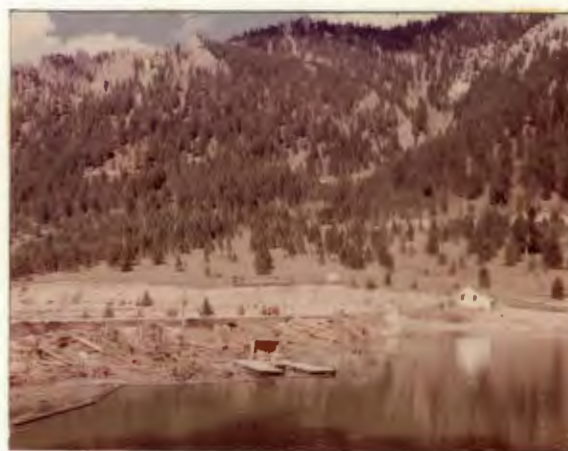
**Fig. 4**  
**FAULT IN NORTH ABUTMENT**

The Hebgen fault is close to the north shoreline for several miles and is on the side hill of the north abutment only about 700 feet from the end of the dam.

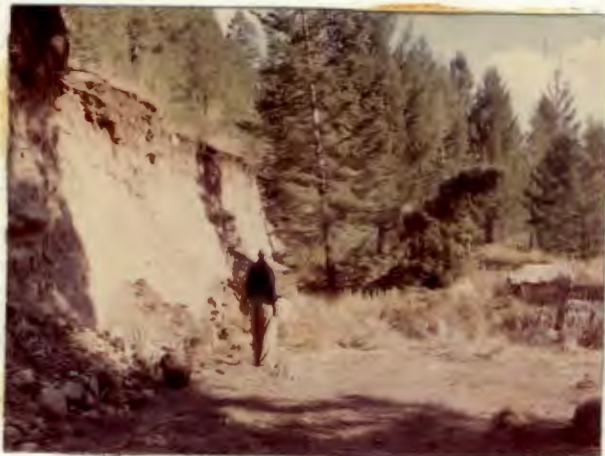
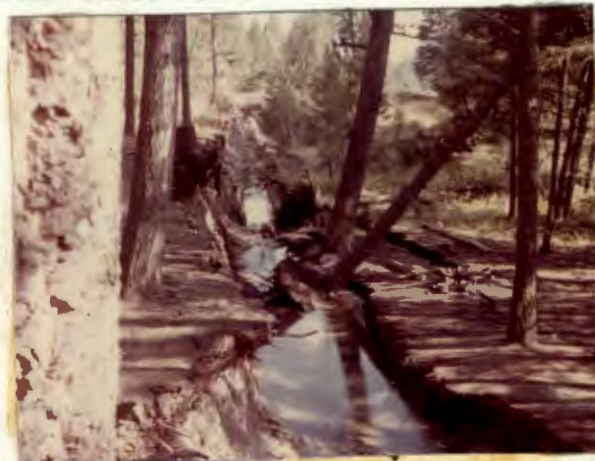
Fig. 5

Vertical displacement along the faults is clearly visible from the air throughout much of their length. A short distance downstream from the dam where they pass through a public campground, the vertical displacement is 12 to 15 feet, with an apparent down-thrust on the river side.

HEBGEN FAULT AT CAMPGROUND DOWNSTREAM FROM DAM

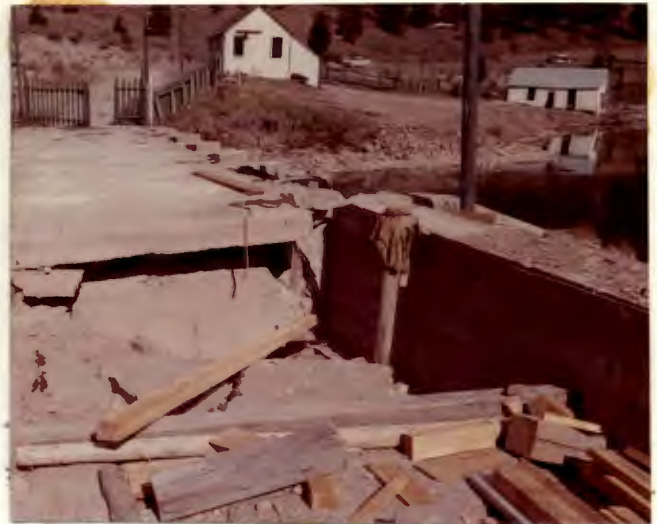
Embankment. Considerable settlement and cracking occurred in the earth embankment, generally small near the left abutment and a maximum from about the center of the dam northward to the right abutment. The crest settled approximately one foot for the first 300 feet from the left abutment, 1 to 2 feet in the next 300 feet, with a maximum of about 4 feet adjacent to the spillway.

**Fig. 8**  
**CREST SETTLEMENT**  
**ADJACENT TO SPILLWAY**

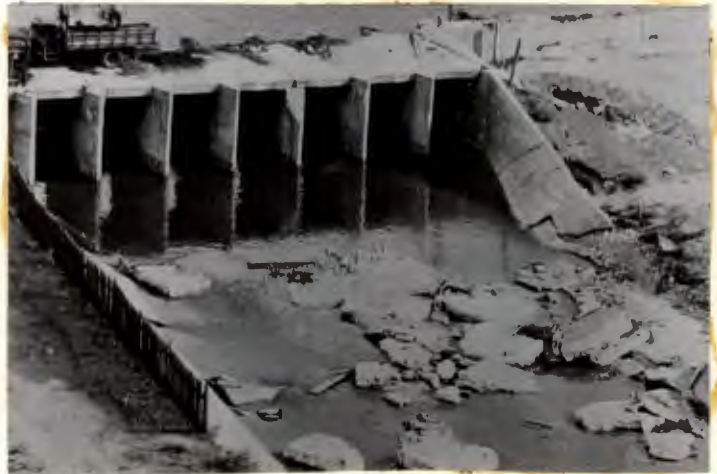
Spillway. The spillway was discharging approximately 1,000 cfs over the flashboards at the time of the quake. The severe shock and the downward and outward movement of the right abutment terrace pushed the entire spillway about 1.8 feet into the dam, severely cracking the left headwall. The entire

control structure settled about one foot, but remained substantially intact with the piers still vertical so that it was operable. The spill was shut off several hours later by installing additional flashboards. The lining of the trapezoidal spillway

Fig. 10  
SPILLWAY CONTROL STRUCTURE  
(M. P. Co. Photo)

damage was stopped by installing flashboards. Although the control structure is still operable, complete

reconstruction will be necessary. Reservoir control is now being accomplished by the intake and the low level outlet conduit, which suffered only slight damage. By September 11, the reservoir had been drawn down about 50,000 acre-feet to elevation 6539, or 5 feet below the maximum.

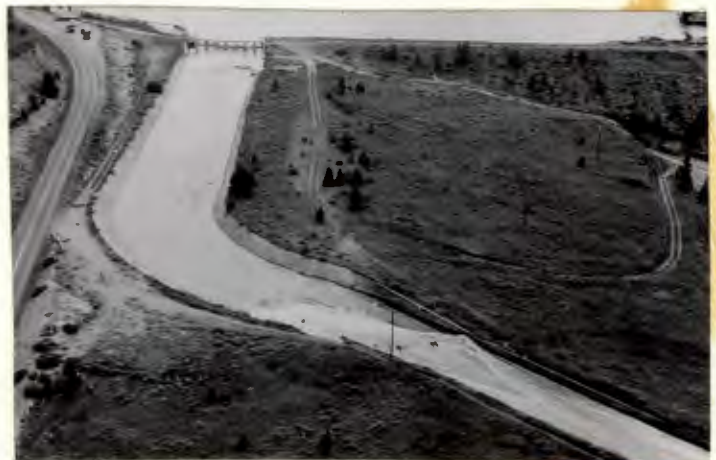
channel was severely disrupted just below the control structure and at several downstream locations. The flow through the control structure abetted this deterioration and the lower end of the spillway washed out, with a continuing progressive failure upstream until further

Fig. 11  
SPILLWAY CHUTE  
(M. P. Co. Photo)

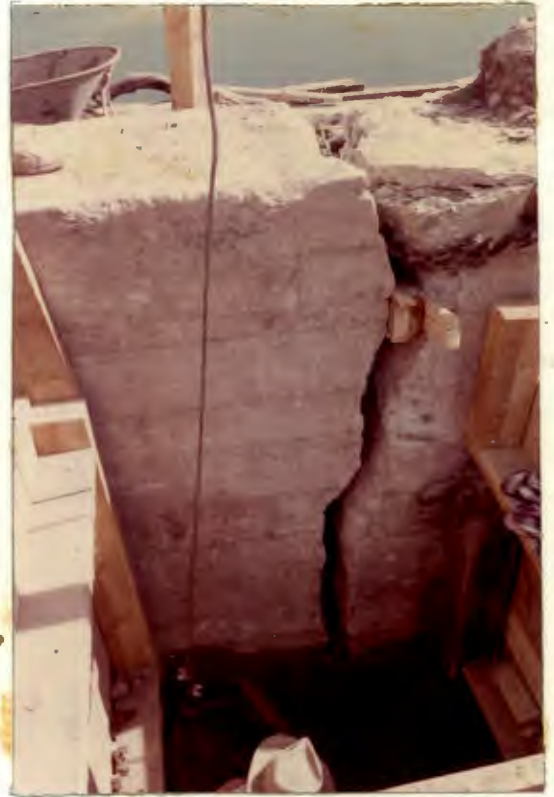
There is a 3-inch wide vertical crack in the core wall about 470 feet north of the left abutment, and three additional small cracks between this point and the spillway.

While the core wall might be expected to crack at the point where the base was stepped vertically upward from rock to a foundation on deep overburden, the top of this crack is nearly 100 feet south of this point.

**Fig. 9**  
**CRACK IN CORE WALL**

At the time of our inspection, an exploratory shaft was being excavated adjacent to the crack on the downstream side of the core wall. Although this had reached a depth of only about 10 feet at the time, the gravelly material was becoming increasingly dry, indicating that the upper portion had been saturated by surface water rather than by seepage through the crack.

Apparently there is but little leakage through the core wall as a result of the cracking. Originally there was some concern in this respect since a considerable seepage flow issued from the river bank of the terrace near the downstream toe of the dam. As soon as flow through the spillway was shut off, however, this seepage stopped and it became apparent that the flow entered the terrace material from the broken spillway channel lining rather than by seepage through the dam.

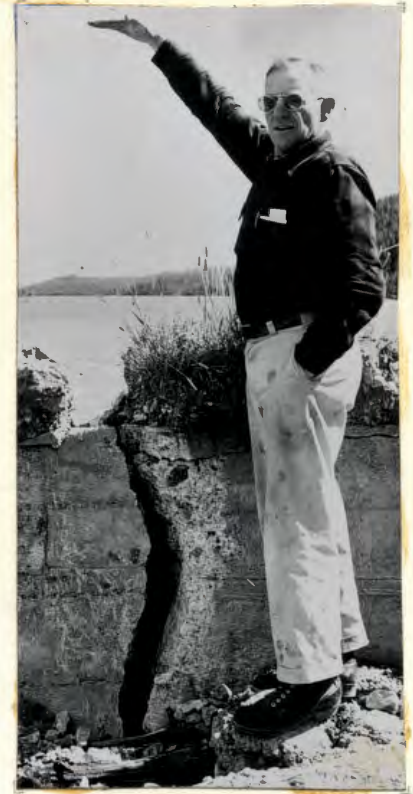
Waves. The resident operator of the dam lives in a cottage along the main road approximately 1500 feet downstream from the dam. At the first shock of the earthquake, which occurred during the night, he rushed out to the road, which is adjacent to the river. It was bright moonlight, and visibility was good. He first noted a greatly increased flow in the river and, thinking that the dam might have failed, ran up the road to higher ground where it crosses the right abutment. He then saw that the badly disrupted spillway was probably the cause of the increased flow. He noted, however, that water had apparently flowed over the top of the dam. According to his report, within the next few minutes a large wave or swell travelled down the reservoir, rode up the upstream face and poured over the core wall to a depth of about 3 feet. As the wave receded, a deep trough developed and, judged from the height of the intake structure, exposed a vertical depth of approximately 30 feet of the upstream face below the water surface. Subsequently, two similar waves of long duration flowed over the core wall at intervals of several minutes, likewise causing deep troughs in their wake. It thus seems apparent that at least four waves (one before the operator arrived) overtopped the dam.

Fig. 12  
HEIGHT OF WAVE  
(M. P. Co. Photo)

It seems somewhat doubtful, however, that the waves actually flowed in a 3-foot depth of solid water over the top of the core wall. The erosion of the downstream slope was less severe than might be expected if that much water

had overpoured the core wall on four successive occasions. Numerous small gulleys, generally about 12 to 18 inches deep with maximum spot depths of as much as 3 feet, were created but there was no general washout of a substantial amount of material. Furthermore, and probably more significant, there is a small wood frame valve house approximately one-third the distance down the downstream slope and about 100 feet north of the left abutment. The foundation timbers of this structure are partially rotted and it would not have been difficult to overturn the house. The structure, however, although slightly canted and somewhat eroded around the base, was still essentially in place. It is doubtful that it could have withstood flows of water such as the operator described as overtopping the dam. It seems more reasonable that the waves riding down the reservoir and up the upstream slope created a large splash as they hit the 3 to 5 feet of exposed vertical face of core wall, thus creating an impression of considerably greater height.

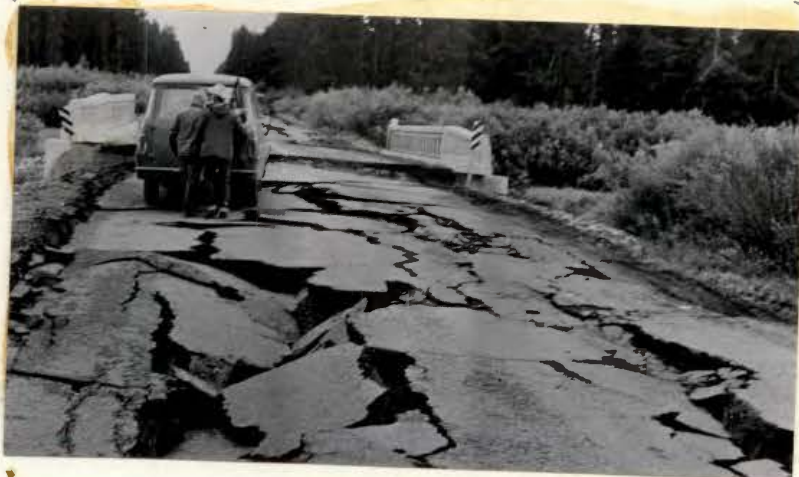
Roads. The main access road, State Highway 287 from West Yellowstone down the Madison River canyon, was severely disrupted at several locations, especially where the road was on fill, such as adjacent to small bridges. At these locations, the fill flattened out, causing deep cracks in the road surface with abrupt vertical offsets where the fill settled adjacent to bridge abutments. This type of damage, although rather extensive, was relatively easy to repair. Little damage occurred to the concrete bridges, perhaps because they are founded on firm material.

Fig. 13  
TYPICAL DAMAGE TO STATE  
HIGHWAY 287 AT SMALL BRIDGE  
(M. P. Co. Photo)

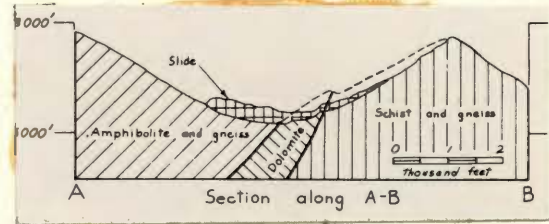
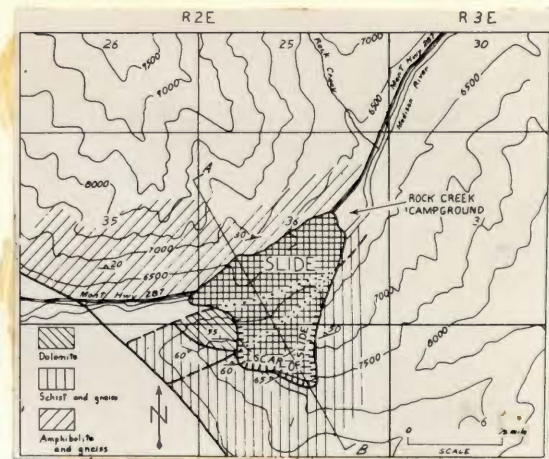
triggered a slide along planes of weakness in the weathered schist on a face oriented a little upstream of parallel to the river with its top extending slightly back of the crest of the ridge. The volume of rock involved was about 43, 000, 000 cubic

Fig. 14  
DIAGRAM OF LANDSLIDE  
(GeoTimes, Oct. 1959)

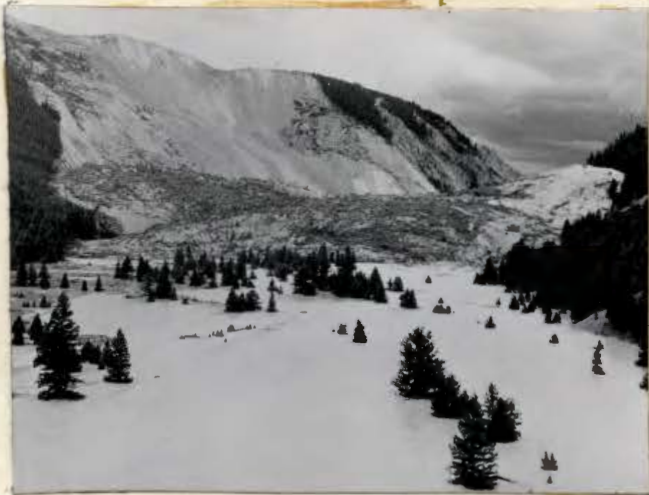
Flow through the disrupted spillway of Hebgen Dam, augmented by some 200 to 300 cfs inflow downstream, quickly began to form a lake (later named Slide Memorial Lake) behind the slide embankment.

**Fig. 18**  
**FILLING OF SLIDE MEMORIAL LAKE**  
**(M. P. Co. Photo)**

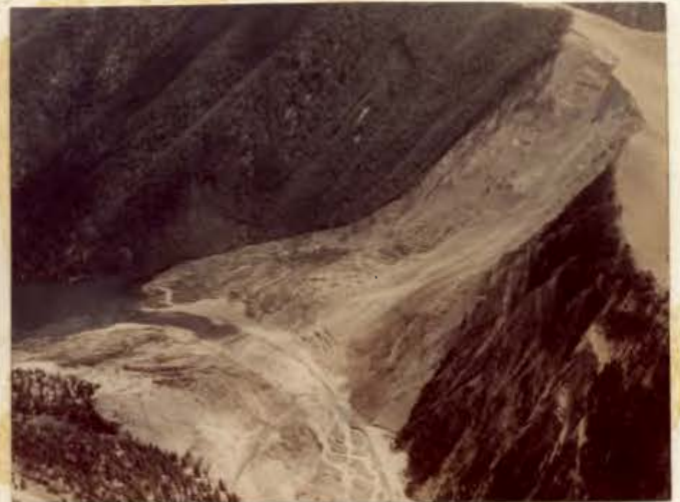
**Fig. 19**  
**AIR VIEW OF LANDSLIDE, LAKE,**  
**AND EXCAVATED SPILLWAY**

As the lake filled, leakage of approximately 200 cfs developed, principally through the north side, which was not blanketed as thoroughly by the fine material. It is reported that this seepage flow quickly cleared up, indicating that no major piping was occurring. If the lake had filled to the full depth of the slide, it would have had a volume of nearly 100,000 acre-feet with a surface partially submerging the toe of Hebgen Dam. The possibility of failure of the slide embankment, especially by overtopping, would have created a tremendous hazard in the downstream valley.

Acting under emergency orders, the Corps of Engineers, with the advice of several consultants, mobilized a large amount of equipment and began excavating a spillway over the top of the slide to safely conduct the flow. This was cut into the low part of the slide to a depth of 30 feet, reducing the maximum

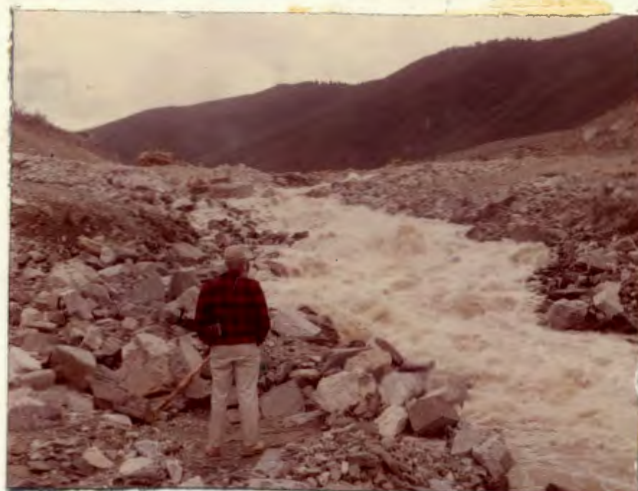
On September 12, a controlled flow of approximately 700 cfs was flowing through the spillway. This was regulated at Hebgen Dam, releases from which were being controlled by the Corps of Engineers. Velocity in the flat gradient crest section was low, the water flowing without riffles. As the velocity increased down the back slope, considerable erosion was taking place, developing a series of small cascades.

**Fig. 22**  
**CHUTE SECTION OF SPILLWAY**

Although the channel appeared to be stabilizing itself to a considerable extent, it meandered to the weak spots and tended to concentrate in a narrow, deeper channel. This was being remedied by dumping large rock at the points of weakness and by dozers working in the stream pushing material into the low spots to keep the flow spread over a considerable width.

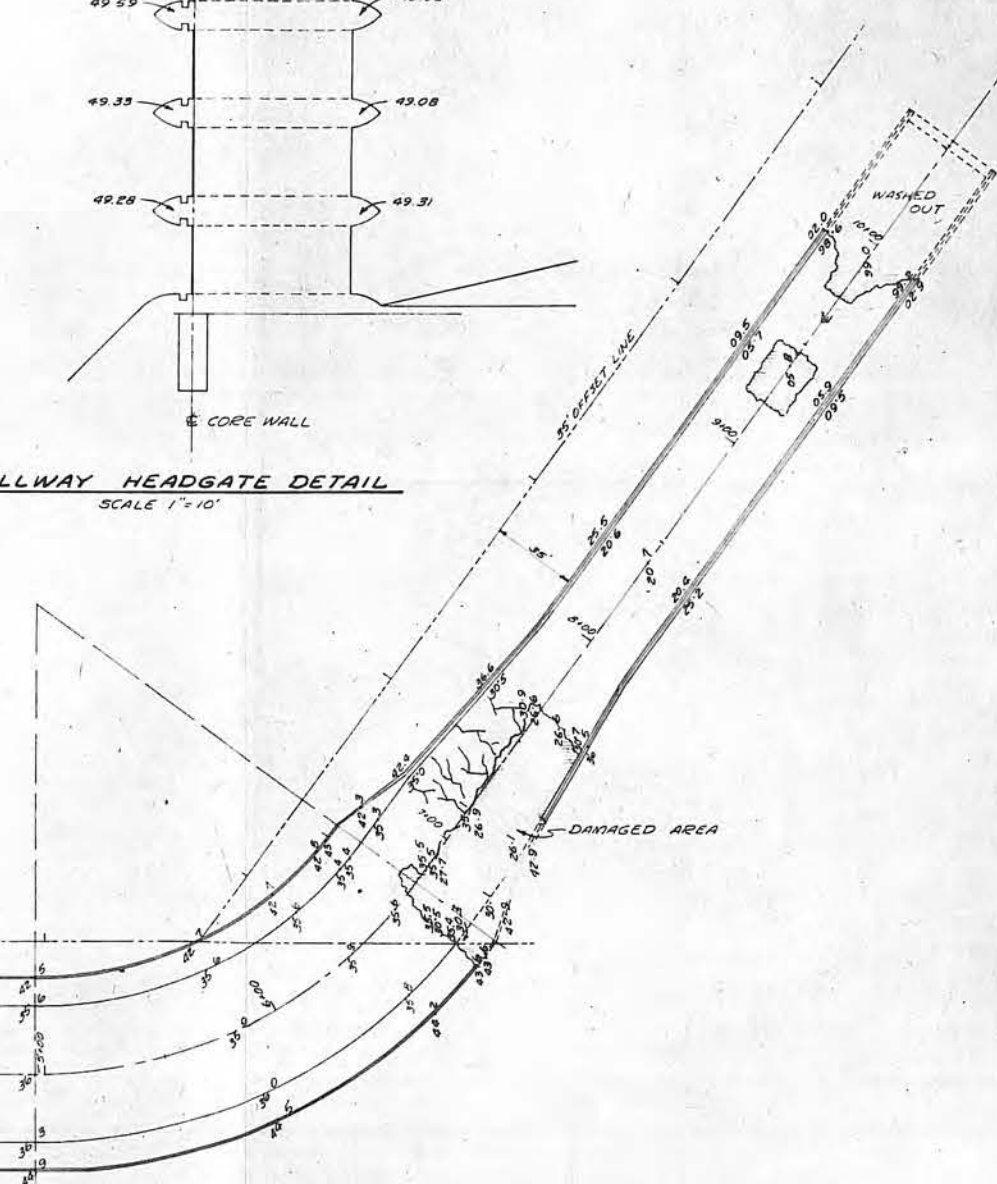
PLATE 3

of the fault to the north abutment, the dam must have been subjected to tremendous disruptive forces. Subsequent to the earthquake, a careful survey was made to measure the deflections and settlements, which are shown in plan on Plate 3 (Drawing 140-59) and on three sheets of cross sections, Plates 4-6. Various elevations and distances in the vicinity of the left abutment, as measured in the recent survey, check relatively with previous measurements and, therefore, this abutment was assumed to have remained stable in measuring the movements. These quantitative data were supplemented by verbal information obtained in discussions with Ray Ball, Glen Jones, and the resident operator at the dam.

HEBGEN DAM  
MONTANA POWER COMPANY  
TOPOGRAPHY AND EARLY  
QUAKE DAMAGE INVESTIGATION

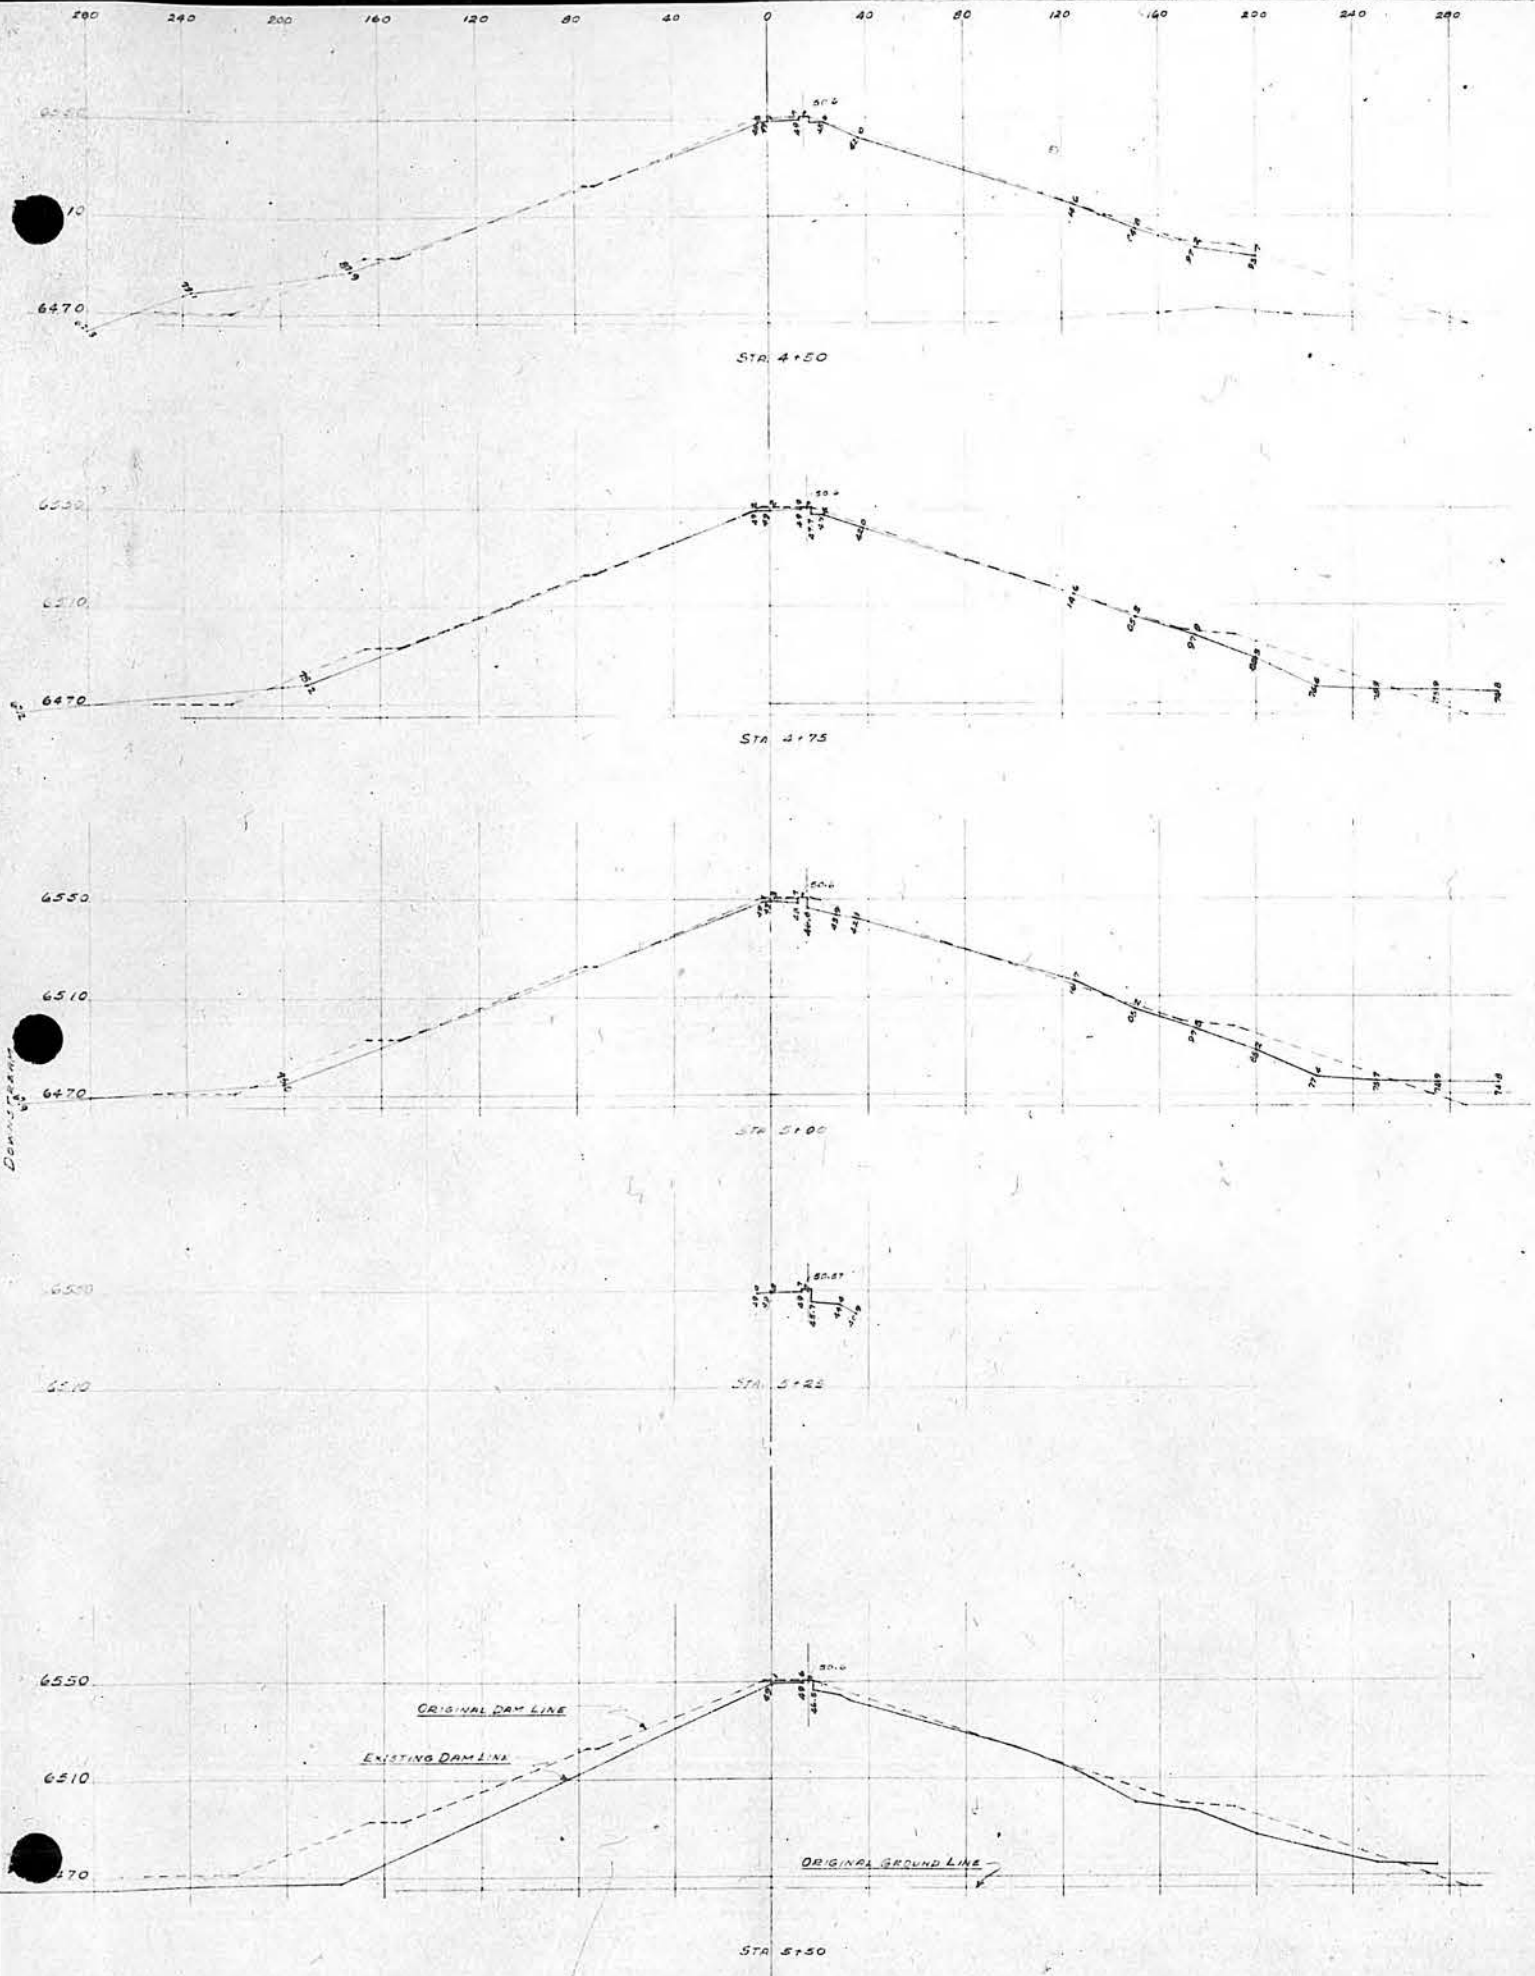
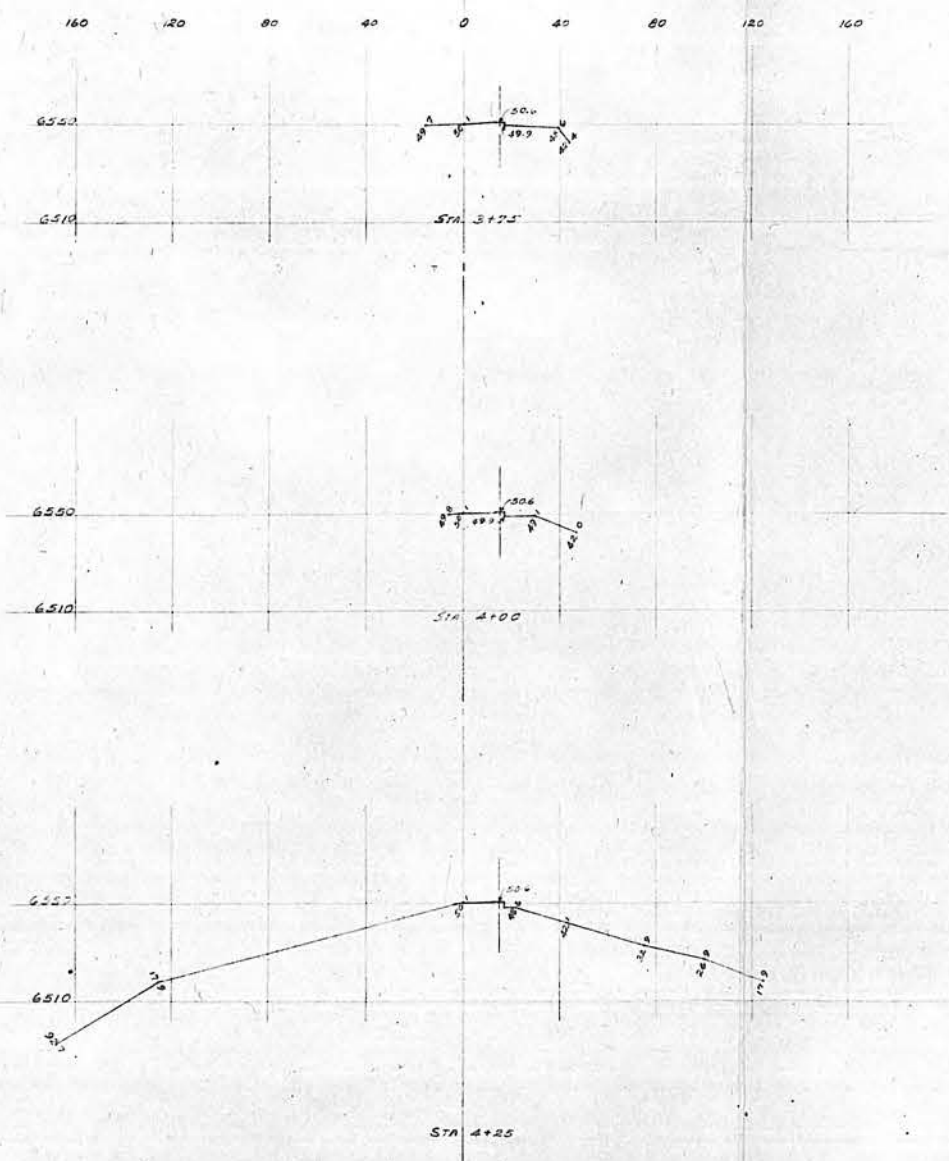
**PLATE 4**

HEBGEN DAM  
 CROSS SECTIONS  
 AFTER AUG 17, 1959 EARTHQUAKE  
 SHEET #1

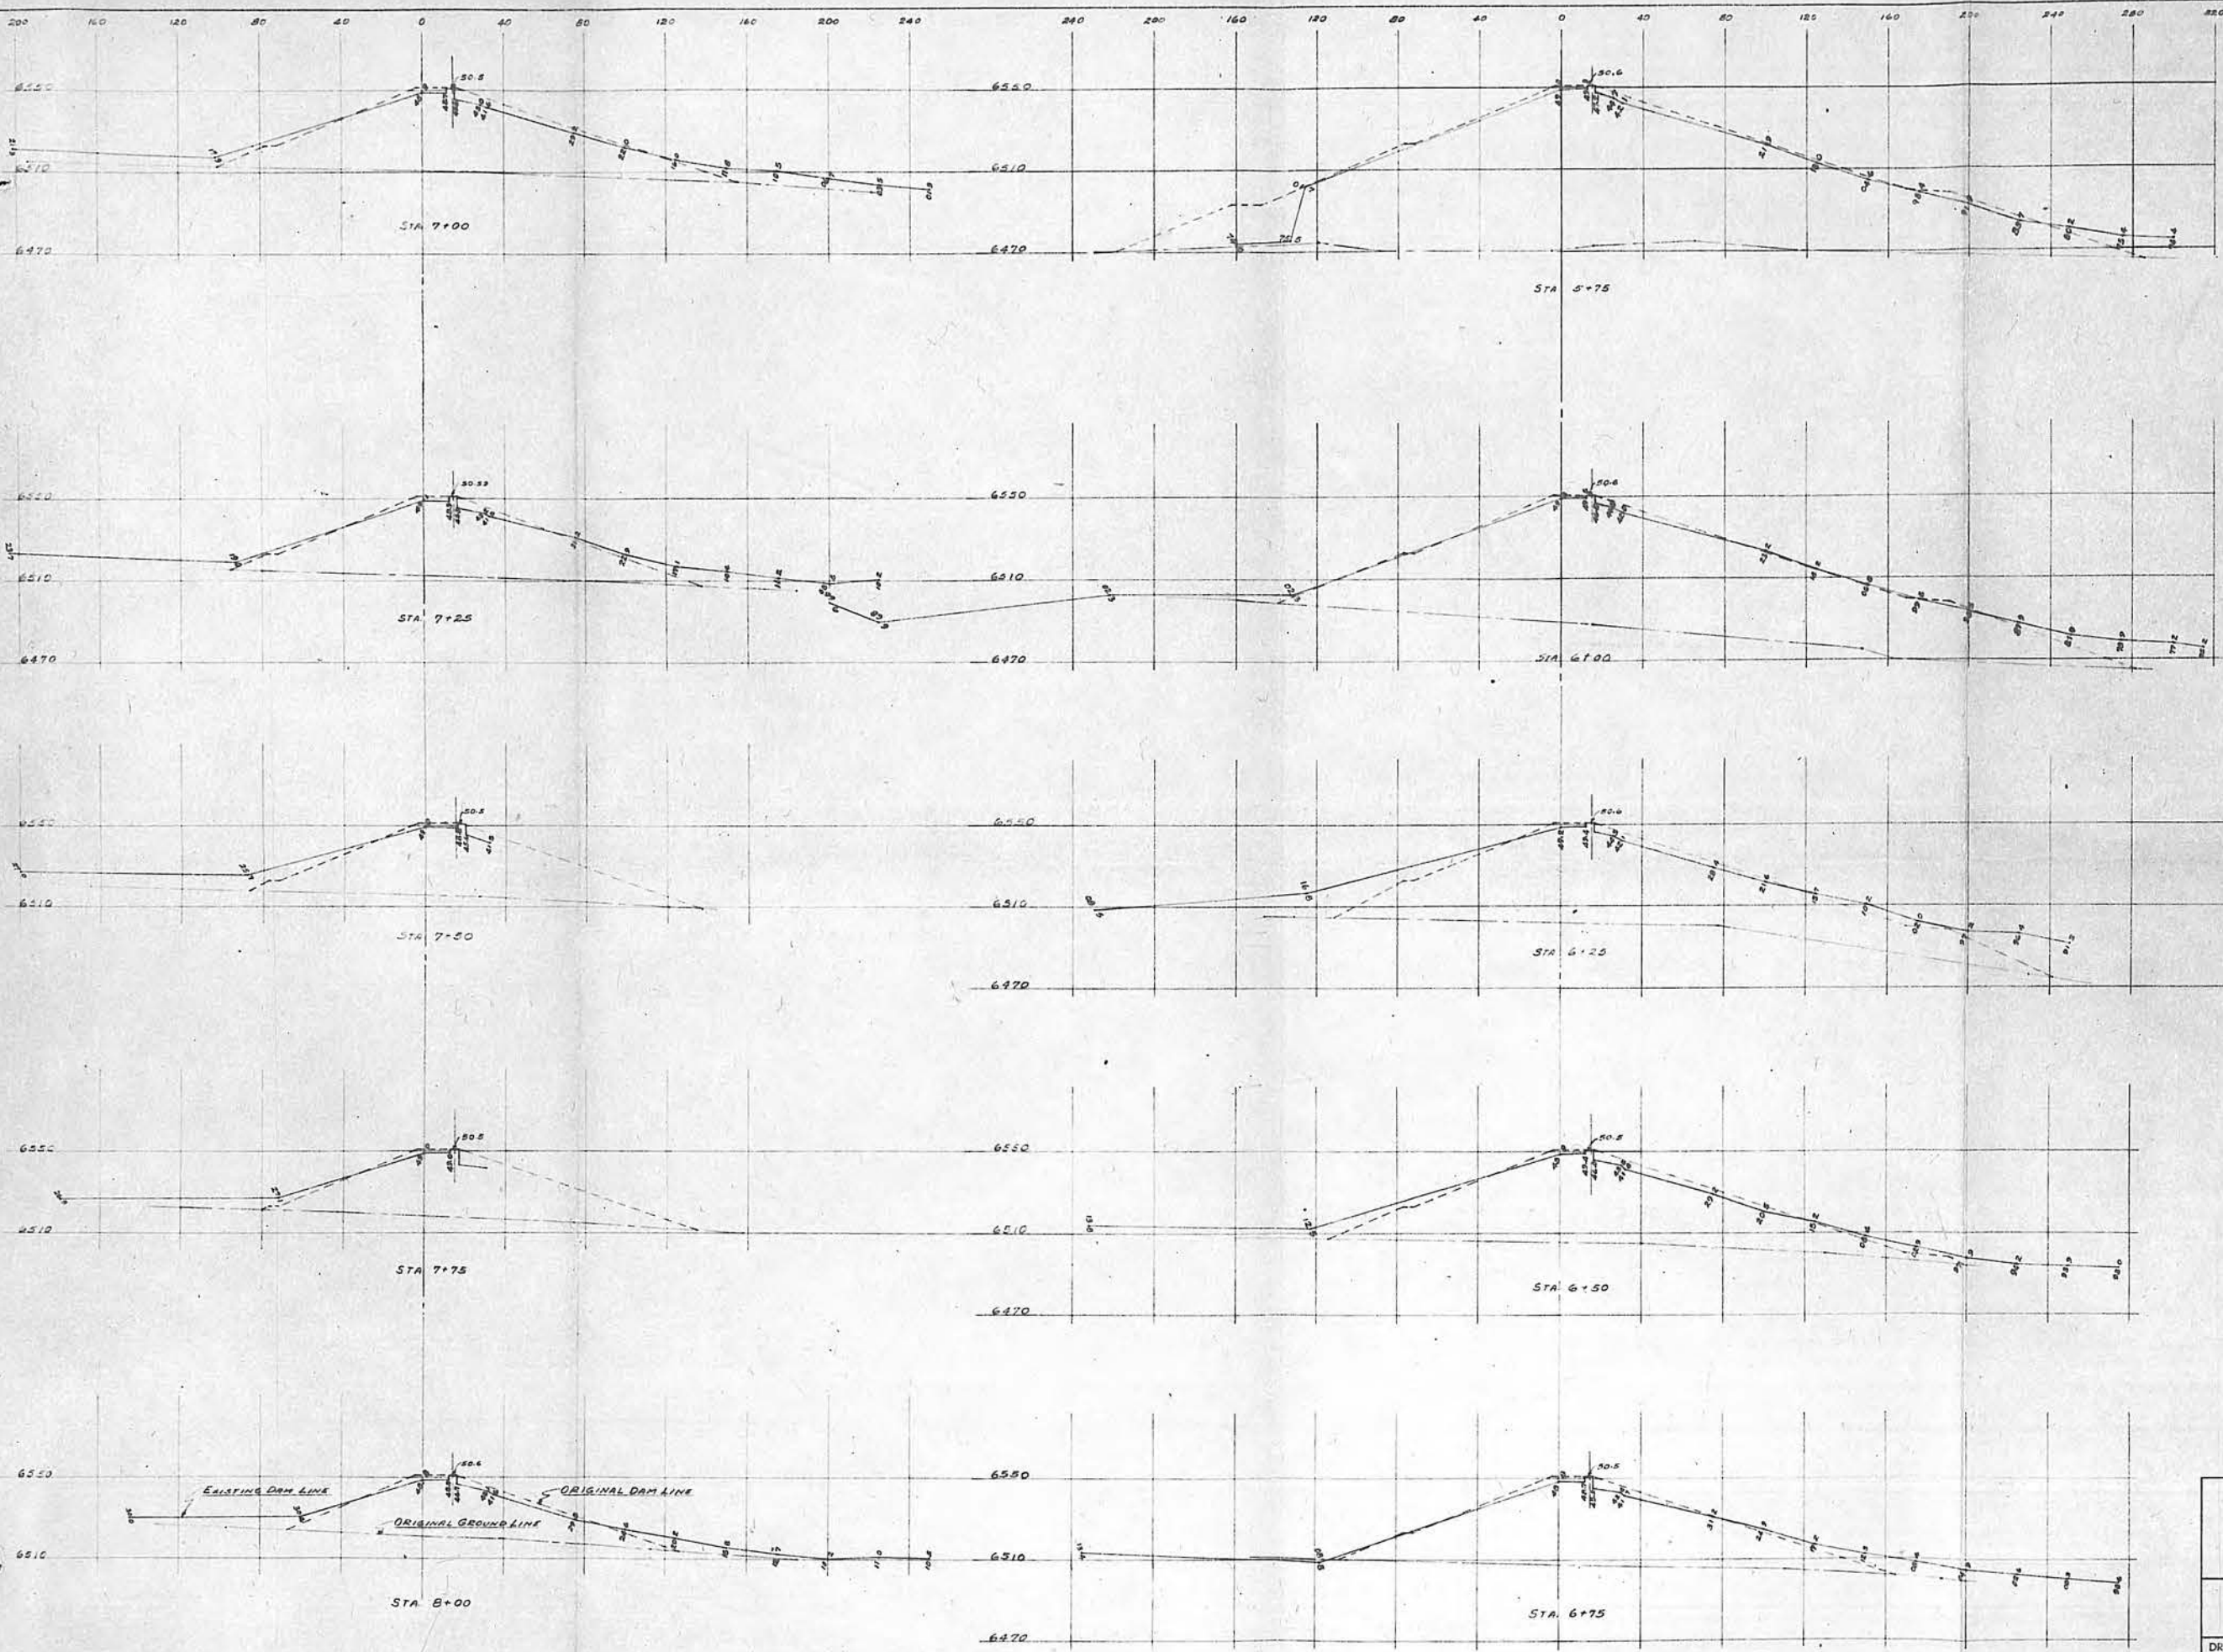
PLATE 5

HERGEN DAM  
 CROSS SECTIONS  
 AFTER AUG. 17, 1959 EARTHQUAKE  
 SHEET # 2

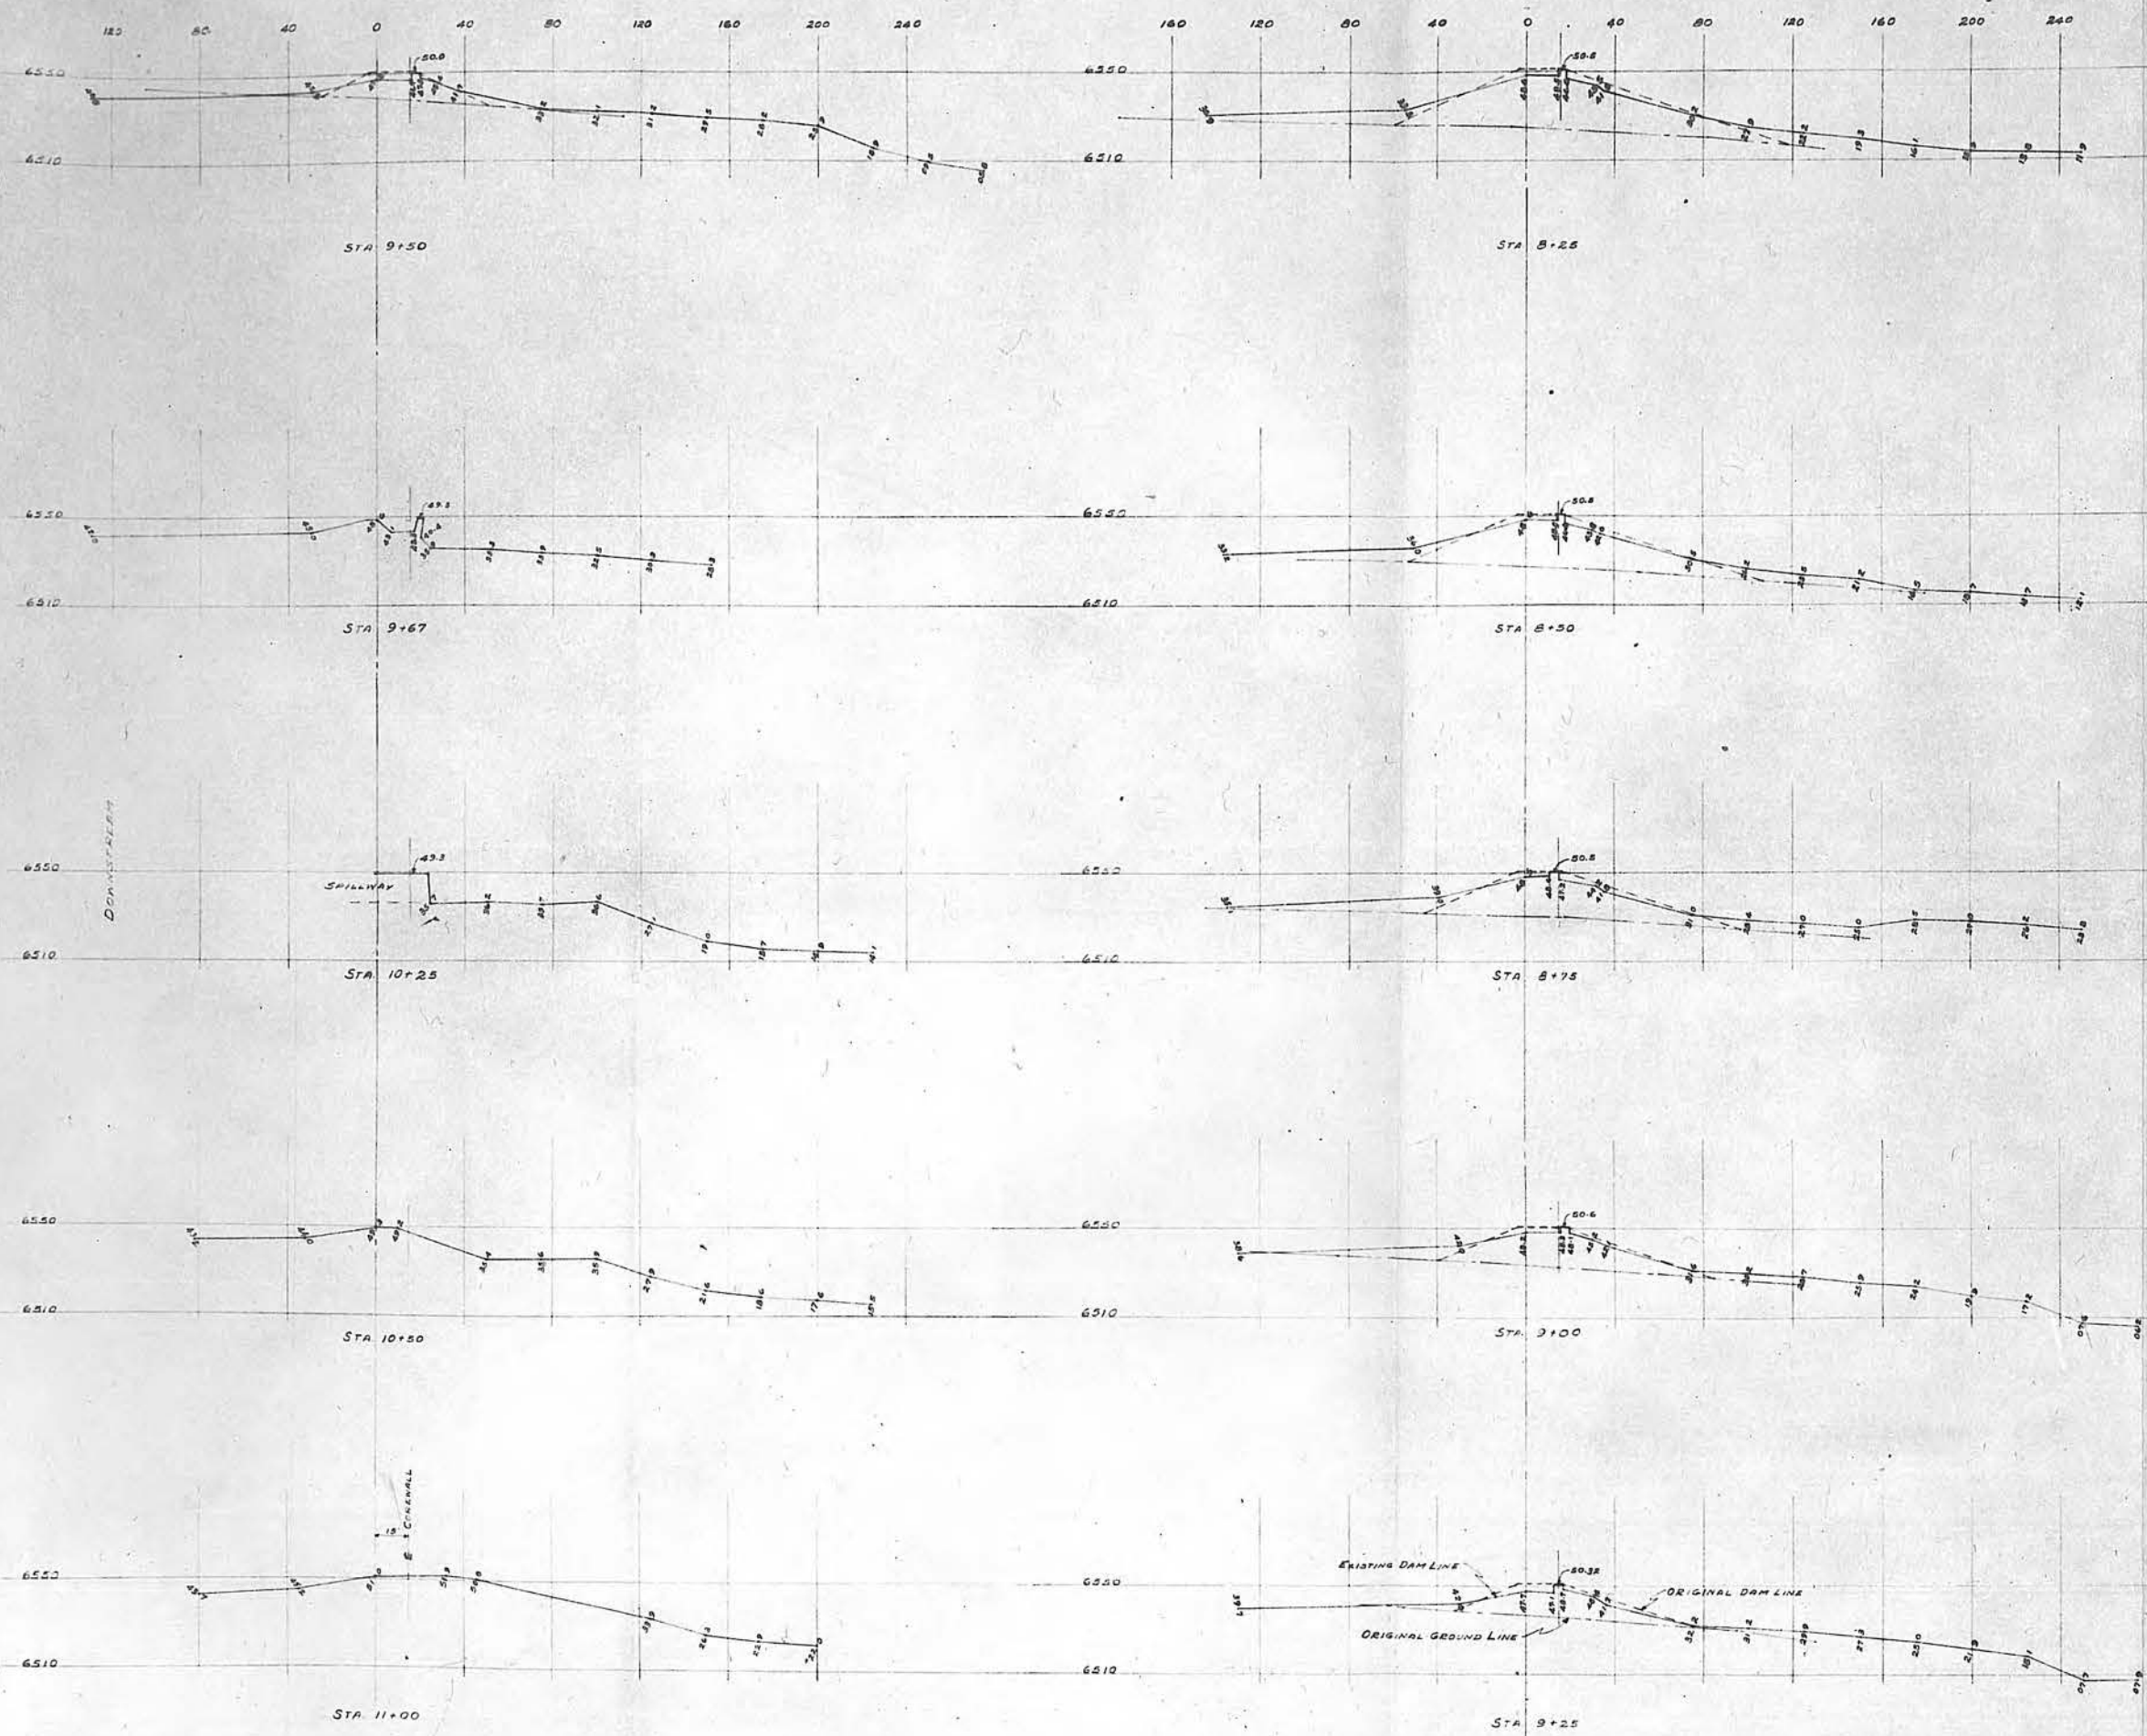
PLATE 6

AFTER AUG. 17, 1959 EARTHQUAKE
