The Norwegian Water Resources and Energy Directorate
nve@nve.no

Investigation of adverse event at Braskereidfoss Dam, Våler Municipality

On 09/08/2023, an adverse event occurred at Braskereidfoss Power Station where the embankment dam failed.

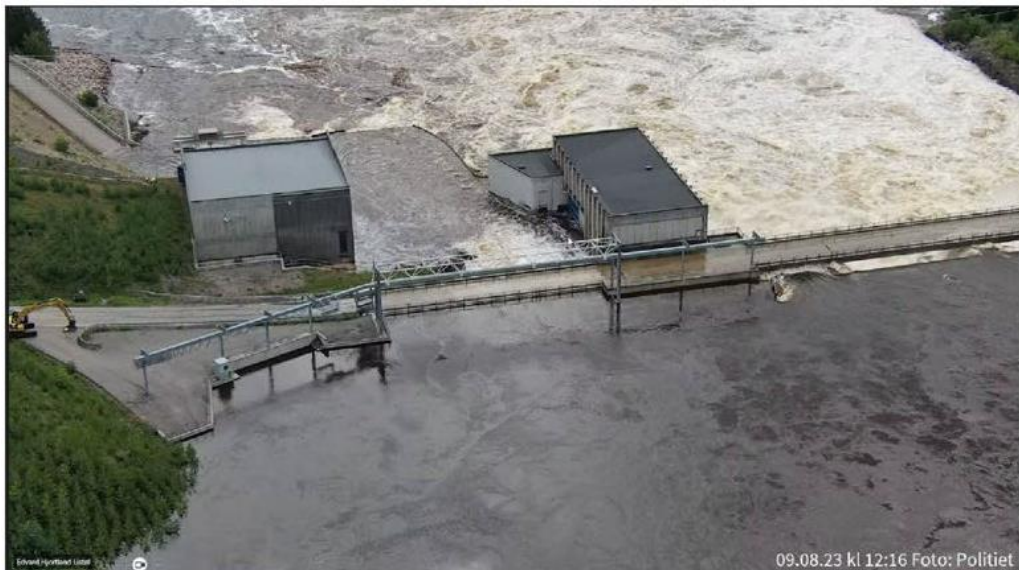
Photo 1: Braskereidfoss Power Station, 09/08/2023 at 12:16. The water is flowing over the floodgates and the buttress dam and into the two power plants (Photo: Police/Source NVE).

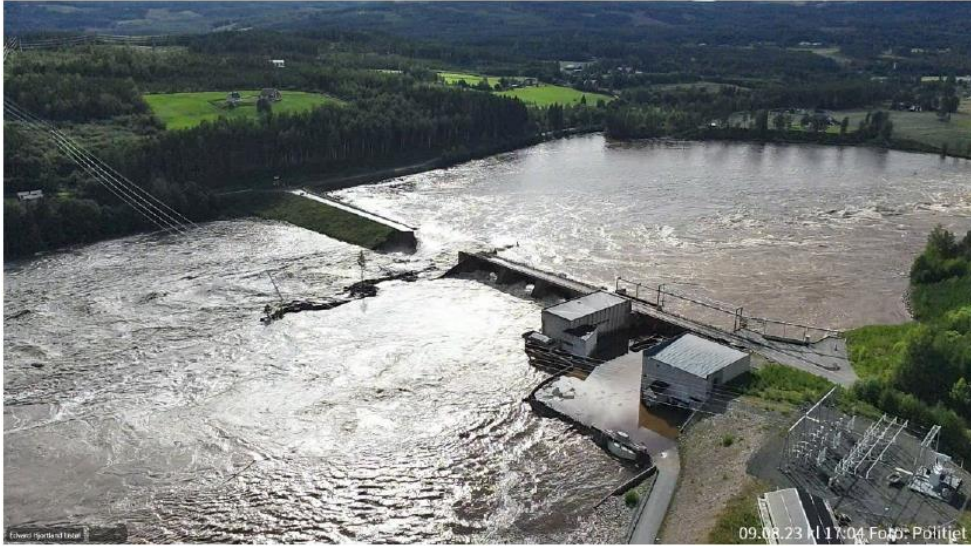
Photo 13: After the failure of the embankment dam at 17:04 (Photo: Police/Source NVE)

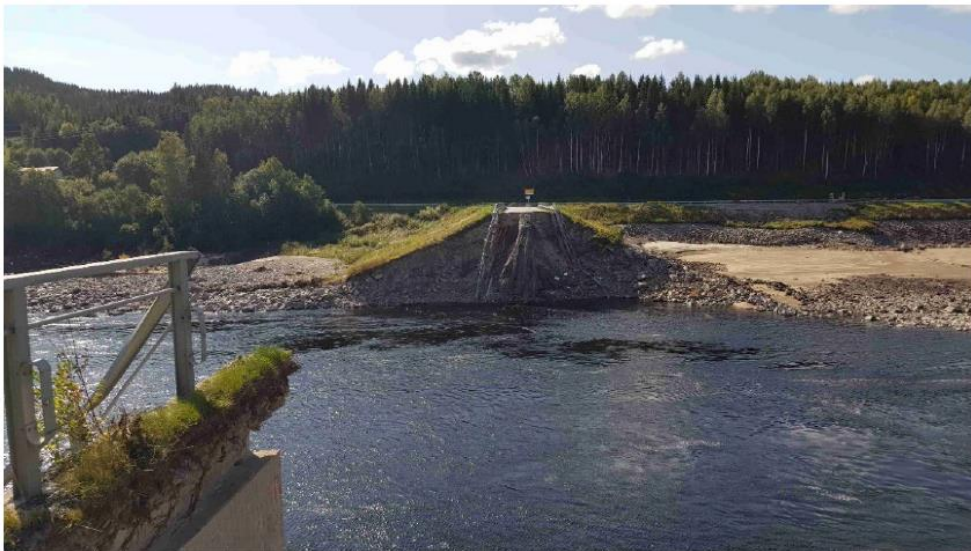
- The reasons why the embankment dam failed were not investigated since this topic is deemed to have been adequately covered already in the reassessment report for Braskereidfoss 2018 /2/. This report concluded that: "The embankment dam does not satisfy the freeboard requirements necessary to prevent overflow. The embankment dam will be vulnerable to heavy erosion from overtopping in the event of a flood disaster. The assessment is that the dam will not withstand overtopping in a disaster situation."

Photo 14: Remains of the embankment dam after dam failure (photo: DNV)

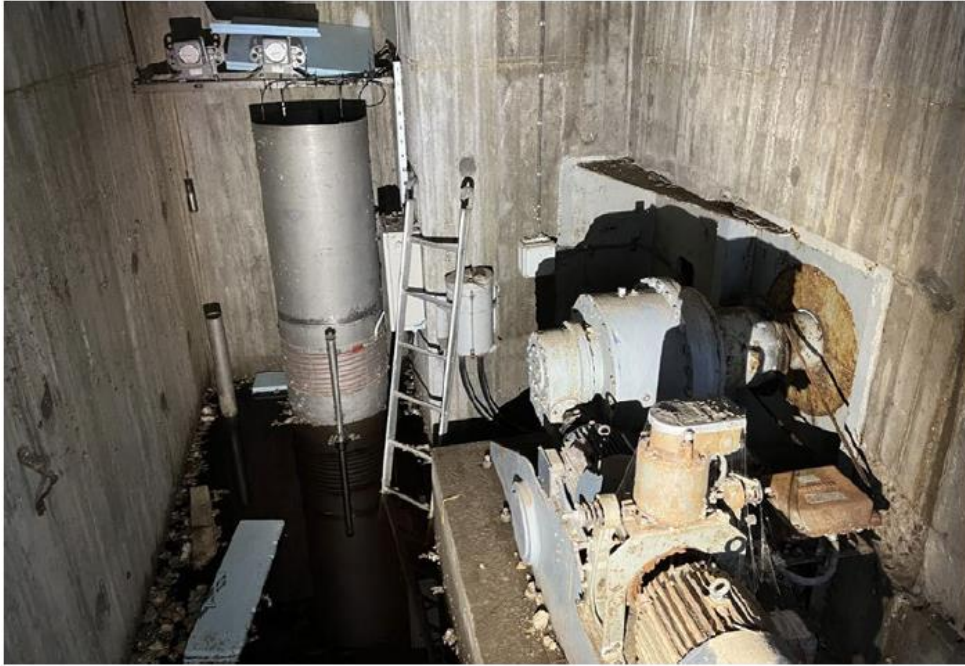
**Photo 15: Gatehouse in pillar, with submerged machinery.
The photo was taken after most of the water had been drained.
Water can still be seen at the bottom of the gatehouse (Photo: DNV)**

- The gate pillars should be made watertight so that water does not flow in and fill the rooms in the event of a major flood.
- Connection using a portable drill attached to the motor shaft should be established instead of hand cranking. At the same time, establish good marking on the chain or position marking to avoid skewed raising and jamming.

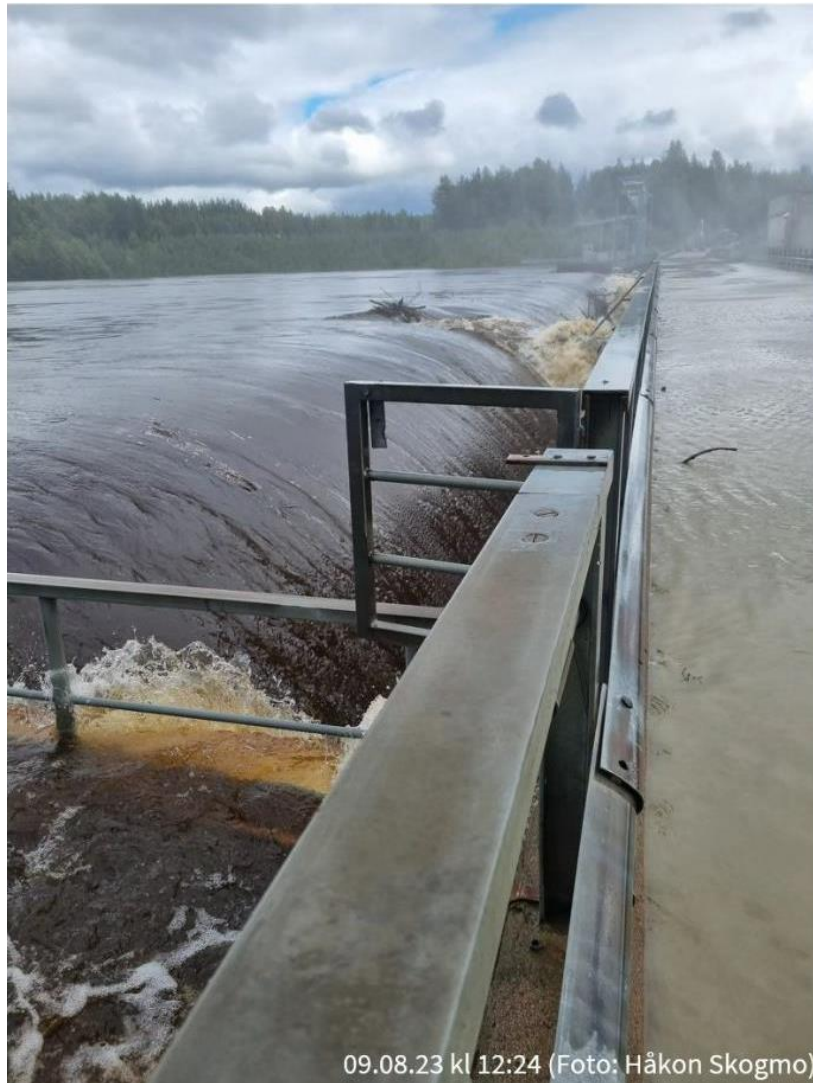
When the plate girders and gate struts are 'filled' with water, this results in a significant additional load on the raising mechanism.

Here the water level is at the height of the roadway/dam crest at approx. contour line 166.5 metres above sea level.

An overtopping of the floodgates as in the August flood will result in significant overloading of the raising mechanisms, especially the chains and gears. A thorough examination of their condition after such overloading is therefore very important.

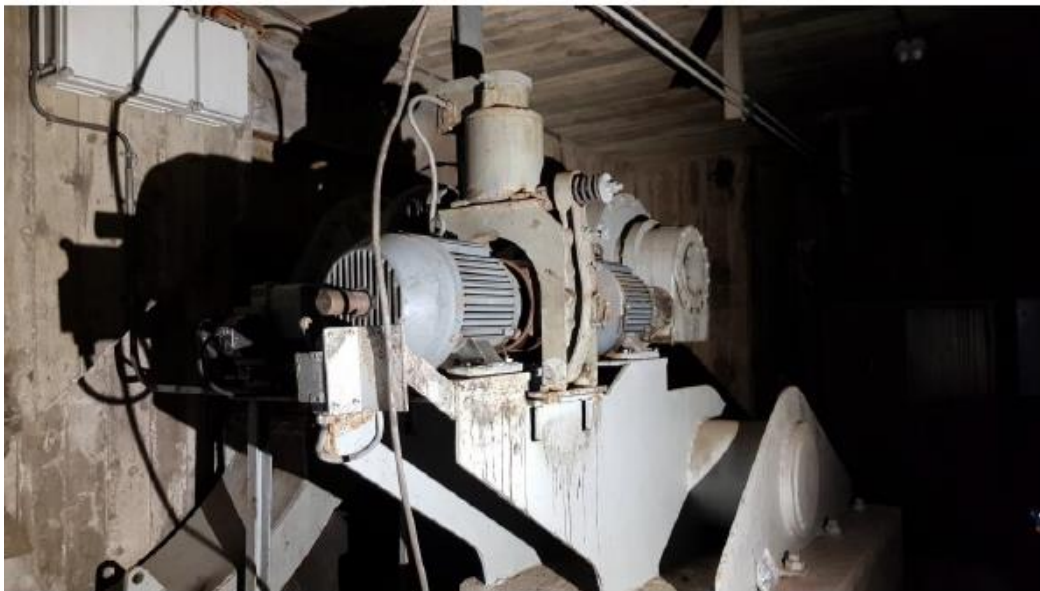
A non-torsion-proof segment gate requires the gate to be raised equally on both sides to avoid deformation and jamming in the guides. The works for the floodgates are therefore equipped with a synchronous motor that ensures that the main motors (asynchronous) are run at equal speed during manoeuvring. Between the motors and chain gears, there is first a worm gear and then a planetary gear that provides exchange from motor to chain. There is a band brake with an actuator between the motors, which is applied when the gate is not moving. As soon as the motors start, the brake is released.

If the gate is stuck in ice or by other blockages, the motors will start and contribute torque until the coupling between the motors breaks. The coupling normally functions as a fracture protection mechanism to prevent the gears or chain being damaged as a result of overloading. If the coupling does not break, the gear teeth can break and the chain be stretched or otherwise damaged.

Chain works – floodgates. Photo: DNV

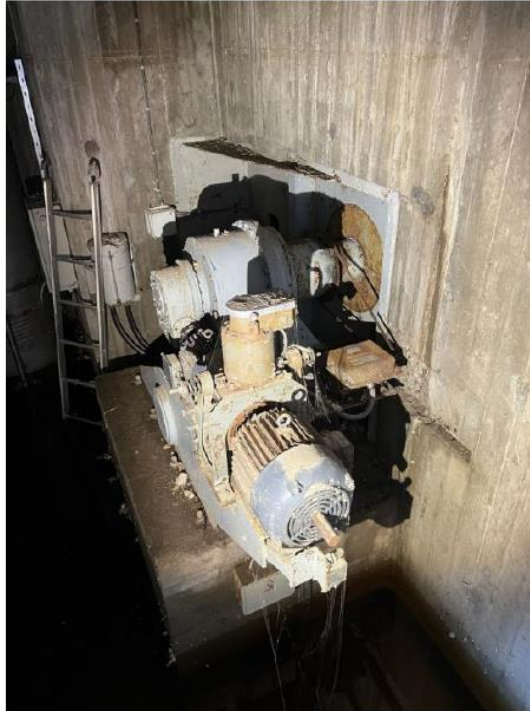
- The raising mechanism has been through the 'wars', experiencing considerable overload!
- The old machinery has worked well, but it may be difficult to obtain spare parts in the years to come.
- The machinery has been submerged, and the motors and actuators may still need to be replaced in order to get the gates operational as soon as possible.

Gate works and motors that have been submerged.
