Subject: Fwd: FW: EST Activation IOR, Space Shuttle Columbia Disaster

This report describes the first phase of a study designed to improve the management and the safety of the black tiles of the Space Shuttle orbiter. This study is based on the coupling of a probabilistic risk assessment (PRA) model and relevant organizational factors. In this first-phase report, a first-order PRA model is developed and used to design a risk-based criticality scale combining the probabilities and the consequences of tile failures. This scale can then be used to set priorities for the maintenance and gradual replacement of the black tiles.

# **Orbiter Assessment of STS-107 ET Bipod Insulation Ramp Impact**

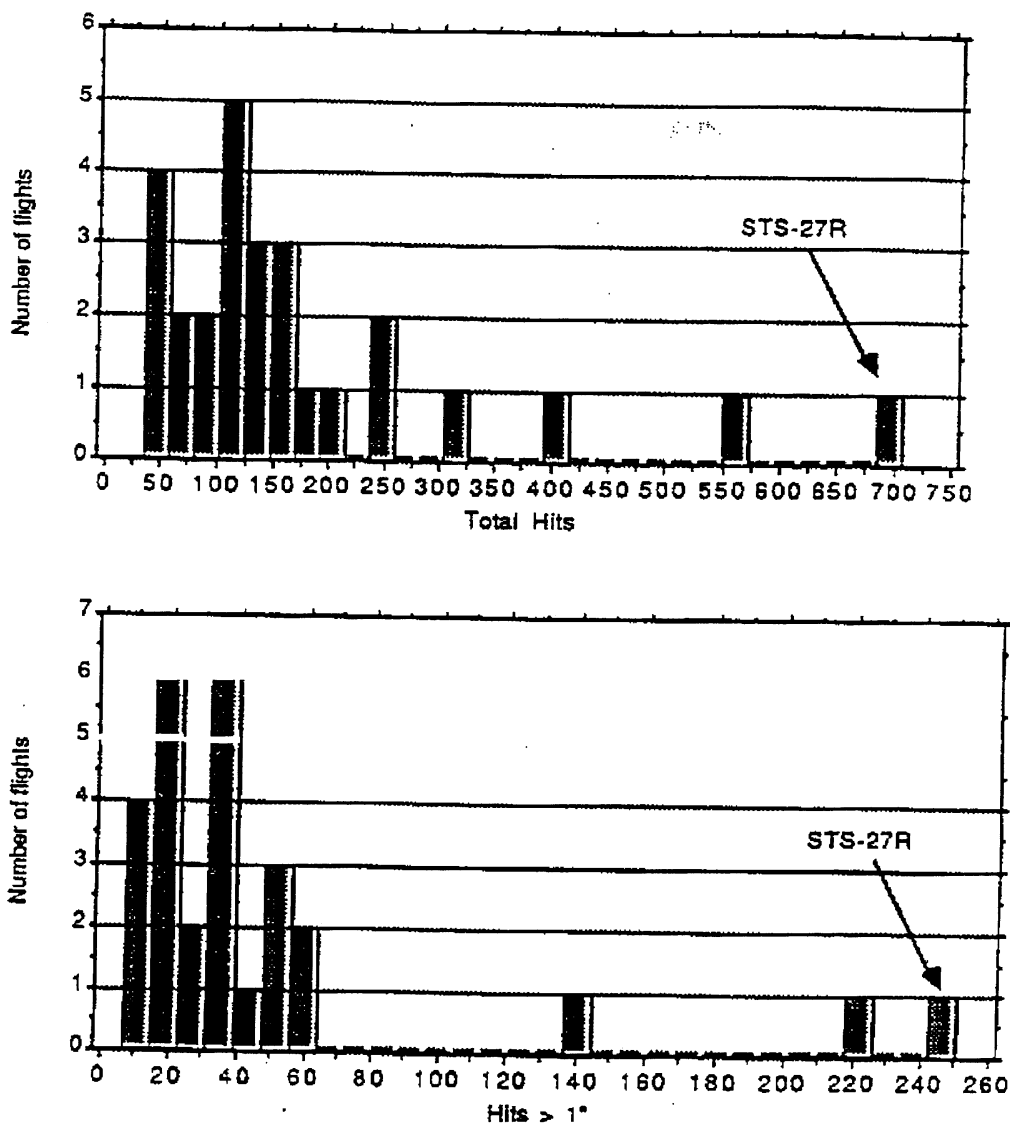
Figure 5: Histogram of tile damage due to debris.

Indicates the number of flights that experienced a specified amount of debris damage (i.e. four flights had 40-60 total hits, two different flights had 60-80 total hits, etc.) based on available data for the first 33 flights (missing: first five missions and STS-51L)

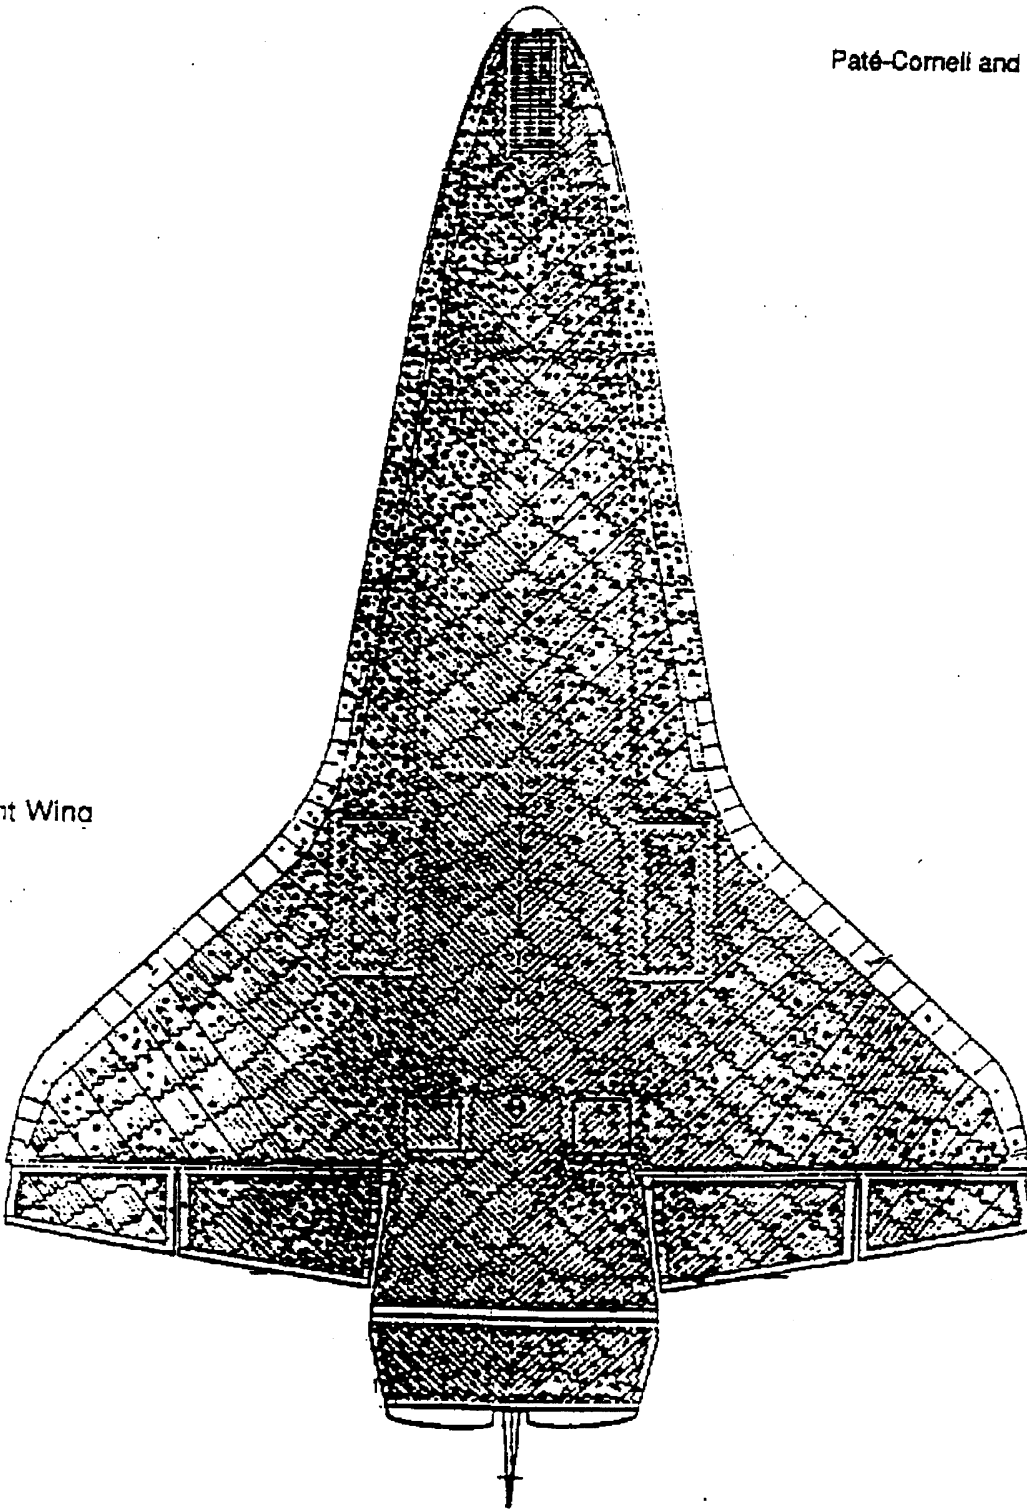
Figure 6: Accumulated major debris hits (lower surface)  
for flights STS-6 through STS-32R

To define the debris zones, we plotted all known debris damage from the first 33 flights on a single shuttle layout (see Figure 6.) These data came from J. W. McClymonds (1989) at Rockwell in Downey. Areas with similar damage intensity were grouped together into high, medium, and low debris damage areas (see Figure 10.) An estimated probability of tile damage due to debris per flight was determined by dividing the number of hits by the number of tiles in each area and by the number of flights. A similar plot and calculation was done for all damage to black tiles over one inch in size. (Historically about one fourth of the damage has been greater than one inch in size.) It should be noted that the only missing tile to date caused by debris is in one of the "high debris damage areas".

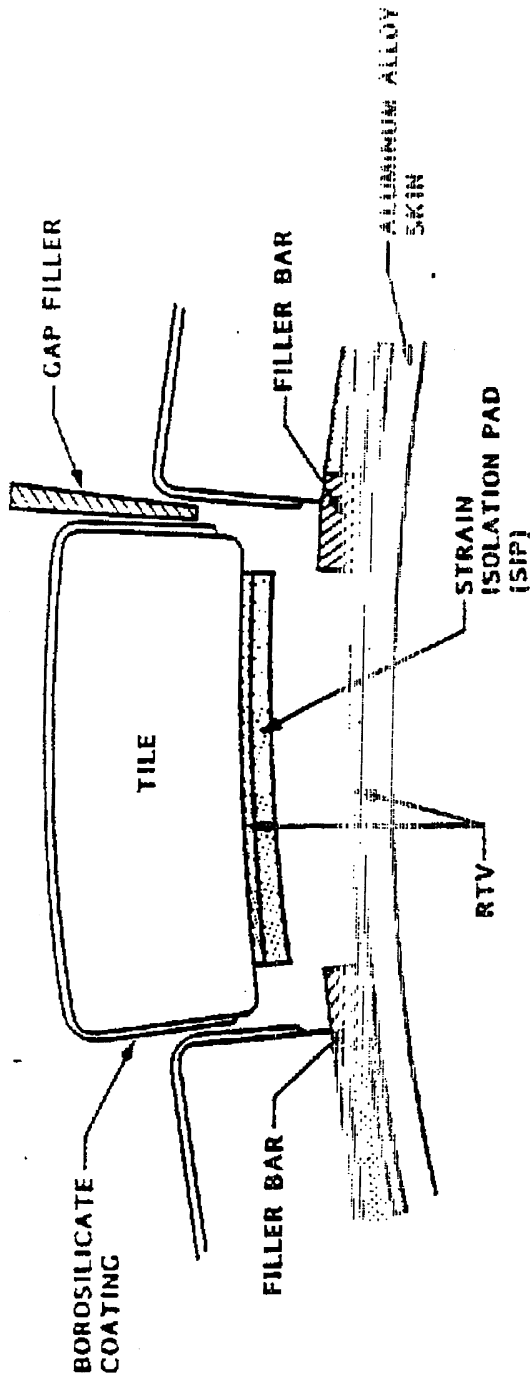
## PROBLEM OVERVIEW

### PROBABLE CAUSE OF BOND PROBLEMS

- POOR ADHESION BETWEEN SIP AND RTV
- POOR ADHESION BETWEEN RTV AND ORBITER SKIN
- PHYSICAL INTERFERENCE IN CAVITY; SIP RESTS ON EDGE OF FILLER BAR

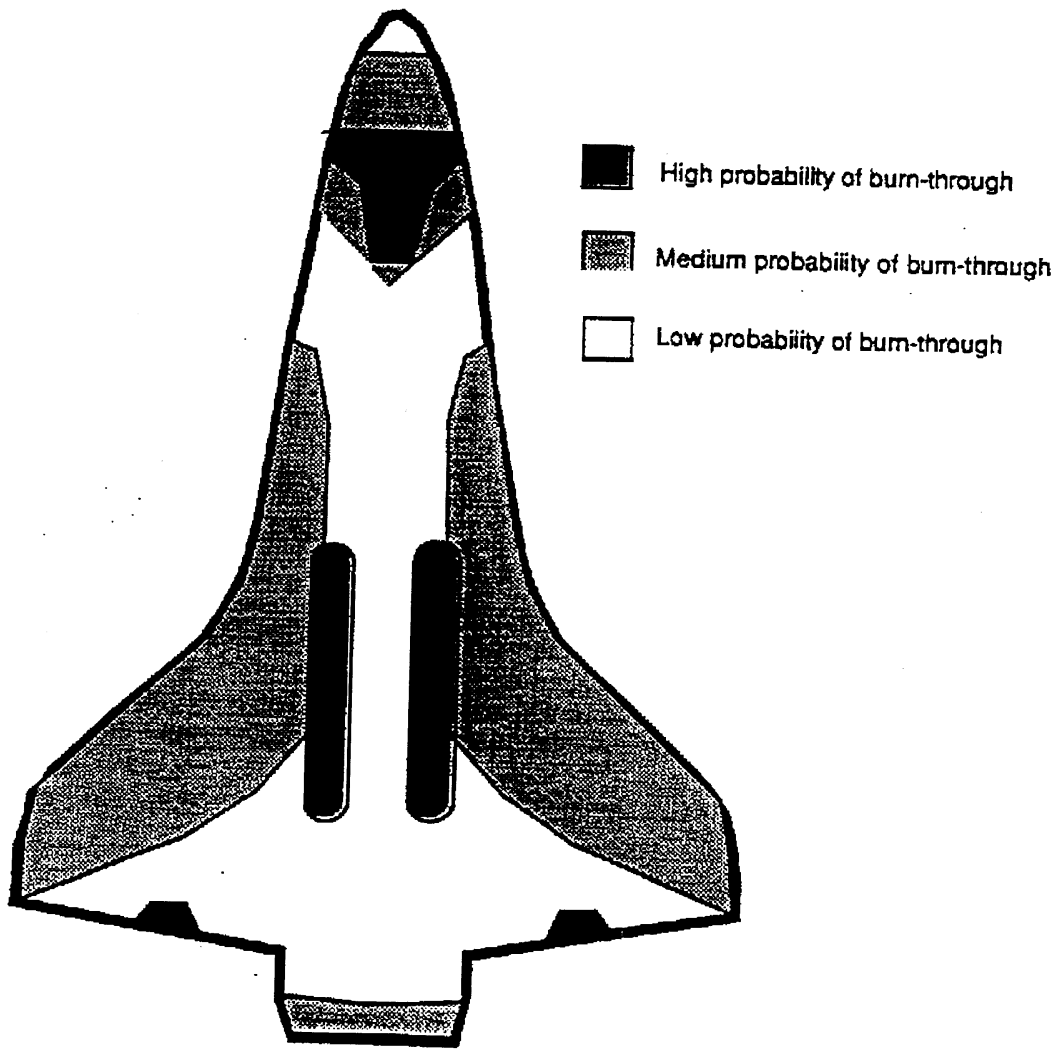
Figure 11: Partition of the orbiter's surface into three types of burn-through zones (index: k)

"...that the two areas just in board of the main landing gear have been noted as being in the high burnthrough area. This is not strictly speaking a burnthrough problem. The structure in those areas is extremely sensitive to temperature differences and would fail even without a burn-through. However, because of their sensitivity to temperature, these two areas were grouped in the high burn-through category."

Note that the two areas just in board of the main landing gear have been notated as being in the high burn-through area. This is not, strictly speaking, a burn-through problem. The structure in those areas is extremely sensitive to temperature differences and would fail even without a burn-through. However, because of their sensitivity to temperature, these two areas were grouped in the high burn-through category.

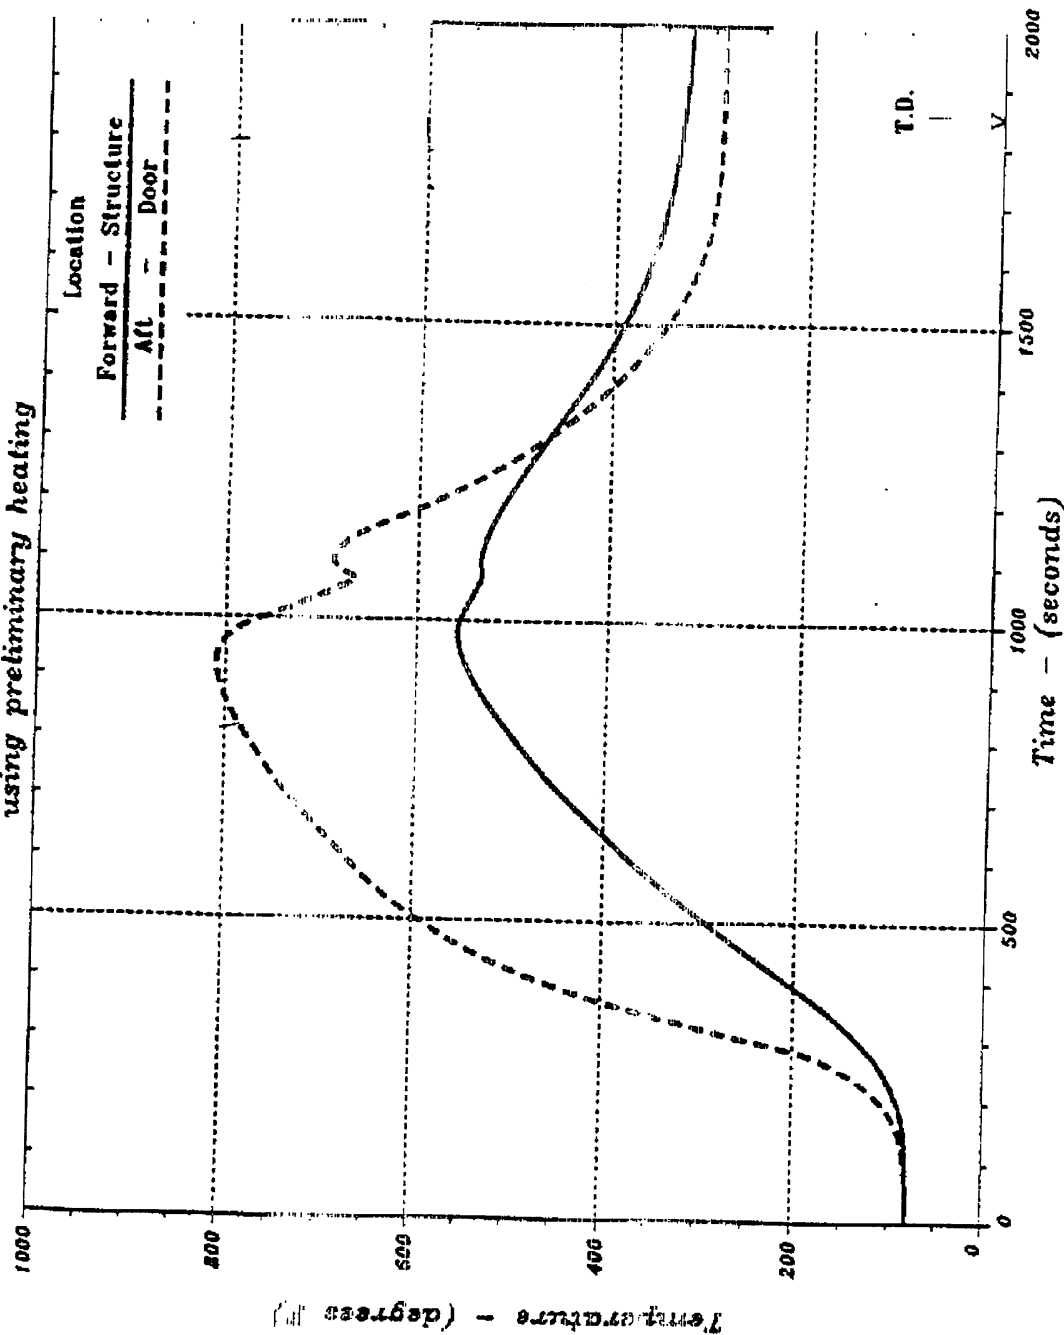
Figure 22: Re-entry thermal analysis of lost tile cavity

STS-27 Re-Entry Thermal Analysis of the  
Lost Tile Cavity on the Orbiter Starboard Chine  
Aluminum Structure Temperature Transients  
using preliminary heating

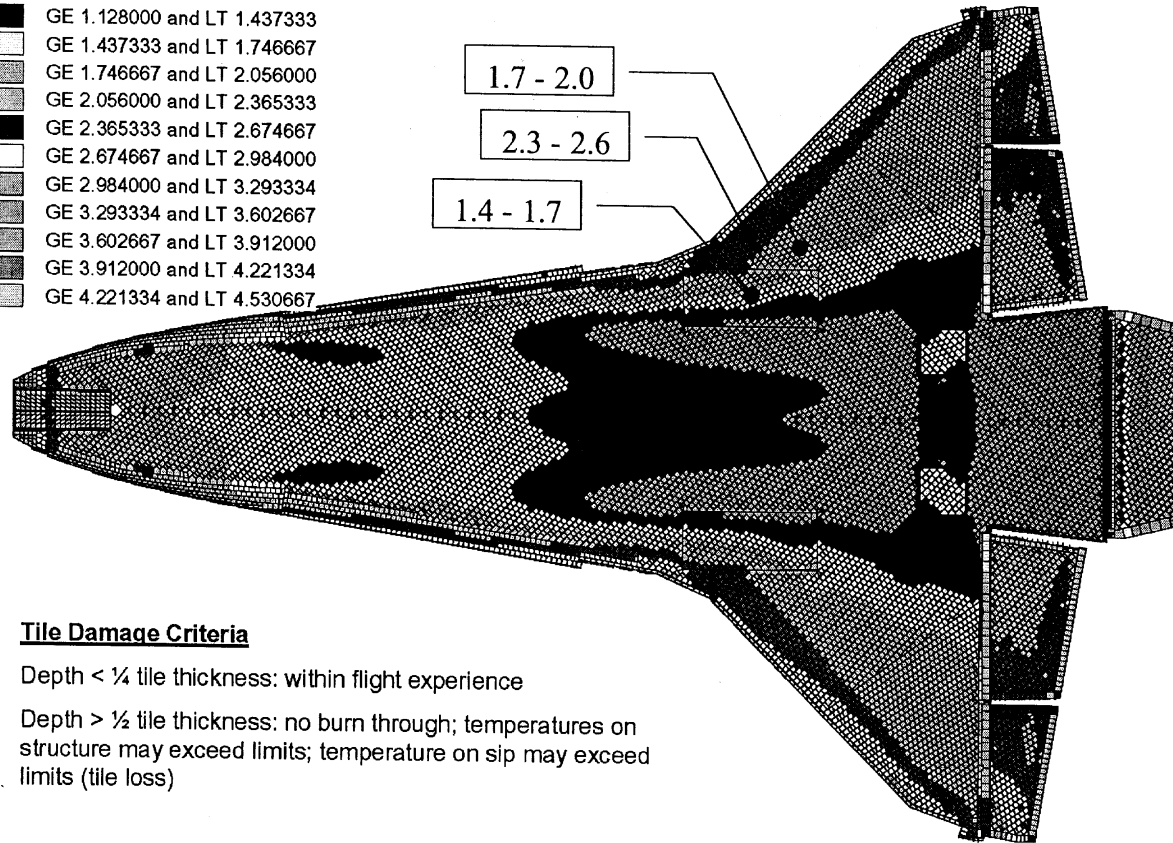
## Tile Damage Criteria

Depth < ¼ tile thickness: within flight experience

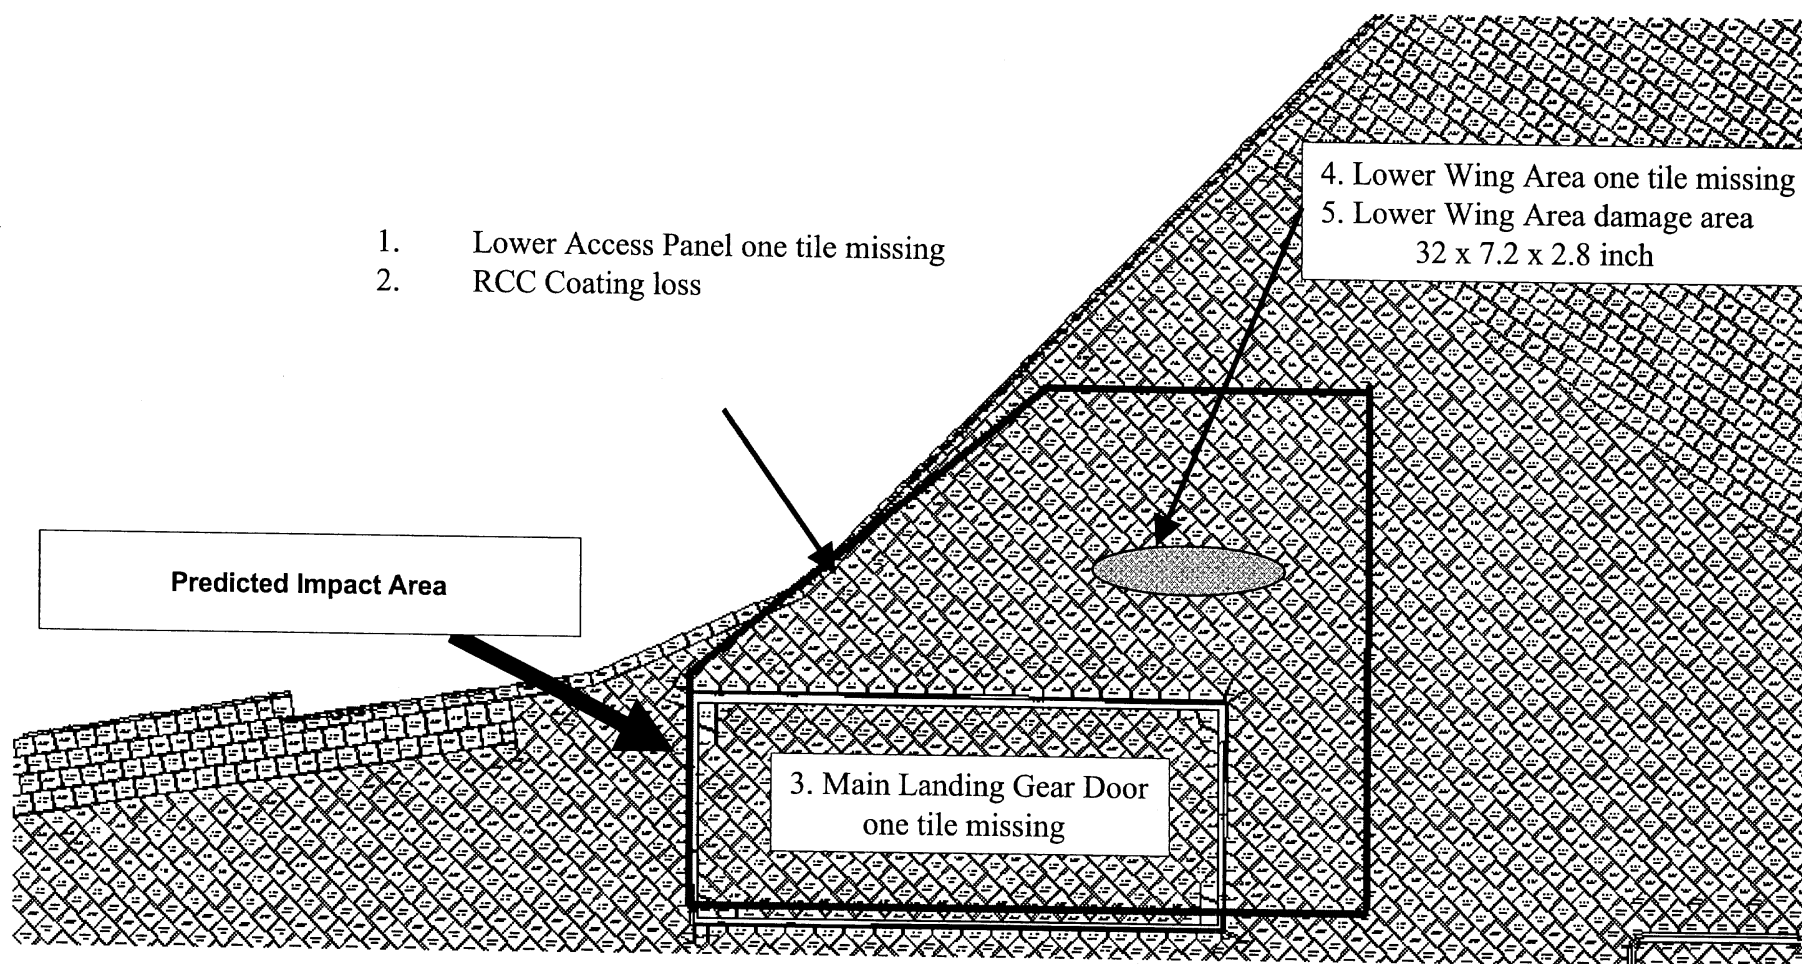
# Impacted Lower Surface Location Thermal Predictions

Case	Location	Assumptions	Results
1	Access Panel (one tile missing)	Loss to last layer of TMM Densified layer ~ .2 inches	Temperature of Al Tube Carrier 790 °F No issue
2	RCC Panel 9 Lower Flange OML (Coating Missing)	Coating loss and Carbon substrate exposed	Substrate thickness: 0.193 inches Loss .09 inches No issue
3	Main Landing Gear Door ( one tile missing)	Loss to last 2 layers of TMM Densified layer ~ .4 inches	Temperature of Structure 540 °F No issue
4	Lower Wing Area (one tile missing)	Loss to last 2 layers of TMM Densified layer ~ .4 inches	Temperature below 350 °F design req. No issue
5	Lower Wing Area (32 x 7.2 x 2.8 inch) Damage	Loss to last layers of TMM Densified layer ~ .2 inches	
6	Main Landing Gear Door ( several tiles Lost)	Loss to last layers of TMM Densified layer ~ .2 inches
