COLUMBIA

ACCIDENT INVESTIGATION BOARD

REPORT VOLUME I
AUGUST 2003

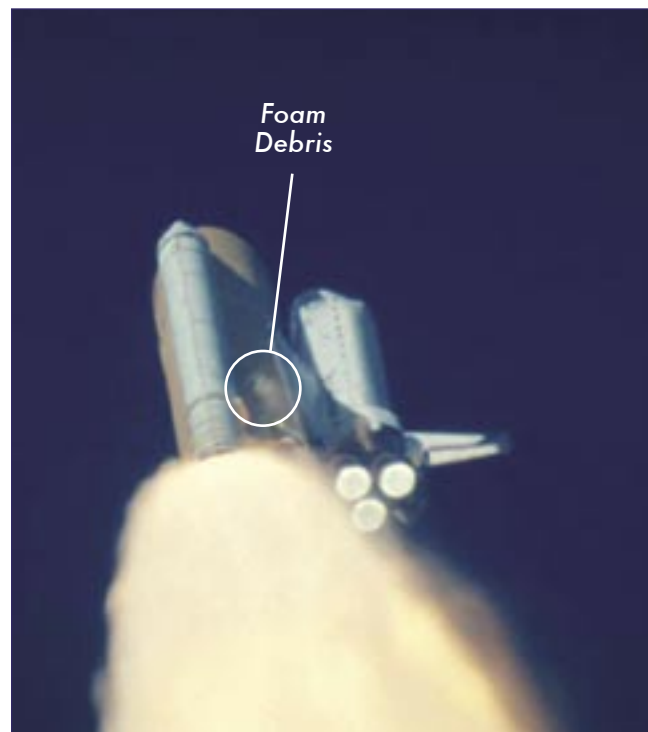
Figure 2.3-2. A shower of foam debris after the impact on *Columbia's* left wing. The event was not observed in real time.

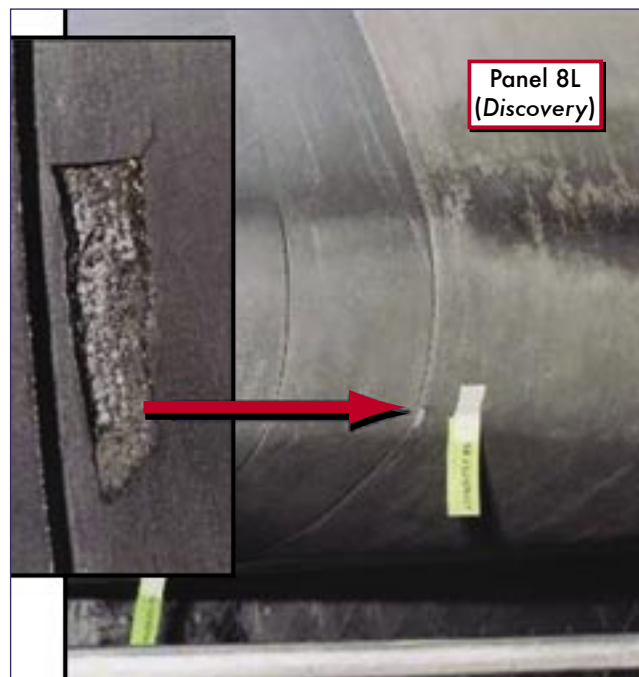
Figure 3.3-5. RCC panel 8-left from *Discovery* had to be scrapped after STS-103 because of the damage shown here.

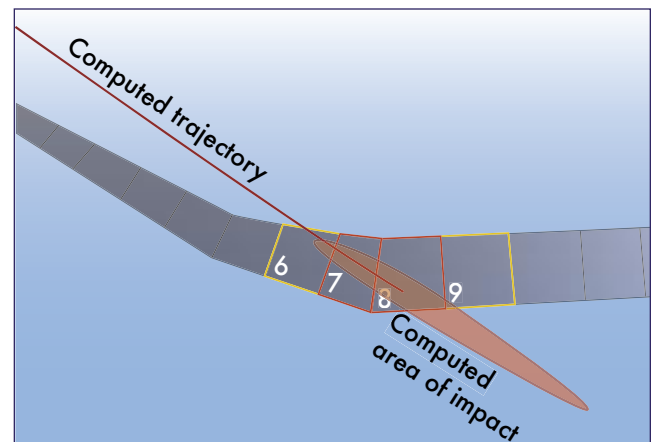
Figure 3.4-3: The best estimate of the site of impact by the center of the foam.

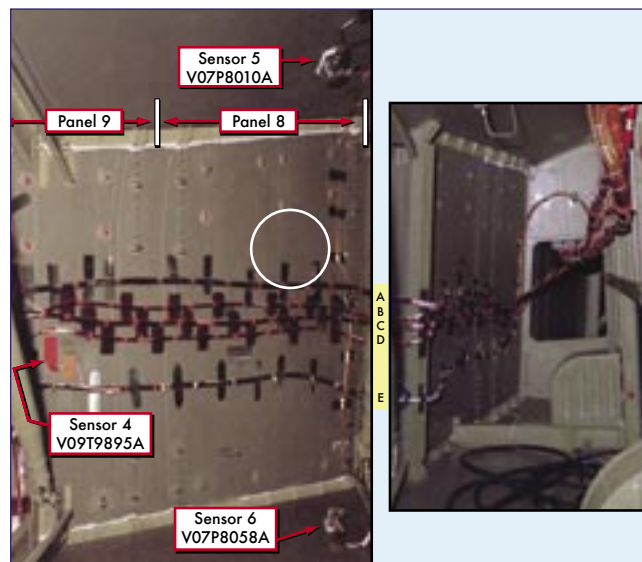
Figure 3.6-8. The left photo above shows the wiring runs on the backside of the wing leading edge behind RCC panel 8 – the circle marks the most likely area where the burn through of the wing leading edge spar initially occurred at EI+487 seconds. The right photo shows the wire bundles as they continue forward behind RCC panels 7 and 6. The major cable bundles in the upper right of the right photo carried the majority of the sensor data inside the wing. As these bundles were burned, controllers on the ground began seeing off-nominal sensor indications.

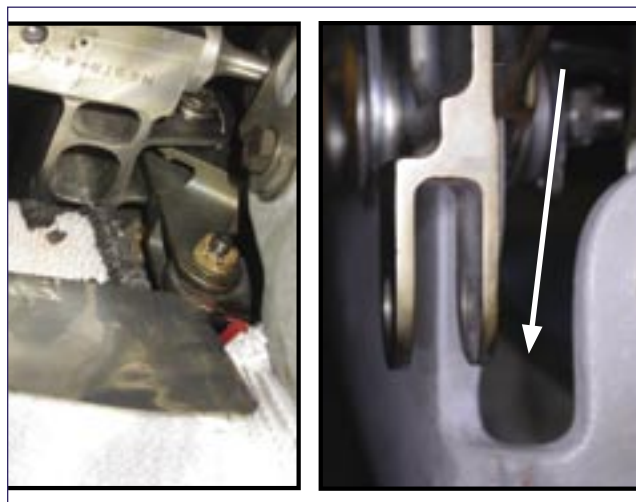
Figure 3.7-2. Each RCC panel has a U-shaped slot (see arrow) in the back of the panel. Once superheated air entered the breach in RCC panel 8, some of that superheated air went through this slot and caused substantial damage to the Thermal Protection System tiles behind this area.

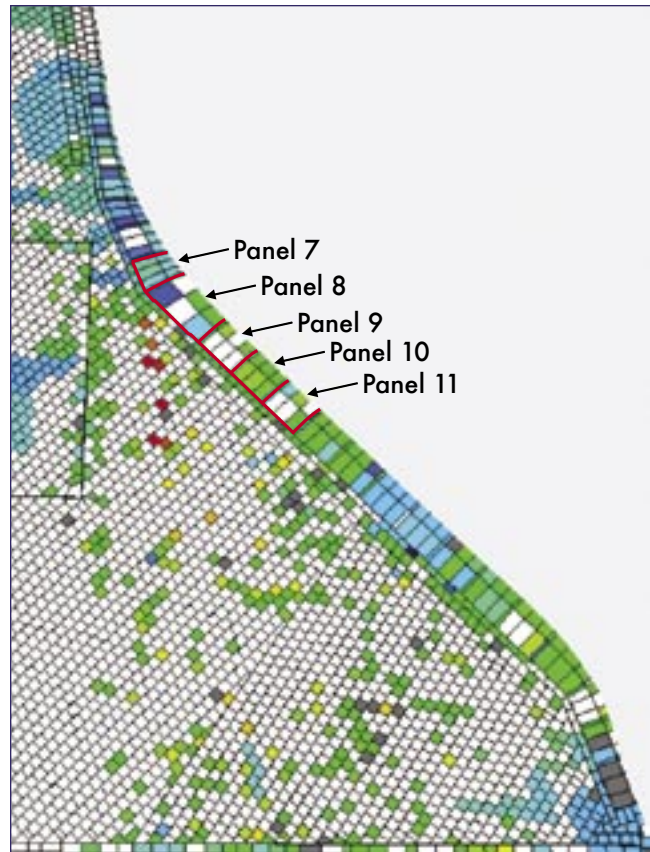
Figure 3.7-6. The tiles recovered farthest west all came from the area immediately behind left wing RCC panels 8 and 9. In the figure, each small box represents an individual tile on the lower surface of the left wing. The more red an individual tile appears, the farther west it was found.

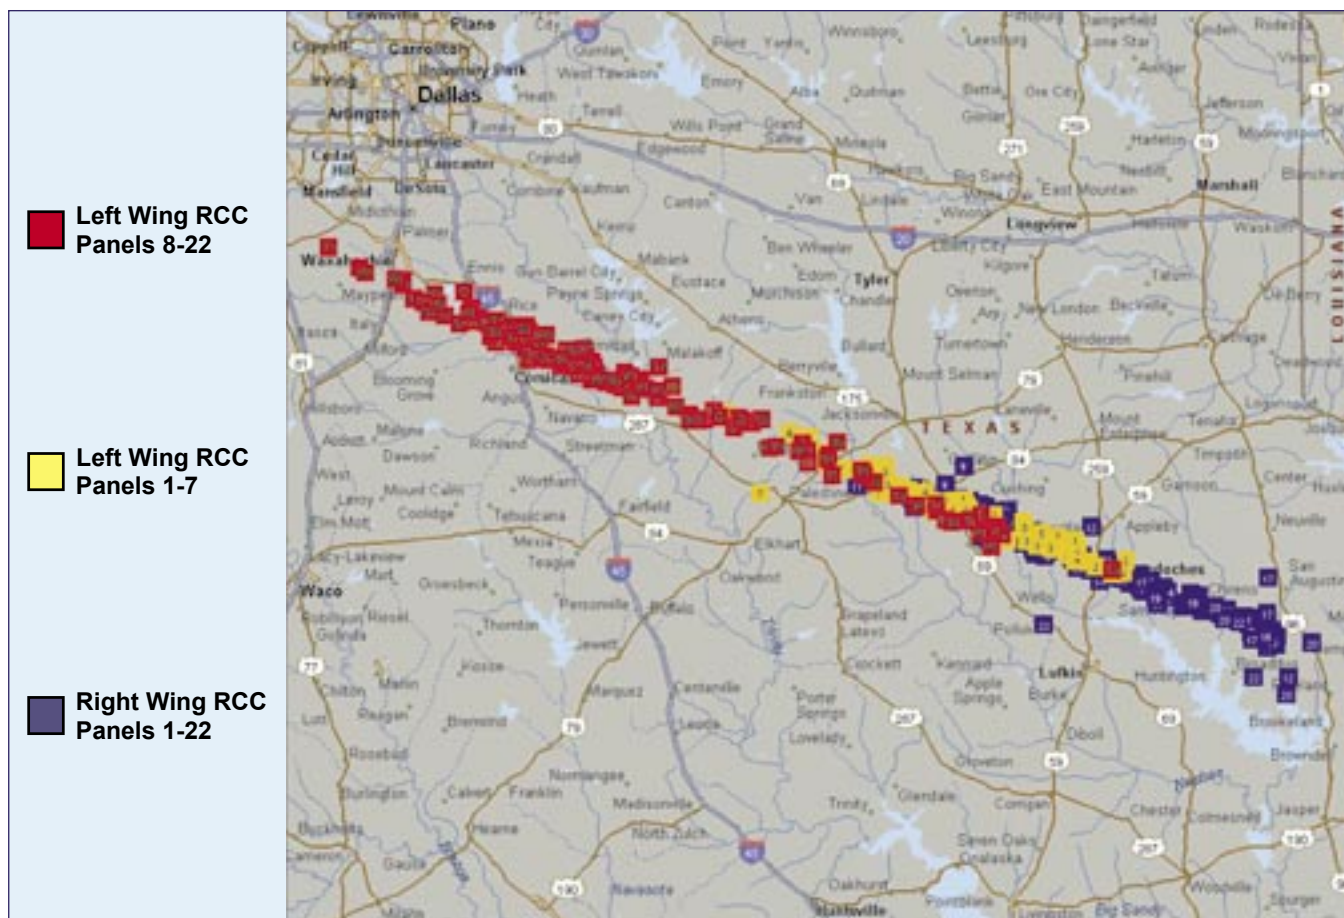
Figure 3.7-5. The location of RCC panel debris from the left and right wings, shown where it was recovered from in East Texas. The debris pattern suggested that the left wing failed before the right wing, most likely near left RCC panels 8 and 9.

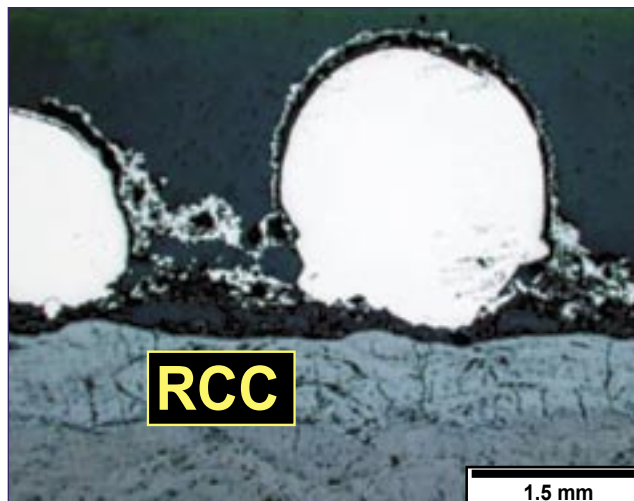
Figure 3.7-8. Spheroids of Inconel 718 and Cerachrome were deposited directly on the surface of RCC panel 8-left. This slag deposit pattern was not seen on any other RCC panels.

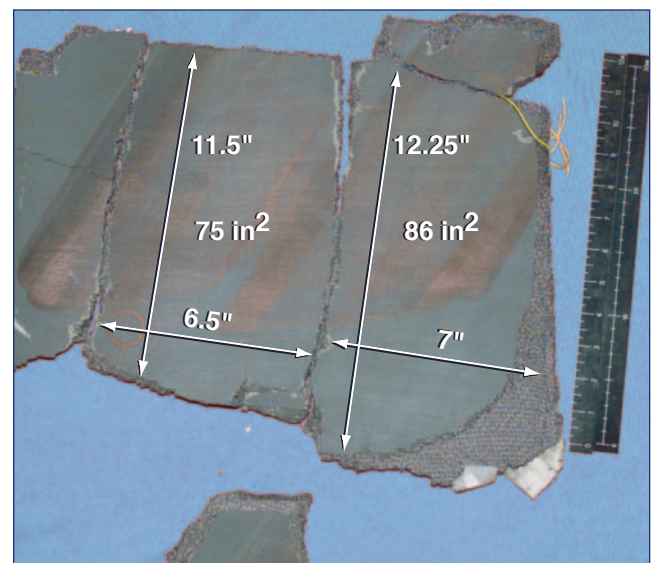
Figure 3.8-11. Three large pieces of debris from the panel face sheet were lodged within the hollow area behind the RCC panel.

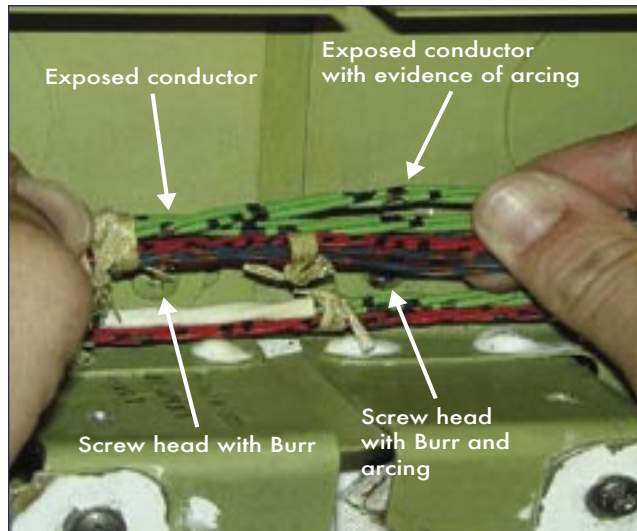
Figure 4.2-2. Arc tracking damage in Kapton wiring.

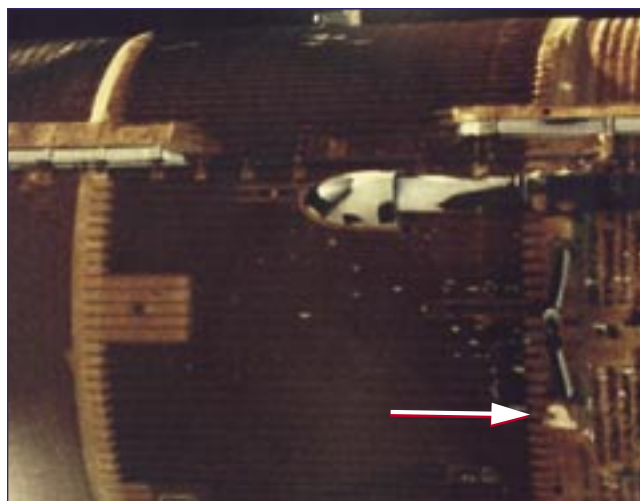
Figure 6.1-2. The first known instance of bipod ramp shedding occurred on STS-7 which was launched on June 18, 1983.

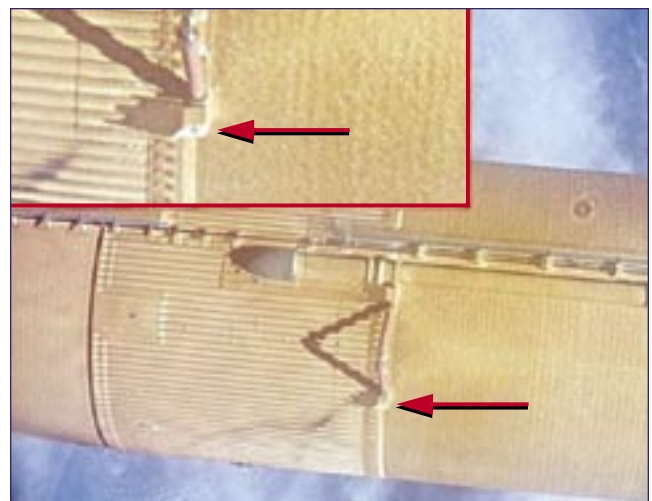
Figure 6.1-3. Only three months before the final launch of Columbia, the bipod ramp foam had come off during STS-112.
