**UNITED STATES ENVIRONMENTAL PROTECTION AGENCY
REGION 9
75 HAWTHORNE STREET
SAN FRANCISCO, CALIFORNIA 94105**

DATE: January 30, 2024

SUBJECT: CLEAN AIR ACT INSPECTION REPORT
Waste Connections Chiquita Canyon Landfill, Castaic, CA

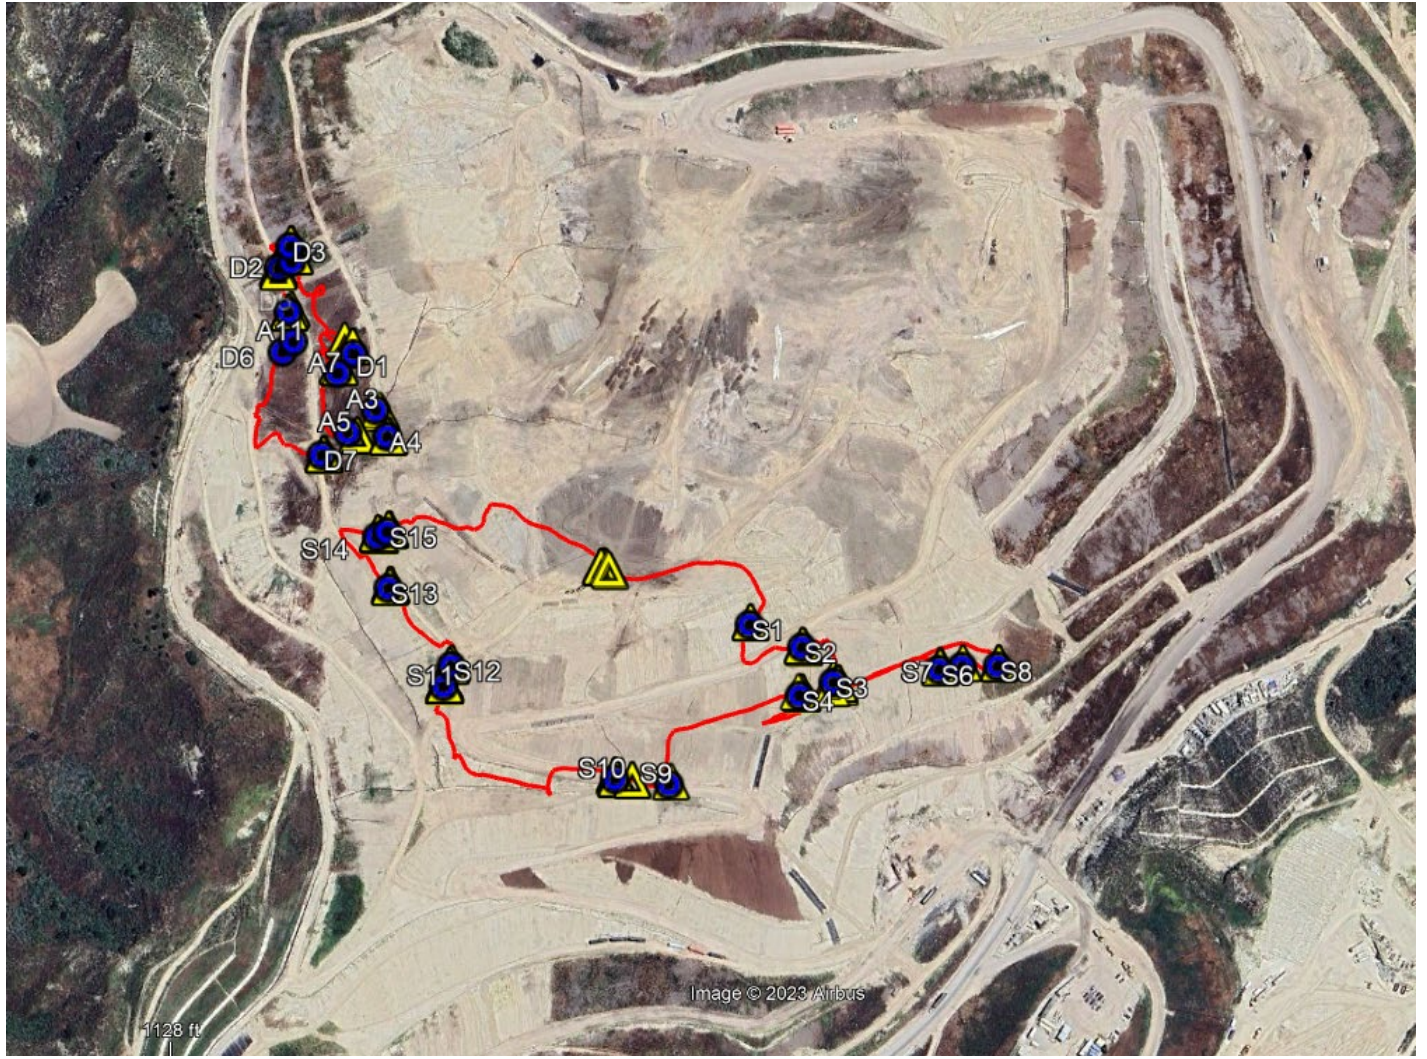
On Day 2, EPA conducted surface emissions monitoring at 30 wells and detected concentrations above 500 ppm at 13 wells. On Day 3, EPA conducted surface emissions monitoring on the west side of the landfill and on the south side of the top of the landfill and detected concentrations above 500 ppm at 50 unique locations.

FIGURE 1: IRWIN 438: SURFACE EMISSIONS MONITORING PATH WITH MONITORED EXCEEDANCES AND IDENTIFIERS, 1/9/24

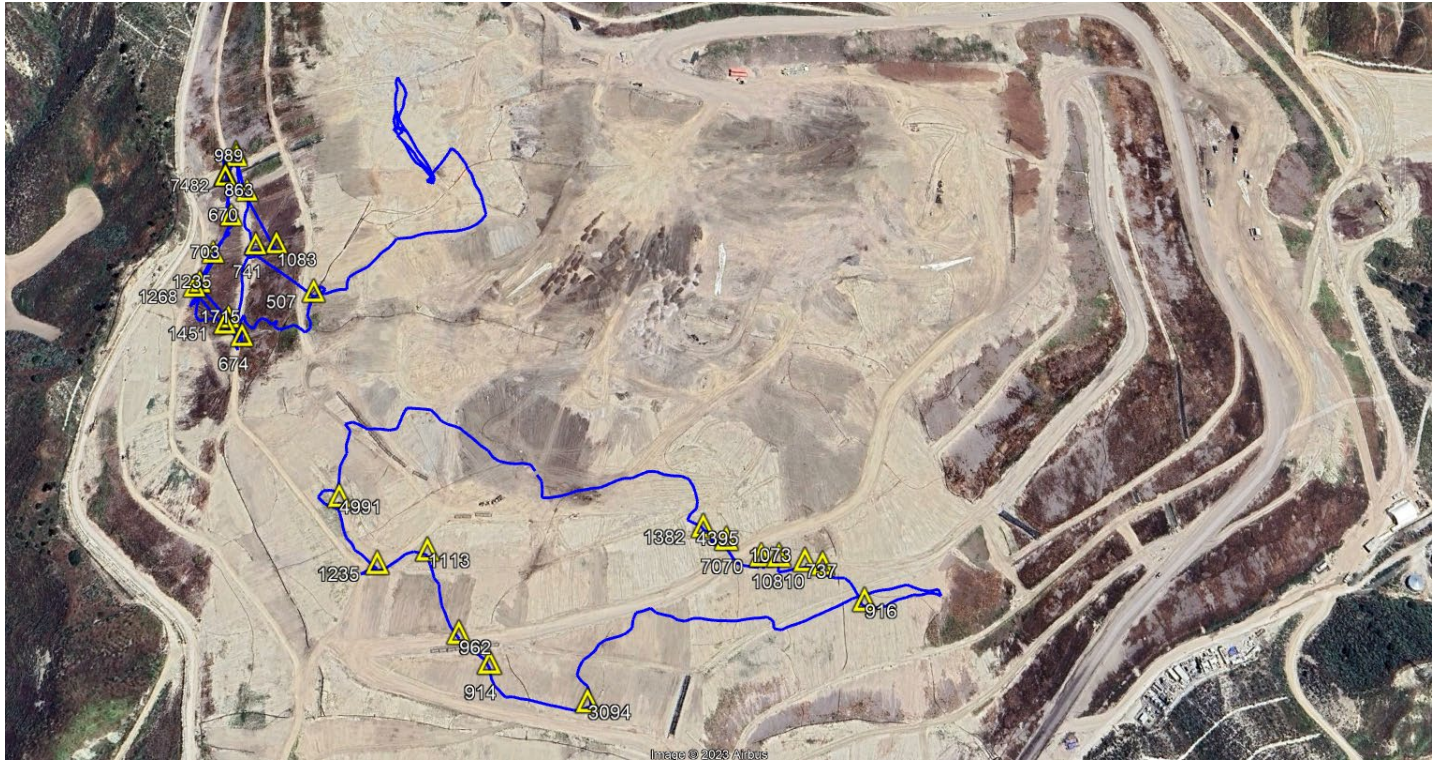
FIGURE 2: IRWIN 439: SURFACE EMISSIONS MONITORING PATH WITH MONITORED EXCEEDANCE CONCENTRATIONS, 1/9/24
