Report of a Level 3 (formal) Investigation

Network Rail

Margam East Junction, South Wales: Death of two track workers who were struck by a
Swansea to London Paddington train: 3 July 2019

SMIS2317549

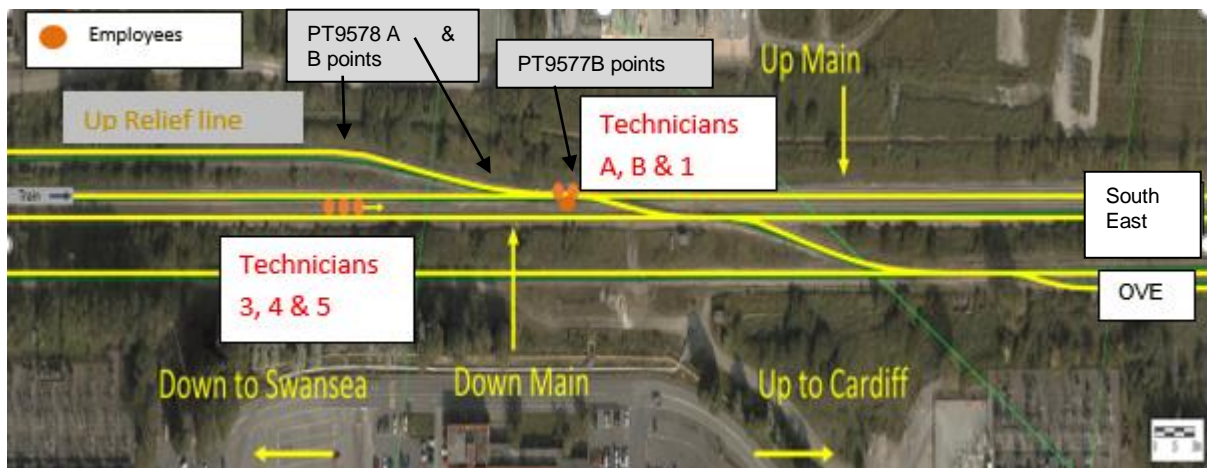
Fig. 2

- D3.1. Facing east and looking from Up Main line towards PT9577B points, towards Pyle, Bridgend, Cardiff and London the line to the immediate left of the Up Main line is the up-Relief line. To the immediate right is the Down Main line and beyond this line, separated by shrubs and trees, is the Ogmore Vale line (OVE).

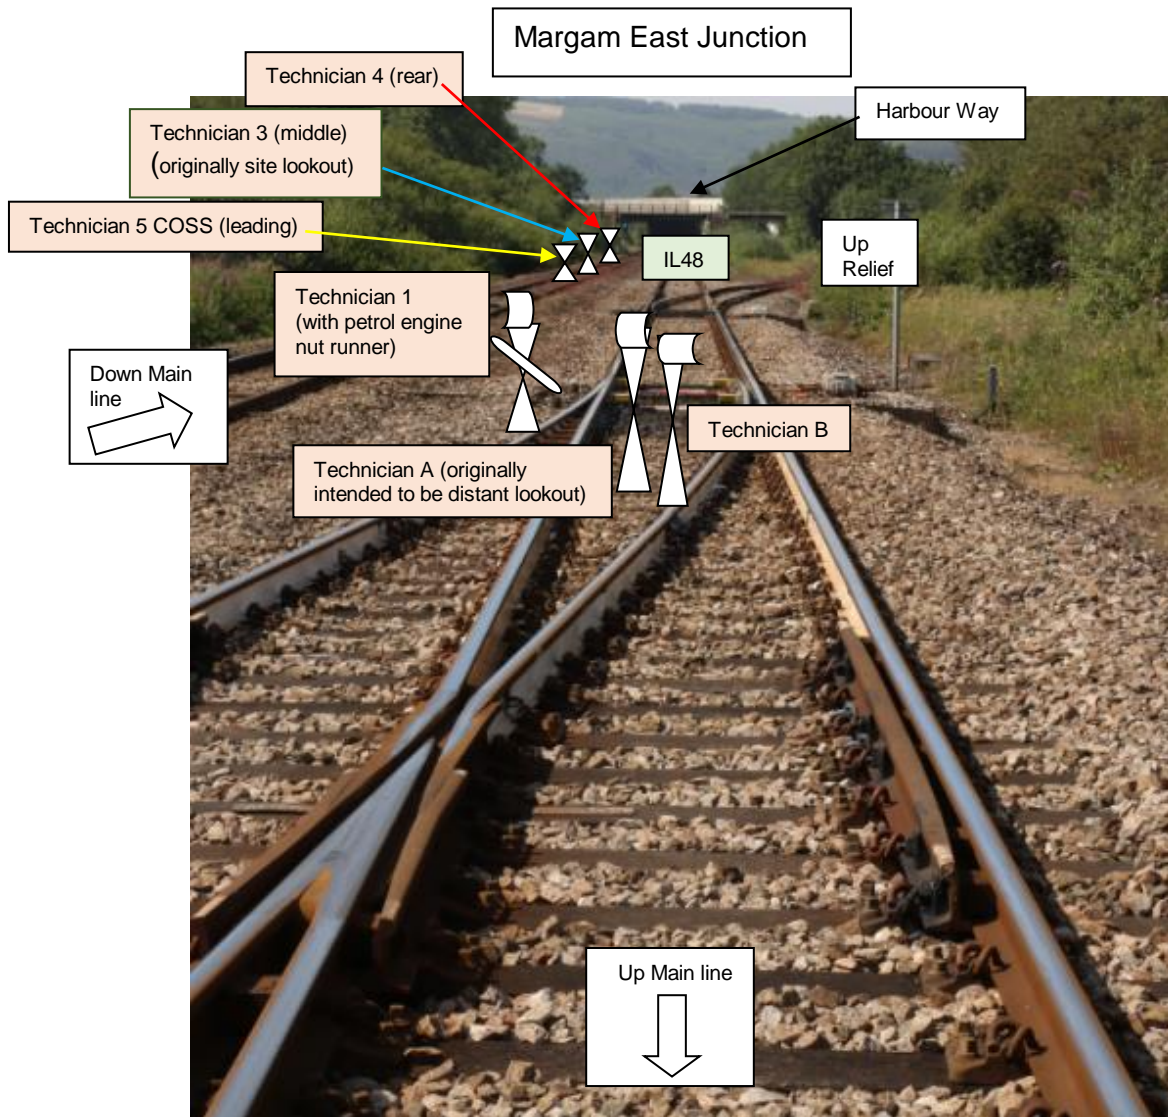
E1.8. Thereafter, the COSS and two others, one of which was identified as a Lookout in the SWP, walked away from the other three team members to undertake work on Insulated Rail Joints (IRJs). They walked towards the Up Relief line where they inspected two IRJs and then onto the Down⁹ Main line where they worked on two IRJs. They subsequently walked in the four-foot of the Down Main line back towards the first group of staff located some 150 – 170 yards away on the adjacent Up Main line. The latter group were involved in work to free, lubricate and re-tighten crossing bolts on PT9577B points. There was no safe system of work in place for those working on PT9577B points.

Fig.3 A simple representation of the site immediately prior to the accident - Technicians A, B and 1 were all wearing ear defenders

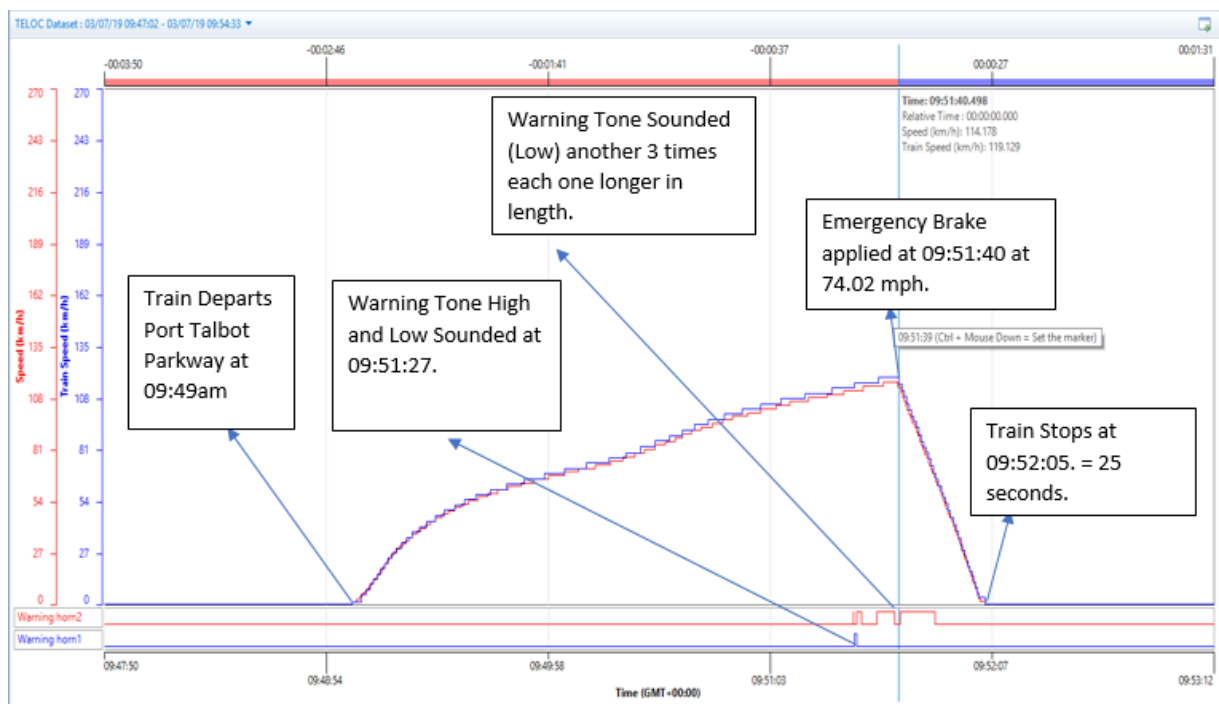
Fig. 5

F26.3. The driver noted that there were staff on or near the line and the 1st warning of the train's approach was given using the low to high tone when the train was travelling at a speed of 70.626 mph. The speed of the train increased slightly to 72.324 mph. Nonetheless the 1st warning was given at circa 201 m 14 ch, some 1386 yards (63 ch) from point of impact.

F26.4. The train travelled 460 yards (20.937 ch) from the initial operation of the warning horn to the application of the emergency brake 13 seconds later.

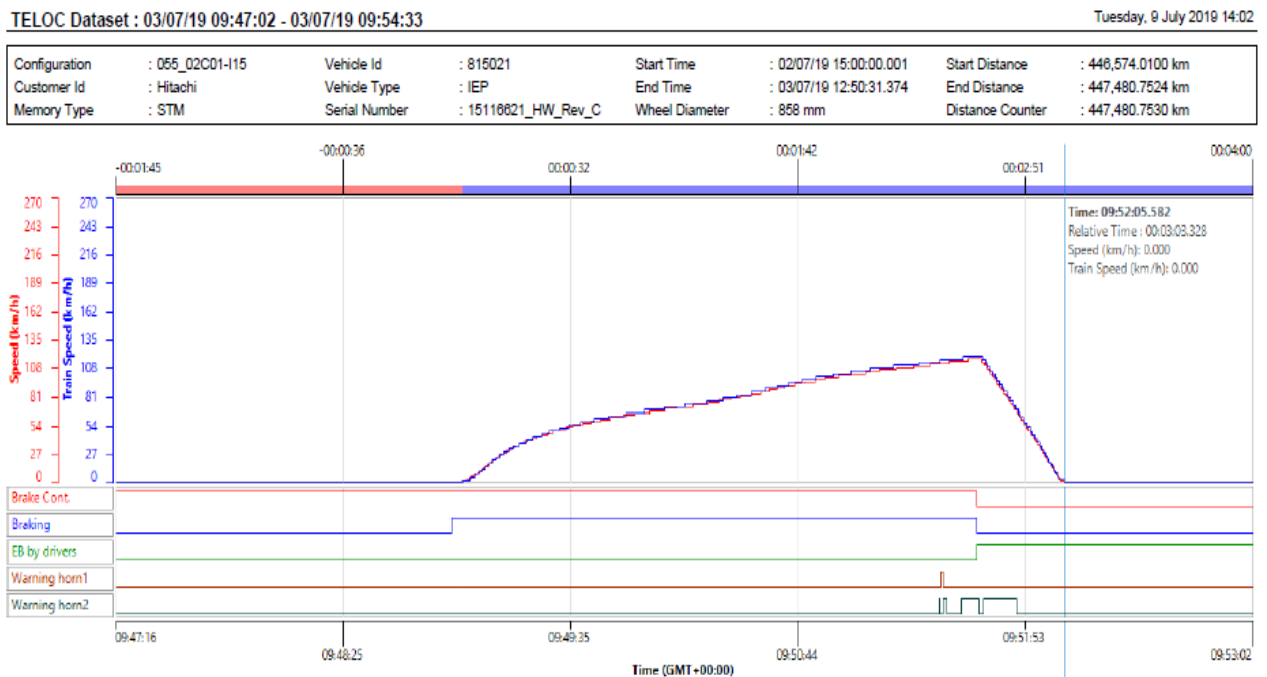
Fig. 6

- F26.5. A second warning was given for a period of five seconds using the low tone between 09:51:34 and 09:51:39 while the train was travelling at a speed of 72.325 mph.
- F26.6. A third warning was given by again using the low tone for 11 seconds between 09:51:40 and 09:51:51. The track workers were struck by the train at 09:51:51.
- F26.7. The driver had applied the emergency brake 11 seconds before impact, at 09:51:40 and stopped 14 seconds later at 09:52:05, some 25 seconds following the initial application of the brake.

- F26.8. The speed of the train was 72.32 mph when the emergency brake was applied, and this reduced to 42.958 mph when the track workers were struck by the train. This was an average speed of 57.64 mph which equated to 311.9 yards (285.34 m (14.18 ch)) from when the emergency brake was applied to point of impact. The train travelled 883.08 yards (40.44 ch) within this timeframe.

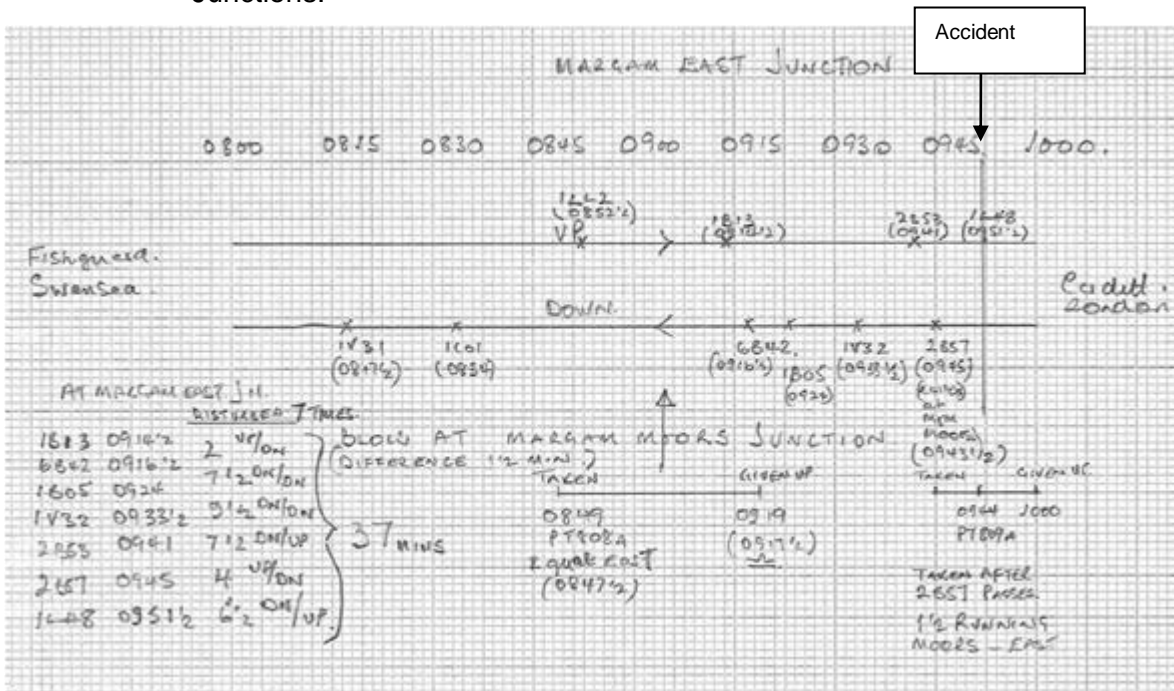
Fig. 7 Outline of the timings of trains at Margam East Junction

- f) The team had separated into two groups of three by 09:14. The diagram above shows train movements on the up and down line and how these train movements would have affected those working at Margam East Junction, for example, with Technician 1 stood in the six-foot working on the Up Main line but within 6' 6" of trains on the Down Main line. They would have had to respond to a train passing either on the Up or Down Main line on average every six minutes in the 37-minute period between 09:14½ and 09:51½. This could have created an environment where, with their collective experience, they had become excessively tolerant of the risk.
