Wetland Delineation Report

14 Mile Fence Replacement
U.S. Customs and Border Protection, San Diego Sector
San Diego County, California

January 2018

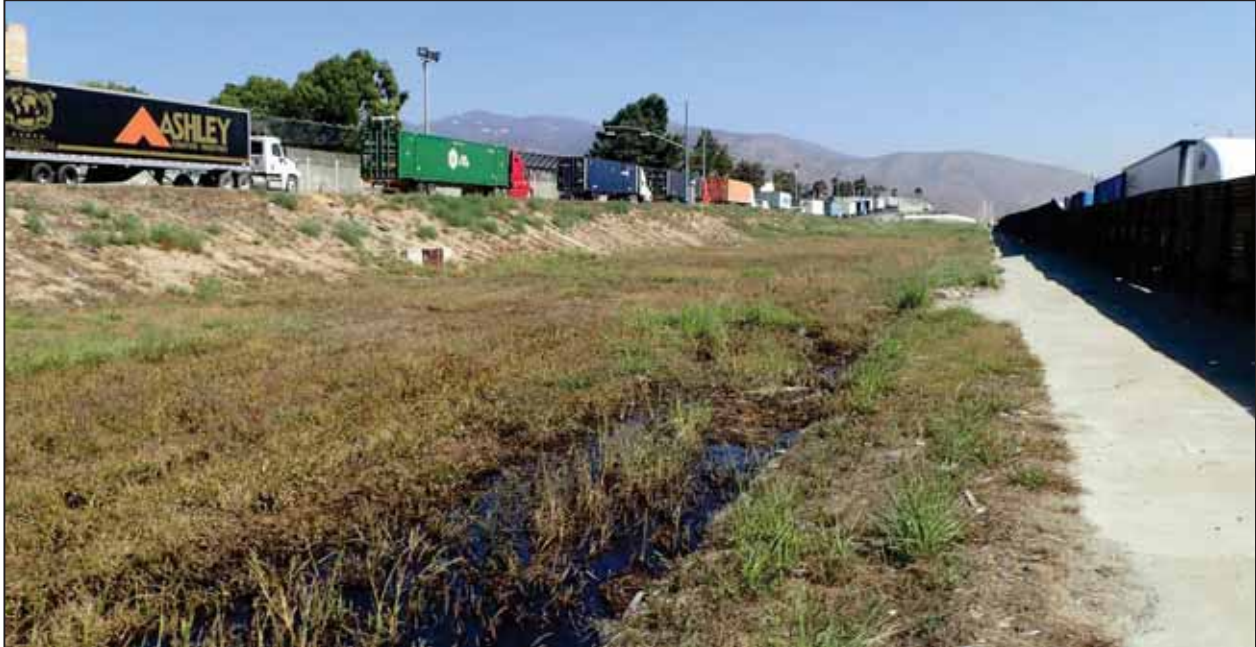
Photograph 1. Image is taken at W19, a manmade detention basin wetland, approximately 0.4 mile east of the Otay POE. Significant areas of these features were saturated or inundated during the surveys. View facing east. Photograph taken on October 12, 2017.

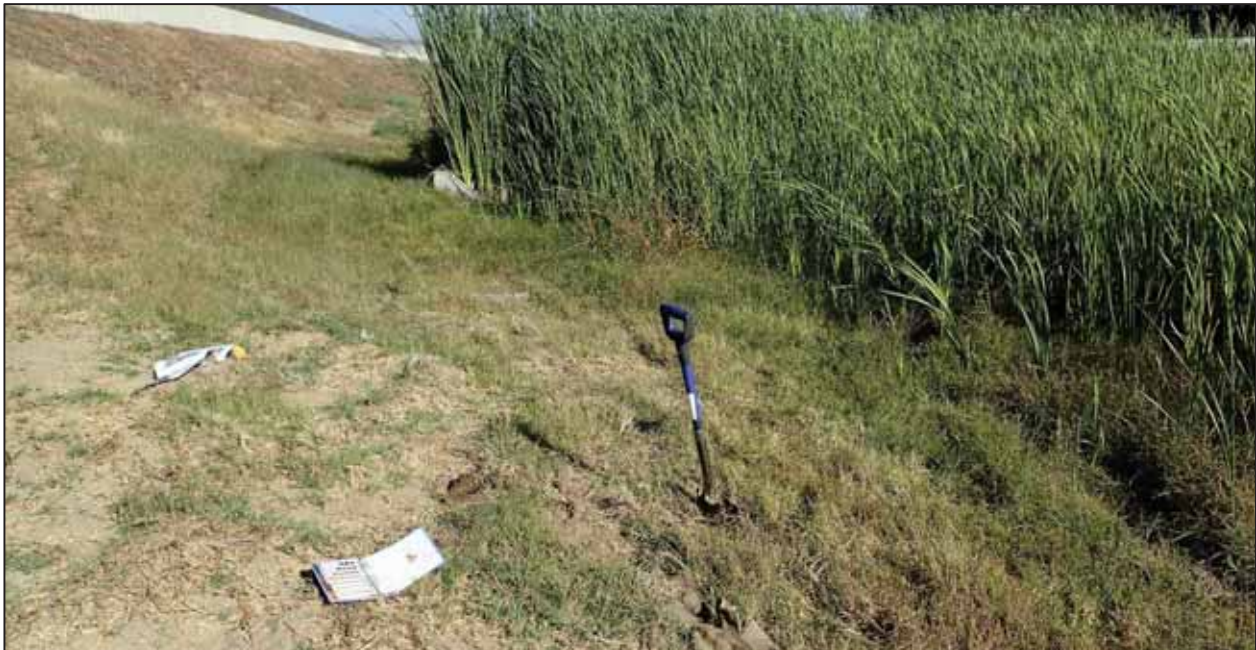
Photograph 2. Emergent marsh, W02, a saturated and inundated area at the entrance to a culvert, south of the water treatment plant west of the Tijuana River. The feature is dominated by cattails and barnyard grass. View facing east. Photograph taken on October 10, 2017.

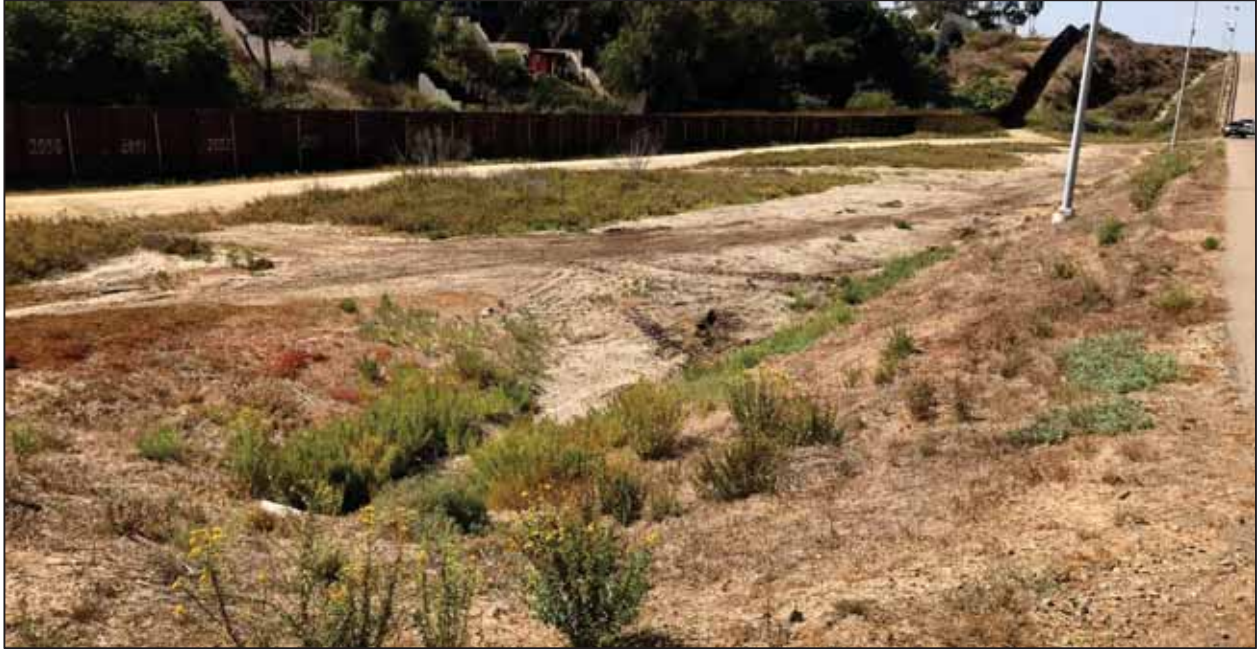
Photograph 3. Image depicts W01, a highly disturbed emergent marsh wetland characterized by pickleweed and alkali heath, located approximately 0.4 mile east of Friendship Park. View facing southwest. Photograph taken on October 9, 2017.

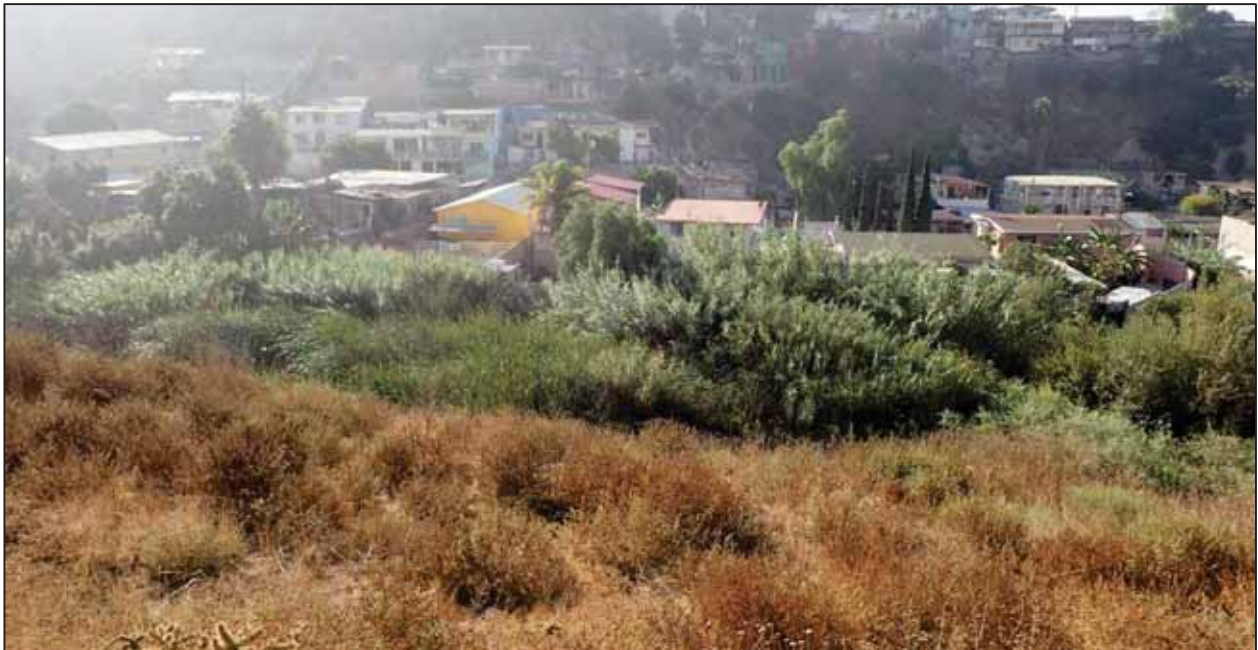
Photograph 4. Image depicts emergent marsh W05, a portion of a remnant stream channel located approximately 0.6 mile east of the San Ysidro POE. The feature was inaccessible during the survey but was assessed with binoculars and aerial imagery and appears to remain inundated and/or saturated for a substantial duration. It is dominated by cattails, with giant reed and willows at the edges of the feature. View facing south. Photograph taken on October 11, 2017.

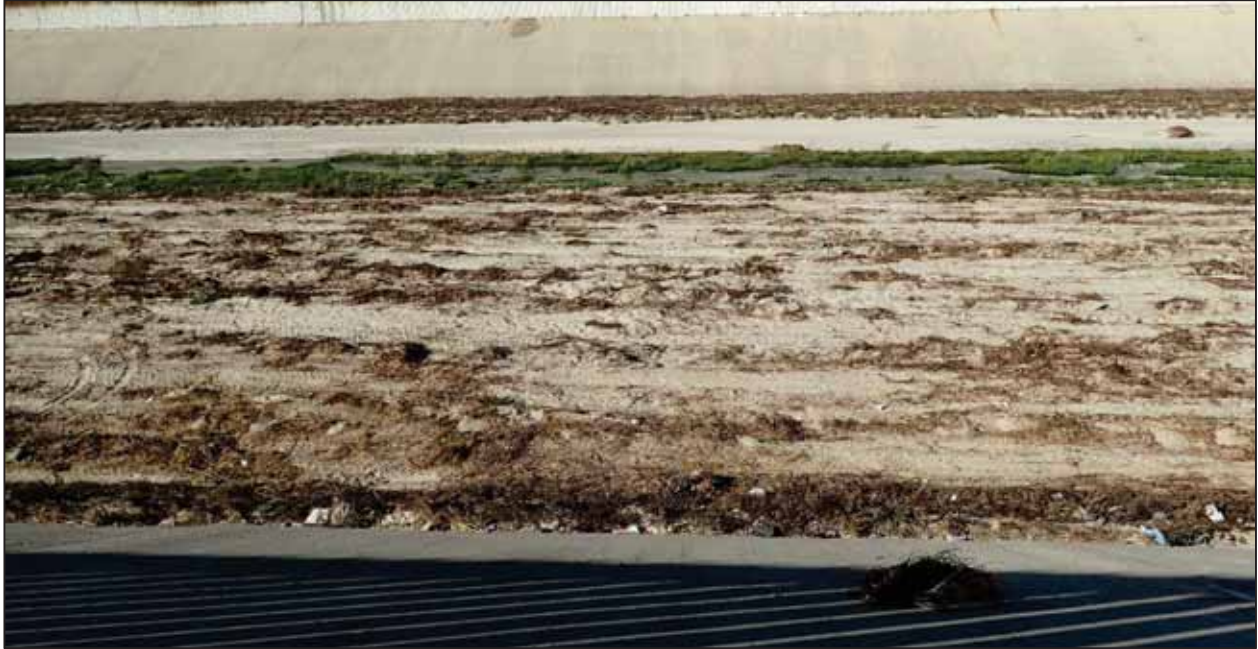
Photograph 5. Image depicts a portion of the Tijuana River approximately 300 feet downstream of the Study Area. The portion of the Tijuana River within the Study Area, mapped as a perennial stream (S10), contained less sediment than what is depicted above. View facing north. Photograph taken October 10, 2017.

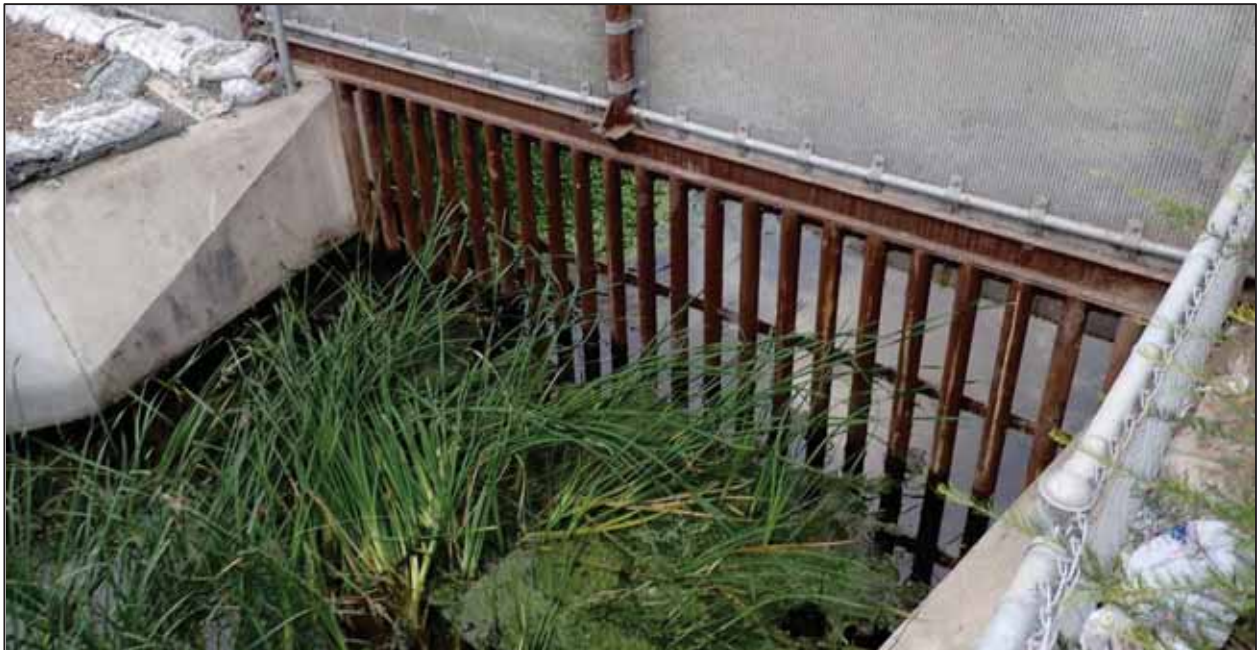
Photograph 6. Image is of wetland ditch W03, located in a concrete drainage channel near the north bank of the Tijuana River, approximately 0.4 mile west of the San Ysidro POE. Sufficient sediment has accumulated to support vegetation dominated by cattails and dock. Based on aerial imagery, it is expected that W04, the eastern portion of the concrete channel, is similar in hydrology and vegetation to W03. View facing south. Photograph taken on October 12, 2017.

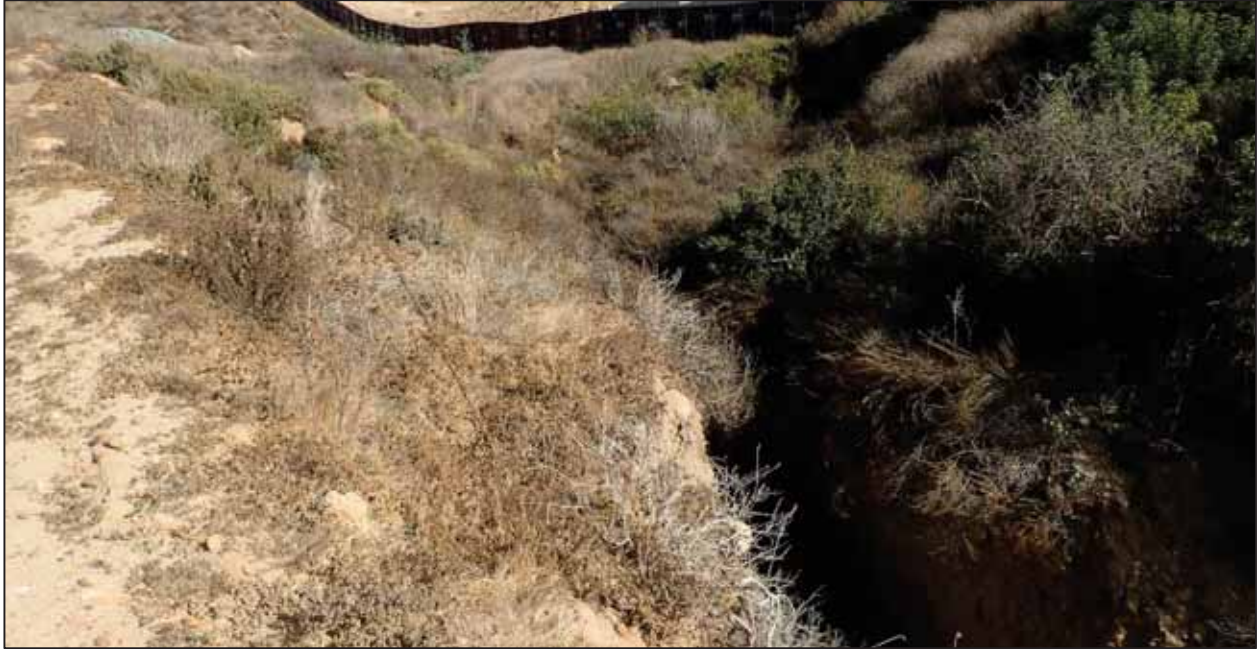
Photograph 7. Image depicts the narrow, deeply incised upper reach of S01, approximately 0.75 miles east of Friendship Park. View facing south. Photograph taken October 9, 2017.

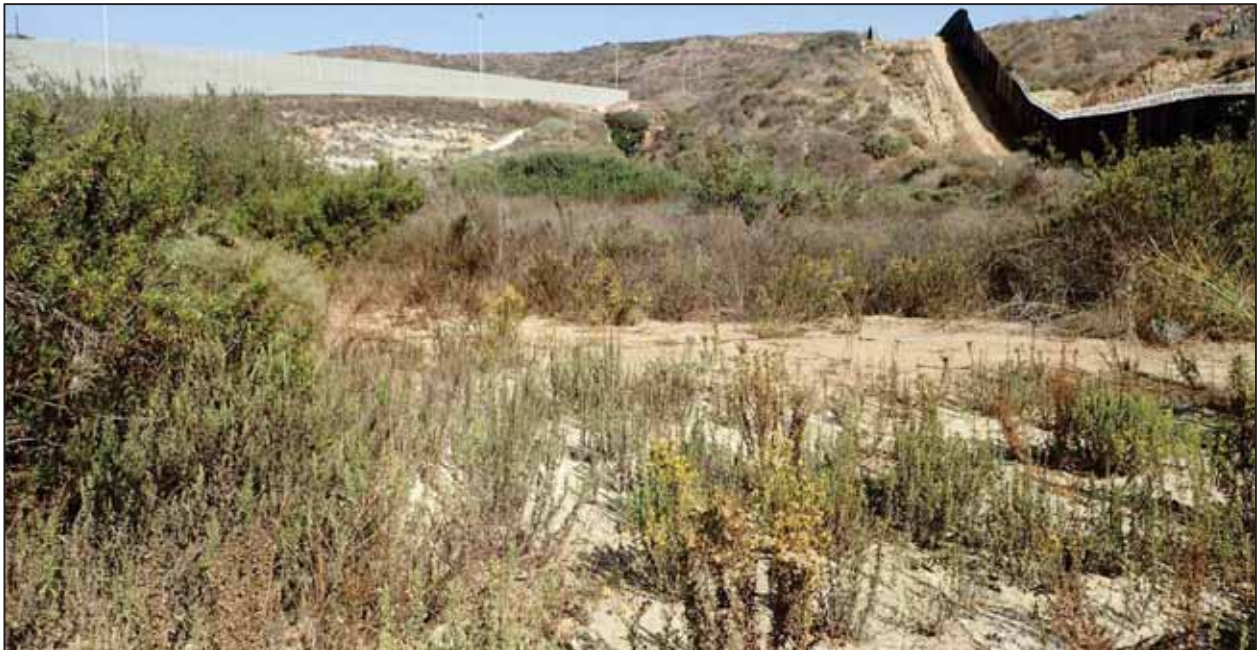
Photograph 8. Image depicts the broad, floodplain portion at the lower portion of S01, approximately 0.6 mile east of Friendship Park. View facing east. Photograph taken October 9, 2017.

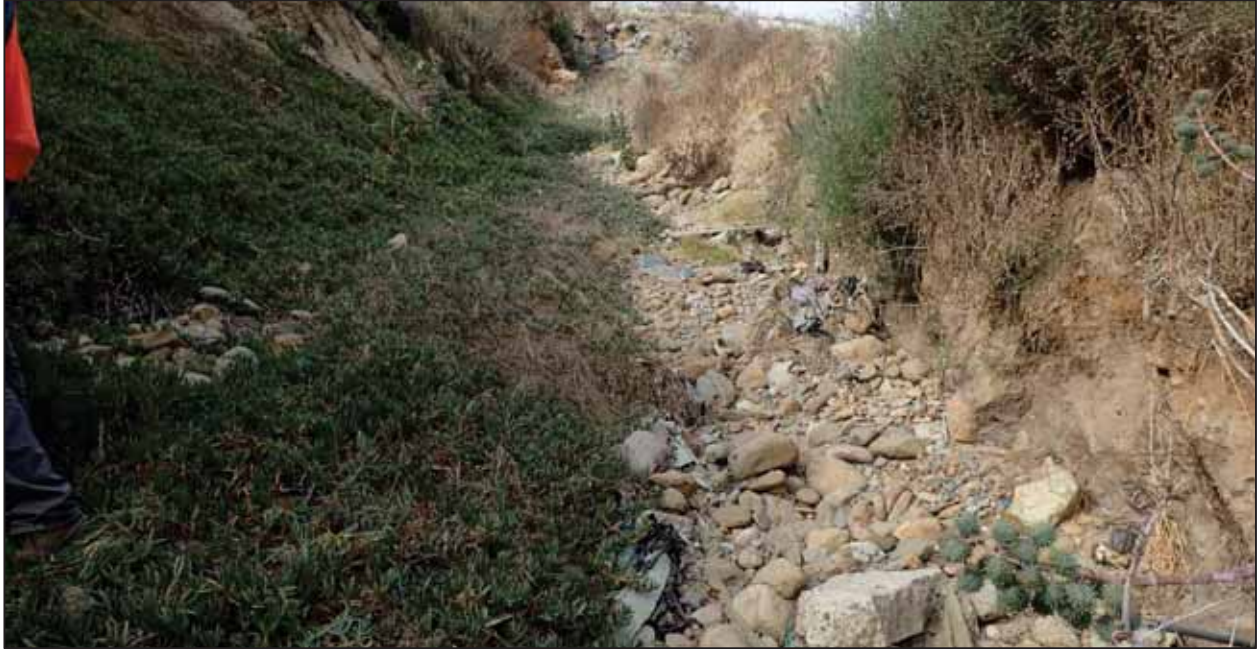
Photograph 9. Image depicts the narrow, deeply incised upper reach of S09, below the outfall of the Silva Drain Canyon Collector, approximately 2 miles west of the San Ysidro POE. The location was sampled as CS05. View facing southwest. Photograph taken October 13, 2017.

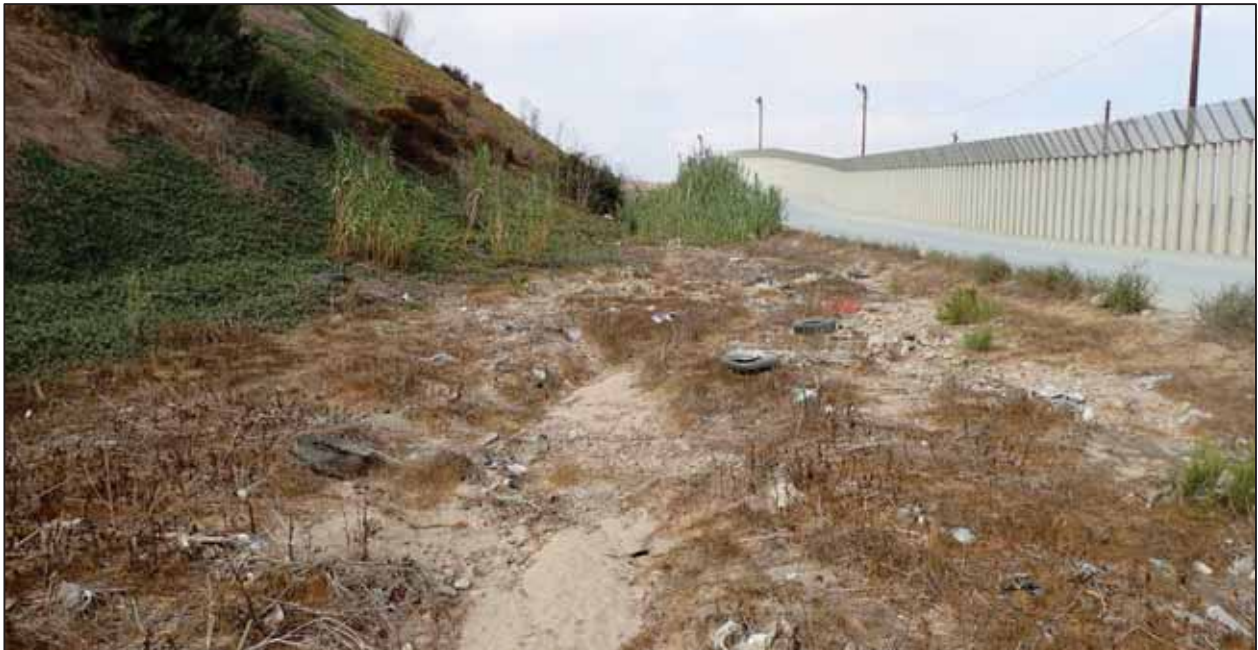
Photograph 10. Image depicts the broad, floodplain portion at the lower portion of S09, approximately 1.8 miles west of the San Ysidro POE. View facing west. Photograph taken October 13, 2017.

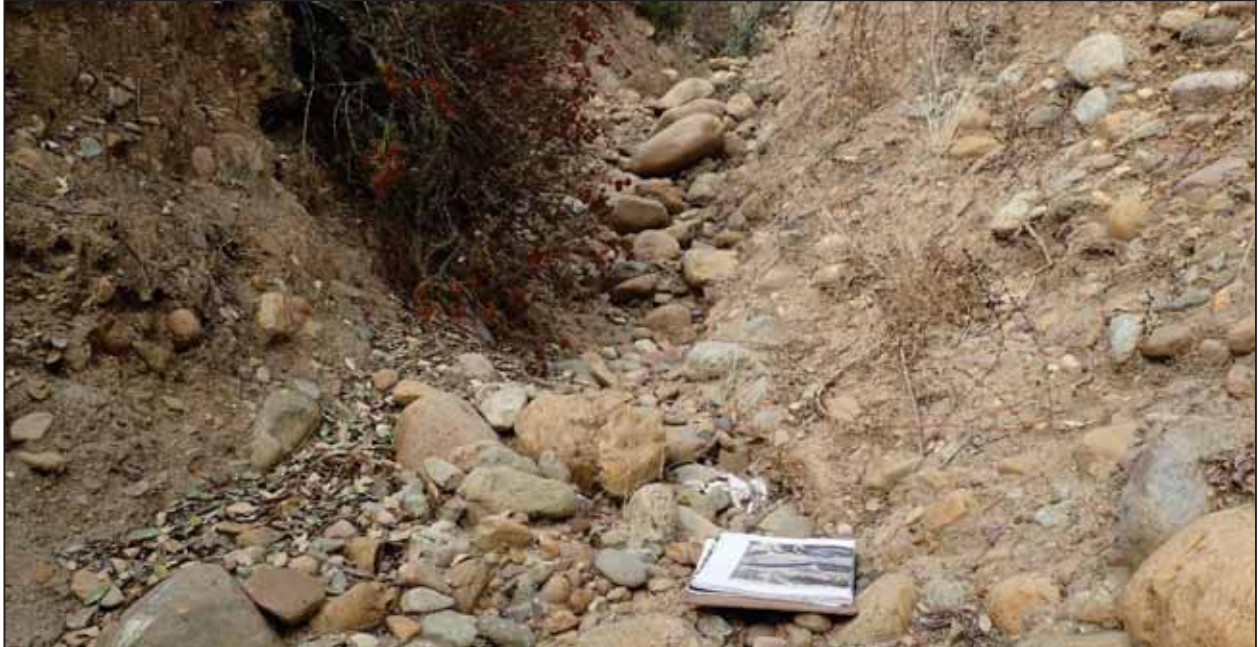
Photograph 11. Image depicts a portion of S05, a steep, deeply incised ephemeral drainage on the western slope of Smugglers Gulch. The location was sampled as CS04. View facing east. Photograph taken on October 13, 2017.

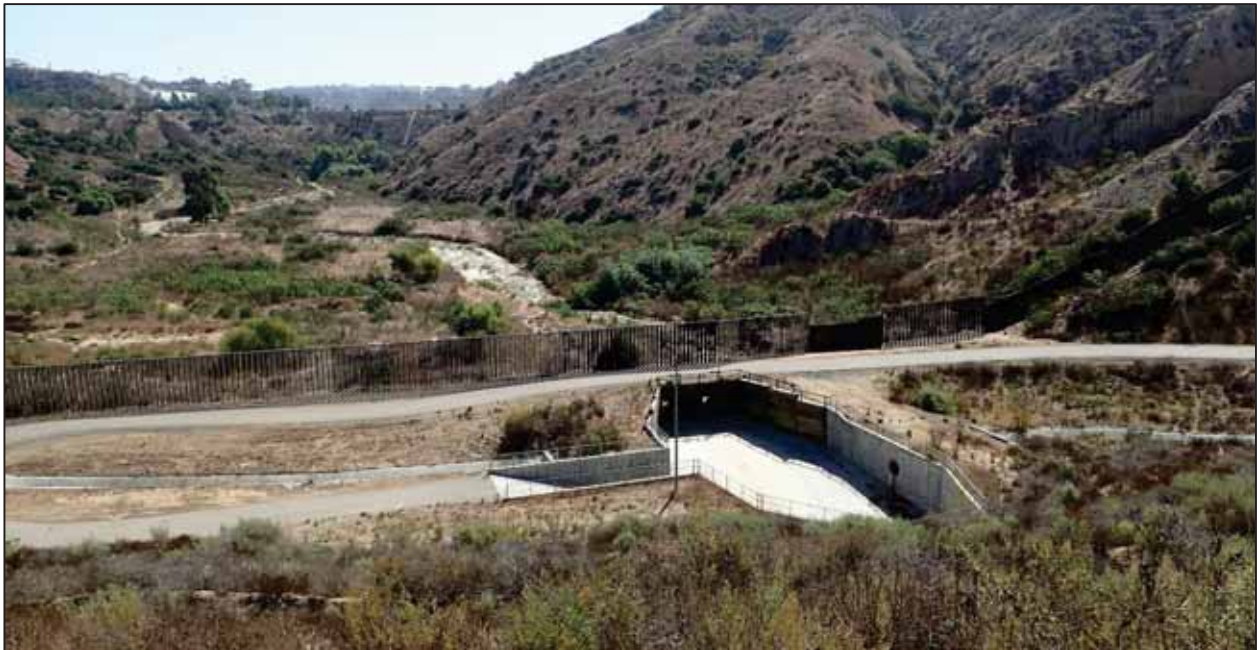
Photograph 12. Image depicts S07, the natural and concrete channelized portion of the ephemeral drainage in Smugglers Gulch. View facing south. Photograph taken October 10, 2017.

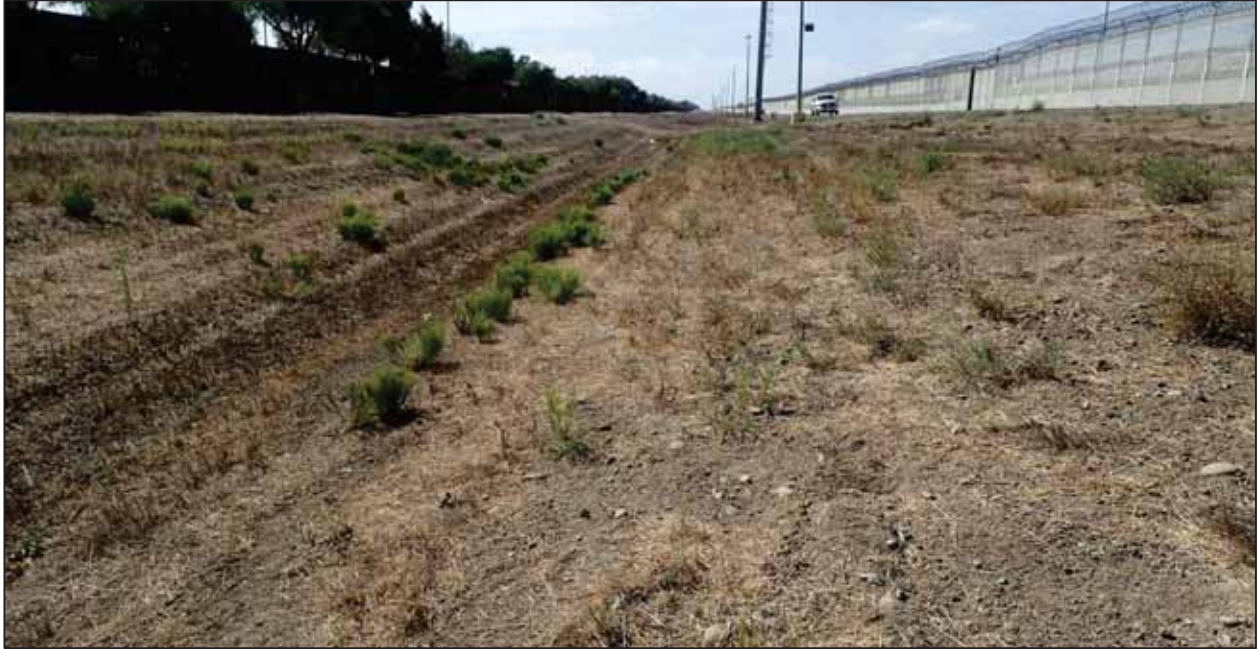
Photograph 13. Image depicts a representative seasonal wetland depression (W11) in the Study Area, located approximately 2.3 miles west of the Otay POE, The depressions were shallow, closed, and seasonally ponded. View facing west. Photograph taken on October 11, 2017.

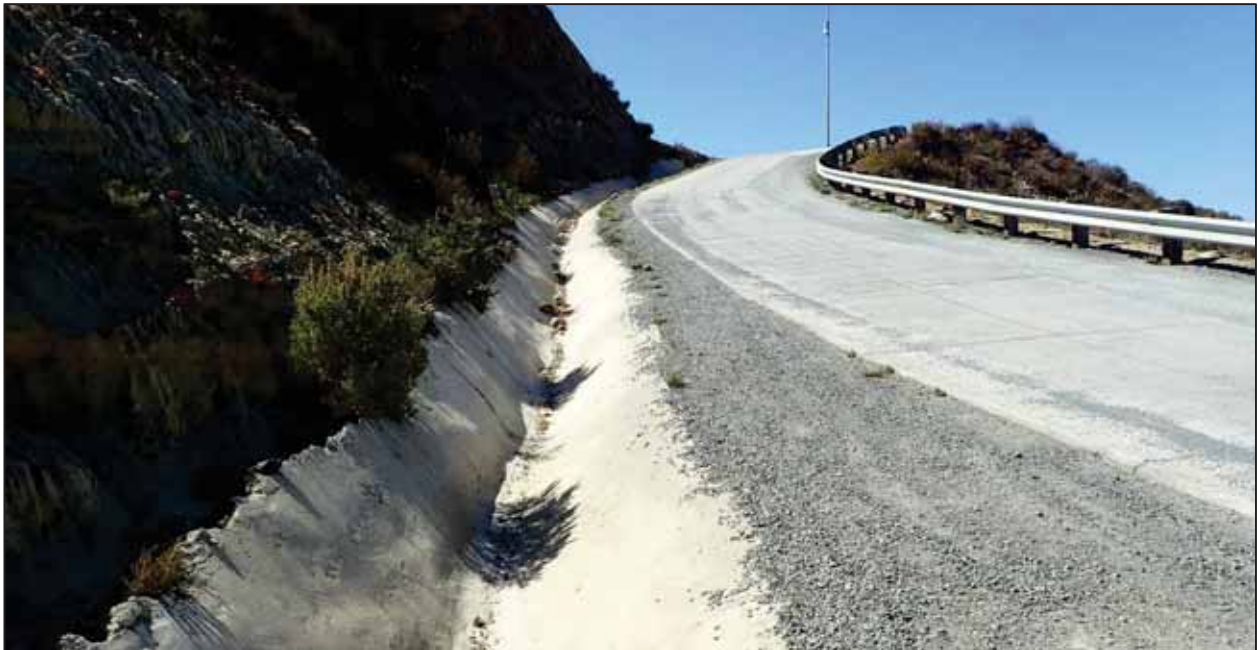
Photograph 14. Image depicts an example of a concrete, V-shaped drainage on the eastern slope of Bunker Hill. Such features are constructed in uplands and drain roadsides and other uplands. Such features were considered non-jurisdictional. View facing west. Photograph taken October 10, 2017.

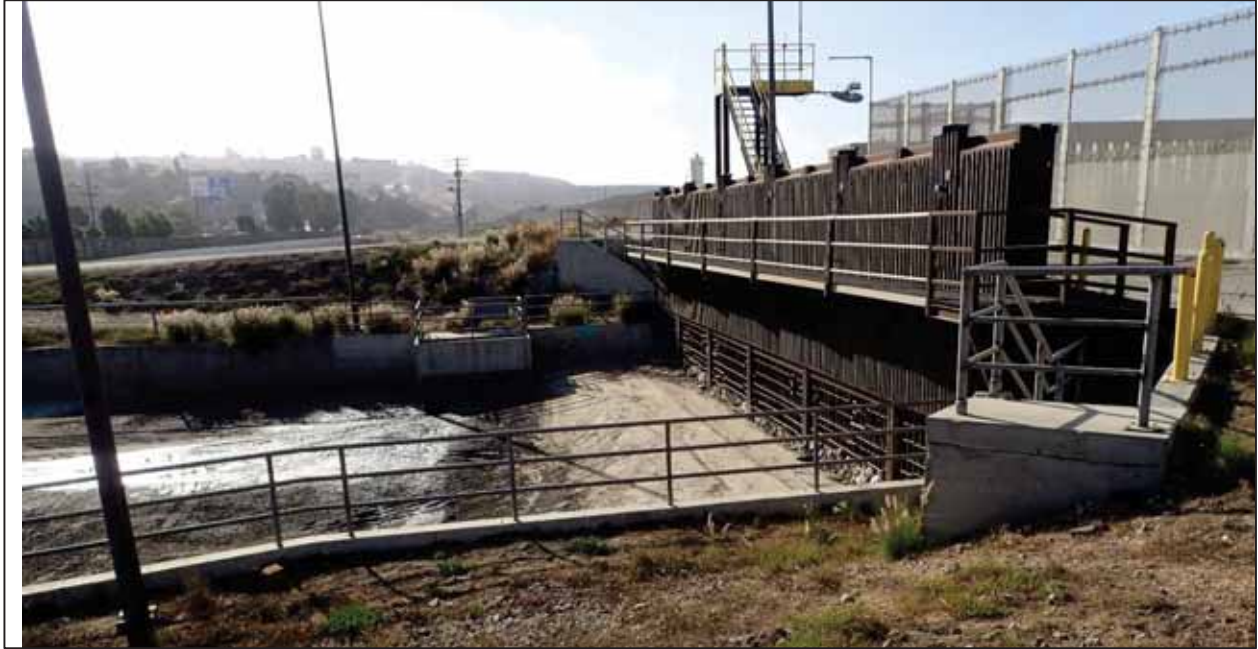
Photograph 15. Example of a non-jurisdictional concrete drainage, located to the southeast of the waste treatment facility. View facing west. Photograph taken on October 13, 2017.

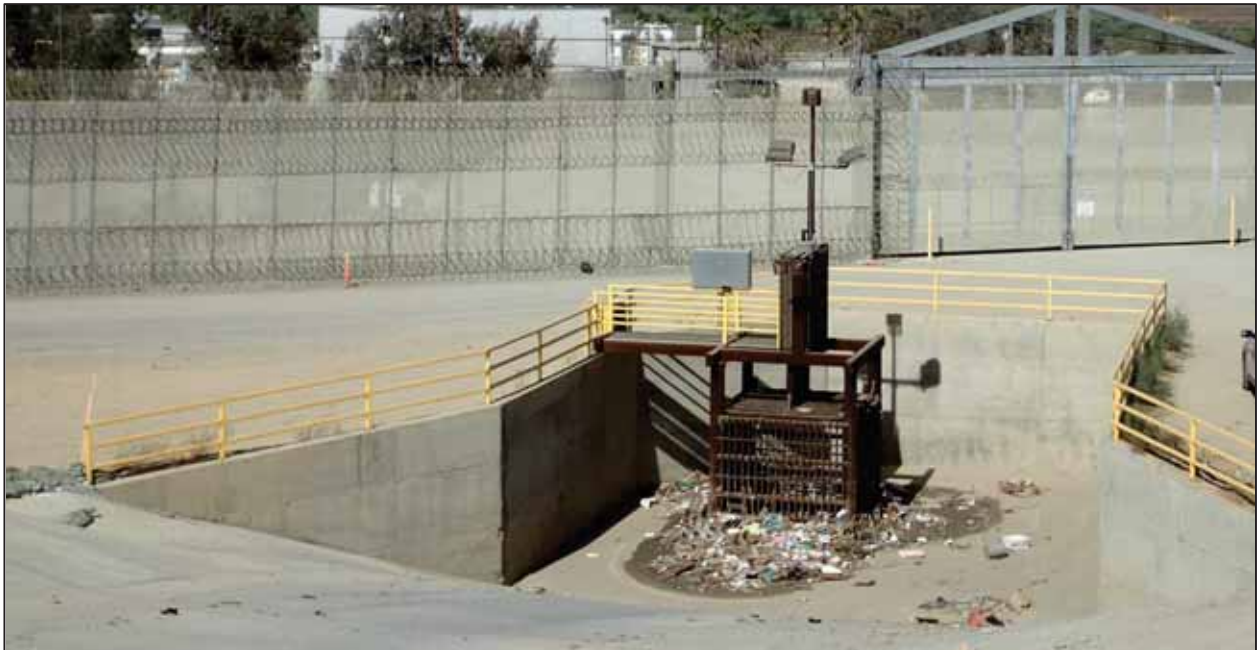
Photograph 16. Non-jurisdictional concrete drainage, located to the southwest of the waste treatment facility. View facing north. Photograph taken on October 10, 2017.

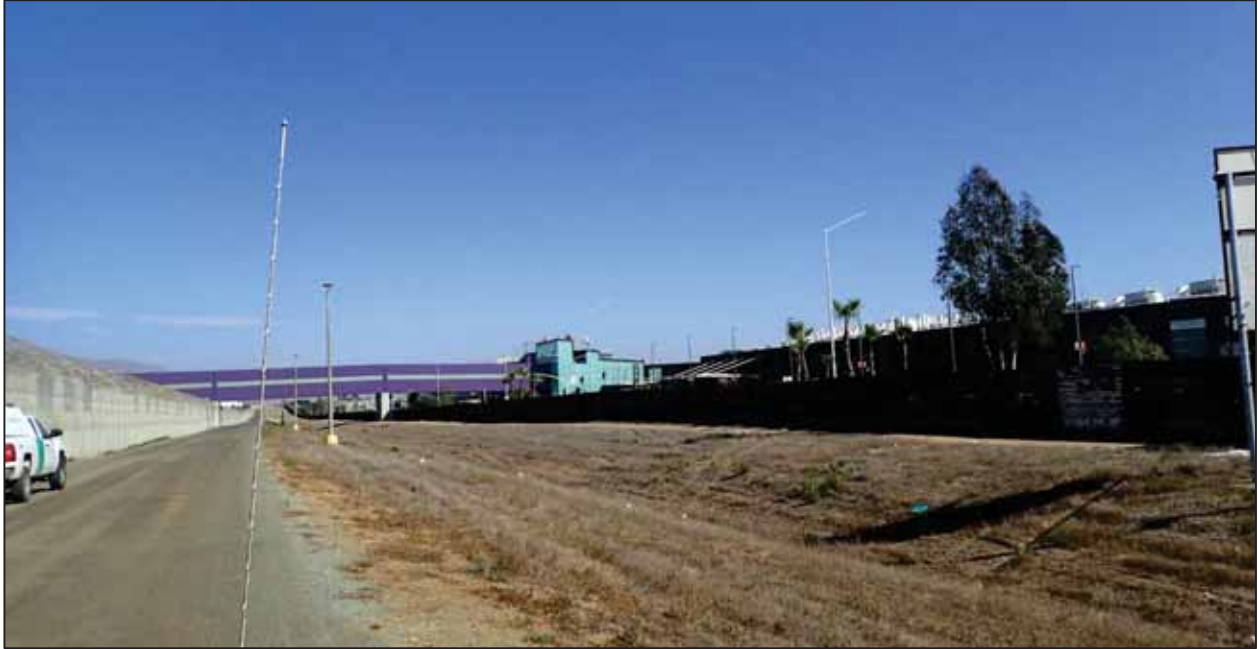
Photograph 17. Image depicts an example of the long, shallow, linear, upland, manmade swales in the grassland habitat located between the legacy and primary fences beginning approximately 1.5 miles east of the Otay POE. Indicators of flow were not observed in these features, and the three wetland parameters were typically not met, either. Occasional closed depressions within these swale met the three wetland parameters, and such features were mapped as seasonal wetland depressions. View facing east. Photograph taken October 11, 2017.
