***Final Environmental Assessment
for the
Paradise Cove West
U.S. Customs and Border Protection
Mitigation for Southwestern Willow Flycatcher***

**This mitigation project is required for Right-of-Way AZA 34173 under
U.S. Fish and Wildlife Services Biological Assessment 22410-2007-I-
0212 and Biological Opinion 22410-2008-F-0195**

**Environmental Assessment Reference Numbers:
DOI-BLM-AZ-C020-2019-0015-EA**

April 2019

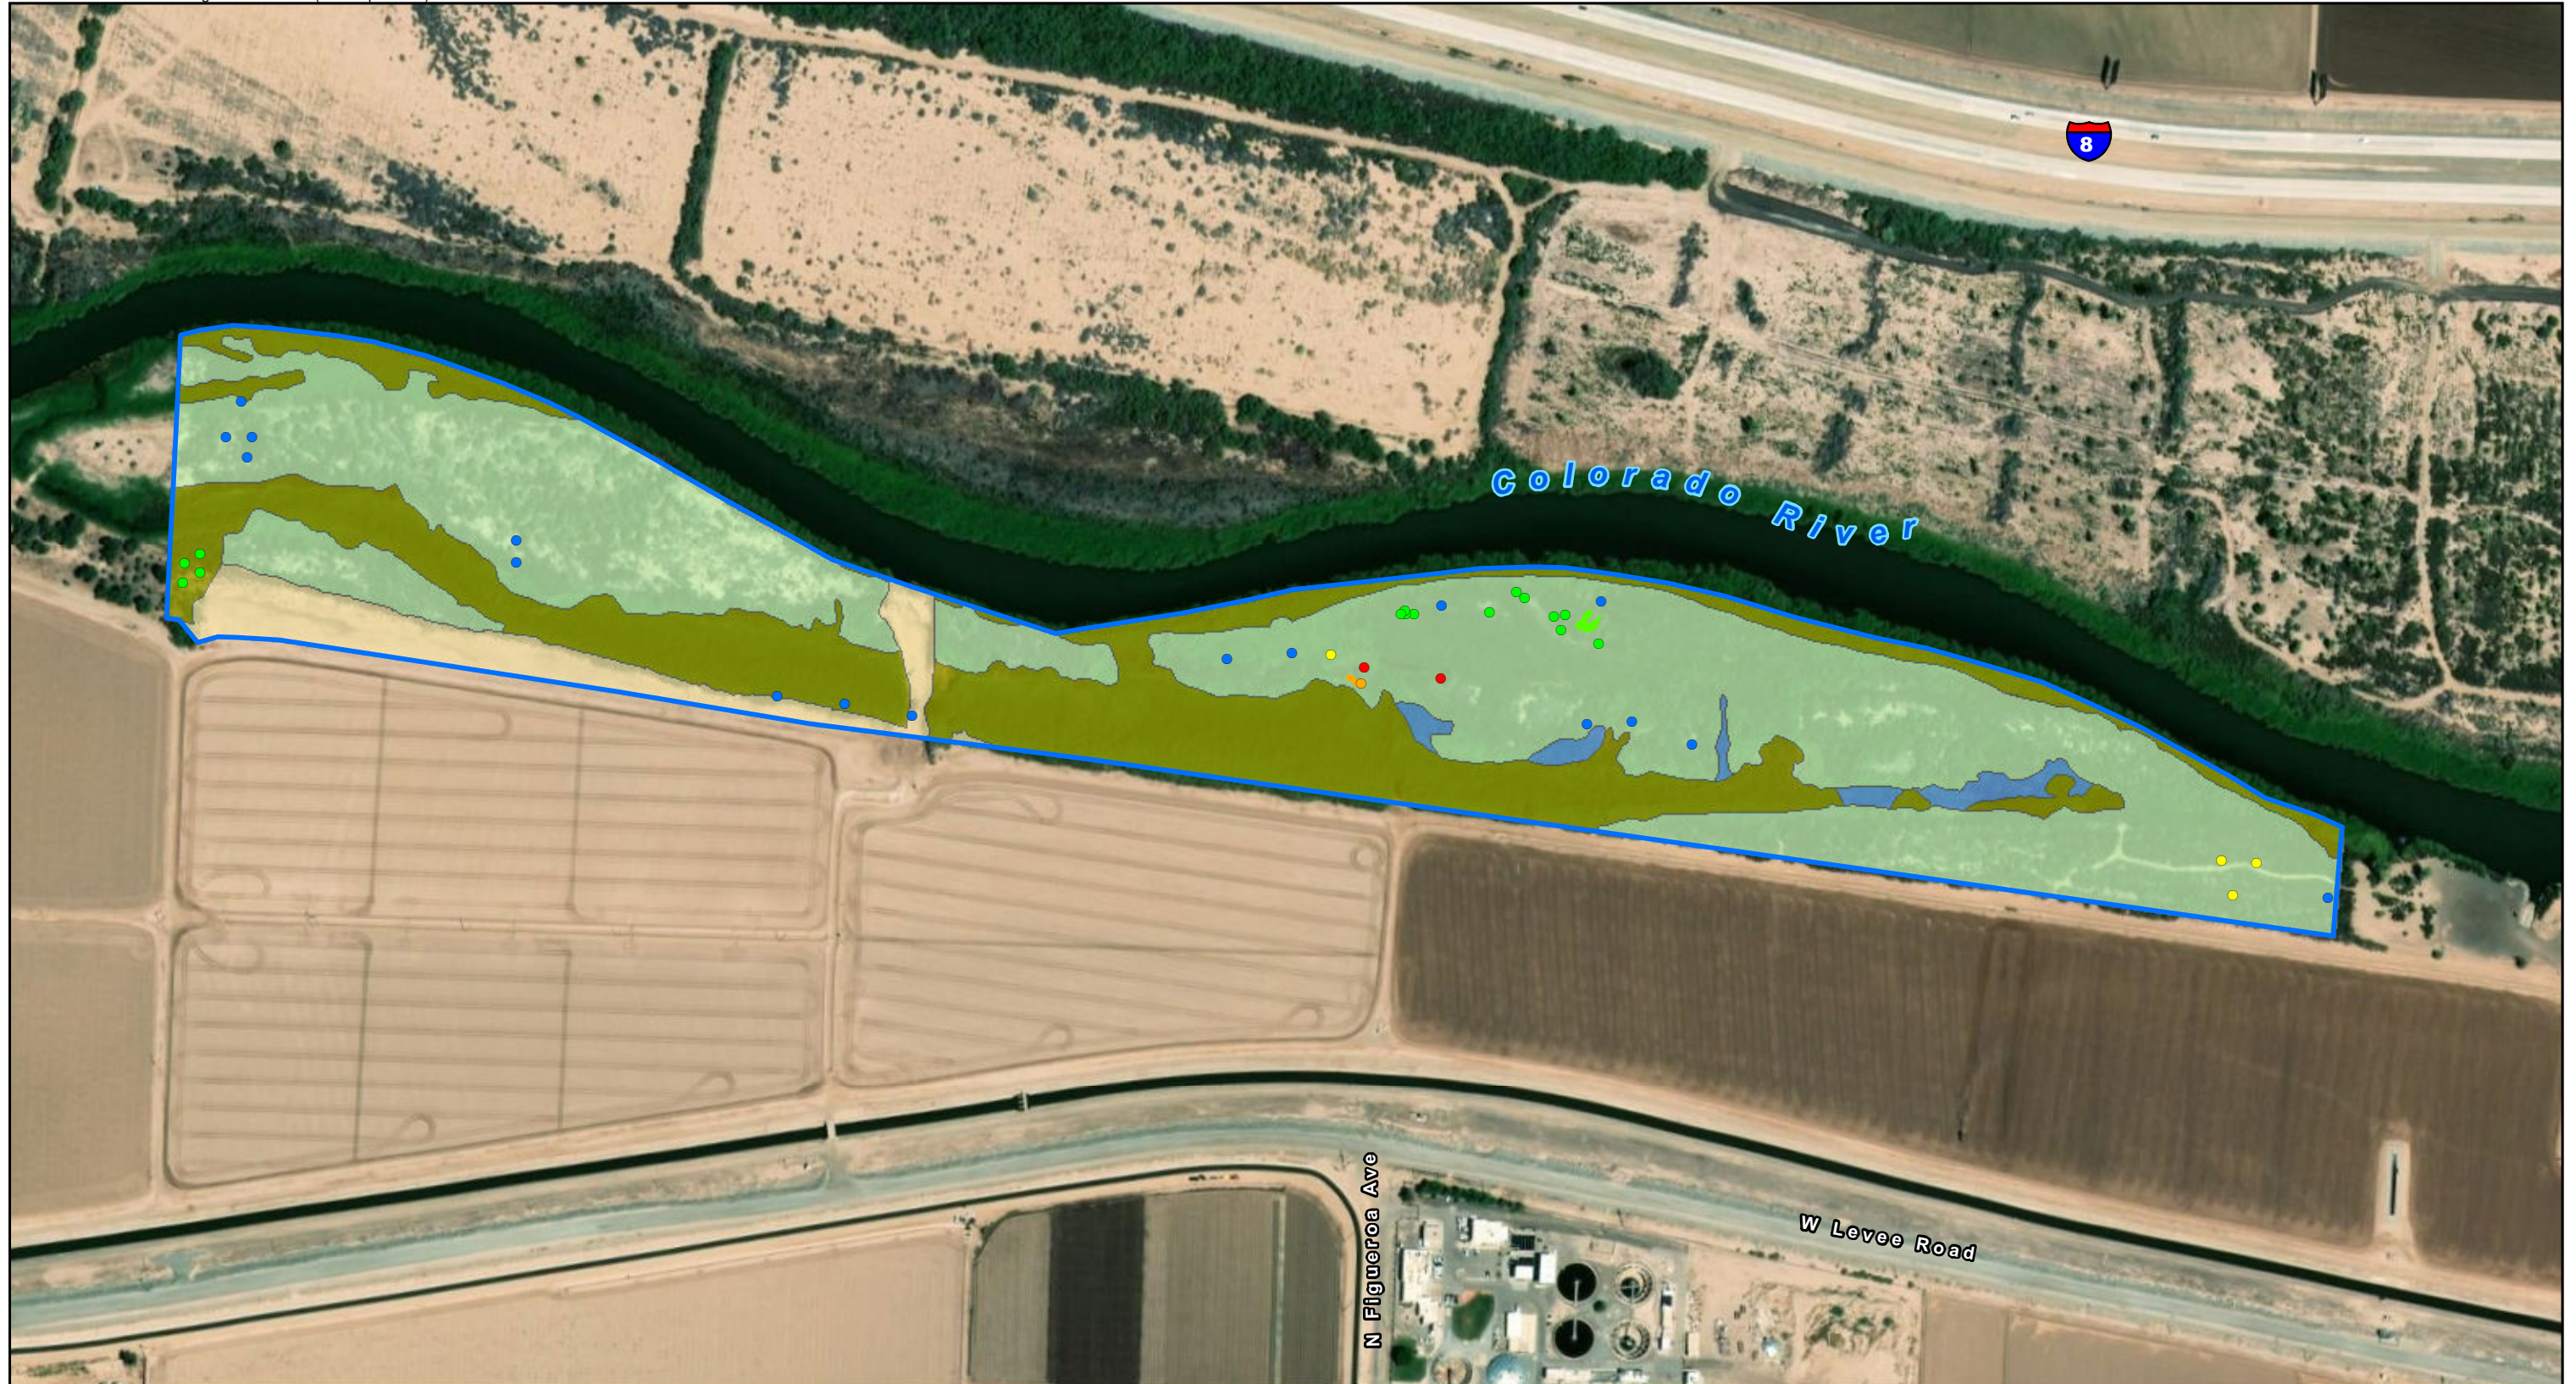
FIGURE 3
No Action Alternative

Paradise Cove West Mitigation Area (50.35 ac.)

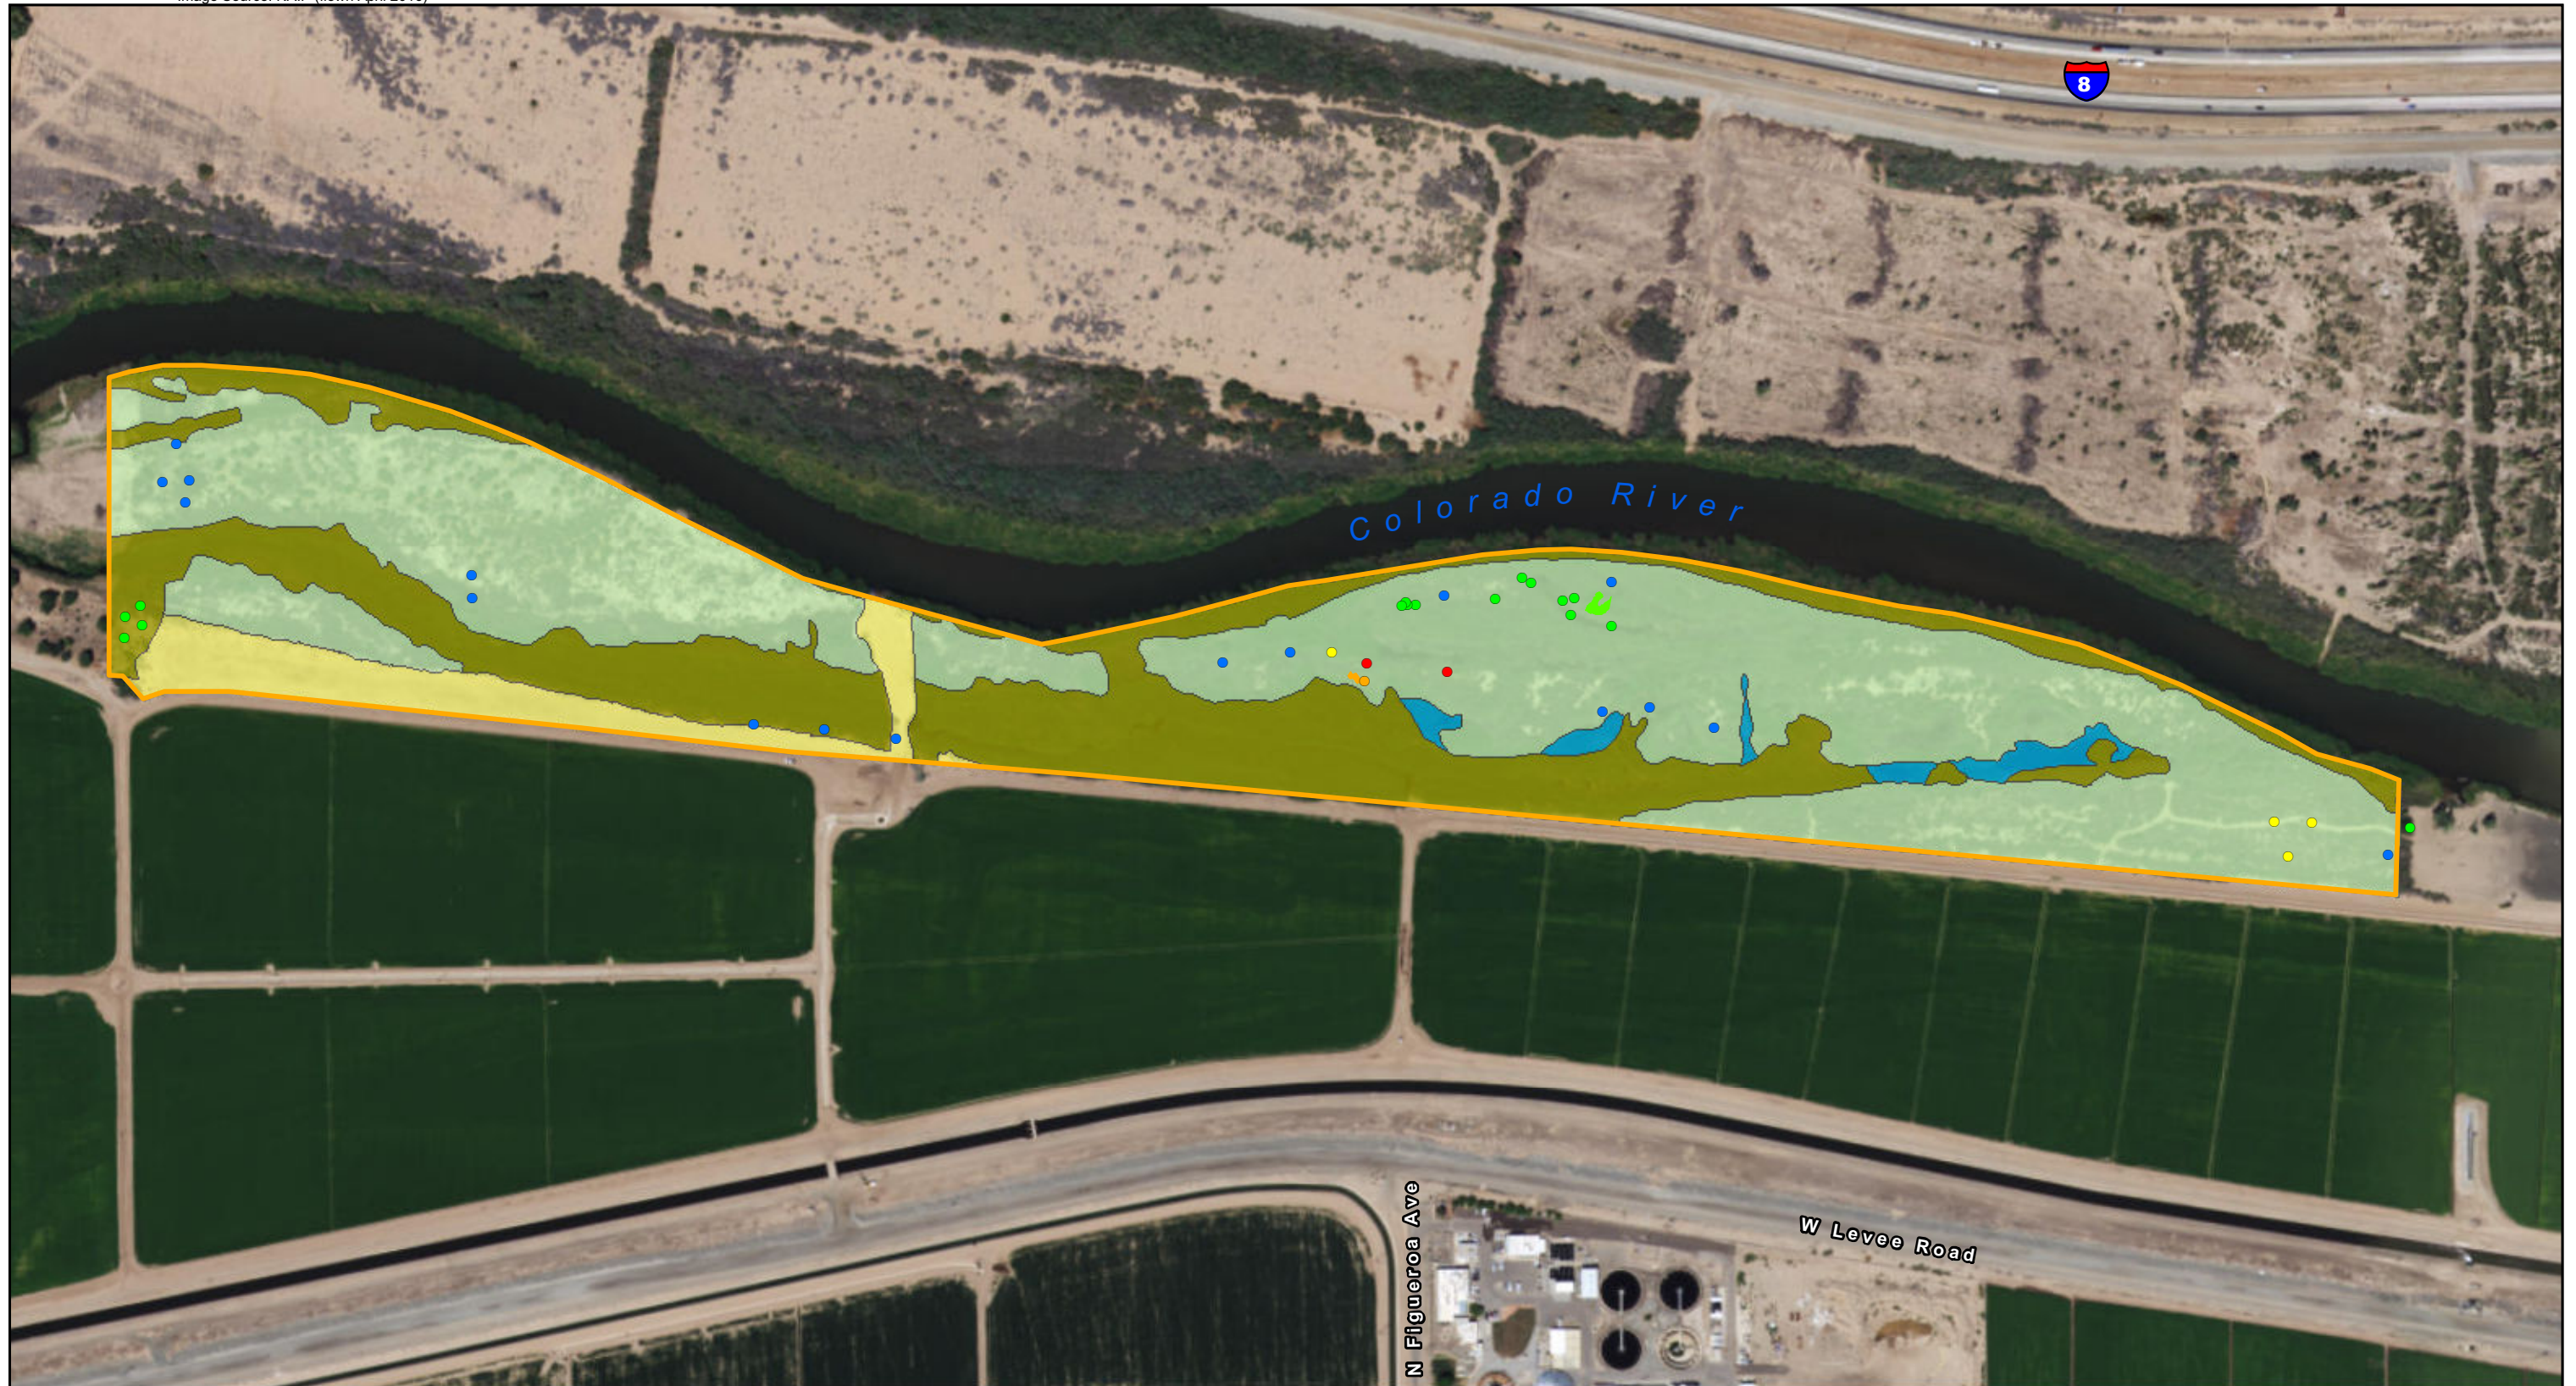
FIGURE 6
Paradise Cove West Existing Vegetation

Paradise Cove West (50.35 ac.)

- Athel Tree
- Wolfberry
- Cottonwood
- Screwbean Mesquite
- Goodings Willow

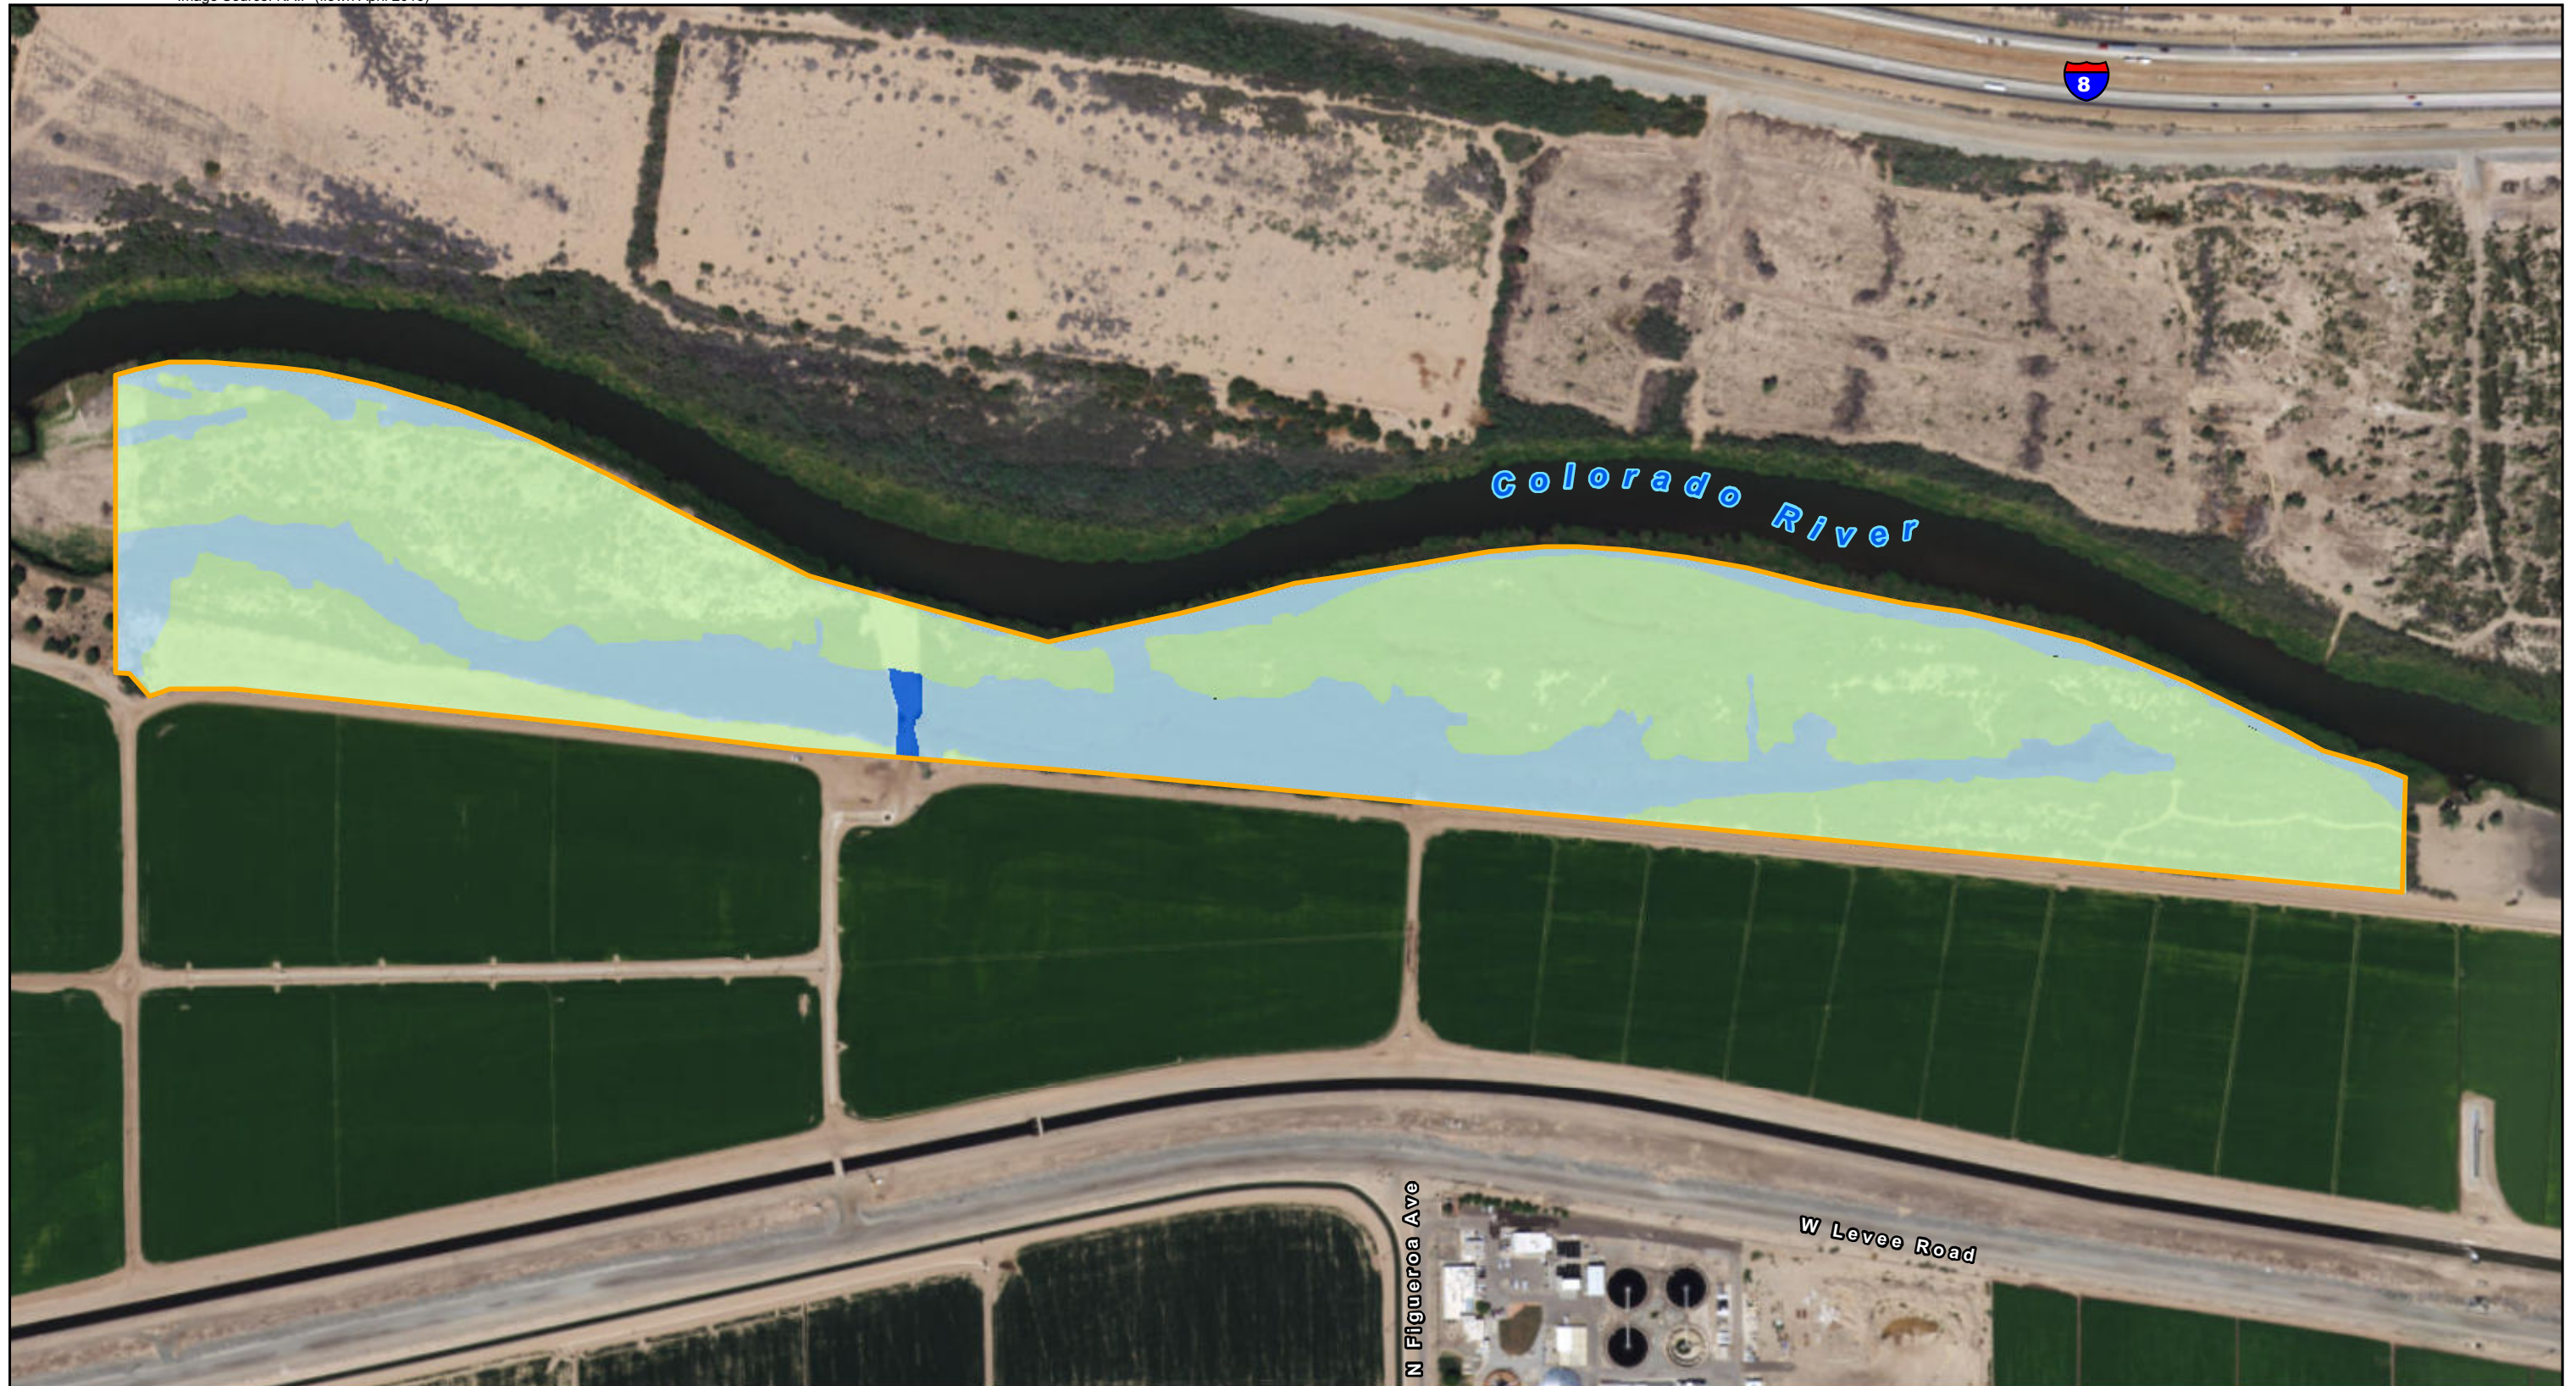
- Paradise Cove West
- Jurisdictional Waters**
- ACOE Wetland
- ACOE Wetland (Disturbed)
- Upland

ACOE jurisdictional areas on-site total 16.55 acres, all of which are considered ACOE wetlands (Table 2). This acreage consists of common reed western North America temperate semi-natural herbaceous vegetation and broadleaf cattail western herbaceous vegetation associated with the Colorado River. Jurisdictional waters on-site are shown on Figure 5.

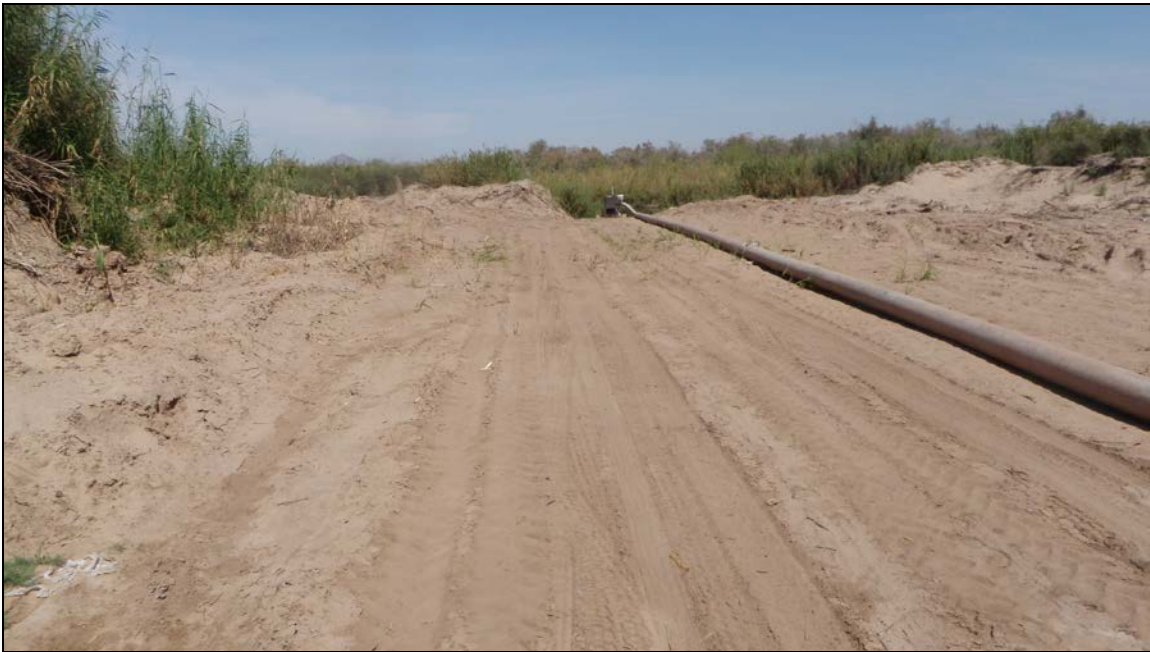
PHOTOGRAPH 5: Central grubbed area across jurisdictional wetlands. Two water pumps and 12-inch-diameter water pipe were observed.
