APPENDIX A

Public Consultation Materials

RE: Notice of Availability of Draft Environmental Assessment Roads Improvement Project, Laredo, Texas, Laredo Sector, U.S. Customs and Border Protection, Department of Homeland Security

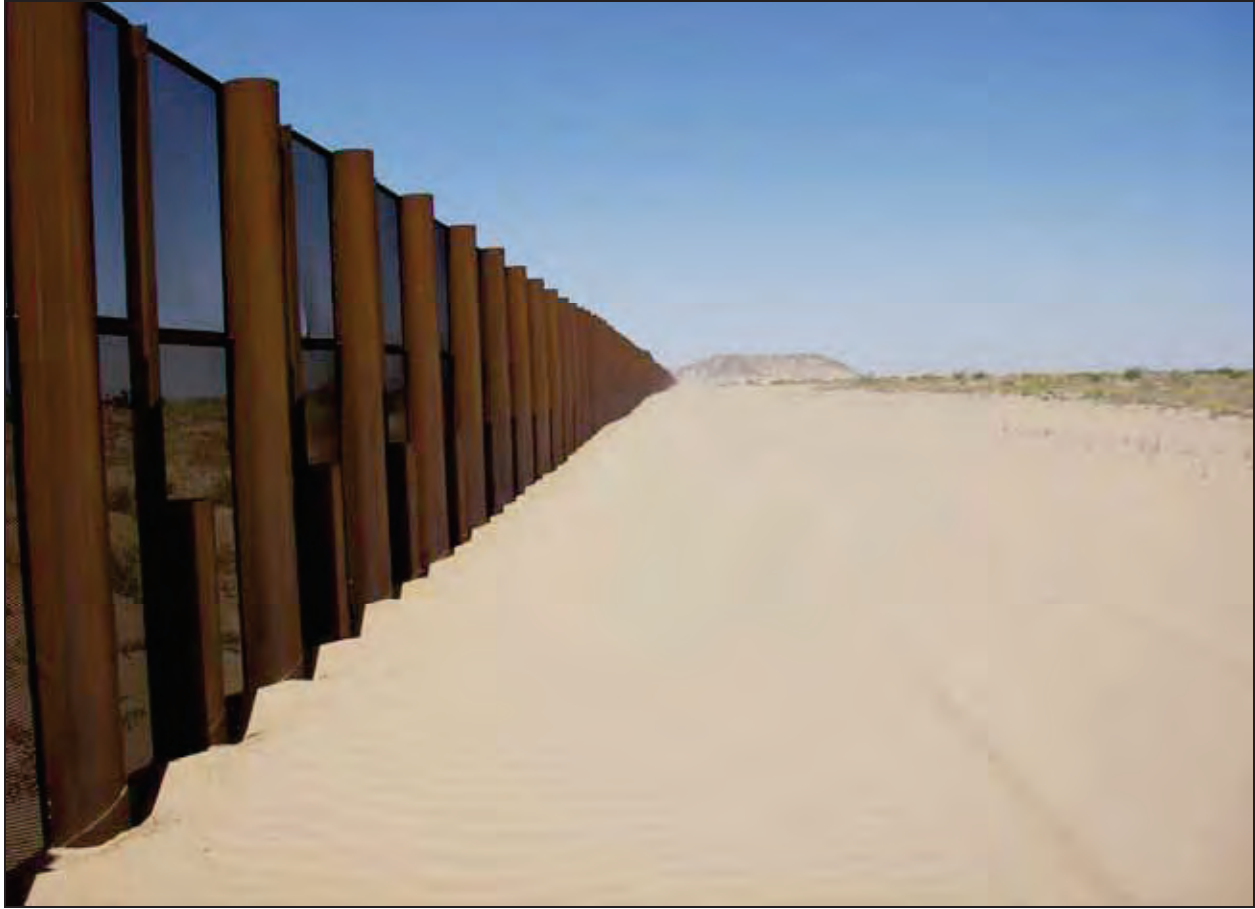
Figure B-9. FC-5 Sand Road (Photograph)

FC5 – Sand Road

The proposed sand road consists of 16-18 feet travel lane at a 0% cross slope. The proposed section consist of natural ground – no foundation base. Drainage ditches are not proposed for this type road. Existing FC-5 roadways may vary from proposed roadway specifications.

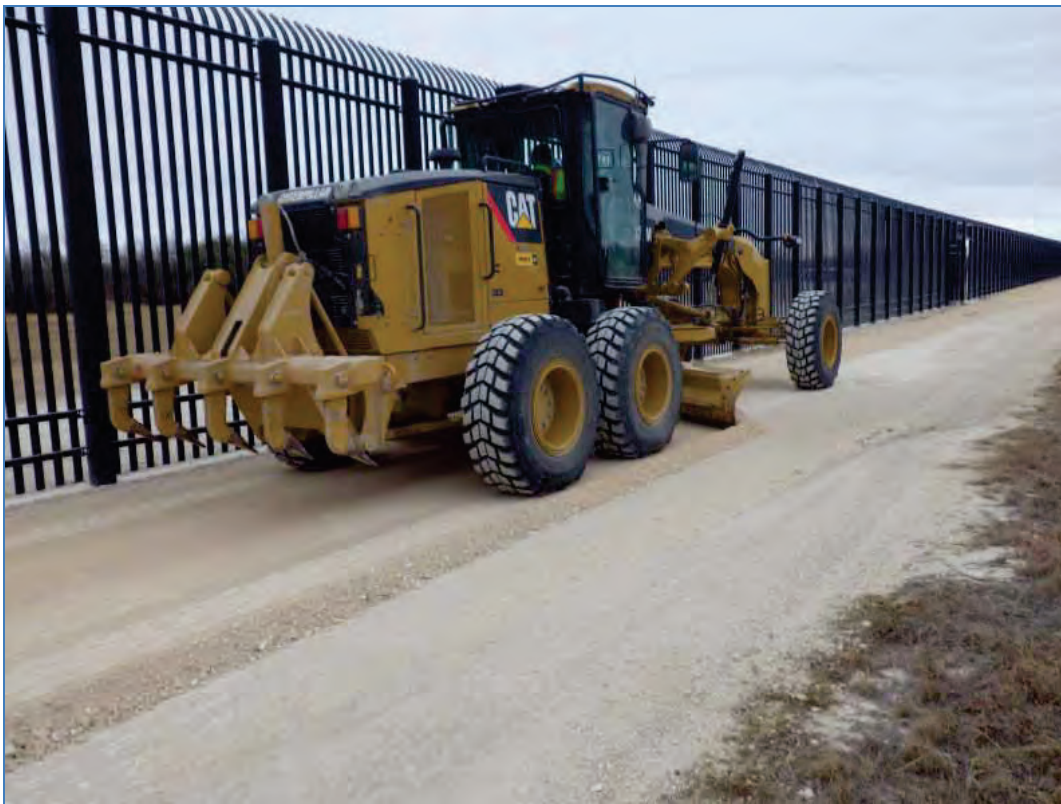
Figure B-11. Standard Grading Equipment

Grading with the use of commercial grading equipment (see **Figure A-11**) is proposed to restore an adequate surface to FC-3 roads. USBP sector personnel and contract support personnel well-versed in grading techniques would be employed for such activity. A poorly regraded surface quite often results in rapid deterioration of the surface. The restored road should be slightly crowned and absent of windrows in the gutter line to avoid ponding and channeling within the road during rain events. Any associated roadside drainage would be maintained to ensure that runoff is relieved from the road surface quickly and effectively without creating further erosion issues. The addition of material to these roads to achieve the proposed objective would be kept to a minimum. All necessary erosion-control BMPs would be adopted to ensure stabilization of the project areas.

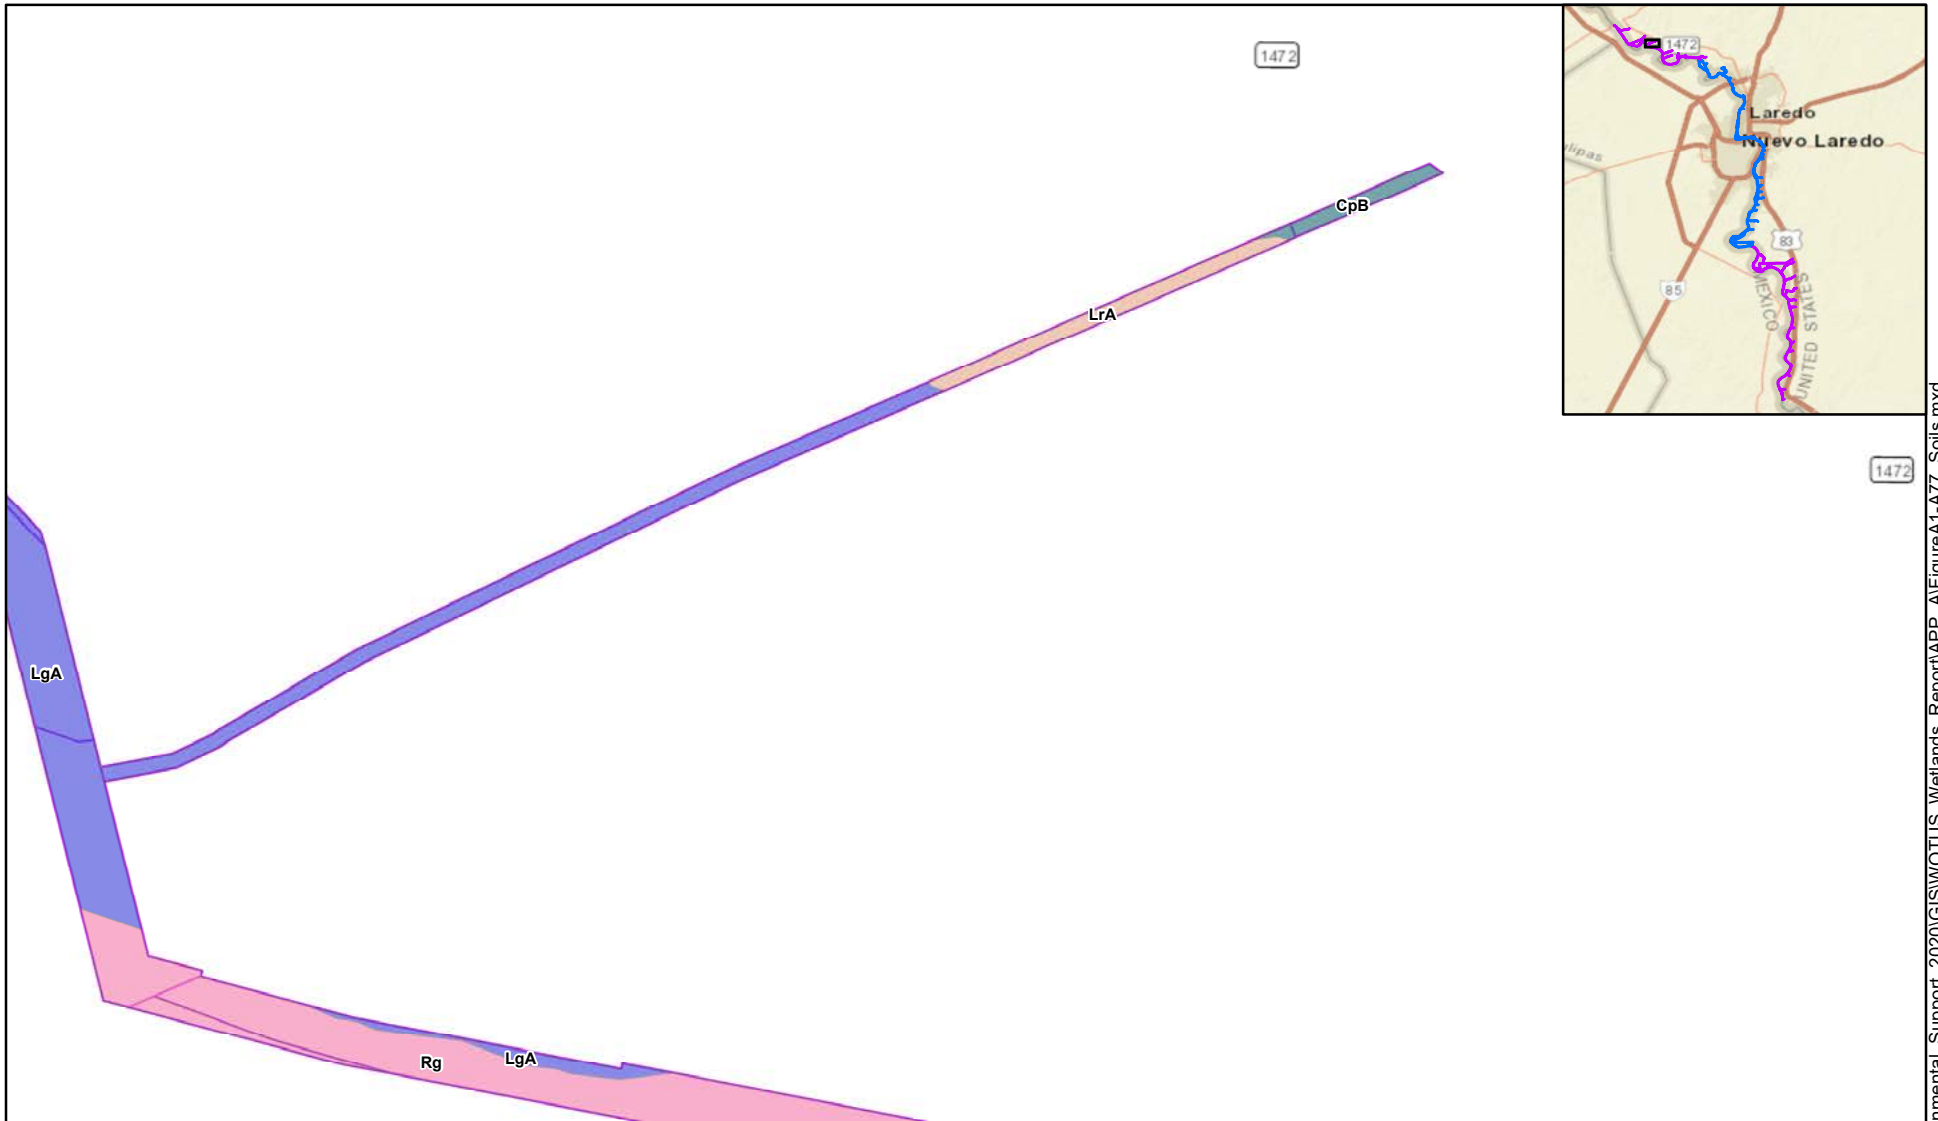
Figure A6. Soils Map - Phase II

- Laredo Roads Corridor
- LgA, Lagloria loam, 0 to 1 percent slopes
- Rg, Rio Grande very fine sandy loam, occasionally flooded
- LrA, Laredo silty clay loam, dry, 0 to 1 percent slopes, rarely flooded
- CpB, Copita fine sandy loam, 0 to 3 percent slopes
- Phase II

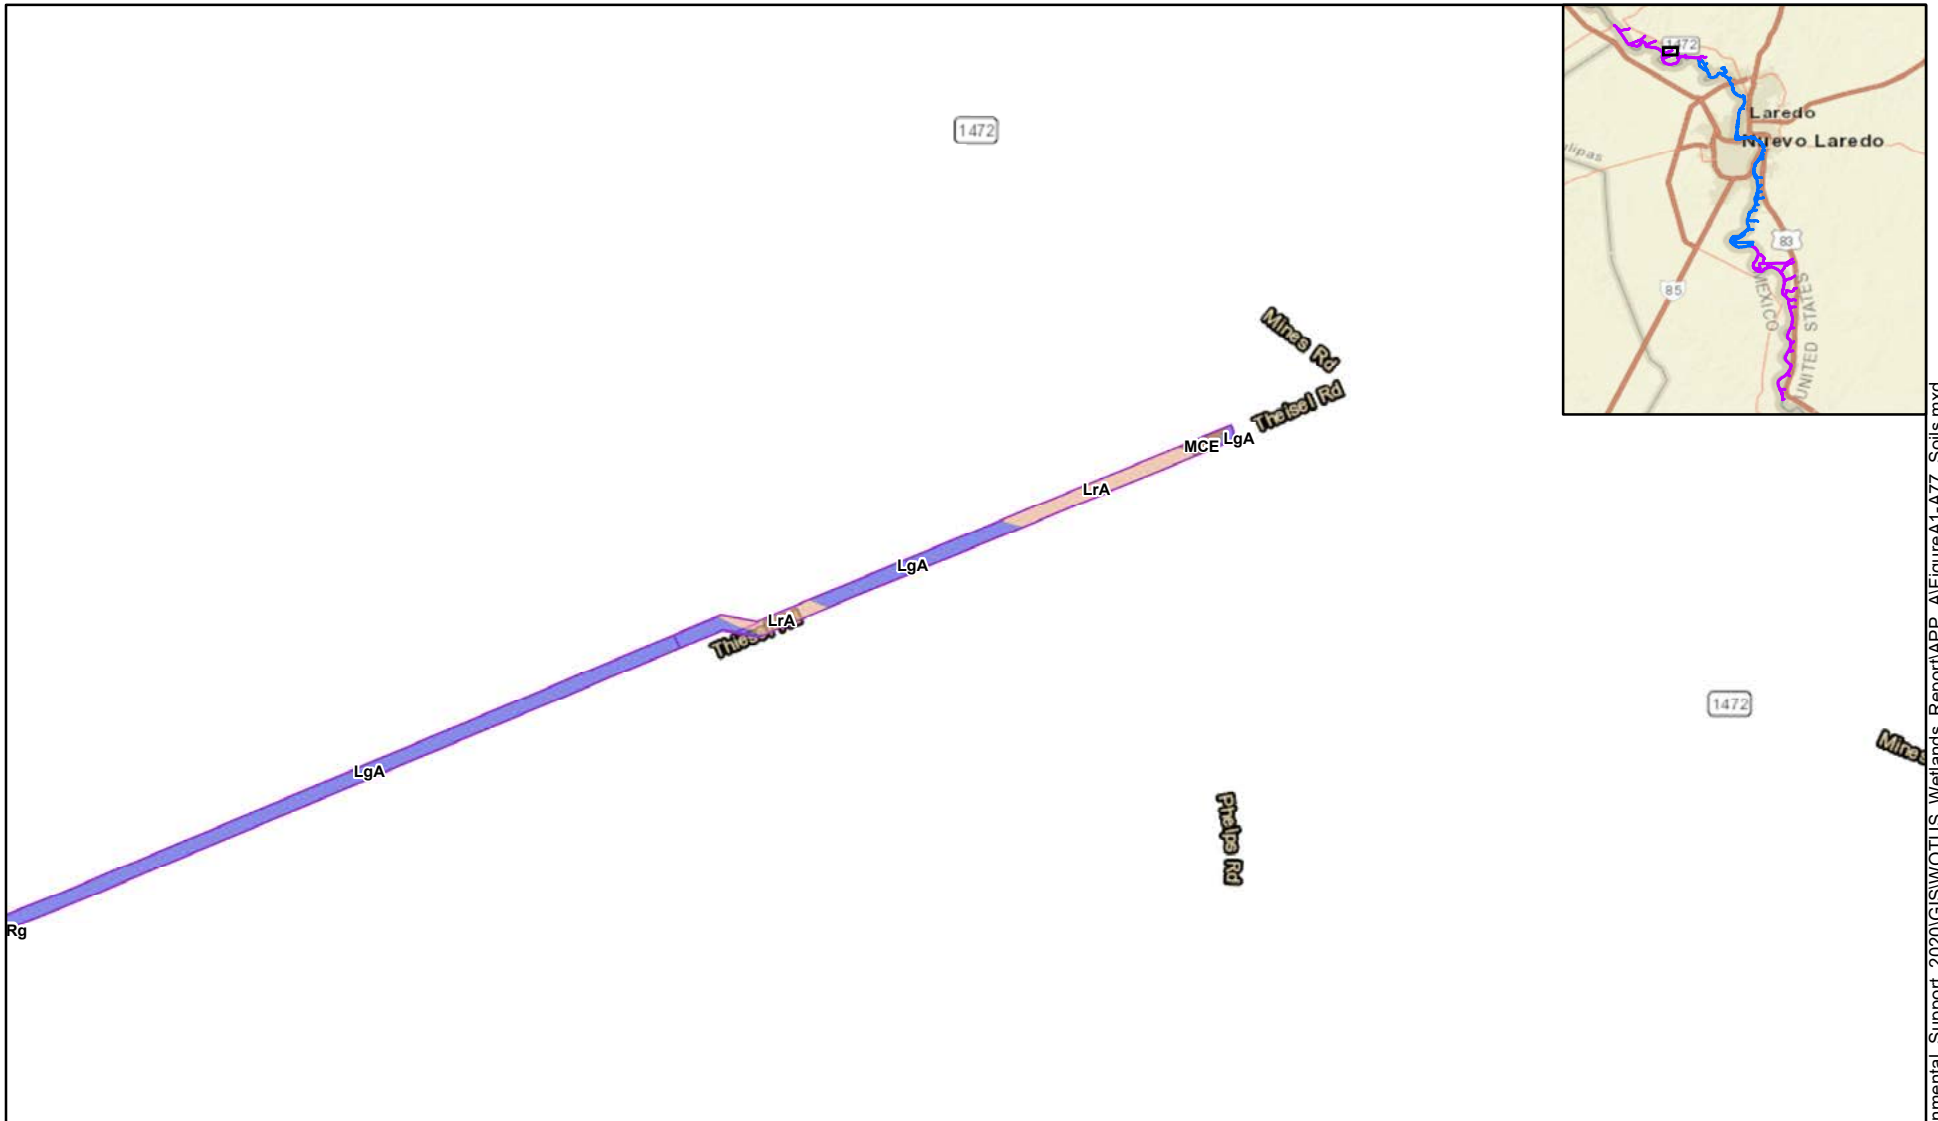
Figure A8. Soils Map - Phase II

Legend		
Laredo Roads Corridor	LgA, Lagloria loam, 0 to 1 percent slopes	MCE, Maverick-Catarina complex, gently rolling
LrA, Laredo silty clay loam, dry, 0 to 1 percent slopes, rarely flooded	Rg, Rio Grande very fine sandy loam, occasionally flooded	Phase II

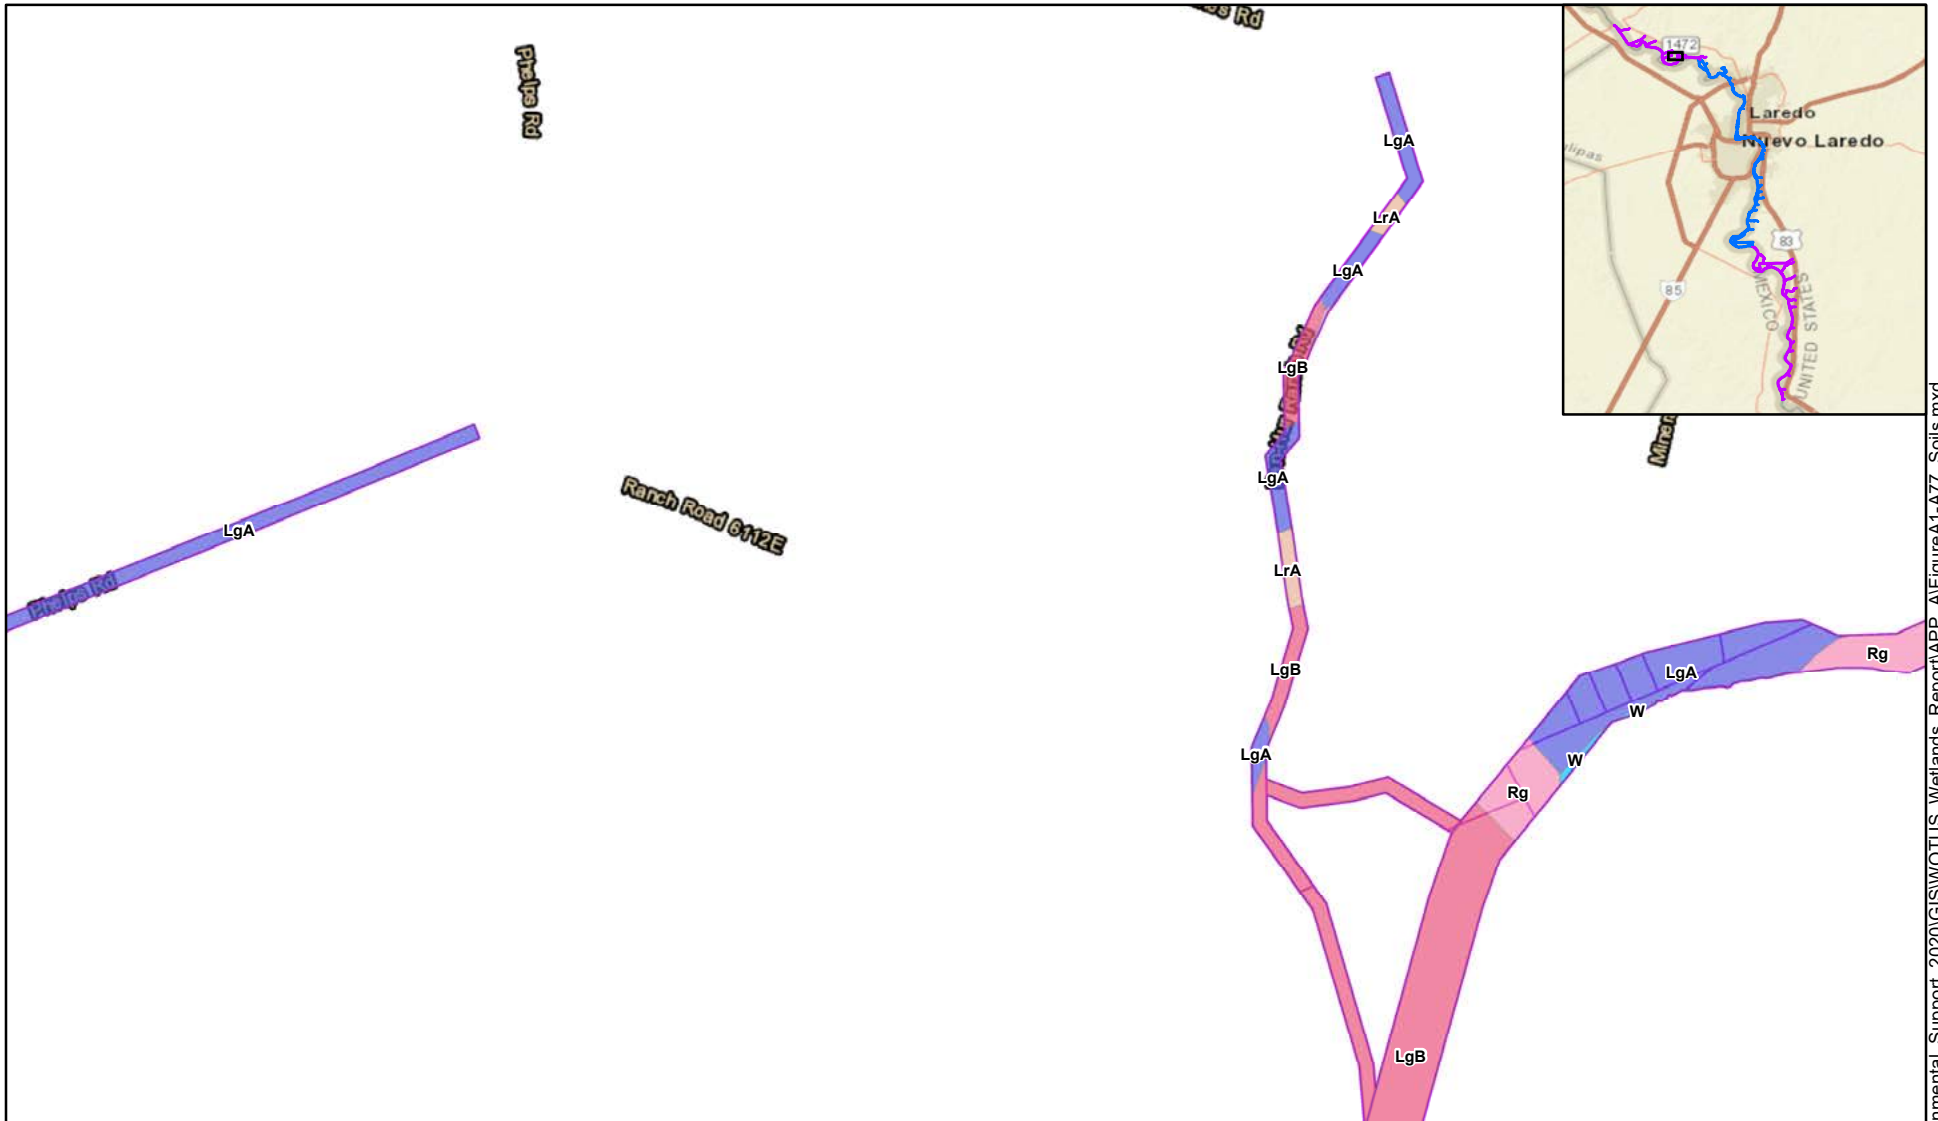
Figure A12. Soils Map - Phase II

- Laredo Roads Corridor
- LgA, Lagloria loam, 0 to 1 percent slopes
- LrA, Laredo silty clay loam, dry, 0 to 1 percent slopes, rarely flooded
- LgB, Lagloria loam, 1 to 3 percent slopes
- Rg, Rio Grande very fine sandy loam, occasionally flooded
- W, Water
- Phase II

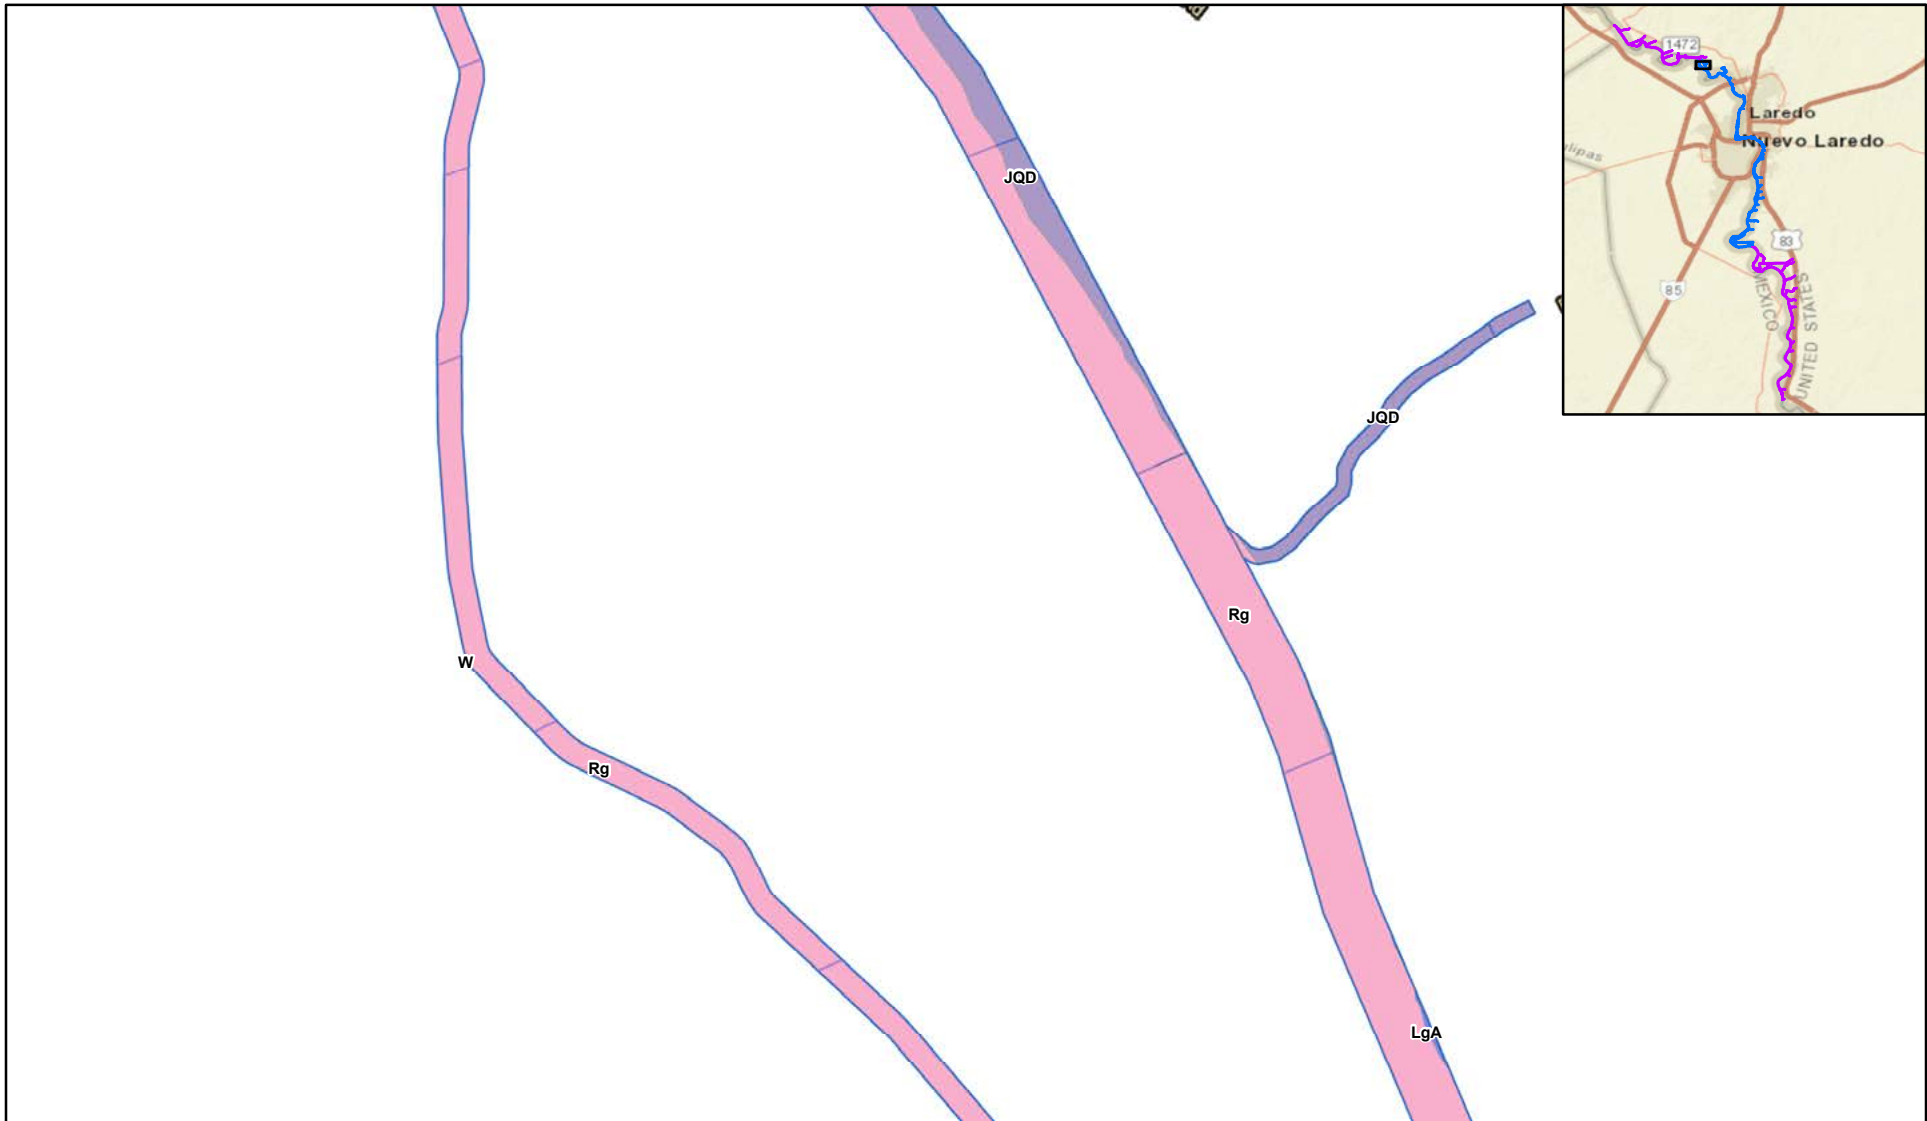
Figure A15. Soils Map - Phases I and II

Legend			
	Laredo Roads Corridor		Rg, Rio Grande very fine sandy loam, occasionally flooded
	JQD, Jimenez-Quemado complex, 1 to 8 percent slopes		LgA, Lagloria loam, 0 to 1 percent slopes
	W, Water		Phase I

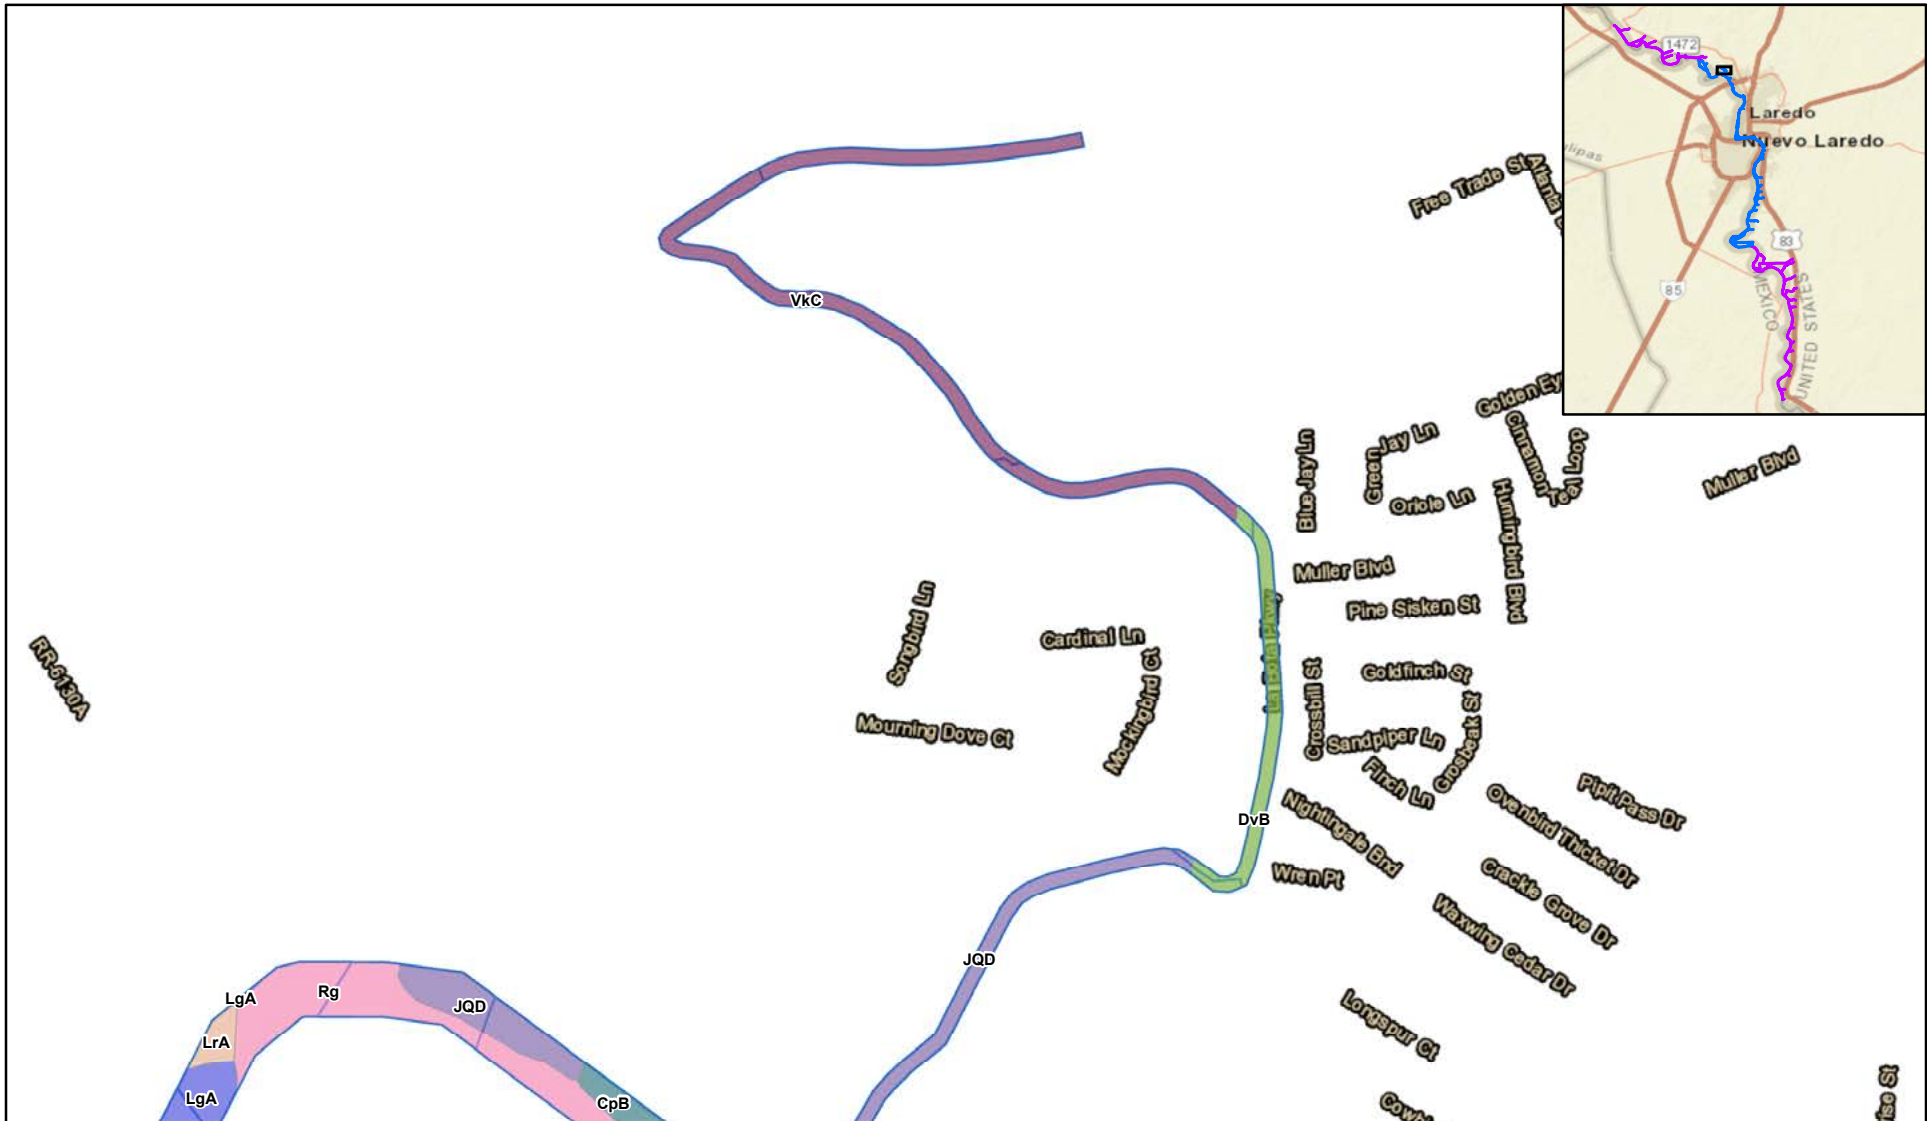
Figure A18. Soils Map - Phase I

Legend		
Laredo Roads Corridor	CpB, Copita fine sandy loam, 0 to 3 percent slopes	LrA, Laredo silty clay loam, dry, 0 to 1 percent slopes, rarely flooded
DvB, Duval very fine sandy loam, 0 to 3 percent slopes	Rg, Rio Grande very fine sandy loam, occasionally flooded	JQD, Jimenez-Quemado complex, 1 to 8 percent slopes
JQD, Jimenez-Quemado complex, 1 to 8 percent slopes	Vkc, Verick fine sandy loam, 1 to 5 percent slopes	LgA, Lagloria loam, 0 to 1 percent slopes
LgA, Lagloria loam, 0 to 1 percent slopes	Phase I

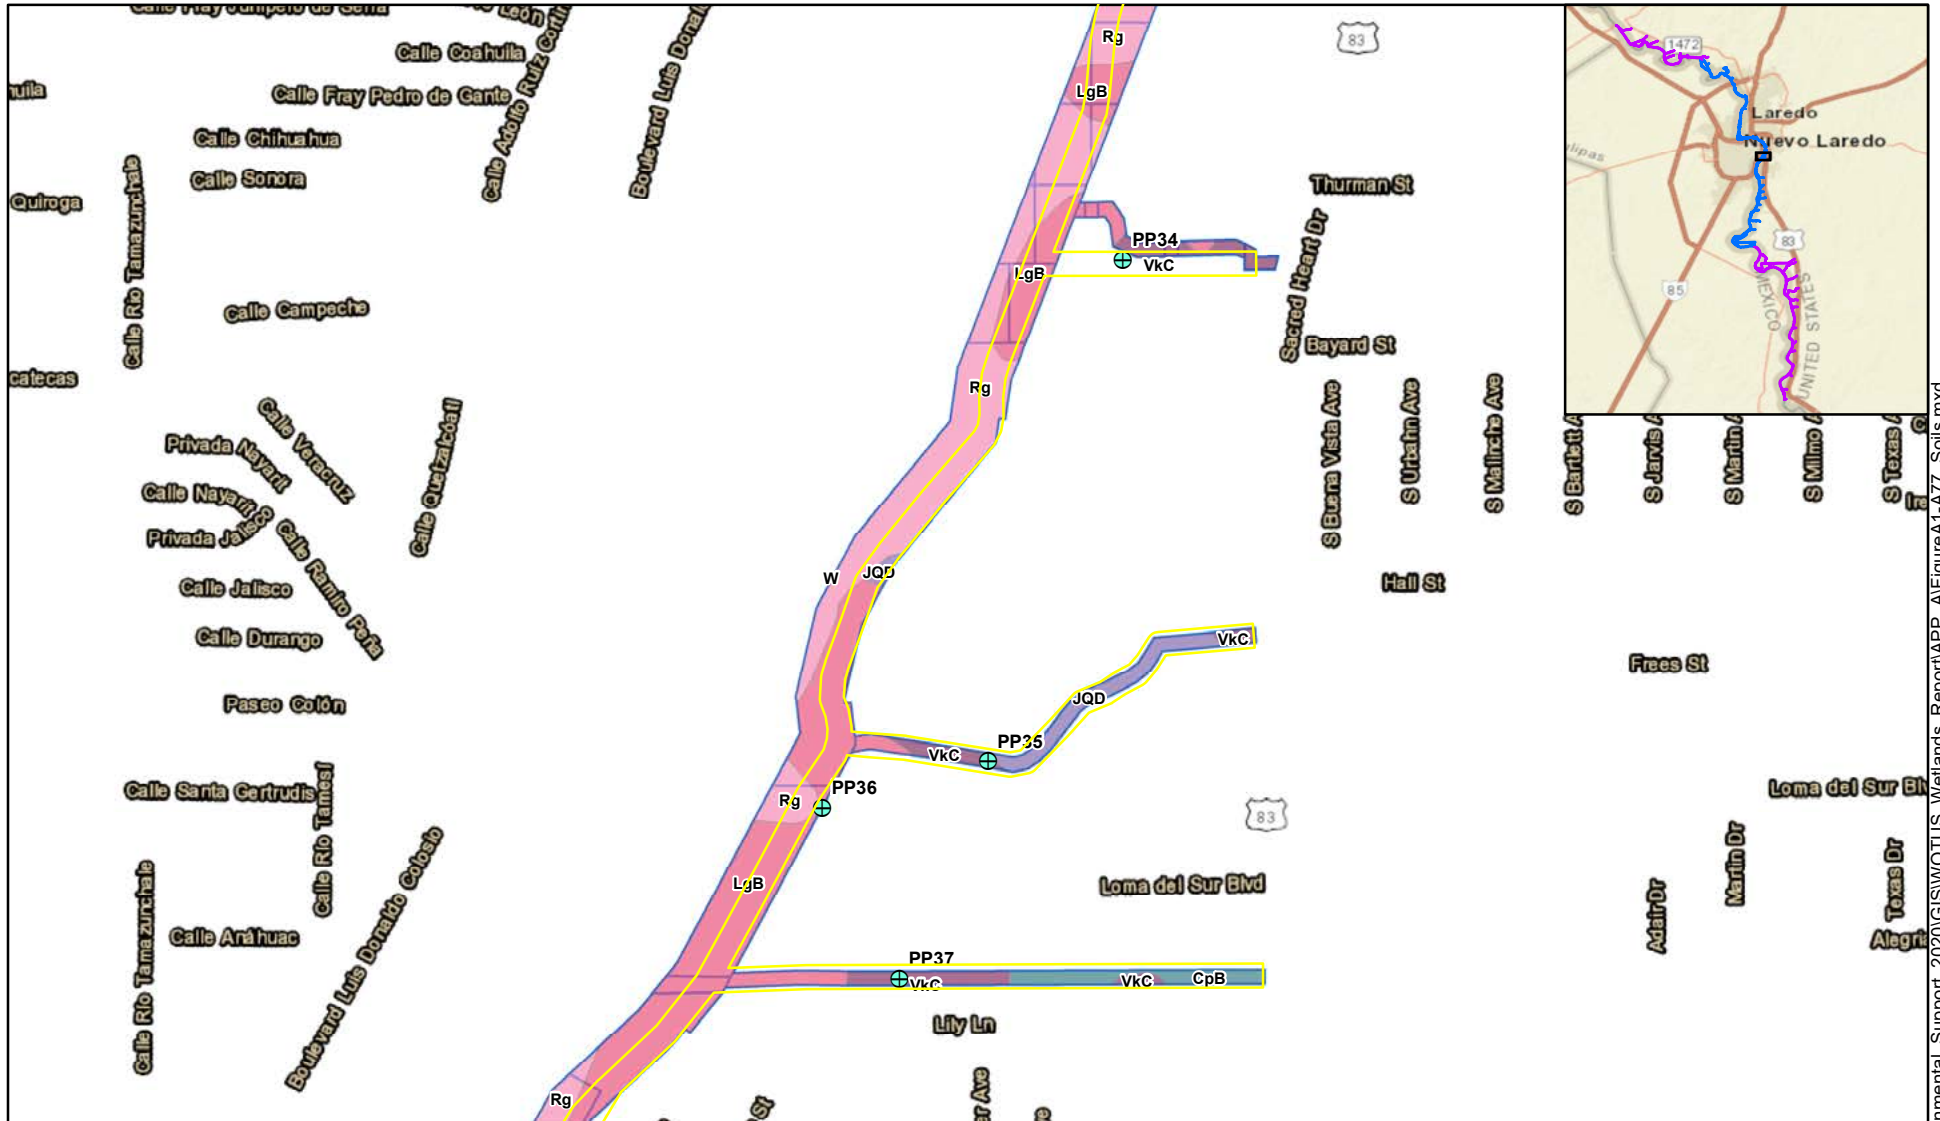
Figure A33. Soils Map - Phase I

- ⊕ Photo Point
- ▭ Laredo Roads Corridor
- CpB, Copita fine sandy loam, 0 to 3 percent slopes
- JQD, Jimenez-Quemado complex, 1 to 8 percent slopes
- LgB, Lagloria loam, 1 to 3 percent slopes
- Rg, Rio Grande very fine sandy loam, occasionally flooded
- Vkc, Verick fine sandy loam, 1 to 5 percent slopes
- W, Water
- Phase I

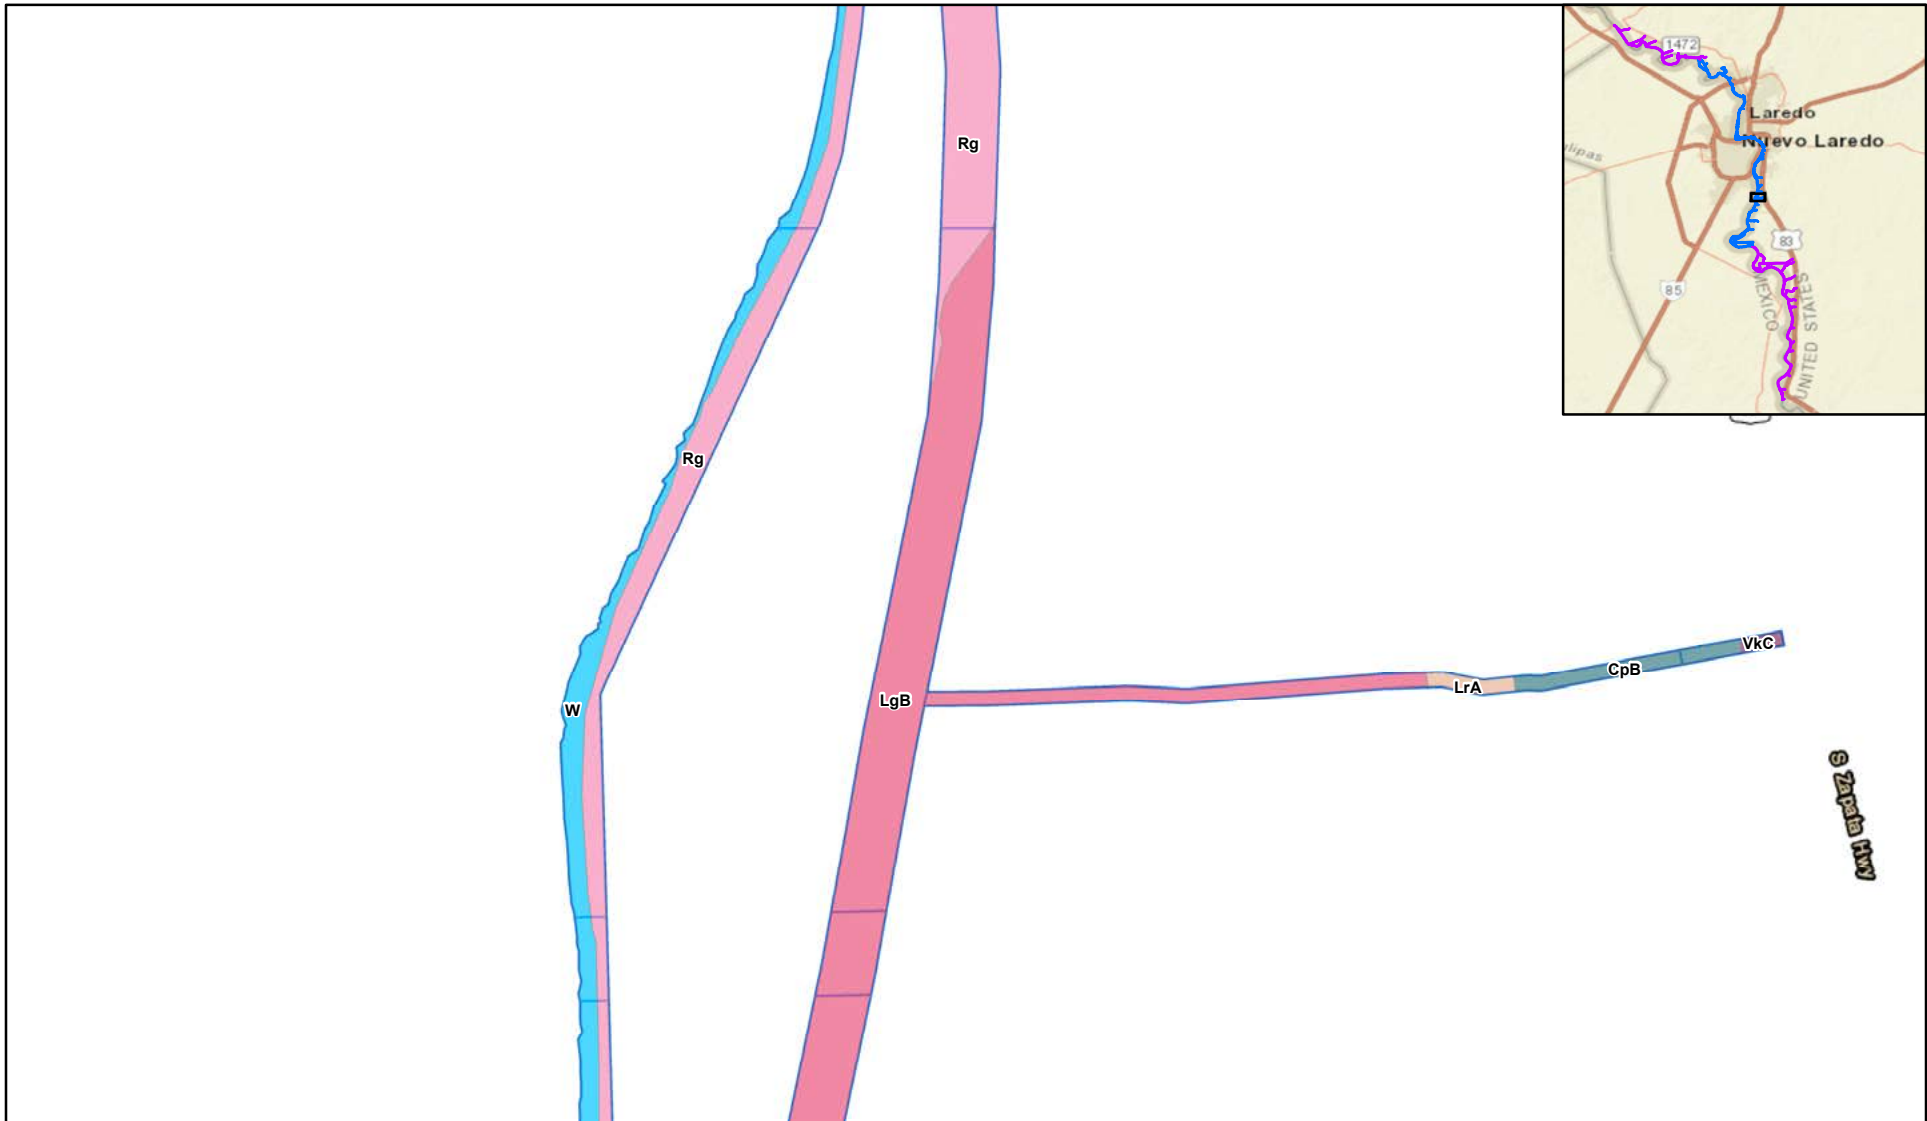
Figure A39. Soils Map - Phase I

Legend		
Laredo Roads Corridor	CpB, Copita fine sandy loam, 0 to 3 percent slopes	Rg, Rio Grande very fine sandy loam, occasionally flooded
LgB, Lagloria loam, 1 to 3 percent slopes	Vkc, Verick fine sandy loam, 1 to 5 percent slopes	W, Water
LrA, Laredo silty clay loam, dry, 0 to 1 percent slopes, rarely flooded	Phase I

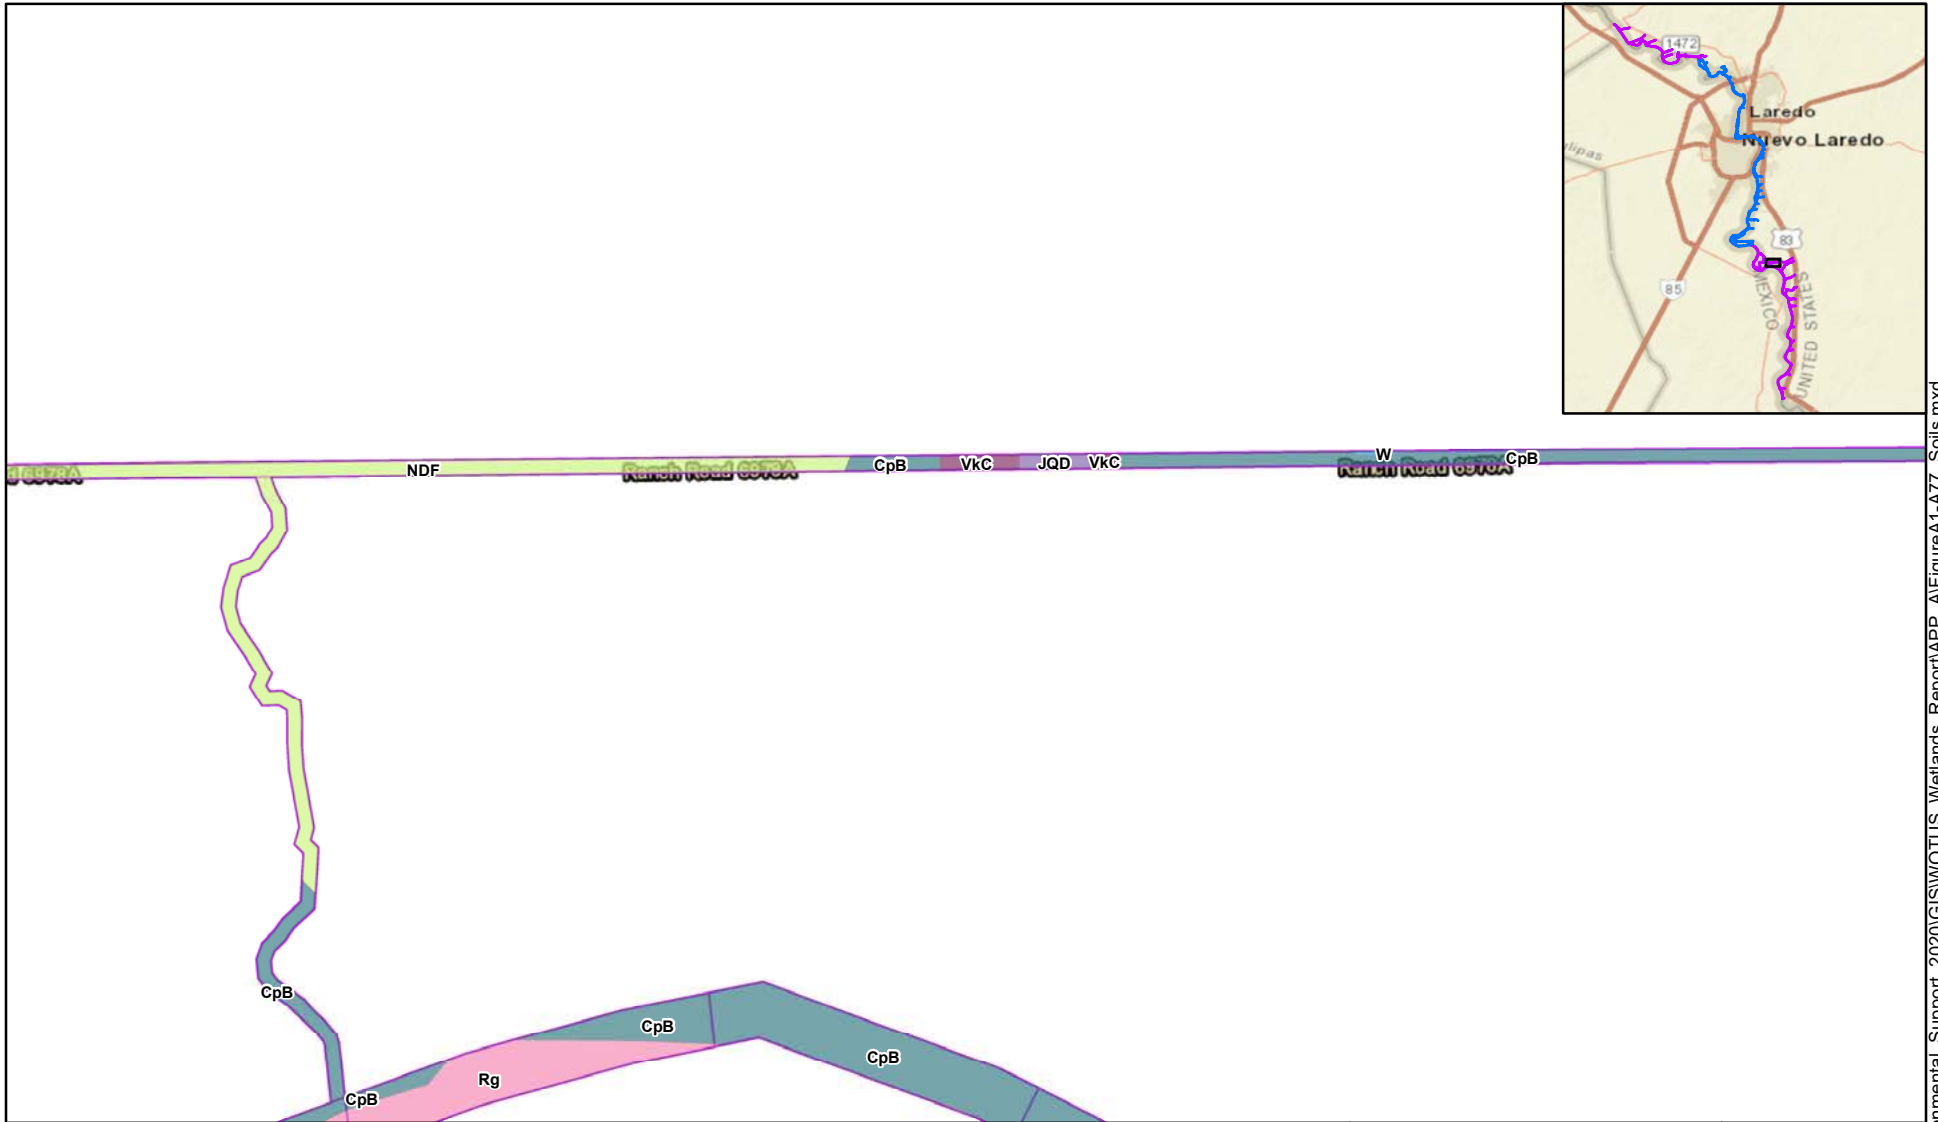
Figure A52. Soils Map - Phase II

- Laredo Roads Corridor
- CpB, Copita fine sandy loam, 0 to 3 percent slopes
- Rg, Rio Grande very fine sandy loam, occasionally flooded
- JQD, Jimenez-Quemado complex, 1 to 8 percent slopes
- VkC, Verick fine sandy loam, 1 to 5 percent slopes
- NDF, Nido-Rock outcrop complex, hilly
- W, Water
- Phase II

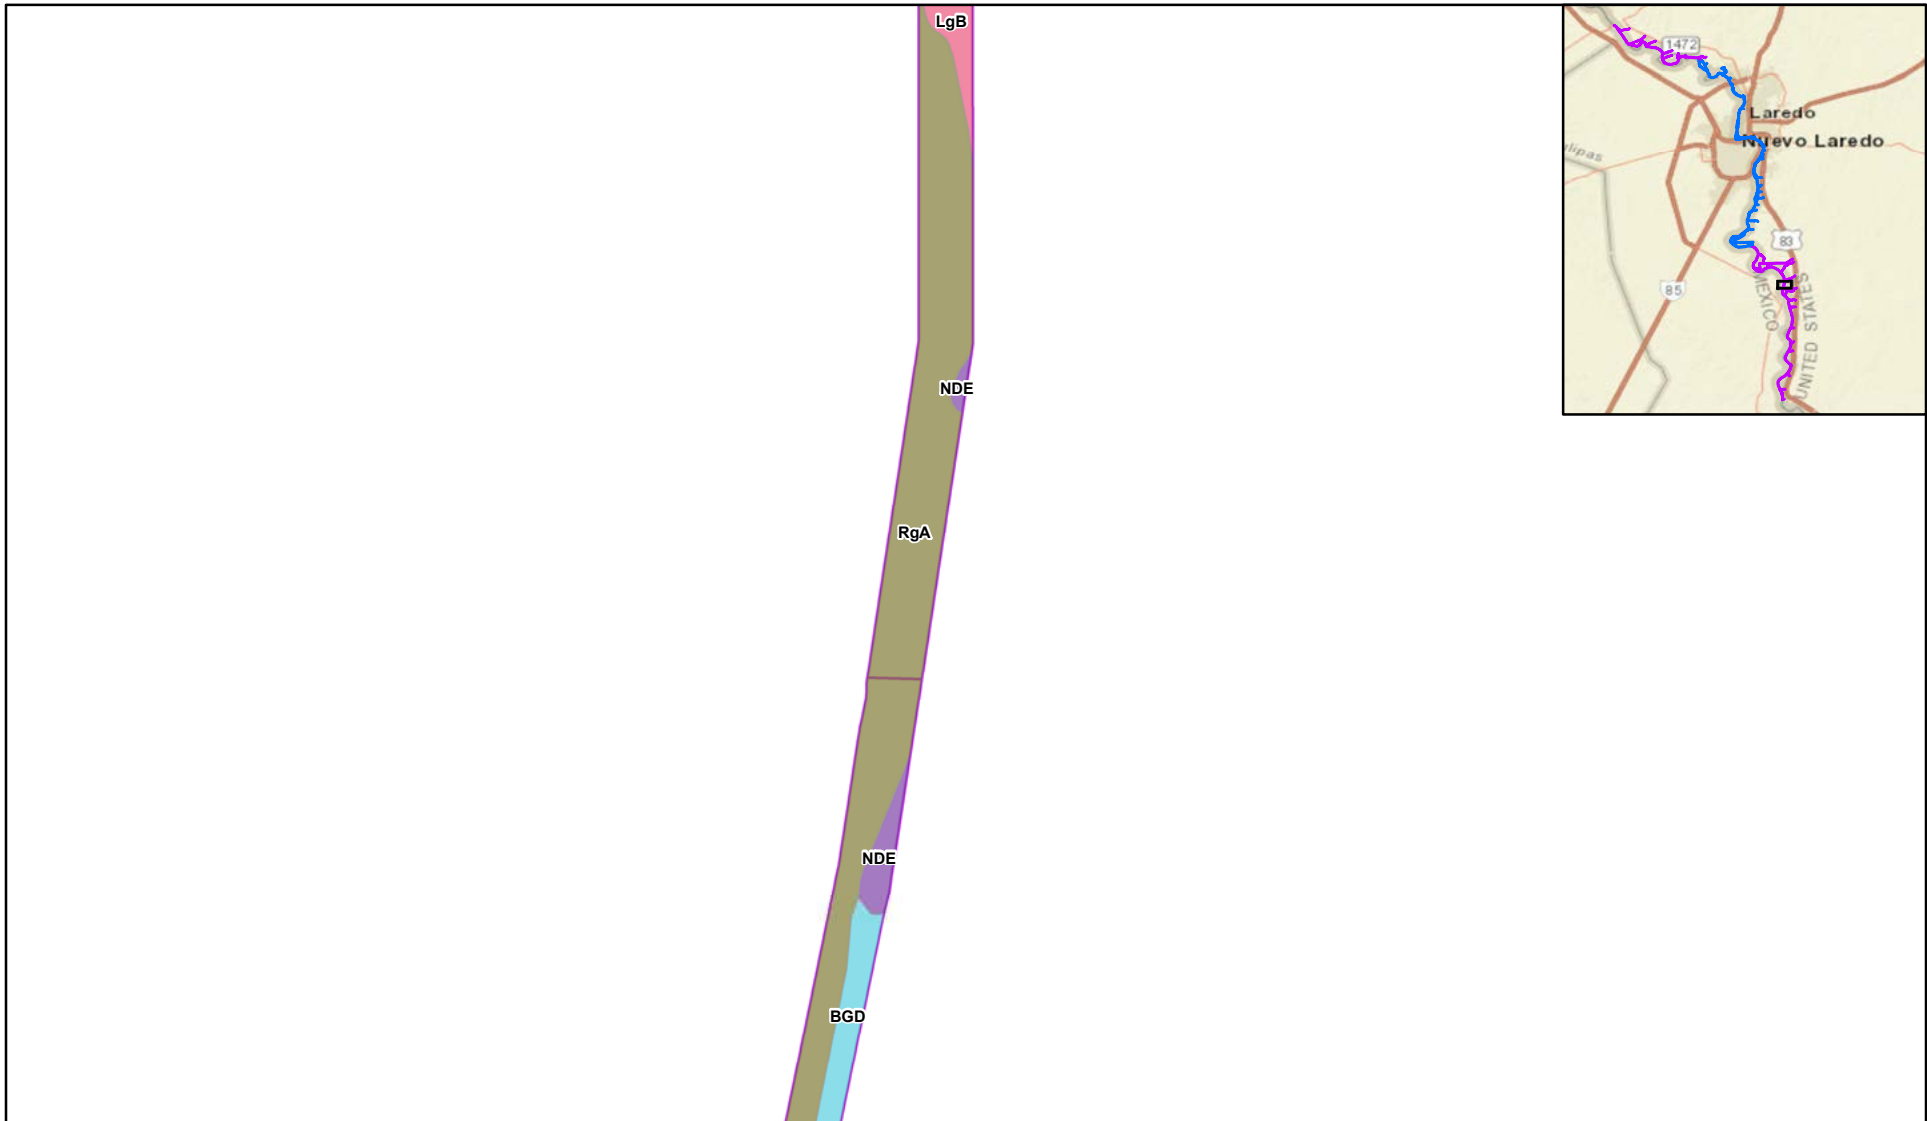
Figure A59. Soils Map - Phase II

Legend	
Laredo Roads Corridor	BGD, Brennan-Gullied land-Maverick association, 1 to 8 percent slopes, eroded
LgB, Lagloria loam, 1 to 3 percent slopes	NDE, Nido-Rock outcrop complex, 3 to 15 percent slopes
RgA, Rio Grande very fine sandy loam, 0 to 1 percent slopes, occasionally flooded	Phase II
