APPENDIX A

Public Consultation Materials

RE: Notice of Availability of Draft Environmental Assessment Roads Improvement Project, Laredo, Texas, Laredo Sector, U.S. Customs and Border Protection, Department of Homeland Security

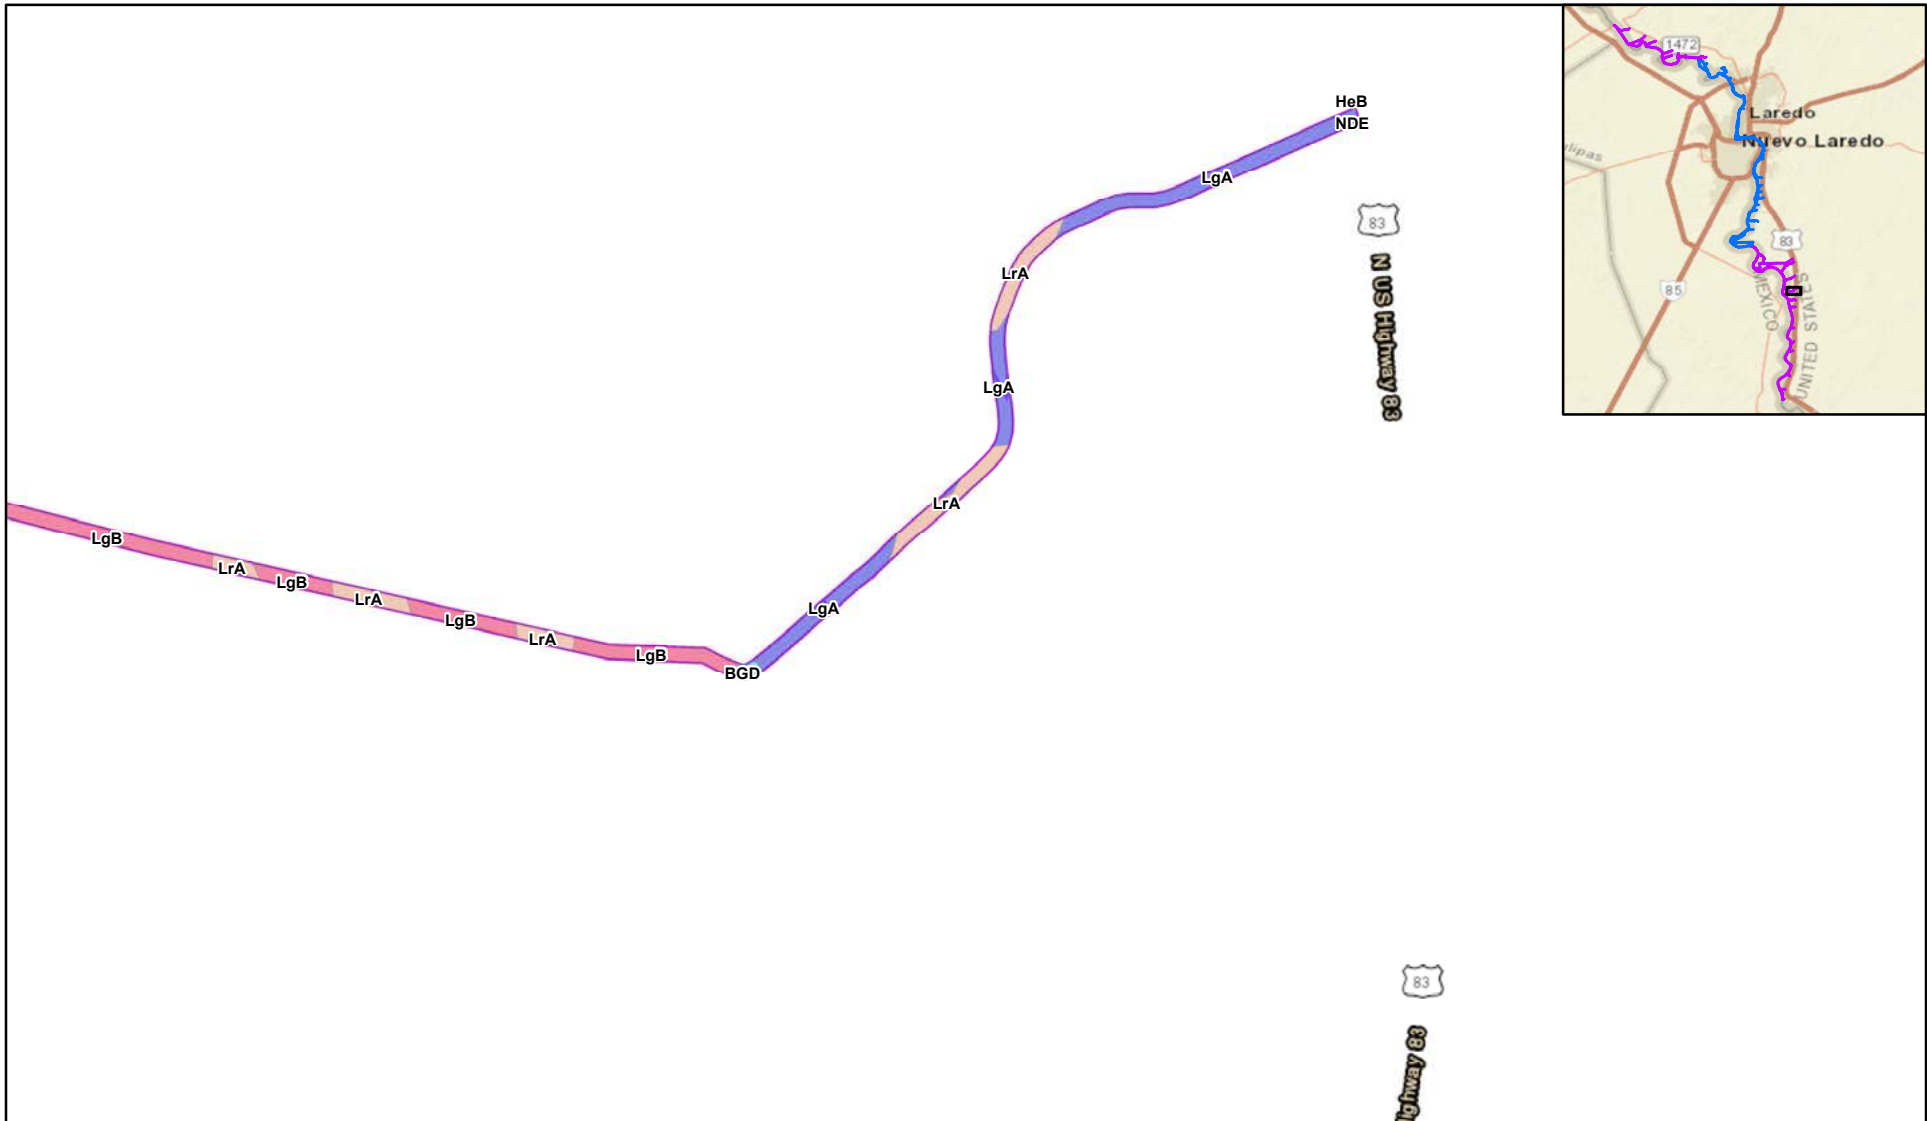
Figure A61. Soils Map - Phase II

Legend	
Laredo Roads Corridor	BGD, Brennan-Gullied land-Maverick association, 1 to 8 percent slopes, eroded
HeB, Hebbronville loamy fine sand, 0 to 3 percent slopes	LrA, Laredo silty clay loam, dry, 0 to 1 percent slopes, rarely flooded
LgA, Lagloria loam, 0 to 1 percent slopes	NDE, Nido-Rock outcrop complex, 3 to 15 percent slopes
	LgB, Lagloria loam, 1 to 3 percent slopes
	Phase II

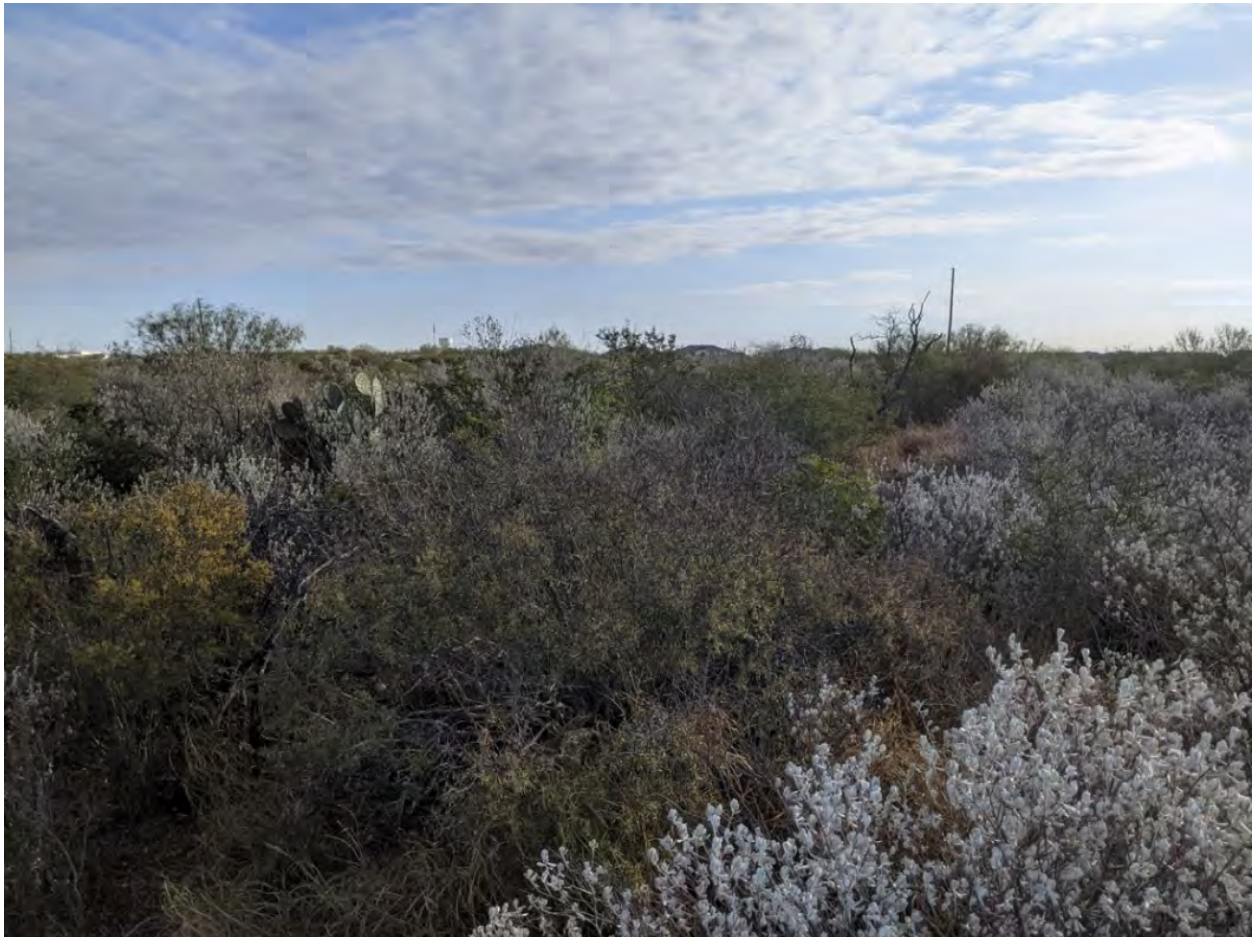
1 The Tamaulipan chaparral thornscrub community consists of thickets of stiff, xerophytic, usually
2 evergreen brush (Photograph 1). Dominant species include blackbrush acacia (*Vachellia rigidula*),
3 honey mesquite (*Prosopis glandulosa*), spiny hackberry (*Celtis ehrenbergiana*), guaiacum
4 (*Guaiacum angustifolium*), cenizo (*Leucophyllum frutescens*), lotebush (*Ziziphus obtusifolia*),
5 Texas prickly pear (*Opuntia engelmannii*), Christmas cholla (*Cylindropuntia leptocaulis*),
6 *Condalia* spp., and *Castela* spp. (Jahrsdoerfer and Leslie 1988). Tamaulipan thornscrub provides
7 important habitat for a rich diversity of wildlife.

**Photograph 1. Characteristic Tamaulipan thornscrub
habitat within the Project Corridor.**

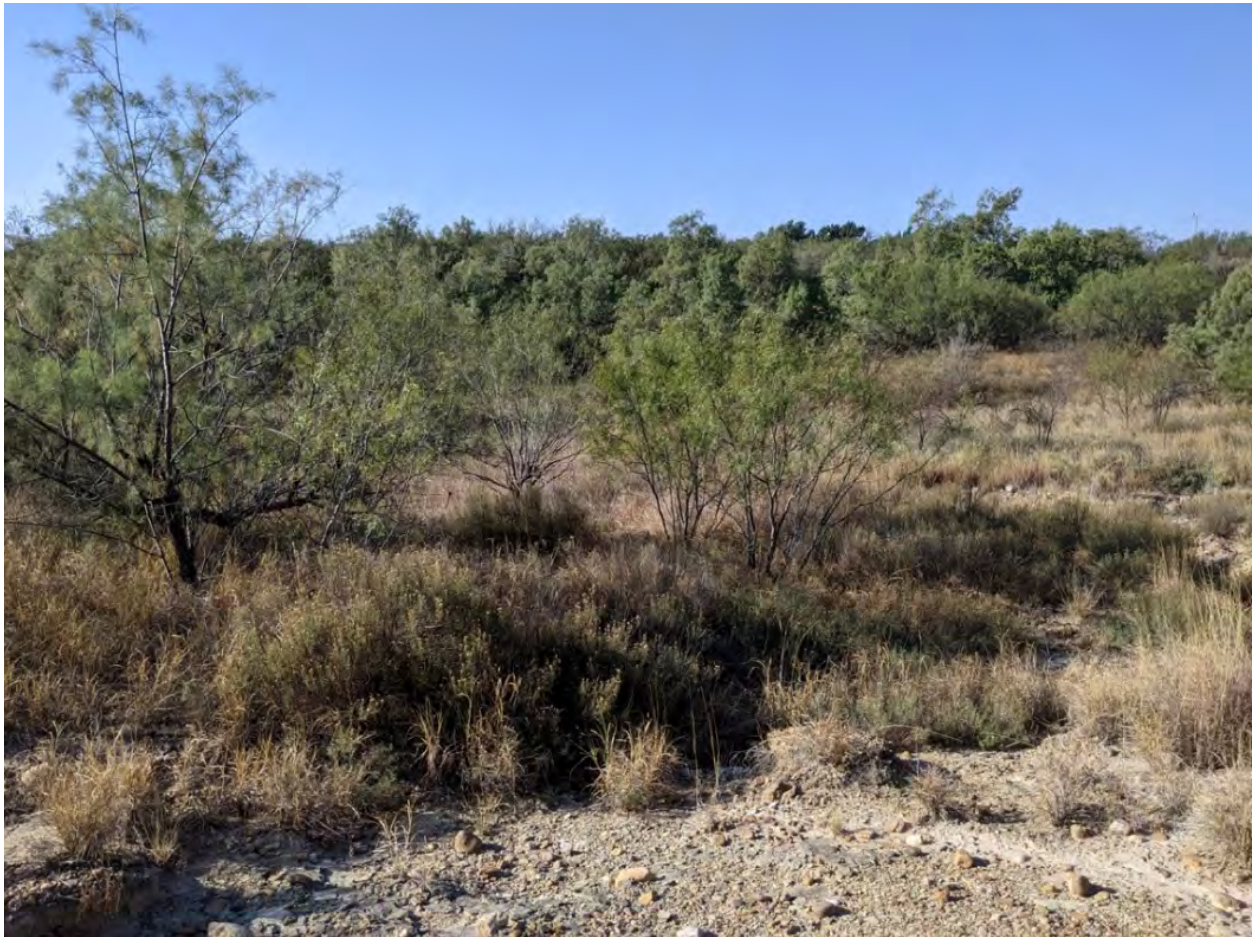
Mesquite savanna/woodland consists of an open savannah-like bosque containing scattered honey mesquite and, less commonly, Texas ebony (*Ebenopsis ebano*) trees with a grassland/herbaceous understory (Photograph 2). This community resembles Tamaulipan mezquital woodland habitat

1 with a more prevalent grassland and sparser overstory. Due to heavy grazing and other disturbance,
2 much of the curly mesquite grass (*Hilaria belangeri*) that historically dominated the understory of
3 the mezquital habitat has been removed and replaced by non-native grasses such as buffelgrass
4 (*Cenchrus ciliaris*) and Guinea grass (*Panicum maximum*), as well as encroaching brush and cacti.
5 The shrub layer may include plants such as desert olive (*Forestiera angustifolia*) and lotebush.
6 Hardwood trees and understory forbs may be present but do not make up the dominant cover. This
7 habitat type provides moderate wildlife value depending on its successional development.

**Photograph 2. Characteristic mesquite savanna/woodland
habitat within the Project Corridor.**

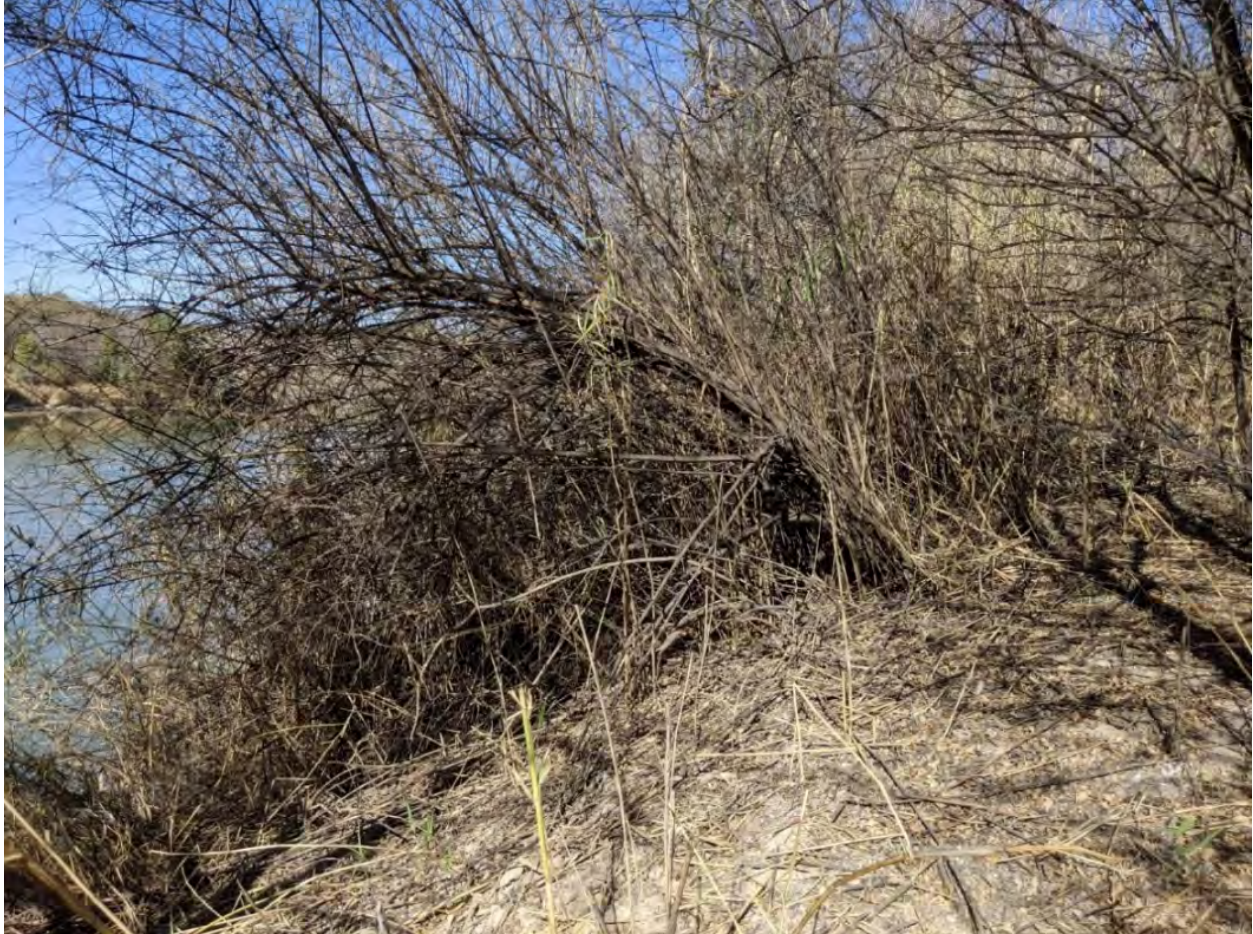
affect the following federally listed species: ashy dogweed, Zapata bladderpod, Texas hornshell, jaguarundi, and ocelot. BMPs will be observed.

Respectfully,

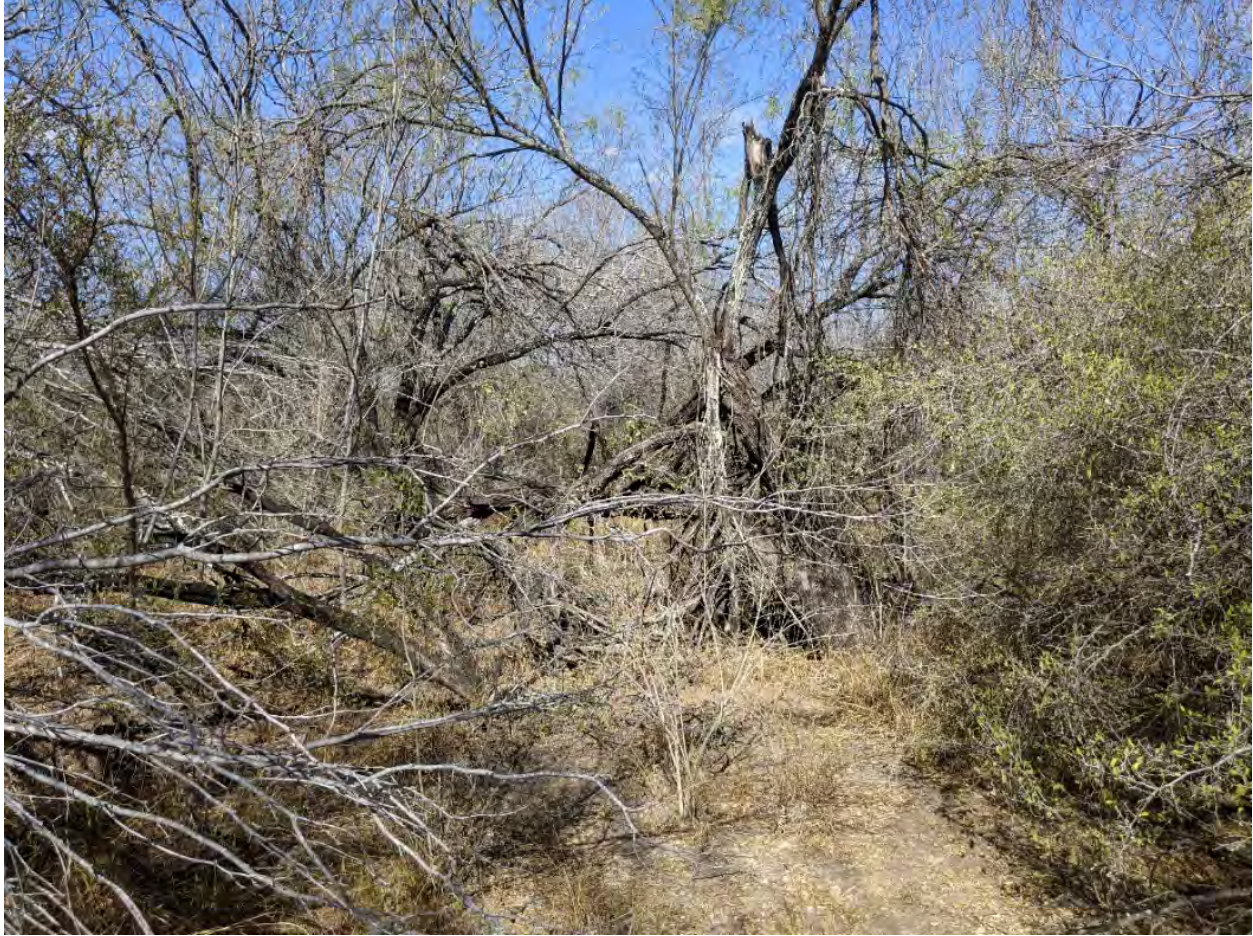
Dear Ms. Barnes:

The existing patrol road is split into two separate segments of 7.5 miles and 6.7 miles within USBP Laredo North and Laredo South sectors, respectively. The Laredo North patrol road begins approximately 1 mile south of the World Trade Bridge Port of Entry (POE) and runs south along the U.S./Mexico international border stopping at the Texas Mexican Railway International Bridge POE. The Laredo South patrol road begins at the Juarez-Lincoln POE and runs south along the U.S./Mexico international border stopping approximately one-half of a mile south of the Laredo College South Campus. In addition to road improvements, the Proposed Action includes the construction of three bridges, multiple low water crossings, and pipe/culvert drainage crossings.

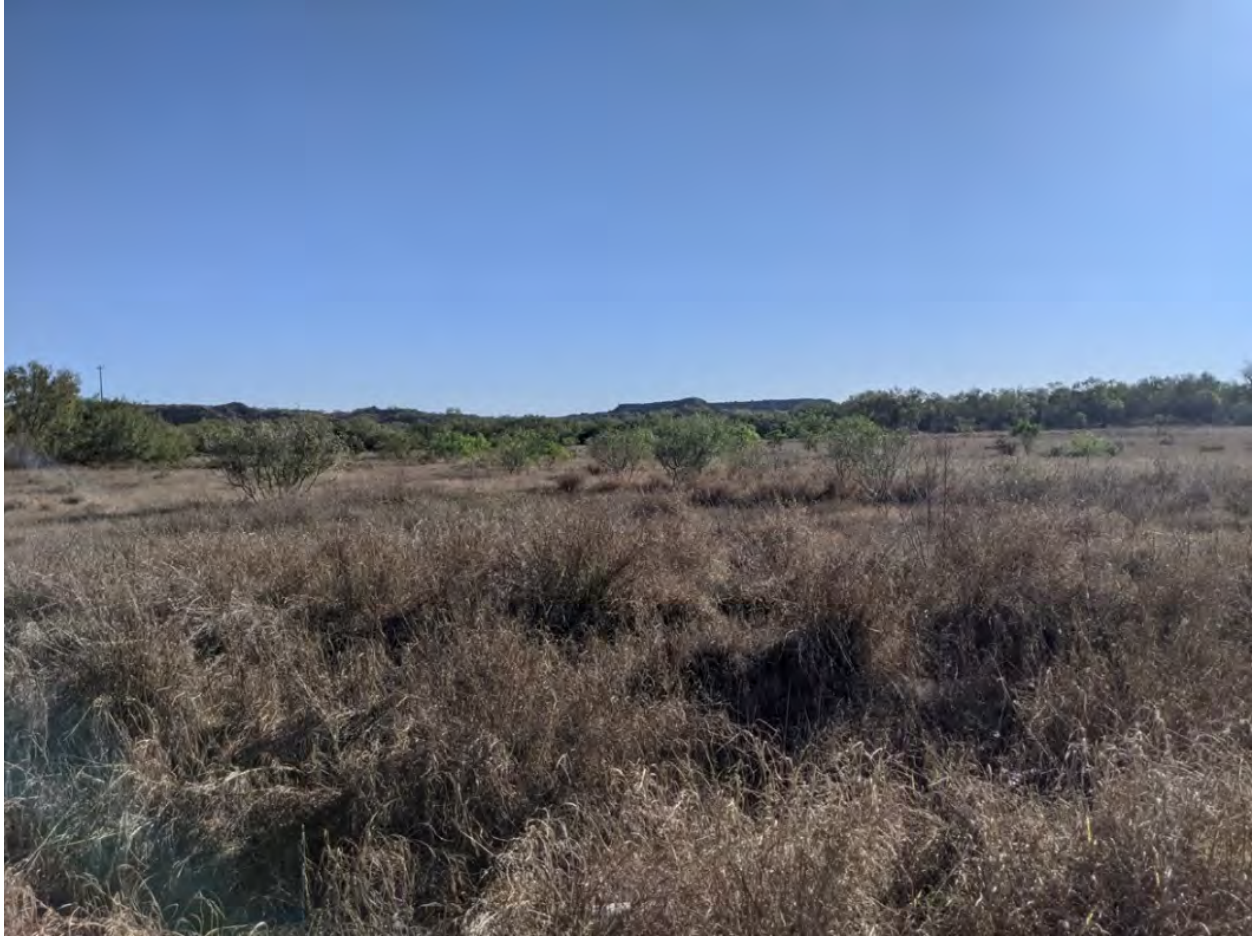
Bridges would be constructed across Las Manadas Creek, Zacate Creek, and Chacon Creek. All necessary materials such as gravel, topsoil, or fill would be imported to the site. No on-site materials will be used except for material within the existing roadway. To the maximum extent practicable, all material sources would be certified weed-free. The Rio Grande between Eagle Pass and Laredo is considered to be currently occupied by Texas hornshell mussel (TWPD 2014). Critical habitat has been designated for this species in the Rio Grande, approximately 0.25 miles north (upstream) of the project area (Chacon Creek) where a large population of Texas hornshell mussels are found.

- Creek flow could be temporarily diverted around active construction areas, providing that downstream flow rates are not reduced.
- After construction, the FC-2 all-weather road would be topped with an application of non-toxic soil stabilizer (e.g., Lignin, Soiltac, Environtec, or other suitable soil stabilizer) to minimize sediment runoff from the finished road into adjacent aquatic habitats. Soil stabilizer would be reapplied following any road maintenance that disturbs the roadbed surface in the area of the disturbance; when the road surface shows signs of wear and erosion, leading to sediment runoff into adjacent aquatic habitats; or at a minimum annual reapplication to maintain the surface. The soil stabilizer used to top the upgraded FC-2 all-weather road will be confirmed by aquatic wildlife specialists to be non-toxic to freshwater mussels and host fish species that are integral to the Texas hornshell lifecycle to prevent long-term adverse impacts to Texas hornshell.

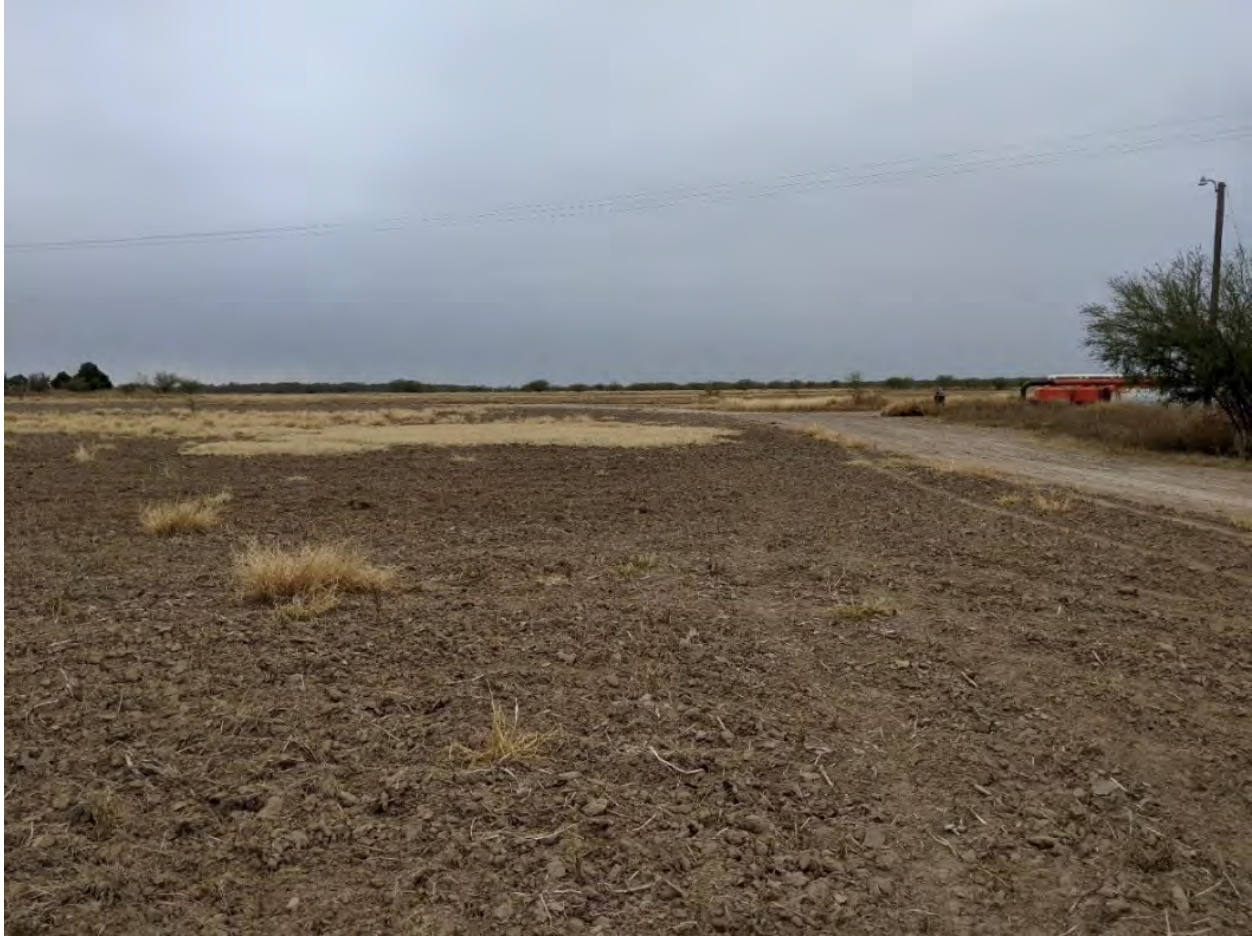
The agricultural field community type includes active or recently fallow cropland, and ruderal species growing amongst the crop rows such as low amaranth (*Amaranthus polygonoides*), Pennsylvania cudweed (*Gamochaeta pennsylvanica*), and false ragweed (*Parthenium hysterophorus*) (Photograph 8).

1
2 **Photograph 8. Characteristic agricultural field within the Project Corridor.**
