# ENVIRONMENTAL STEWARDSHIP SUMMARY REPORT

for the Construction, Operation, and Maintenance  
of Vehicle Fence and Related Tactical Infrastructure  
Sections EV-1A/EV-1B and FV-1B,  
Sonoita Station and Douglas Station,  
U.S. Border Patrol Tucson Sector,  
Arizona

July 2012

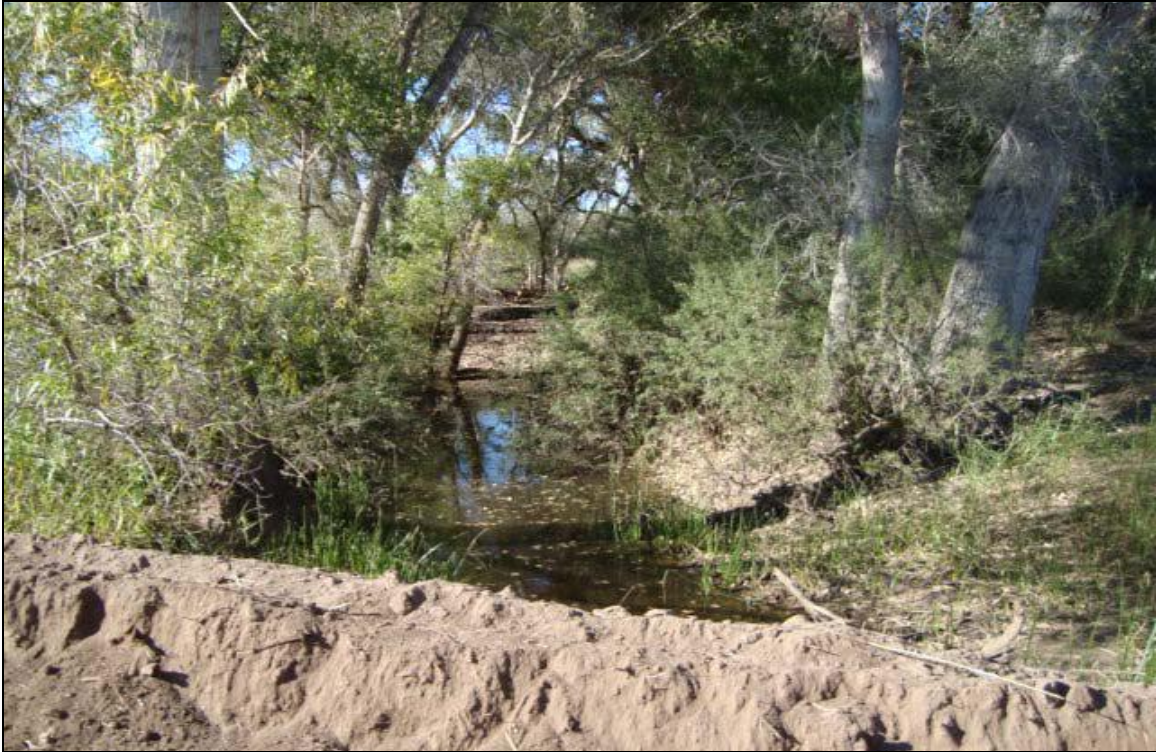
Two incidents occurred during construction. In the first, on October 20, 2008, a bulldozer operator worked past the end point of the area surveyed by the environmental monitor and authorized for vegetation removal (see Figure 2-5). The operator bulldozed a path through the bottom of Black Draw. The environmental monitor was observing vegetation removal activities elsewhere on the section and did not witness the event. Shortly after the incident, the monitor arrived at Black Draw and observed small fish both upstream and downstream from the bulldozed area, but was unable to get close enough to identify the species. The monitor was also unable to verify whether any federally listed species were harmed by the incident.

**Figure 2-5. Photograph of Unauthorized Work in Black Draw in Section FV-1B**

The BRP indicated that three federally listed fish species occur in Black Draw, but these species were not identified. USFWS information indicated that there were known occurrences of the beautiful shiner, Yaqui catfish, Yaqui chub, and Yaqui topminnow in Black Draw, a tributary of the Rio Yaqui Basin. Three of these species, the beautiful shiner, Yaqui catfish, and Yaqui chub, were listed with designated critical habitat, and the clearing activities affected this critical habitat.

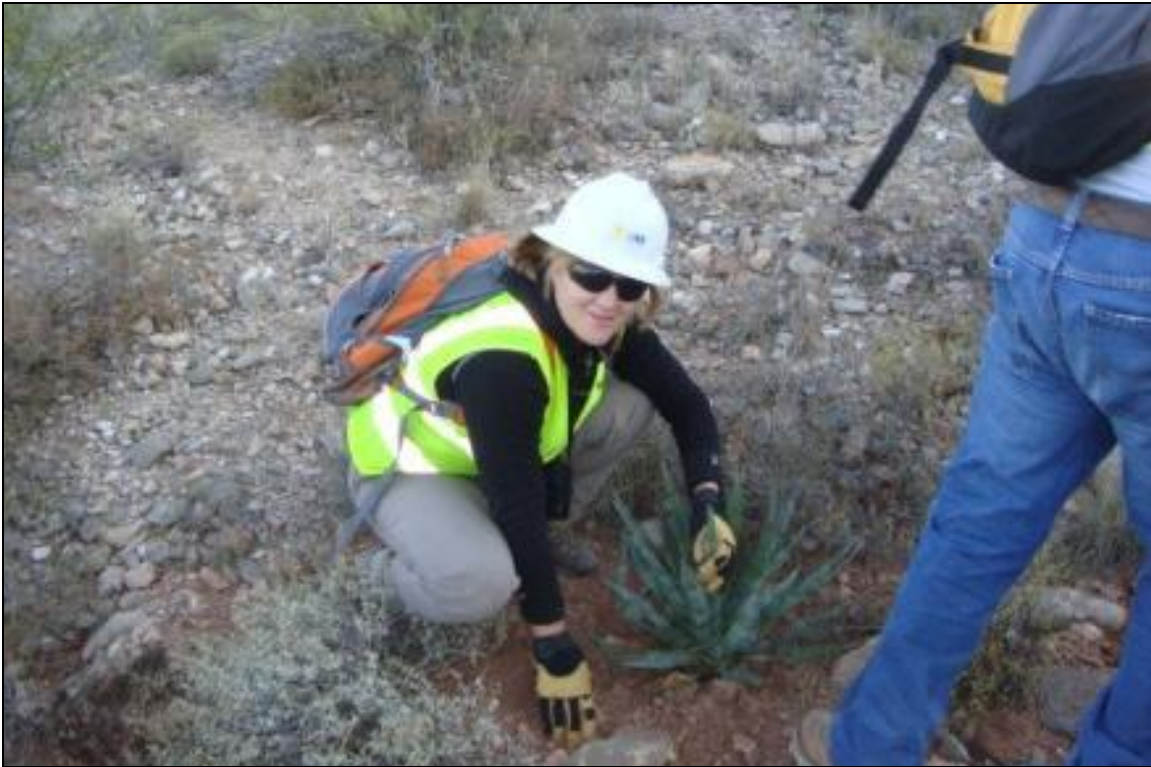
As was the case for EV-1B, environmental stewardship collaboration resulted in lower than expected impacts on agave (*Agave palmeri*) plants, a forage species for the endangered lesser long-nosed bat (*Leptonycteris curasoae*) than originally expected. While no formal salvage plan was developed, the construction contractor and environmental monitor worked together to salvage individual agave plants found within the project corridor. A salvage protocol developed for Section E-2A was used for the salvage activities. The environmental monitor worked ahead of the clearing and grubbing equipment to flag salvageable plants (those less than 18 inches in diameter). Construction crew members and the environmental monitor transplanted 33 agave plants from the construction path in Section FV-1B into nearby similar habitat (see Figure 2-6).

**Figure 2-6. Photograph of Agave Relocation in Section FV-1B**

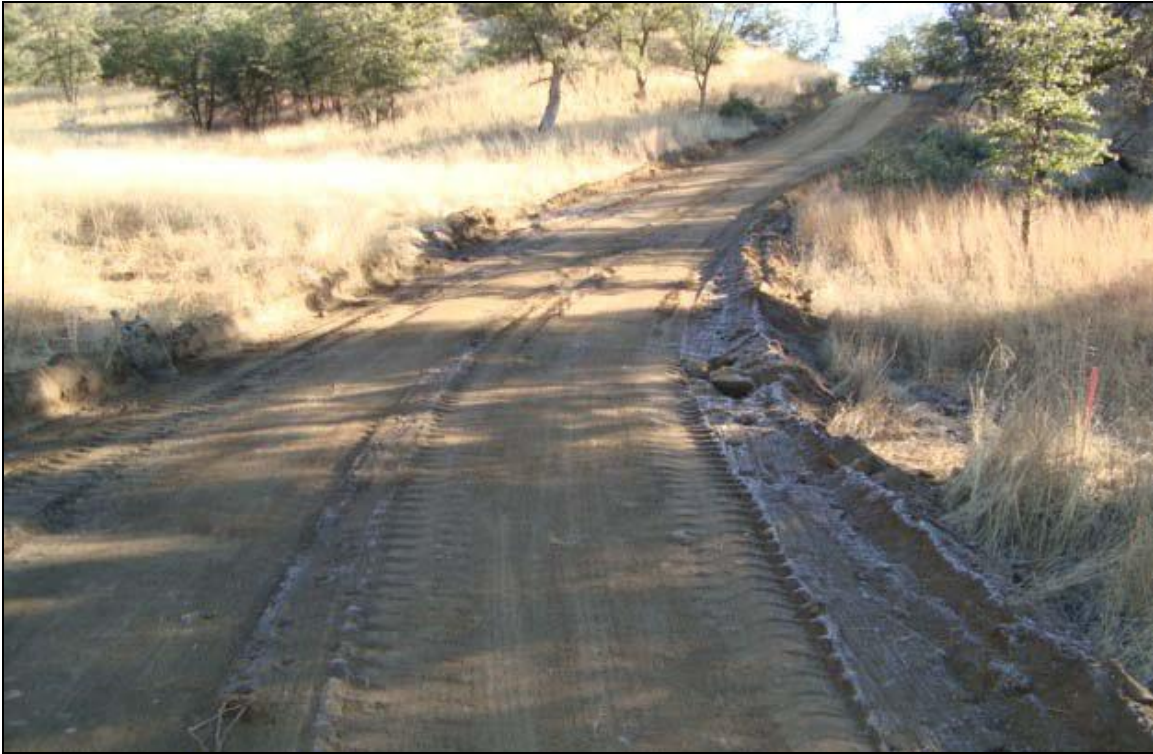
No new access roads were planned in the ESP, which anticipated that existing access roads would be adequate for construction in Section EV-1B. However, additional construction was required for turnaround areas along existing access roads, and one unnamed access road required widening for a portion of its length to accommodate construction traffic. Additionally, an access road outside the construction corridor had to be created around a rock outcrop on the fence line (see Figure 3-3). The post-construction survey found the actual area of new access road to be 0.37 acre, which is 0.37 acre more than the proposed design in the ESP.

**Figure 3-3. Photograph of Access Road for Section EV-1B**

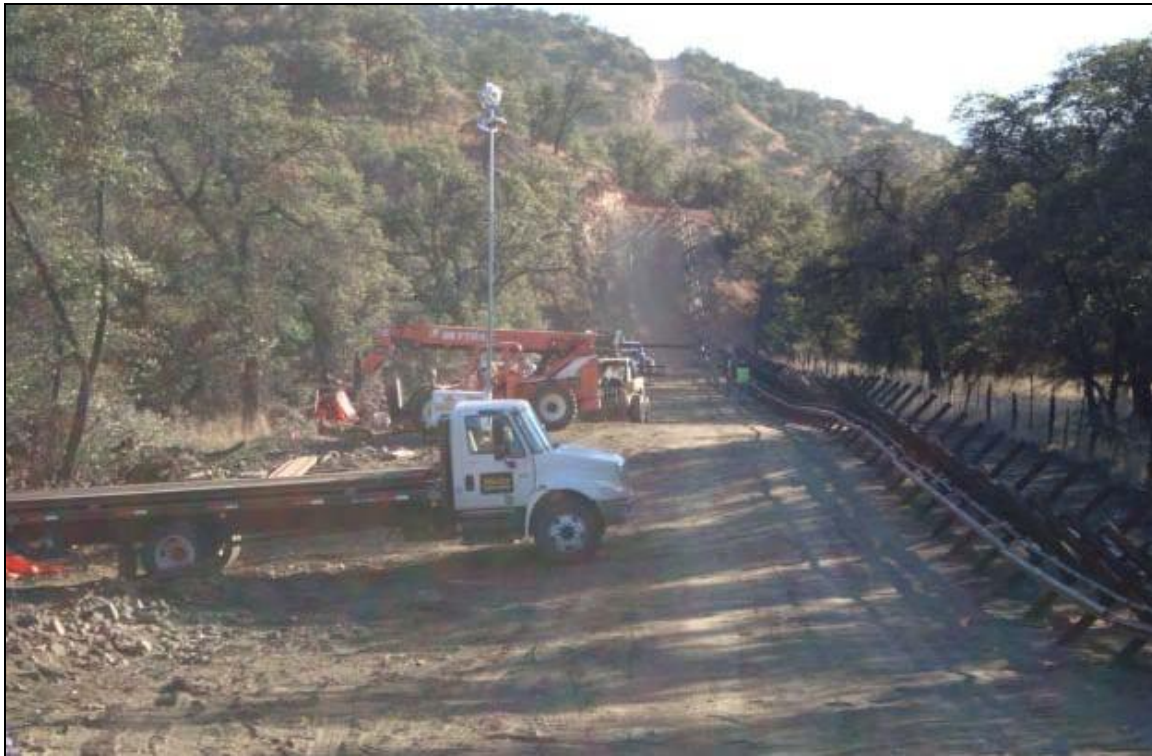
The analysis in the ESP indicated that the construction corridor for Section EV-1B could require ground disturbance up to 120 feet north of the U.S./Mexico international border due to the rugged terrain (see Figure 3-4). According to the post-construction survey, the contractor used an area significantly narrower than the allowed construction design. The ESP indicated that the designed construction corridor for EV-1B contained 40.1 acres. The post-construction survey calculated the actual affected area to be 18.88 acres, which is 21.22 acres less than anticipated.

**Figure 3-4. Photograph of Section EV-1B Fence Construction on Steep Terrain**

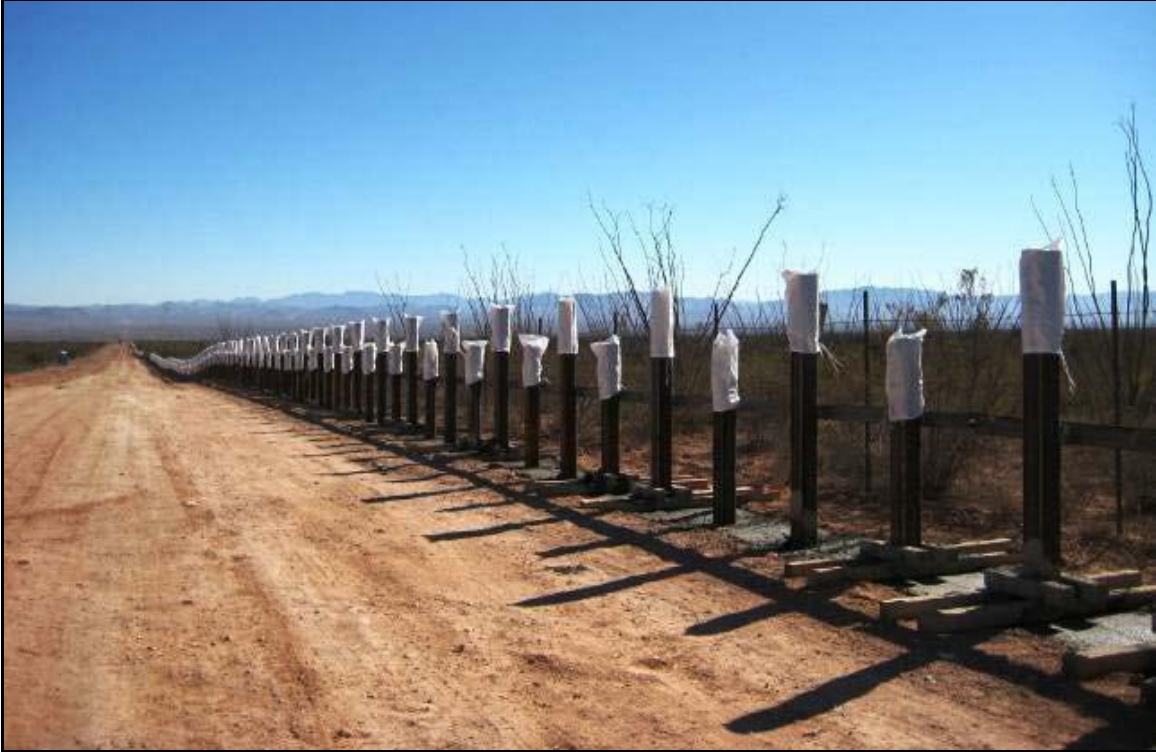
The ESP indicated that the 60-foot-wide construction corridor for Section FV-1B contained 120 acres (see Figure 3-5). According to the post-construction survey, the contractor used an area narrower than the design allowed. The post-construction survey calculated the actual affected area to be 118.84 (see Figure 3-1), which is 1.16 acres less than anticipated.

**Figure 3-5. Photograph of Section FV-1B Fence Construction**

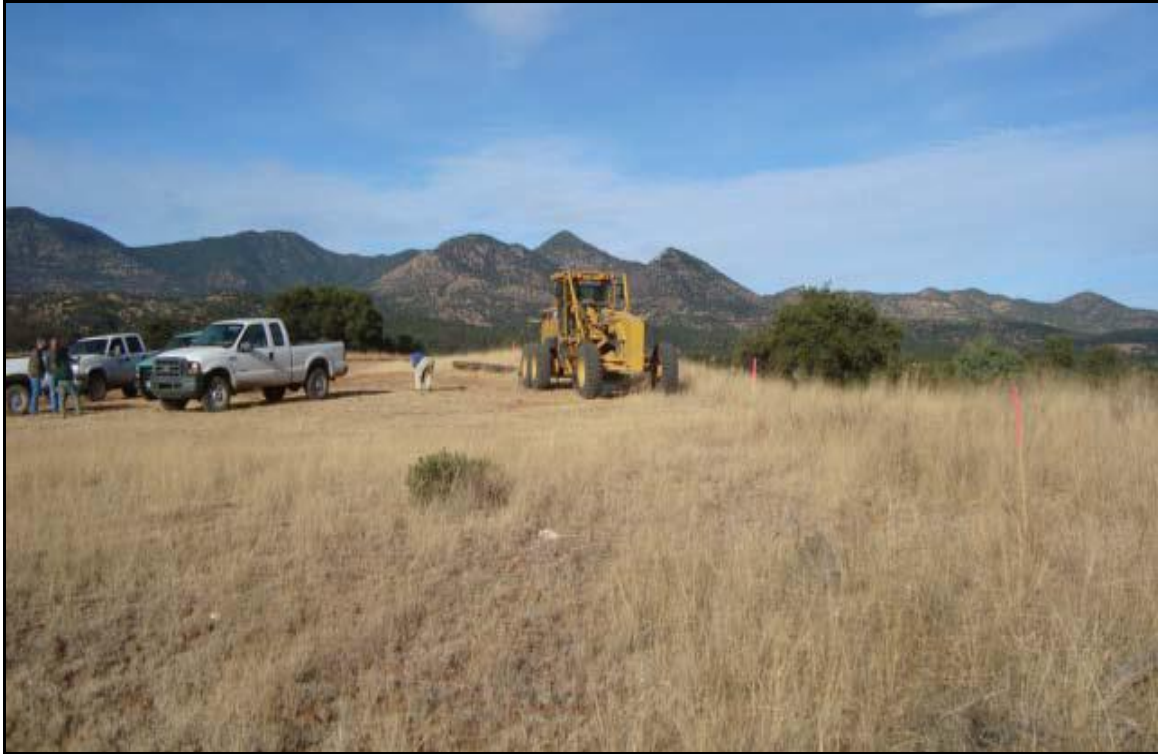
The ESP anticipated two staging areas totaling 3.5 acres for facilitating construction of Section EV-1B. Instead, the project used seven smaller staging areas. Additionally, the east end staging area was extended to accommodate an archaeological site (see Figure 3-6). The post-construction survey calculated the actual affected area to be 5.24 acres, which is 1.74 acres greater than anticipated.

**Figure 3-6. Photograph of Staging Area for Section EV-1B**

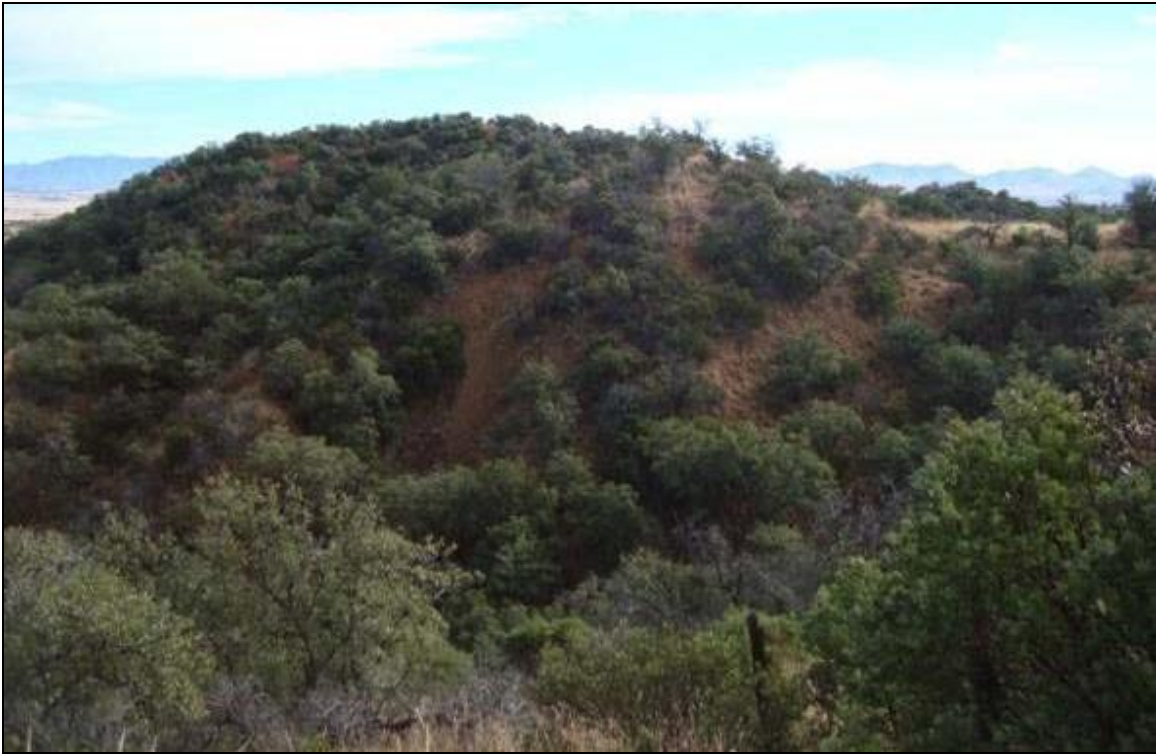
The December 2008 Tucson Sector BRP identified and assessed the composition, structure, and general health of vegetation communities within the project corridor (see Figure 3-7). The analysis in the BRP indicated that the project would permanently affect approximately 40 acres of vegetation. The project as a whole, however, affected less acreage of native vegetation than anticipated in the construction plans, thereby minimizing the need for mitigation due to loss of habitat. TI construction and installation permanently altered approximately 24.5 acres of existing land uses, soils, vegetation, wildlife habitat, and potential habitat for protected species. The contractor disturbed approximately 15.5 less acres than anticipated for the access roads,

**Figure 3-7. Photograph of Vegetation in Section EV-1B**
