MAPPING OF DEBRIS FLOWS BY THE MORPHOMETRIC ANALYSIS OF DTM: A CASE STUDY OF THE VRÁTNA DOLINA VALLEY, SLOVAKIA

Mapping of debris flows by the morphometric analysis of DTM: a case study of the Vrátna dolina Valley, Slovakia

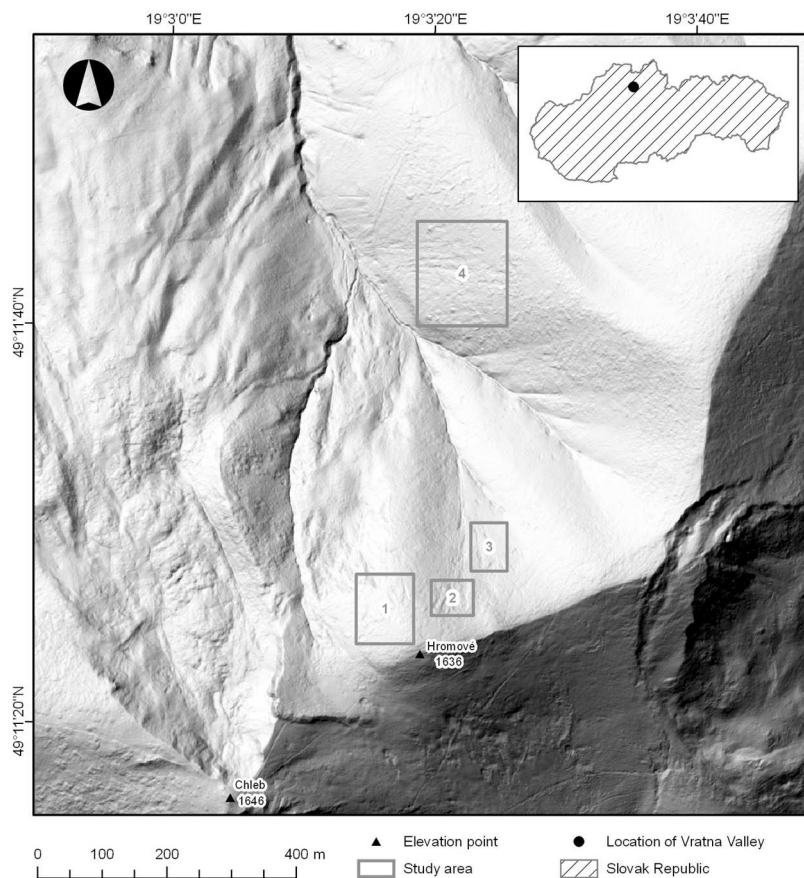
Fig. 1. Study area and tested localities

The Vrátna dolina Valley is situated in northern part of Slovakia in the Malá Fatra Mountains, Kriváň part (Fig. 1). The whole valley is oriented north-south direction on the north side of the mountain chain and it is long about 7 km from the beginning at the Terchová municipality up to the mountain ridge. The study area is located in the highest parts of the valley and it is divided into the 4 smaller test regions. The extent of the study area is 8 km² (Fig. 1).

The verification of the results in the monitored area was carried out by comparing them with the data obtained from the field survey. Four locations with the occurrence of active slope failures recorded were identified for the evaluation of the results. Three of these sites are located at the top of the slope near the Hromové Mt. (Figs. 1 and 5). One site is located in the central part of the slope and is characterized by a higher level of afforestation compared to other localities. The location of individual sites is shown in Fig. 1.

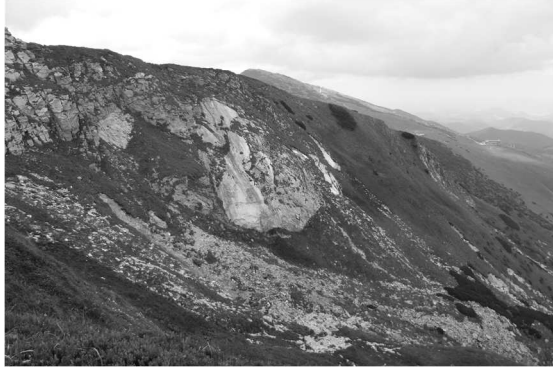
Fig. 3. Head scarp below the Chleb Mt. summit on the north side

The altitude difference between the head scarp and toe of the rockslide is 600 m. In the head scarp two main horseshoe-shaped escarpments have formed. One of them reaches to the Chleb summit and strongly violates its original dome shape. The maximum height of escarpment rock walls is 50 m (Fig. 3). Sliding, or the collapse of Jurassic limestone rock masses took place along the shale strata of the Carpathian Keuper (Upper Triassic). General stratification is 30 – 40° to the North, thus down the slope. As in dozens of cases in the Mesozoic mountains of Slovakia, the rigid, tectonically broken blocks of Jurassic limestone, lying on plastic Keuper shale strata, have induced the formation of slow creep deformation, which over time has transformed into a large-scale rockslide (Fig. 4).

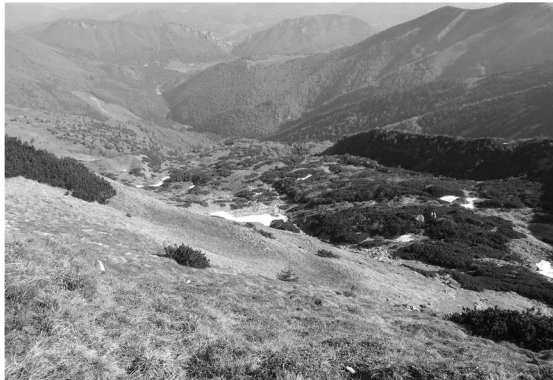
Fig. 4. Rockslide on the northern flanks of the Chleb Mt.

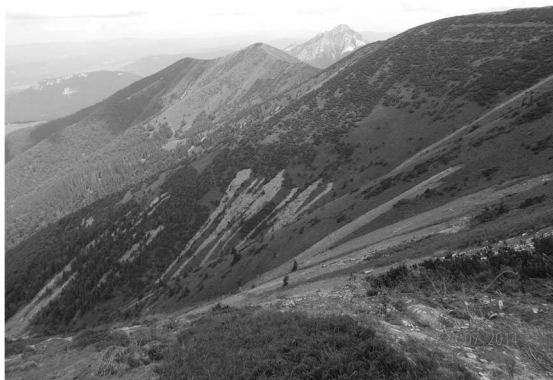
Fig. 5. Head scarps of debris flows below the Hromové Ridge (northern flanks)

Colluvial deposits are characterized by a large lithological variability depending on the basement rock. Loamy-stony and clayey deluvia are developed on marl sediments of the Mráznicna Fm. Debris flows were activated in these deluvial sediments below the ridge of about 1 600 – 1 500 m a.s.l. (Fig. 5).

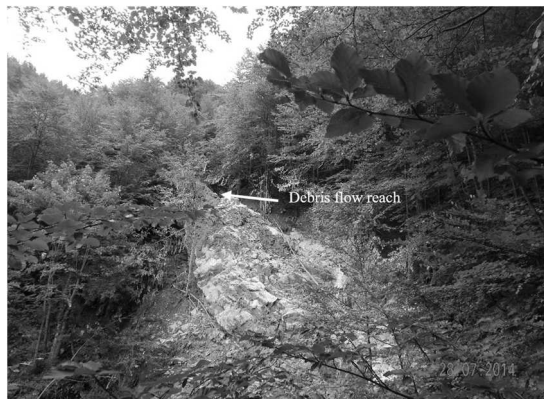
Fig. 6. Debris flow had a speed of several m.s^{-1}
Arrow indicates maximum level of the flow.

Approximately 800 meters from the lower lift station of Vrátna, the thickness of a rolling mass of water-rock-earth-trees was measured on upright trees (Fig. 6). It seems that the thickness of the flow here reached up to 2 m. A creek with the depth of a mere 20 cm flowed there at the time of inspection (July 28th, 2014).

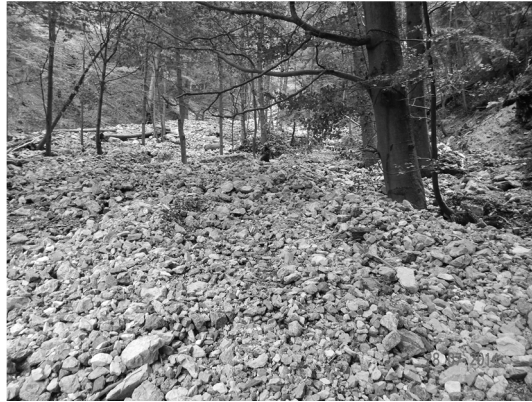
Fig. 7. One of the two of main debris flows

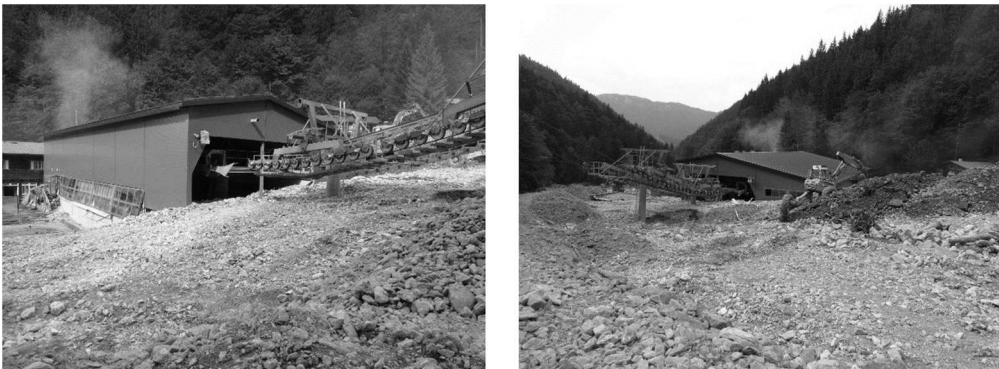
Fig. 8. Cable line terminal at the toe of the debris flow

The total cubic capacity of the displaced material is estimated by the team of the State Geological Institute of Dionýz Štúr (SGIDS) at a minimum of 100,000 m³. The toe of the debris flow reached the cable line terminal (Fig. 8), which indeed experienced property damage, but without any serious static damage to buildings and lift poles. However, the catastrophe hit the cars at the car park or those along the road to Terchová (Fig. 9). The car passengers and the visitors managed to escape to the surrounding slopes, from where they observed the disastrous flow, taking everything, which crossed the way to the flood-wave.

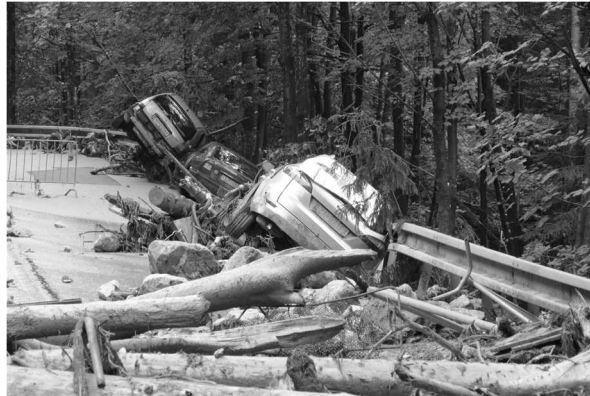
Fig. 9. Cars smashed by the debris flow

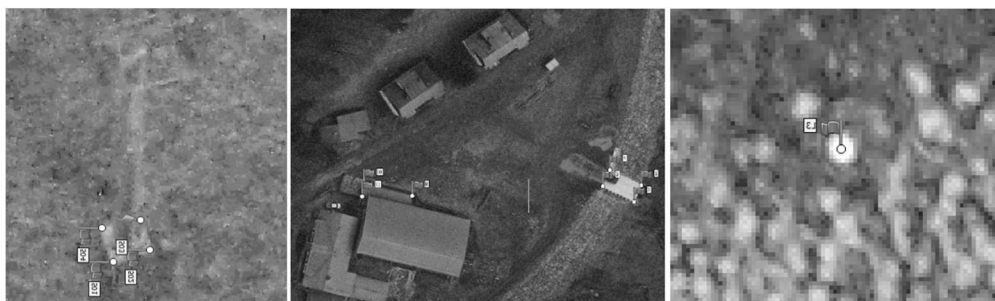
Fig. 11. Types of signalisation of the control points

From left: padstone of the pole, corners of the roofs and bridge and circle target on the terrain.

Overall 32 control points (CP's) were measured in the SkPOS network by the GNSS instruments Trimble R10 with an accuracy in position $mYX = 0.02$ m and vertical accuracy $mH = 0.05$ m. Some points (which were not possible to measure by GNSS) were measured by tacheometry with a connection to the GNSS measurements. The control points were signalized by the padstones of the cable car poles (Fig. 11 left), the edges of newly built bridges, corners of roofs (Fig. 11 middle) or targets on the ridge pre-set in November, 2014 (Fig. 11, right part). Some CP's served for ALS point cloud adjustment, other for photogrammetric georeferencing and some for both.

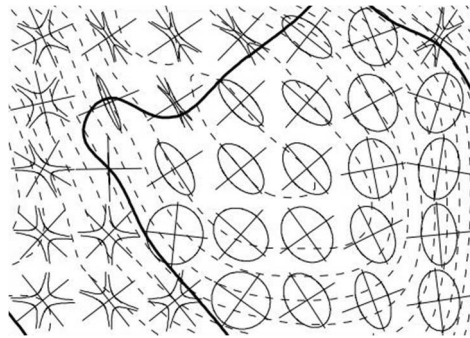
Fig. 13. Areas of elliptical and hyperbolic points are delineated and Dupin's indicatrices are drawn at every point of a surface (Dirstein et al. 2013 and Geoproxima 2019)

Proxima system (Fig. 15) uses this descriptor as classifier of all surface points. For example elliptical concave, elliptical convex and hyperbolic points, defined by the Dupin's indicatrix shape, form three basic categories of surface shape (Fig. 13).

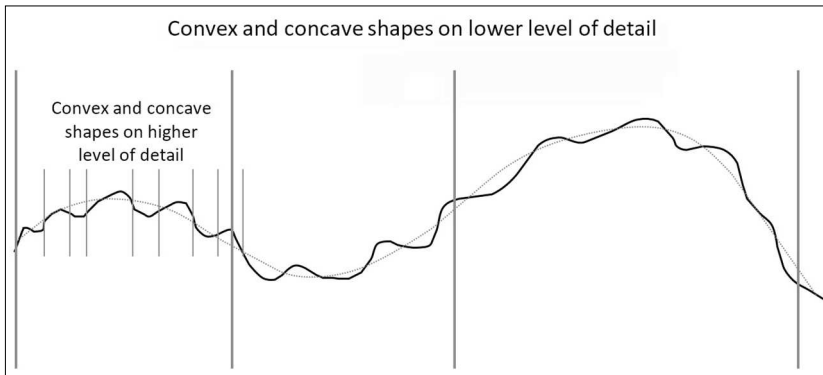
Fig. 14. Example of profile curve divided to convex and concave shapes on two levels of detail

A database of morphometric properties can be constructed at various levels of detail. The level of detail is similar to window size when calculating surface properties using other methods such as Wood (1996). Selecting a specific level of detail is important when interpreting results and depends on the particular application. A small level of detail in general captures very detailed shapes of the surface meanwhile a high level of detail provides higher generalization and captures only significant shapes (Fig. 14).

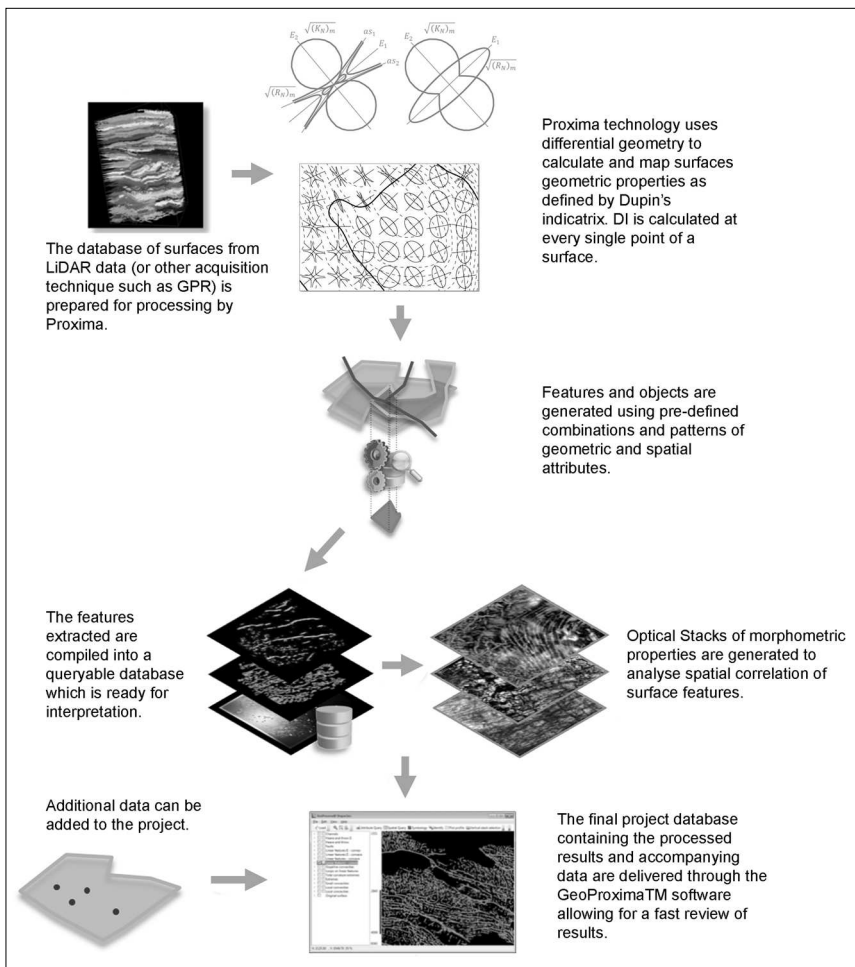
Fig. 15. Schematic representation of the Proxima processing procedure (Paštka et al. 2015)

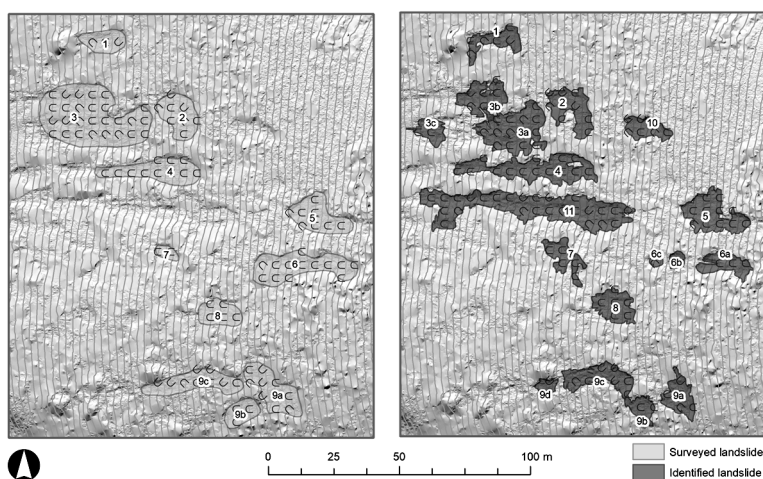
Fig. 19. Surveyed (left) and numerically detected landslides (right) in location 4 (see Fig. 1)

Location 4 (Fig. 19), located in the central part of the slope, is characterized by a higher degree of afforestation than was the case of the previous three sites. This fact also influenced the arrangement of the slope deformations. Where the forest stands, the development of slope failures in this area was moderated. Nevertheless, the field measurements confirmed the presence of several active slides with an area ranging from 36 to 753 m². The application of the Proxima technology over the digital terrain model has enabled the identification of terrain-surveyed landslides (Fig 19 and Tab. 7). In some cases, the higher level of detail has again led to the separation of the numerically identified landslides into multiple areas (area no. 3 into areas 3a, b, c, no 6 into 6a, b, c – Fig. 19) In addition, the algorithm identified the additional slope deformations that were not recorded during the survey, for instance due to inaccessible landscapes (areas no. 10, 11).

Tab. 7. Comparison of the surveyed and numerically detected landslide areas in location 4

Landslide identification	Surveyed area (m ²)	Identified area (m ²)
1	122.98	119.52
2	197.35	191.03
3	752.86	573.44
4	255.92	339.31
5	225.74	239.07
6	333.64	174.28
7	36.12	118.21
8	133.34	154.99
9	575.06	418.42
10	-	104.31
11	-	680.06
Total	2,633.01	3,112.62
