## APPENDIX L. 1989 HYDRAULIC CALIBRATION LOCATIONS

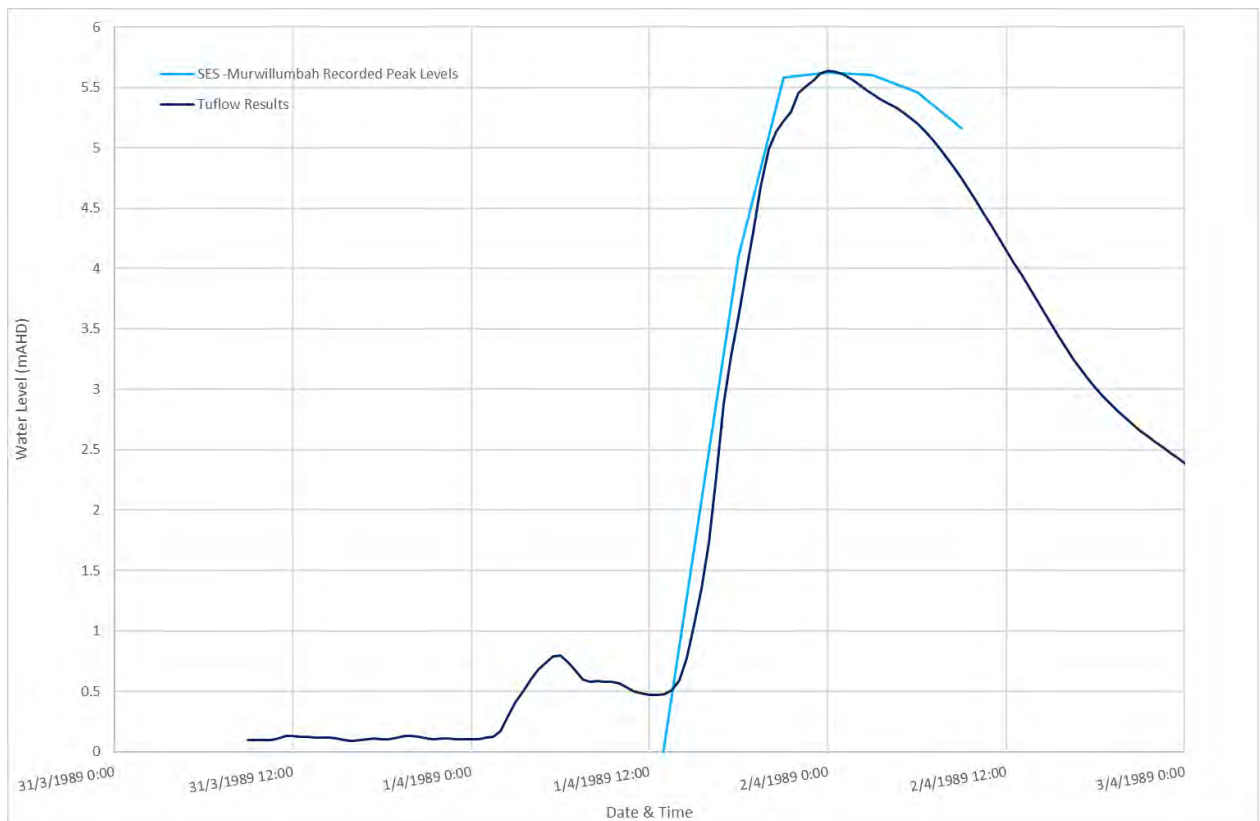
Diagram 122: 1989 Comparison of Water Level at North Murwillumbah

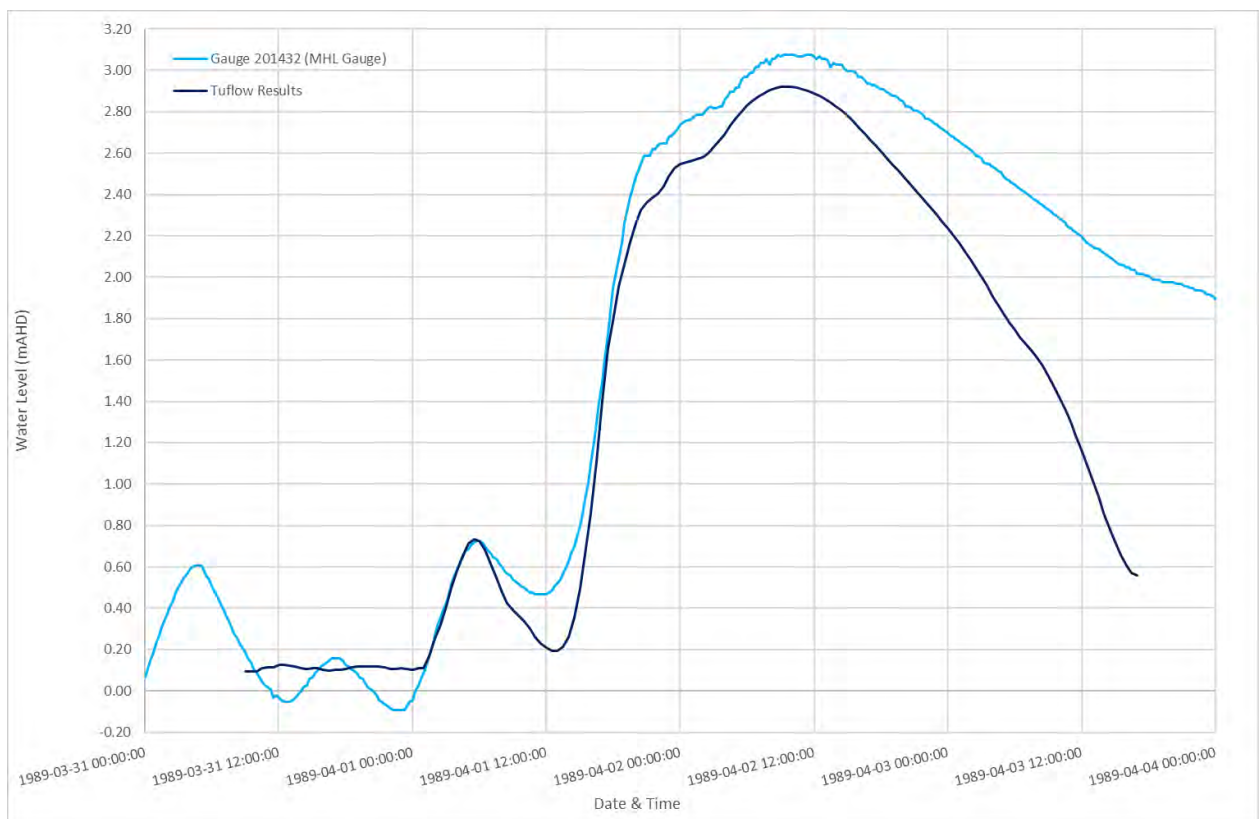
Diagram 123: 1989 Comparison of Water Level at Tumbulgum Gauge

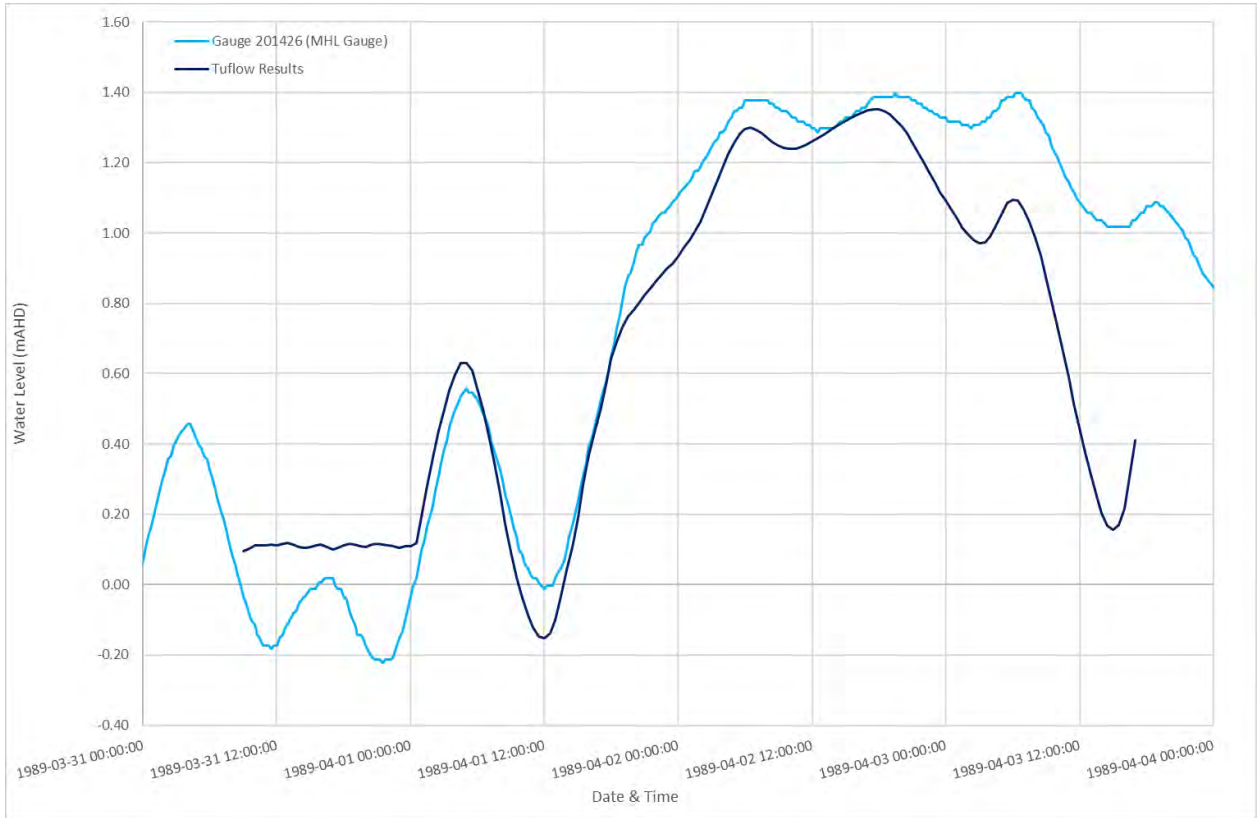
Diagram 124: 1989 Comparison of Water Level at Barney's Point Gauge

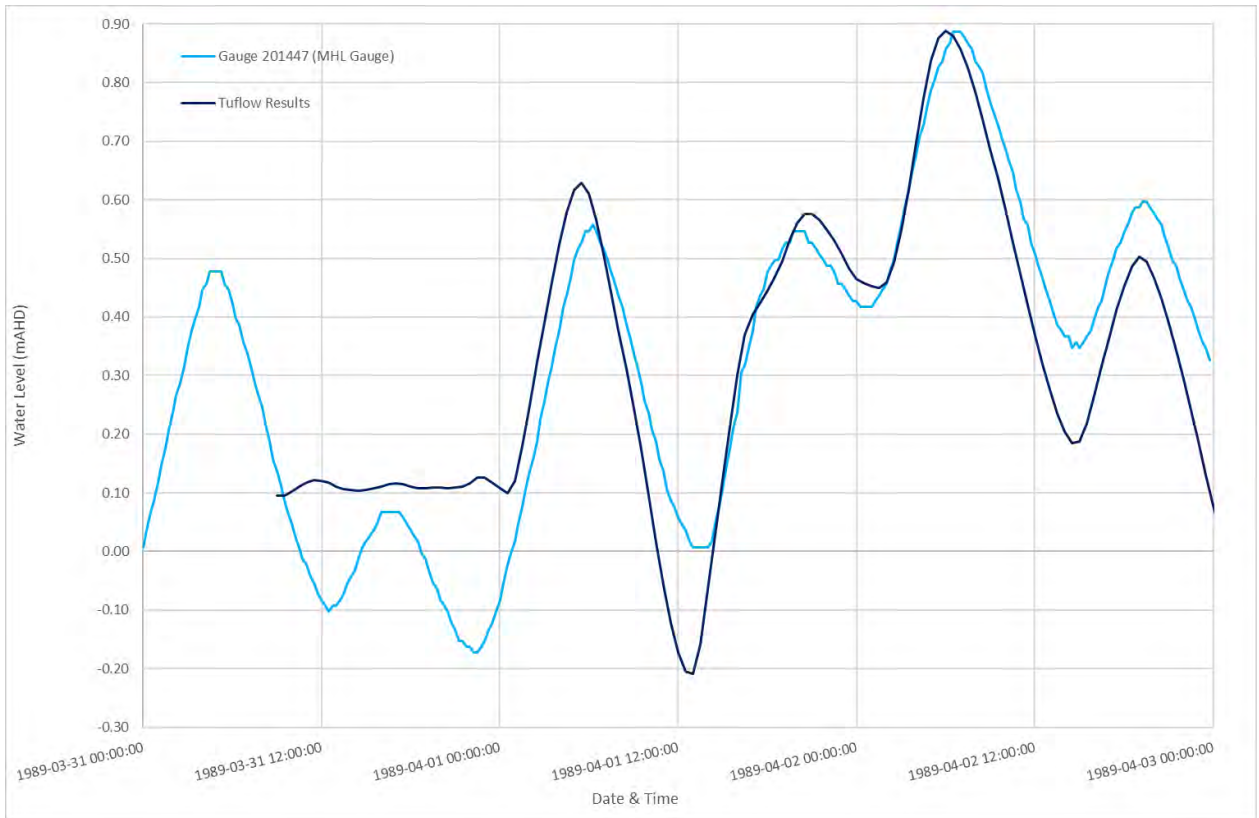
Diagram 125: 1989 Comparison of Water Level at Terranora Gauge

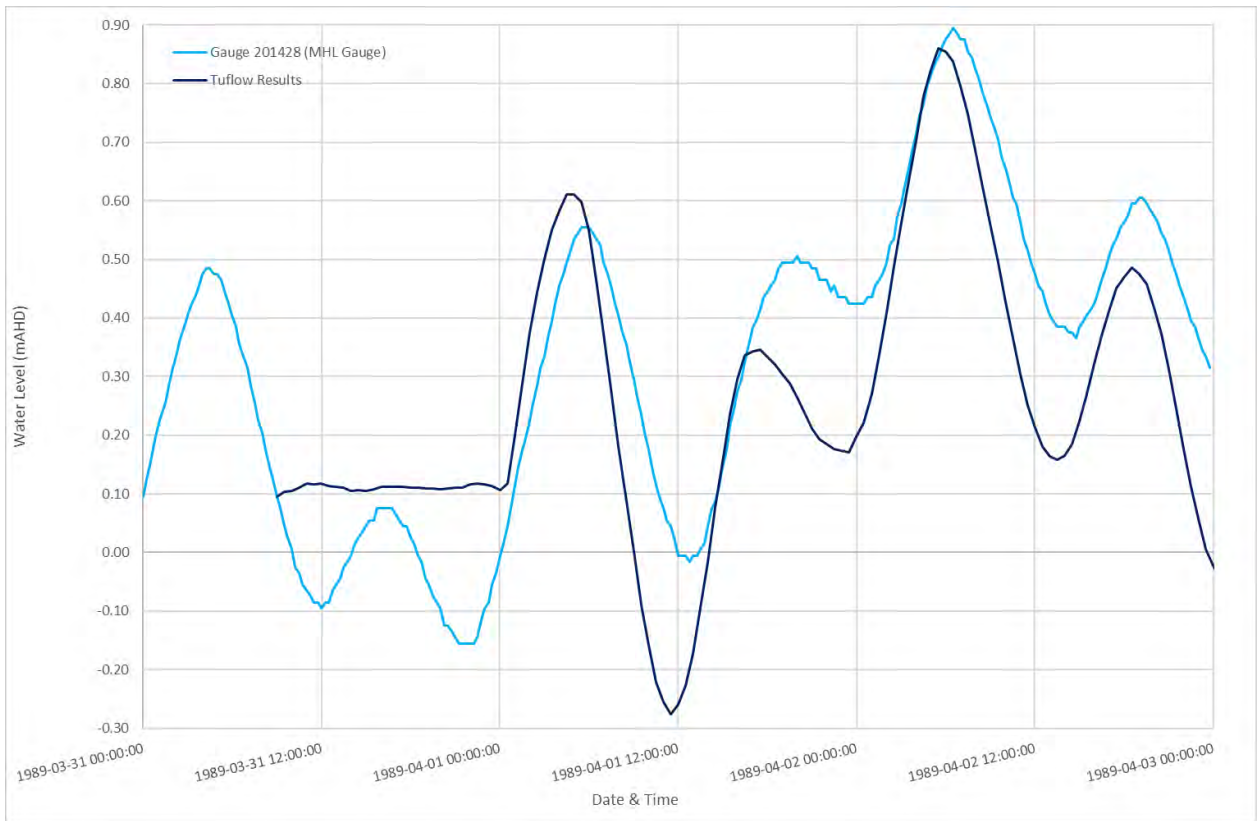
Diagram 126: 1989 Comparison of Water Level at Dry Dock Gauge
