ENVIRONMENTAL  
BUREAU

# Dust Storm Mitigation Update

# Lordsburg Playa Dust Storms

## Road Forks/Lordsburg Playa Dust Mitigation Project

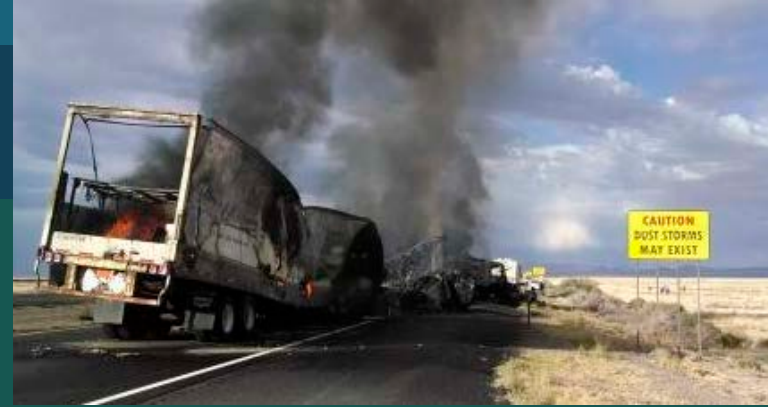
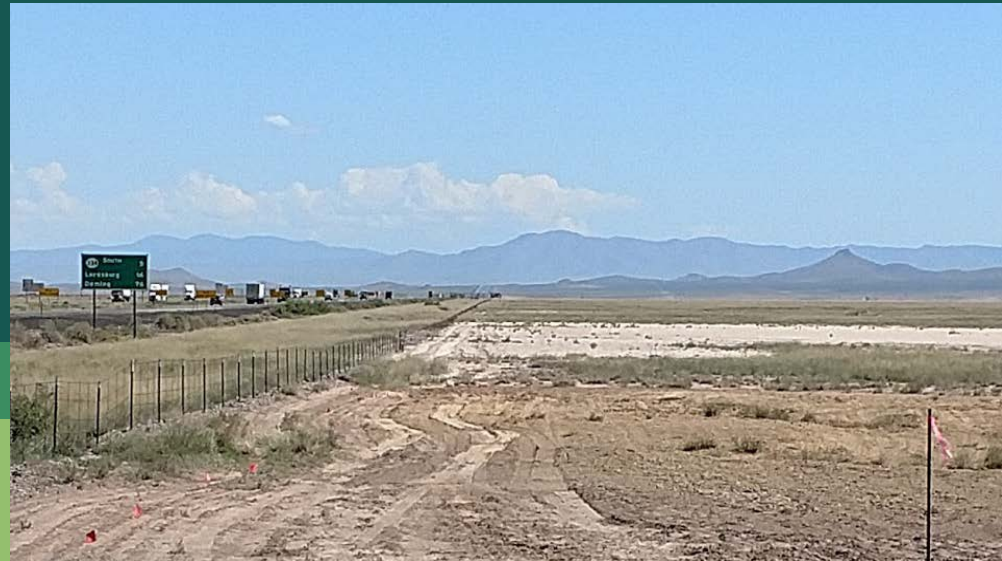
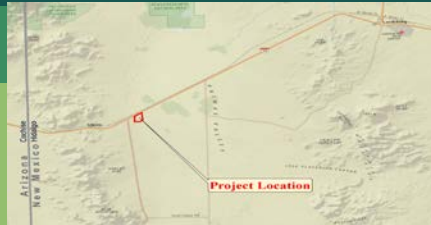
# I-10 MP 6– Road Forks Playa

- Site of Multiple Crash Fatalities
- Sediment Accumulation Caused by I-10 “damming” a drainage swale
- Managed by BLM
- Already monitored by NMSU climatologist for dust activity
- Opportunity to reduce the amount of available dust near the roadway

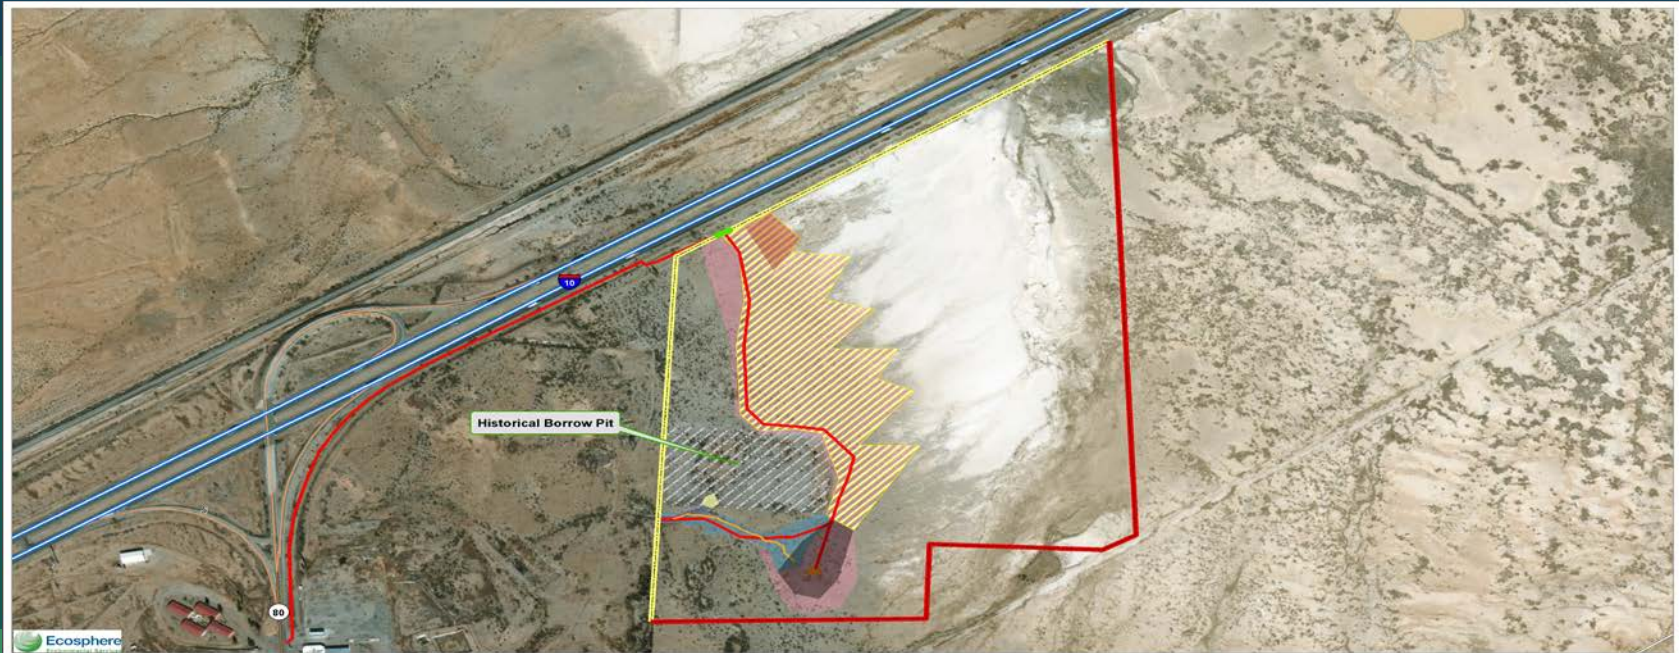
| Access Road | Trash Removal Area | Rock Staging Area | Microborm Concentration |
| Existing Fence | Historical Channel | Media Luna Impact Area | Imprinting and Seeding |
| Access Gate | Headcutting Arroyo | Imprinting, Seeding, and Tackifier Application Area | |
| Proposed Fence | Channel Work | | |

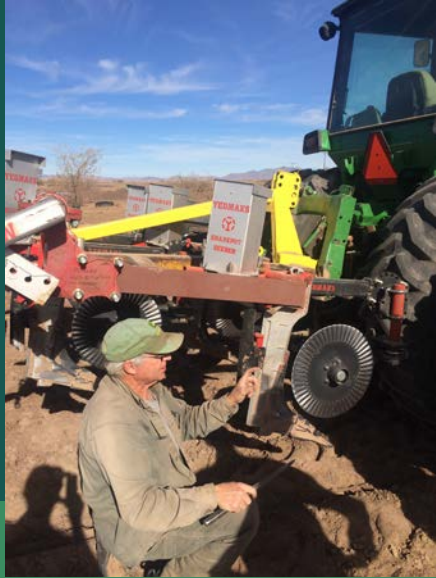
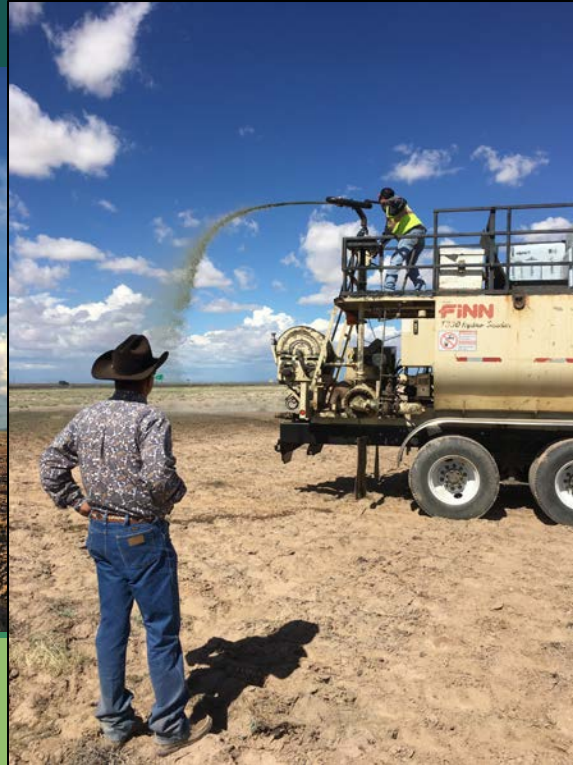
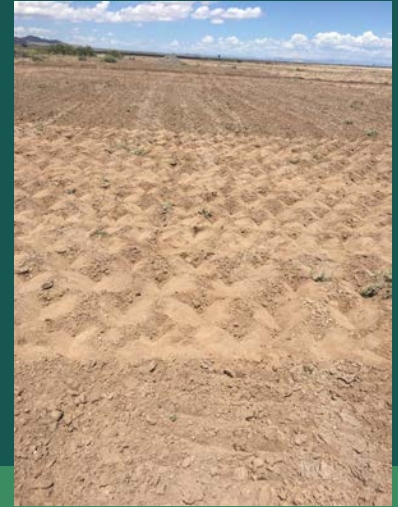
# Sept. 2018: Keylining , Imprinting, Tackifier , Fence

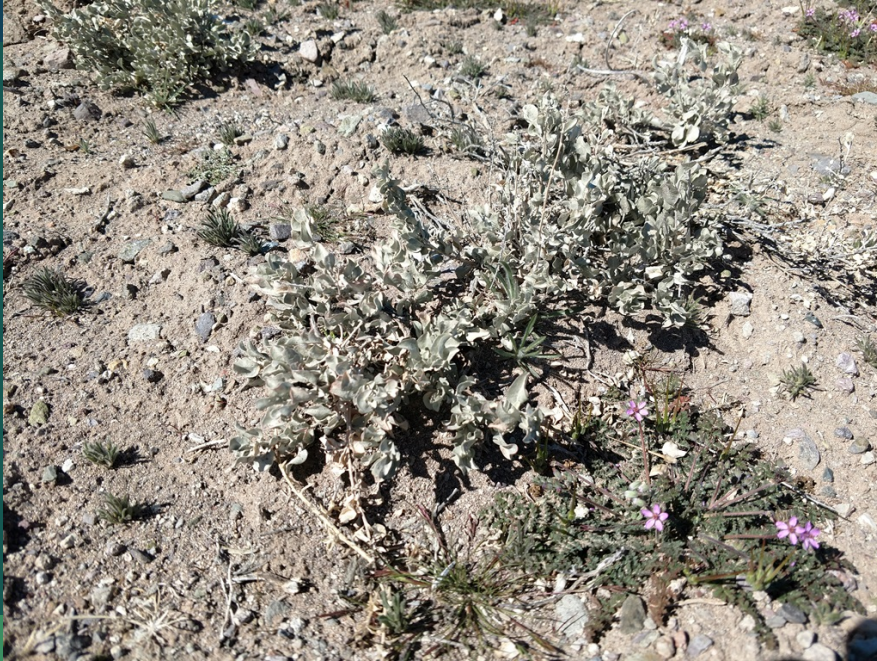
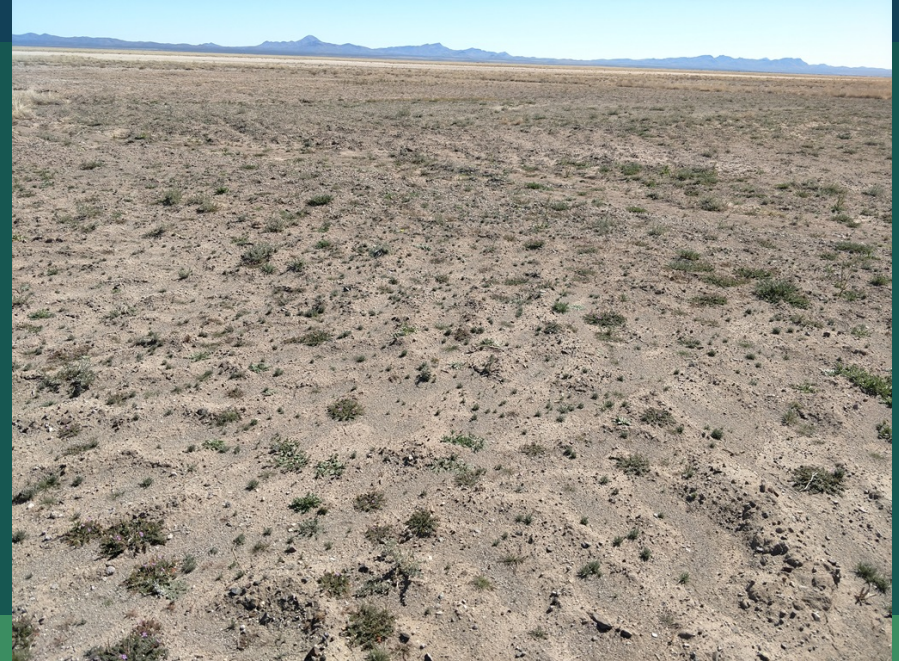
# Native and Non -native Growth within Imprinting Area

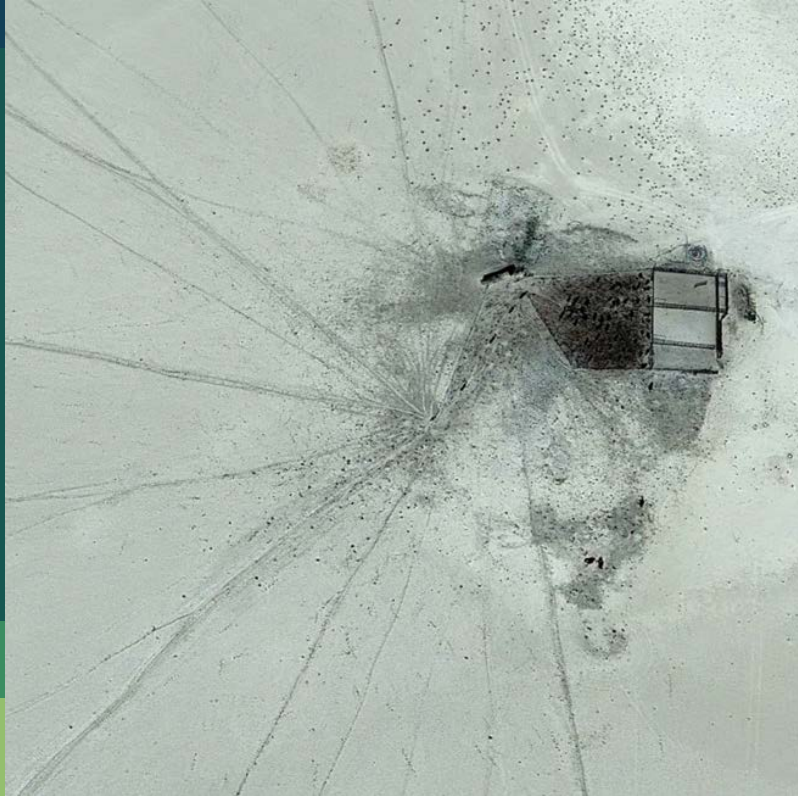
Corral in center of playa

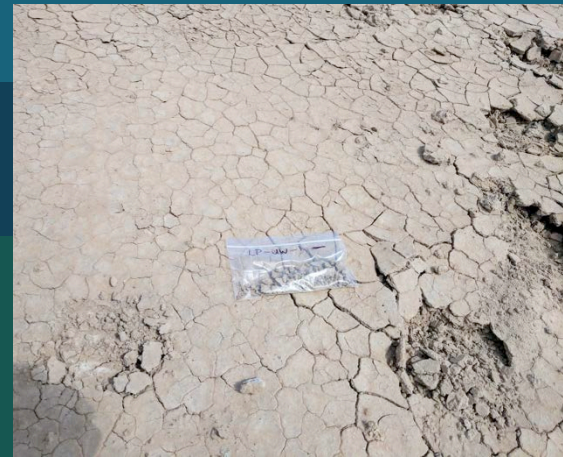
Highly erodible playa surface (cattle footprints)

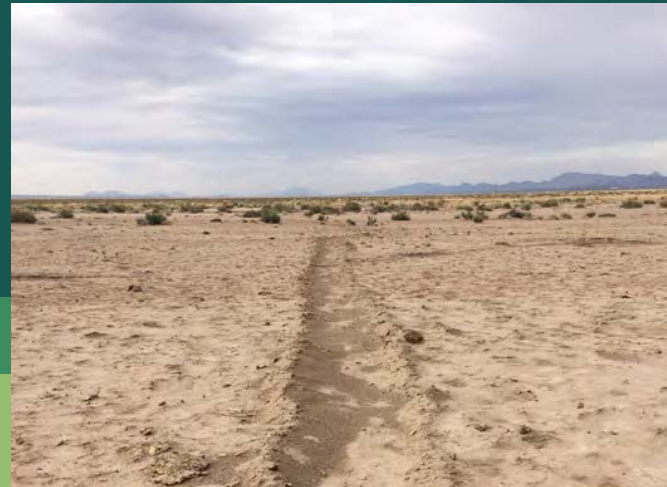
Cattle trail through playa steppe

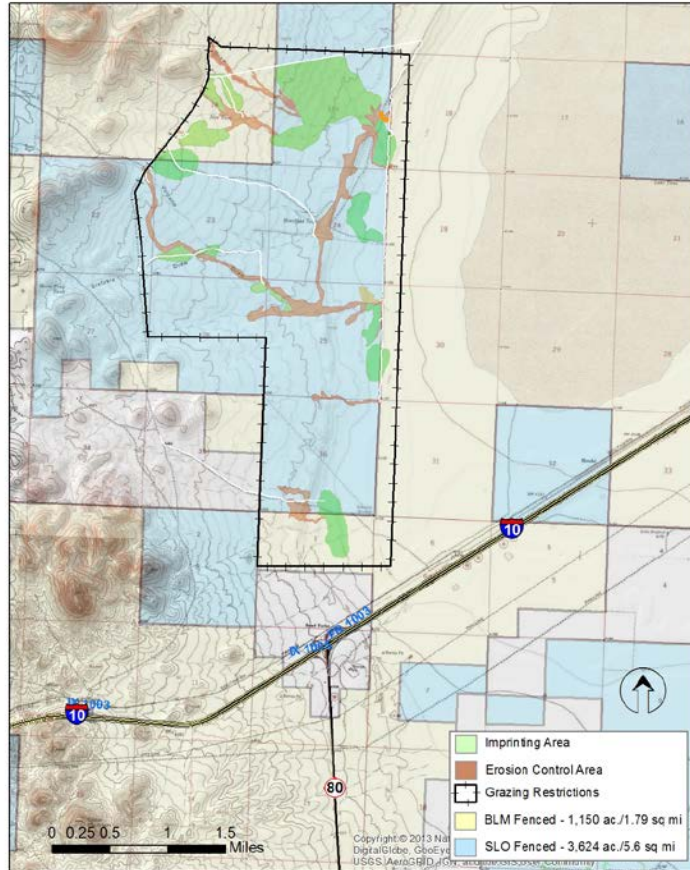
### Phase 3 Proposed Dust Mitigation Actions
