Bonding Basics

The best corrosion protection for underwater metal fittings is a well-designed and -maintained bonding system.

by Steve D'Antonio

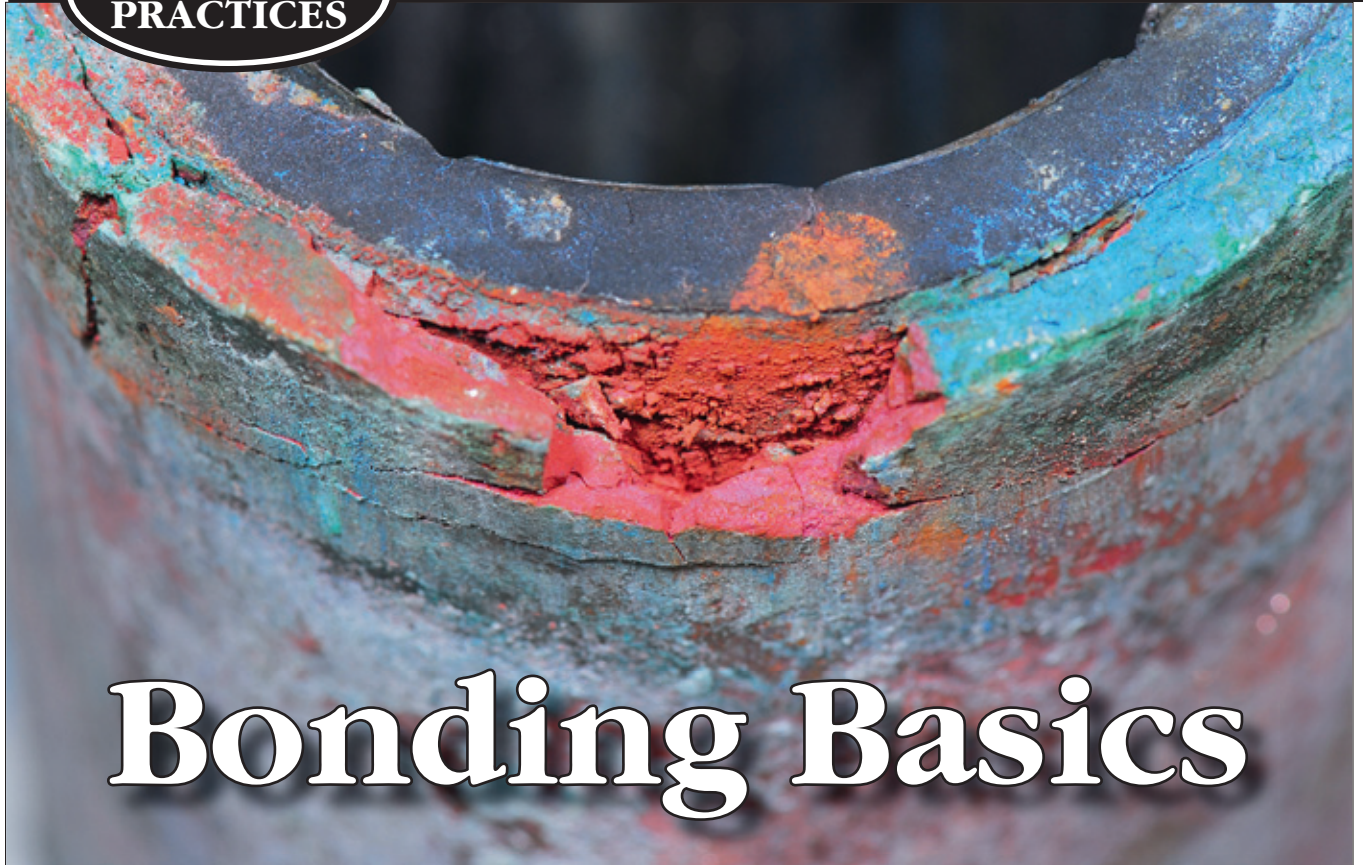
Above—Cutless bearing shells are typically made from brass, and unless galvanically protected through a bonding system, they will dezincify readily, as this one has. The good news is that brass is less noble than most struts, which means the bearing shell will be sacrificed before the more-expensive and difficult-to-replace strut.

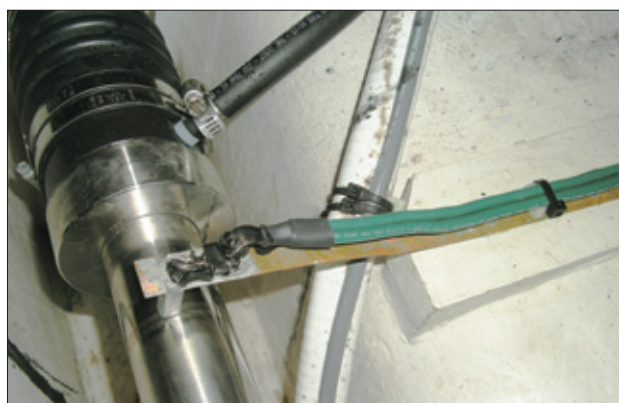
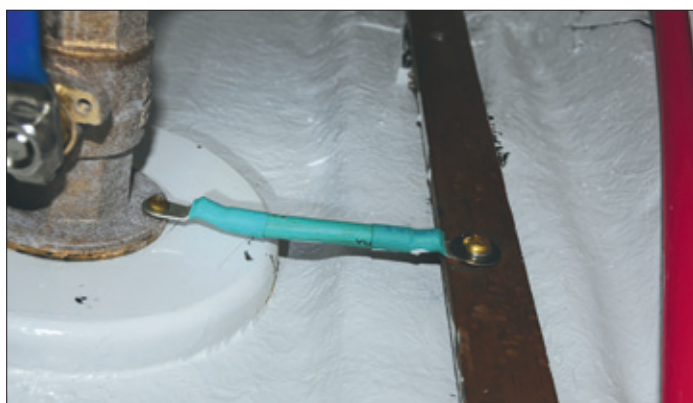
Left—Not all shaft brushes are created equal. Much like the brush contacting an electric motor's commutator, the business end that rides on the shaft should be made of carbon rather than simply a hunk of bronze pipe or rubrail. **Right**—A central bonding strip or bus running the length of a boat allows for bonding wires to be attached anywhere, which keeps those wire runs shorter and reduces resistance. If the strip runs along the inside of the hull well above the bilge, corrosion at connections is minimal.

Shaft brushes are specifically designed to maintain contact with a rotating surface. They resemble the brush in an electric motor's commutator and should be made from the same material: carbon. (Some use a hunk of bronze or brass, both of which are less effective.) To complete connections between these components for the purpose of bonding, the conductors should be a minimum of #8 AWG. If doing double duty as a lightning-protection system, they must be a minimum of #6 AWG.

they rely on central bonding buses. These are copper strips that run the length of the vessel, with various items connected by short lengths of wire. A strip should be a minimum of $\frac{1}{32}$ " (0.8mm) thick and no less than $\frac{1}{2}$ " (12mm) wide. The connections to it are critically important. In no case should they be secured with self-tapping, sheet-metal, or wood screws. If machine screws are applied, the strip must be thick enough to be tapped and must allow a minimum of four threads of engagement. In other cases, through-bolts and nuts may be used to connect a wire's ring terminal to the strip.

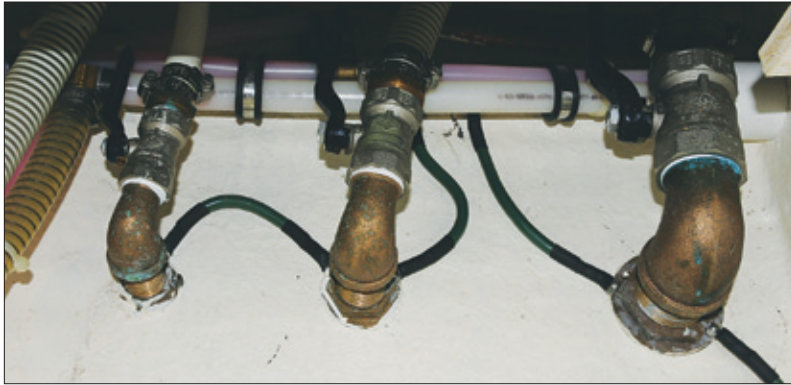
Above—Daisy-chaining bonding wires from fitting to fitting is common and often unavoidable. However, protected components should not serve as a path for current as they do here with ring terminals connecting on either side of the fitting. Instead, the terminals should be stacked one on top of the other (**above right**). Fully 75% of the bonding ring terminals I check are loose. They should be retained with machine screws, never self-tapping screws, regardless of the substrate. **Right**—In the absence of a central bonding strip, bonding bus bars can be placed throughout a vessel to keep drops to individual components short and reduce to the number of connections at each bonded component.

connected to a single component, such as a seacock or strainer, install both ring terminals on the same fastener and stud—rather than separately. This prevents the bonding system's low voltage and current from relying on the comparatively high resistance of the hardware component as a conductive medium.

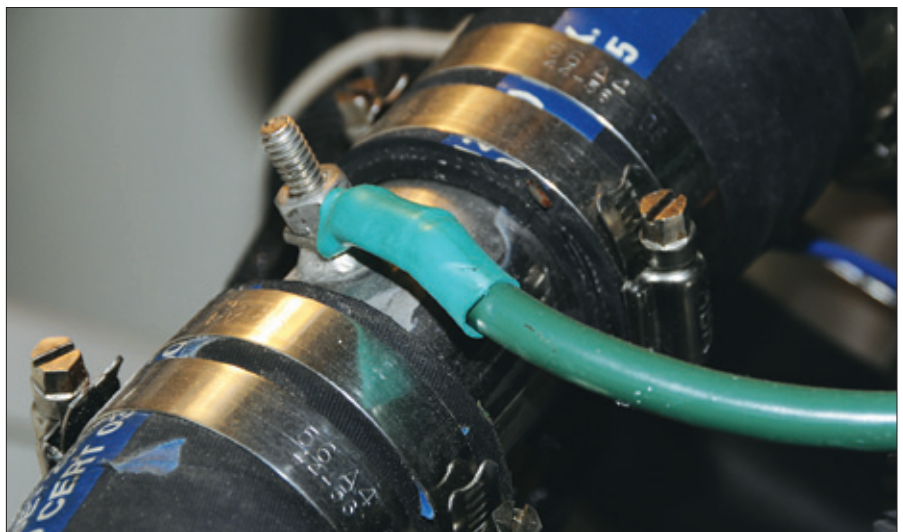
Anodic protection is effective only when the anode and the hardware being protected are immersed in the same body of water. Fittings such as this cooling system connection, regardless of being dutifully bonded, are afforded little protection against corrosion by the hull or engine anodes.

to the bonding system. Although the engine and generator contain seawater, for all intents and purposes that is not the same water the vessel floats in. A common flaw I encounter is that, in spite of often being bonded, metallic raw-water plumbing components installed deep within many vessels are afforded little if any protection. In these cases, where such protection is deemed necessary, non-metallic options such as FRP and proprietary plastics designated for raw-water use offer a preferable alternative.

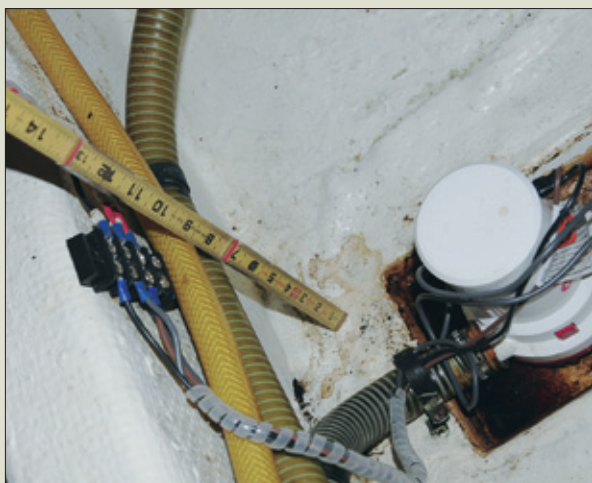
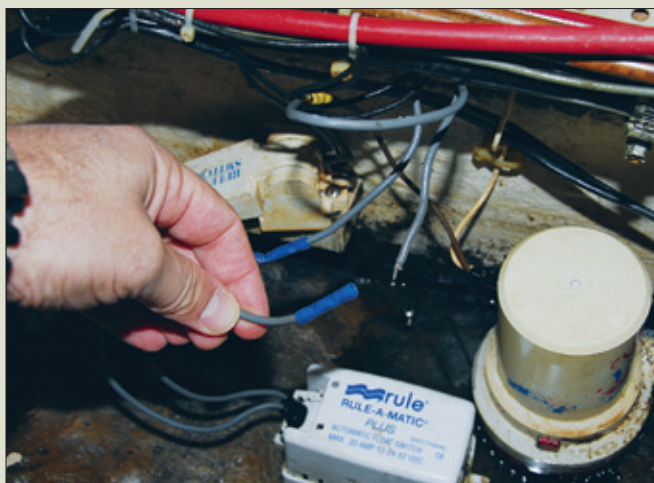
Electrical connections made within reach of bilgewater are a stray-current-corrosion catastrophe in the making. Connections for bilge pumps and switches—the only ones that should be close to bilgewater—must either be a minimum of 18" (46cm) above the base of the pump, or be fully waterproof. Neither installation above is ideal.

Onboard wiring should always be routed above normal bilgewater levels. In areas such as around bilge pumps and switches where you cannot avoid this, pay careful attention to your wire routing and connection methods. My own rule for bilge-pump and related component wiring calls for all connections to be made 18" (46cm) above the top of the pump, using a tinned, insulated terminal strip that, upon completion

of the assembly, I spray with a corrosion inhibitor. As an alternative, or where the 18" elevation is not possible, I rely on waterproof heat-shrink butt splices. Still, in my experience, the source of stray-current corrosion is often damaged float-switch-wiring insulation, so I recommend that you route it out of harm's way, and inspect it regularly for any signs of failure or corrosion.

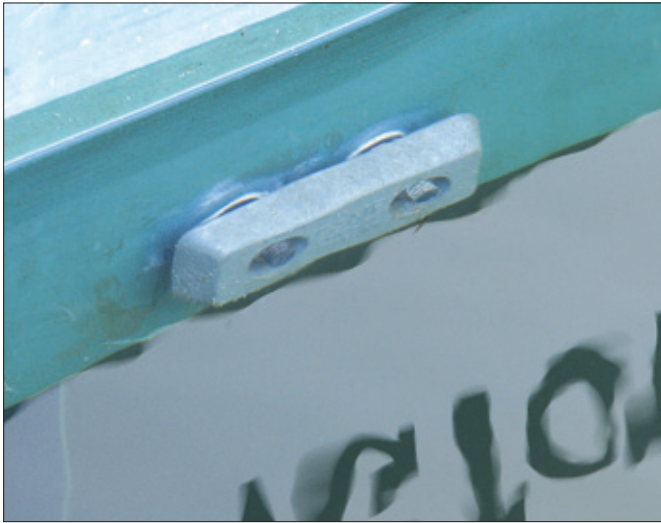
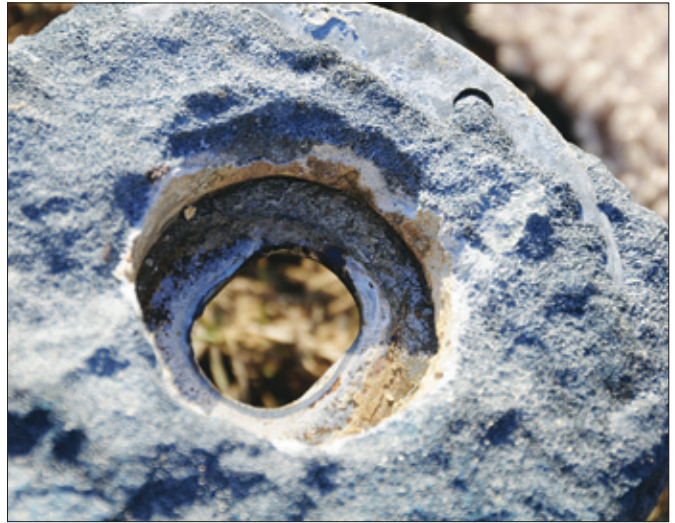
Left—When boat owners boast that their anodes last a very long time, suggest an analysis of the anodes, their attachment to the bonding system, or of the entire bonding system. **Right**—This corroded hull anode reveals the cast-in plate through which the mechanical and electrical connections are made to the hull. This construction ensures that consumption has no effect on the connection or security of the anode.

Anodes that last an unusually long time are suspect. With the vessel hauled, use an ohm meter to check the soundness of the bonding system by connecting one lead to the anode

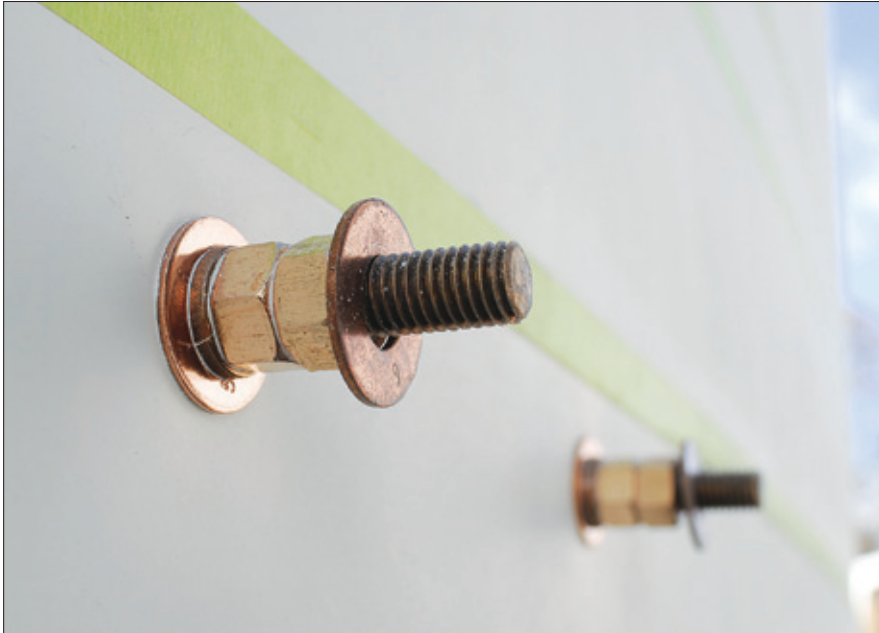
Studs on a new boat await installation of a hull anode. When completed, there should be a gap between the back of the anode and the hull.

not, and there should be a gap between the back of the anode and the hull.

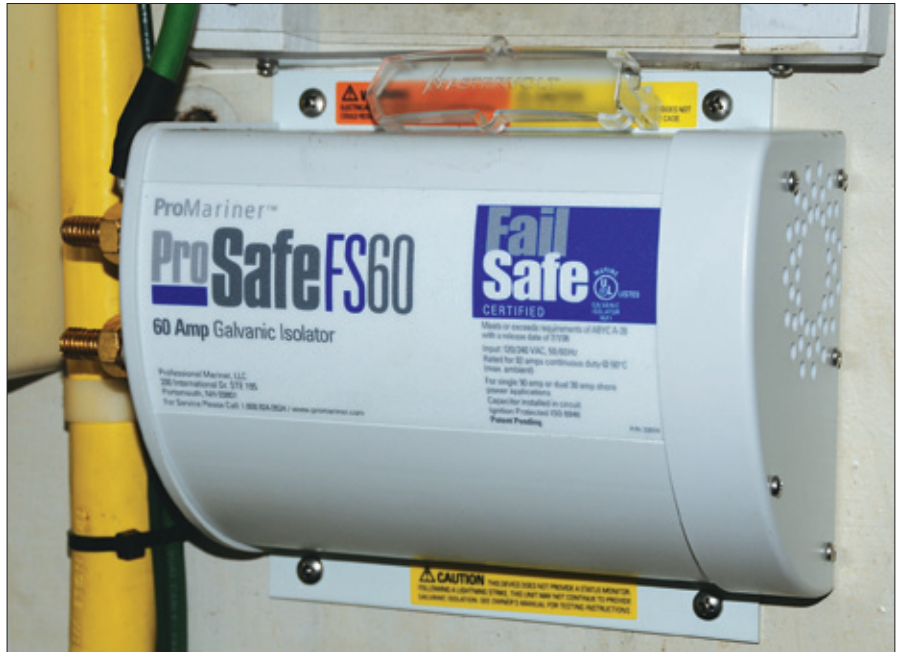
Galvanic isolators are one line of defense in the fight against dockside shore-power-connection-induced corrosion. They reduce the possibility of accelerated anode consumption when boat owners plug cords into shore power.

Galvanic isolators are well worth the comparatively small expense. Even if your customer plugs into shore power for just a day or two a year, it makes sense to recommend a galvanic isolator. As one might expect, not all galvanic isolators are created equal. Select the ones you recommend and install based on the following criteria:

- A fail-safe design that, even in the event of a catastrophic internal fault or a lightning strike, ensures that the isolator will still safely and reliably conduct AC fault current to ground even though it may no longer isolate galvanic current.
- Full compliance with ABYC standard *A-28 Galvanic Isolators* most recently revised as of July 2008.
- UL Marine approval.

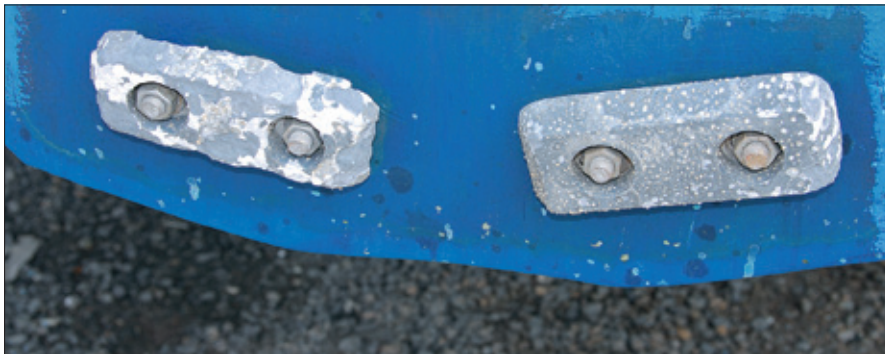
You don't need a multimeter to identify faults with anodic protection or bonding systems; uneven anode consumption is often a sign of trouble that should be investigated.

Instances of uneven anode depletion often indicate problems in a vessel's bonding system or anode installation. They also can be a function of variation in alloy quality and specific anode design. On the vessel I inspected in the boatyard, the problem turned out to be poor contact between the anode and the mounting stud, a common scenario that should not be ignored.
