Technical Manual: Overtopping Protection for Dams

**Best Practices for Design, Construction, Problem
Identification and Evaluation, Inspection,
Maintenance, Renovation, and Repair**

FEMA P-1015/May 2014

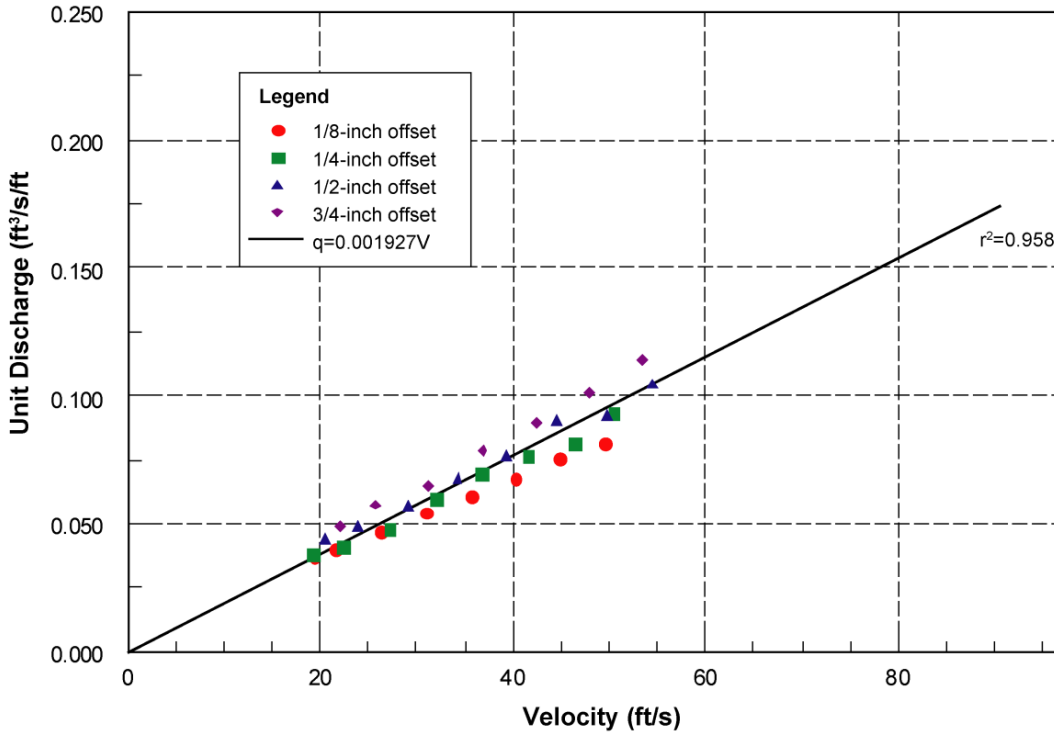
Figure 3-6.—Unit discharge for joint/crack, sharp-edged geometry, 1/8-inch gap (Reclamation, 2007b).

An interesting result of the tests is that the test configurations with the smallest joint gap (see Figure 3-6) resulted in more flow through the joint as compared to test configurations with larger gaps (see Figure 3-7). A smaller gap can also produce higher uplift pressure than a larger gap for the smaller offsets (about 1/4 inch and less). The postulated reason for this is that a recirculation zone is created at the point of the gap entrance that is more effective in blocking flow and transmission of stagnation pressure at larger gaps. The details of the joint were also varied in the studies. Sharp-edged joints were tested as well as joints with chamfered and rounded corners. The chamfered and rounded corners with small gaps performed in a similar manner to sharp-edged joints with wider gaps.

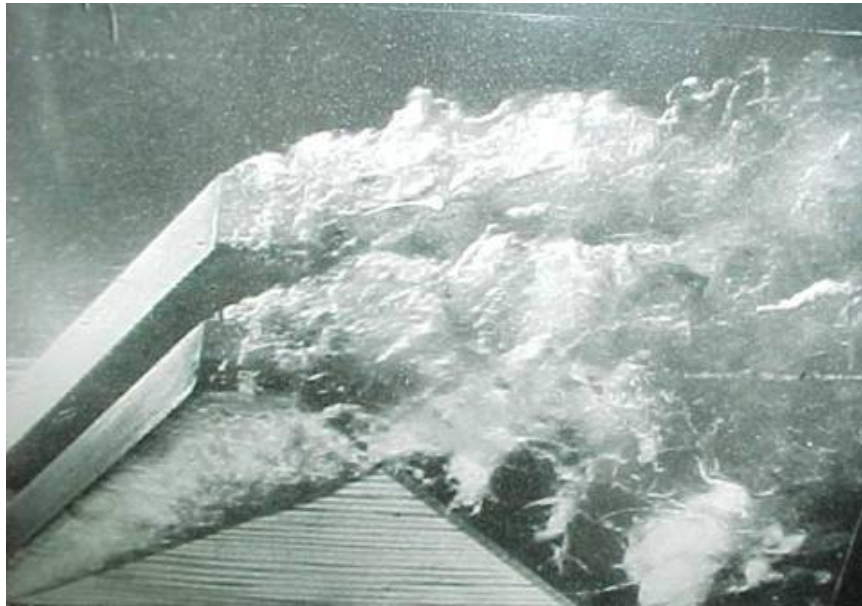
Figure 3-9.—Cavitation created in low ambient pressure chamber (Reclamation, 1990a).

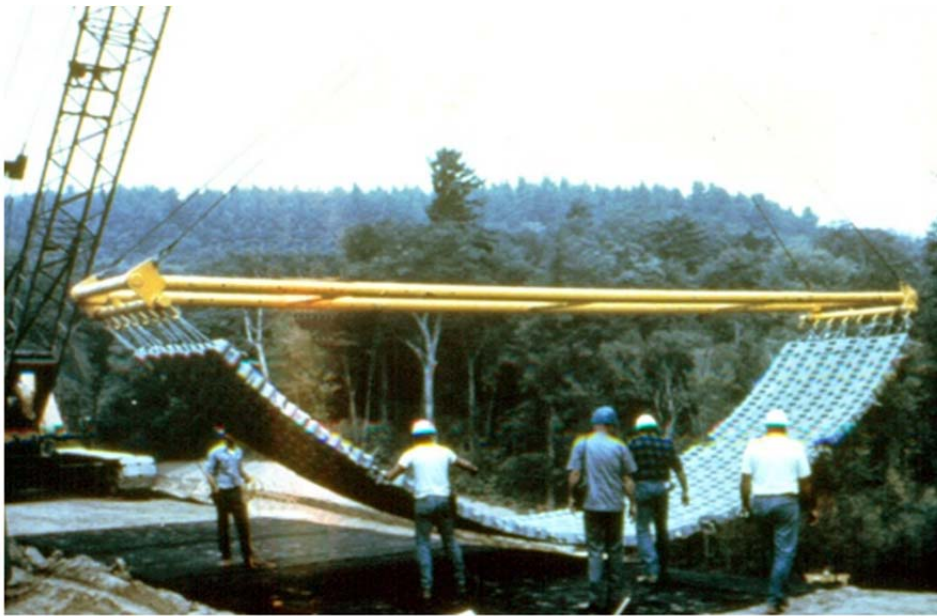
Figure 4-5.—Cabled ACB section being delivered and installed (Reclamation).

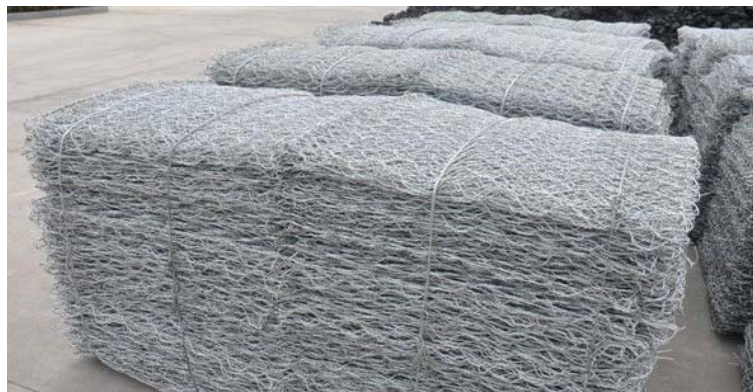
Figure 5-1.—Example of gabion baskets delivered to the project site (Reclamation, courtesy of Chris Ellis).

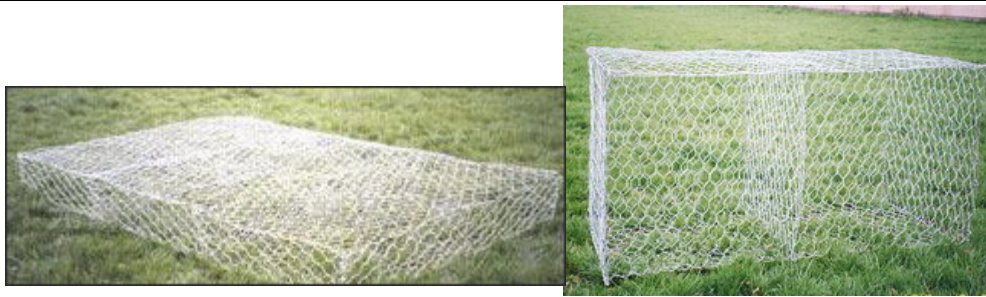
Figure 5-2.—Typical unfilled gabion basket on left and mattress on right. Each is formed with compartments to minimize rock movement within the gabion and deformation of the overall structure. Hexagonal woven steel wire mesh gabions are shown (Reclamation, courtesy of Chris Ellis).

Gabion baskets are typically divided into cells by diaphragms (often at 3-foot centers) to reduce rock movement that can cause deformation. To reinforce the structure, the corners and edges of the baskets are tied and reinforced with heavier gauge wire to prevent unraveling and minimize deformation. Heavier gauge wire and ties are also used to join the adjacent gabions, forming one continuous structure.

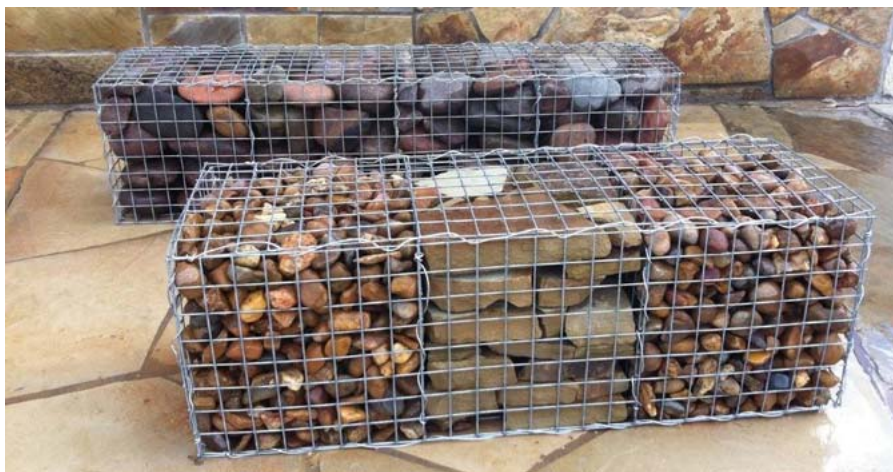
Figure 5-3.—Example of welded wire gabions filled with various rock sizes. (Courtesy of GabionBaskets.net, all rights reserved).

Gabion baskets and mattresses are often manufactured from hexagonal woven steel wire mesh, as specified in ASTM A975. Welded wire gabion baskets and mattresses, conforming to ASTM A974, are also available and offer heavier gauge and more rigid products. Hot dip galvanization, zinc treatments, polyvinyl chloride (PVC) coatings, and stainless steel wire products are available, depending on the site-specific corrosivity exposure and desired design life. The gabions are delivered to the project site with the baskets formed, but collapsed for delivery and handling (Figure 5-1). At the project site the gabions are expanded to form the baskets and mattresses (Figure 5-2). Once placed, the gabions are filled with rock, generally from 2 to 8 inches in size (Figure 5-3). Placement of the rock may be by machine for production purposes or by hand methods if a more aesthetic finished product is desired. Completed gabion structures are shown on Figures 5-4, 5-5, and 5-6.

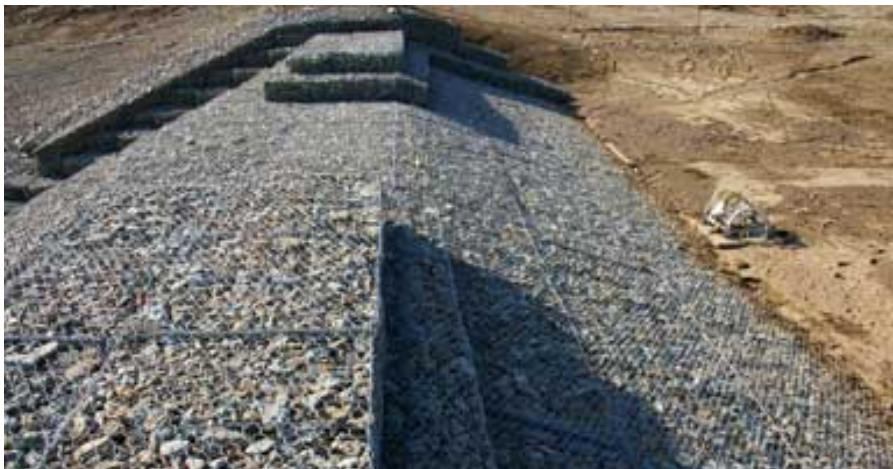
Figure 5-4.—Example of gabion spillway crest structure. (Courtesy of Concrib, all rights reserved)

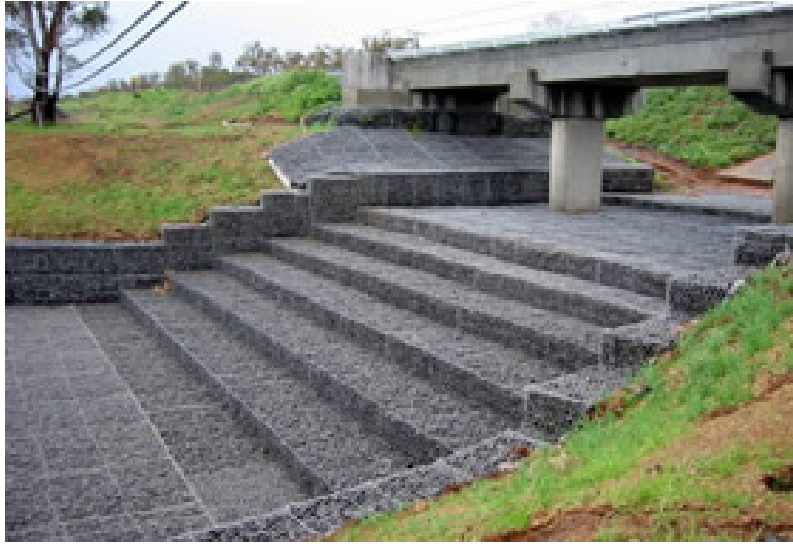
Figure 5-5.—Example of a gabion channel and drop structure.
(Courtesy of Juntong Guanda, all rights reserved)

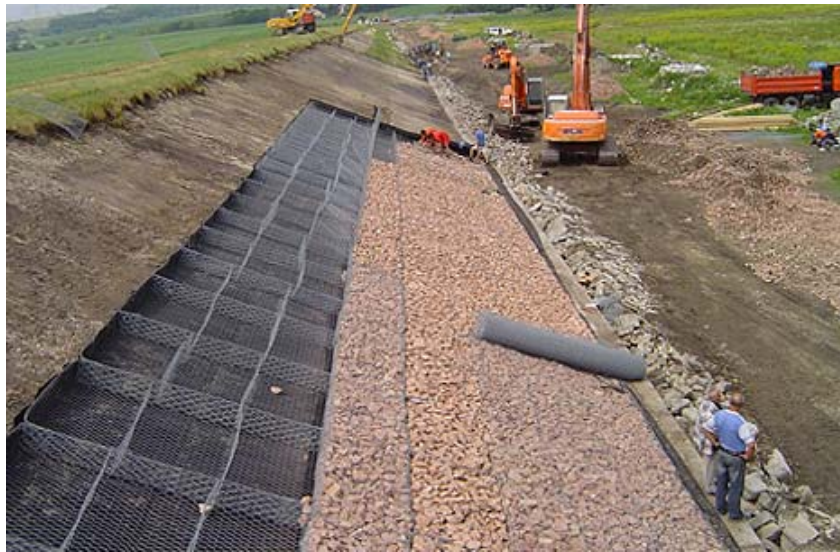
Figure 5-6.—Gabion erosion protection on slope of embankment. Zamoly Reservoir, Hungary (Courtesy of Pannon Gabion Kft, all rights reserved).

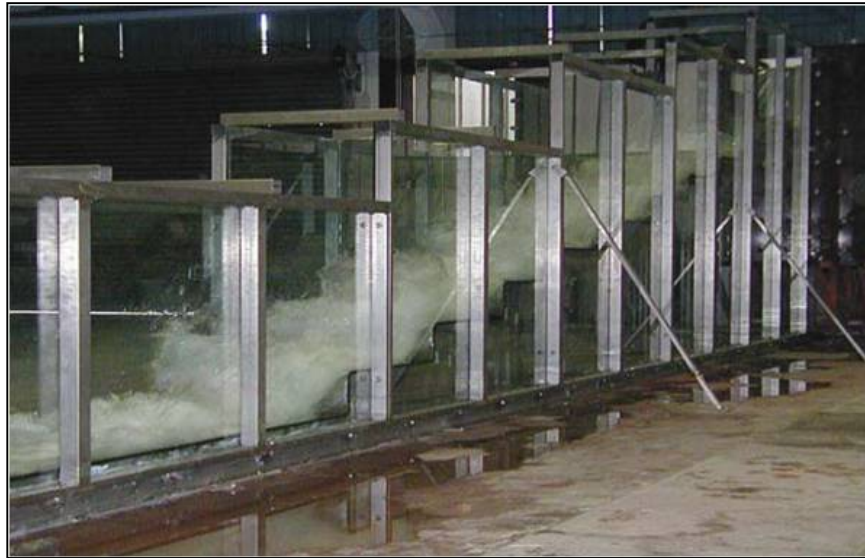
Figure 5-9.—Laboratory test facility at the University of Bari, Italy
(Courtesy of Fratino and Renna, 2009, all rights reserved).

Fratino and Renna (2009) also investigated the influence of rock size, shape, and packing or porosity on the energy dissipation characteristics of stepped gabions. Testing was conducted within the 2-foot-wide flume shown in Figure 5-9, with ten gabion steps each 8-inches-thick forming a 4:1 slope, and subjected to a unit discharge of up to 4.5 ft³/s/ft. This testing revealed that stone size and shape do not significantly influence the flow conditions on the stepped gabion slope for both nappe and skimming flow. The earlier work by Peyras et al. (1992) regarding energy dissipation on gabion steps was therefore confirmed.

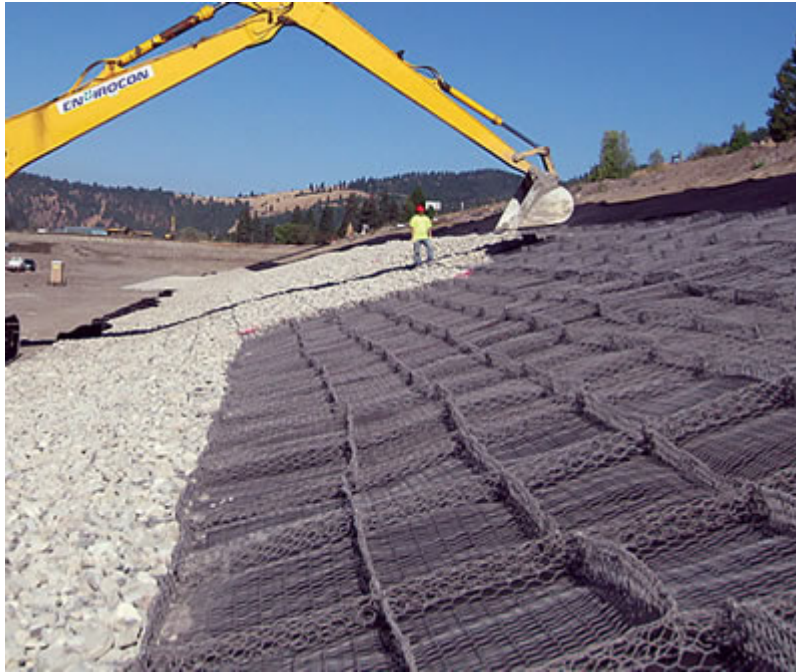
Figure 5-13.—Gabion baskets on slope being filled with rock, Milltown Dam Removal project in Milltown, Montana (Courtesy of Envirocon, all rights reserved).

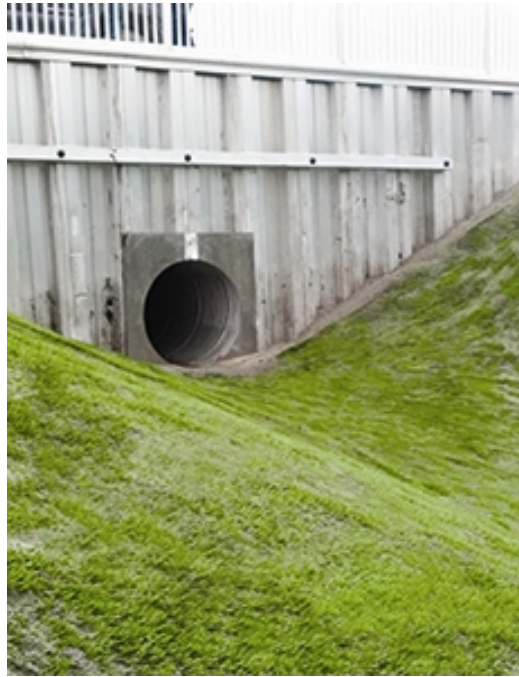
Figure 6.1.—HydroTurf™ Outfall Structure with St. Johns River Water Management District in Florida (Courtesy of Watershed Geo, all rights reserved).

This system thereby offers the environmental and aesthetic benefits of natural vegetation (i.e., low-turbidity surface runoff and natural appearance) as well as the performance and maintenance benefits of hard armor. A typical installation is shown in [Figure 6-1](#).

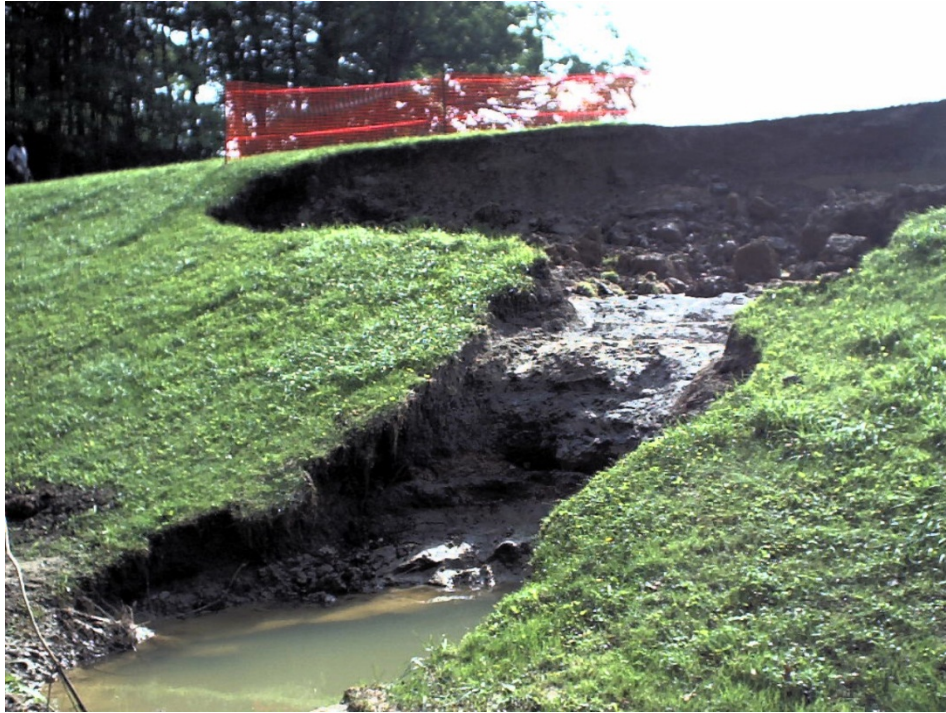
Figure 6-4.—Virginia Kendall Dam in Ohio after 3 hours of overtopping flow (Reclamation, 2003, courtesy of David Gillette).

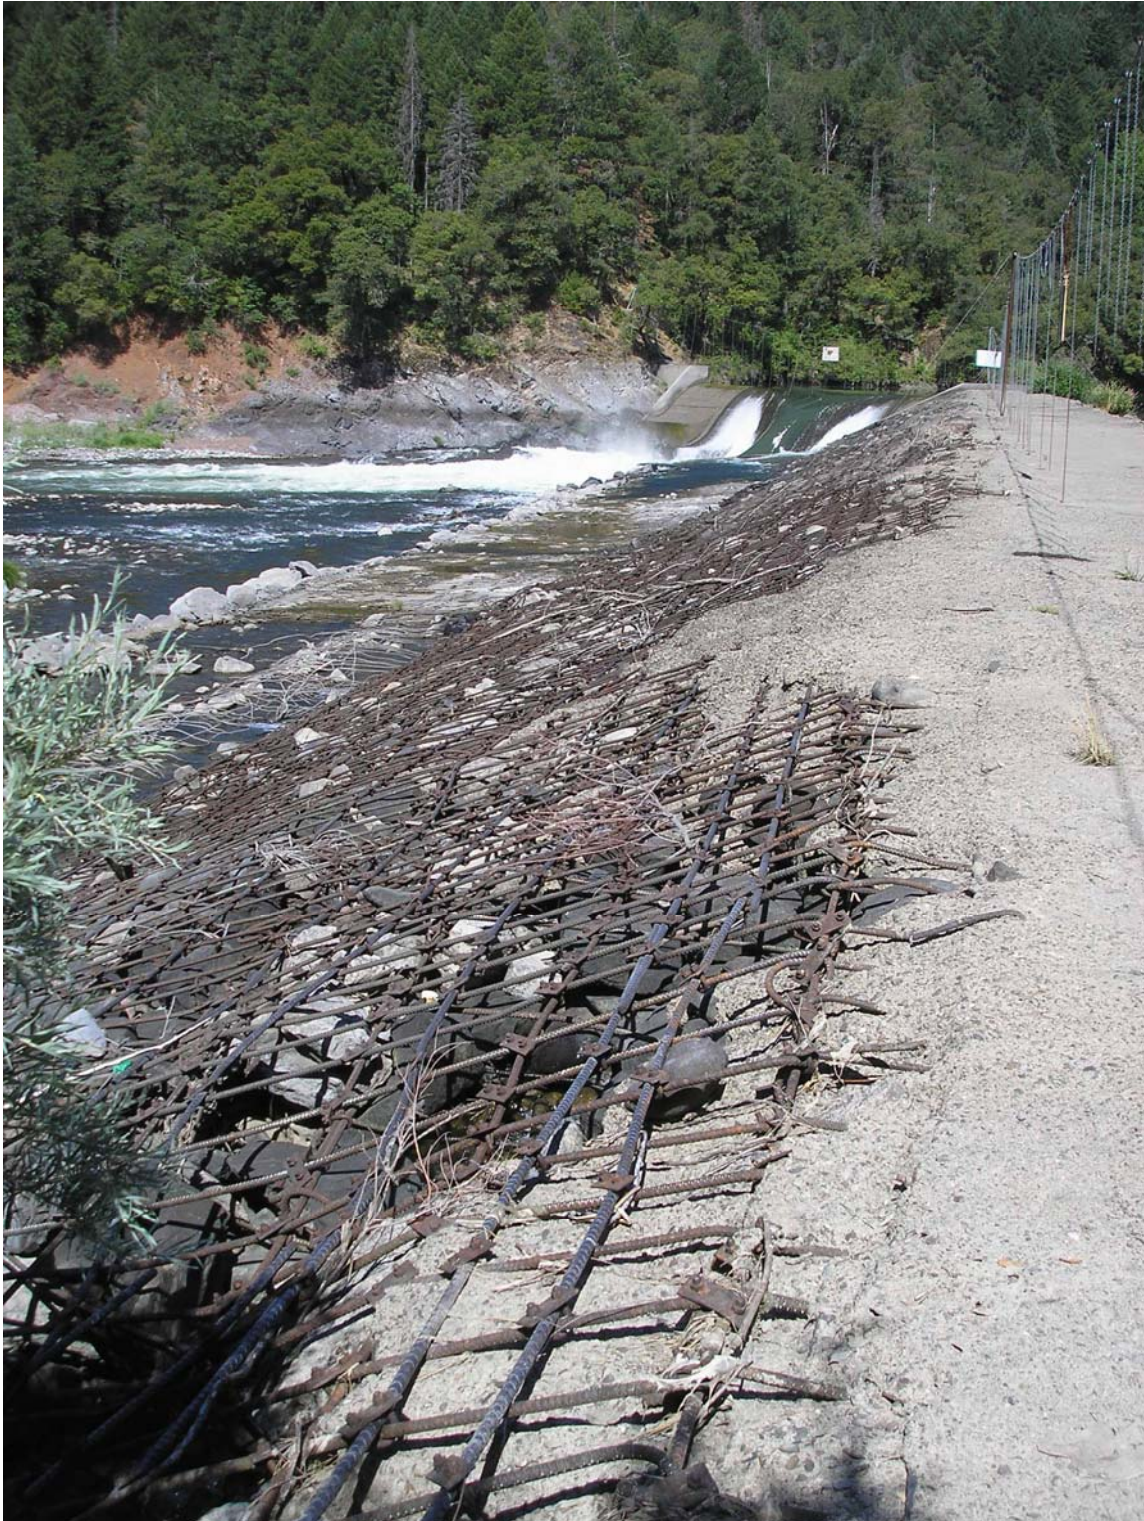
Figure 7-2.—Pit No. 7 Afterbay Dam, looking at downstream face, toward right abutment spillway. Dam crest has been capped with concrete.
(Reclamation, 2007, courtesy of Jared Vauk).

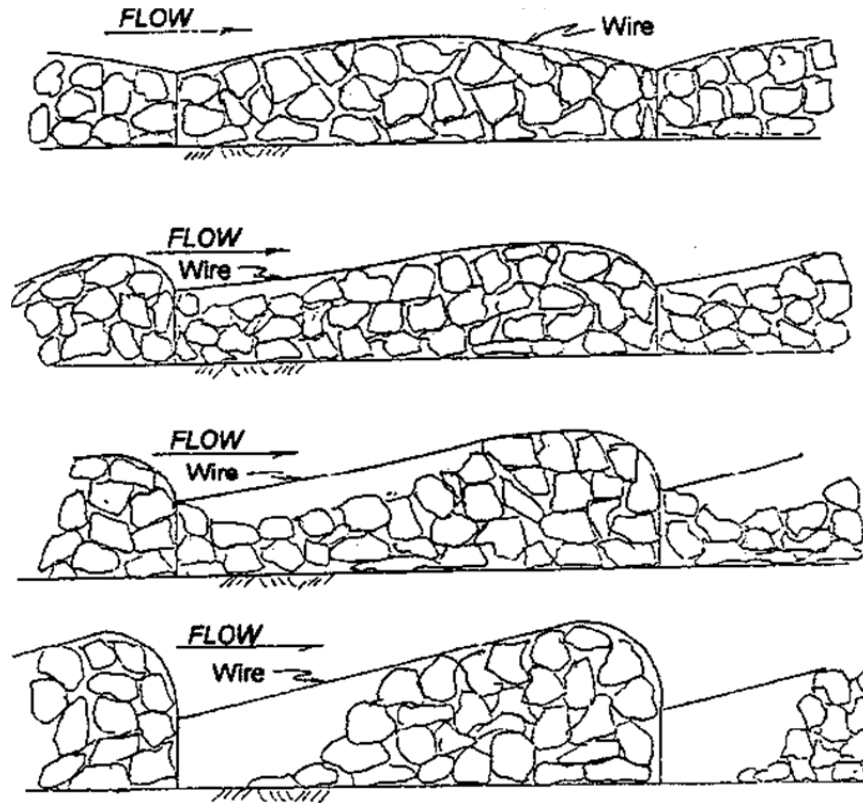
Figure 7-7.—Local pattern of rock movement within a mattress (Simmons et al., 1984).

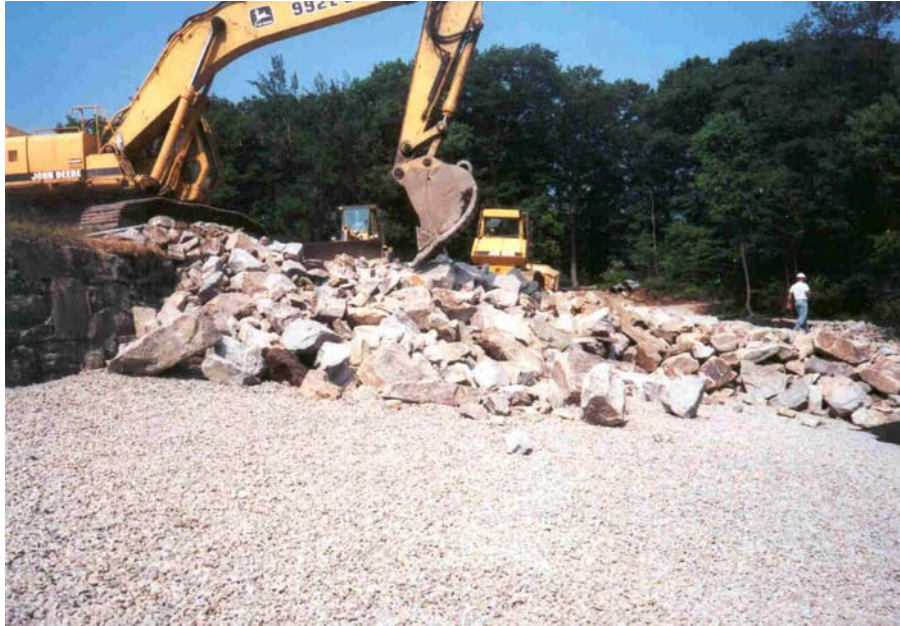
Figure 8-1.— Dumped riprap placement on 6-inch bedding layer for Upper Stoneville Reservoir Dam, Massachusetts (Wooten and Wood, 2002, Courtesy of ASDSO and GEI Consultants, all rights reserved).

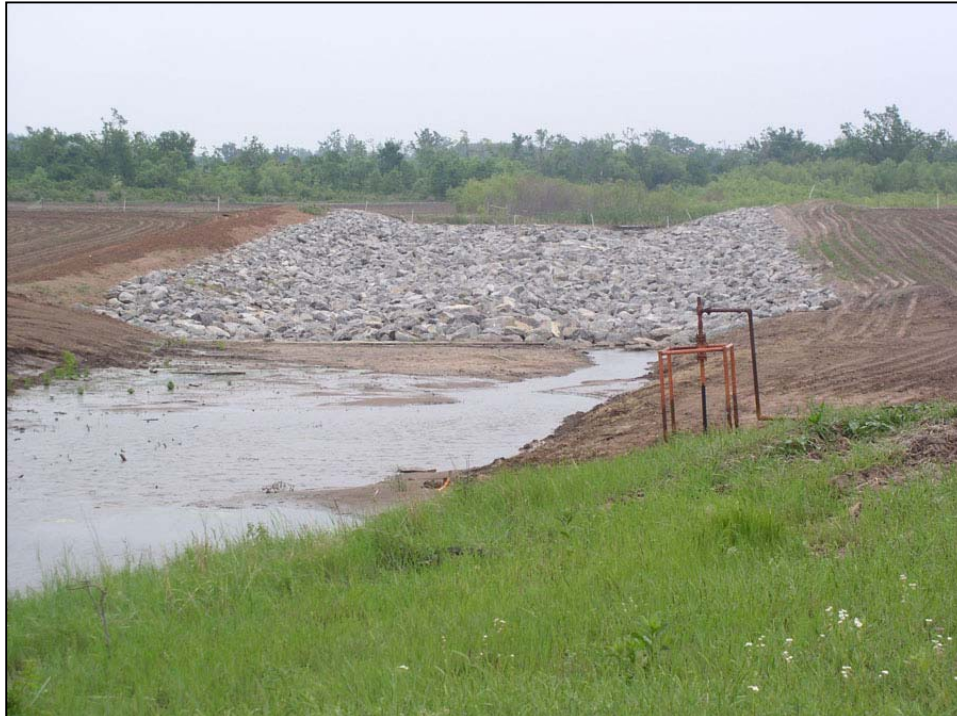
Figure 8-2.—Rock chute spillway on Little Washita Site 13 in Grady County, Oklahoma. This chute was installed in 2010 to convey flows over the remnants of the decommissioned dam (USDA-NRCS, Courtesy of Chris Stoner).

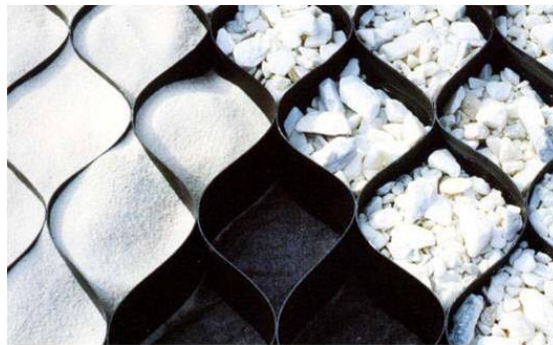
b

Figure 9-1.—Examples of a perforated and solid geoweb system with various fill materials (a) Geoweb™; (b) TerraCell® (Courtesy of WEBTEC, Inc, all rights reserved).

Most products are available in various heights and cell sizes in solid wall or perforated wall (to allow flow between cells) styles. Cell depth typically ranges from 4 to 8 inches. Typical expanded section sizes range from 8 by 2.6 feet to 8 by 40 feet. There are many manufacturers of geocells, all trademarked products, with examples of solid wall and perforated wall products shown in [Figure 9-1](#).

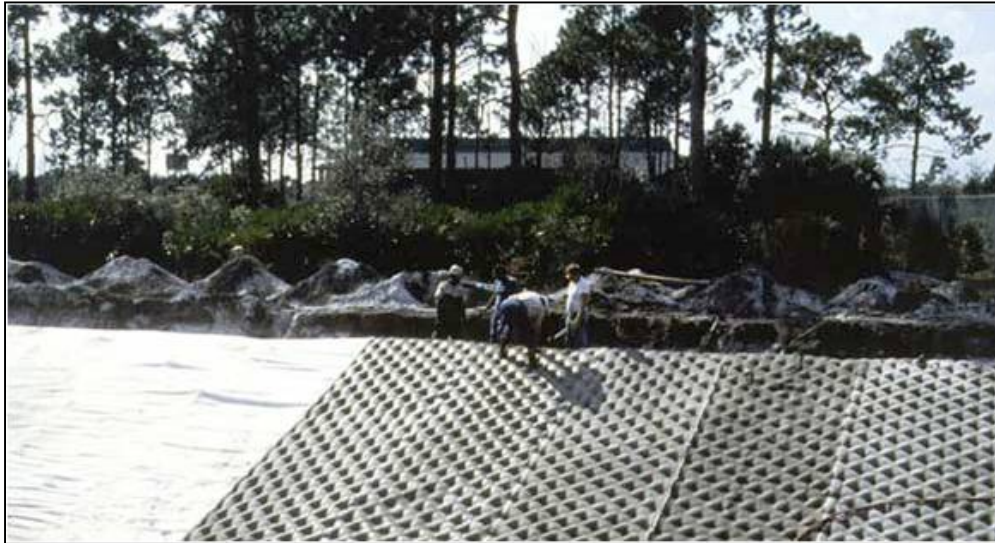
Figure 9-7.—Fabric forms being filled with fine aggregate concrete.
(Courtesy of Donnelly Fabricators, all rights reserved).

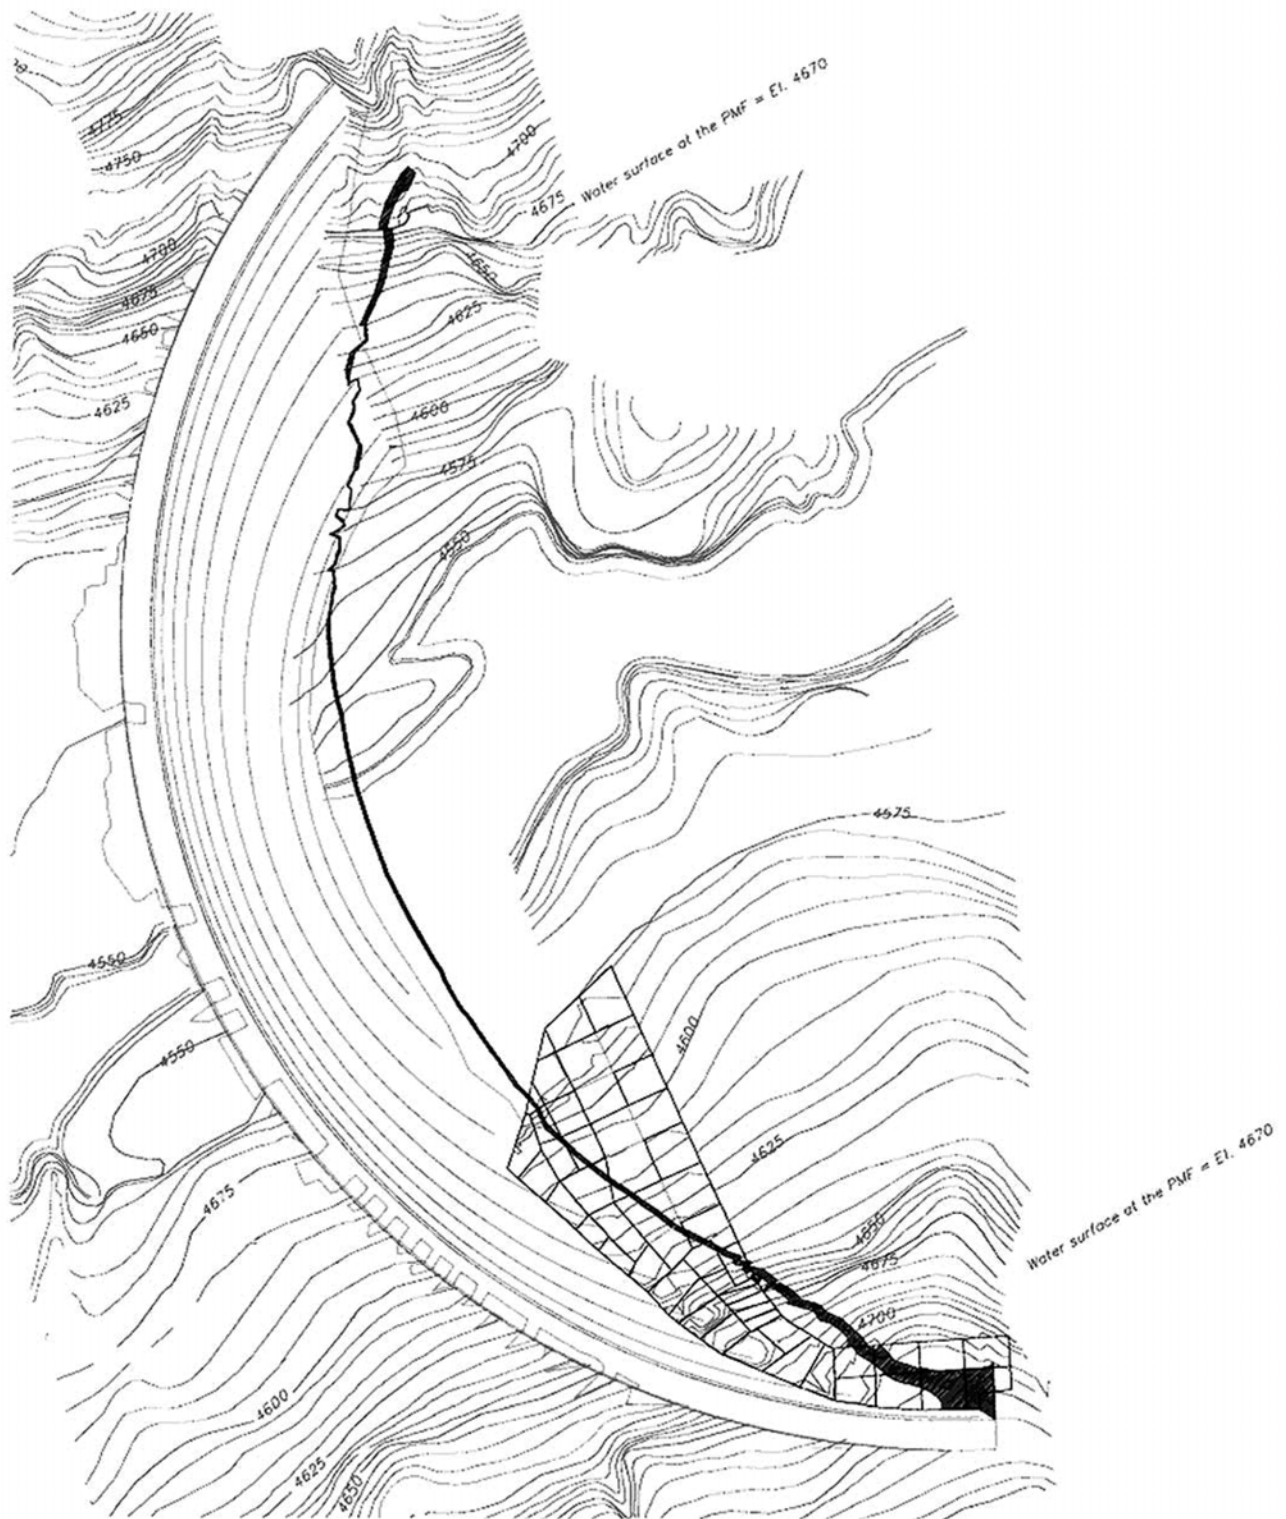
Figure 11-4.—Footprint of the trajectory with no spread of the jet for the PMF overtopping. Note the location of the footprint extends beyond the right abutment protection between contour elevations 4660 and 4710. The tailwater for the PMF is shown on the plan view in blue at Elevation 4670 (Reclamation 2006).

The upper edge of the jet is defined by adding the initial depth or jet thickness to the bottom edge of the jet. These basic equations provide a general indication of the impingement points of the overtopping flows. The impingement point will also vary, depending on the downstream geometries. Higher on the abutments, the jet will impinge a shorter distance from the dam crest, since the vertical distance to the foundation is less. The trajectory of the overtopping flows can be calculated for a number of dam cross sections and the impingement locations then plotted in plan view. This is useful for identifying the portion of the overtopping flows that will discharge into the downstream tailwater, and if overtopping protection is already in place can be used to determine if the extent of the overtopping protection is adequate. Figure 11-3, 11-4, and 11-5 provide examples of this.

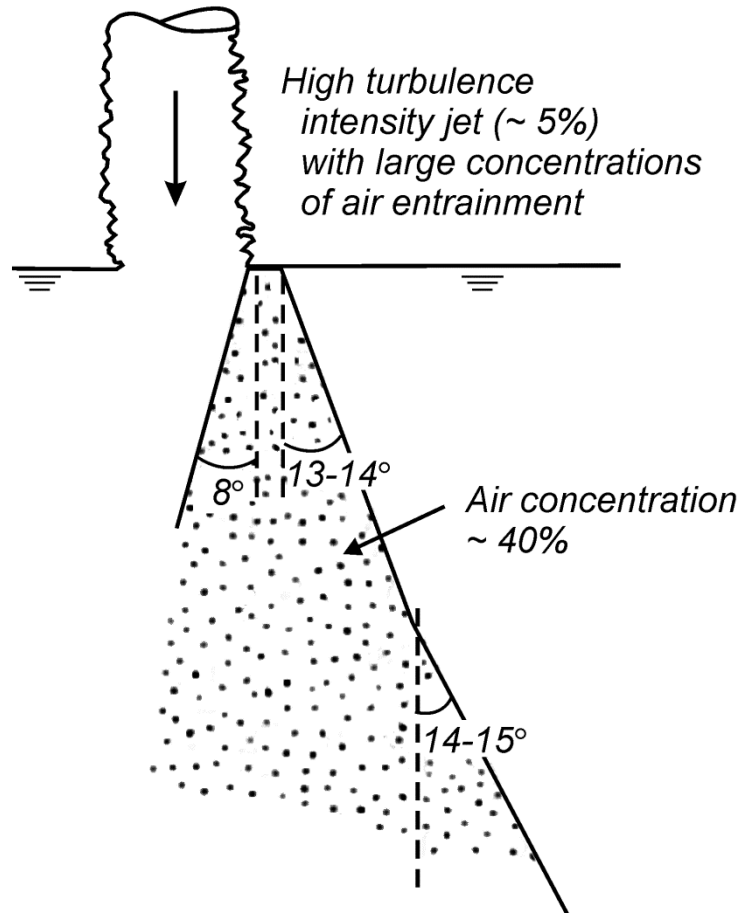
Figure 11-6.—Jet diffusion in a plunge pool for two-phase shear layer and a highly turbulent plunging jet (adapted from Ervine and Falvey, 1987). This case is typical of almost all prototype flows and most model-scale flows.

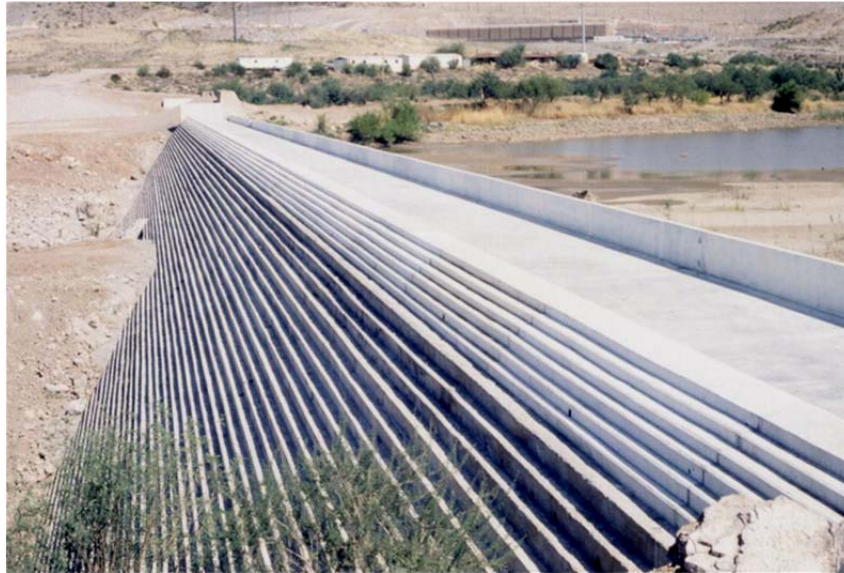
Figure 12-1.—Completed RCC buttress at downstream face of Camp Dyer Diversion Dam in Arizona. Conventional concrete was used for the overflow crest and approach apron. The stepped surface provides energy dissipation for overtopping flows (Reclamation).

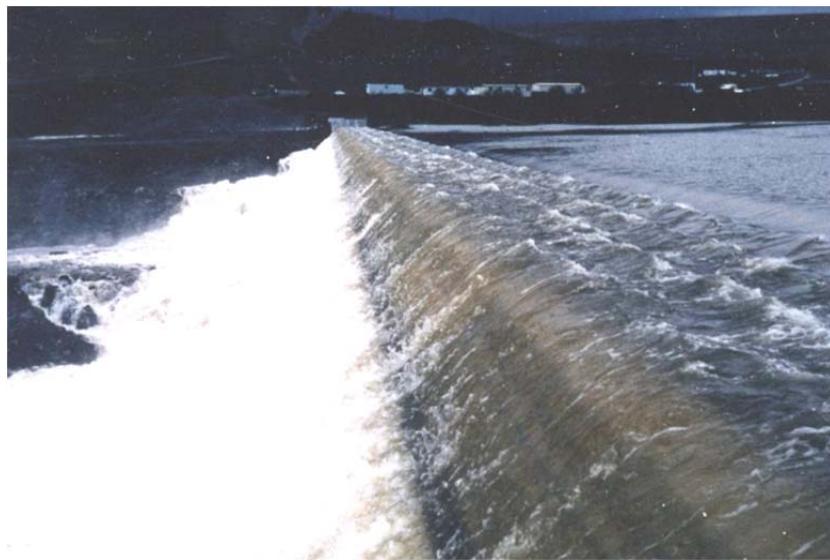
Figure 12-2.—RCC buttress for Camp Dyer Diversion Dam during overtopping in January 1993 (Reclamation).

required for the downstream face of the dam and dike to increase the dead load and sliding resistance of the modified structure. RCC was selected over conventional concrete for its relative economy and ease of construction. Construction was completed in 1992 (Figure 12-1). The structure performed well during overtopping in 1993 (Figure 12-2). Details of this modification can be found in Hepler (1982).

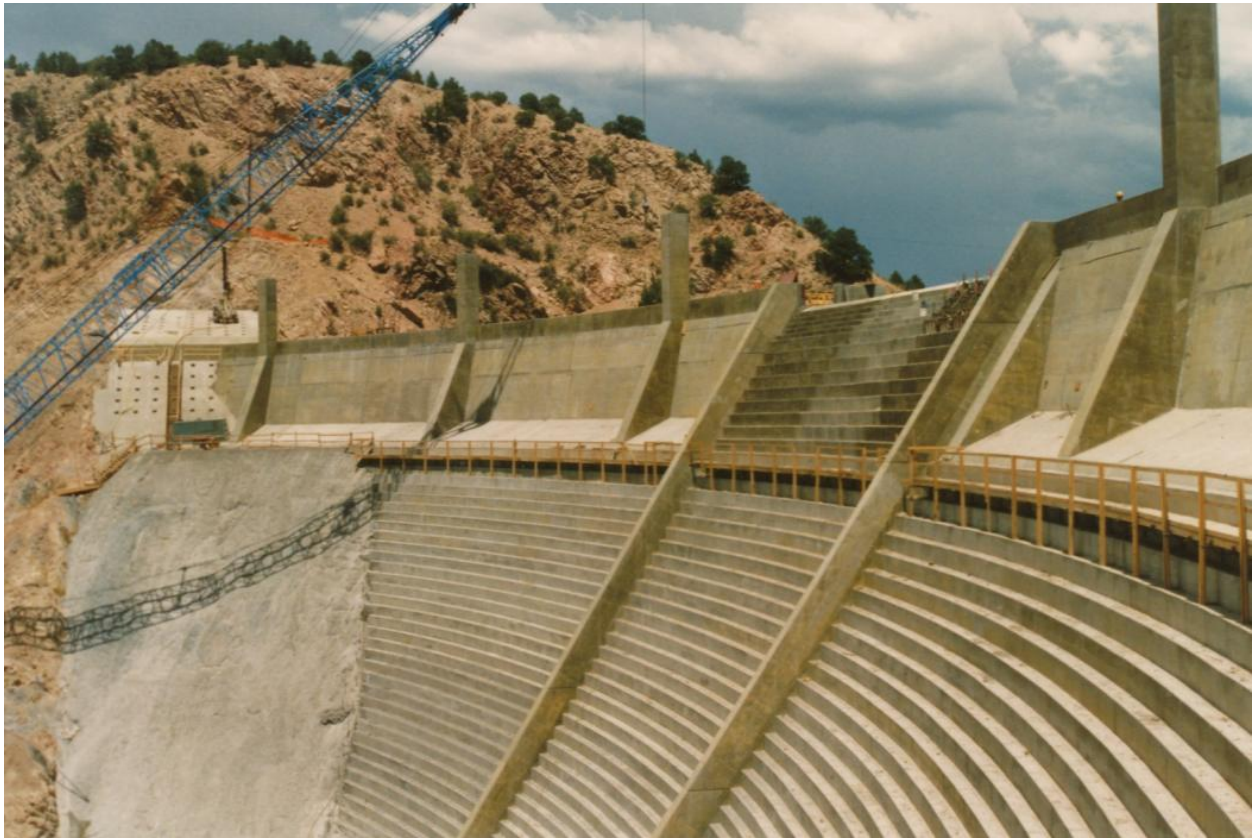
Figure 12-3.—Concrete overtopping protection for Santa Cruz Dam in New Mexico. Splitter piers were provided for overtopping of the entire dam crest (Reclamation).

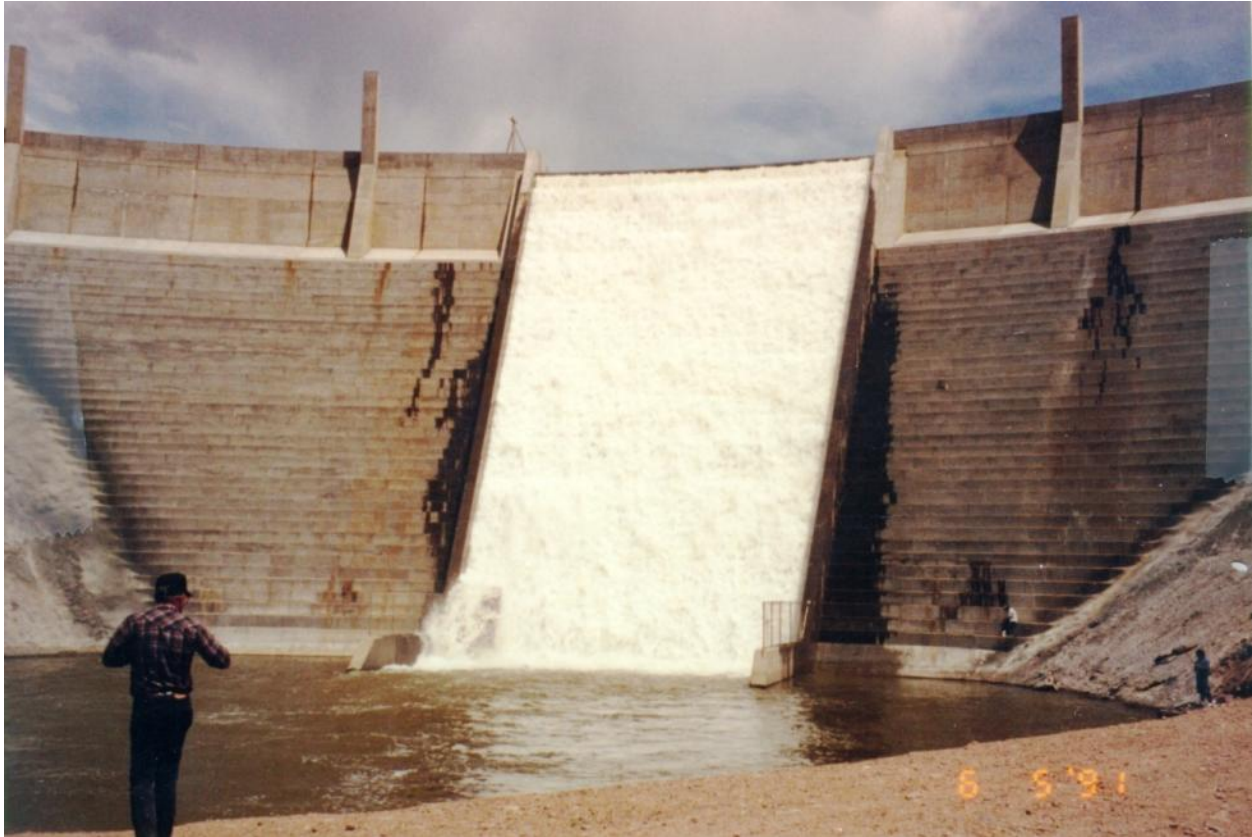
Figure 12-4.—Service spillway flows confined by training walls on stepped downstream face of Santa Cruz Dam (Reclamation).

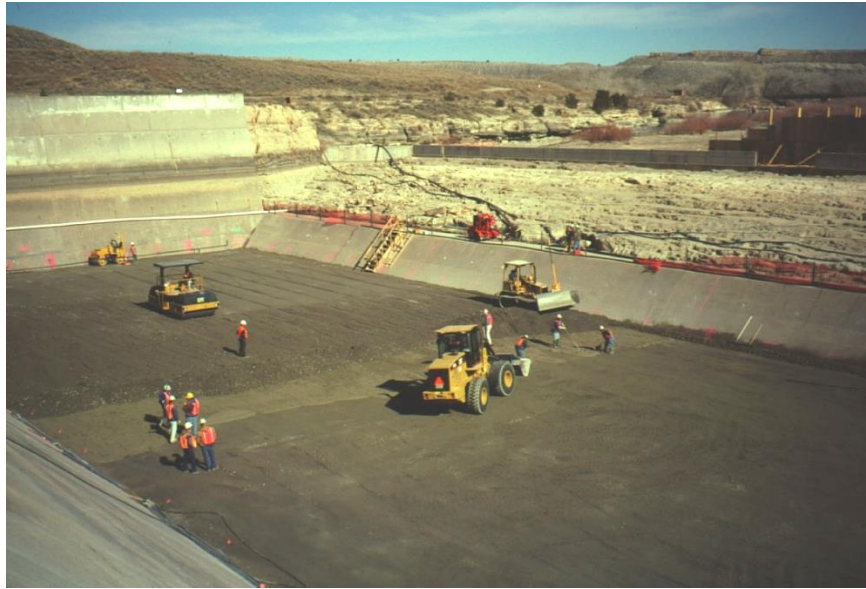
Figure 12-5.—RCC buttress construction within the original spillway plunge pool for Pueblo Dam in Colorado (Reclamation).

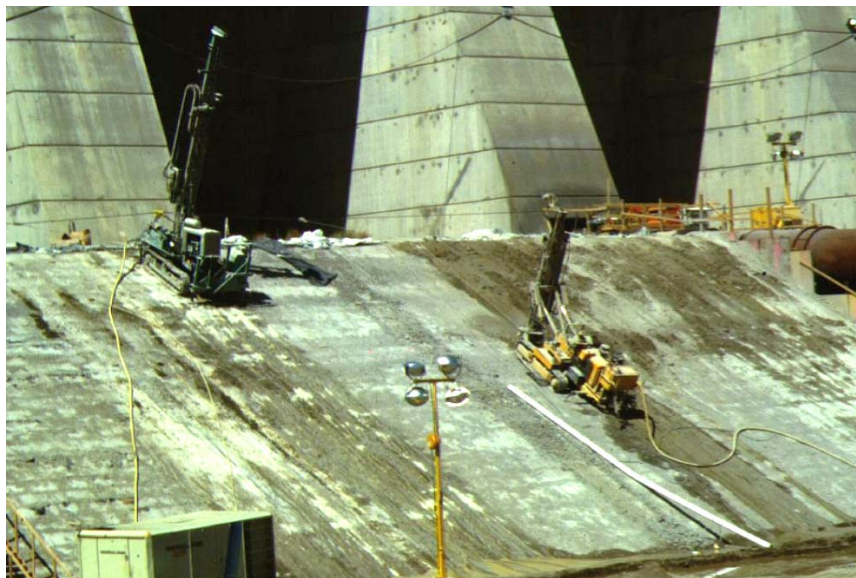
Figure 12-6.—Mechanical anchors being installed through the RCC toe block into the foundation for Pueblo Dam spillway, to improve sliding resistance (Reclamation).

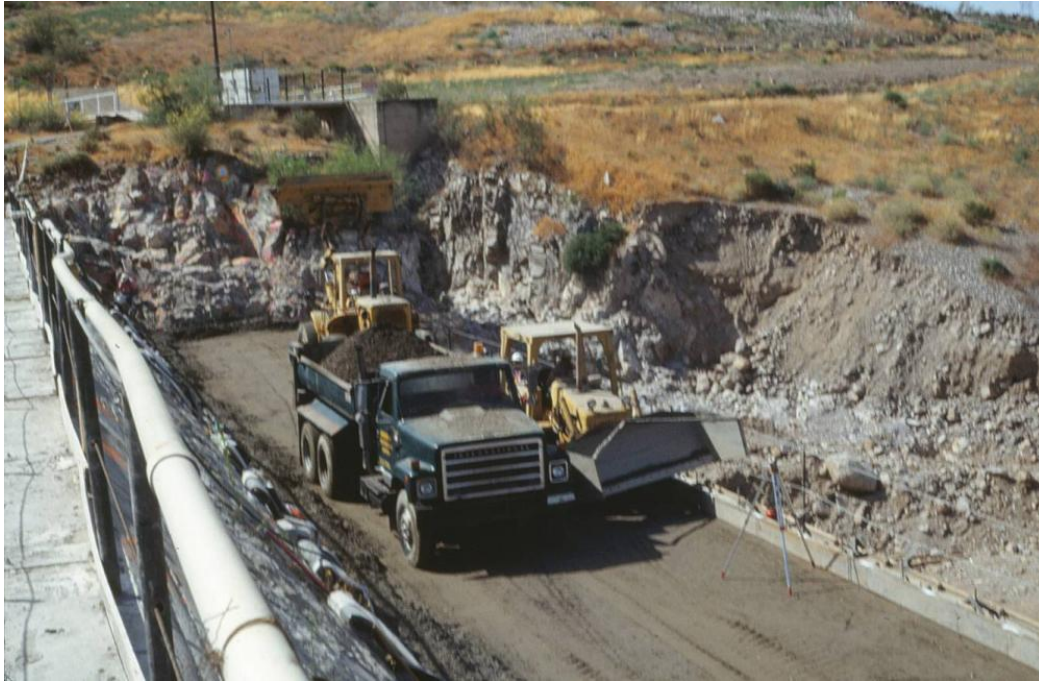
Figure 12-7.—RCC buttress being constructed at downstream face of Camp Dyer Diversion Dam. Width of RCC placement is sufficient for passing construction equipment. Note flat drains on contact surface between dam and buttress. (Reclamation)

- **Camp Dyer Diversion Dam.**—A minimum RCC buttress width of 20 feet, with an 0.8:1 downstream slope, was selected for Camp Dyer Diversion Dam to accommodate two lanes of construction traffic on the RCC lifts for both the dam and dike sections ([Figure 12-7](#)). This was larger than that required by analysis to provide a minimum sliding factor of safety of 3.0. A conventional concrete block having a vertical downstream face was used within the narrow river channel at the maximum section of the dam to facilitate construction and reduce the overall concrete volume. The RCC buttresses were capped by a conventional, reinforced concrete apron and ogee overflow crest to improve hydraulic performance. Although the conventional concrete had joints every 25 feet, no joints were specified for the RCC.

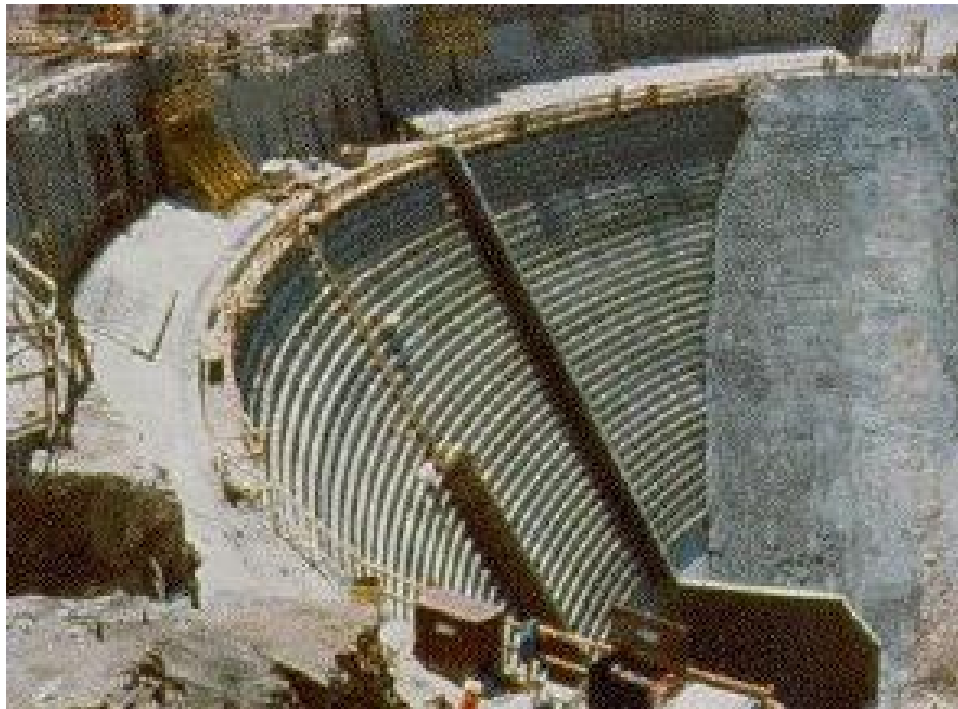
Figure 12-8.—RCC placements followed curvature of existing arch dam, Santa Cruz Dam (Reclamation).

- ***Santa Cruz Dam.***—The RCC buttress for Santa Cruz Dam maintained the curvature of the existing arch dam, and provided 2-foot-high steps on the downstream face for energy dissipation of overtopping flows (Figure 12-8). The stilling basin at the downstream toe was designed assuming a 75 percent reduction of the total energy resulting from the steps. The design requirements for the RCC included a minimum compressive strength of 3,000 lb/in² at 1 year, cohesion between the RCC and existing concrete dam of 50 lb/in² at 1 year, and freeze-thaw durability of 500 cycles (ASTM C666). The use of an air-entraining admixture significantly improved the freeze-thaw durability. Leveling concrete was used around the perimeter of the RCC placement, so that adequate bond would be obtained with the existing dam concrete surface. No mechanical anchorage was provided at the RCC buttress/dam contact.

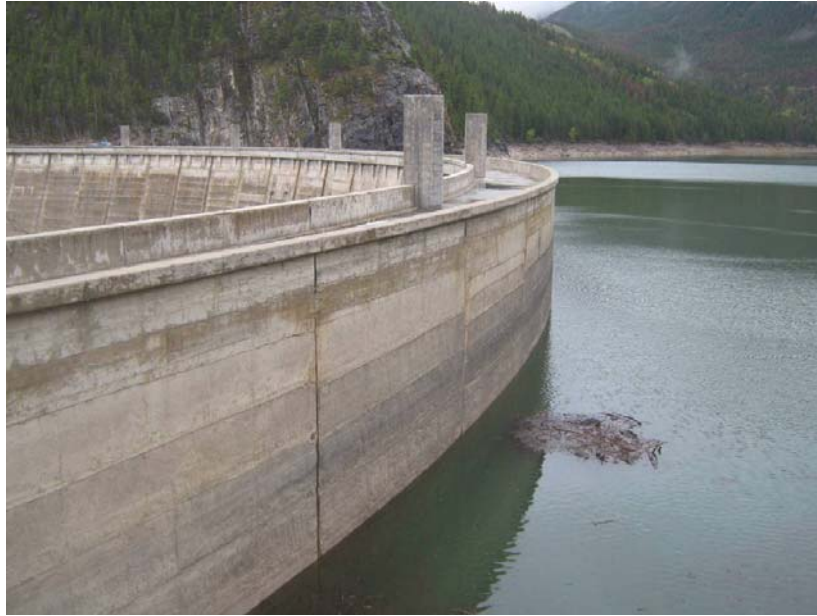
Figure 13-1.—Crest of concrete dam with splitter piers for overtopping flows (Reclamation).

bolts to reinforce and stabilize jointed rock in the abutments and placement of concrete caps on both abutments. The overtopping protection on the right abutment was more extensive than on the left abutment, because the rock was judged to be more erodible on the right side. The reinforced concrete overlays had a minimum thickness of 2.5 feet. Figures 13-1 to 13-5 are of Gibson Dam.
