Technical Manual: Overtopping Protection for Dams

**Best Practices for Design, Construction, Problem
Identification and Evaluation, Inspection,
Maintenance, Renovation, and Repair**

FEMA P-1015/May 2014

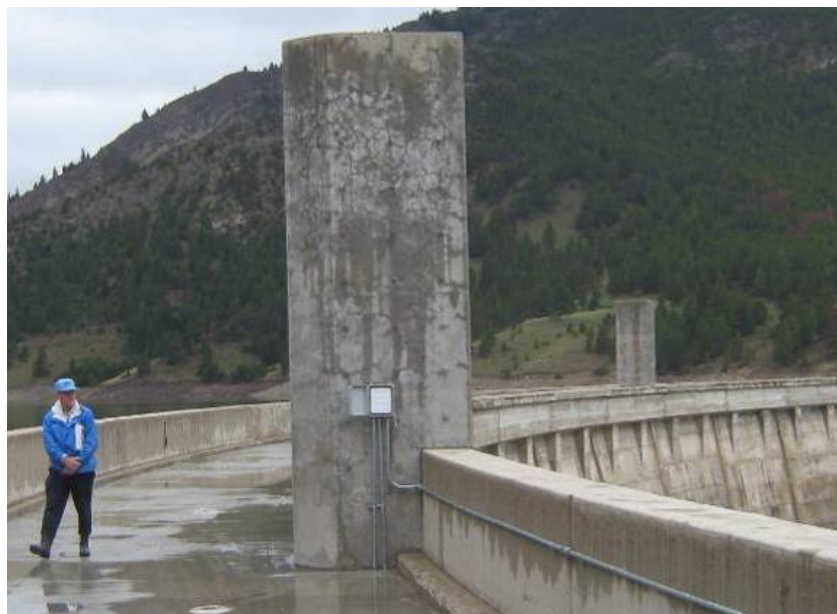
Figure 13-2.—Splitter piers designed to aerate overtopping flows (Reclamation).

bolts to reinforce and stabilize jointed rock in the abutments and placement of concrete caps on both abutments. The overtopping protection on the right abutment was more extensive than on the left abutment, because the rock was judged to be more erodible on the right side. The reinforced concrete overlays had a minimum thickness of 2.5 feet. Figures 13-1 to 13-5 are of Gibson Dam.

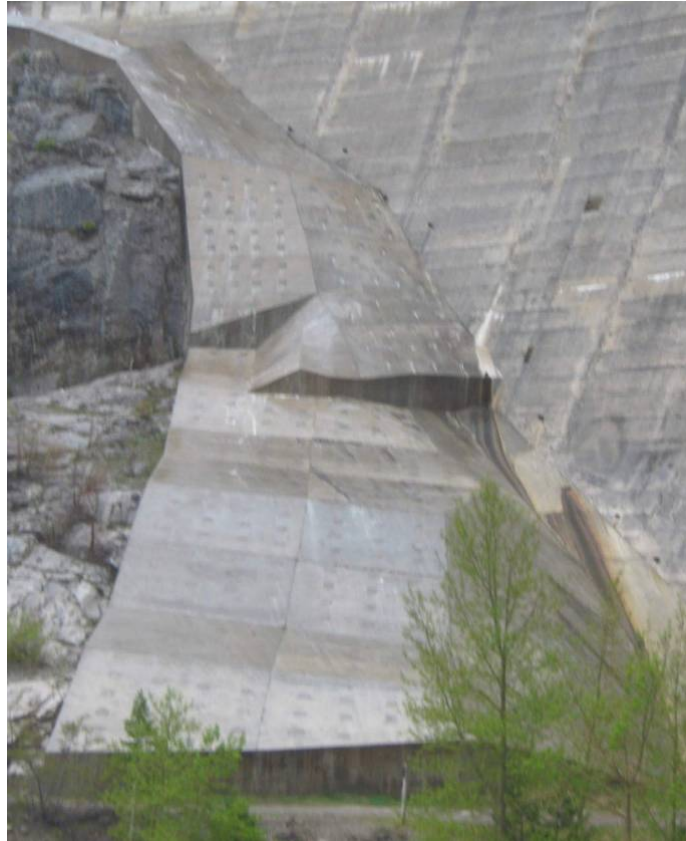
Figure 13-3.—Concrete overtopping protection at downstream toe of dam (Reclamation).

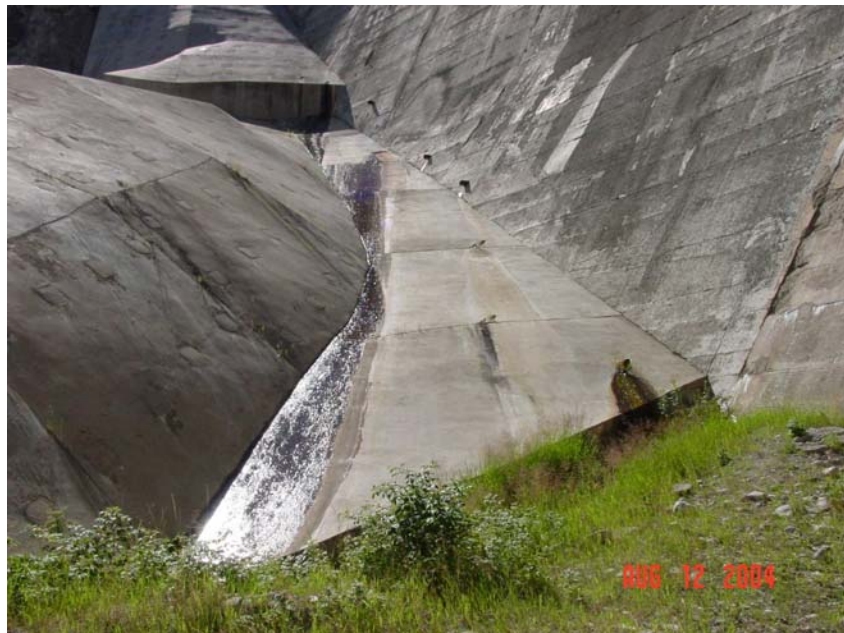
Figure 13-4.—Concrete overtopping protection at downstream toe of dam (Reclamation).

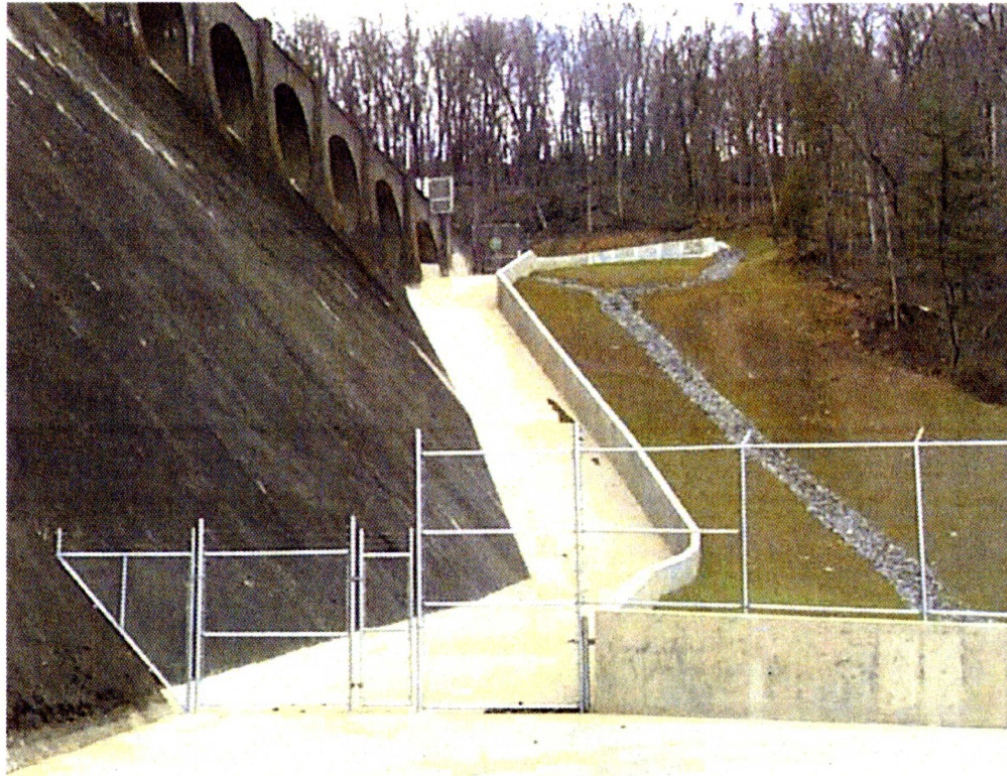
Figure 13-5.—Concrete channel using guide wall to convey overtopping flows (USACE republished in Zaitsoff, 2003).

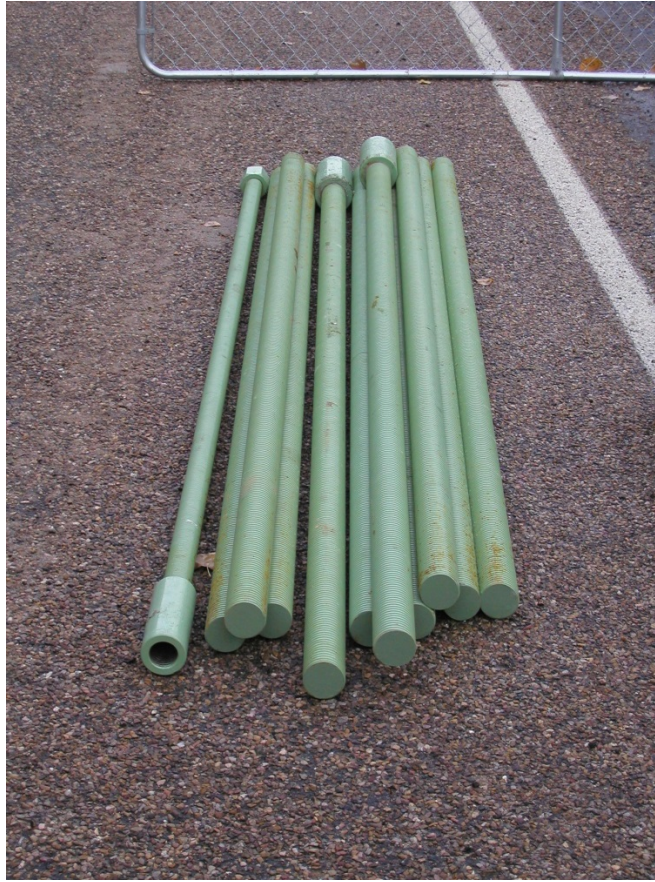
Figure 14-5.—Epoxy coated rock bolts (Reclamation).

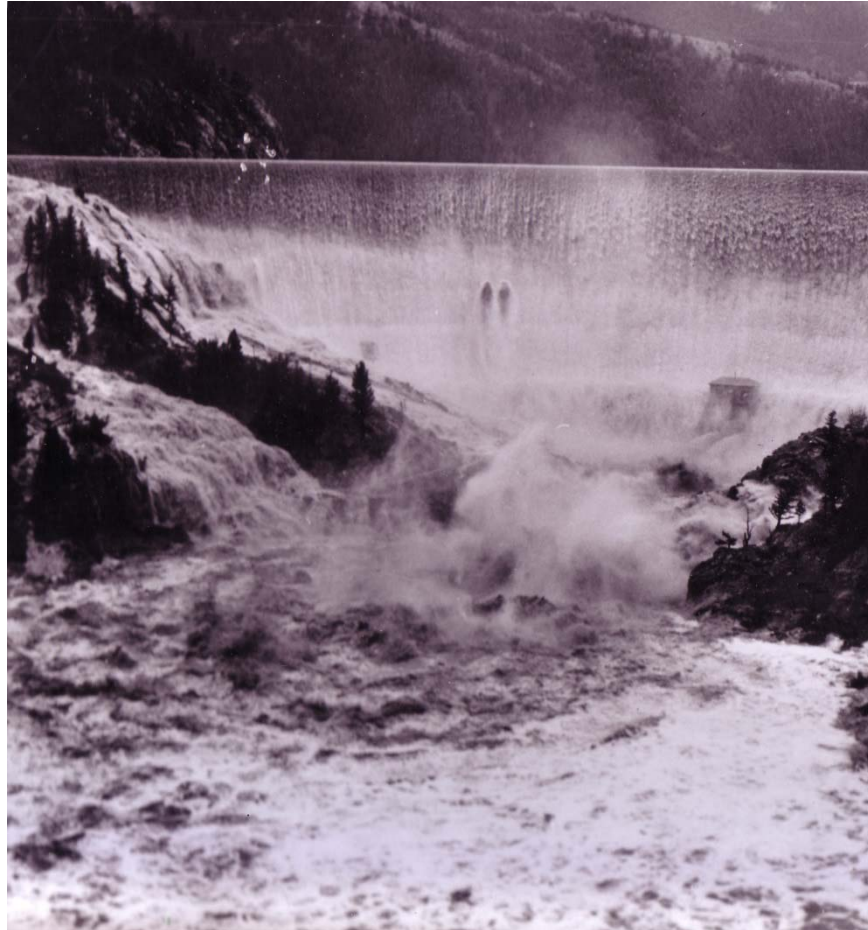
Figure 15-1.—Overtopping of Gibson Dam in 1964 by about 3 feet
(Courtesy of the U.S. Geological Survey [USGS] and USFS).

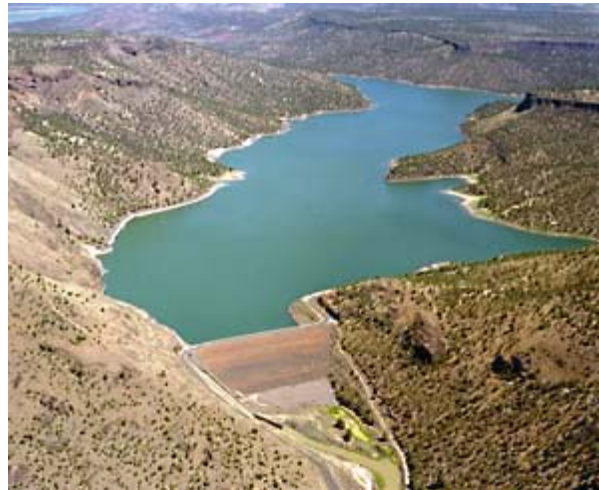
Figure Bowman-1.—A.R. Bowman Dam and Reservoir (Reclamation).

Arthur R. Bowman (A.R. Bowman) Dam is an embankment dam located on the Crooked River, about 20 miles upstream of Prineville, Oregon shown in Figure Bowman-1. The dam is owned by Reclamation and was completed in 1961. Its main purpose is to provide water supply for irrigation. The embankment consists of a wide central core, narrow transitional zones, and rockfill shells. It has a structural height of 245 feet, a crest length of 800 feet, and a crest elevation of 3264 feet. The existing spillway at A.R. Bowman Dam, consisting of a 20-foot-long ogee crest with a concrete-lined chute, has a capacity of about 8,100 ft³/s. The outlet works is a concrete-lined tunnel controlled by two 6- by 4-foot high-pressure gates and is located in the right abutment of the dam. The outlet works discharges into the spillway stilling basin and has a design capacity of 3,300 ft/s.

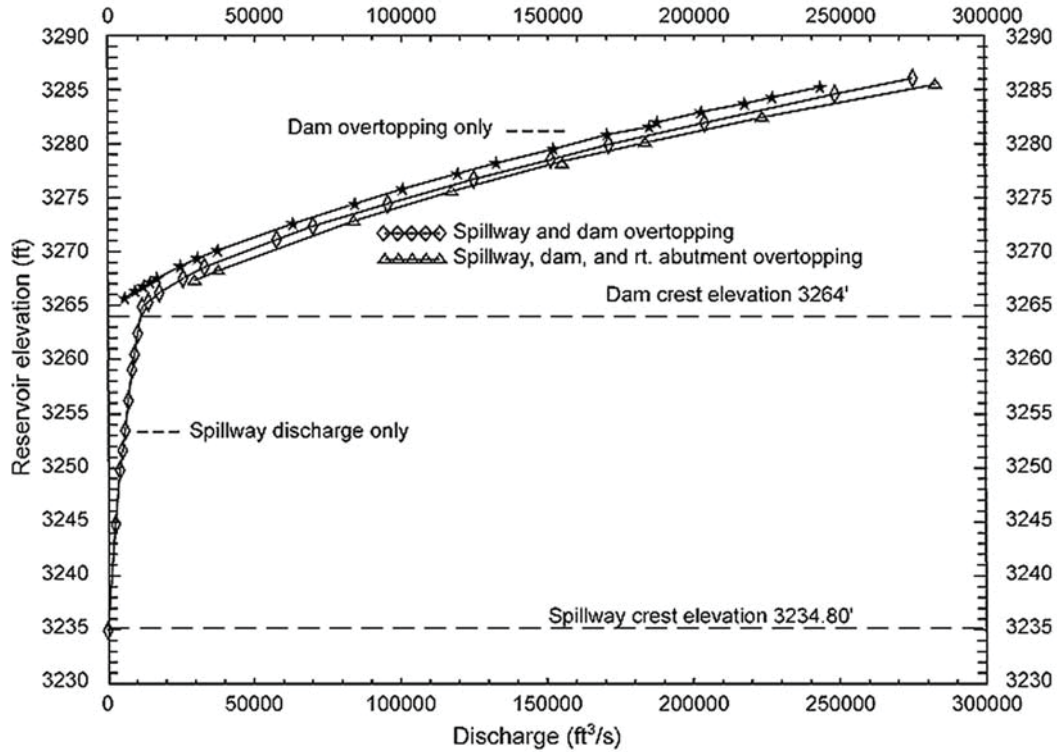
Figure Bowman-7.—Discharge curves for A.R. Bowman Dam (Reclamation figure republished in McGovern and Frizell, 1991).

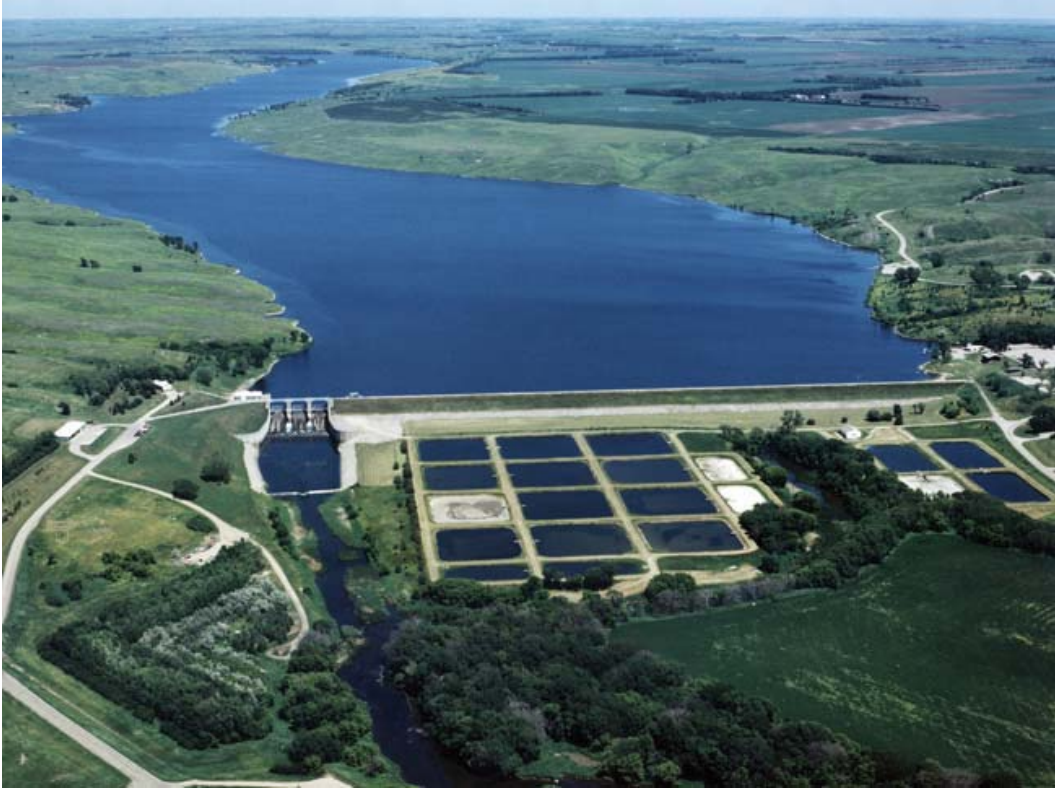
Figure Baldhill-1.—Baldhill Dam, with service spillway at the right end of the dam (looking downstream) and the uncontrolled auxiliary spillway on the downstream face of the dam (Courtesy of USACE).

The second alternative consisted of supplementing the existing spillway capacity with capacity of an uncontrolled auxiliary spillway located on the crest and downstream face of the dam. The crest of the auxiliary spillway was set at elevation 1271 feet and the crest was 1,200 feet long. A slightly sloping crest, consisting of a continuously reinforced concrete slab, was provided at the top of the dam (which was lowered from the original elevation of 1278.5 feet). The chute of the spillway consisted of a continuously reinforced concrete slab on the downstream face of the dam and a continuously reinforced concrete apron slab at the downstream toe of the dam (see Figures Baldhill-2 and Baldhill-3). Riprap was included in the downstream channel immediately downstream of the concrete apron.

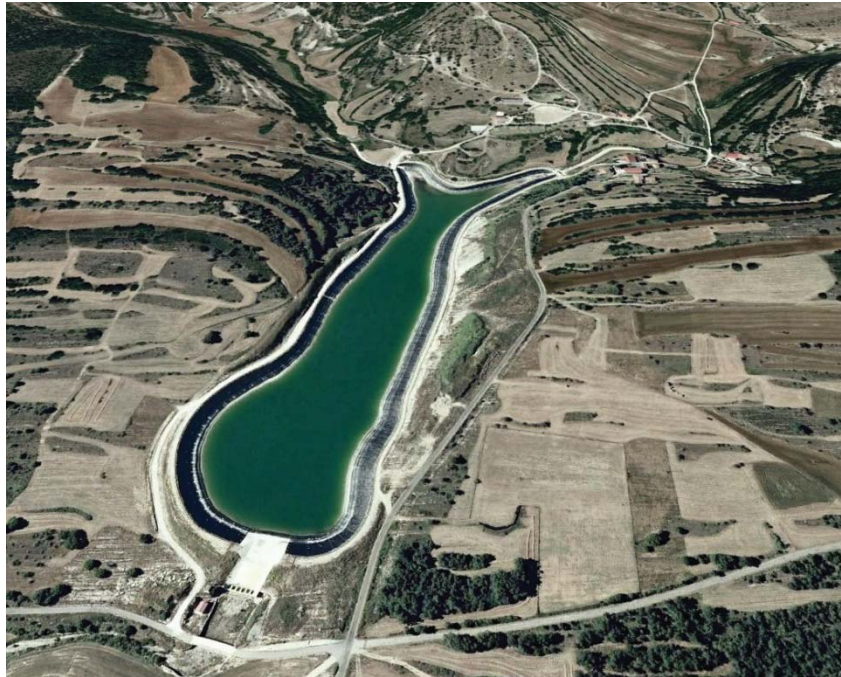
Figure Barriga-1.—Overall view of the completed Barriga Dam water storage project showing the membrane-lined reservoir and stepped block spillway in the lower left hand corner (courtesy of Rafael Morán, all rights reserved).

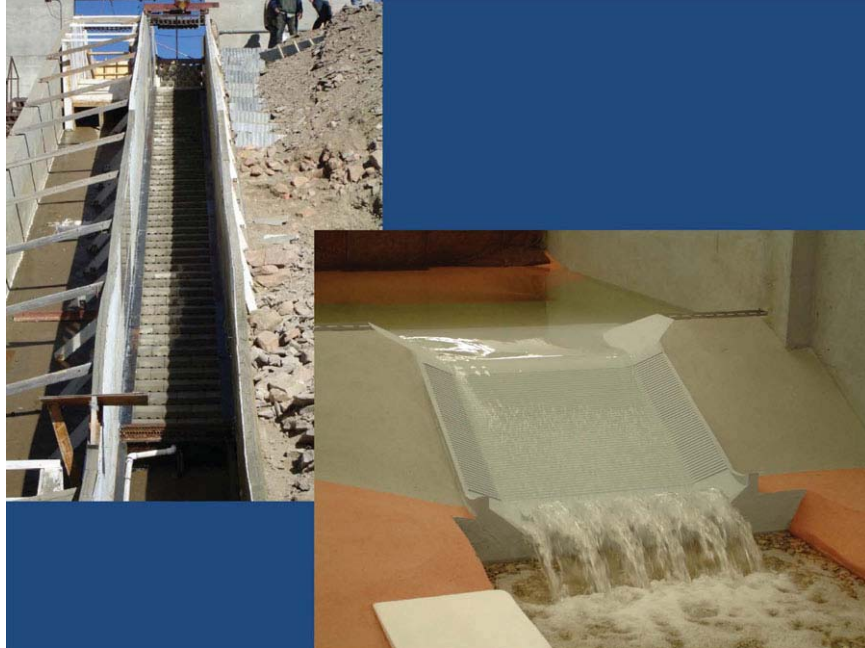
Figure Barriga-2.—(a) Prototype two-dimensional flume testing of the standard ArmorWedge block performance at CSU (upper left) (courtesy of CSU).

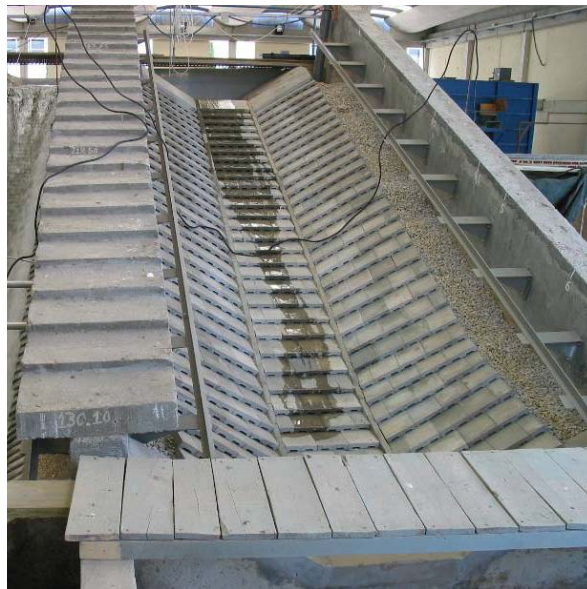
Figure Barriga-3.—Laboratory testing of smaller scale wedge-shaped blocks in a trapezoidal channel over a compacted embankment in Portugal. General testing of velocities, air concentration, depths, pressures on the surface and in the drainage layer, and drainage flows have been accomplished with the data used for the Barriga project (courtesy of LNEC, Portugal, all rights reserved).

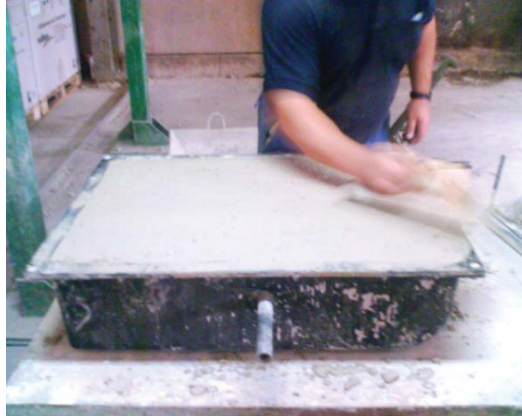
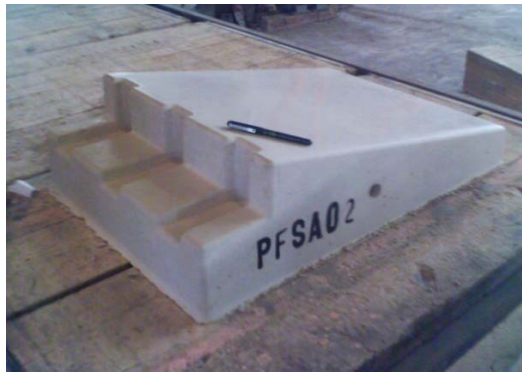
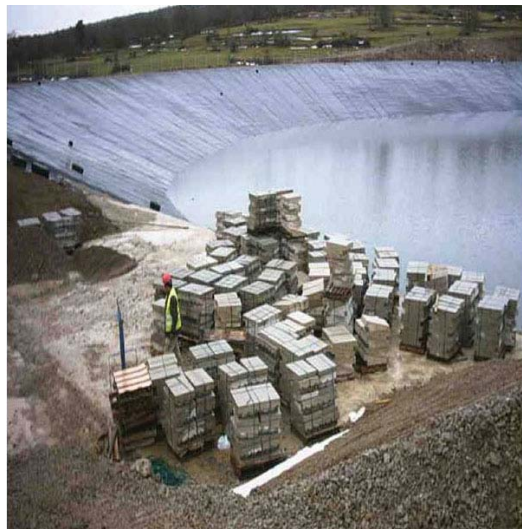
Figure Barriga-6.—a) Concrete block being finished in the plastic mold using a wet cast.
b) Finished block upside down on table in plant.
c) Blocks stacked at dam site on top of compacted spillway crest in preparation for placement
(courtesy of Morán and Toledo, 2006, all rights reserved).

The larger block size for Barriga Dam (1.6 times the standard block of 12 inches wide by 18 inches long) had to be wet cast with special forms made for the project in the U.S. and shipped to a pre-cast factory near the site for manufacturing ([Figure Barriga-6](#)). [Figures Barriga-7](#) through [Barriga-13](#) show the spillway section under construction in 2007.

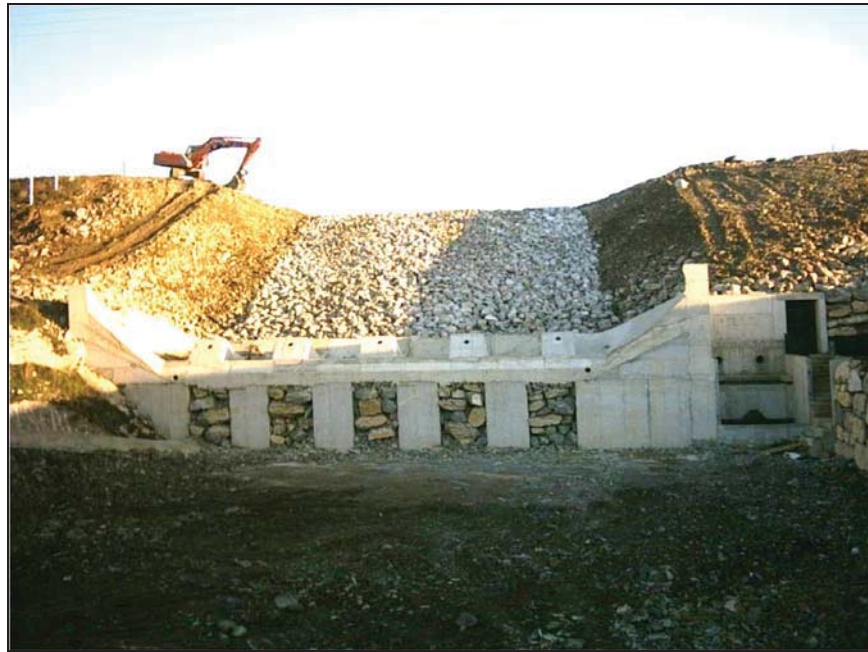
Figure Barriga-7.—Completed flip bucket toe block and drainage with initial grading for block spillway (courtesy of Morán and Toledo, 2006, all rights reserved).

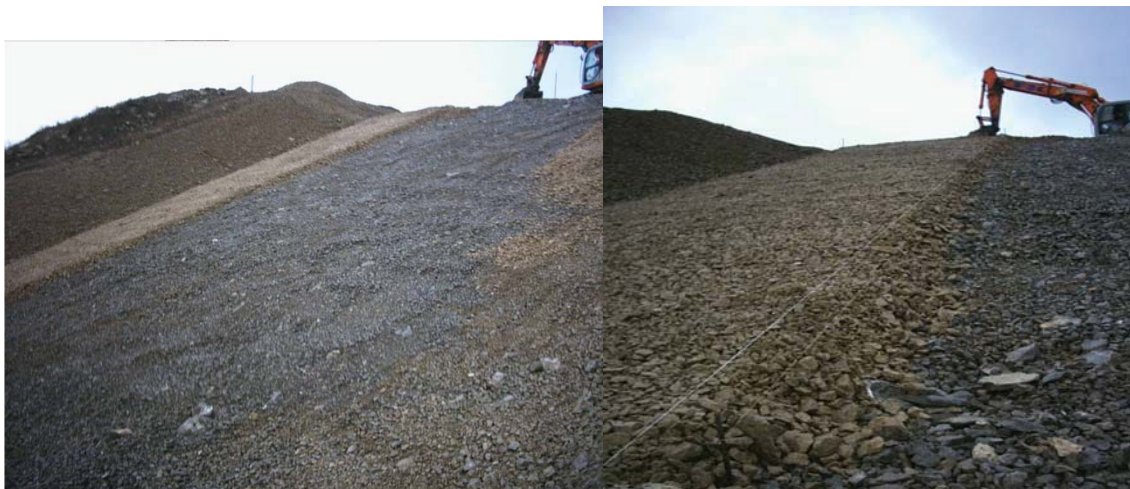
Figure Barriga-8.—Views of the two filter-compatible gravel layers beneath the block system, (a) top bedding layer (left) and (b) bottom drainage layer (right) (courtesy of Morán and Toledo, 2006, all rights reserved).

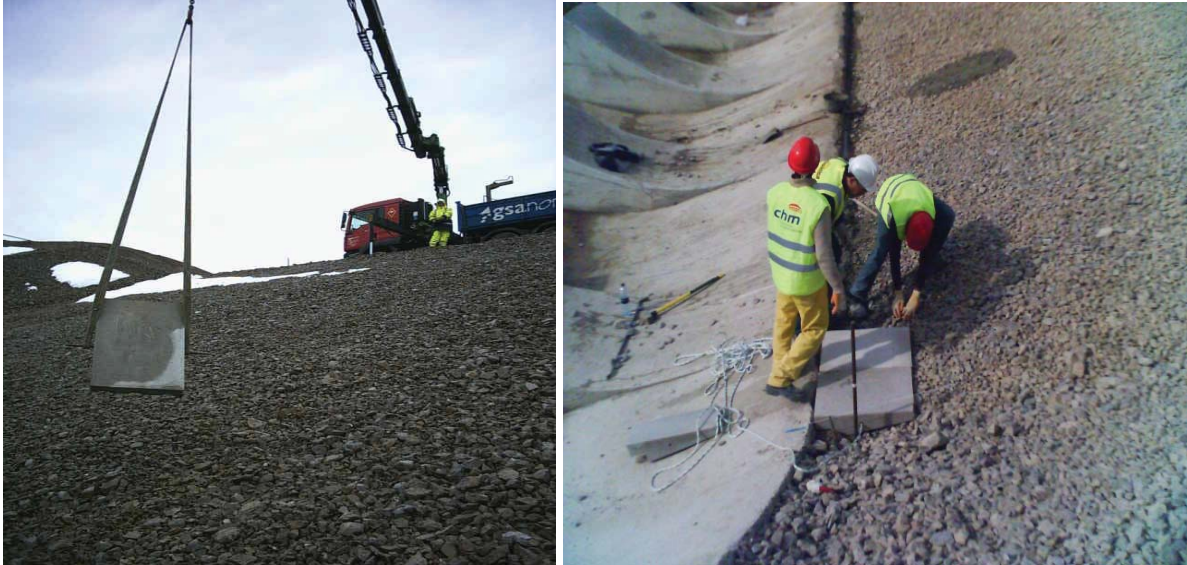
Figure Barriga-9.—Crane passing down a block and placement of the first block at the flip bucket (courtesy of Morán and Toledo, 2006, all rights reserved).

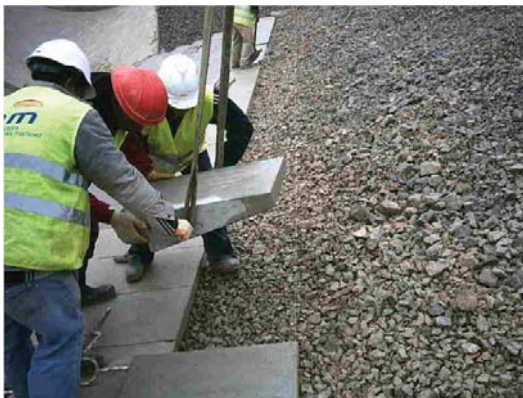
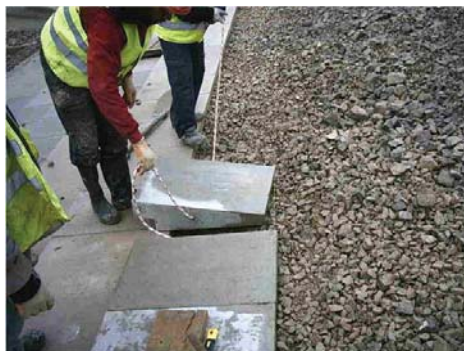
Figure Barriga-10.—View of

a) Block delivery by crane with straps on steel rod through block and

b) Polyester rope being pulled through block (courtesy of Morán and Toledo, 2006, all rights reserved).

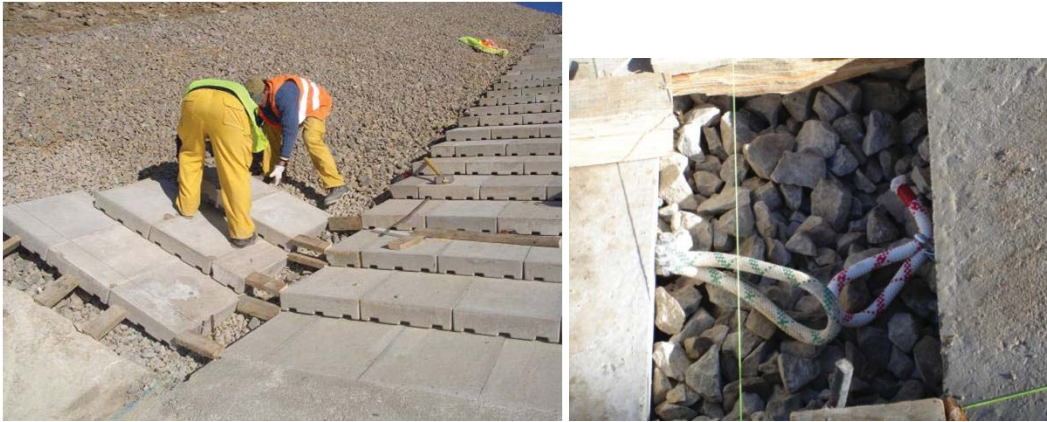
Figure Barriga-11.—View of block placement on side slope (left) and close up of rope in joint (right) (courtesy of Morán and Toledo, 2006, all rights reserved).

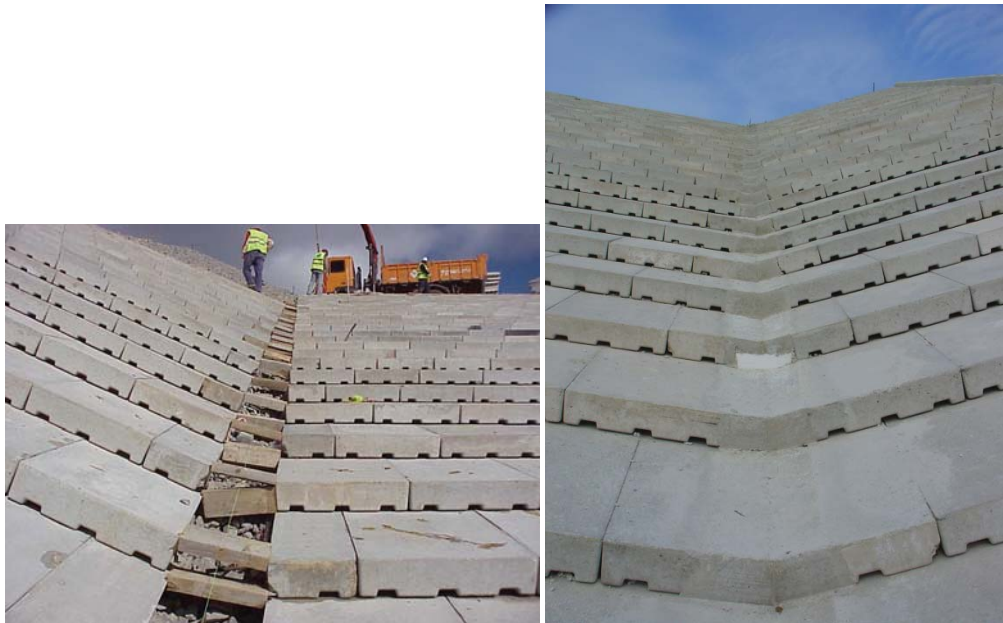
Figure Barriga-12—Views of shimmed joint on left and completed concrete transition on right between invert and side slope (courtesy of Morán and Toledo, 2006, all rights reserved).

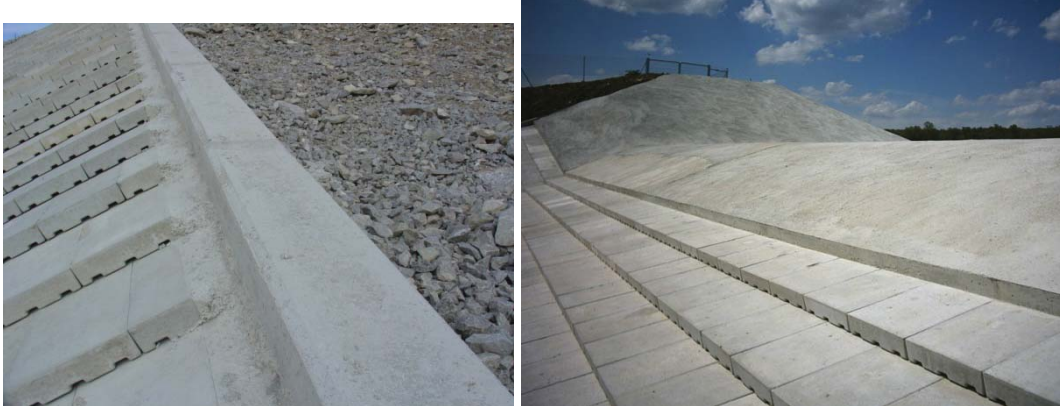
Figure Barriga-13.—View of top caps for the side slope blocks on left and of the completed crest cap on right (courtesy of Morán and Toledo, 2006, all rights reserved).

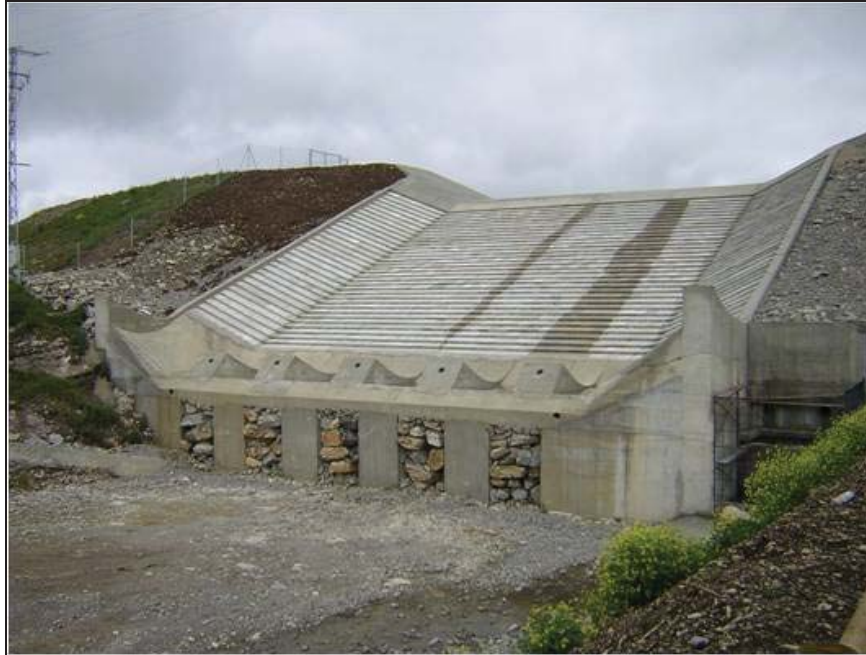
Figure Barriga-14.—Completed spillway prior to operation (courtesy of Morán and Toledo, 2006, all rights reserved).

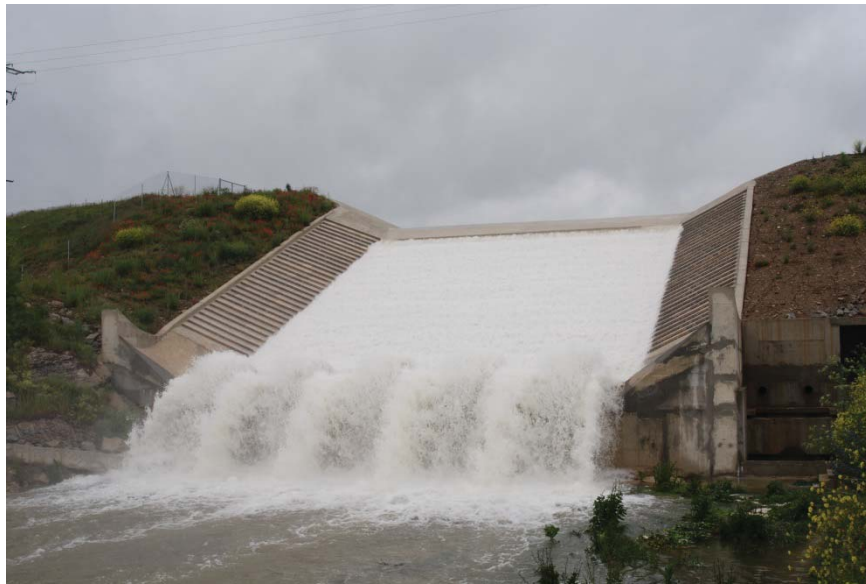
Figure Barriga-15.—Operation in May 2008 with estimated discharge of 350 - 530 ft³/s (courtesy of Morán and Toledo, 2006, all rights reserved).

The spillway has operated annually since March 2008 with flows that are a very small percentage of the design flow, on the order of 350 to 530 ft³/s. No settlement has been observed. Some abrasion from the flow has produced rounding of the sharp corners of the blocks, but this was intended to be done in the manufacturing anyway. There has also been some light deposition of calcium or other film on the surface of the blocks (per personal communication with Rafael Morán, designer). Measurement points were installed on selected blocks within the channel in 2009 to monitor settlements; however, these data are proprietary and not available for review. [Figures Barriga-14](#) through [Barriga-17](#) show the completed spillway and operation.

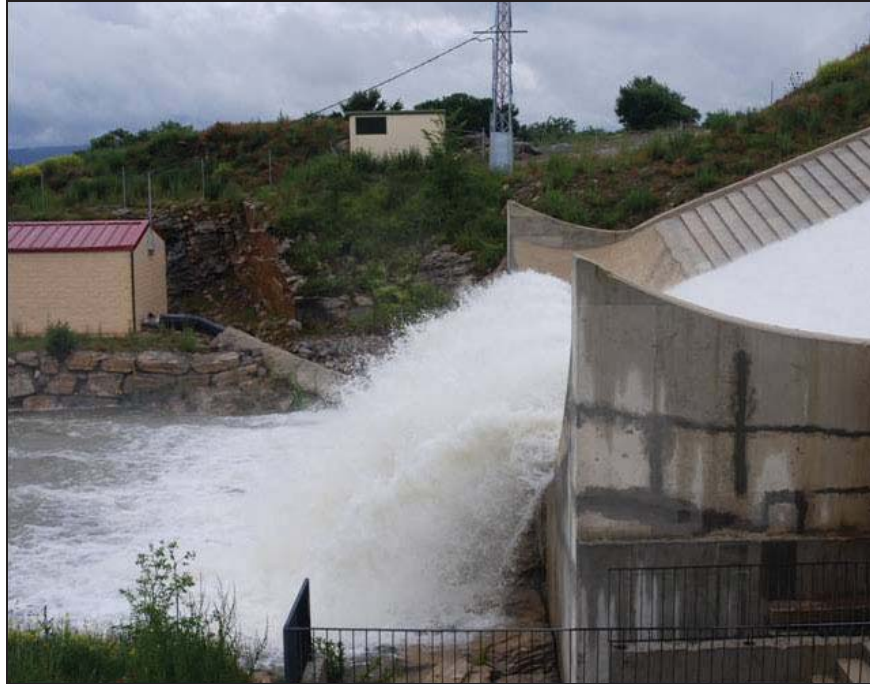
Figure Barriga-16.—Side view of the flip bucket operating (courtesy of Morán and Toledo, 2006, all rights reserved).

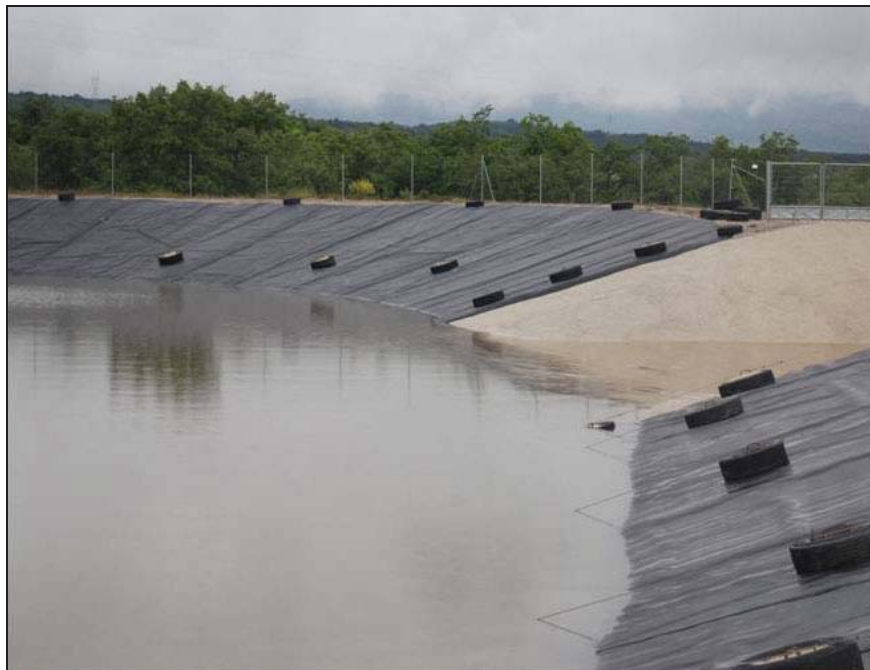
Figure Barriga-17.—View of the lined reservoir and approach conditions into the completed spillway (courtesy of Morán and Toledo, 2006, all rights reserved).

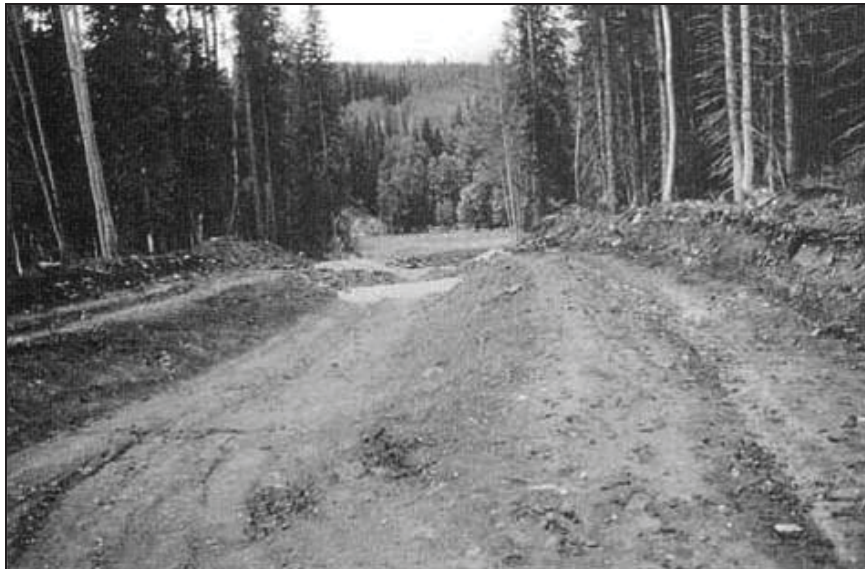
Figure Cottonwood-5.—Preparation of subgrade before geomembrane liner installation in spillway (Reclamation figure republished in Timblin et al., 1988).

[Figures Cottonwood-2](#) through [Cottonwood-6](#), at the end of this case study, show the design details of the Cottonwood Dam No. 5 application. The liner is attached at upstream and downstream concrete sills. The liner is overlapped in the upstream/downstream direction and should not be bonded to provide a positive seal for water while providing relief for any hydrostatic pressures under the liner. It also prevents transfer of hydraulic forces from one sheet to another during operation. The hydraulic jump should occur downstream of the liner on riprap or some other type of energy dissipation structure.

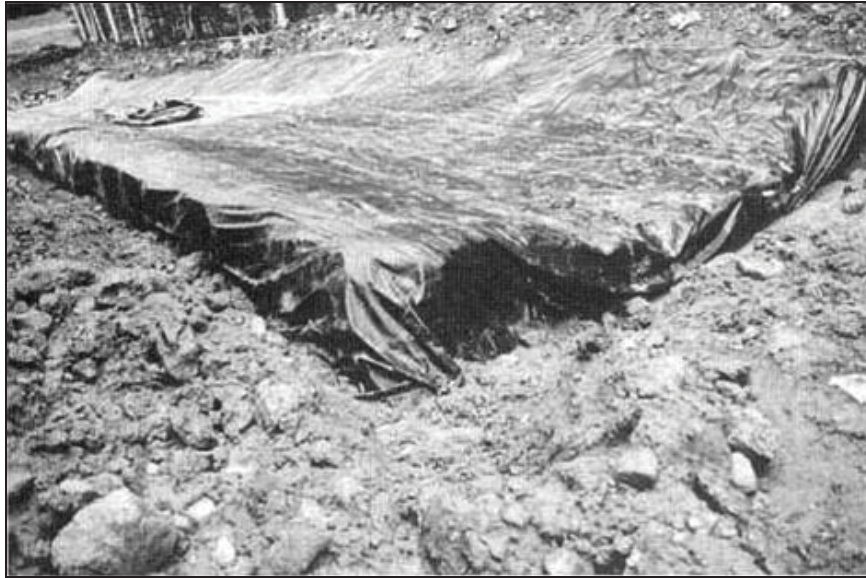
Figure Cottonwood-6.—Section of geomembrane liner installed in spillway before backfilling and compacting anchor trenches (Reclamation figure republished in Timblin et al., 1988).

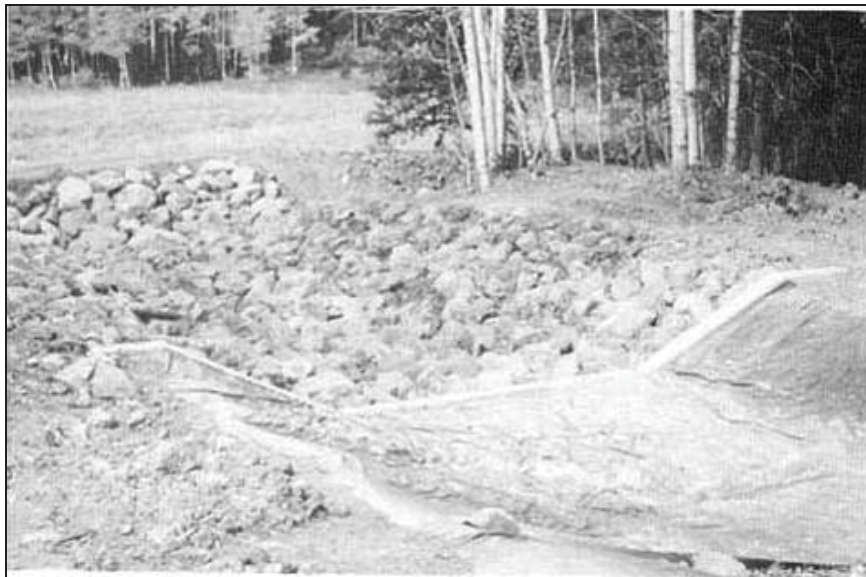
Figure Cottonwood-7.—Downstream end of geomembrane-lined spillway. Note concrete cutoff wall (Reclamation figure republished in Timblin et al., 1988).

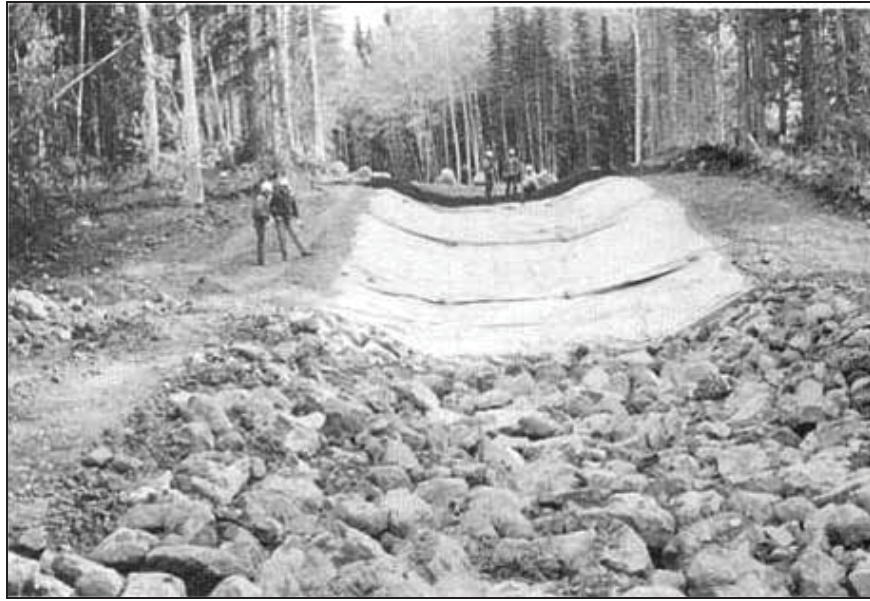
Figure Cottonwood-8.—Looking upstream at geomembrane-lined spillway
(Reclamation figure republished in Timblin et al., 1988).

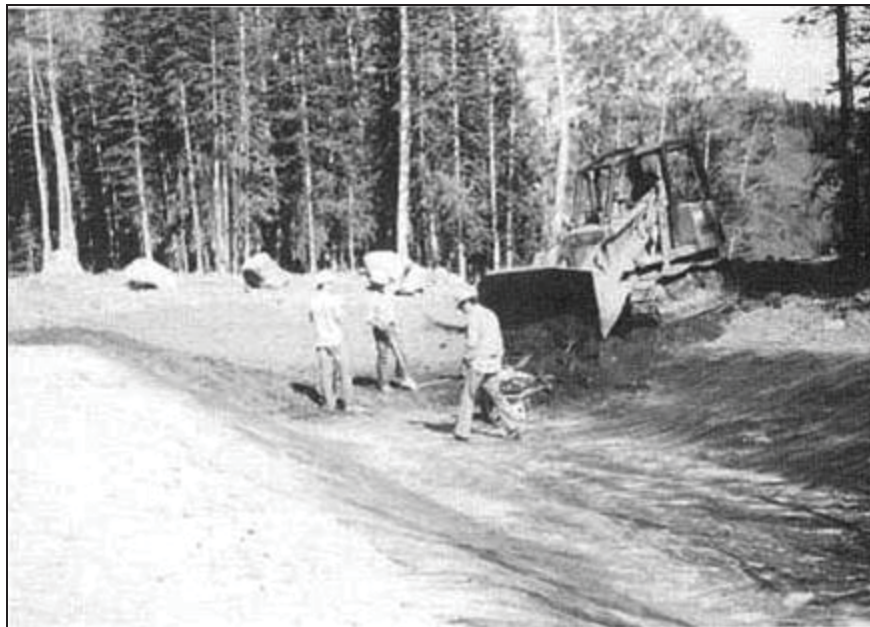
Figure Cottonwood-9.—Placement of soil cover to protect geomembrane liner
from the elements and mechanical damage
(Reclamation figure republished in Timblin et al., 1988).

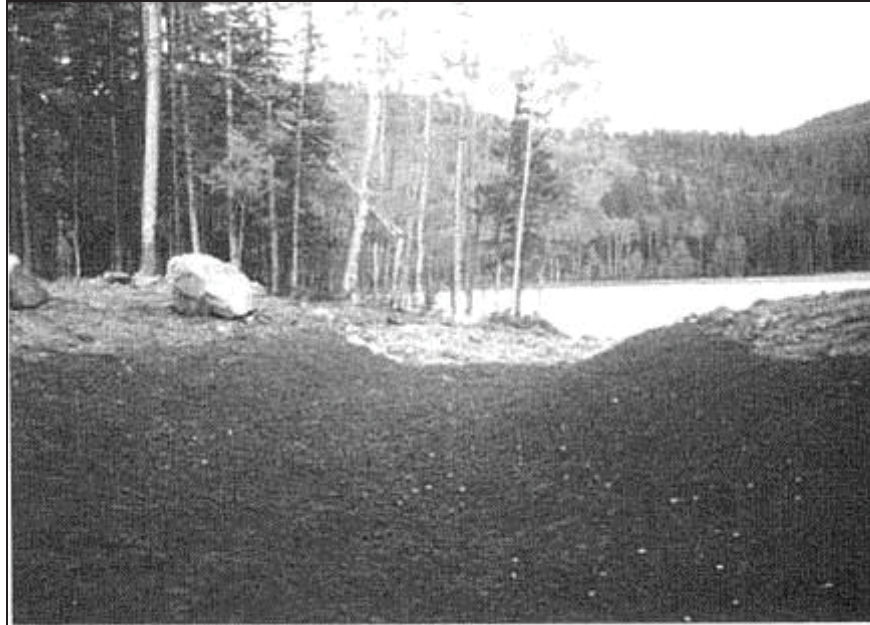
Figure Cottonwood-10.—Completed spillway looking upstream into the reservoir (Reclamation figure republished in Timblin et al., 1988).

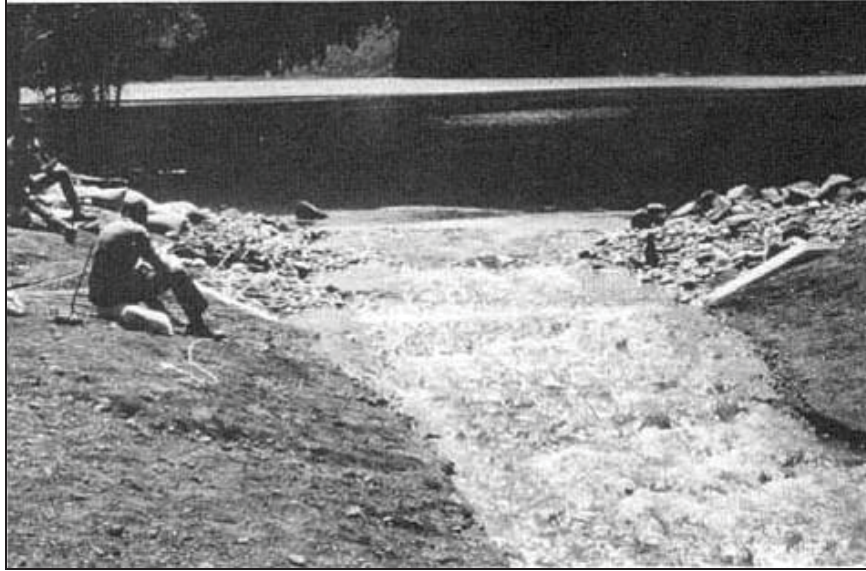
Figure Cottonwood-12.—Flow over spillway crest during operational test. The flow was estimated to be 21 to 25 ft³/s at a maximum velocity of 19 to 26 ft/s (Reclamation figure republished in Timblin et al., 1988).

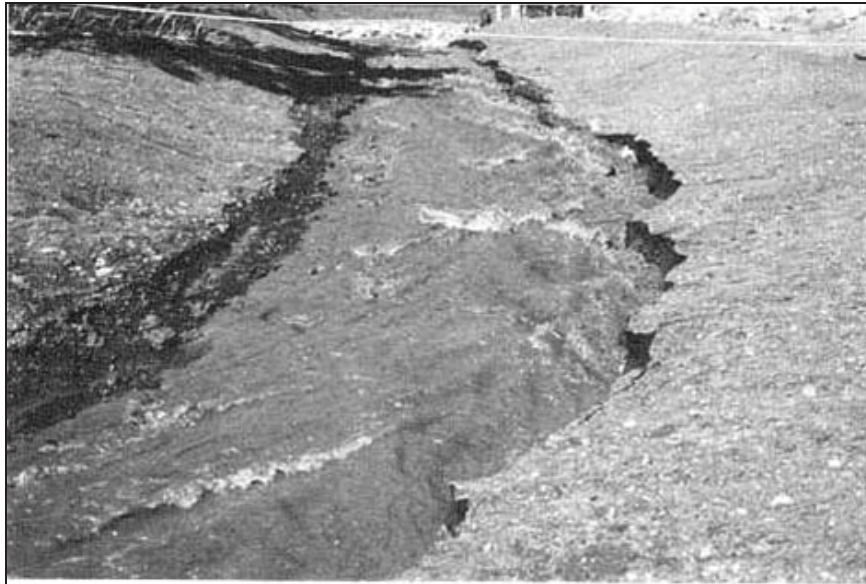
Figure Cottonwood-13.—Flow in the membrane-lined channel during operation. View looking upstream towards the crest with the flat bottom eroded to the edges of the 2:1 side slopes (Reclamation figure republished in Timblin et al., 1988).

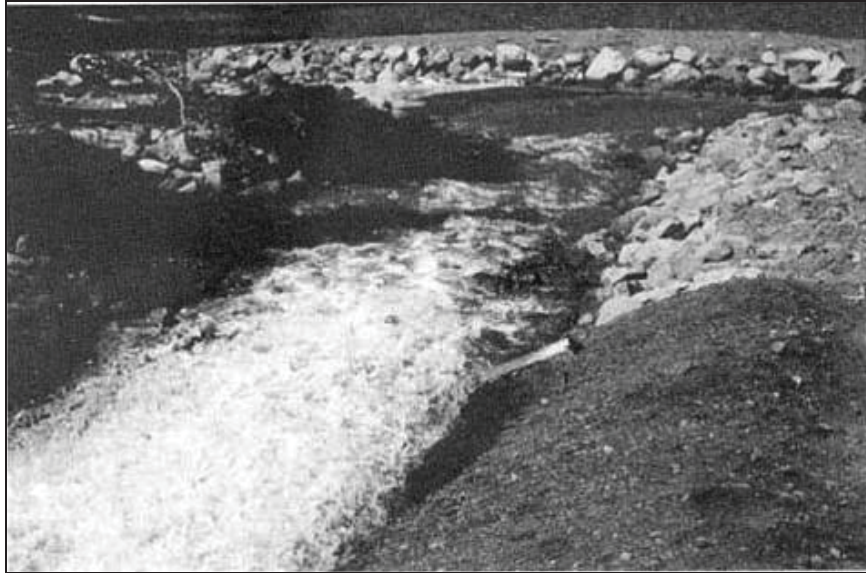
Figure Cottonwood-14.—Flow at the downstream end of the spillway as it entered the riprap basin
(Reclamation figure republished in Timblin et al., 1988).

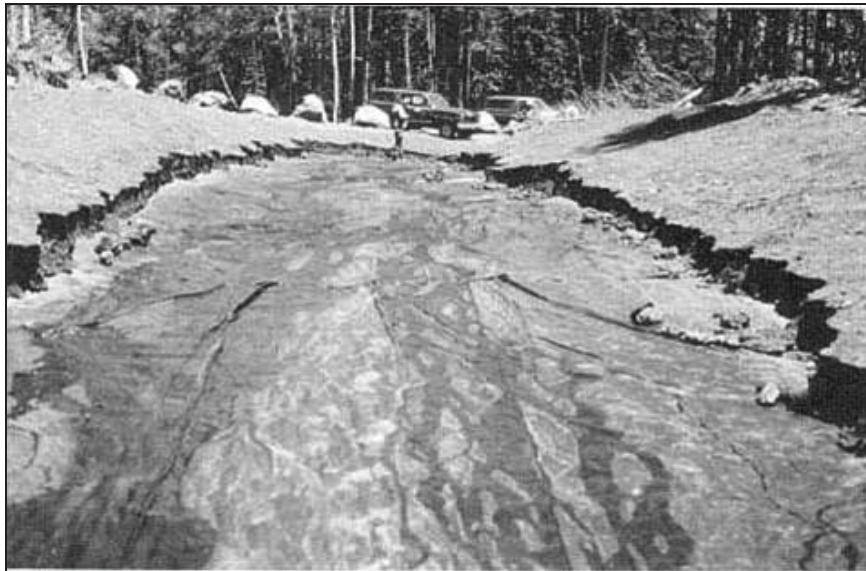
Figure Cottonwood-15.—View looking upstream at the channel after the conclusion of the test
(Reclamation figure republished in Timblin et al., 1988).

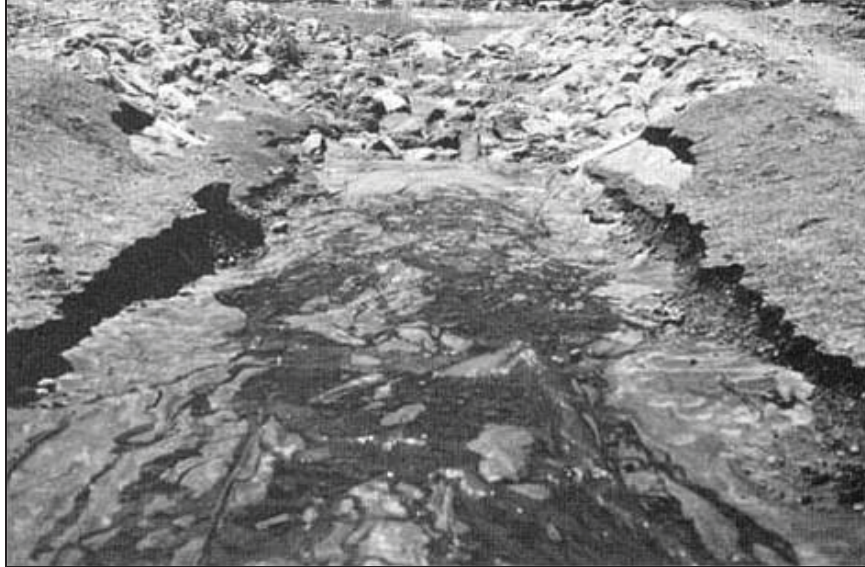
Figure Cottonwood-16.—View looking at the end of the channel after the conclusion of the test
(Reclamation figure republished in Timblin et al., 1988).

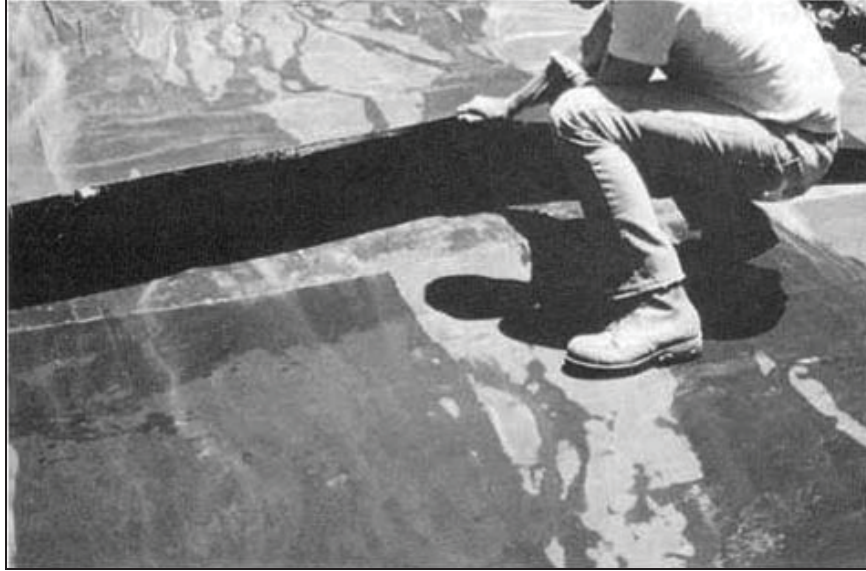
Figure Cottonwood-18.—The overlapped seams were inspected after the test. The geomembrane liner and the earthen materials were all dry under the overlapped areas (Reclamation figure republished in Timblin et al., 1988).
