Technical Manual: Overtopping Protection for Dams

**Best Practices for Design, Construction, Problem
Identification and Evaluation, Inspection,
Maintenance, Renovation, and Repair**

FEMA P-1015/May 2014

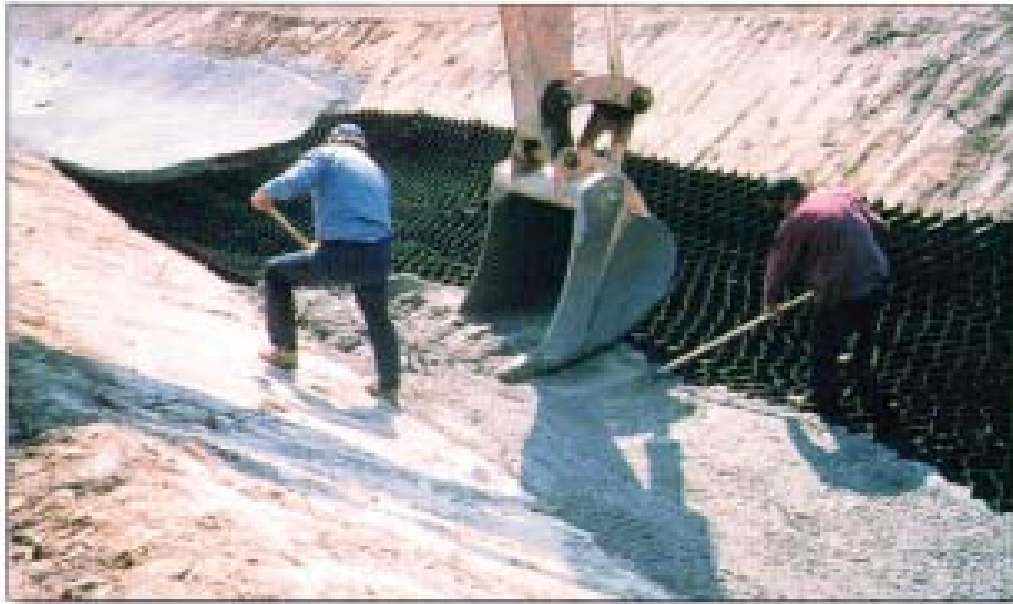
Figure Empire-1– Installation of the GeoWeb CCS with concrete infill for Empire Landfill
(courtesy of Presto Geosystems, all rights reserved).

The channel erosion protection was provided by a 4-inch-thick textured GeoWeb cellular confinement system (CCS) underlain by a nonwoven geotextile and infilled with concrete. The channel was designed to accommodate flows from a 100-year, 24-hour storm producing a maximum discharge of 210 ft³/s and a maximum computed flow velocity of 23.7 ft/s. The critical sliding friction angle for the system was determined to be 28 degrees at the soil and geotextile interface, providing a minimum factor of safety against sliding of 1.3. The concrete infill produced a system weight of about 50 lb/ft², and the system was anchored in place using high-strength, low density polyethylene (LDPE)-coated polyester tendons and 2-foot-long J-pin anchors.

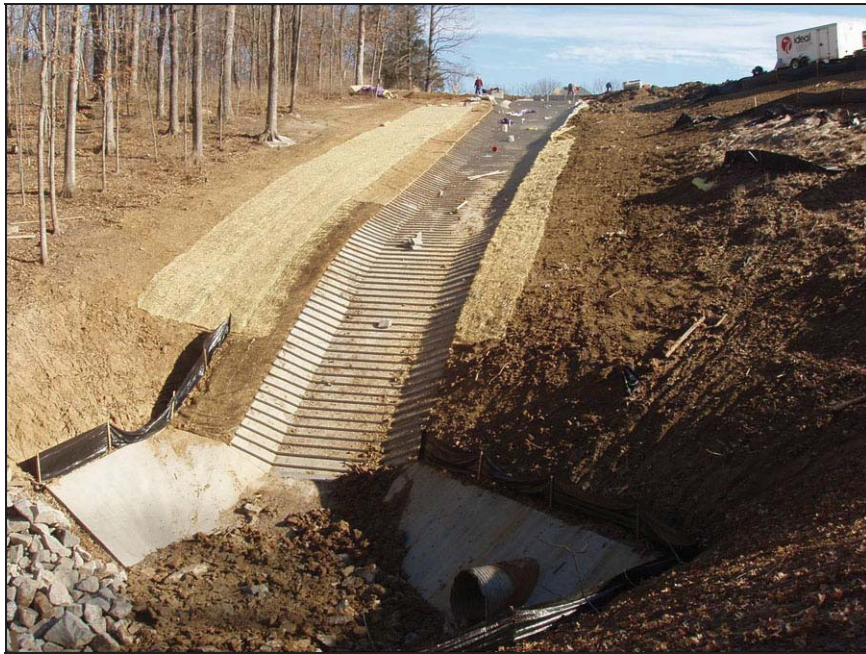
Figure Friendship Village-1. —Overall view of the ArmorWedge auxiliary spillway for the Friendship Village Project nearing completion. The spillway is converging near the top, with three slope changes. The flow will enter an energy dissipating basin shared with the service spillway pipe located to the right in the photo (courtesy of Contech Engineering Solutions, all rights reserved).

No performance of this spillway has been reported. Viewing the few construction photos and information provided raises the question as to whether the joint between the invert and the side slopes is adequately constructed. The joint appears tight, but the blocks are butted up along the joint without any apparent grouting or additional support or structure to prevent a potentially continuous plane for water to flow into the subgrade during operation.

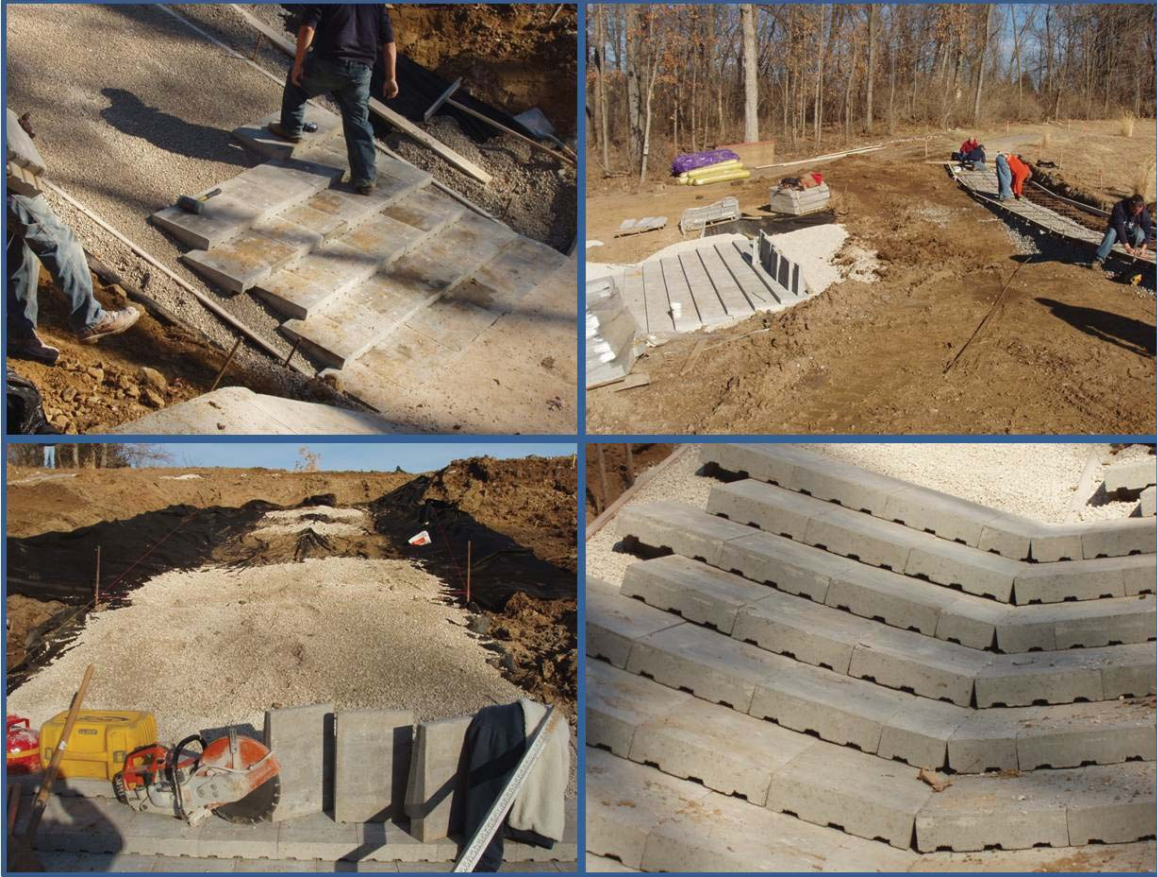
Figure Friendship Village-2. —
Top left photo is of ArmorWedge block placement over graded bedding material near toe

Top right photo is of the toe of the spillway

Bottom right photo is of the placement at the sidewall joint with the invert
(courtesy of Contech Engineering Solutions, all rights reserved).

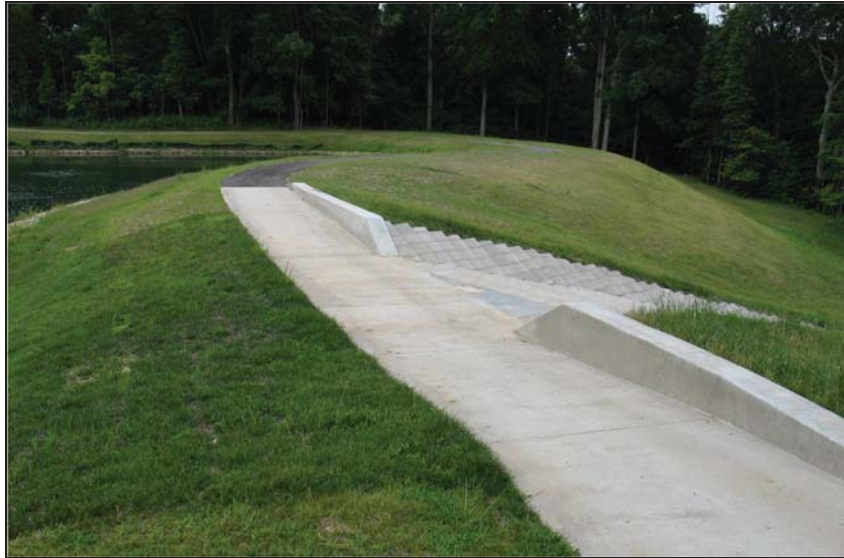
Figure Friendship Village-3.—Finished crest forming a sidewalk for the lake and the top of the ArmorWedge block spillway (courtesy of Contech Engineering Solutions, all rights reserved).

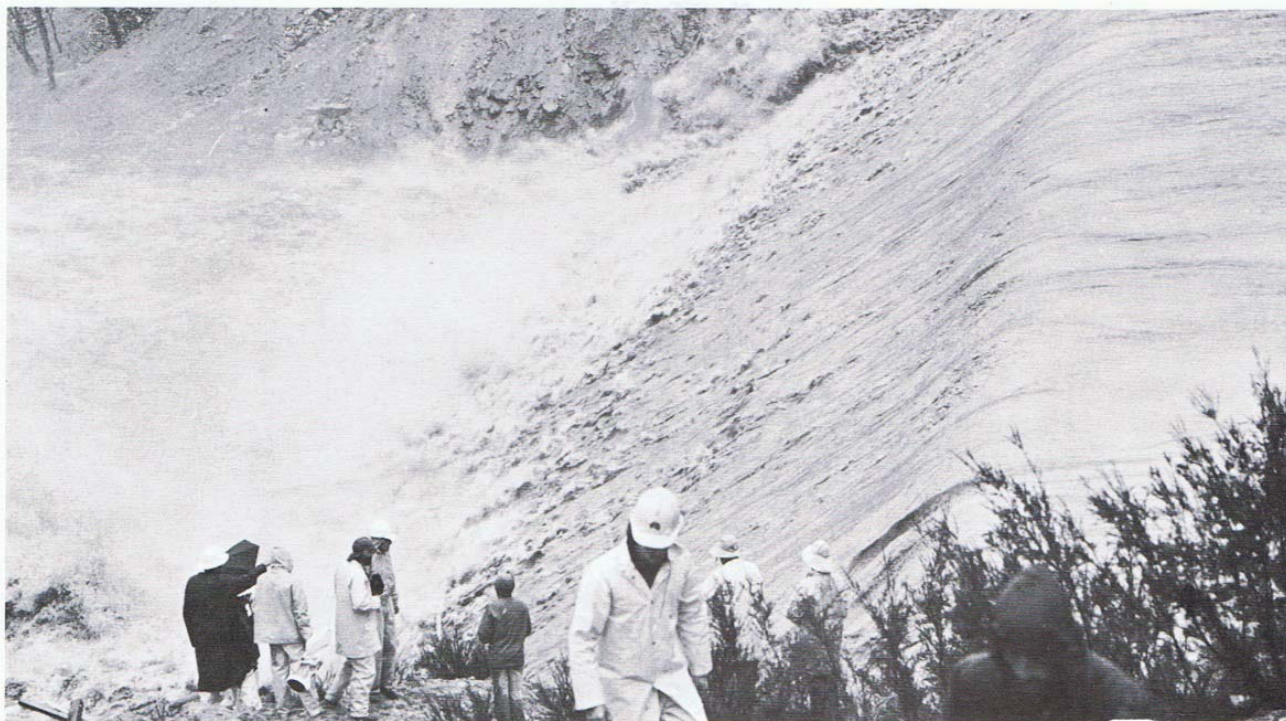
Figure Googong-1.—Overtopping of Googong Dam during construction, October 1976. (Courtesy of Engineering Heritage Canberra, all rights reserved).

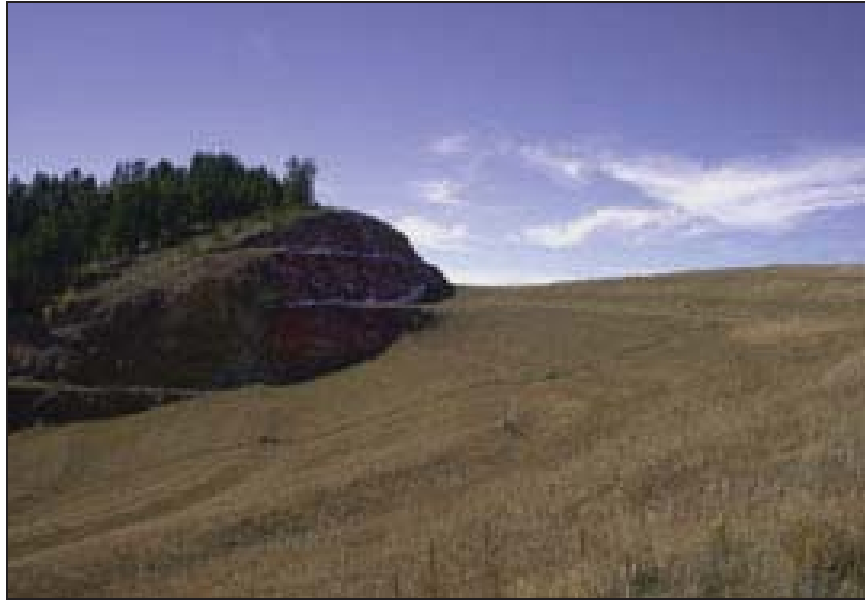
Figure Richmond Hill 1.—A downchute for conveying stormwater runoff from the Richmond Hill reclaimed overburden stockpile in the foreground (Courtesy of Jacobs et al., 2004, all rights reserved).

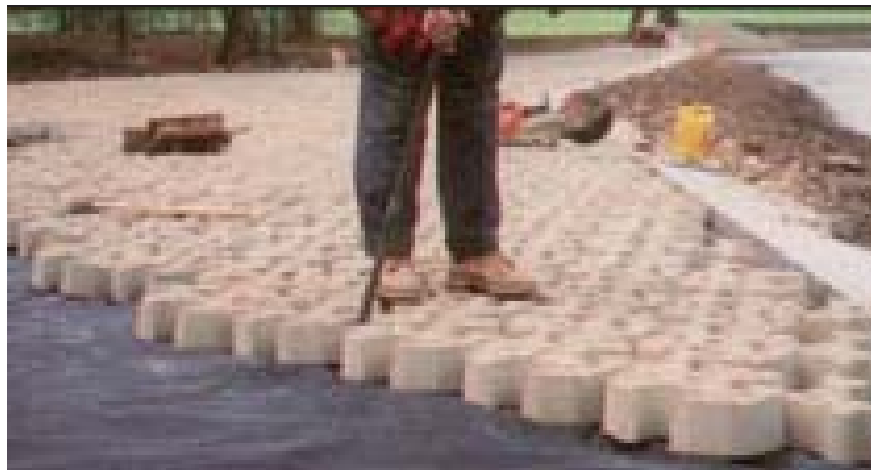
Figure Richmond Hill-3.—Installation of the 40-in-thick ACBs directly over the geotextile prior to backfilling the open space between blocks with topsoil (Courtesy of Jacobs et al., 2004, all rights reserved).

Photos of the installation are shown in [Figures Richmond Hill-3](#) through [5](#). The Tri-lock blocks were manufactured with 4,600 lb/in² concrete.

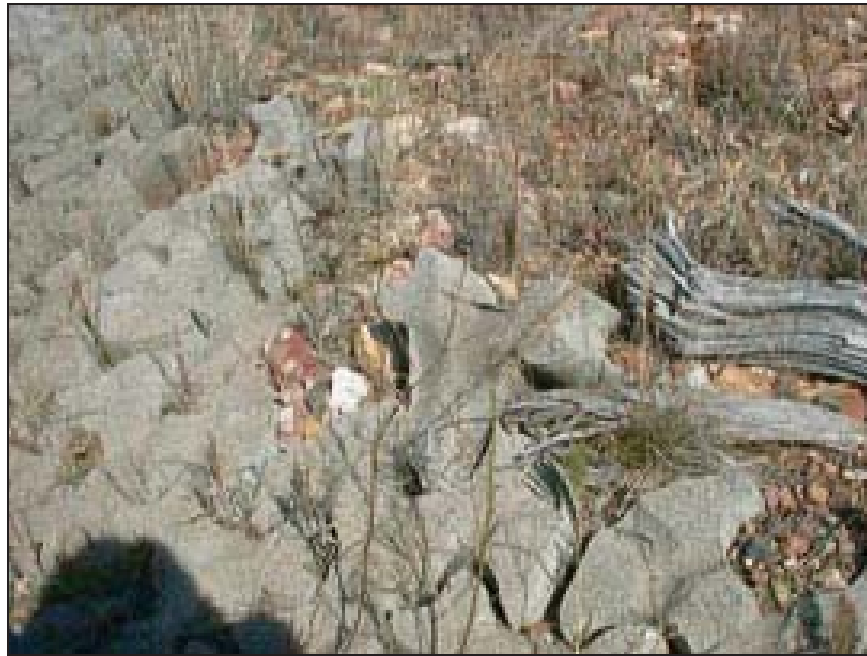
Figure Richmond Hill-4.—Typical sideslope termination with sides of mat anchored into the stockpile (Courtesy of Jacobs et al., 2004, all rights reserved).

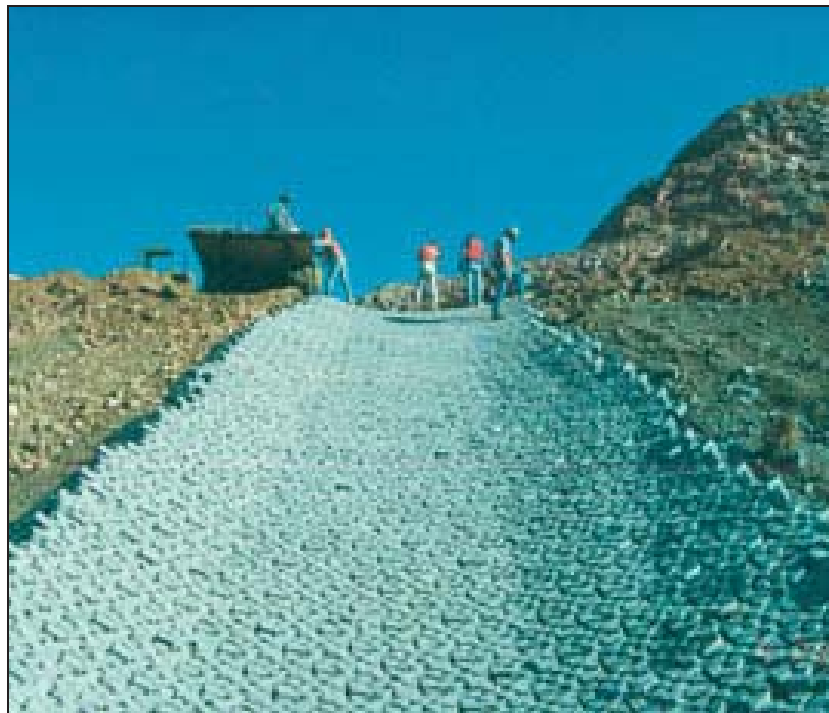
Figure Richmond Hill-5.—Nearly completed downchute constructed of interlocking ACBs. The upstream end of the Tri-lock mat was not anchored as it would be in today's installations. The sides of the mat were anchored into the overburden stockpile cover material (Courtesy of Jacobs et al., 2004, all rights reserved).

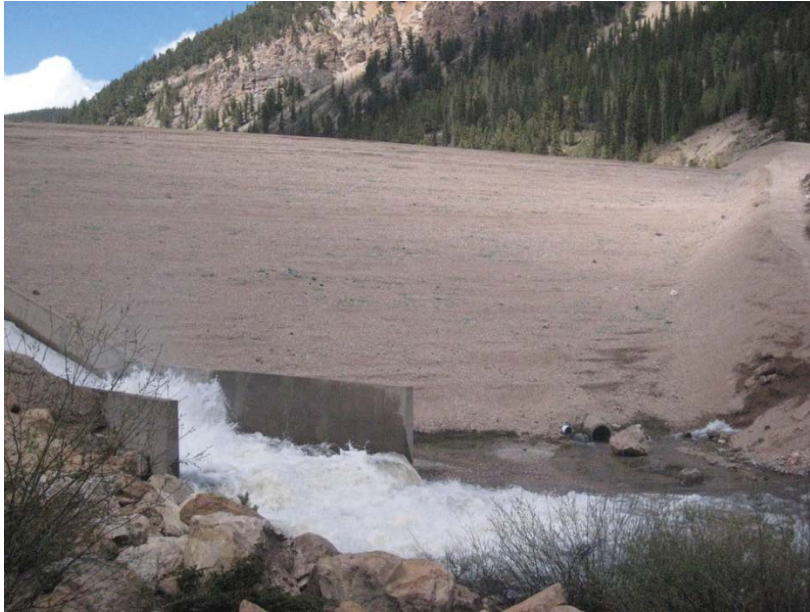
Figure Spring Creek-1.—RCC overtopping protection placed on downstream face of Spring Creek Dam between left abutment groin and right abutment service spillway (shown operating in foreground). (Courtesy of Colorado Department of Natural Resources)

The maximum depth of overtopping during passage of the PMF is about 4.5 feet, with a maximum unit discharge of 44.4 ft³/s/ft. The upper 3 feet of the embankment crest was removed and replaced with RCC, and the downstream face was blanketed with RCC placed in 1-foot-thick, 8-foot-wide horizontal lifts. Lateral containment walls were constructed by placing RCC against the cut slope on the left side and along the existing spillway on the right side. A downstream apron was constructed for a distance of about 60 feet from the toe of the embankment. The apron was anchored at the downstream end by a 5-foot-deep RCC keyway. A 1-foot-thick drainage blanket was provided beneath the RCC on the lower third of the embankment slope. The entire modification was constructed in about one week in August, 1986. The 4,880 yd³ of RCC was placed continuously for 80 hours. The total cost of the modification in 1986 was about \$350,000.

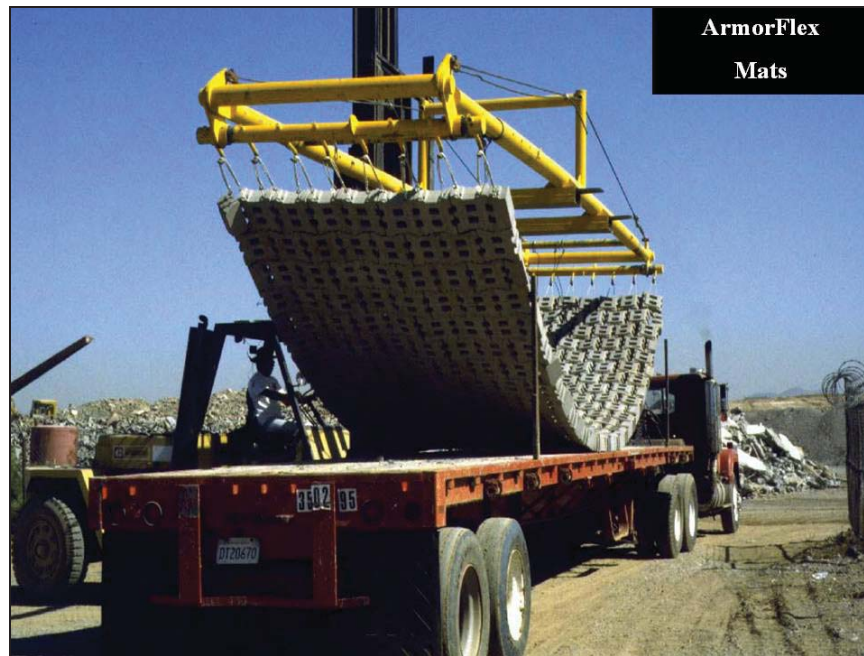
Figure Strahl 1.—Typical transport and stretcher bar, and crane, used for placing cable-tied block mats (Courtesy of Contech Engineering Solutions, all rights reserved).

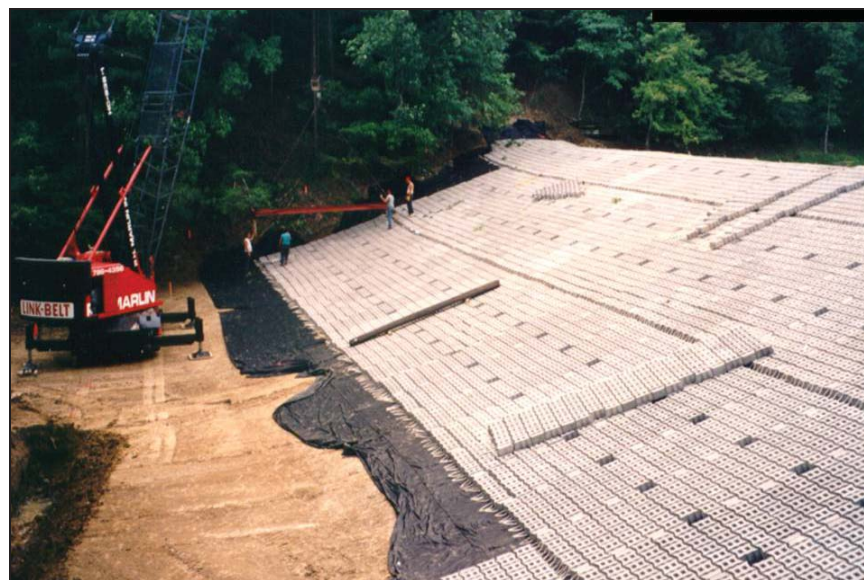
Figure Strahl-2.—Placement of the cable-tied mats over a geotextile on the downstream face of Strahl Lake Dam (Courtesy of Contech Engineering Solutions, all rights reserved).

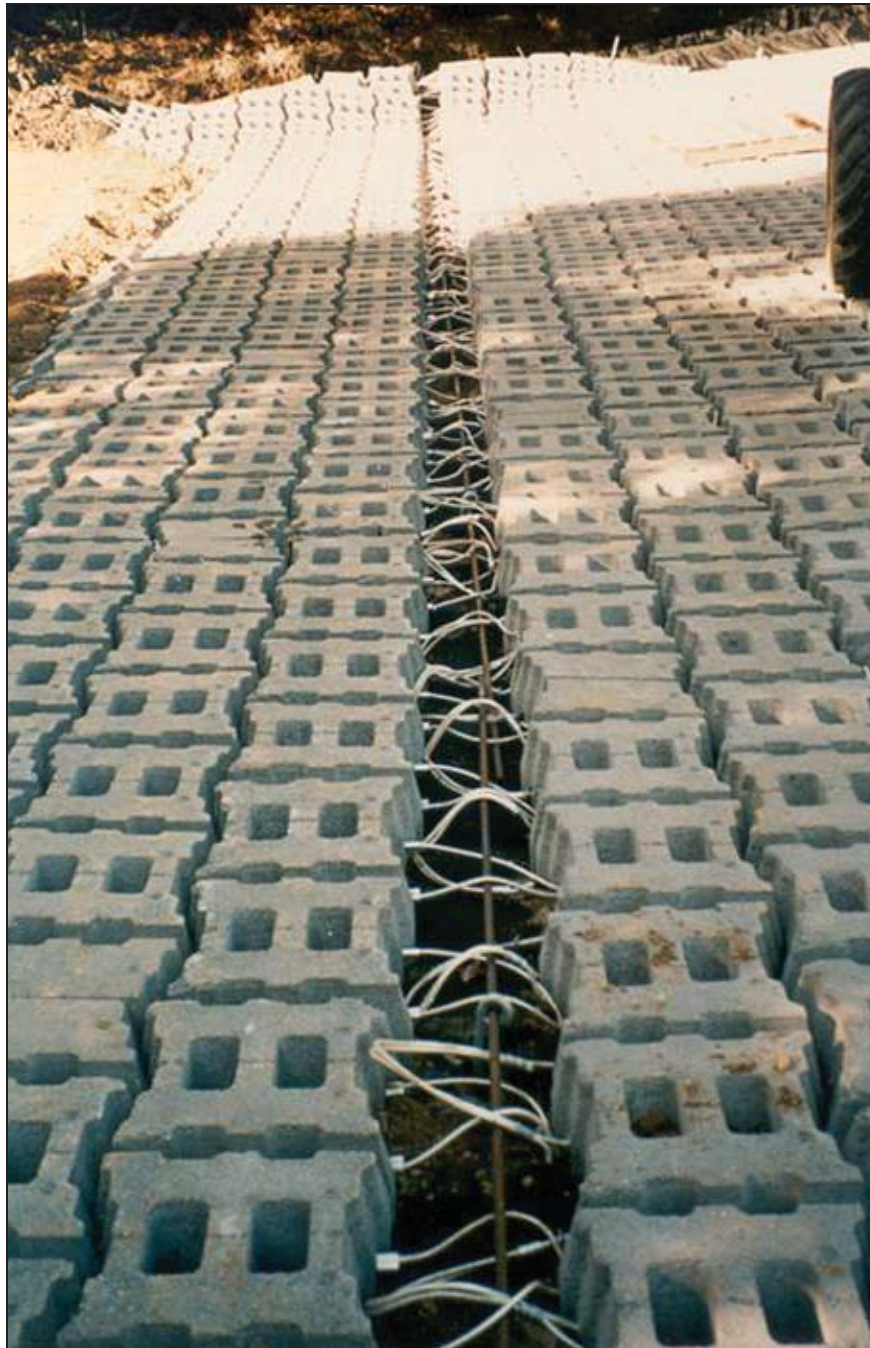
Figure Strahl-3.—View of a typical lateral joint between mats with the cables shown traversing the entire length of the system (Courtesy of Contech Engineering Solutions, all rights reserved).

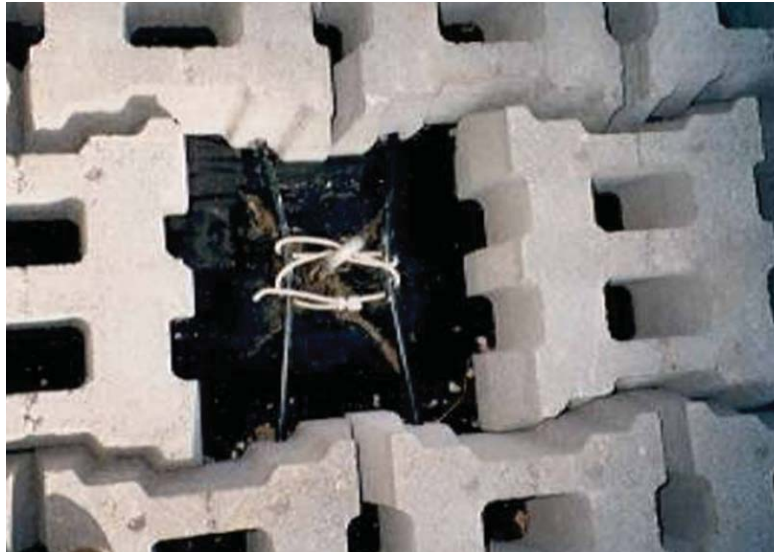
Figure Strahl-4.—Close up view of a typical tied joint prior to filling with grout
(Courtesy of Contech Engineering Solutions, all rights reserved).

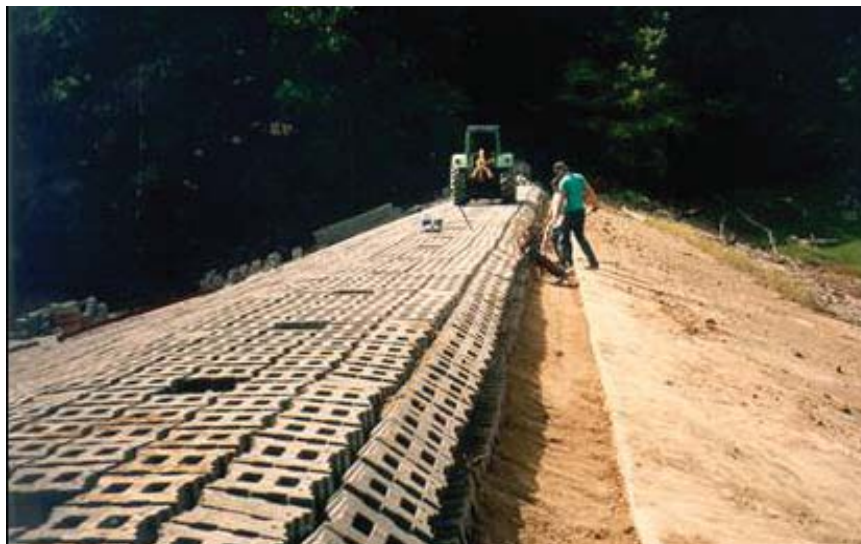
Figure Strahl-5.—View of the upstream trench used to anchor the
system at the crest
(Courtesy of Contech Engineering Solutions, all rights reserved).

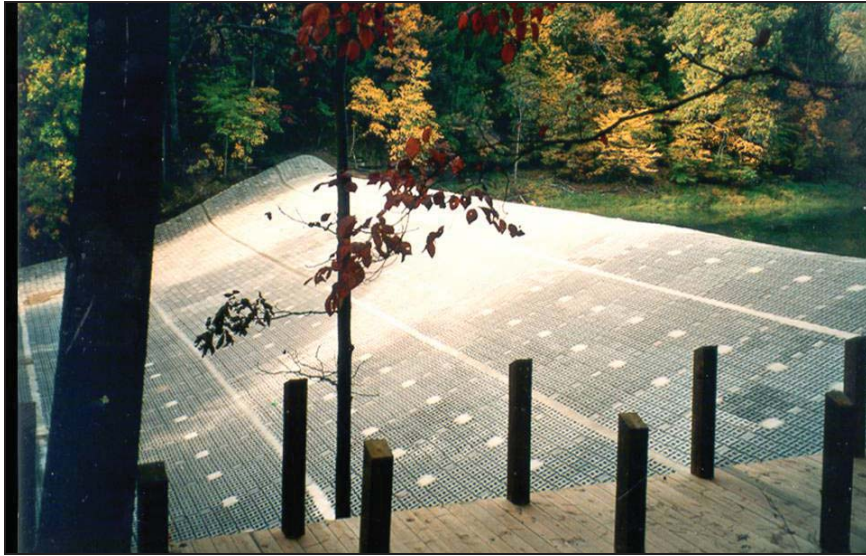
Figure Strahl-6.—Completed view of the cable-tied ACB system at Strahl Lake Dam for overtopping protection. Note all joints have been grouted (Courtesy of Contech Engineering Solutions, all rights reserved).

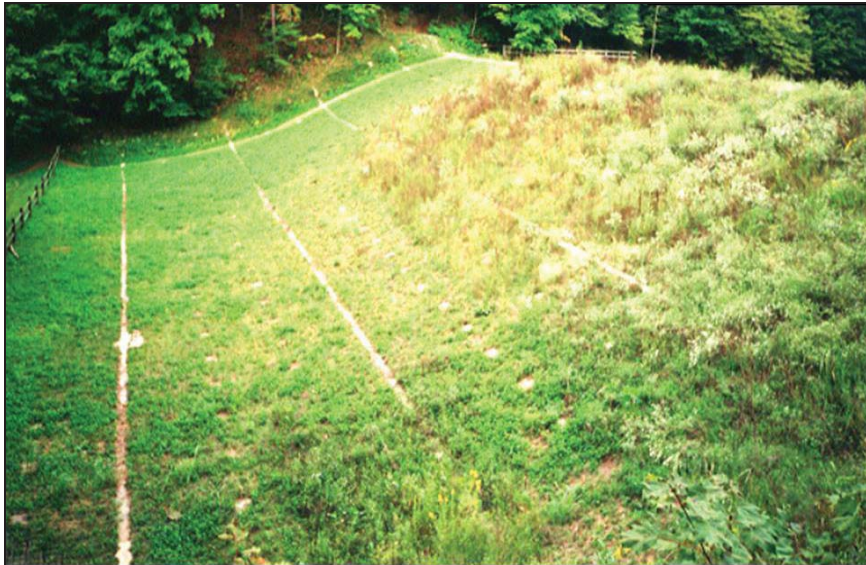
Figure Strahl-7.—Vegetative cover on Strahl Lake Dam overtopping protection (Courtesy of Contech Engineering Solutions, all rights reserved).

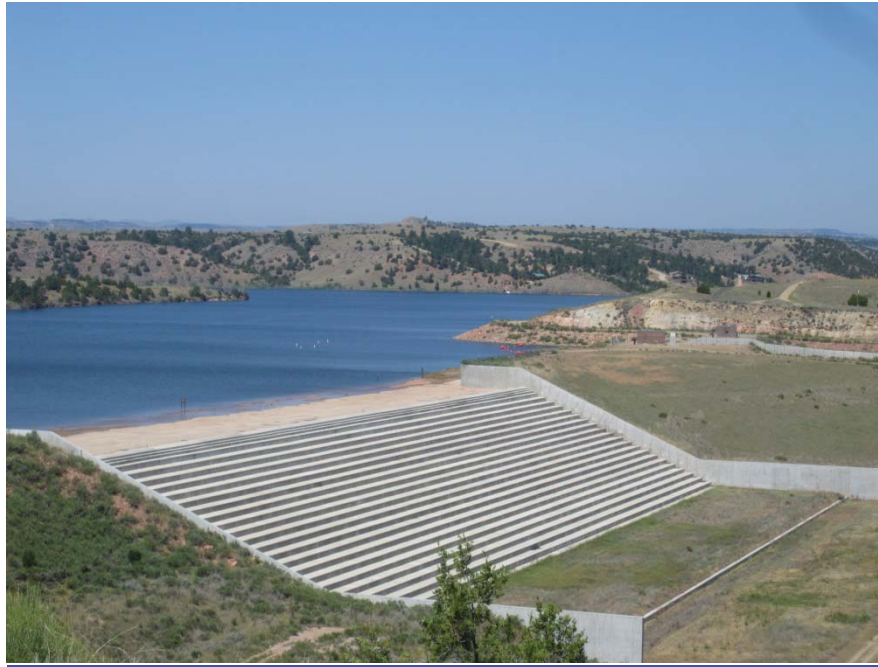
**Figure Tongue-1.—Closeup view of RCC overtopping protection constructed on the downstream face of Tongue River Dam.
(Courtesy of Montana Department of Natural Resources and Conservation [DNRC]).**

Dam safety modifications completed in 1999 for the Montana Department of Natural Resources included the reconstruction of the dam's primary spillway on the left abutment, construction of an auxiliary RCC spillway on the embankment dam, an increase in storage capacity by raising the normal pool by 4 feet, and improvements to public recreational facilities. The primary spillway features a four-cycle, 688-foot-long labyrinth weir with a 150-foot-wide crest, converging chute, and flip bucket, constructed of conventional reinforced concrete, but founded on 46,000 yd³ of low strength RCC. A stepped-chute auxiliary spillway was constructed on the dam crest and downstream slope, and consists of an approach apron, 650-foot-long ogee crest, sloping chute, and stilling basin. The maximum design overtopping head on the crest is 12.5 feet, with a maximum design unit discharge of 167 ft³/s/ft.

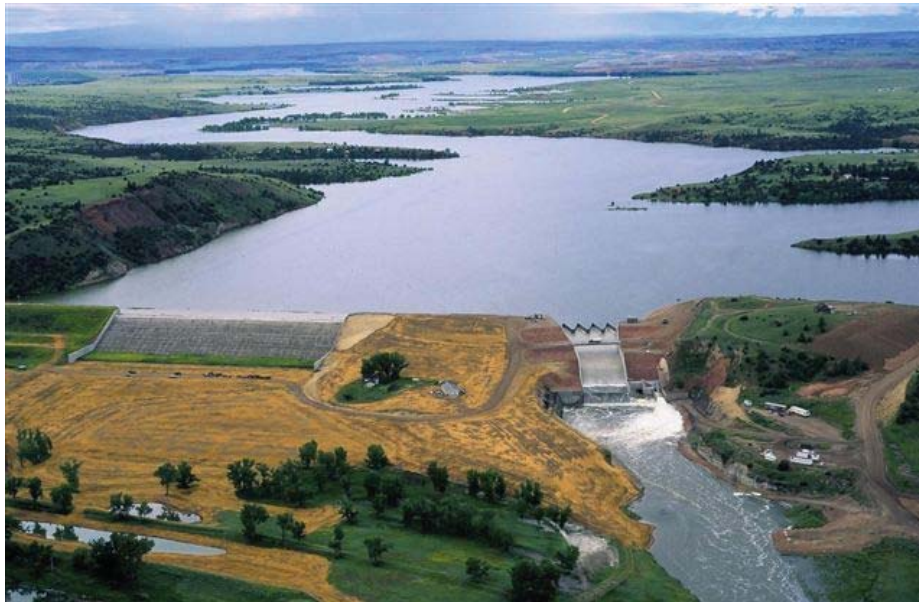
**Figure Tongue-2.—Aerial view of Tongue River Dam in Montana, with service spillway shown at right and RCC overtopping protection shown at left.
(Courtesy of Montana DNRC).**

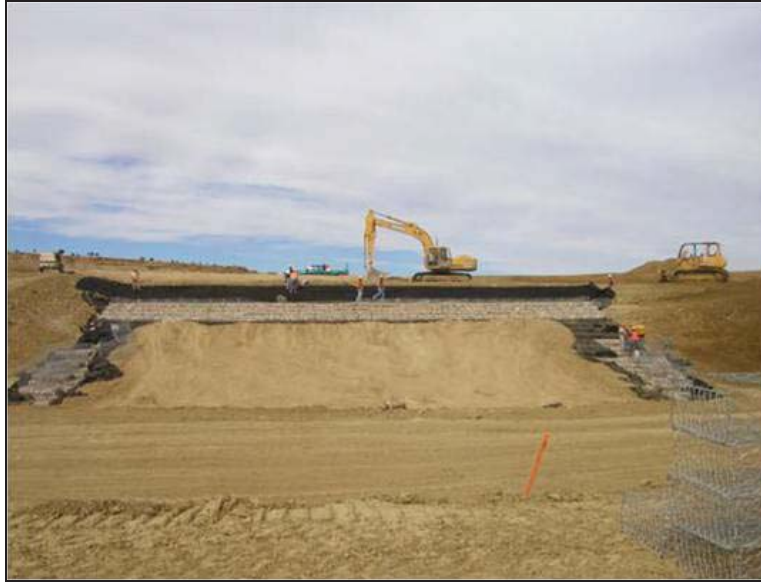
Figure West Cornfield-2.—Dam beginning construction
(Courtesy of Maccaferri, Inc., all rights reserved).

Figures West Cornfield-2 through [West Cornfield-6](#) show the construction of the gabion and gabion mat spillway section on Cornfield Dam in New Mexico.

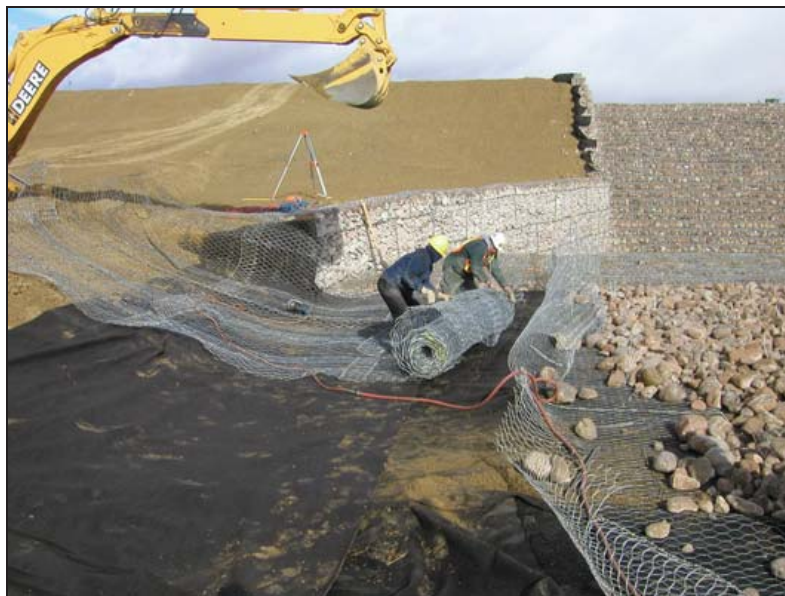
Figure West Cornfield-3.—Unrolling gabion mats in stilling basin
(Courtesy of Maccaferri, Inc., all rights reserved).

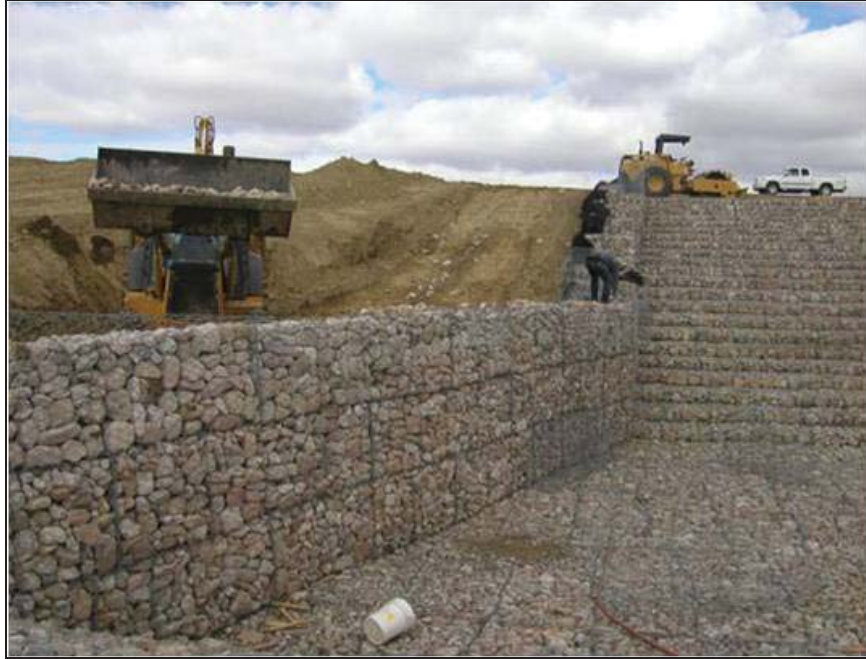
Figure West Cornfield-4.—Constructing stilling basin retaining walls
(Courtesy of Maccaferri, Inc., all rights reserved).

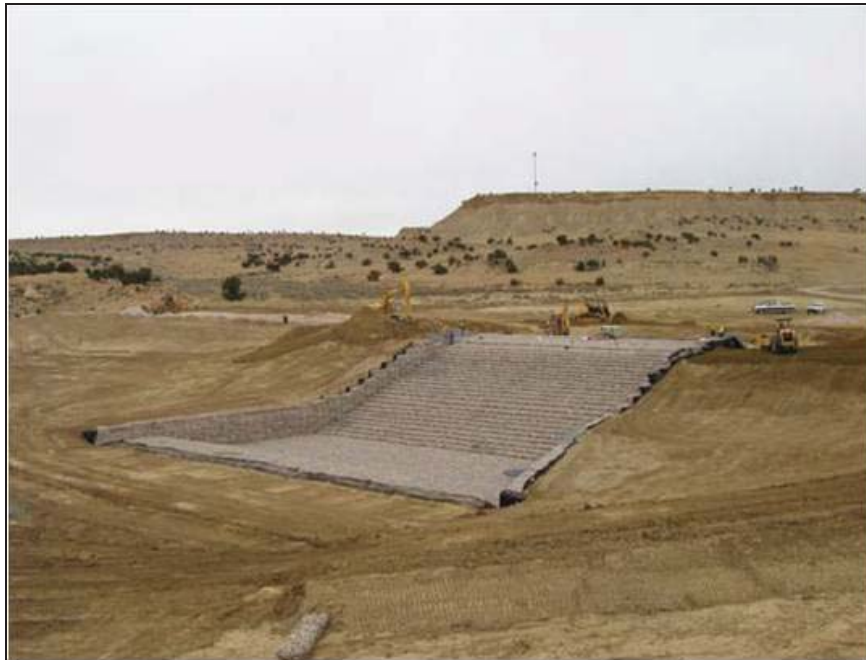
Figure West Cornfield-5.—Construction nearing completion
(Courtesy of Maccaferri, Inc., all rights reserved).

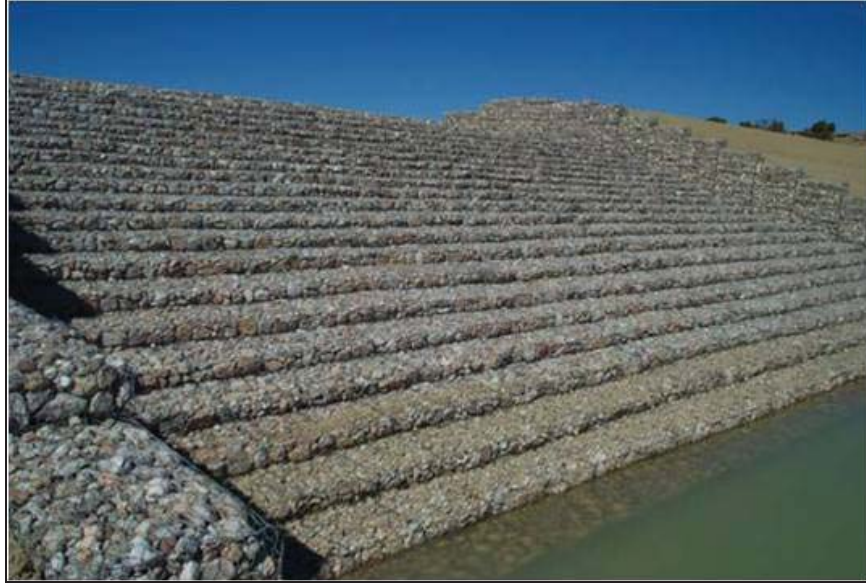
Figure West Cornfield-6.—Completed gabion spillway in 2003
(Courtesy of Maccaferri, Inc., all rights reserved).

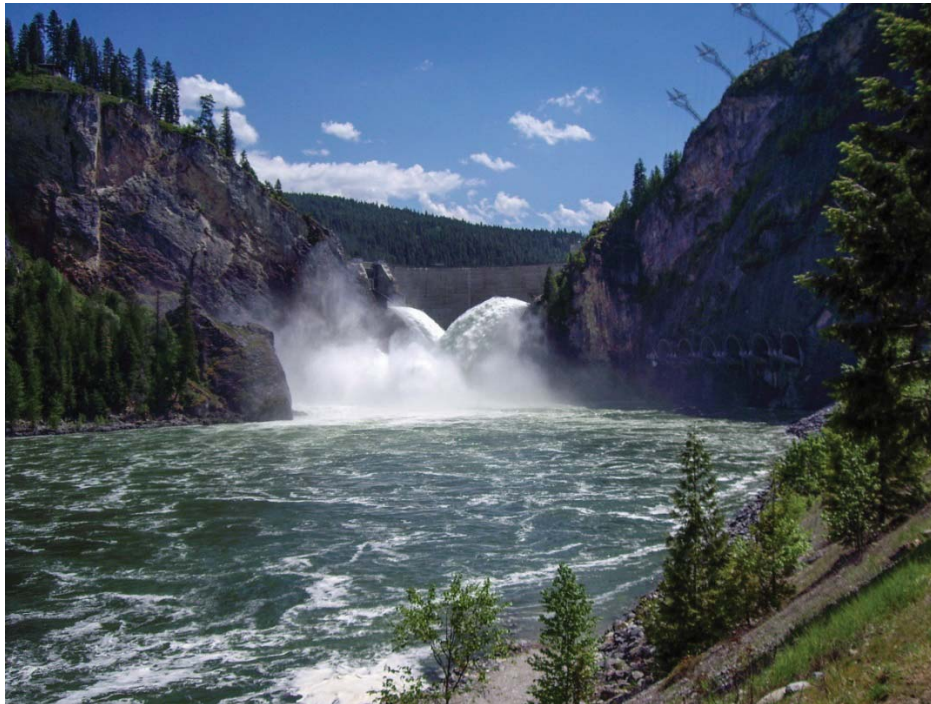
) U X U H % R X C G D U \ Test of spillway gates, May 18, 2006
(courtesy of the City of Seattle, Washington, all rights reserved).

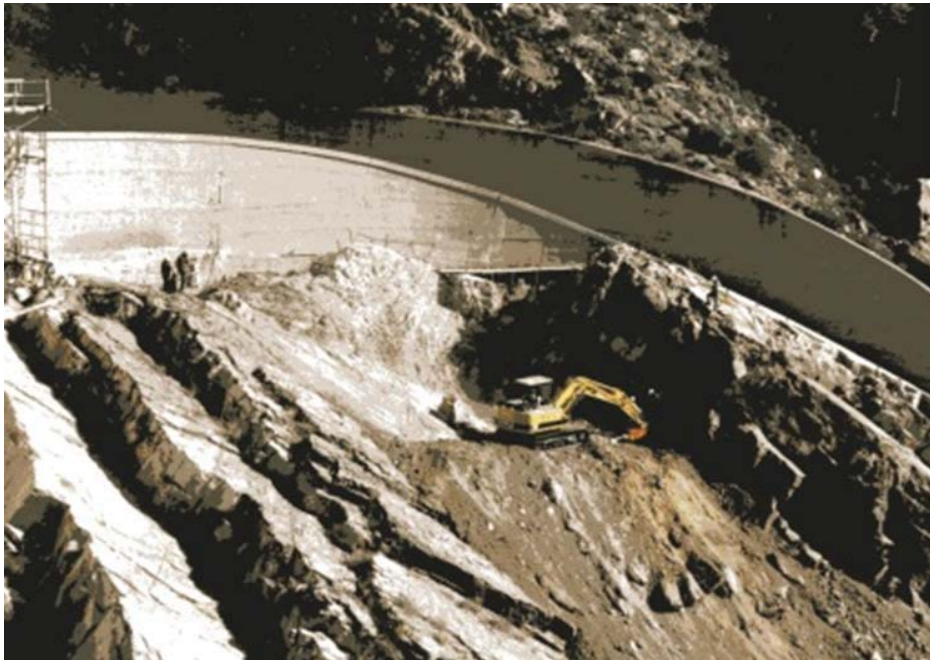
Figure Coolidge- . —Photo of left abutment before any material was excavated or vegetation removed (Reclamation).

and scaling the left and right abutments immediately downstream of the dam to expose the rock units for examination and mapping. Figures Coolidge-4 through Coolidge-7 show the abutments in various stages of foundation clean up. The primary purpose of stripping the abutments of overburden materials were to identify and map specific geologic features that would be used in updated stability analyses, to provide a good understanding of the critical wedge failure planes, and to determine a more realistic estimate for the percent of intact rock. The stability analyses of the left and right abutment rock mass wedges were updated and revised as appropriate using the results of additional exploration, laboratory testing, and detailed geologic mapping of both abutments following the clean up efforts. The additional geologic investigations and revised stability analyses indicated that the two critical wedges on the right abutment were stable and that only one of the critical wedges on the left abutment required stabilization. A large conventional mass concrete buttress wall was the preferred alternative for stabilization of the left abutment. It was also recommended that a system of deep drains be installed to relieve any uplift pressures that could develop within the rock.

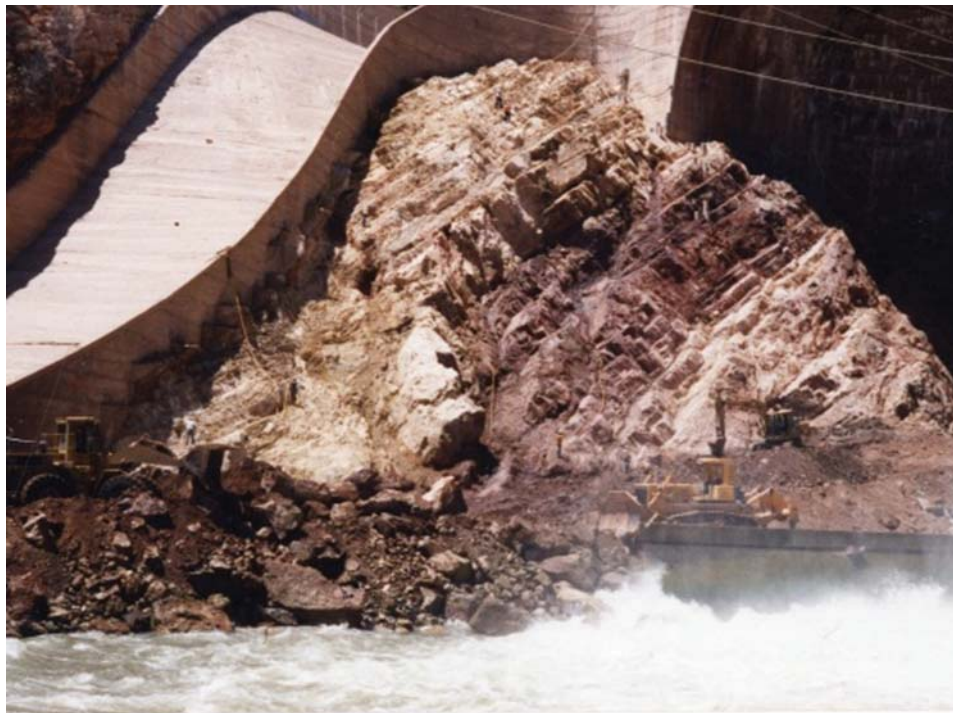
Figure Coolidge-7. —Photo of lower right abutment of dam and right spillway chute. Right abutment overtopping and excavation and cleanup in progress (Reclamation).

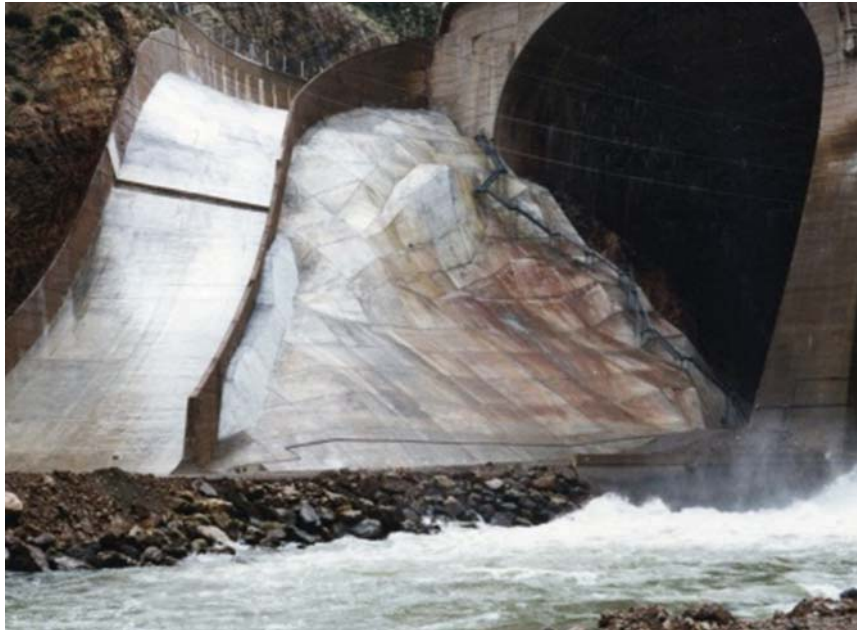
Figure Coolidge-8.—Photo showing finished right spillway concrete overlay and overtopping protection on lower right abutment of dam (Reclamation).

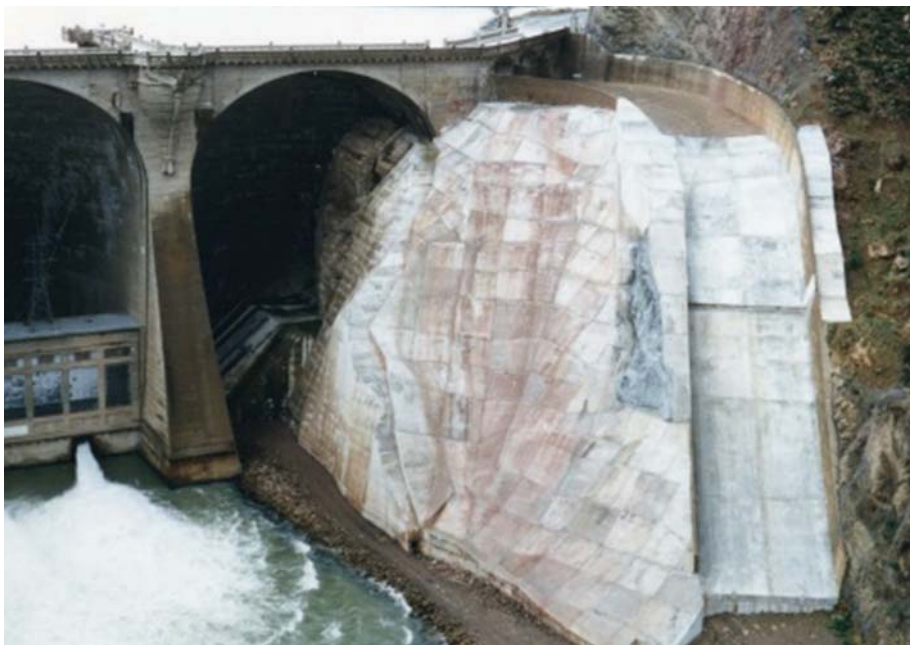
Figure Coolidge-9.—Photo showing finished left spillway concrete overlay and overtopping protection on lower left abutment of dam (Reclamation).

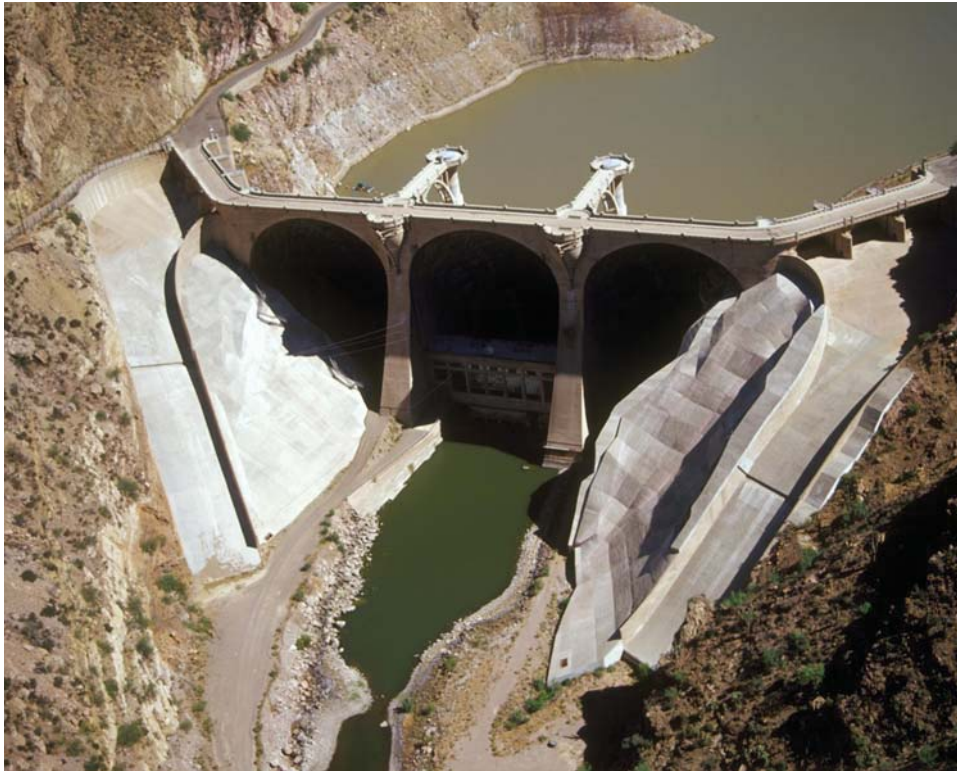
Figure Coolidge-10. —Aerial View of Overtopping Protection at Coolidge Dam (Reclamation).

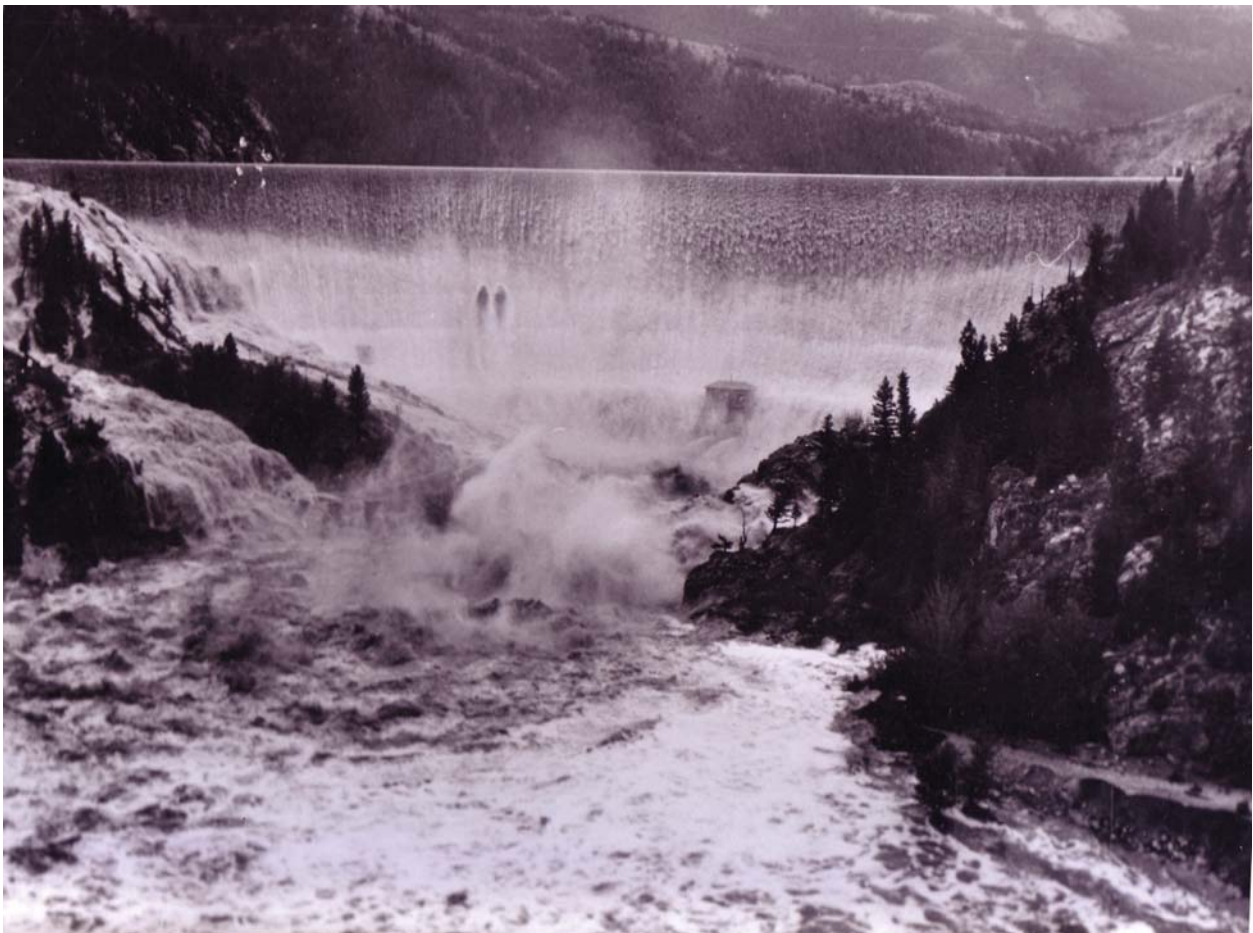
Figure Gibson-2.—Overtopping of on the Sun River, Montana, in June 1964
(Courtesy of USFS and USGS).

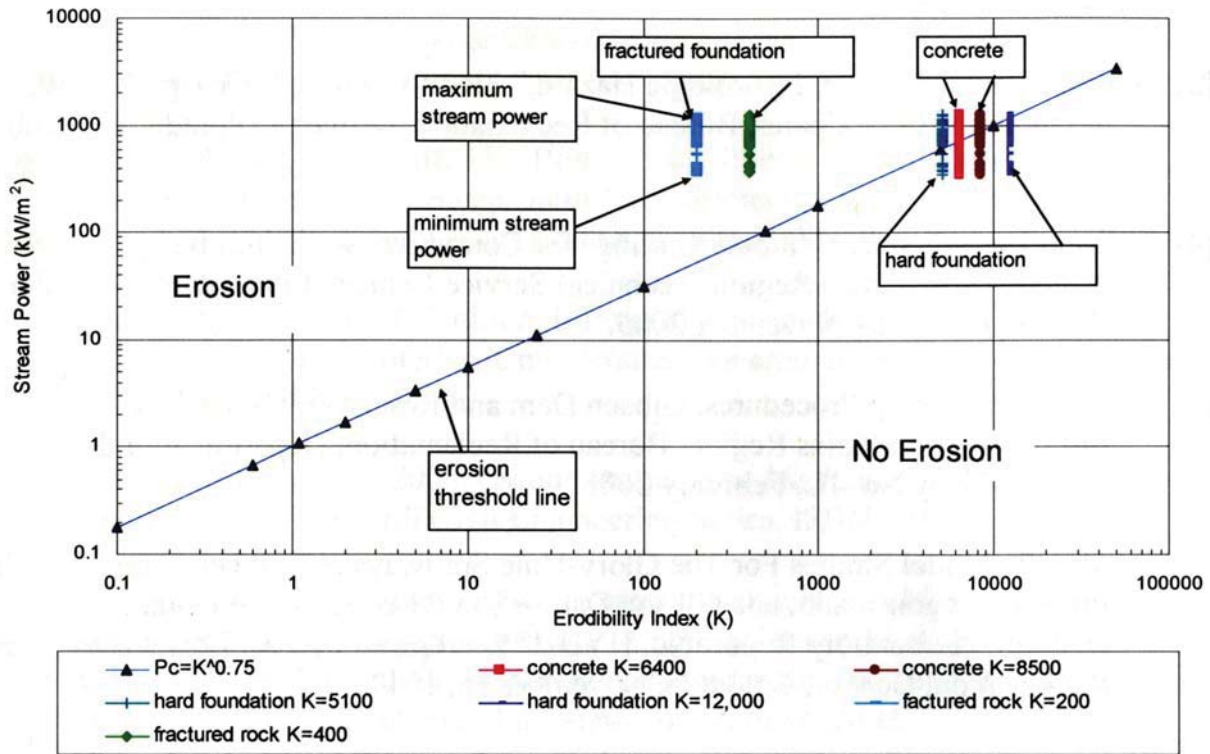
Figure Gibson-6.—Relationship between stream power and erodibility index for the PMF overtopping of Gibson Dam. Estimates shown include stream power above and below the tailwater (Reclamation, 2006).
