Technical Manual: Overtopping Protection for Dams

**Best Practices for Design, Construction, Problem
Identification and Evaluation, Inspection,
Maintenance, Renovation, and Repair**

FEMA P-1015/May 2014

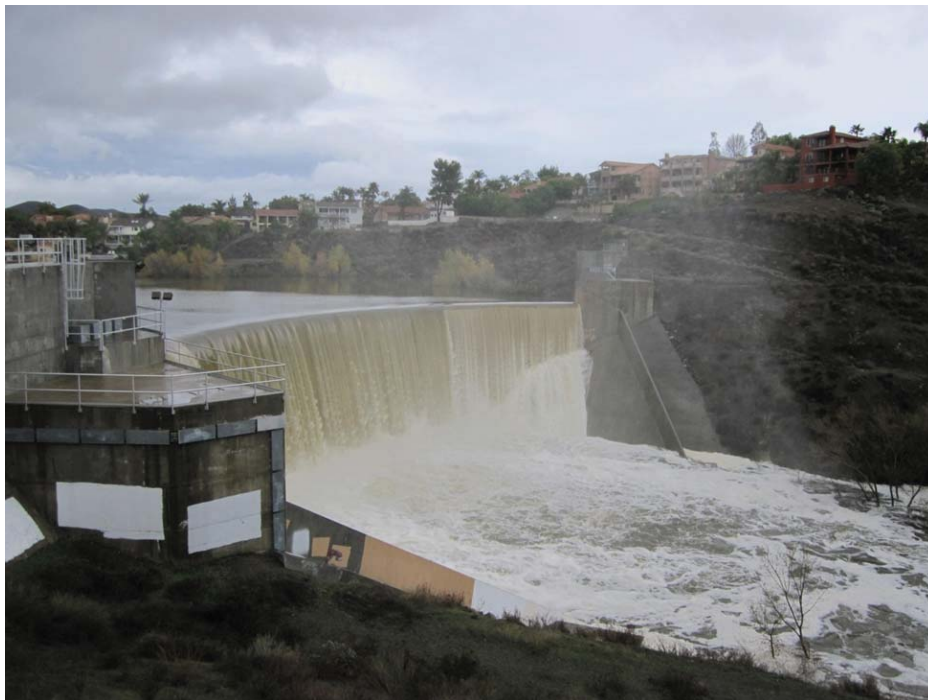
Figure Railroad Canyon-1.—Railroad Canyon Dam during flood event in 2010
(Courtesy of Elsinore Valley Municipal Water District).

The existing overflow spillway is located in the central portion of the dam and consists of nine 20-foot wide bays, with a crest elevation of 1380 feet. Flow through the spillway discharges into a concrete lined plunge pool that is formed by a 15-foot high arch, which is located about 60 feet downstream of the base of the dam. The spillway was designed to pass about 35,000 ft³/s.

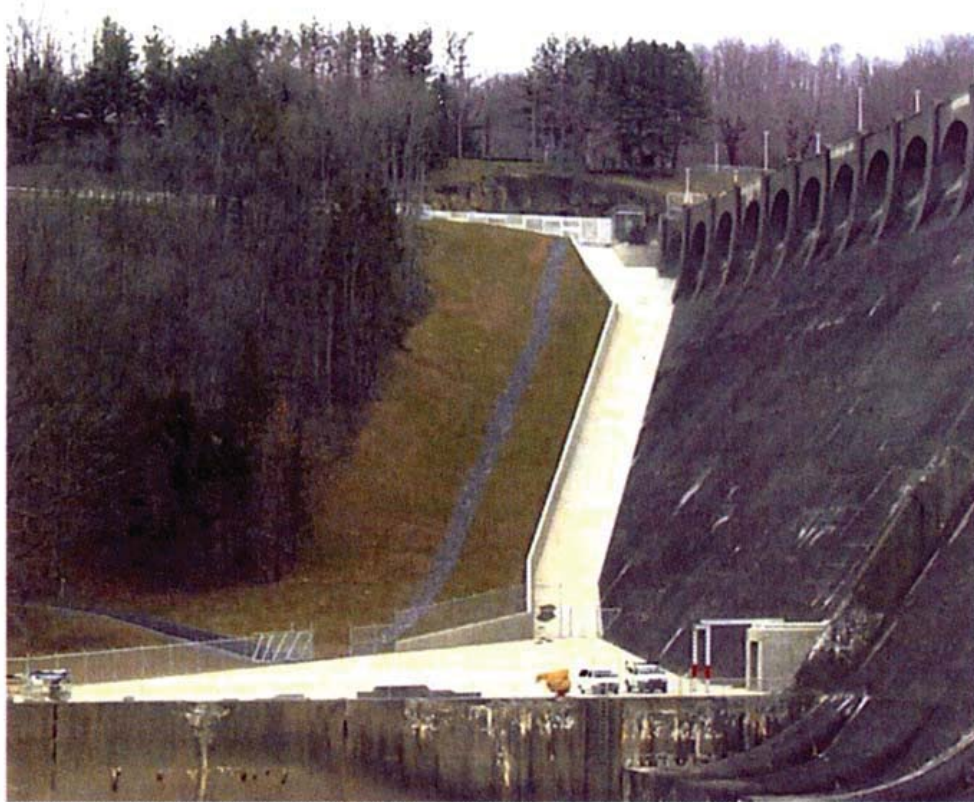
Figure Tygart-1.—Concrete Paving and Channel Along Downstream Right Abutment (Courtesy of USACE).

The overtopping protection consisted of concrete channels and paving which will guide high velocity overtopping flows (which will flow over the downstream parapet walls and then along the downstream face of the dam before collecting in the downstream channel) along the downstream toes of the dam and into the stilling basin and river channel. The channels vary from 30 feet wide and 5.5 feet deep at the top of the slope to 80 feet wide and 8 feet deep at the bottom.

Walls were also added at the downstream end of each abutment to prevent overtopping flows from flowing past the ends of the dam. Additional features of the overtopping protection included replacing all doors and windows of the houses on the dam crest with watertight units or providing them with waterproof covers and reinforcing the entrances to adits at the toe of the dam and providing watertight doors. These measures were taken to prevent flooding of the interior of the dam, which would possibly leave the structure inoperable for a period of time. Figures Tygart-1 and [Tygart-2](#) show the downstream features that were added to provide overtopping protection.

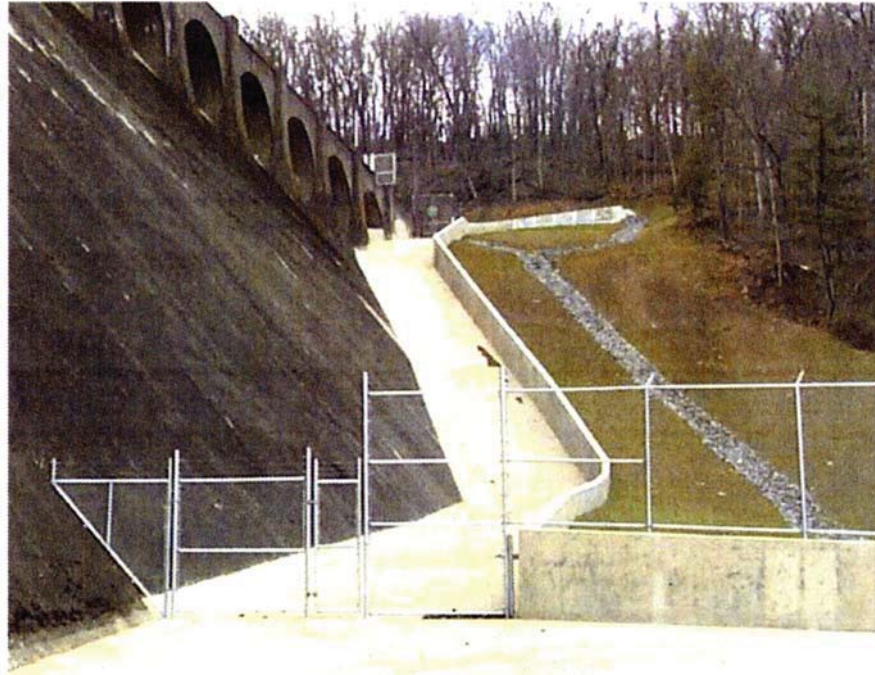
Figure Tygart-2.—Concrete Paving and Channel Along Downstream Left Abutment (Courtesy of USACE)

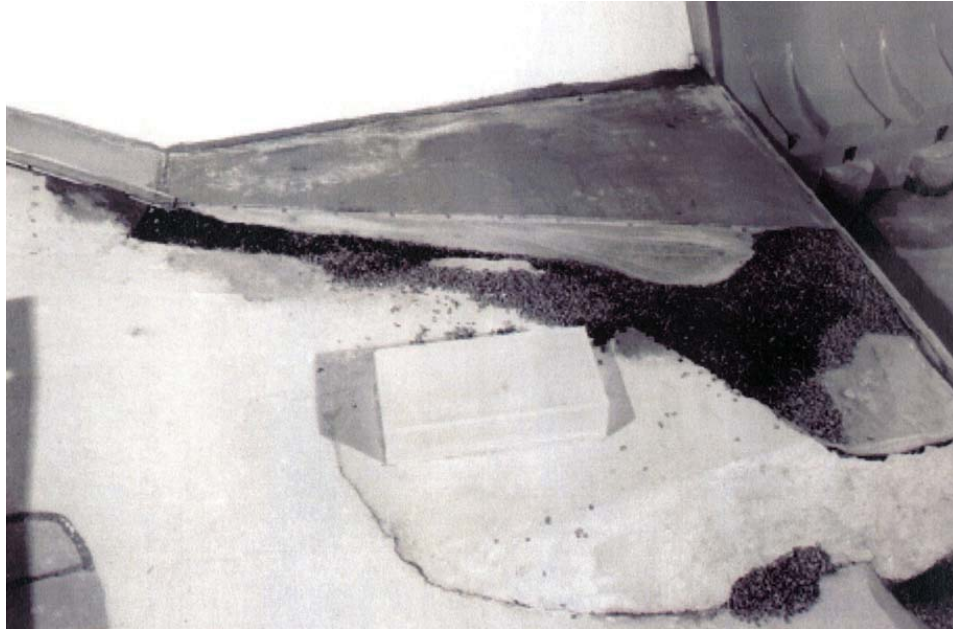
Figure Tygart-3.—Type 2 design, damage resulting from PMF flow for 1 hour (Courtesy of USACE, 1999).

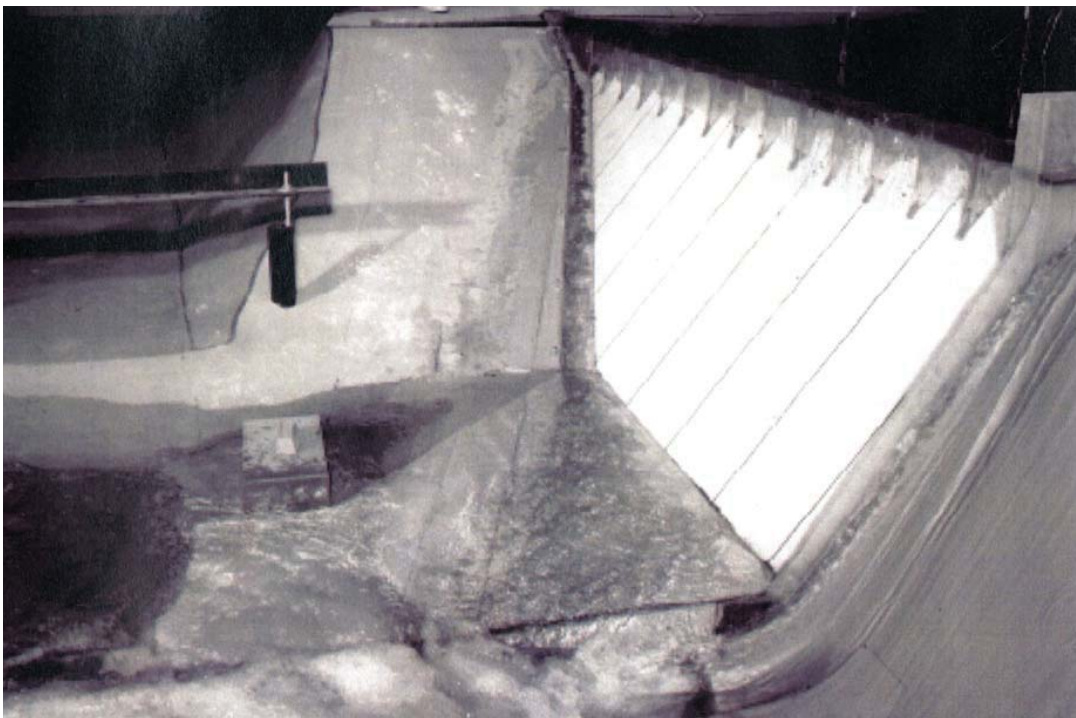
Figure Tygart-4 - Type 4 design, PMF overflow on right side of dam ($Q = 373,120 \text{ ft}^3/\text{s}$) (Courtesy of USACE, 1999)
