SUMMARY REPORT

EPA Internal Review of the August 5, 2015 Gold King Mine Blowout 8/24/2015

The purpose of this report is to provide the EPA Internal Review Team's (Team) assessment of the events and potential factors contributing to the blowout from the Gold King Mine (GKM) in Colorado on August 5, 2015. This report provides the Team's observations, conclusions, and recommendations that regions may apply to ongoing and planned site assessments, investigations, and construction or removal projects at similar types of sites across the country.

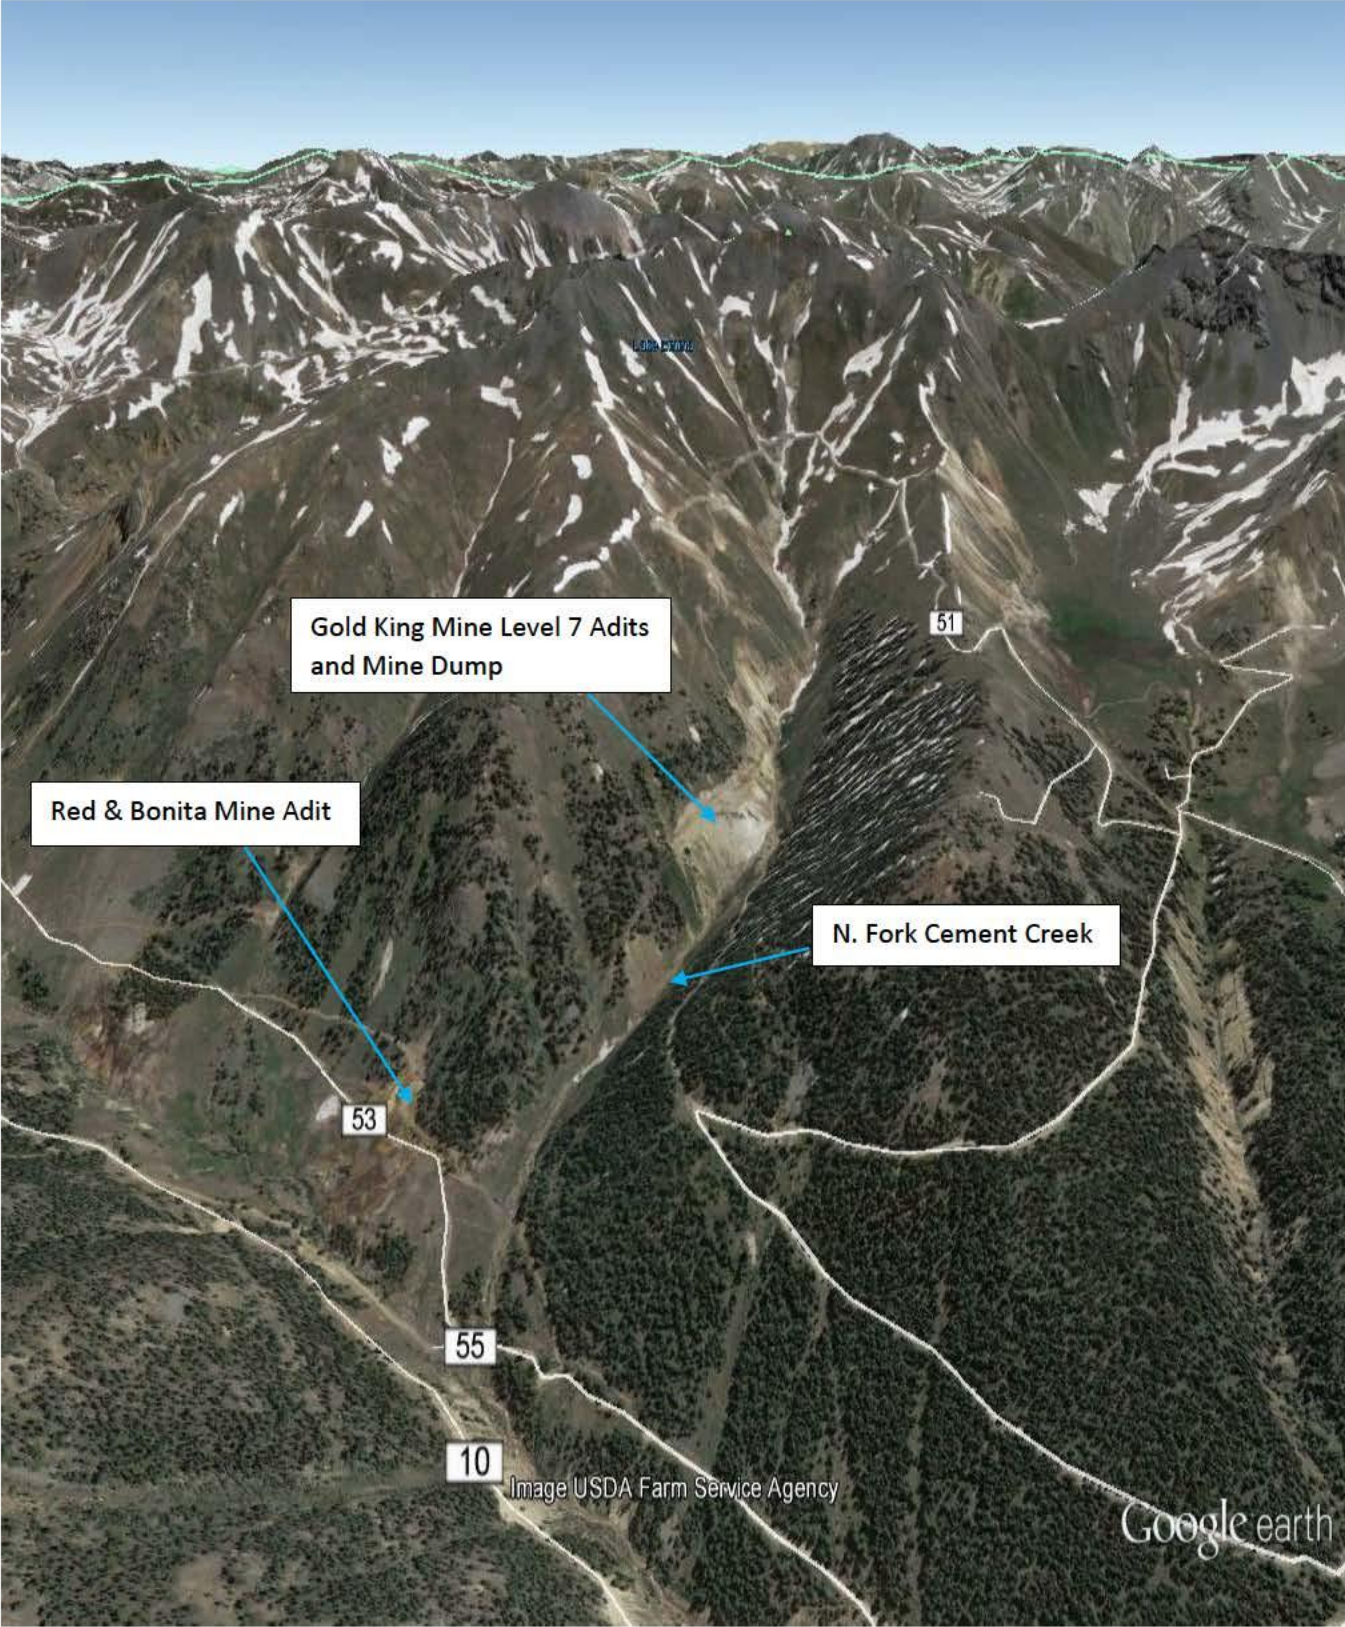
Photo 2 Google Earth June 2015 Image - Gold King Level 7 and Red & Bonita Mine Adits

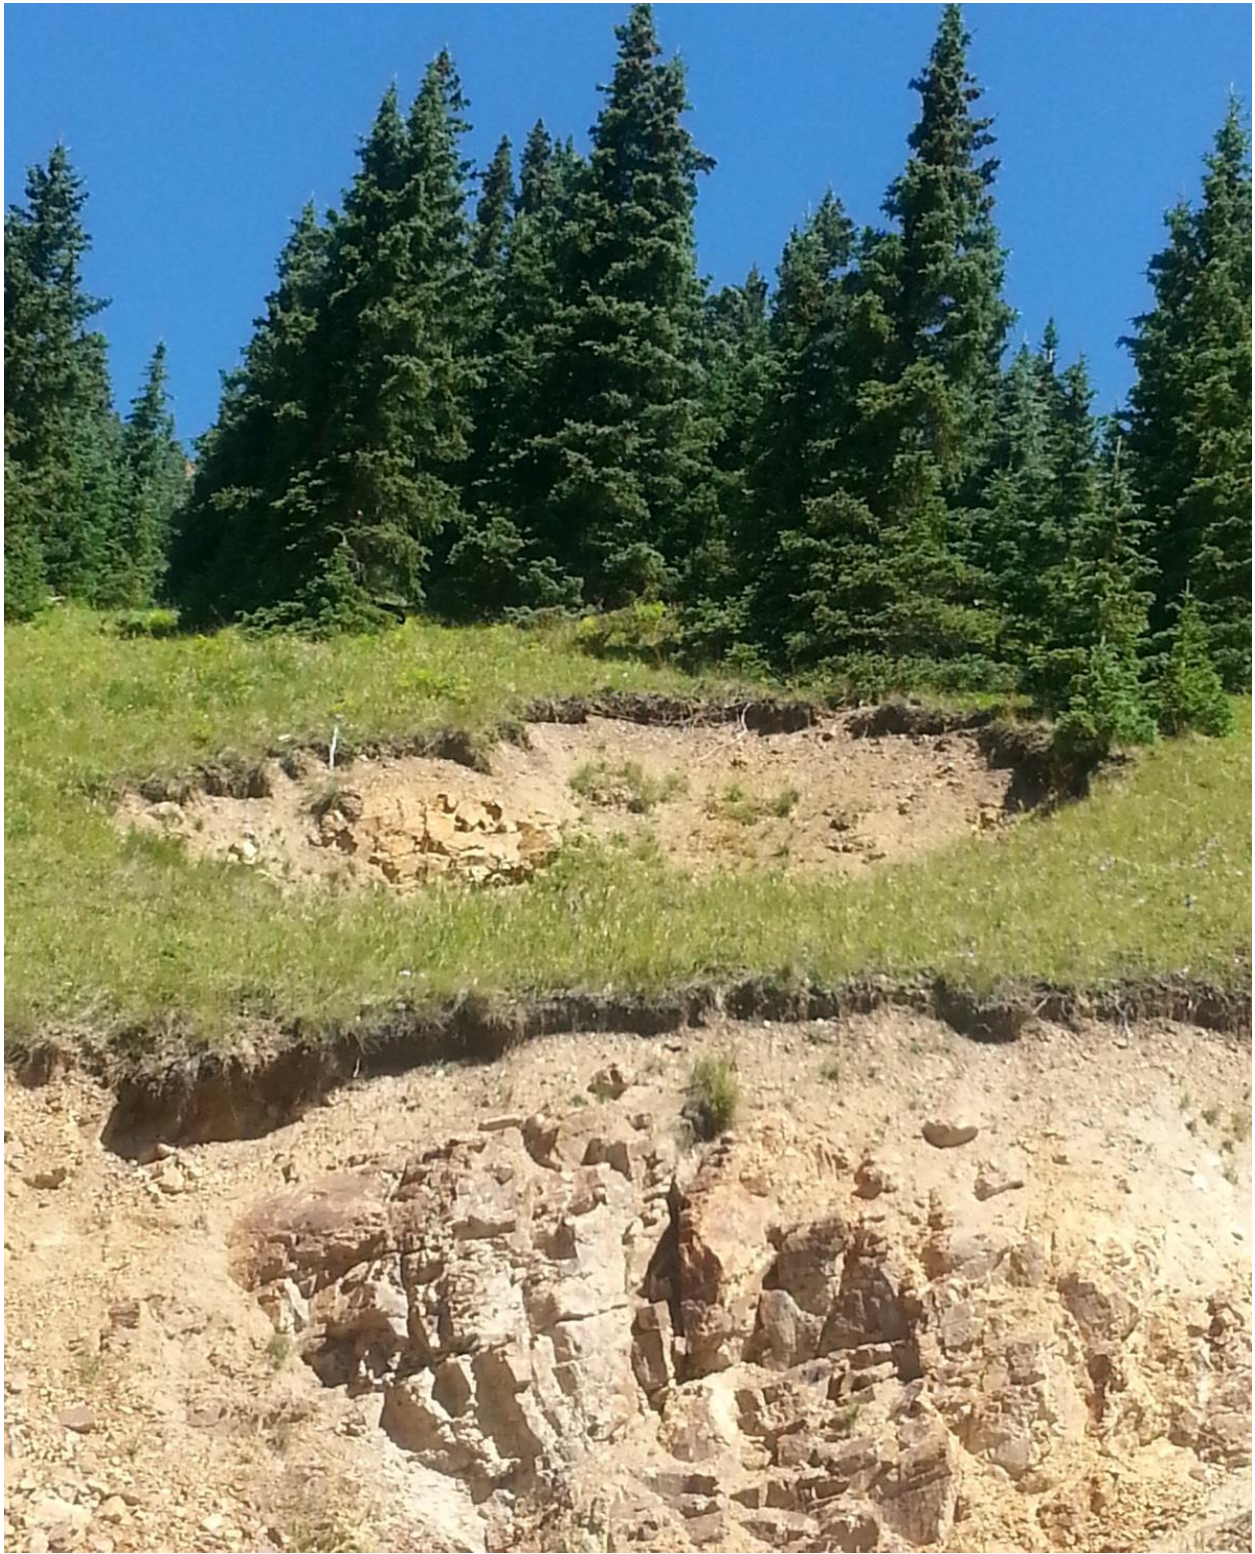
Photo 3 August 18, 2015 – Sink Hole and Slope above Gold King Mine Old Adit

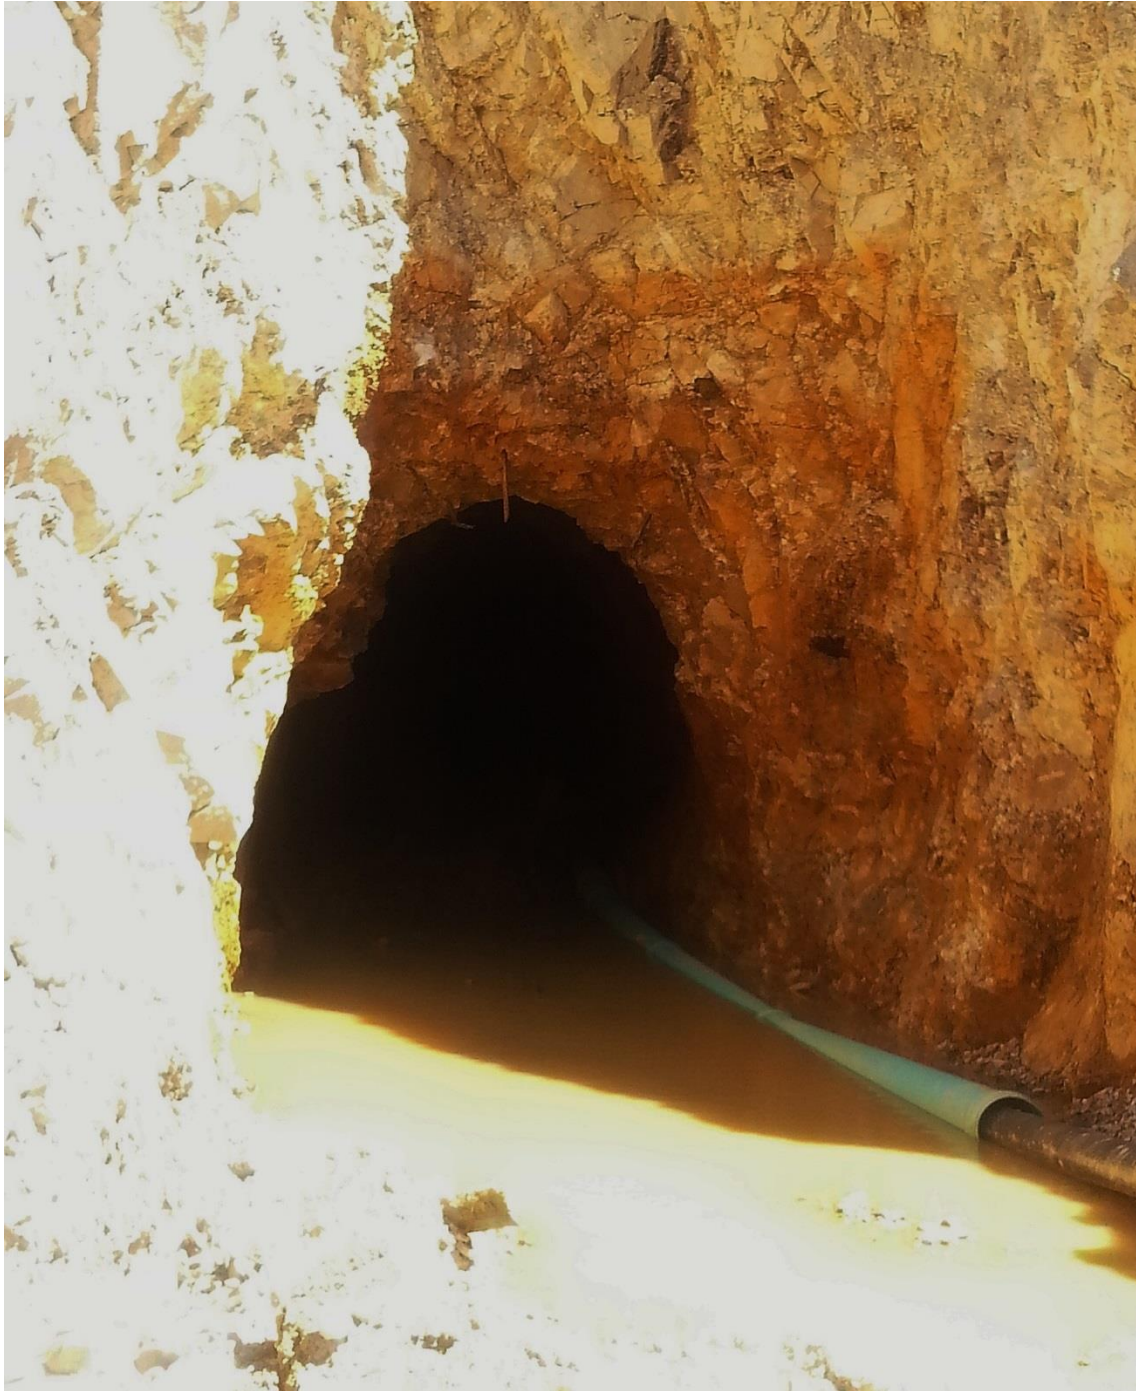
Photo 4 August 18, 2015 – Gold King Mine Level 7 Adit post-blowout

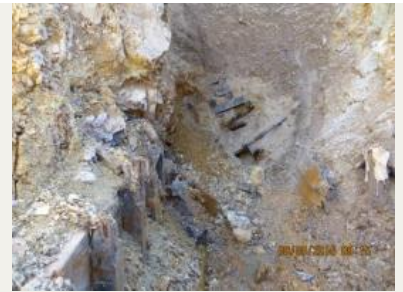
Description: Ongoing 2015 investigation work.

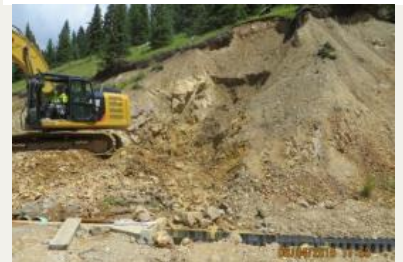
Description: 2015 investigation progress check

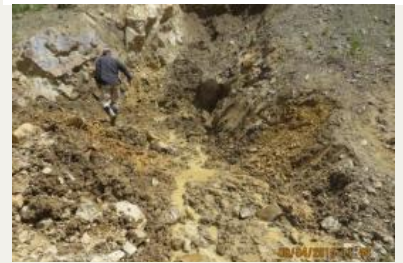
Description: Adit excavation work 2015.

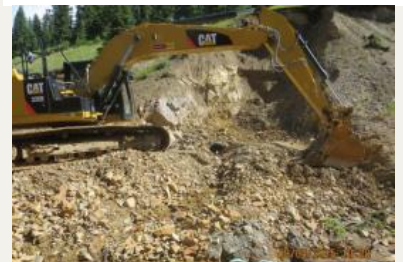
Description: Initial investigation work in 2015.

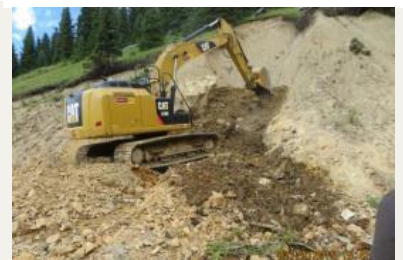
Description: 2015 initial site conditions, facing northeast

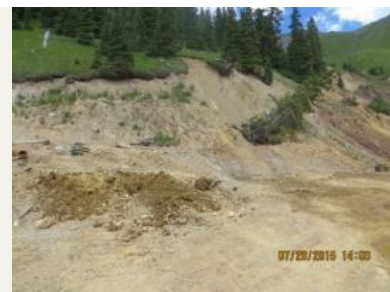
Description: 2015 initial site conditions, facing west.

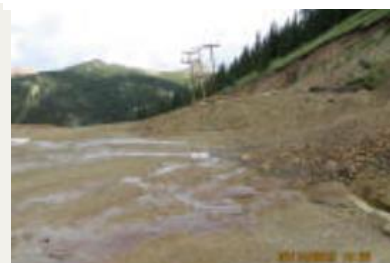
Description: Restored berm 2014 with added drainage pipes in foreground.

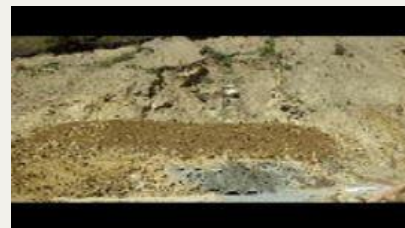
Description: Installation of new pipes to collect adit discharge.

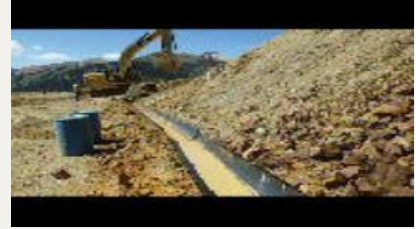
Description: 2014 excavation work.

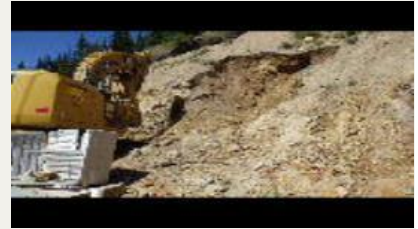
Description: Gold King Mine discharge flowing east in half pipe channel during preparations for 2014 site work.

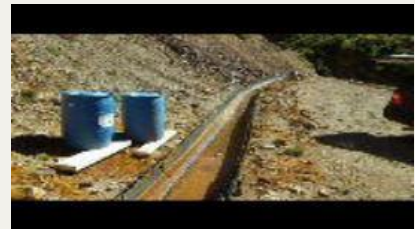
Description: Water flowing slowly from opening 100 feet west of main Gold King Mine adit.

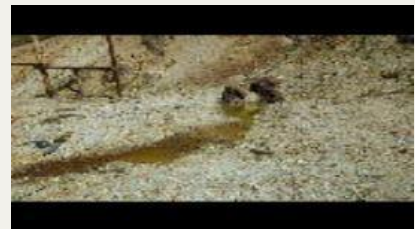
Description: Gold King Mine prior to 2014 site work
