Using aerial drones to select sample depths in pit lakes

DN Castendyk *Golder Associates Inc., USA*

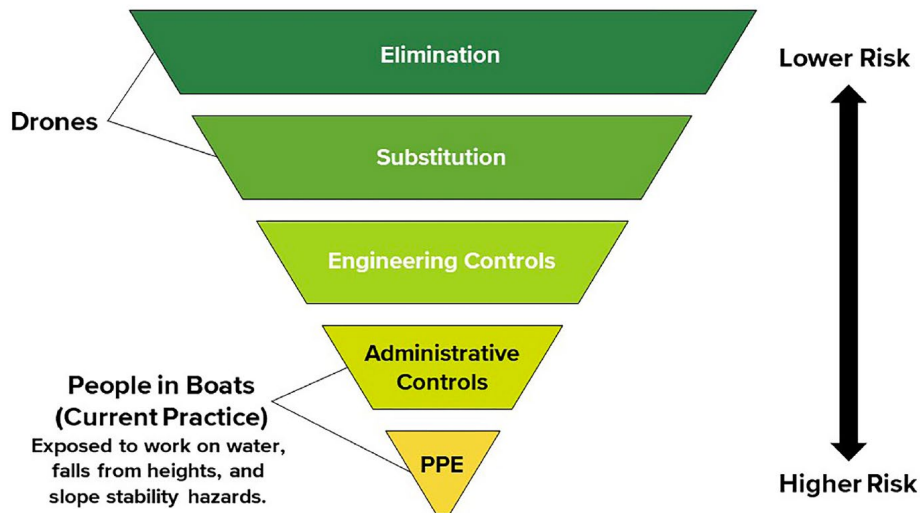
Figure 1 Hierarchy of risk control options for pit lake sampling showing the ‘elimination’ of work on water as the most effective risk control option, and work on water with staff wearing personal protective equipment (PPE) as the least effective control option. Aerial drones produce low risk through elimination whereas the status quo practice of boat-based sampling creates high risk

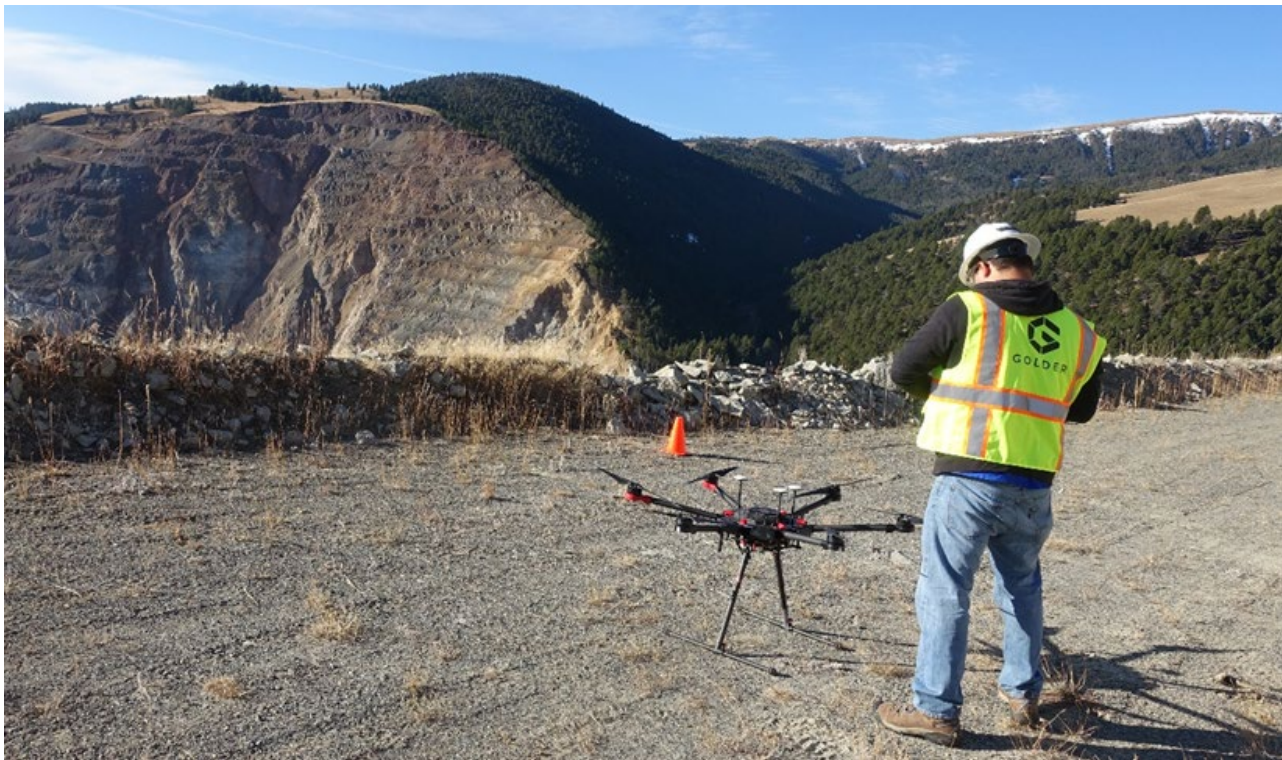
Figure 3 The DJI Matrice 600 drone during a pre-flight check at the Montana Tunnels Pit Lake

Aerial drone water sampling has been made possible by recent advances in both aerial drone technology and multiparameter water monitoring equipment. In 2016, the Chinese aerial drone manufacturer DJI (Da-Jiang Innovations) released the *Matrice 600*, a six-rotor, or hexa-copter, drone aircraft for approximately USD 4,500 (Figure 3). With the ability to lift a payload of approximately 6 kg, this high-lift-capacity drone has made it affordable to transport equipment other than cameras below aerial drones, such as water sampling devices capable of collecting 2 L-volume samples. This make and model aerial drone is used by at least three drone water sampling service providers in North America.

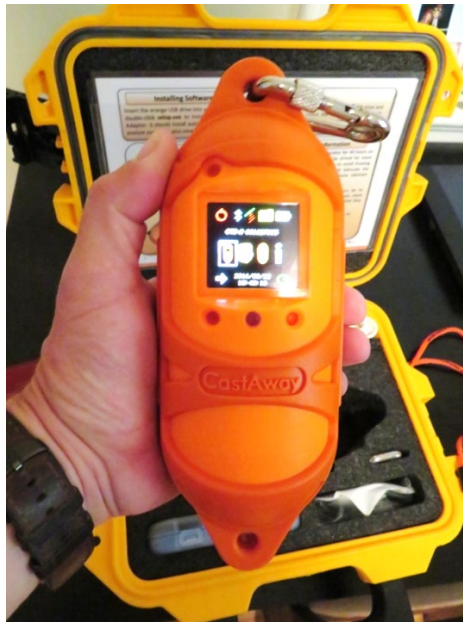
Figure 4 The YSI CastAway-CTD (conductivity-temperature-depth) probe

Over the past decade, multiparameter probes have become smaller, lighter, and more rugged, serendipitously resulting in equipment that is well-suited for aerial drone deployment. One example is the YSI (Yellow Springs Instrument) *CastAway*, a conductivity-temperature-depth (CTD) probe which measures in situ temperature and electrical conductivity to depths down to 100 m (Figure 4). The device calculates water density from temperature and electrical conductivity. This CTD weighs 0.45 kg and measures parameters at five times per second during its descent and ascent through the water column (<https://www.sontek.com/castaway-ctd>). Upon retrieval, the CTD rapidly transfers data to a laptop computer via Bluetooth connection, and the companion software graphically displays profiles of in situ parameters which can be used to select sample depths. The *CastAway* costs approximately USD 6,500.

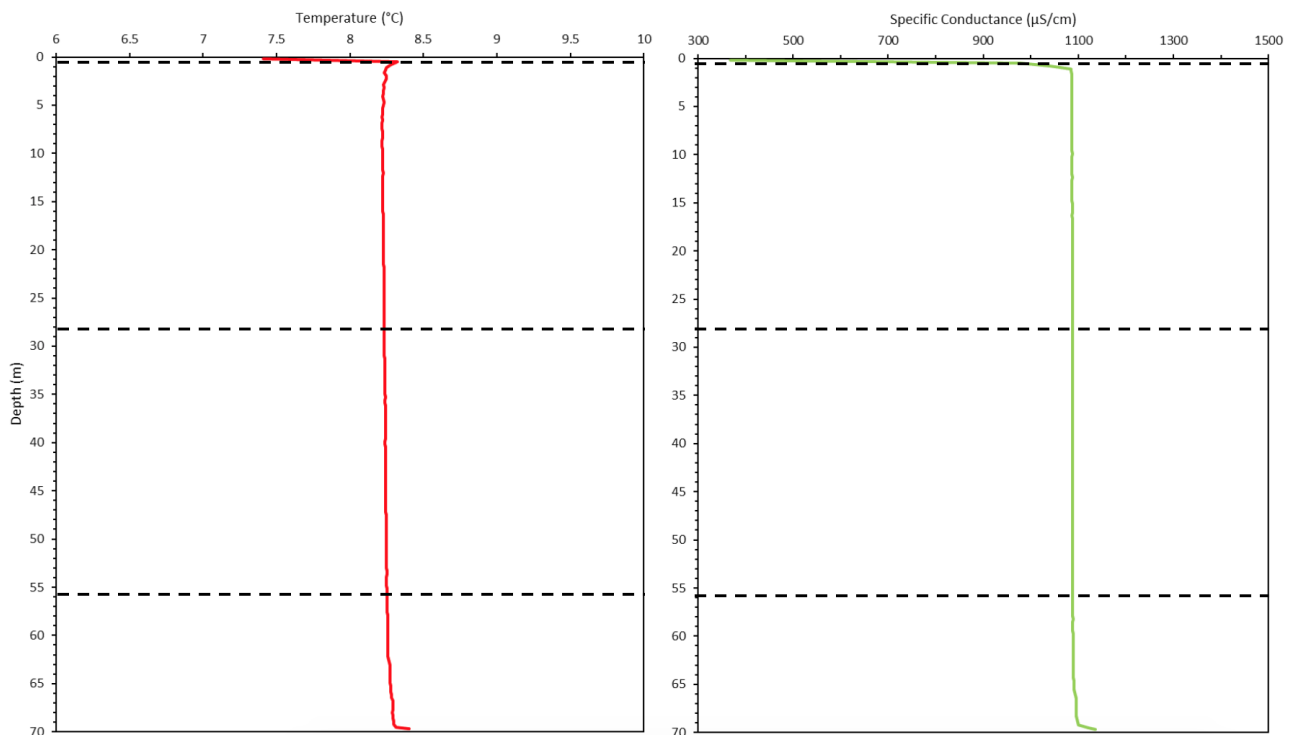
Figure 5 Temperature (left) and specific conductance (right) profiles from the Montana Tunnels Pit Lake on 23 October 2018. Horizontal dashed lines indicate corrected sample depths

Under direction from MDEQ, Golder flew the aerial drone above a point on the water surface that was believed to overlie the deepest location within the pit lake. Flight 1 lowered a *CastAway-CTD* through the water column that recorded the maximum depth at this location (70 m) and measured in situ profiles of temperature and electrical conductivity. Temperature and specific conductance were uniform from the top to the bottom of the water column and indicated the lake had recently undergone complete mixing during autumn turnover (Figure 5).

The temperature profile showed a uniform water column temperature of approximately 8.2°C, with slightly cooler water at the surface of the lake, and slightly warmer water at the lake bottom (Figure 5). This profile is characteristic of a lake which has recently mixed from top to bottom as a result of autumn turnover. Because the maximum density of water occurs at 4°C, the water column was expected to continue to fully circulate until the entire water column achieves a temperature of 4°C. Once the surface water drops below that temperature, winter stratification would develop. Cooler surface water may represent recent rainfall on the lake surface and/or radiant heat loss during the previous evening. Bottom temperatures probably reflect heat released from bottom sediments.

The specific conductance profile showed a uniform water column of approximately 1,087 µS/cm, with a lower conductivity in the first 1.5 m of the water column (300 µS/cm) and slightly higher conductance at the lake floor (1,135 µS/cm) (Figure 5). Specific conductance indicated the relative concentration of TDS in lake water. The profiles in Figure 5 suggested that the chemistry of the lake was well mixed from top to bottom. As such, Golder expected that water samples collected from any depth would have a similar water quality. Lower values at the surface most likely indicated dilution by recent rainwater, whereas elevated values at the lake bottom possibly indicated higher TDS within the mud layer at the lake bottom.

Based on evidence of homogeneous conditions in the water column, Golder expected homogenous water quality throughout the lake. In this instance, one sample from the middle of the lake would have represented the water column. To ensure homogeneous conditions, three water samples were targeted based on a uniform sample spacing of 30 m, at 0, 30, and 60 m depth. Flight 2 collected a 2 L water sample from the deepest depth. Flight 3 attempted to collect a sample from the immediate surface of the water, but upon return, the sample chamber contained only 0.6 L. Flight 4 lowered the sampling device to three metres below the surface and returned with a 2 L sample. Flight 5 collected a 2 L sample from the mid-depth of the lake. Post processing of pressure transducer data showed the actual sample depths to have been 0, 28, and 56 m

Golder predicted the following changes would occur in the weeks following the sampling event. The density of the surface layer would continue to increase as the surface layer cooled from 5.2 to 4.0°C, with 4.0°C corresponding to the maximum density of freshwater. As the density of the surface layer increased, surface-layer-mixing would deepen. If the lake is holomictic, the density of the surface layer will ultimately exceed the density of the underlying water column, and the entire lake would circulate from top to bottom. This event would be called 'complete autumn turnover'. If complete turnover occurred, it would homogenise the temperature and specific conductance profiles, eliminating the temperature spike at 18 m as well as the gradual increase in temperature and specific conductance in the deep layer. The resulting profile would look similar to Figure 5 only with higher specific conductance.

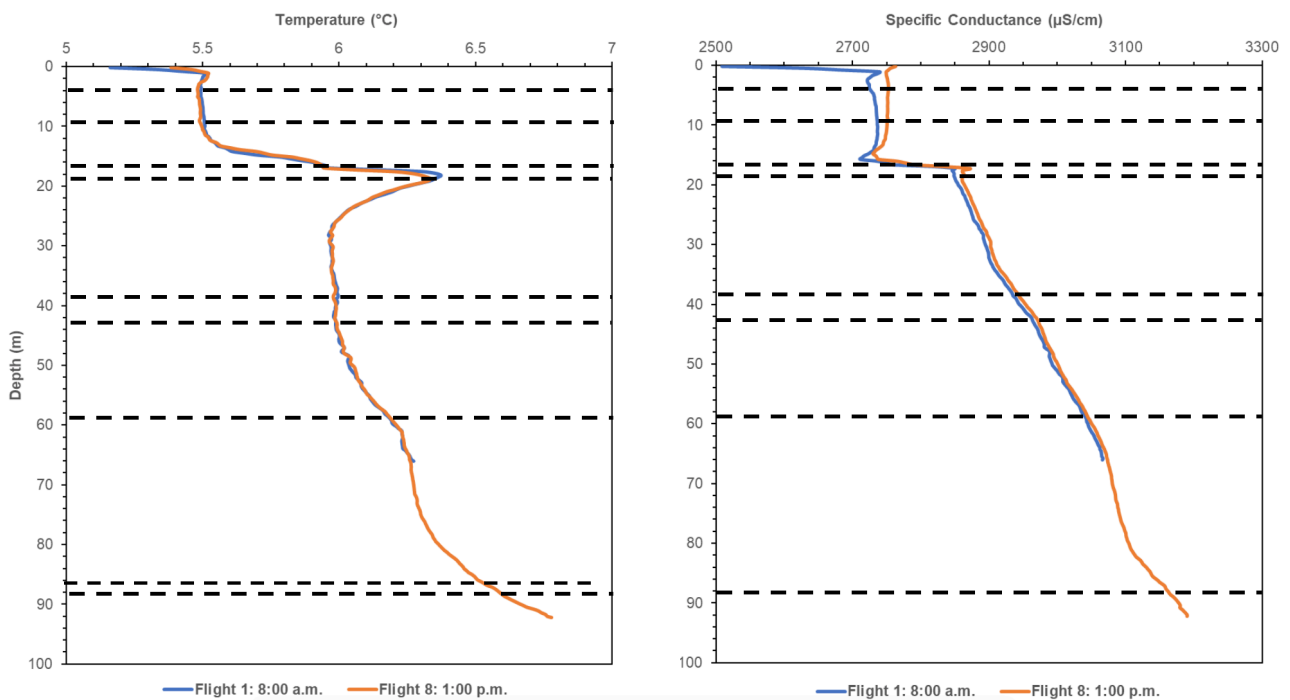
Figure 6 Temperature (left) and specific conductance (right) profiles from the Thompson Creek Pit Lake on 13 November 2018. Horizontal dashed lines indicate corrected sample depths

Two in situ profiles of temperature and specific conductance were collected five hours apart during Flights 1 (66 m) and 8 (92 m) (Figure 6). The close similarity between each profile indicates consistency in the profiling method and that little change occurred within the water column during water sampling.

Temperature and electrical conductivity indicated the presence of a shallow layer from 0 to 13 m, a transitional boundary from 13 to 26 m, and a deep layer from 26 m to 92 m (Figure 6). Uniform temperature and specific conductivity profiles in the shallow layer, above 13 m depth, indicate that the layer was well mixed above this depth at the time of sampling. Mixing is driven by wind acting on the water surface. The coldest temperatures in the lake (5.2°C) occurred at the surface of the lake which indicates radiant heat loss during the previous evening.

Between 13 to 26 m depth, temperature increases by about 1°C to 6.4°C (Figure 6). At the same depth, specific conductance slightly increased by 200 $\mu\text{S}/\text{cm}$ to 2,900 $\mu\text{S}/\text{cm}$. This may indicate the presence of tailings pond water pumped into the lake or groundwater entering the lake. In both cases, the influent water most likely has a different temperature, TDS concentration, and density than the ambient lake water. This density difference causes the influent to rise or fall through the water column until it arrives at a depth of neutral buoyancy, in this case 18 m depth. This was a unique layer targeted by the 17 m sample.

Below the transitional boundary, temperature and specific conductance increase to the lake bottom (Figure 6). The temperature increases of 0.5°C may be due to heat released from pit walls and/or bottom sediment, or the addition of groundwater (~11°C). The specific conductance increase of 200 $\mu\text{S}/\text{cm}$ may be due to groundwater inflow, tailings pond water, and/or the downward settling of suspended particulate matter (i.e. mineral precipitates) from the surface.

- Specific conductance (Figure 6), pH, and major cations and TDS concentrations (Table 4) show only minor changes between the shallow and deep layers. This is typical of a holomictic lake. The deep layer of meromictic lakes typically exhibits significantly higher TDS than the shallow layer and may also have a slightly higher pH.
- The deep layer exhibited little to no sulphide concentrations. This is typical of a holomictic lake. The deep layer of meromictic lakes typically exhibits anoxic conditions where sulphide is generated as a product of sulphate reduction.

- Identification of unique layers worthy of investigation (e.g. the 17 m-deep sample in Thompson Creek Pit Lake, Figure 6).
- Interpretation of the physical state of the lake with respect to seasonal stratification or mixing.
- Justification for a minimum number of samples for geochemical characterisation.
- Selection of sample depths within individual layers.
