CRISIS AVERTED

It started off as a simple sealant replacement job, but quickly turned more serious when an unassuming facade revealed potentially catastrophic structural damage of the Silverton Condos in Silver Spring, Md.

Silverton Condominiums

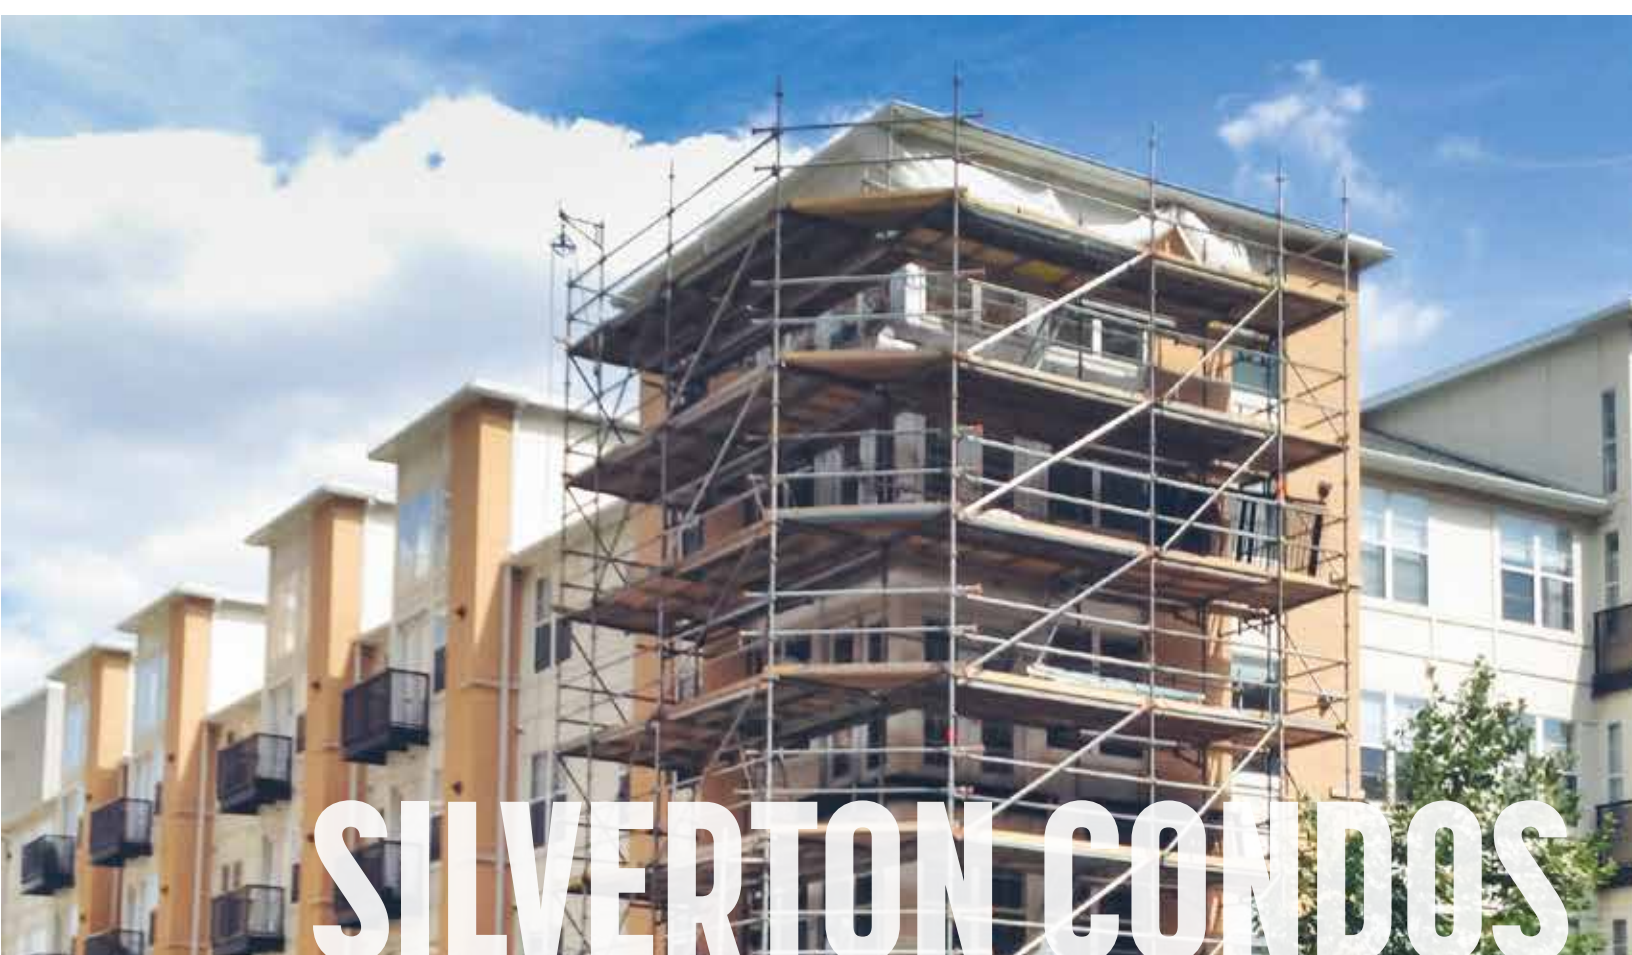
The damage behind the wall components and cement board panels included severely deteriorated plywood sheathing, 2'x8' window and door headers, corner structural framing posts, and built-up joists throughout the three-unit corner tier — all damage concealed by the cladding material on the outside.

The expanded scope of work now included shoring and temporary support needed to remove and replace deteriorated wood framing

with newly designed structural members and connectors, removal and re-installation of existing windows and replacement of the building's French doors with sliding glass ones. Finally, a complete building envelope approach was taken with the application of a new and vastly improved air and water barrier system to prevent any more leaks at the buildings east/west corridor condo units.

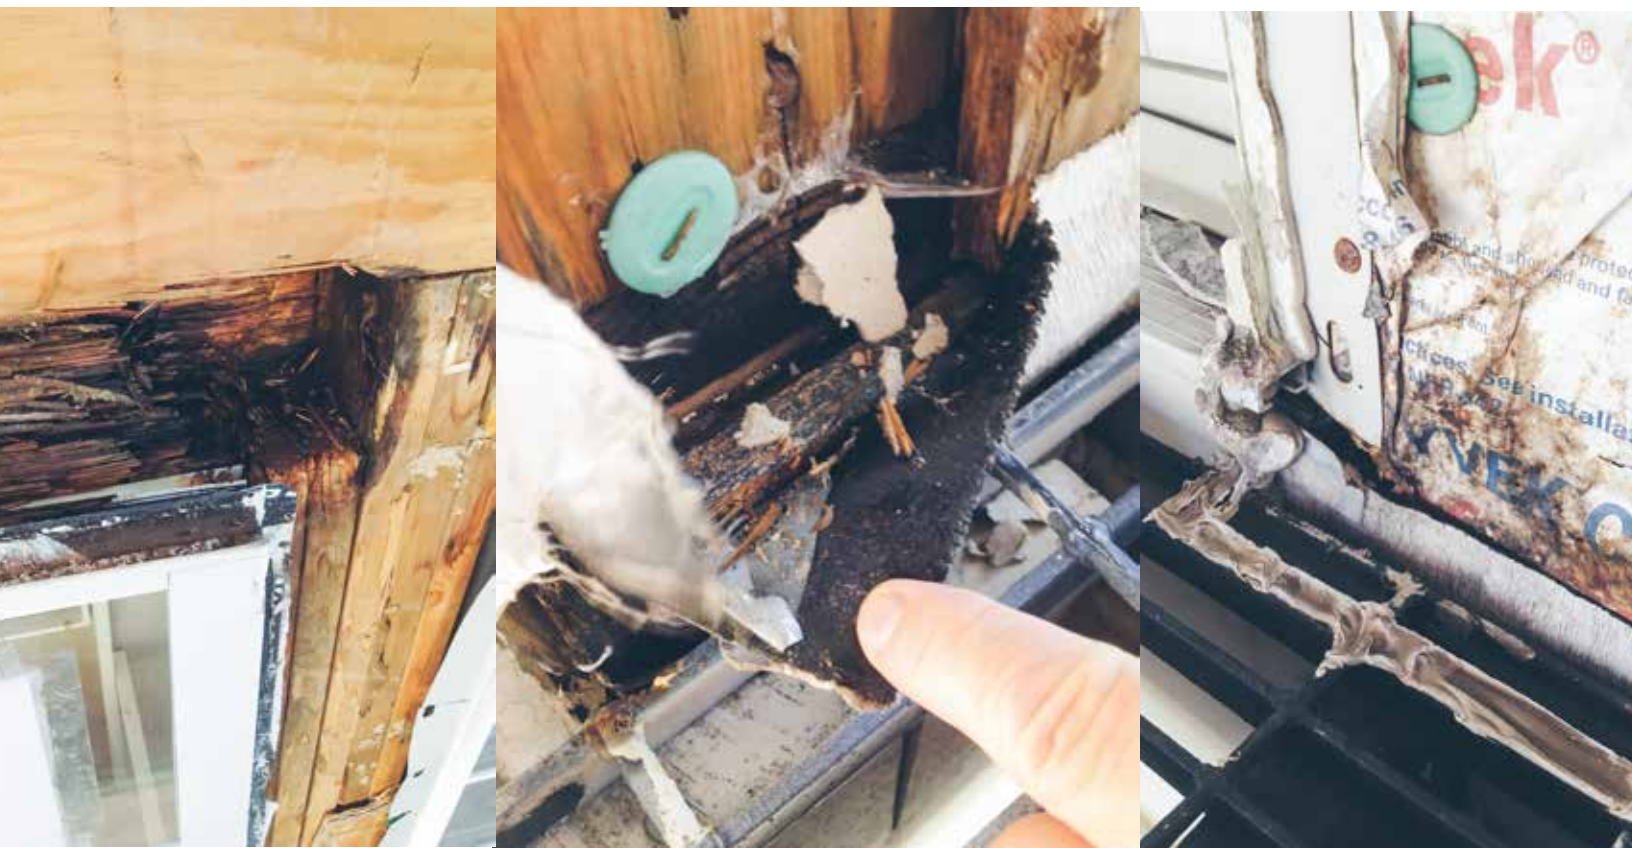
SRW President Dave Etchison said the situation encountered at Silverton is not uncommon to see, and yet no less unnerving, considering what might have happened had it gone unchecked. "There were large, multiple structural wood framing members that had been essentially reduced to cardboard. Unfortunately we see this type of deterioration frequently. In fact, we make a living going behind people and repairing what wasn't done right the first time — which is ultimately the long-term impacting issue," he said.
