METROPOLITAN BUILDING

RENEWED GLORY FOR A SEATTLE STAPLE

A miraculous restoration in Seattle is overcoming painted masonry, water-related deterioration, and collapsed walls from seismic events.

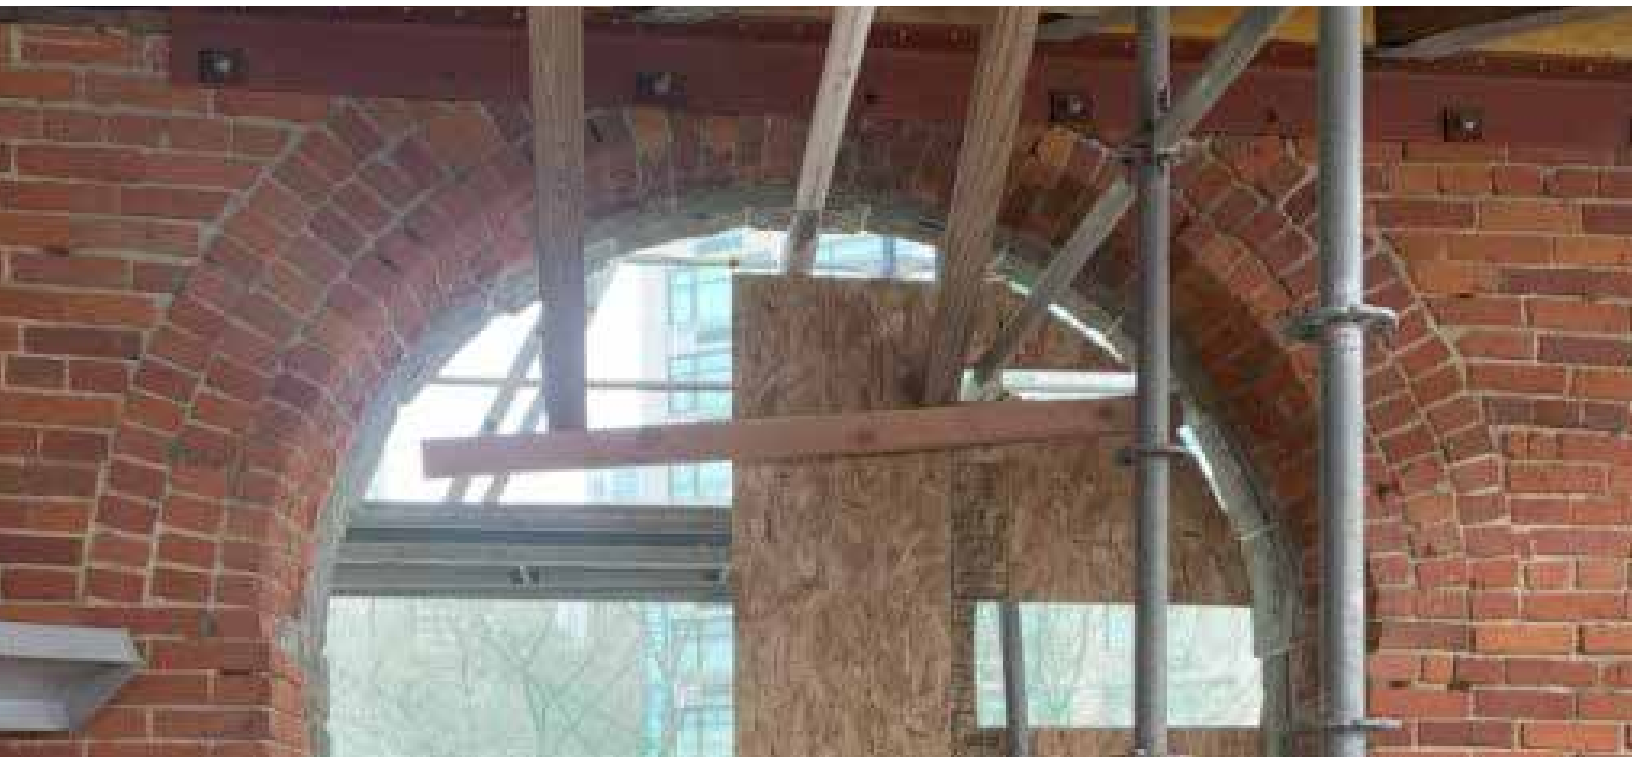
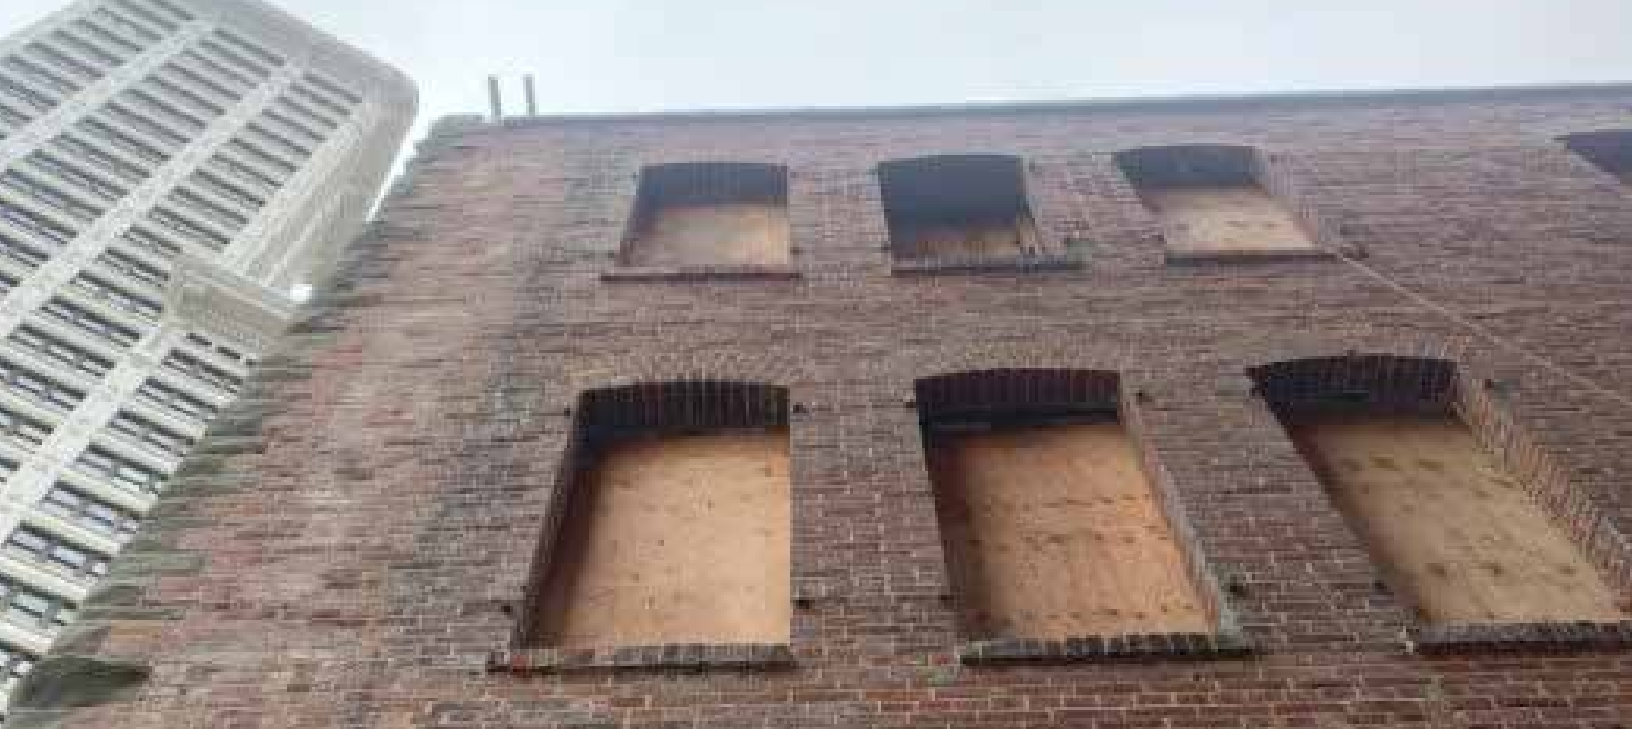
The building itself “is a really fascinating stone façade restoration,” he adds. “The main façade is clad in sandstone, and it had been painted for 70 or 80 years. I have no idea when the paint was applied, but the paint had damaged the stone because it traps water.”

Step 1 for the design-build team involved figuring out how to get the paint off, including what method to use while minimizing damage to the historic stone surface.

As of Spring 2023, Aalfs says crews were nearly done with the paint removal portion using PROSOCO’s SafStrip 8.

“We thought we’d lose a lot of the stone surface because there were areas where some of the stone had deteriorated due to moisture damage,” he says. “It was soft, and those areas were retooled, but it’s much better than what we expected. We tried a whole lot of different methods with testing and settled on that method. The contractor made some adjustments once we got going and it’s really been successful.”

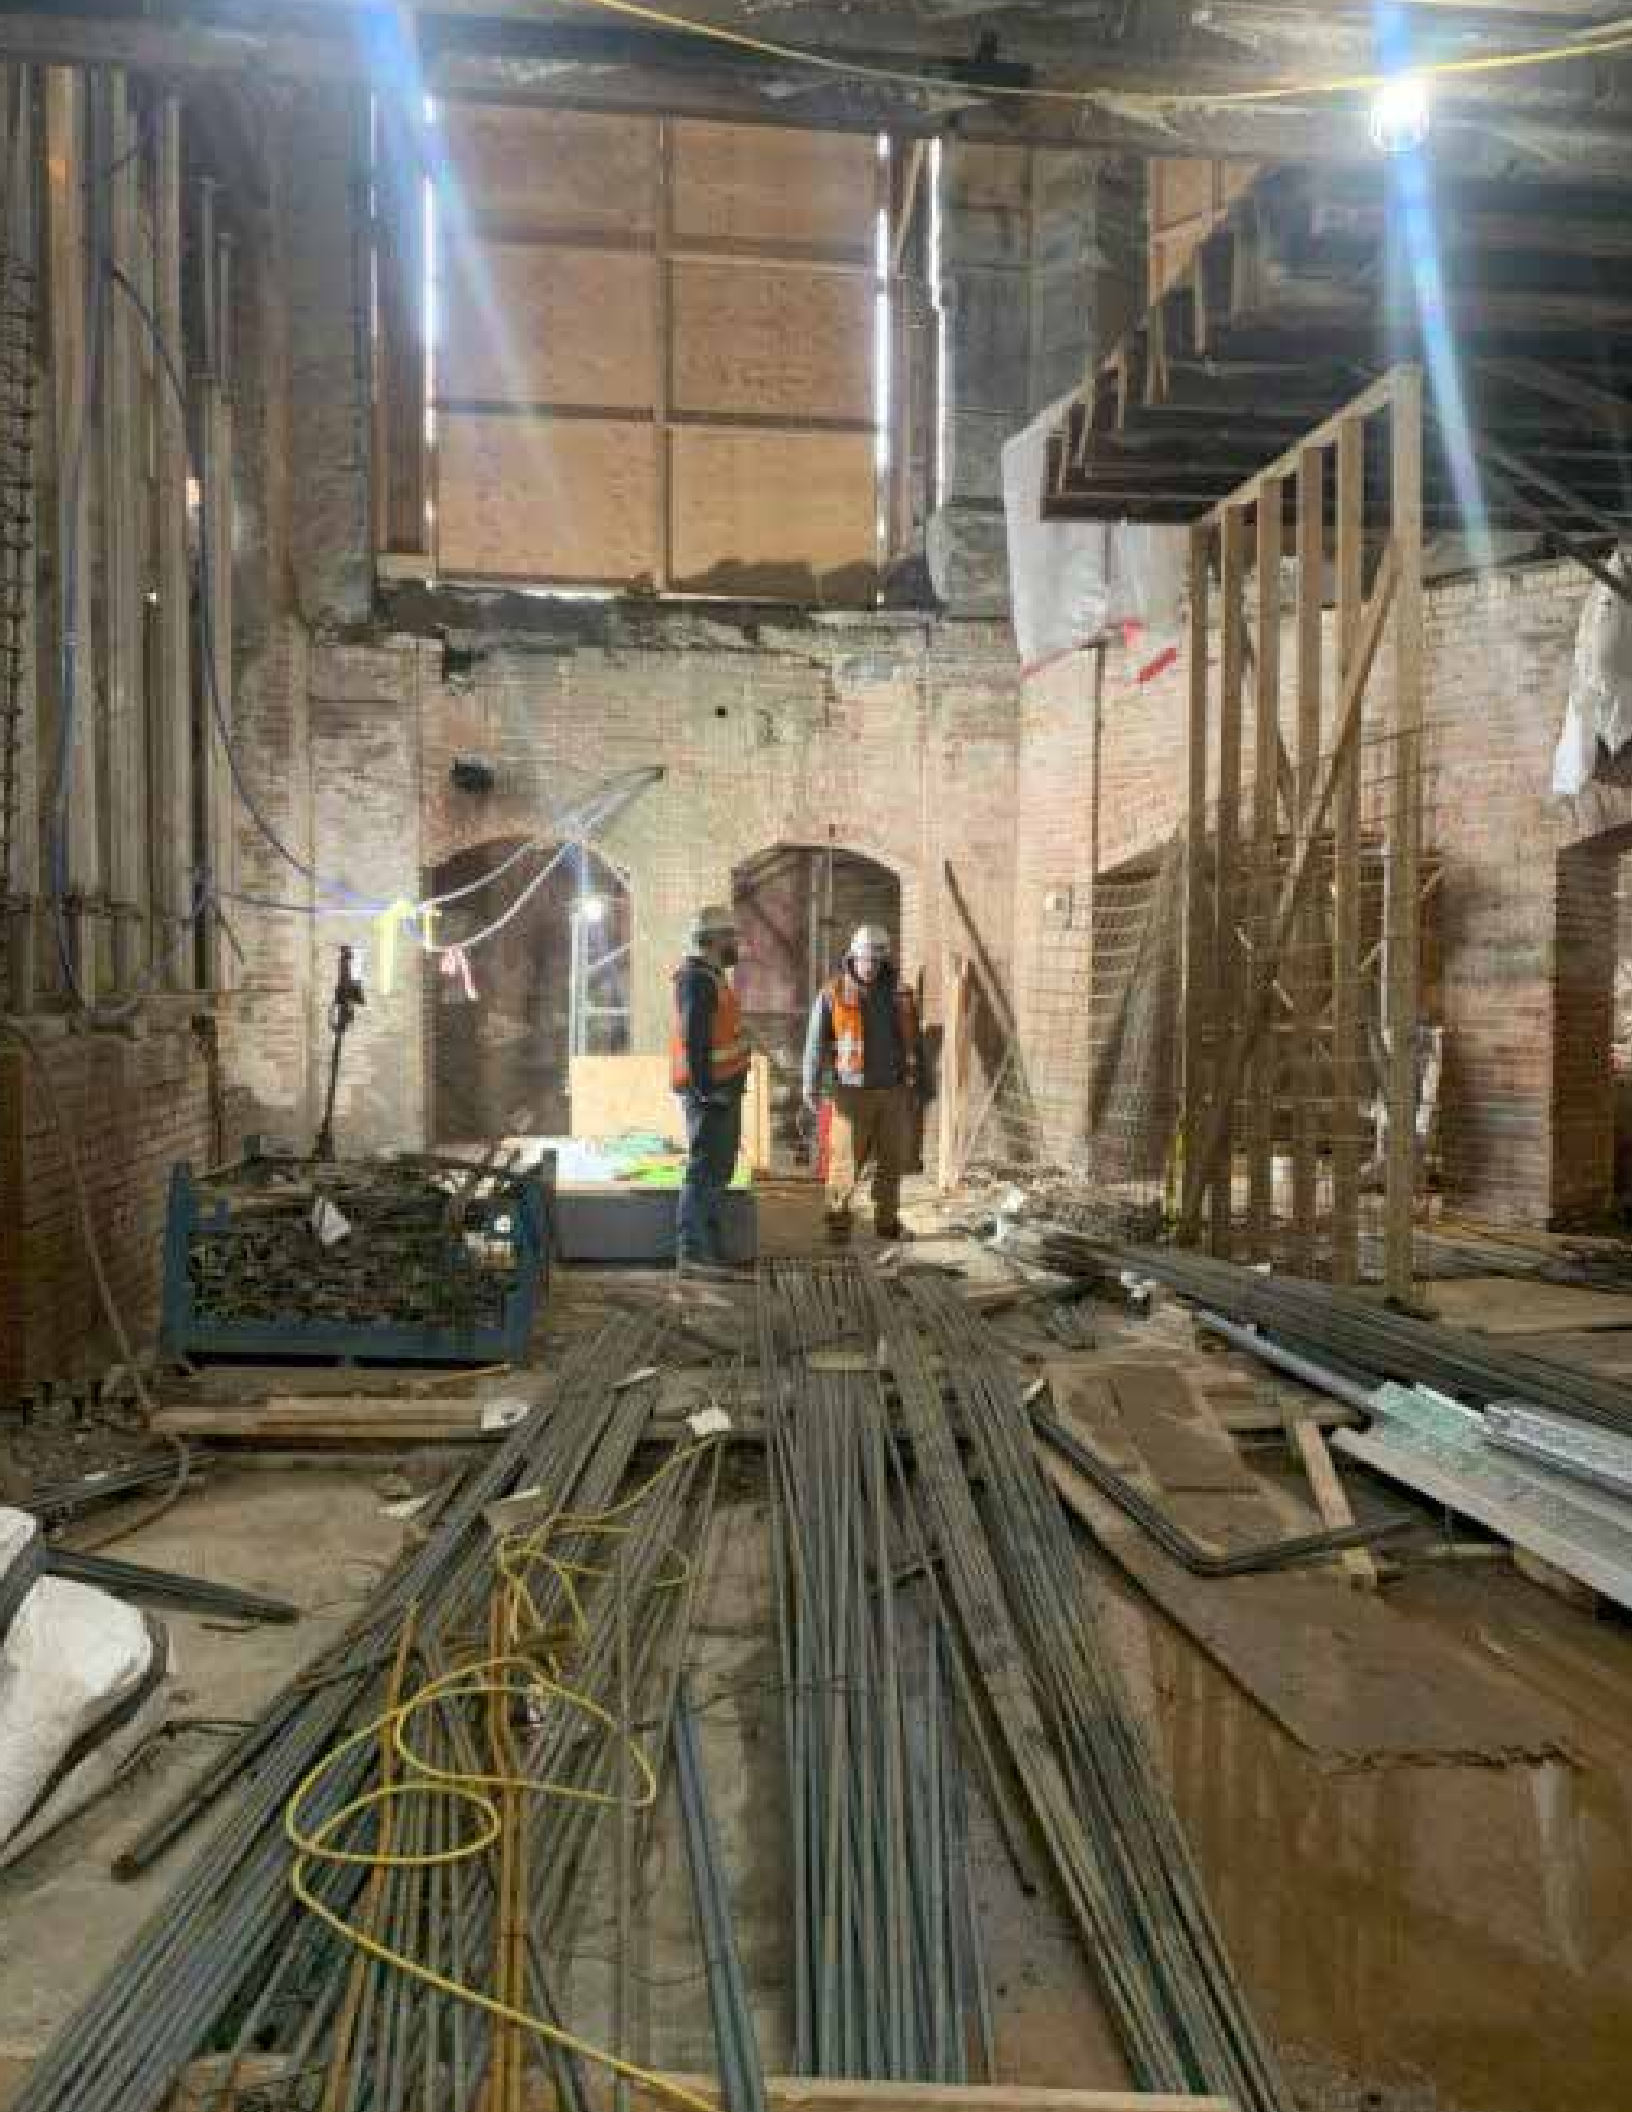
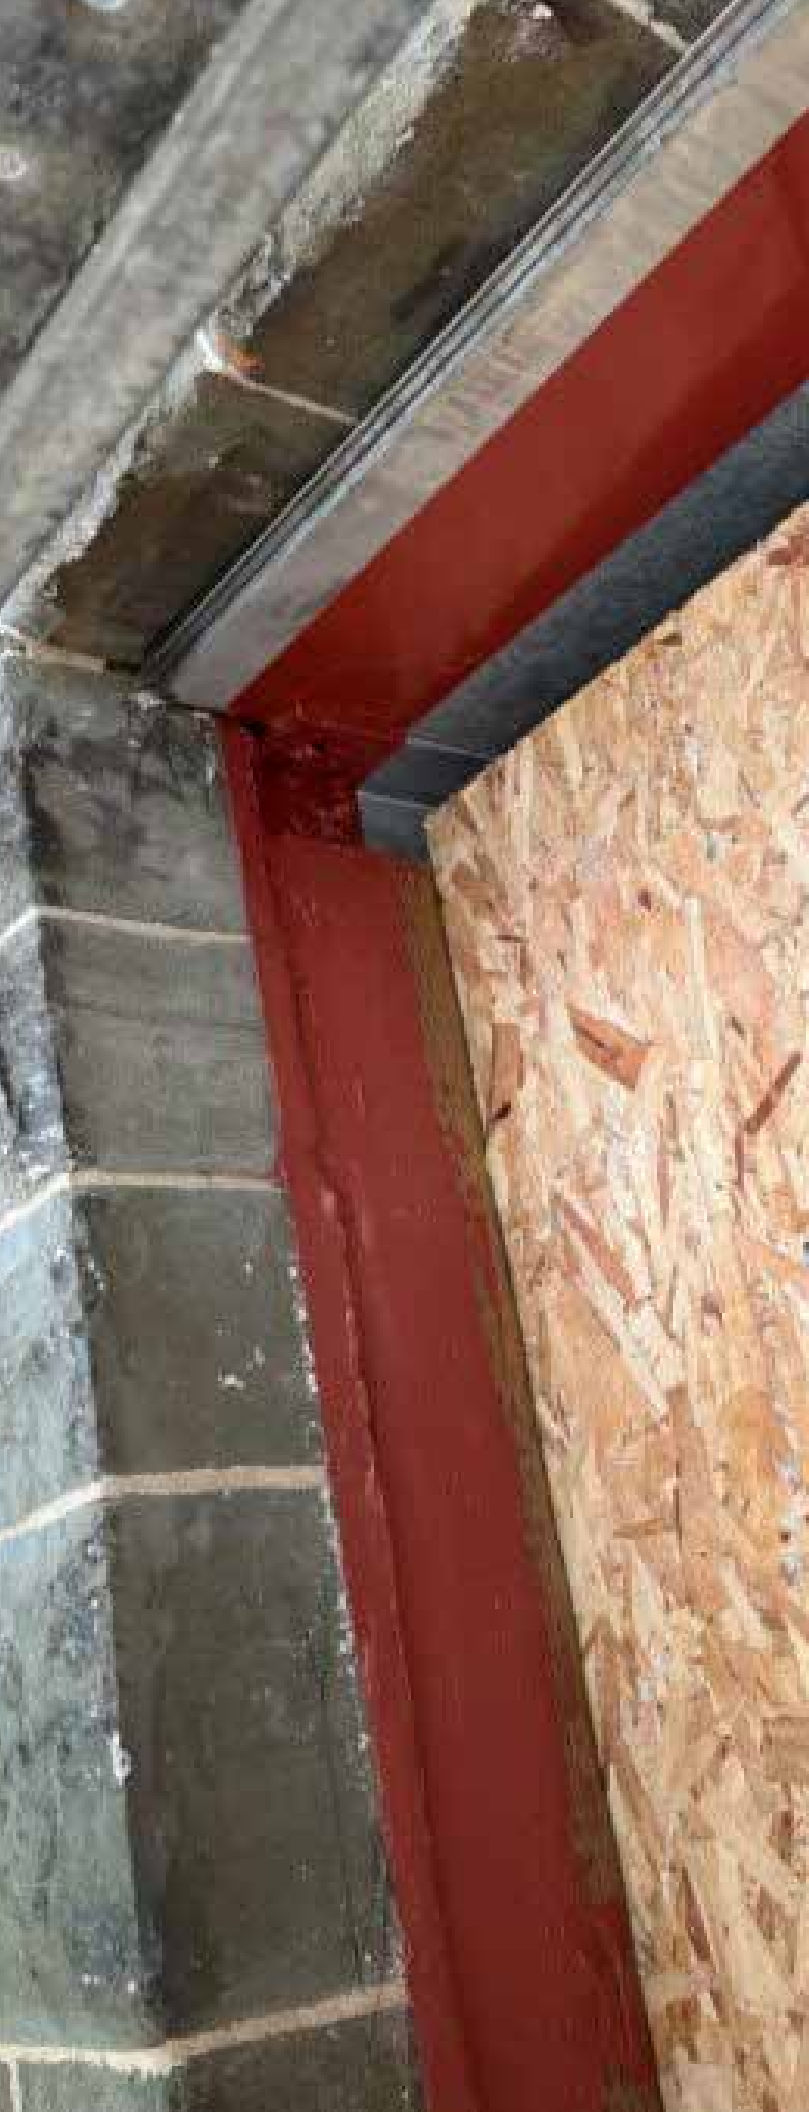
and the substrates were consolidated and protected with Sure Klean Weather Seal H40.

Additionally, the rough openings were covered with R-Guard FastFlash, a fluid-applied waterproofing membrane that optimizes airtightness in building envelopes.

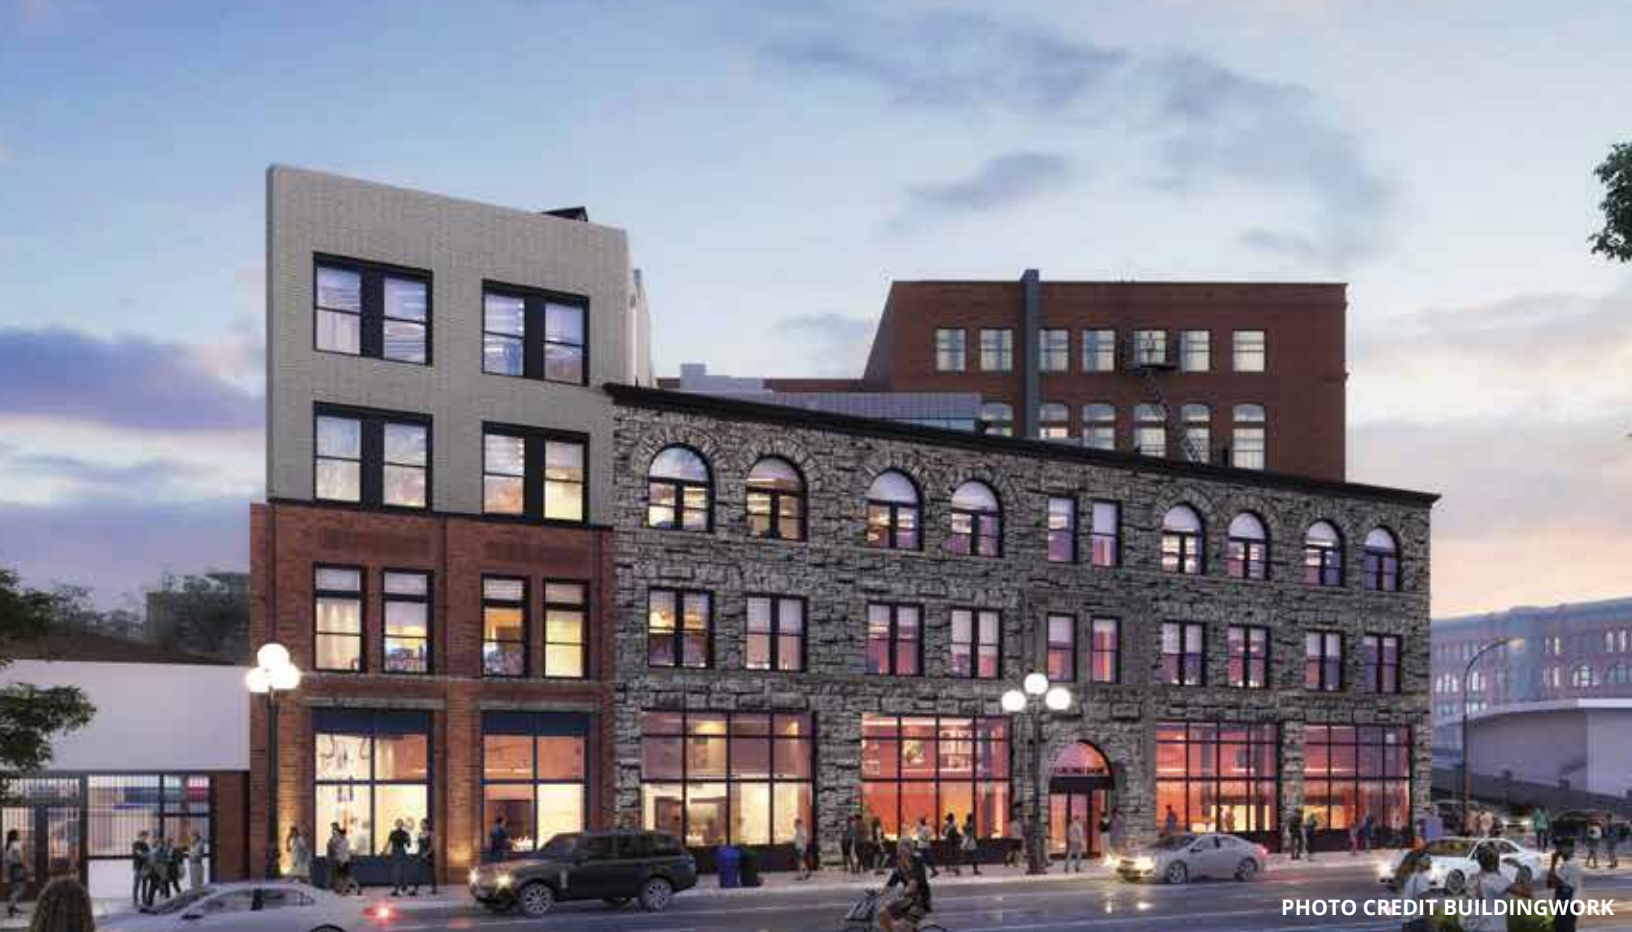
“It was just covered in gray paint to the point where you couldn’t distinguish the stone,” he says. “It looked like frosting on a cake. Now that we’ve got it removed, you’re seeing the individual stone, the carvings, and the detail is re-emerged. It’s amazing.”
