The Effects of Armoring Shorelines—The California Experience

Gary B. Griggs¹

Griggs, G.B., 2010, The effects of armoring shorelines—The California experience, *in* Shipman, H., Dethier, M.N., Gelfenbaum, G., Fresh, K.L., and Dinicola, R.S., eds., 2010, Puget Sound Shorelines and the Impacts of Armoring—Proceedings of a State of the Science Workshop, May 2009: U.S. Geological Survey Scientific Investigations Report 2010-5254, p. 77-84.

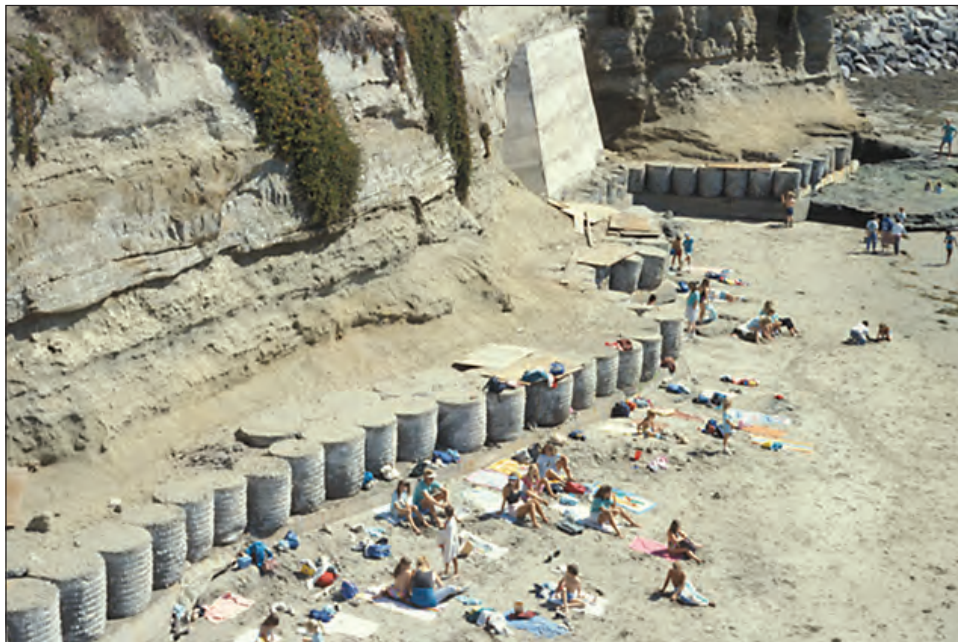
Figure 1. These cliffs in Capitola, California have been protected by a home-made seawall with visual impacts for beach users.

Any armoring structure built to protect either cliff, bluff, dune or back beach development will have some aesthetic impacts (fig. 1). Whether a seawall, bulkhead, revetment or some other form of stabilization or protection, there is a visual impact that can be much greater to the beach user or general public than to the owner of the property being protected, who may not even see the structure. In California, the visual impact of coastal armor is probably the issue that most concerns the

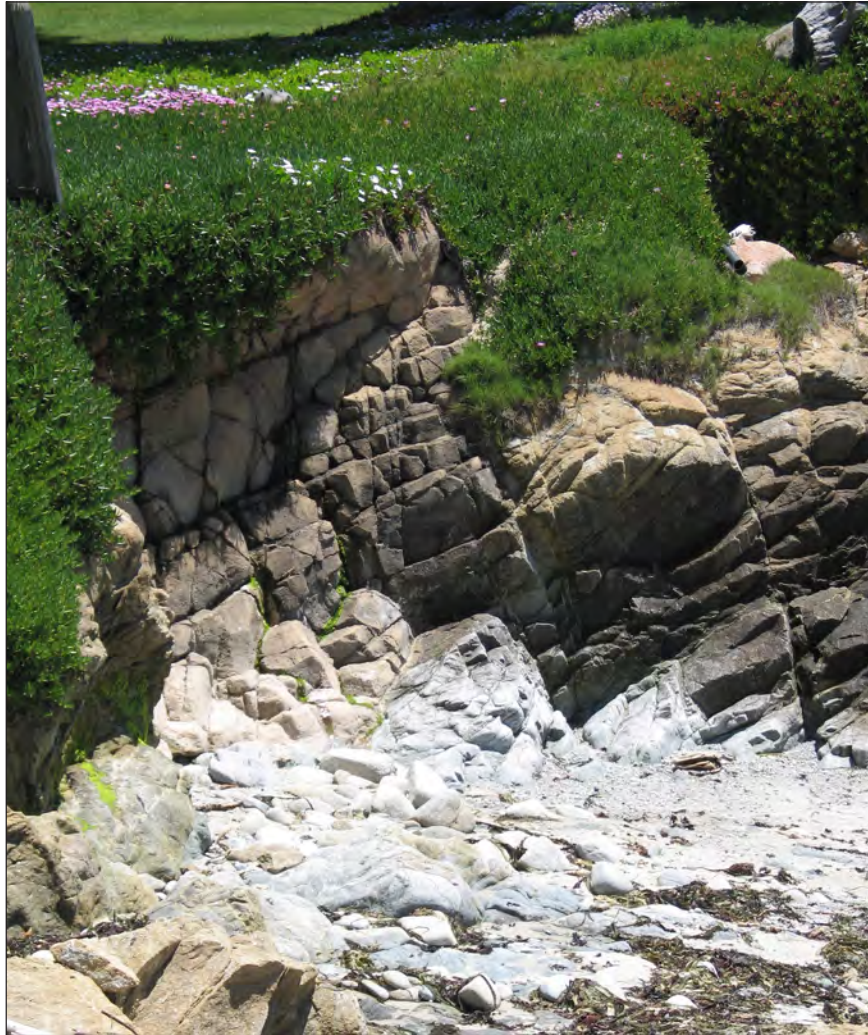
Figure 2. Bluff reconstruction and stabilization along the Pebble Beach area of the Monterey Peninsula, where the exact textures and colors of the existing granitic rock were duplicated to minimize visual impacts.

One relatively recent approach in California has been the use of soil nail walls or sprayed concrete, which is colored and textured to match the native rock in the cliffs. Colored and textured gunnite or soil-nail walls have been used to stabilize highway road cuts, but only recently has this approach been applied to coastal protection projects as a way to mitigate the visual impacts. These structures involve anchoring soil nails or tie backs into the bluff materials, and then constructing a steel-reinforcing frame that mimics the shape of the existing bluff. This mesh is then covered with about a foot of gunnite, followed by a second 6- to 12-in. thick layer, which is textured and colored to match the adjacent rock as closely as possible (fig. 2). Weep or drain holes must be built into the structure in order to avoid the buildup of water behind it.

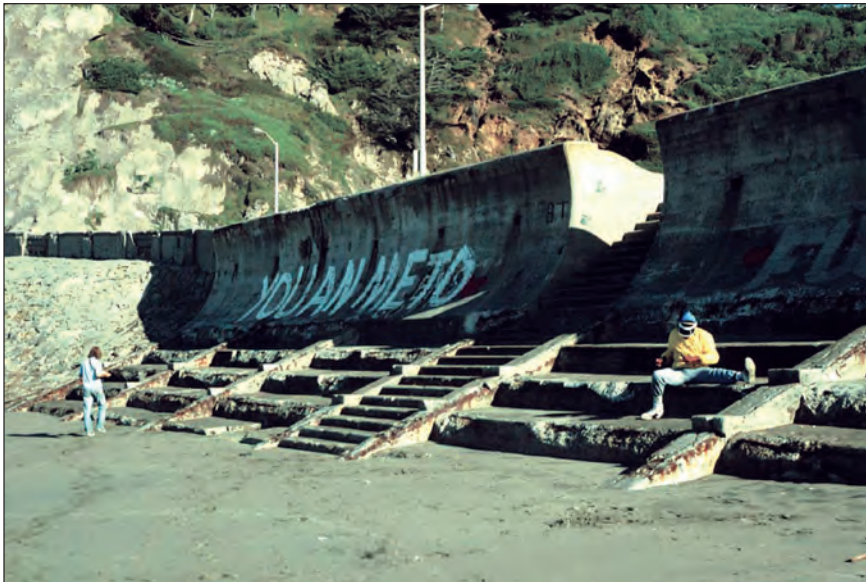
Figure 3. The massive and carefully engineered O'Shaughnessy Seawall in San Francisco was built in 1928 and has stood the test of time.

When any protective structure is built at the base of a bluff, cliff, or dune, or well out on the beach profile, a predictable amount of beach will be covered by the structure. The effect is immediate beach loss, the extent of the loss being a function of how far seaward and alongshore the structure extends. Where a relatively thin vertical seawall or soil nail wall is built, there is usually very little beach loss because the structure has a very small cross-shore width, perhaps only several feet. Some very large concrete seawalls, however, such as the O'Shaughnessy seawall along San Francisco's Ocean Beach (fig. 3), or the Galveston seawall, do have an appreciable width and will cover over more beach area.

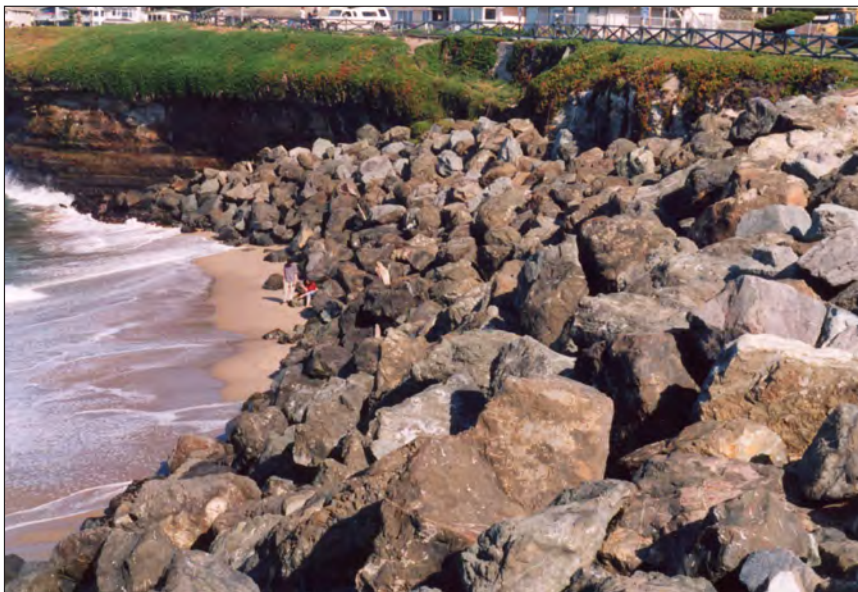
Figure 4. This revetment in the city of Santa Cruz has eliminated the entire beach through placement loss.

On the other hand, where riprap or a revetment is placed to protect a bluff, it may reach a height of 15 to 25 ft or more, and extend seaward at a 1.5:1 or 2:1 slope, covering 30 to 50 ft of beach (fig. 4). This placement loss can easily be calculated for any proposed revetment knowing the cross-sectional area and alongshore length, and this impact can then be quantified in relation to how much adjacent or surrounding beach area would still be available. In other words, if the existing beach is very narrow, say 30 ft on average, the riprap may cover the entire beach. Where the beach is wider, riprap may cover only one-third to one-half of the available beach area.

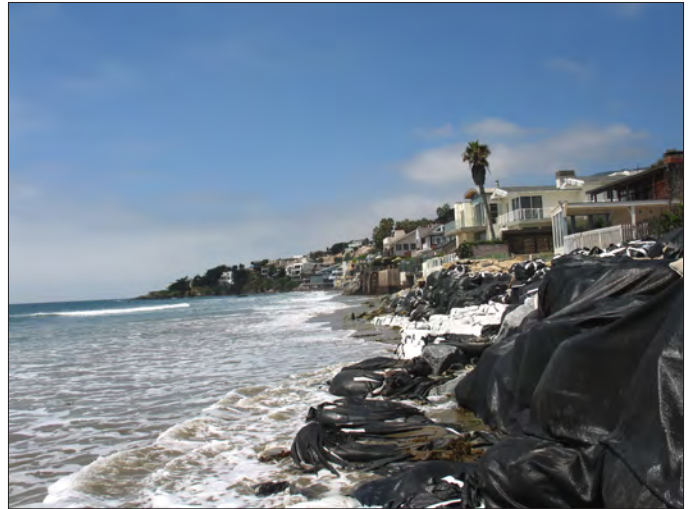
Figure 5. Under winter beach conditions, lateral access is significantly reduced due to the encroachment of these temporary protection structures onto the beach at Malibu.

While a seawall normally extends a lesser distance seaward than a revetment, both structures can restrict lateral access if the beach is narrow or present only seasonally. Knowing tidal ranges and wave run-up at a particular site, as well as typical beach widths or elevations during differing times of the year, a reasonable prediction of the amount of time that lateral access would be lost can be made. At some locations, stairways and elevated walkways have been built over these structures to help mitigate this impact.

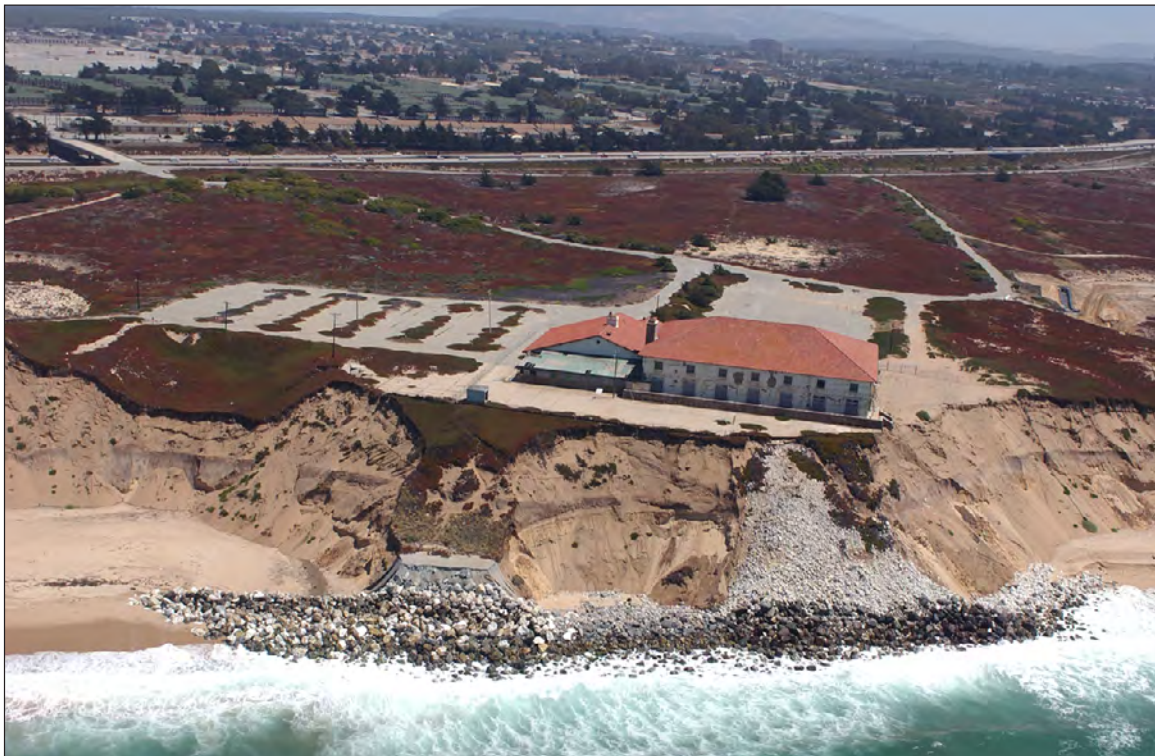
Figure 6. Passive erosion in southern Monterey Bay, California, has eliminated the beach in front of this riprap as the bluffs on either side continue to erode at more than 6 feet per year.

Whenever a hard structure is built along an eroding coastline, the shoreline will eventually migrate landward on either side of the structure (fig. 6). The effect will be gradual loss of the beach in front of the seawall or revetment as the water deepens and the shoreface profile migrates landward. This process is designated as *passive erosion* and has been well documented along many different shorelines (Griggs, 2005). Passive erosion takes place regardless of the type of protective structure emplaced. This process is perhaps the most significant long-term effect of shoreline armoring.
