Monitoring of downstream passage of small fish at the TUM-Hydro Shaft Power Plant Prototype

Test report no. 429

Client: Bavarian Environment Agency (LfU)
86177 Augsburg

Obernach, June 2016

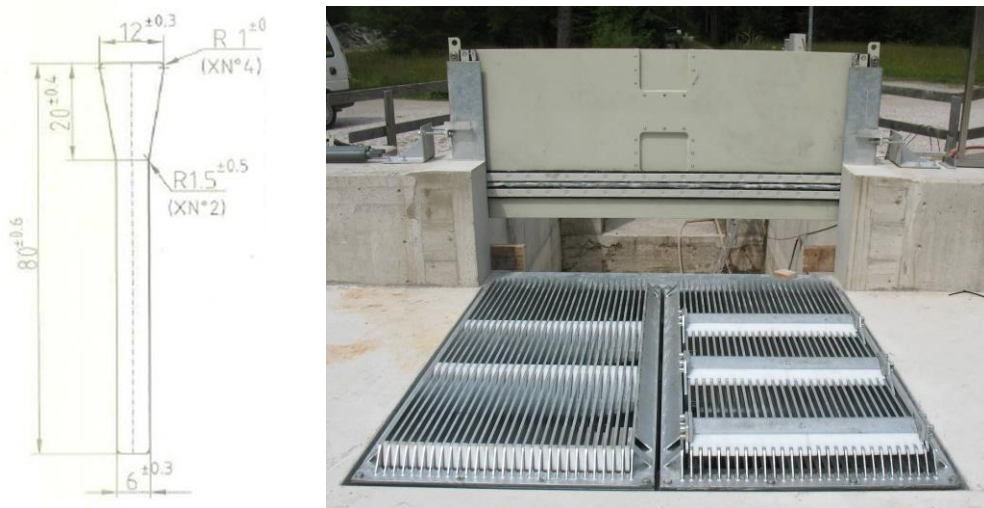
Figure 3: Bar profile and sizes [mm] (left) and screen + sluice gate seen from the head water (right) - gate raised and without the overflow profile - see Figure 4 for the overflow profile

The steel hydraulics constructions were provided by Muhr GmbH (Brannenburg, Germany). The shaft was covered by a screen with 2 m x 2 m surface which featured a special bar profile and 20 mm bar clearance. It was divided in two partitions due to the trash rack cleaning installations. This circumstance was also used to implement two different cleaning techniques for simultaneous testing. A sluice gate completed the installation. It was equipped with a smoothly formed overflow profile in order to avoid fish damage. Figure 3 shows the steel hydraulic constructions and the employed bar

profile. Several details of the steel hydraulics construction became of special interest during the research campaign as will be discussed later on (chapter 3.1.3).

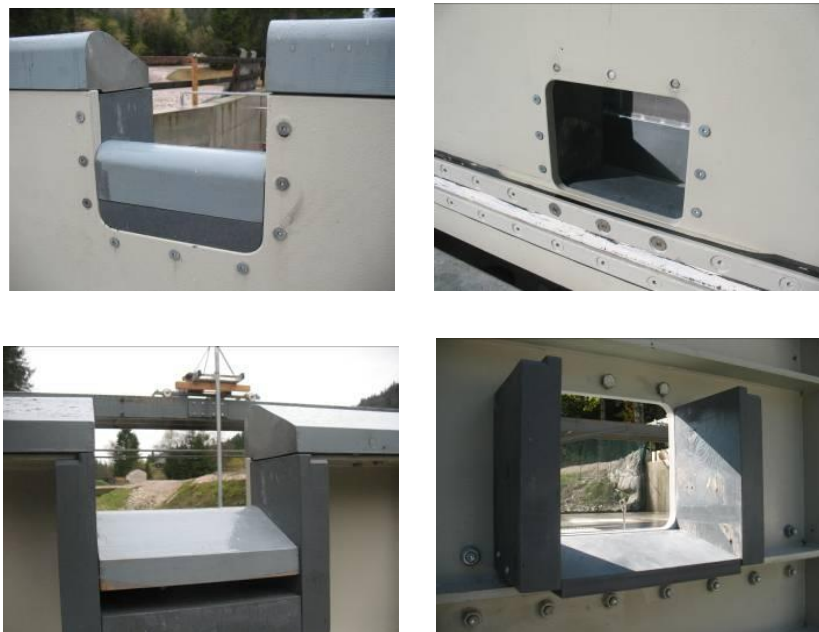
Figure 4: Fish downstream migration opening variants: Surface near (left column) and bottom near (right column) positioning seen from the head water (top row) and from the tail water (bottom row)

To provide a migration corridor from the intake area to the tail water, the sluice gate was equipped with a surface near and a bottom near opening which could be employed optionally. Each one resulted in a flow cross section of 30 cm width and 25 cm height. Details were formed to prevent fish damage during the passage. Figure 4 shows both arrangements.

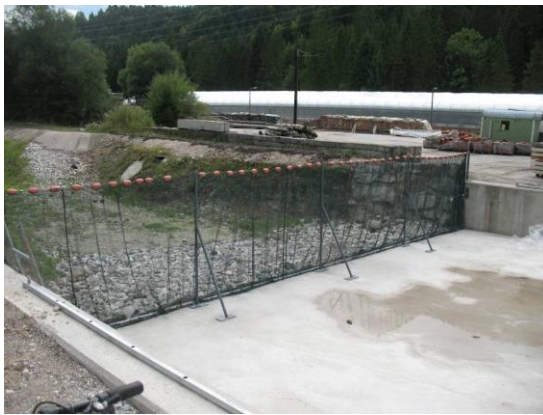
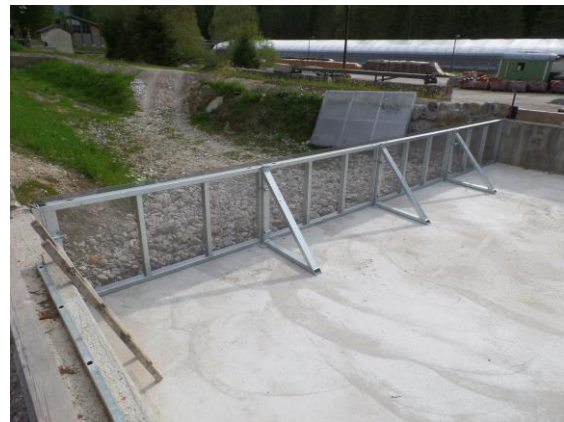
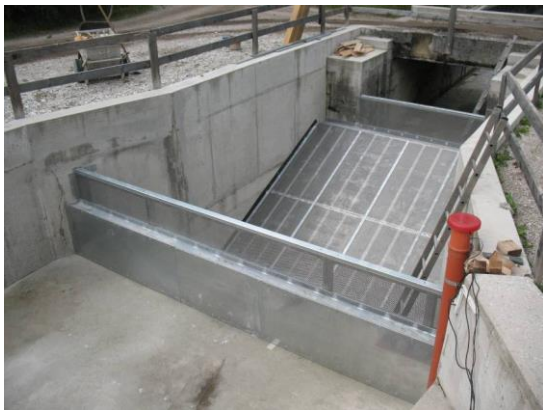
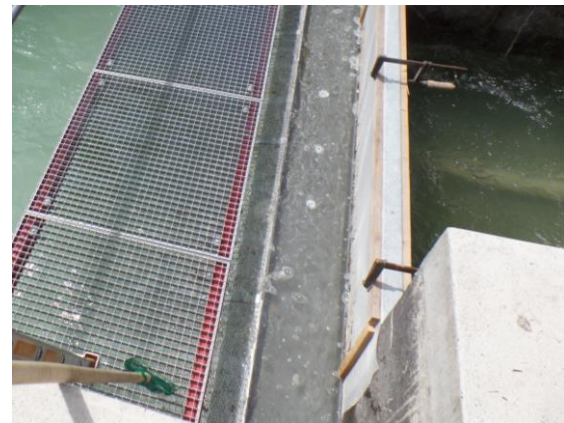
Figure 5: Fish barriers in the test setup: Schematic diagram (top – fish barriers represented as red lines), net installation upstream the test section in 2013 (middle – left) and the corresponding fish barrier in 2014 (middle – right), arrangement of metal plates in the tail water area (bottom – left) and the fish retrieval flume at its downstream end (bottom – right); Flow direction from the left to the right

A number of “fish barriers” were added to the hydro power setup in order to facilitate the fish passage experiments. To prevent fish from leaving the test section and also to avoid fish from the river system to enter the area, the test facility was sealed of the surrounding channel system. At the upstream end of the concrete head water floor a net with 6 mm mesh size was employed in 2013. It was replaced by a vertical plane of perforated metal plates in 2014. The resulting head water area was 7.5 m long and 10.1 m wide with 0.9 m water depth. Since floating debris from the river could block the flow cross section, all relevant material was extracted from the water in a station upstream of the flume gauge by cleanable screens and perforated metal plates.

Downstream the draft tube a sloped plane of perforated metal plates was installed. The upper end was slightly under the tail water surface and joined a small flume which served to retrieve the fish. A vertical plane of perforated metal plates joined the flume at the downstream direction to avoid any passage to the channel system. The sloped arrangement of the plates yielded a hazard-free guidance of the fish towards the flume near the surface. Both, vivid and dead fish could easily be extracted in the flume. Consequently, all observed injuries and death downstream the draft tube could be attributed to the screen and turbine passage.

To distinguish whether fish migrated through the screen and the turbine or via the bypass, an additional plane of perforated metal plates was installed in the cross section of the draft tube outlet. It was combined with metal plates which ensured a water cushion downstream of the migration corridor of at least 80 cm to prevent fish injury during bypass passage. It should be noted that any fish upstream migration via the opening in the gate or the turbine could be excluded as the flow velocities in these areas exceeded the swimming capacity of the fish. No upstream migration corridor was included in the test setup. Thus, the three installed fish barriers divided the test section in three areas and enabled the record of all fish downstream passages. Figure 5 illustrates the partitioning of the test setup.

The employed perforated metal plates featured stainless steel RV 10 – 14 specifications, i.e. 10 mm hole diameter. For tests with fish length smaller than 10 cm in 2014 the perforated metal plates were furthermore covered by synthetic mesh with 4 mm opening size. The construction of the fish barriers in head and tail water included a number of details to prevent any loop holes or hazard for the fish and to facilitate careful and effective fishing.

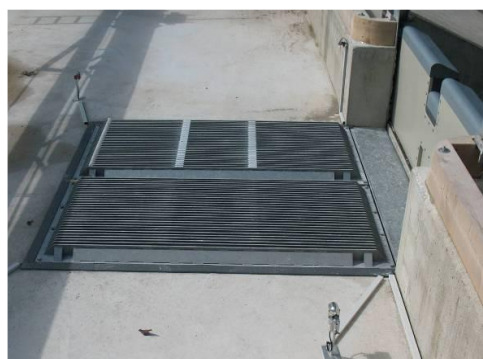
Figure 7: The employed screen as seen from the right bay

In addition to the actual fish behavioral studies a number of flow velocity measurements were conducted to verify the maximum velocities at the screen as well as the flow field distribution. The measurements were done with a 3D Nortek Field ADV probe. The measurement grid had a lateral resolution of 39 cm in both directions. It covered the whole intake plane and was positioned 4.6 cm above the screen surface. At each point the velocity for all three dimensions was recorded for at least 60 s and the time averaged velocities were calculated. The analysis of the results revealed a remarkable influence of the trash rack cleaning devices. The movable combs of the trash rack cleaner resulted in a local reduction of the flow cross section and an inhomogeneous flow field. Consequently the maximum approach flow velocities towards the screen were higher than scheduled. The trash rack cleaner combs on the orographic right field were dismantled for the fish experiments to reduce their influence as far as possible. Figure 7 provides an image of the employed screen with cleaner combs only installed in the orographic left field of the screen plane. These could not be removed due to statically reasons.

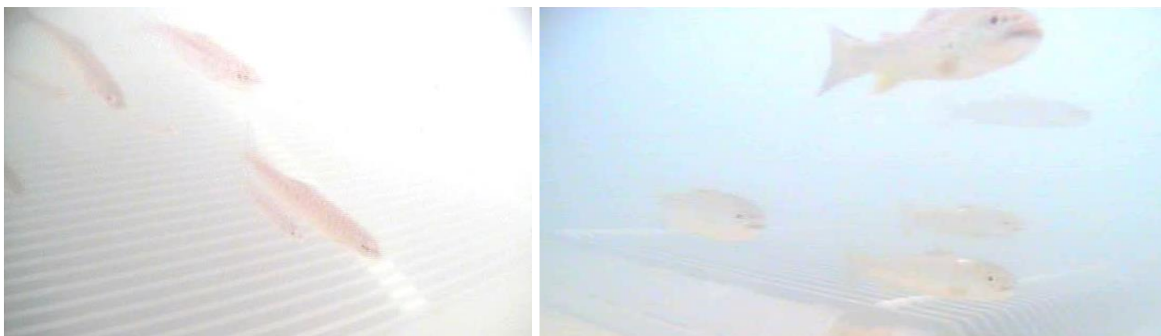
Figure 10: Grayling with about 11 cm body length (left image) and brown trout with about 18 cm body length (right image) above the screen

The visual observation of the fish behaviour was hindered by the high water turbidity during almost all tests (c.f. Table 6). Only for some tests fish movement was visible from the outside or by the underwater video devices. The recorded material did not include sequences of fish in contact with the screen and can thus not clarify the screen passage process and potential damage due to the passage through the screen. Figure 10 shows examples of the video documentation.

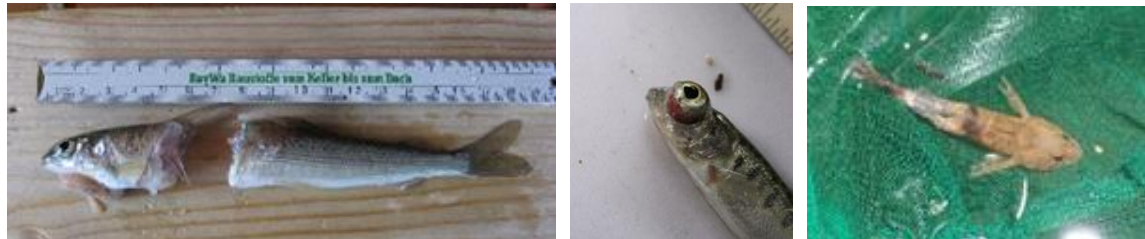
Figure 11: Typical damage schemes: Grayling with transection (left), grayling with eye damage (middle) and bullhead with injured back (right)

All investigated species and all employed size categories were concerned by mortality due to turbine passage. The injury and mortality rates depended on the underlying fish and facility specifications. The obtained values are summarized in chapter 3.1.4. Details with regard to the fish lengths and a discussion of the results are provided in chapter 3.3. The majority of the injured or killed fish showed mechanical damage (29 individuals) and mostly severe mechanical injury (runner blade strikes with

serious cutting wounds) with instant loss of life (19 individuals). Furthermore, a number of eye damage was observed (10 individuals). Figure 11 shows typical damage schemes.

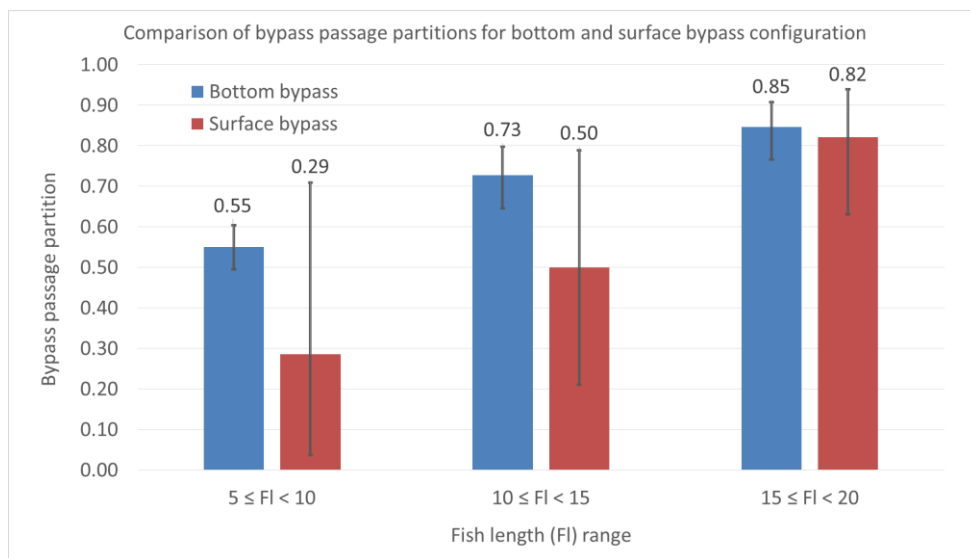
Figure 17: Comparison of the bypass passage partitions for bottom and surface bypass in dependency of the intended fish size categories, including 95 % confidence intervals

The possibility of controlled and flexible laboratory conditions at the test site was used for the competitive testing of surface near and bottom near bypass positions. A generalized comparison of both bypass variants is provided in Figure 17 which features pooled data with regard to fish species and approach flow velocities. The bypass passage partitions for the bottom near arrangement were higher for each of the intended fish length categories.

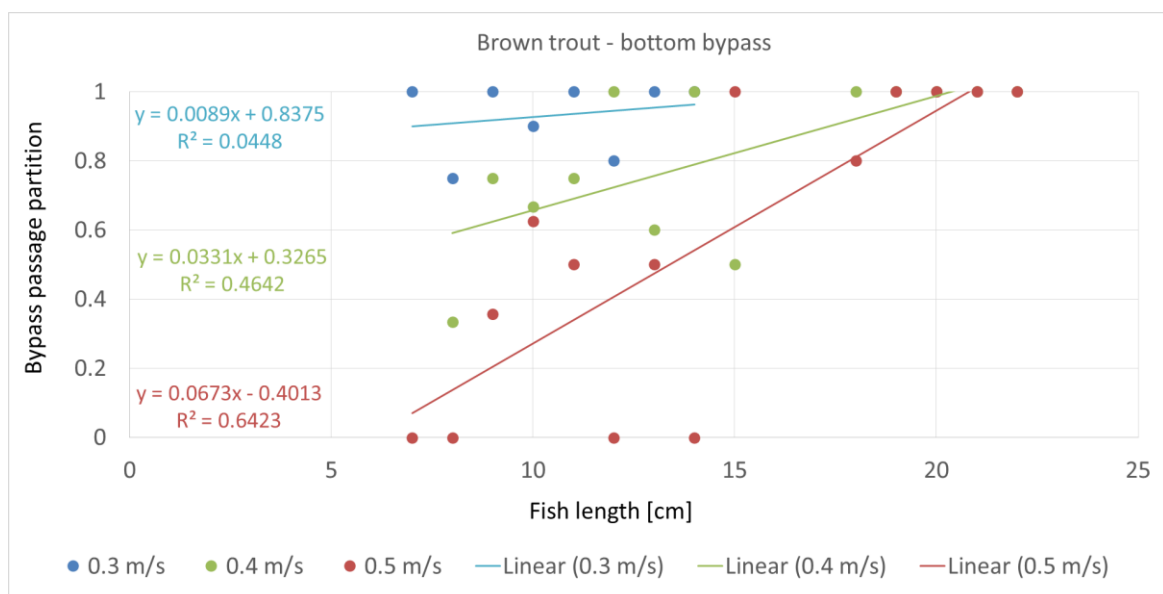
Figure 20: Bypass passage partitions in dependency of the fish length and the approach flow velocity for the brown trout and the bottom near bypass configuration

To further analyse the species specific behaviour of brown trout and grayling, the approach flow velocity was taken into account. Figure 20 and Figure 21 show the relations between the facility and fish specifications on the one hand side and the resulting bypass passage on the other hand side for both species. Only data for the bottom bypass configuration was considered in order to avoid an influence of data pooling. The bypass passage partitions for each approach flow velocity were differentiated with cm-resolution of the fish length. For the assessment of the parameter influence a first order approximation by fitted linear functions was included. It has to be acknowledged, that this approach serves merely to illustrate basic trends. The linear approach is not suitable for comprehensive modelling of the actual fish behavior. A respective statistical modelling of the obtained data was beyond the scope of the project. The uncertainty of the deduced functions is documented by the respective coefficients of determination.

For the brown trout the offset of the linear functions is strictly monotonic decreasing and the inclination is strictly monotonic increasing with inclining approach flow velocity. The crossing point of the functions is above a fish length of 20 cm. Hence, the bypass passage incidence is increasing with increasing fish length and with decreasing approach flow velocity. The dependency of the bypass passage incidence on the fish length is more developed for higher approach flow velocities. These results show a well comprehensible systematic.

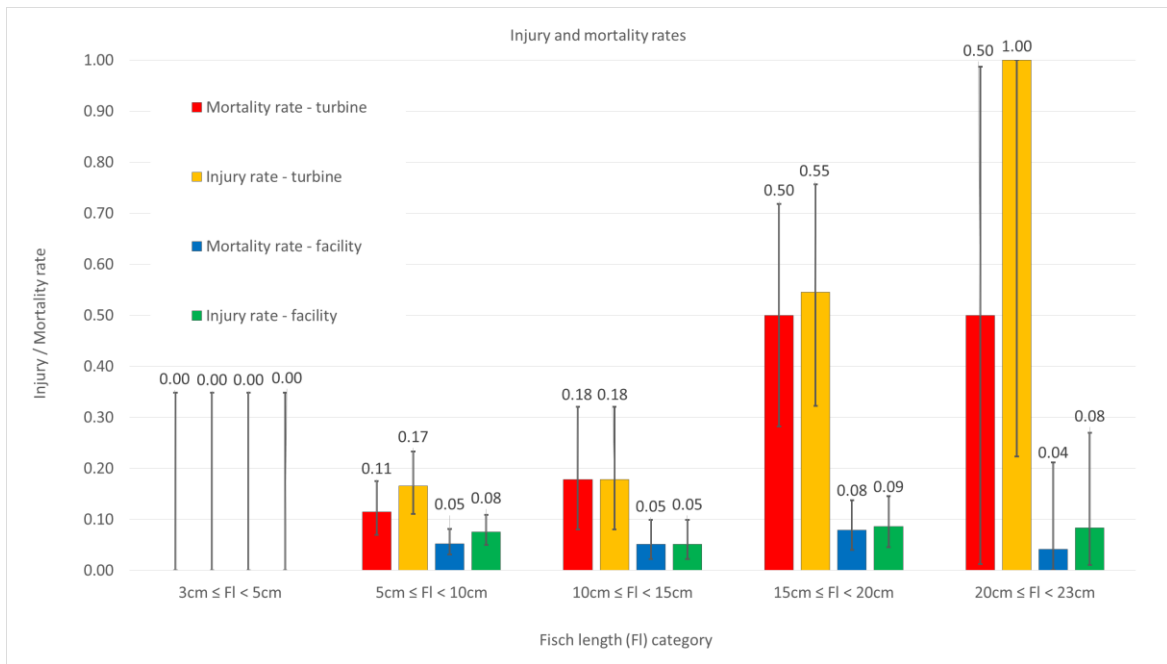
Figure 23: Injury and mortality rates with regard to the fish length categories, including 95 % confidence intervals

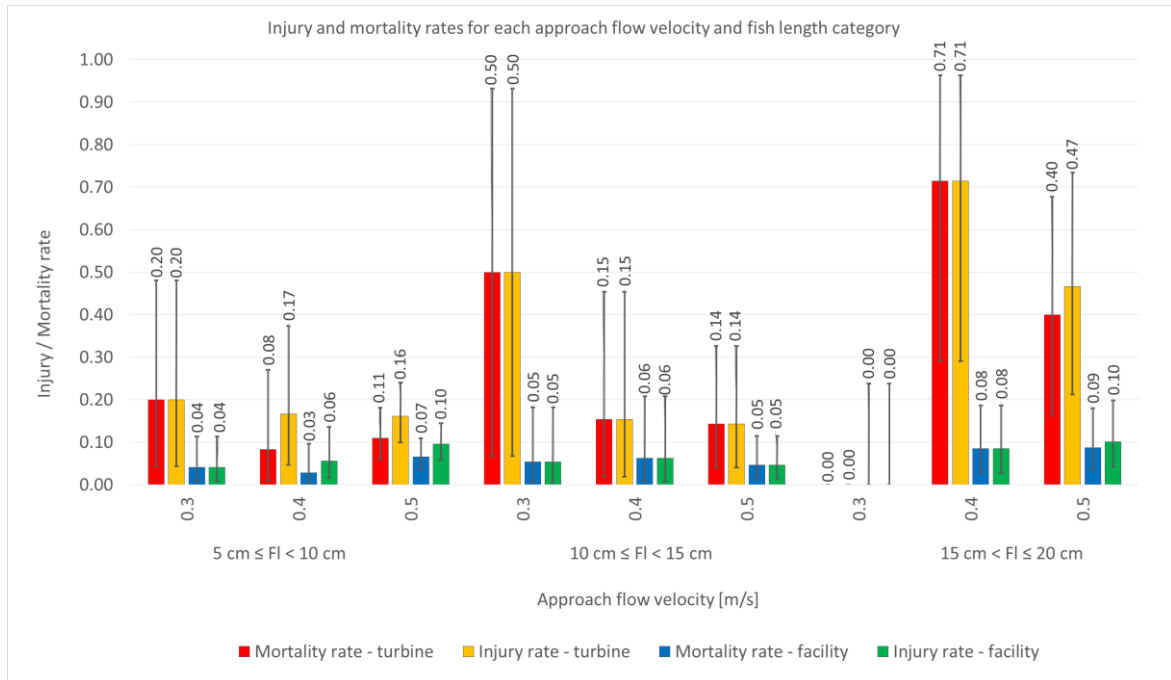
Figure 25: Injury and mortality rates with regard to turbine and facility passage for different approach flow velocities and fish length ranges, including 95 % confidence intervals

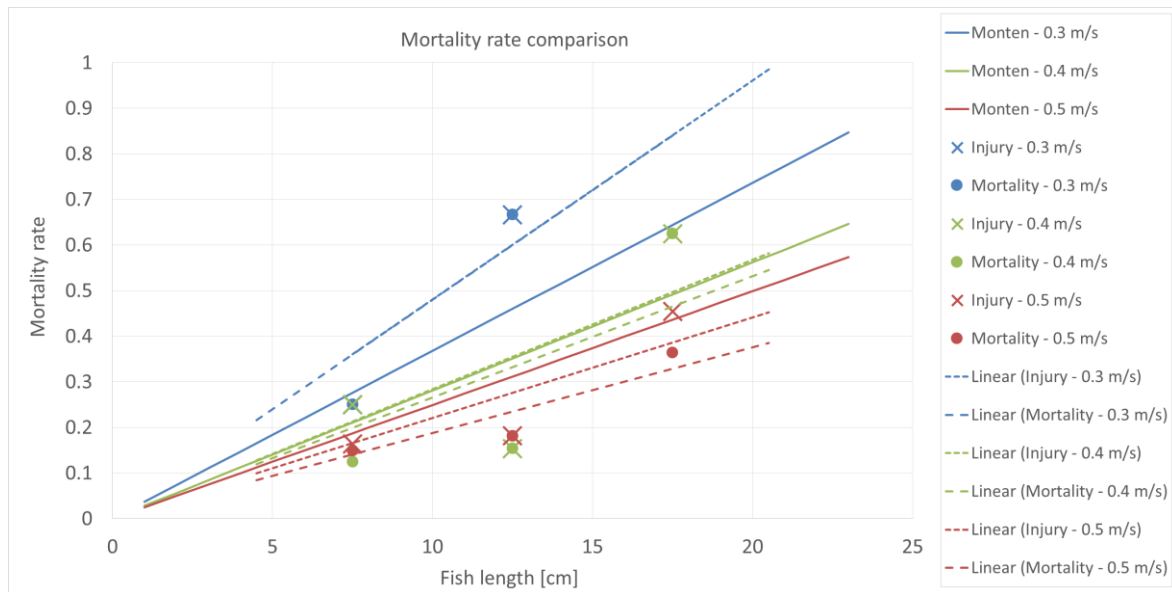
Figure 27: Calculated mortality rates and observed injury and mortality for brown trout and grayling – with velocity differentiation

It should be acknowledged that the presentation in Figure 27 does not account for the underlying case numbers of each data point. A comprehensive analysis (which would also include the actual fish length) was beyond the scope of the project but might be accomplished in ensuing research. The present analysis shows that the obtained data is coherent with literature references concerning the basic relations between mortality and fish length as well as between mortality and turbine discharge. The magnitude of the observed mortality (respective injury) rates with regard to turbine passage is in the range of the model predictions for the given facility specifications.
