Minute 319
Colorado River
Limitrophe and Delta
Environmental Flows
Monitoring
Interim Report
May 19, 2016

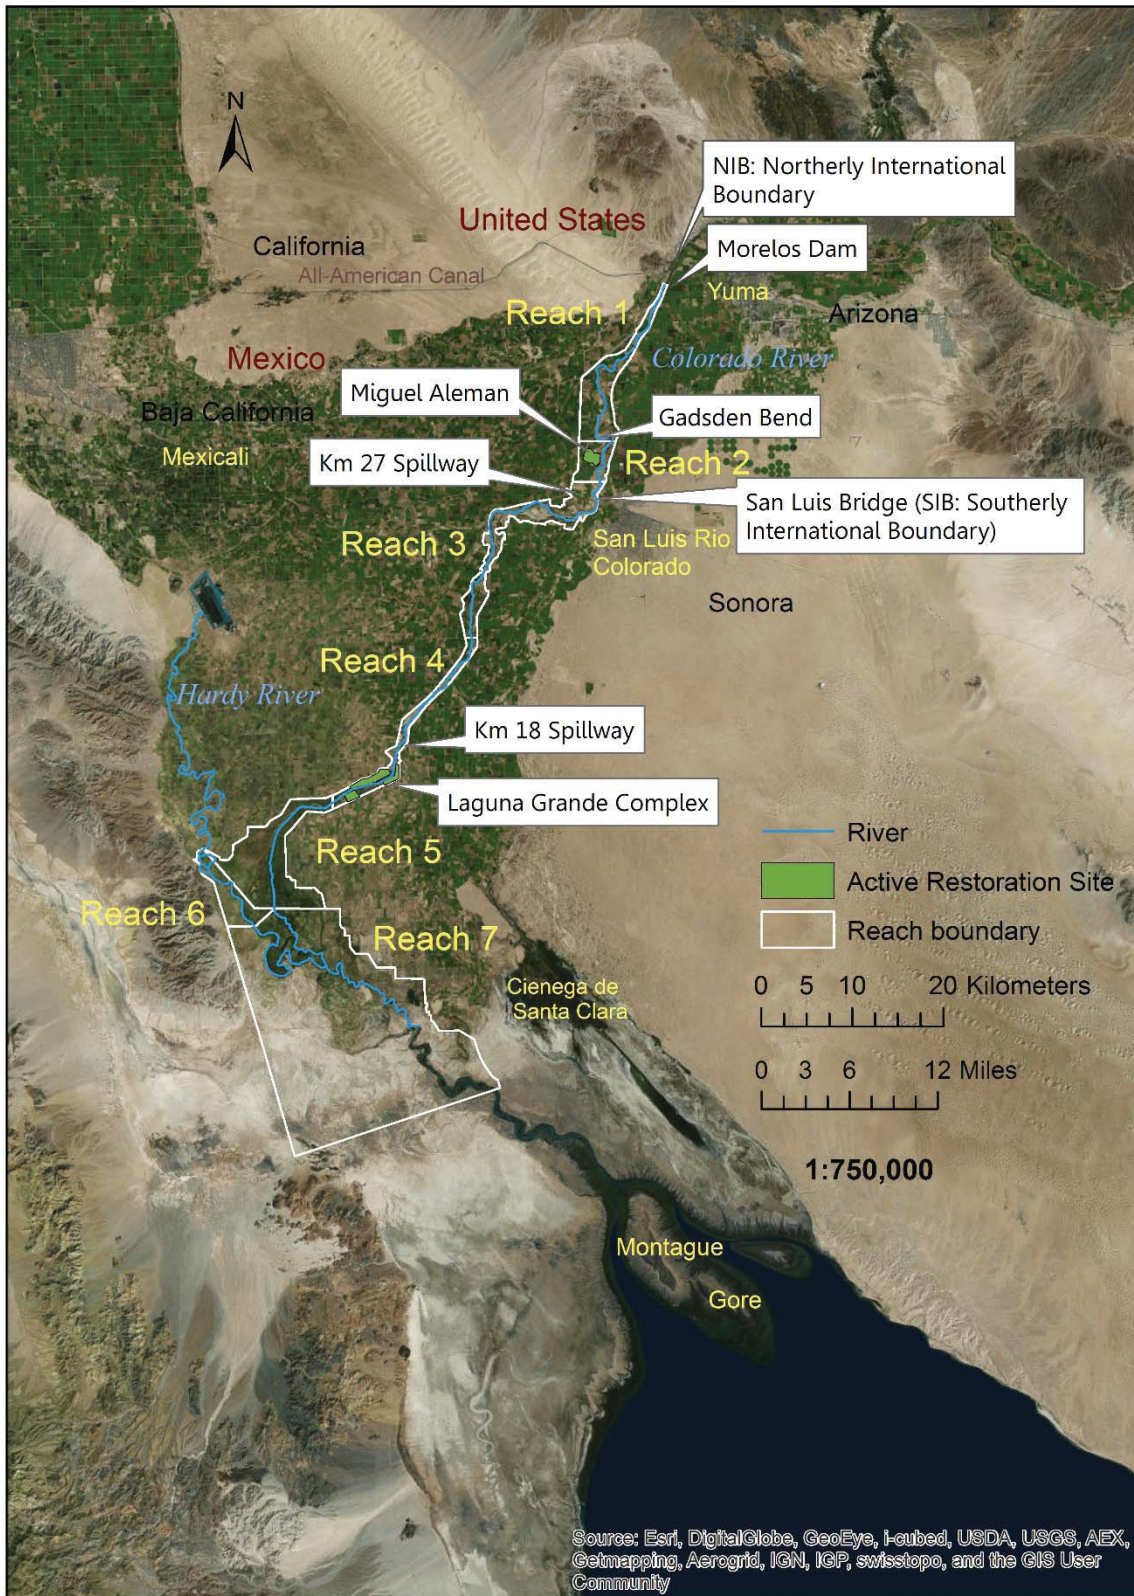
Figure 1-1. Colorado River delta study reaches for Minute 319 monitoring activities.

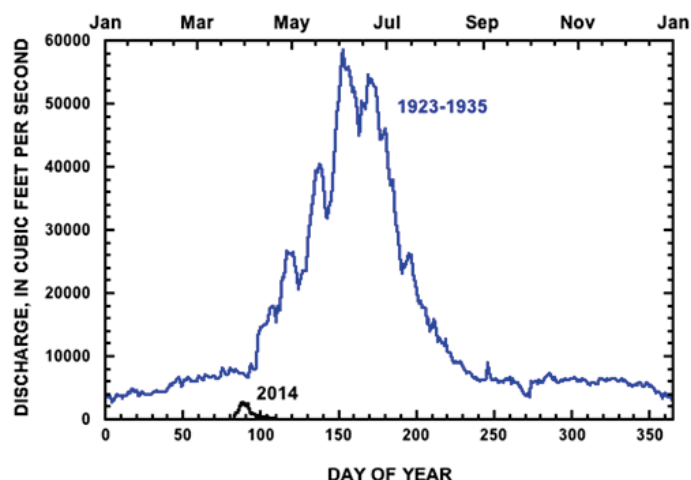
Figure 2-1. Comparison of the 2014 pulse flow hydrograph (black line) and the median hydrograph of Colorado River discharge in the delta prior to completion of Hoover Dam (blue line, 1923-1935) (Schmidt 2014).

This condition has existed essentially since Lake Powell began filling in 1963, with notable exceptions during isolated wet years when flood waters released from Morelos Dam flowed to the Gulf (Glenn et al., 1996). For example, in January 1993, January 1997, and January 2001, an estimated 92, 88, and 147 million cubic meters (Mm³) (75,000, 71,000 and 119,000 acre-feet (af)), respectively, flowed past SIB, the most reliable historical measurement site¹. By comparison, 59 Mm³ (48,000 af) flowed past SIB during the 2014 pulse flow. Figure 2-1 compares the 2014 pulse flow to the median hydrograph prior to completion of Hoover Dam.

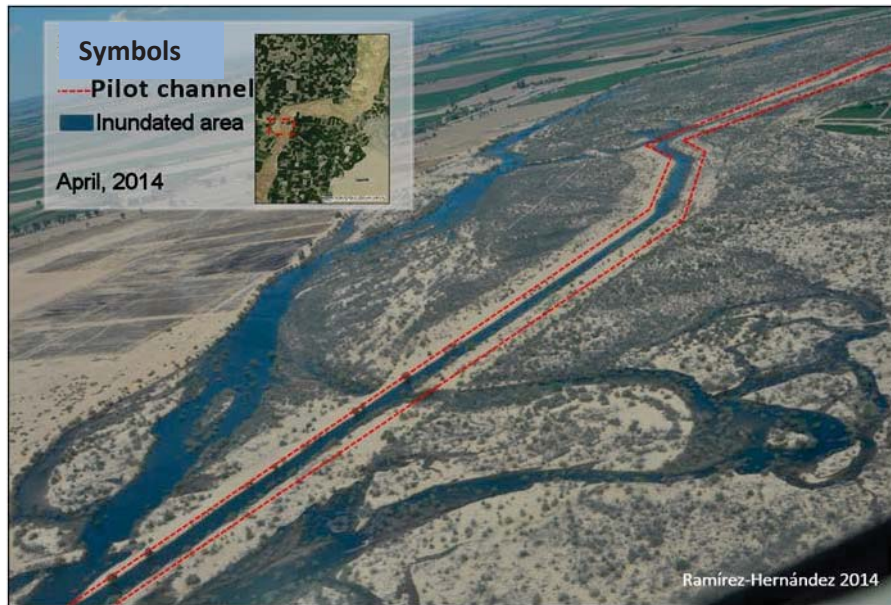
Figure 2-5. Oblique aerial view of a typical portion of Sector 4 during the pulse flow, showing the extent of inundation of the pilot channel and off-channel depressions.

Off-channel infiltration volumes and rates were particularly high in Sectors 4 and 5 (Table 2-2). An aerial view of Sector 4 during the pulse flow (Figure 2-5) illustrates the extent of inundation of off-channel depressions. As the peak flow receded, the depressions became isolated from the main channel, allowing the remaining water to infiltrate and evaporate (Figure 2-6, bottom). Inundated areas in other Sectors generally remained connected to the main channel, allowing water to continue flowing downstream (Figure 2-6, top).

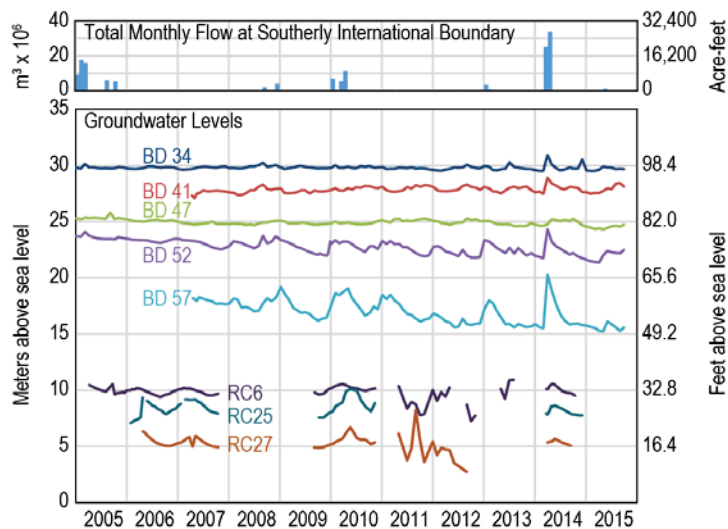
Figure 3-2. Groundwater elevations along the river corridor juxtaposed to monthly flow at Southerly International Boundary (SIB), 2005-2015. For piezometer locations, please see Appendices A and C

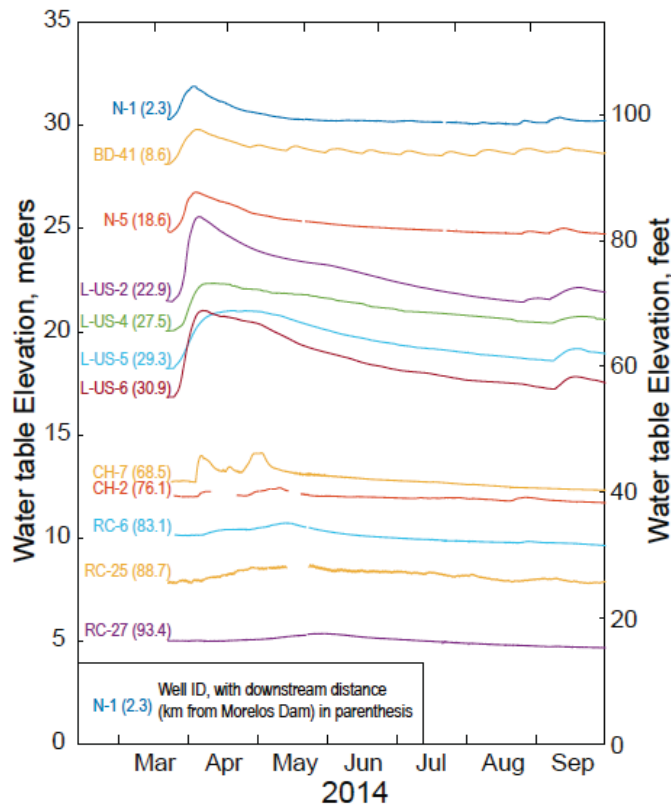
Figure 3-3. Hydrographs recorded at representative piezometers along the river corridor, showing how the pulse flow response varied downstream and attenuated with time. River kilometers from Morelos Dam to each piezometer are shown in parentheses.

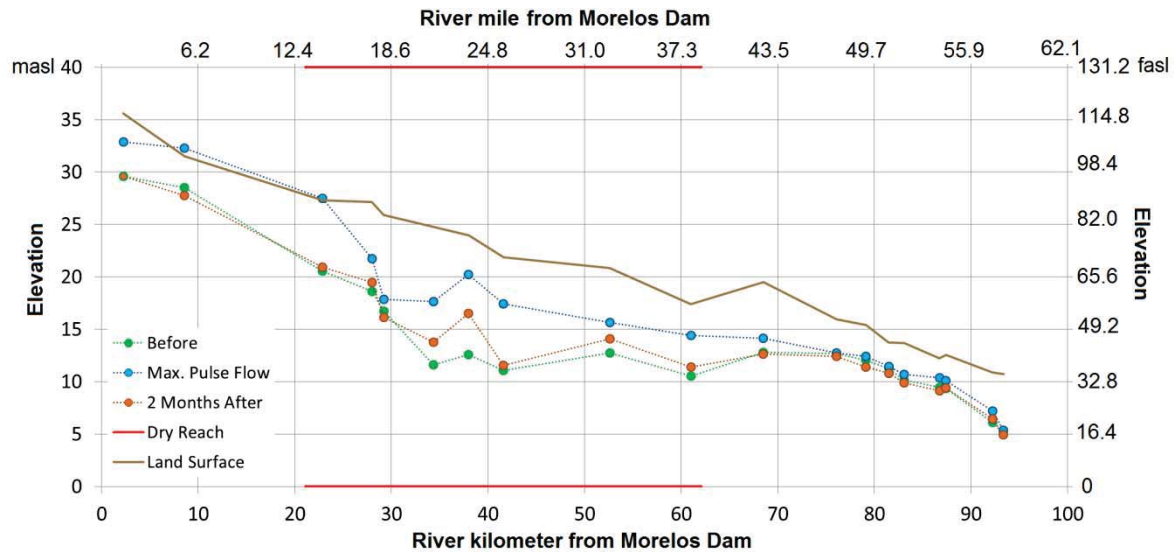
Figure 3-4. Groundwater level changes along the river corridor, showing groundwater elevations relative to the floodplain surface (at piezometer locations) before (March 2014), during, and two months after the pulse flow peak passed each location.

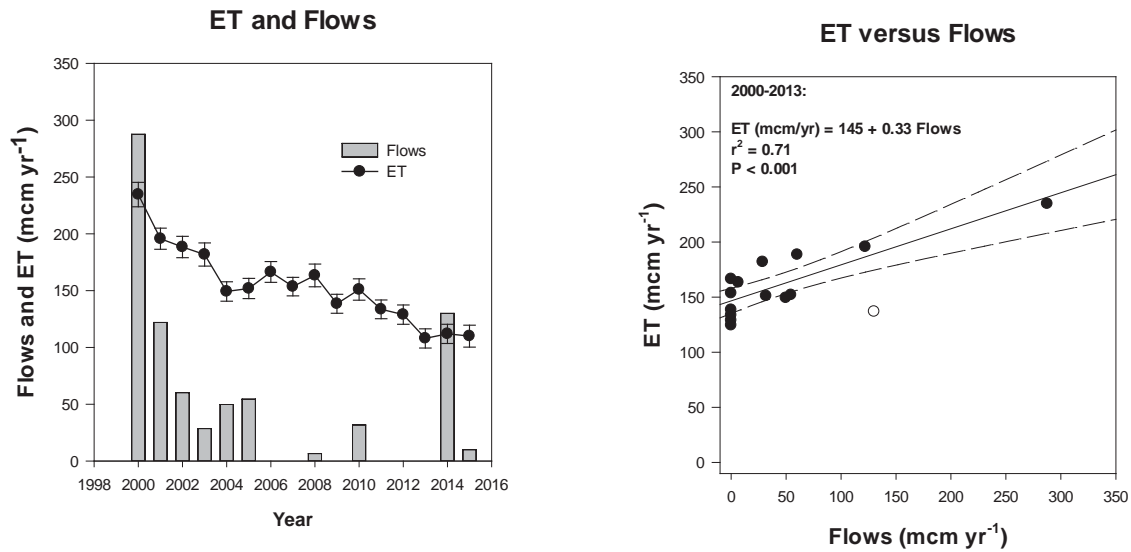
Figure 3-6. Left: Annual ET from the riparian corridor and surface flows at SIB, 2000-2015. Right: regression of ET against surface flows, 2000-2013. The 2014 ET (open circle) fell outside the 95% confidence interval of the regression (dashed line) and was omitted from the analysis.

As mentioned previously, annual ET from groundwater generally has been decreasing since 2000. In 2014, this trend temporarily reversed, perhaps in response to the pulse flow (figure 3-6, left). The 2014 pulse flow did not increase ET to the magnitude predicted by the regression equation in Figure 3-6 (right), perhaps due to the deteriorated condition of the vegetation. The 2015 response likely reflects greenness of existing vegetation; newly germinated vegetation would have been too small in 2015 to be

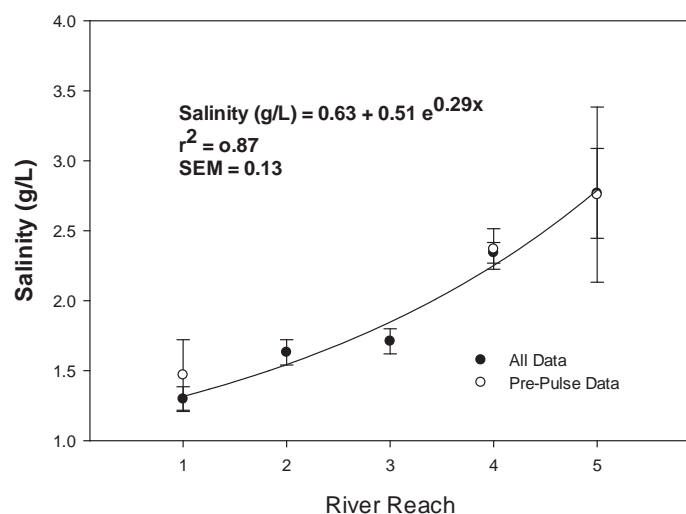
Figure 3-7. Groundwater salinity measured in 69 piezometers along the riparian corridor from March to May 2014, measured as specific conductance (dS/m) and converted to salinity (g/L) using a factor of 0.62 (based on groundwater analyses reported in Dickenson et al. 2006). Vigorous growth of cottonwood and willow trees requires a salinity concentration of less than 2.5 g/L (4 dS/m), although the trees can tolerate up to 5 g/L (8 dS/m) (Shafroth et al., 2008; Glenn et al., 1998).

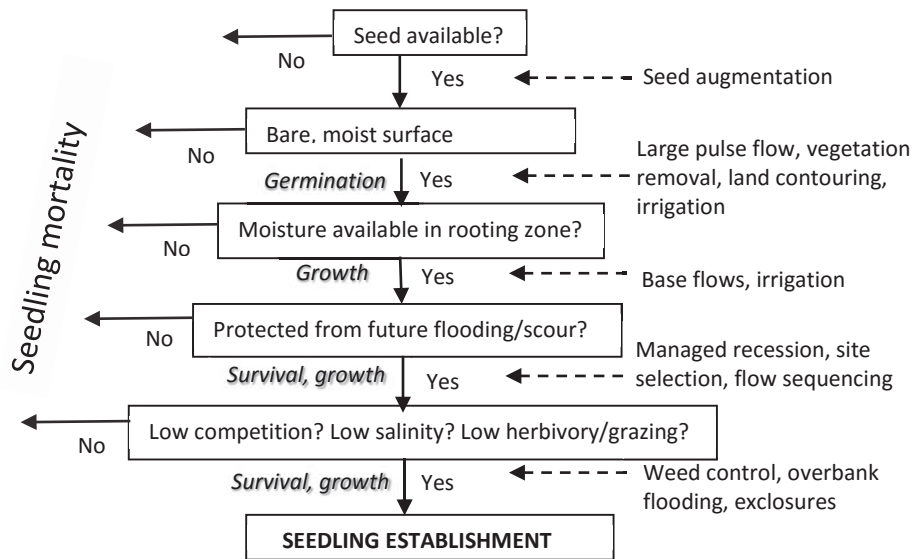
Figure 5-1. Key requirements for germination and establishment of pioneer riparian trees and shrubs. Requirements are described inside the boxes in the form of questions and are presented sequentially. If a requirement is met (“yes”), then germination, survival, or growth occurs and the next requirement is examined (downward facing arrows). If a requirement is not met (“no”), then seedling mortality is likely (solid arrows facing left). Management actions are indicated on the right side of the figure, with dashed arrows pointing to the condition or requirement addressed by the management action.

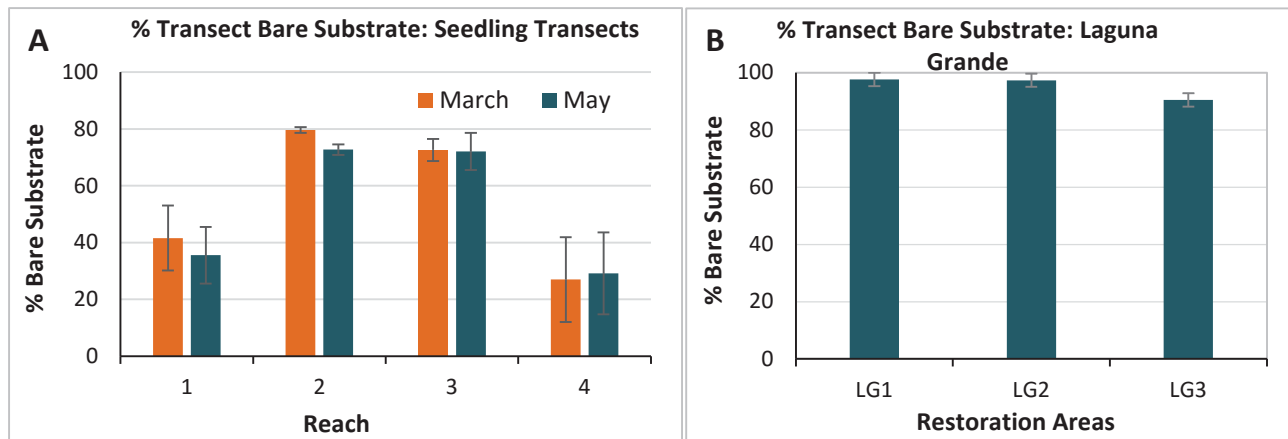
Figure 5-3 A. Average percent of transect with bare soil before (March) and after (May) the 2014 pulse flow along the unprepared seedling transect sites. **B.** Average percent of transect with bare soil cover in prepared sites (extracted from May 2015 data, and assumed to be representative of bare soil cover in March 2014 after clearing).

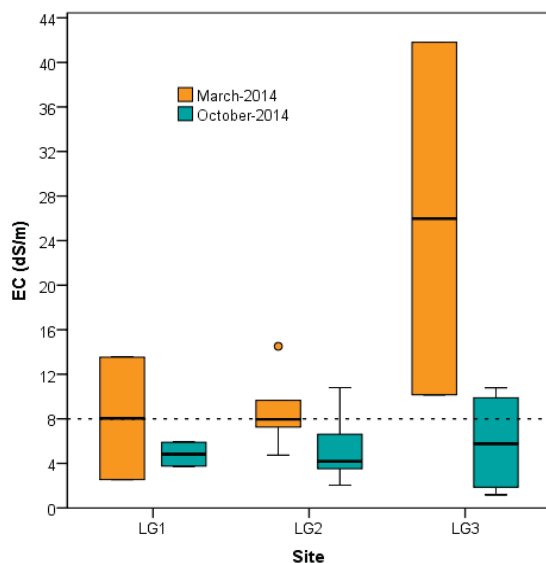
Figure 5-5. Surface soil salinity in prepared restoration areas: LG1 (Herradura), LG2 (Cori), and LG3 (CILA).

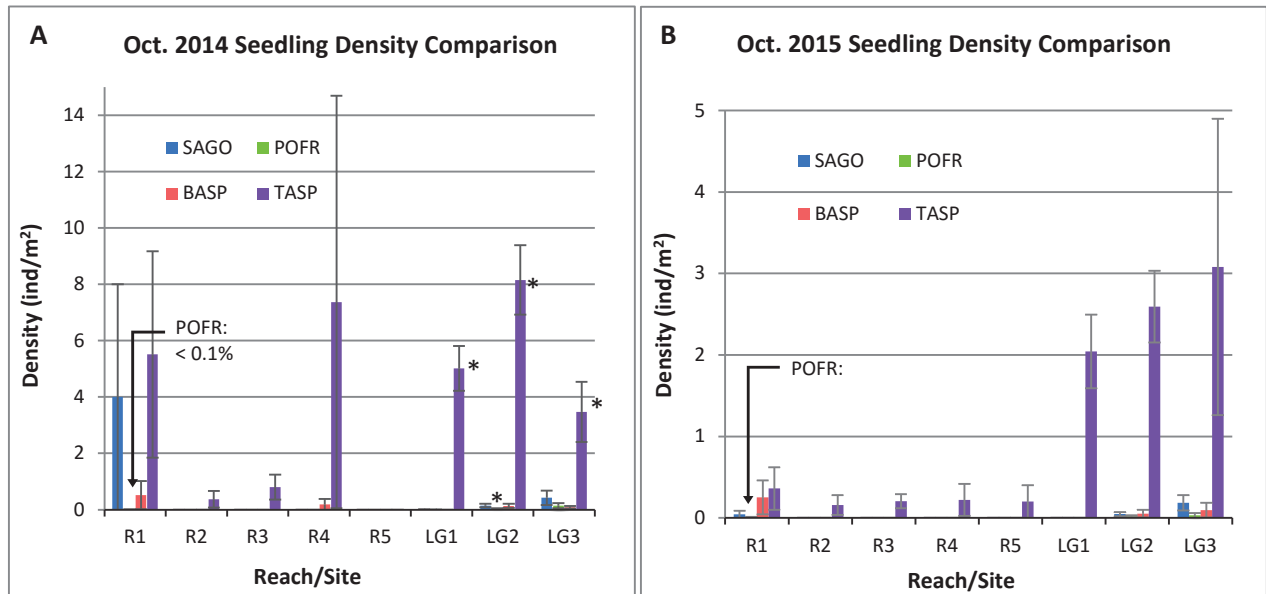
Figure 5-8a and 5-8b. Seedling density in long-term seedling plots in Reaches 1-5 and 4x5-meter plots in restoration sites LG1-3 in October 2014 (left) and 2015 (right). POFR = cottonwood (*Populus fremontii*); SAGO = willow (*Salix gooddingii*); TASP = tamarisk (*Tamarix* species); BASP = baccharis (*Baccharis* species). R1-5 = Reaches 1-5. Restoration sites: LG1 = Herradura; LG2 = Cori; LG3 = CILA. Note different scale on y-axis between 2014 and 2015.

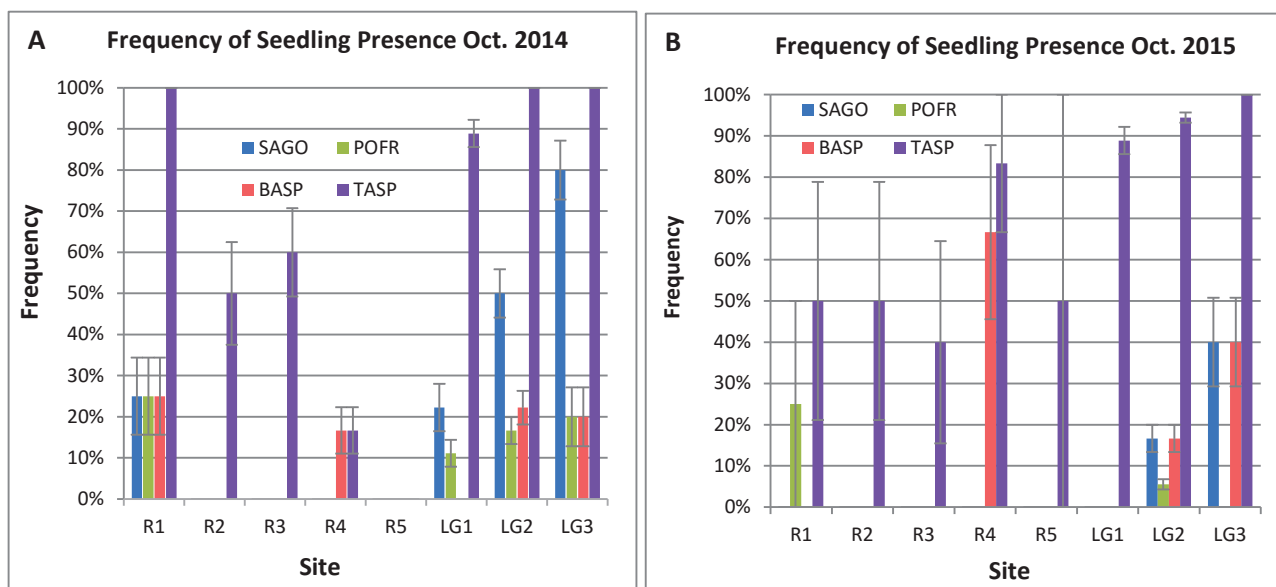
Figure 5-9a and 5-9b. Frequency of seedling occurrence in 1-meter belt transects in river reaches (R1-R5) and Laguna Grande prepared areas (LG1-LG3) in October 2014 (left) and 2015 (right). POFR = cottonwood (*Populus fremontii*); SAGO = willow (*Salix gooddingii*); TASP = tamarisk (*Tamarix* species); BASP = baccharis (*Baccharis* species). R1-5 = Reaches 1-5. Restoration sites: LG1 = Herradura; LG2 = Cori; LG3 = CILA.

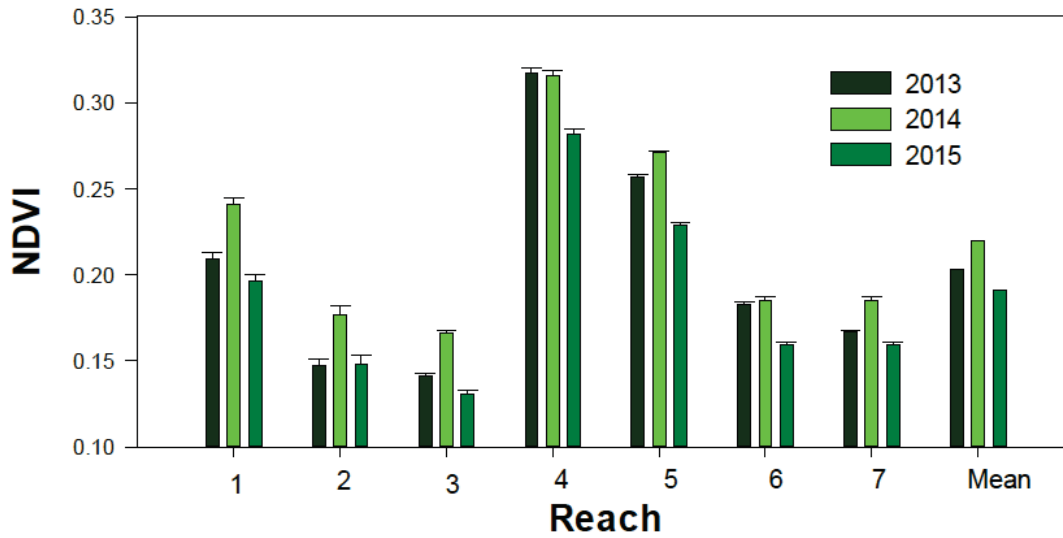
Figure 6-2a (top). NDVI in entire riparian zone, by river reach, in August of 2013, 2014, and 2015. **6-2b (bottom).** NDVI in inundation zone, by river reach, in August of 2013, 2014, and 2015.

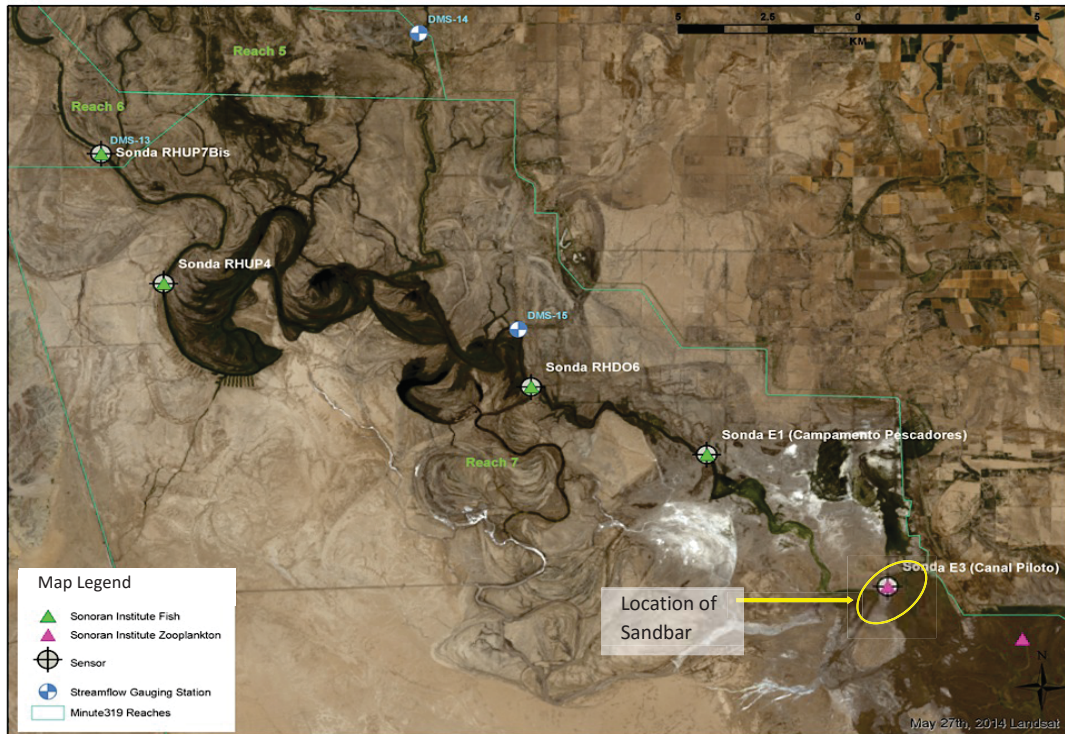
Figure 8-2. Map of Sonoran Institute monitoring locations in the lower Delta region. Green triangles: fish monitoring locations; pink triangles: zooplankton monitoring locations; sonde = sensor locations; blue and white circles: discharge monitoring stations.

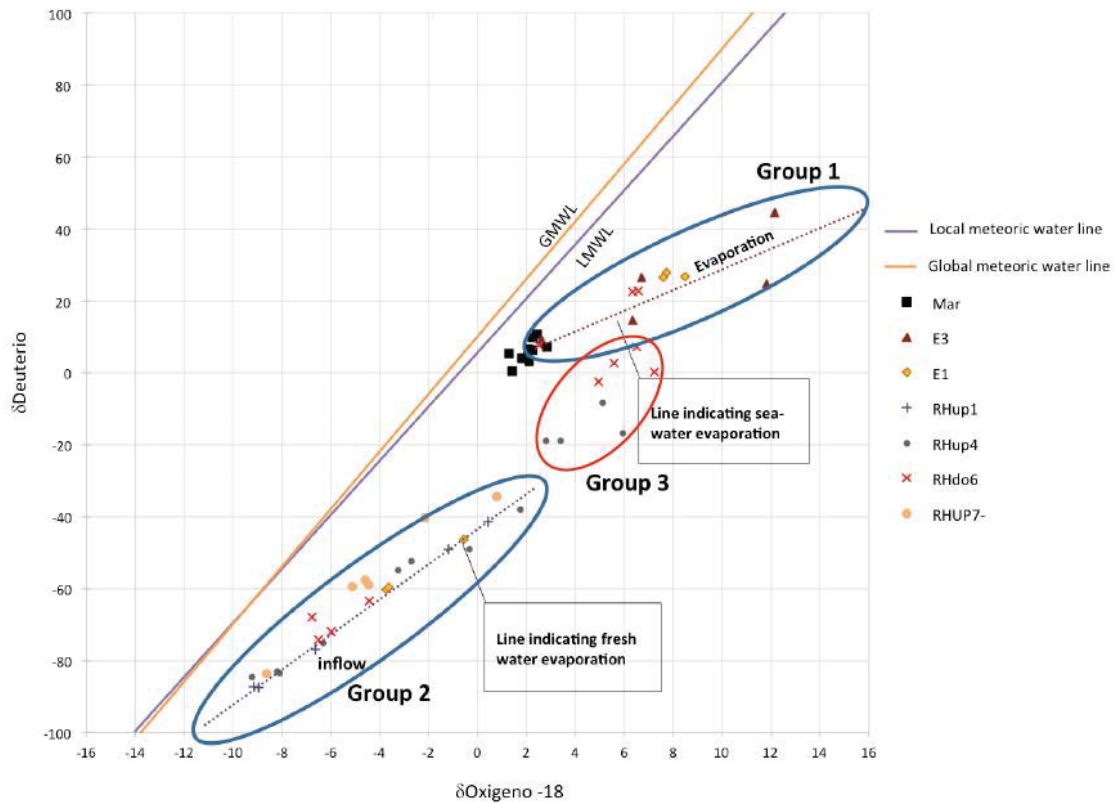
Figure 8-4. $\delta^{18}\text{O}$ and δD of water samples taken monthly in 2014 at different locations in the upper estuary and lower Hardy River. GMWL = Global Meteoric Water Line; LMWL = Local Meteoric Water Line.
