SL740-AE-RPT-010

U.S. NAVY SALVAGE REPORT USS GUARDIAN (MCM 5) REMOVAL

March 2014

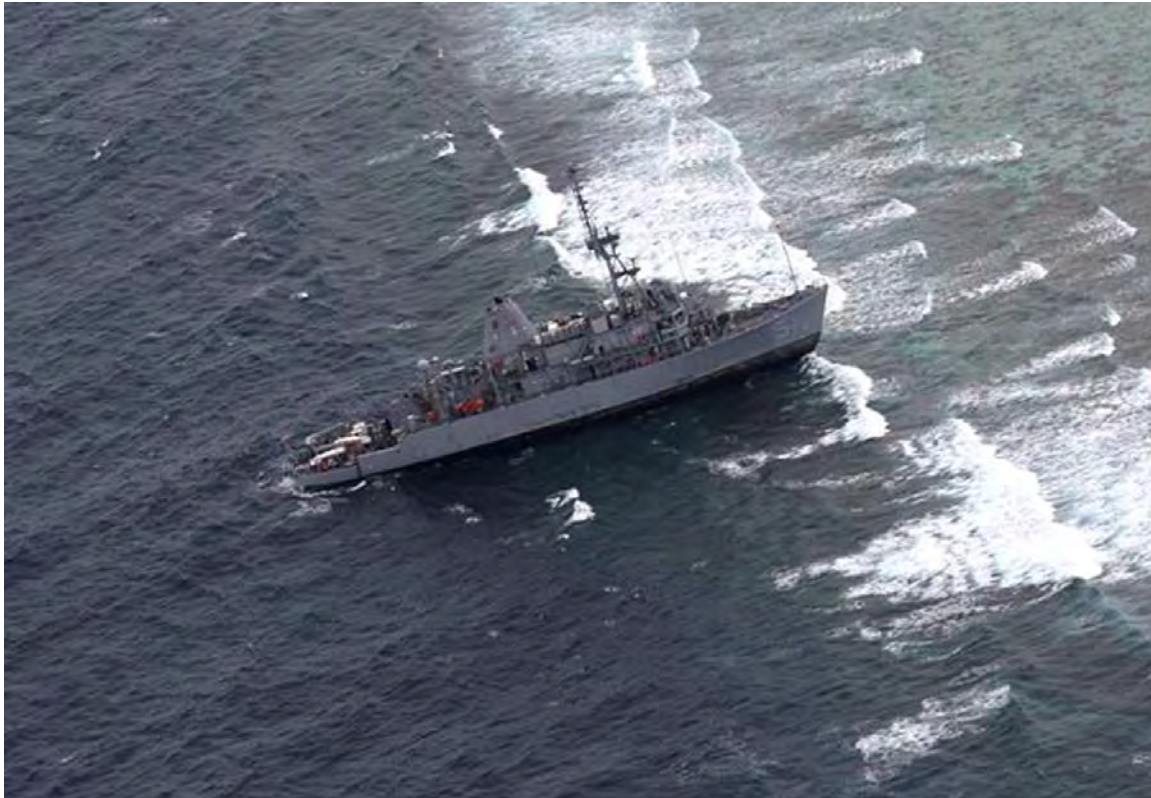
Figure 1-2. USS GUARDIAN (MCM 5) aground on Tubbataha Reef on morning of 17 January 2013.

Upon initial grounding, GUARDIAN became stranded bow on, perpendicular to the reef wall on a heading of 192° T. Figure 1-2 is an aerial view of GUARDIAN, bow on to the reef. Reports from the ship, as summarized from the DC log, indicated that Auxiliary Machinery Room

(AMR, 3-41-0-E) had suffered severe impact and a hole was noted under NR 1 Air Conditioner and flooding was estimated to be about 4 gal/min. About 5 min later a second hole was seen under NR 2 Air Conditioner (AC) with the same flooding rate. A third hole was reportedly seen in the AMR with a total flooding rate estimated to be 11 gal/min and the water level had risen to 5 feet. Additionally, the bulkhead between the AMR and Main Machinery Room (MMR, 3-63-0-E) at frame 63 was noticed to be lifting allowing free communication between the two compartments. At the forward end of the ship in the forward hold (3-1-0-V) there were no noticeable hull breaches or cracking with an initial water level of about 2 in. The forward pump room (3-28-0-E) was ordered shut by the Damage Control Assistant (DCA) despite unknown structural damage as the space was flooded to capacity. Additionally, the bow thruster (3-14-0-E) had noticeable movement from the flexing of the hull with a water level of 4 in and rising. In the after end of the ship minimal flooding was reported as water was seeping through the transom in Aft Steering (3-107-0-V). Significant structural damage was reported by the DCA on the mess decks located on the main deck above the AMR and MMR due to cracks on the bulkheads. Furthermore, the Quick Acting Watertight Hatch (QAWTH) located between engineering passageway and the crew's mess on the main deck twisted and partially jammed evident from the hatch powerfully springing open in the DCA's face.

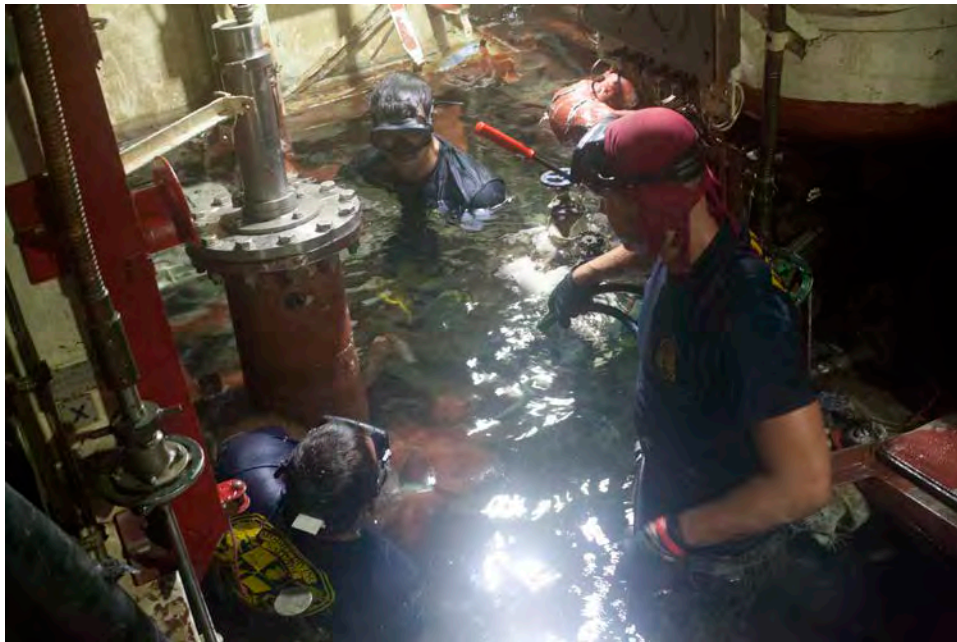
Figure 1-3. MDSU ONE divers working to remove machinery prior to hull sectioning.

Safety of personnel was considered one of the highest priority objectives of the GUARDIAN Wreck Removal operation. Every day the SITREP was issued with a reminder to all that safety of personnel was a priority. GUARDIAN's operation site was approximately 90 nm from the nearest hospital. An accident on the reef site would require extraordinary measures to safely and quickly transport a patient to that hospital so every effort was made to avoid that possibility. Conditions on GUARDIAN were treacherous and required constant vigilance. Inboard the skin of the ship was dark and required lights to be strung and portable generators for powering those lights. Heavy seas often complicated the climb aboard from small boats. The decks were slippery and often wet from sea spray. Much work had to be done in the ship's lower levels which were flooded to chest height and oil covered. Diving or snorkeling conditions were less than ideal. Figure 1-3 shows the working conditions at the base of the hull in one of GUARDIAN's machinery spaces.

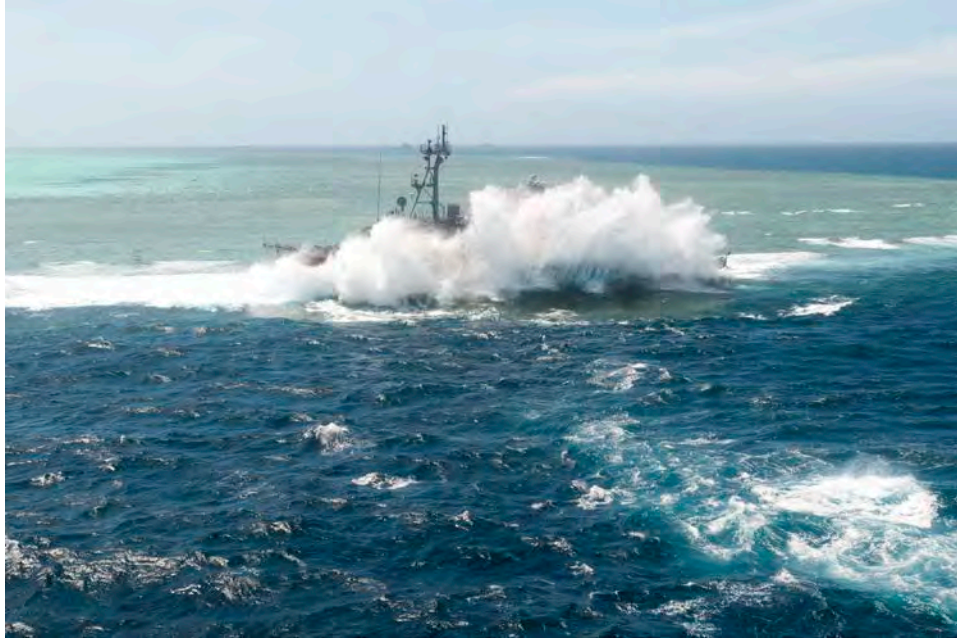
Figure 1-4. Strong wind and surf throughout the winter monsoon season at times restricted the salvors ability to access the vessel and weakened the hull's structure.

Following the initial grounding by the bow, GUARDIAN was broached broadside and pushed up onto the reef by the prevailing wave action running parallel to the atoll. During salvage, her hull's port side was buffeted by beam seas resulting in deterioration of her Glass Reinforced Plastic (GRP) and wood hull construction. Wave and wind action works to transversely rock and weaken the hull members, producing continued deterioration of the intact strength of the hull girder. Figure 1-4 is an image of waves impacting GUARDIAN on 24 February.

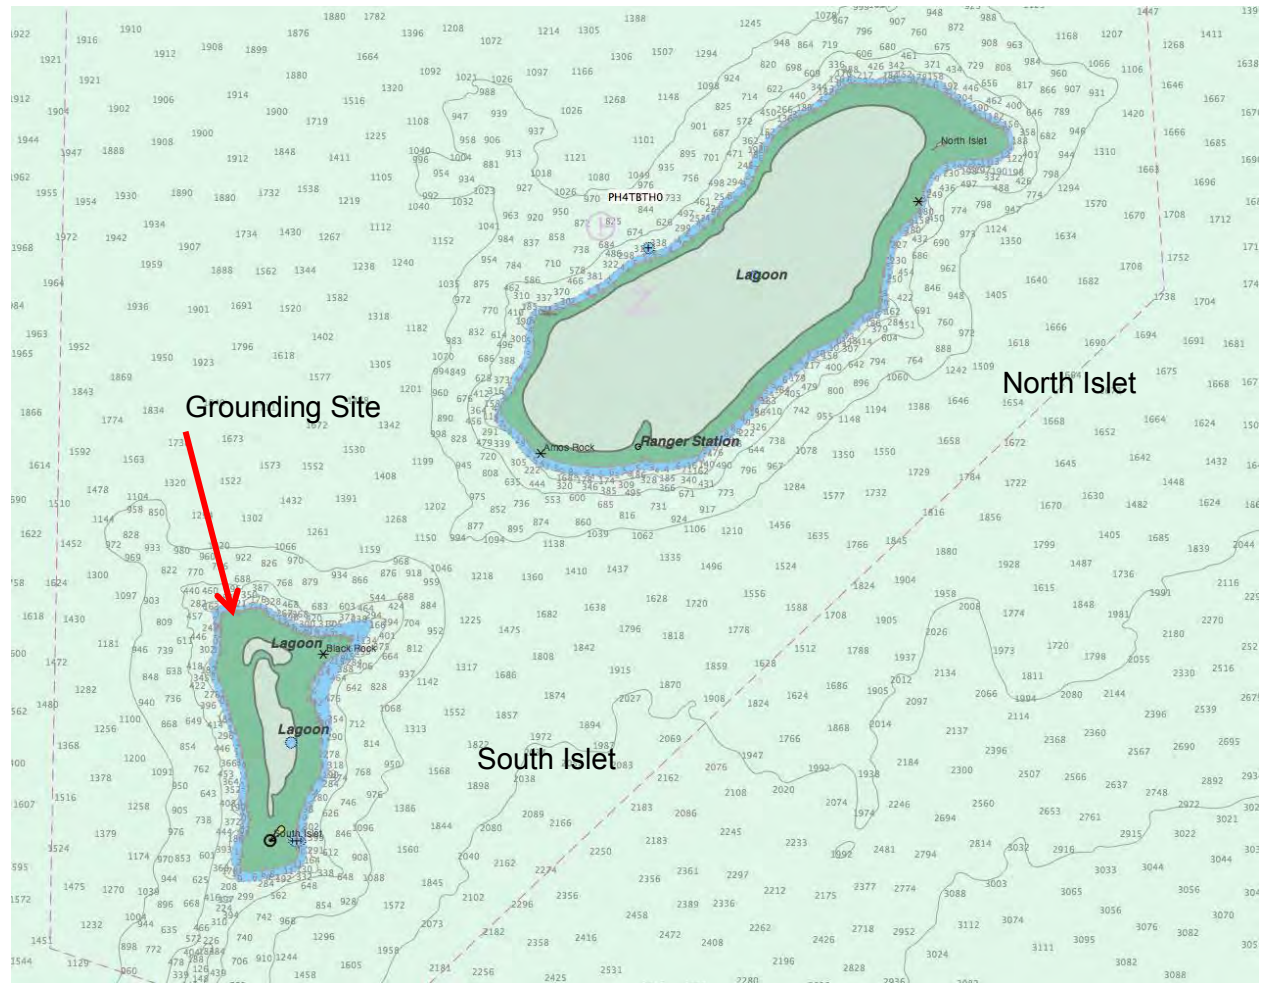
Figure 1-5: Bathymetry of Tubbataha Reefs and Grounding Site (Soundings in Meters), Courtesy NAMRIA (National Mapping and Resource Information Authority), Philippines

The Tubbataha reefs sit atop volcanic atolls and the seafloor of these seamounts rise rapidly from the surrounding Sulu Sea basin. The atolls are shown in Figure 1-5 below.

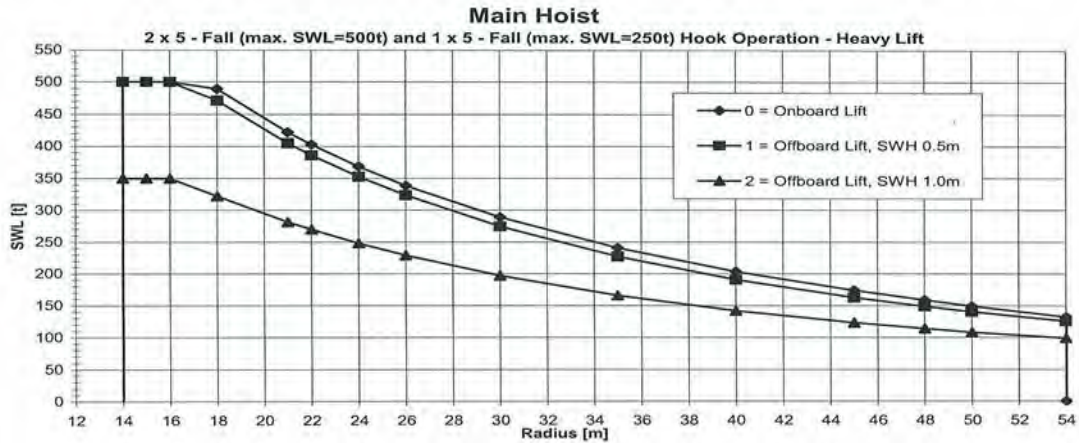
Figure 5-3. SMIT Borneo crane capacity curve. Note the reduced lift capacity when 0.5 meter or 1.0 meter wave conditions are present.

Borneo’s task was to begin removing heavy equipment from GUARDIAN’s fantail and topsides. Following that, they would begin removing the mast, the funnel, the cable reel, and then the superstructure (02 level then the 01 level). BORNEO’s main boom was capable of a 500MT lift at a maximum reach of 16m but that capacity dropped off with additional distance and with a raise in wave height. BORNEO’s Main Hoist capacity curves are provided as figure 5-3

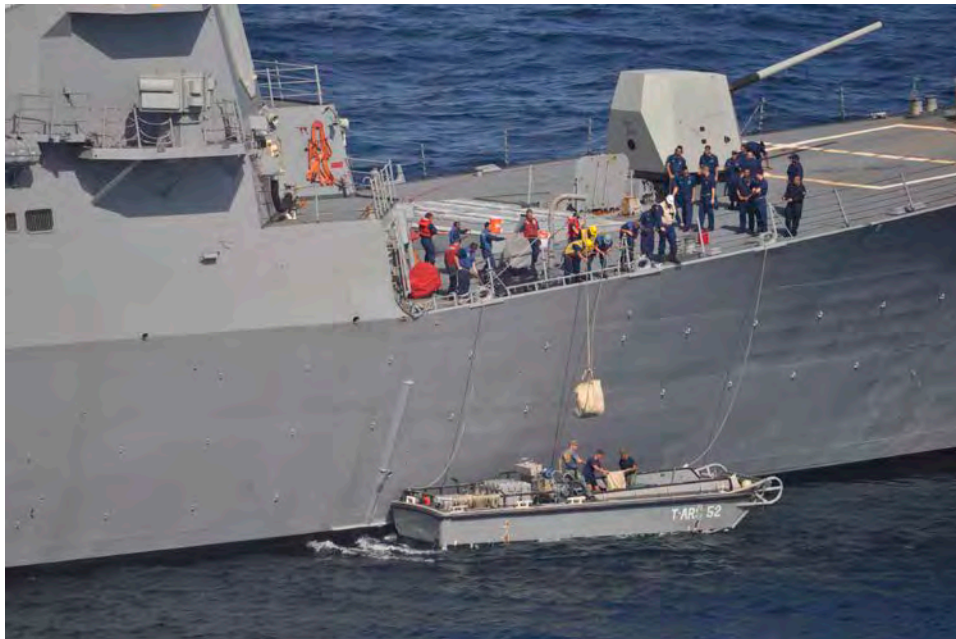
Figure 5-6. Sensitive / High value item recovery. USNS SALVOR's workboat, crewed by MDSU One, alongside USS MUSTIN unloading high value material removed from USS GUARDIAN.

The salvage teams recovered any reusable equipment and any potentially sensitive or classified material. Ordnance and ammunition were accounted for and removed immediately after the salvage assessment on 22 January 2013. All sensitive or high value items from within the hull and on deck were removed by RHIB to other vessels to be inventoried and returned to the fleet. All classified material that was not destroyed by the GUARDIAN crew, was removed and taken to the USS MUSTIN for inventory. This process took approximately five days to accomplish due to sea state and small boat transport inefficiencies.

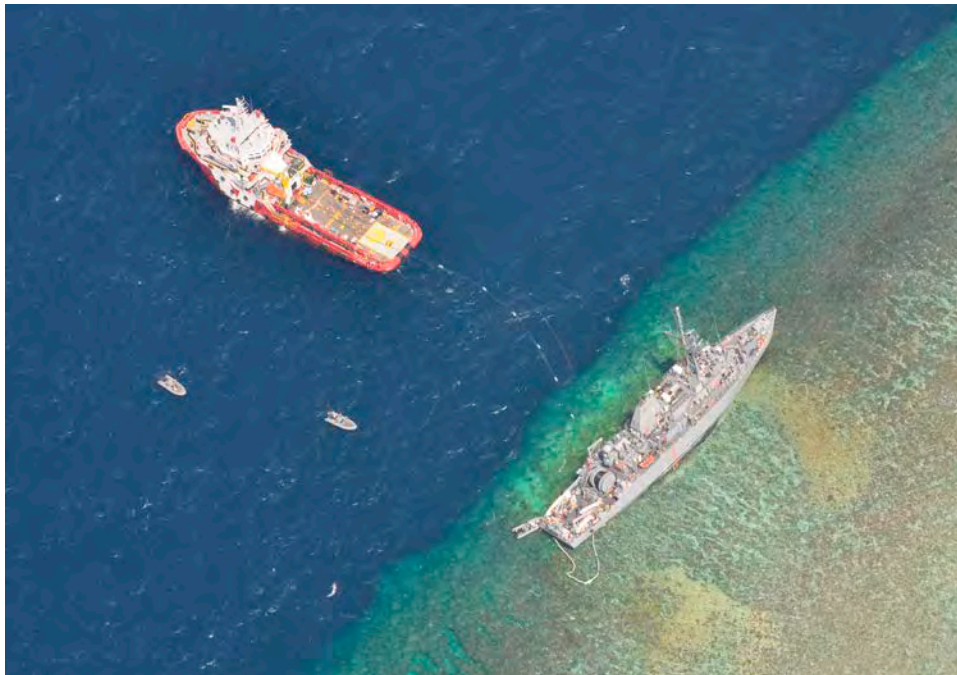
Figure 5-7. VOS APOLLO in DP mode positioned next to the reef taking fuel and oily waste from GUARDIAN. Note buoyed hose running between the ships.

VOS APOLLO arrived Puerto Princesa, Philippines from Singapore on 20 January and was the primary platform for removing the hazardous material. SMIT and OOC engineers embarked onboard VOS APOLLO and began the fuel offload from USS GUARDIAN via a portable pneumatic pump on 22 January 2013. After all fuel was removed, taking approximately two days, the team proceeded to skimming operations within the main engine spaces. This method was inefficient due to the spaces being tidal and unknown oily discharge locations. Once all systems were flushed, it became easier to remove the oily waste. This was an ongoing process for the first two weeks of the salvage operation.

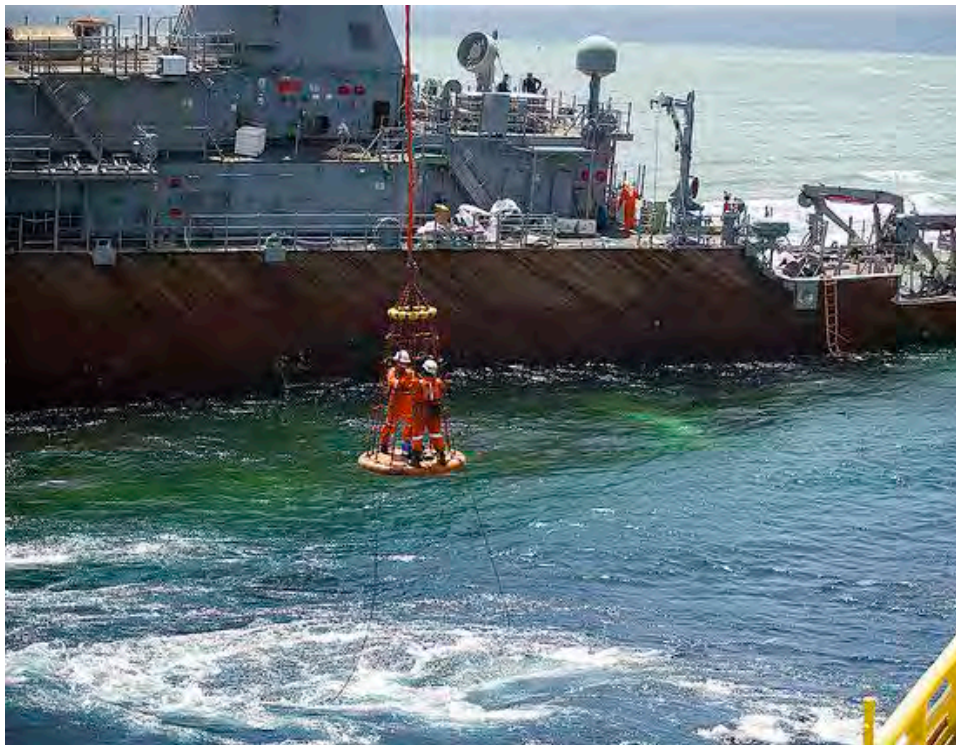
Figure 5-9. Smit salvors riding Bully Pugh from JASCON to GUARDIAN

With JASCON 25, a Bully Pugh was used to transfer personal and salvors could be deposited on the upper decks of GUARDIAN without regard to moderate waves. Use of the Billy Pugh was also incorporated into the evacuation plan in case of injury on GUARDIAN. Figure 5-9 is an image of two SMIT salvors riding the Billy Pugh between ships.

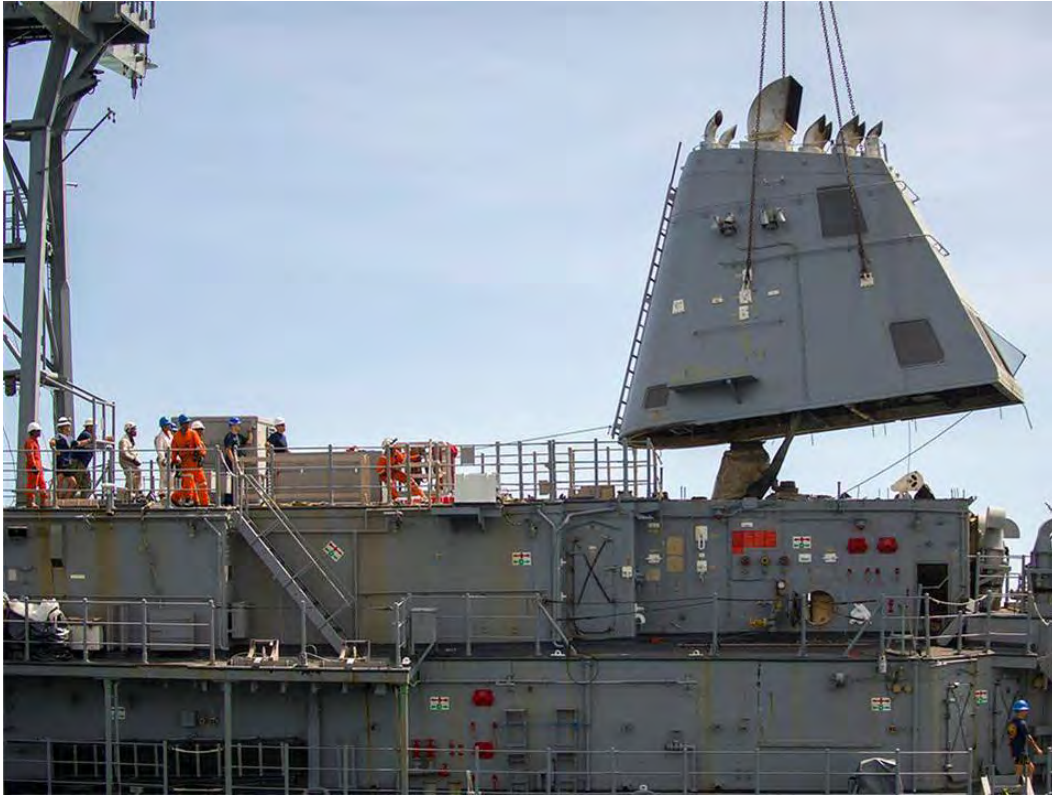
Figure 5-10. SMIT and MDSU ONE team members standing forward on 02 level while the stack is lifted off GUARDIAN.

In the days following, many topside items were removed including the significant items such as the magnetic cable reel assembly (23 Feb), the stack (26 Feb), and the mast (27 Feb). Figure 5-10 is an image of the stack or funnel being removed from GUARDIAN. Additional topside equipment that was removed during this phase included the dipping sonar, fantail winch, MNV davits and the small boat/slewing arm davit.

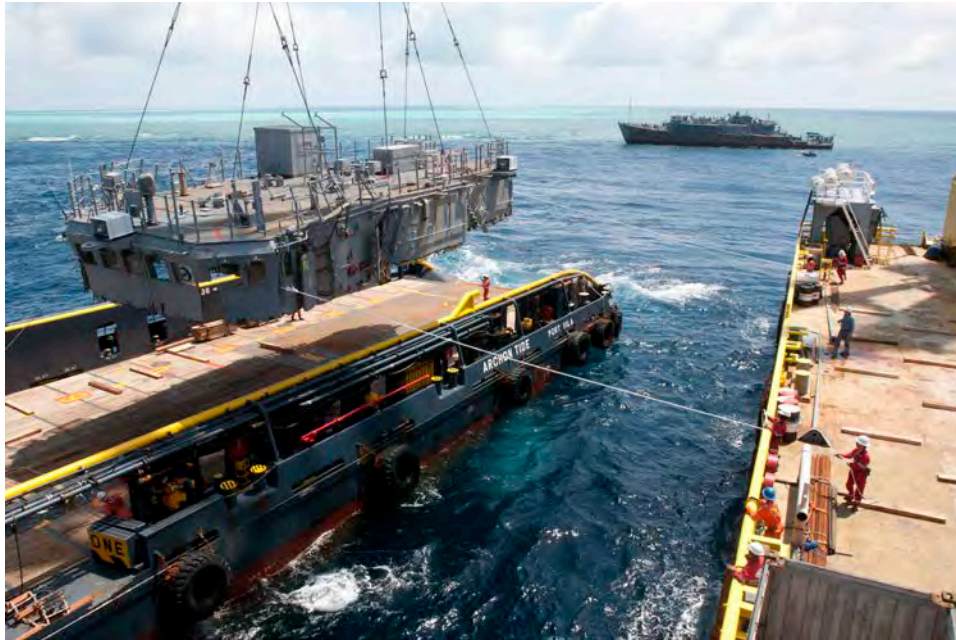
Figure 5-12. 02 level being transferred from JASCON 25 to Archon Tide for further transfer to barge S-7000. Note GUARDIAN in background with 01 level remaining.

With slings in place, the final requirement was making the bulkhead and support beam cuts. The order of the cuts was as follows: Interior non-transverse bulkheads, interior transverse bulkheads, exterior forward bulkhead, exterior aft bulkhead, exterior port bulkhead, and the final cuts were made along the exterior starboard bulkhead. All the exterior bulkheads consisted of major support beams (8”x”8 with a 1’ steel rod in the center), bulkhead framing (2”x4”) and the bulkhead surface (Marine grade plywood, 2” thick). Because of the multiple components of the design, the bulkhead framing and the bulkhead itself were cut first, with the 8x8 support beams left as final cuts for all sections. From planning to lift, the 02 level removal took 3 days. Figure 5-11 shows the 02 level plan with the sling paths annotated. Figure 5-12 shows the 02 level being transferred to ARCHON TIDE from JASCON 25 after it was removed from GUARDIAN.

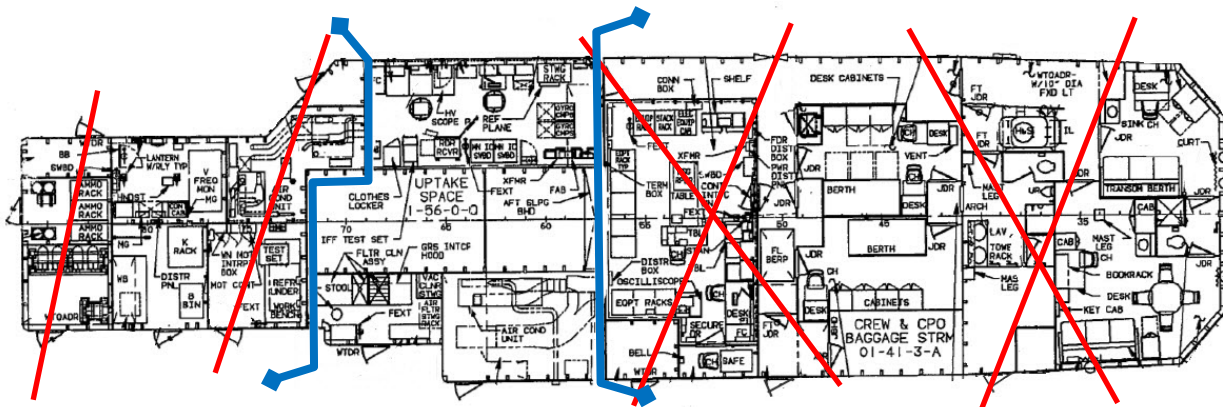
Figure 5-13. 01 level plan showing cut lines in blue and sling paths in red.

The 01 level was prepared in the same manner as the 02 level. However, because the 01 level was almost twice the length of the 02 level deck house, it was decided that two major sections would be lifted: Forward 01 section (frames 28 to 56) and Aft 01 section (frames 72 to 86). The 01 level portion surrounding the stack (frame 57 to 68, port and starboard) were left in place to provide work areas for the eventual stack/exhaust duct clearing. The forward 01 level proved to be more of a challenge, namely passing of slings through Radio, required removal of several communications gear racks and the cutting and removing of thousands of feet of wire and conduit. The sling paths for the 01 level sections can be seen in Figure 5-13.

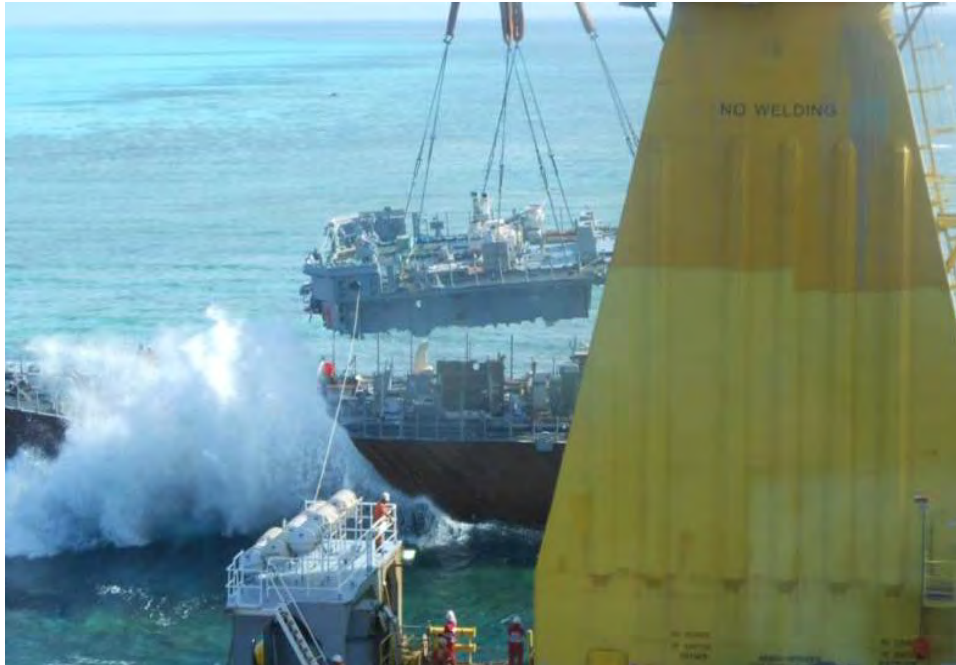
Figure 5-14. 01 level forward being lifted off GUARDIAN. Note waves breaking on hull. This lift followed a number of days where high waves prevented operations on GUARDIAN.

The process of cut preps and lifts of the 01 level took 6 days although two of those days weather conditions prevented transferring salvors to GUARDIAN due to high waves. Figure 5-14 is an image of the 01 level (forward section) being lifted off GUARDIAN on 8 March. The final lifted weights of the superstructure pieces were: 02 level - 24 mT, and 01 Level - 38 mT.

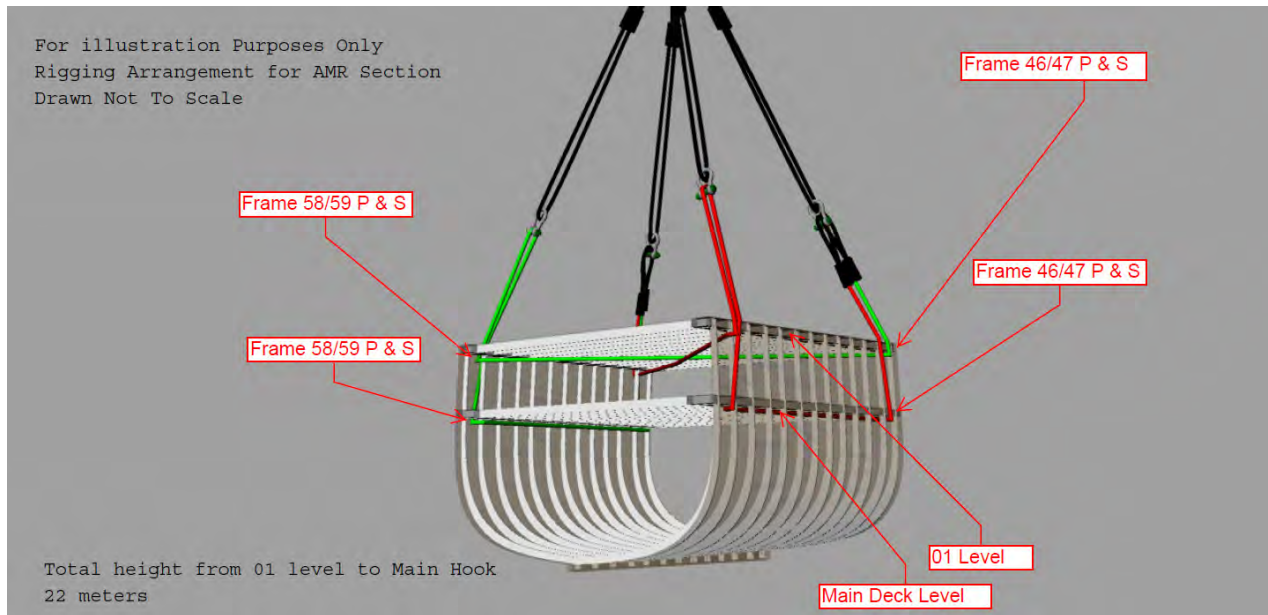
Figure 5-15 – Auxiliary Machinery Room lifting arrangement

The plan was to crisscross two continuous 71mm wire slings for the AMR and MMR lifts. A single sling was run both athwartships and diagonally. This ensured the sling load was equalized across two decks levels and three corners of the hull section. Figure 5-15 shows a cutaway illustration of the AMR lifting arrangements.

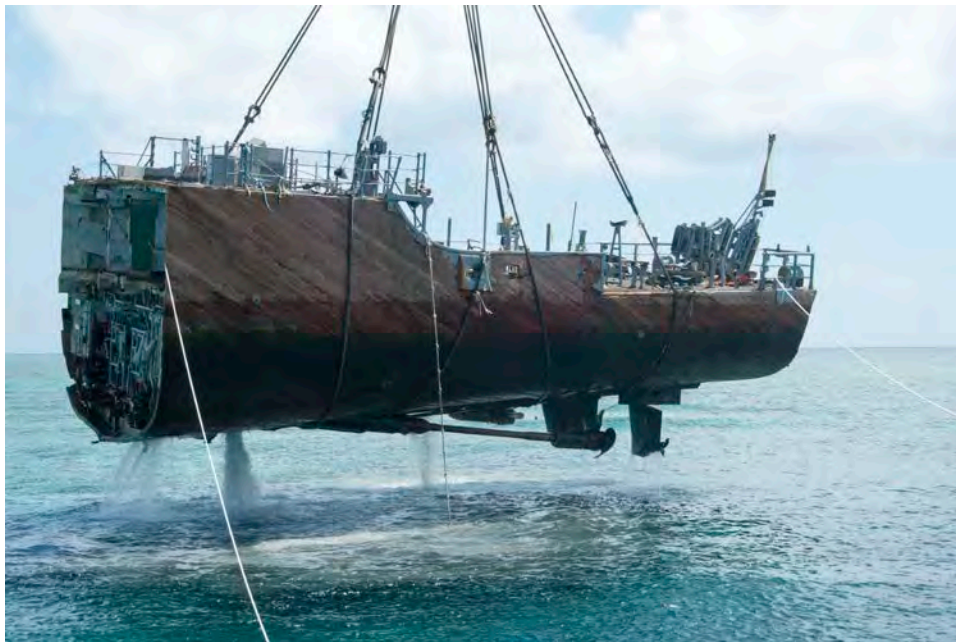
Figure 5-17. Stern section lift, conducted on 30 March, cleared the reef for a final cleanup.

For the stern section, the salvage team was successful running messenger lines under the hull and pulling 4 lift slings under the hull planking. The slings were tied to deck fixtures on at the gunnel to prevent them from slipping forward or aft. Figure 5-17 shows the stern section after it had been raised and the 4 slings passing under the hull.

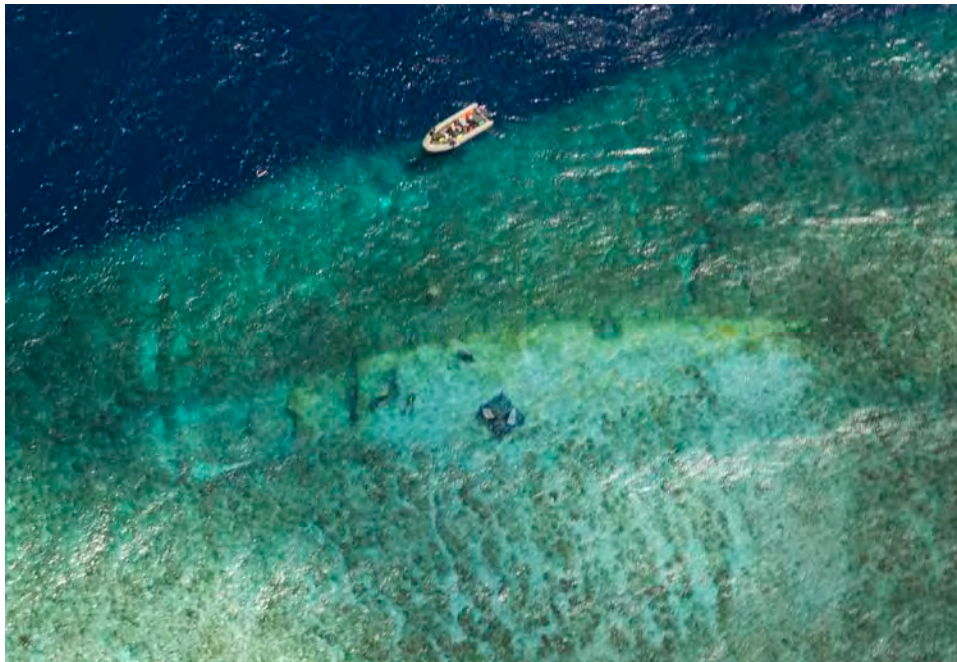
Figure 5-18. MDSU ONE divers swimming the wrecksite on 1 April. Note salvage basket positioned on reef for collection of debris.

JASCON 25 remained on site through 4 April to support aerial photography of the reef. Tubbataha Reef Management and USN MEA representative remained to develop the Reef Assessment Plan. MDSU One and USNS SAFEGUARD remained on site to support the assessment process.

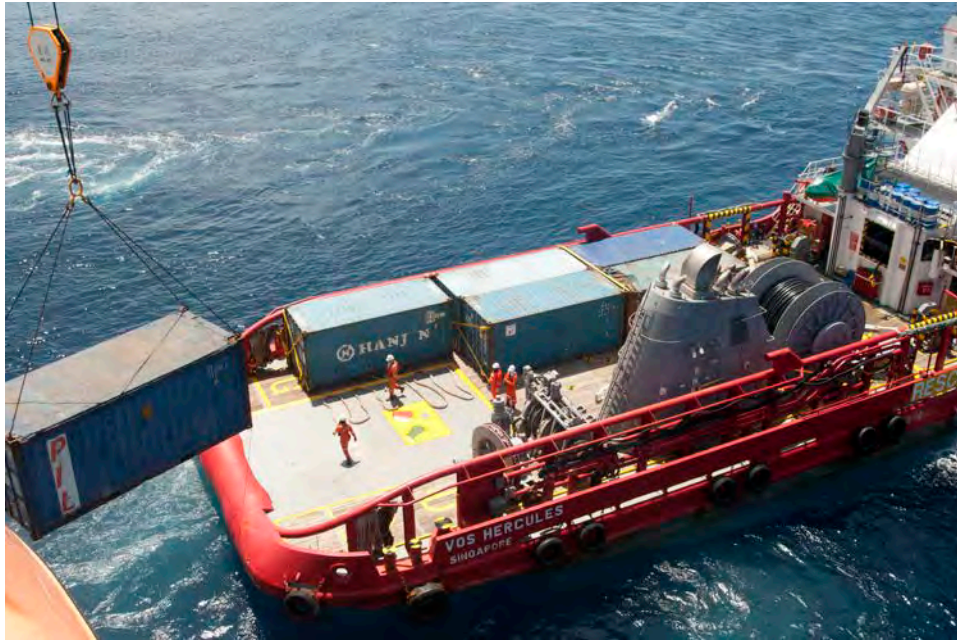
Figure 6-1. VOS Hercules receiving CONEX boxes from SMIT Borneo. Note cable reel and stack already loaded.

On 17 and 18 March, Six CONEX boxes, the magnetic cable reel, the exhaust funnel or stack and other mine hunting equipment was loaded onto VOS HERCULES and after clearing customs, departed for Sasebo, JA. After arriving on 28 March, all six containers and remaining gear were removed and cleared. All contents were processed in bldg 6000. Material issue requests in support of MCM1, MCM7, and MCM10 have been received and authorized by CNSP. Figure 6-1 shows the VOS HERCULES load out of the CONEX boxes and equipment.

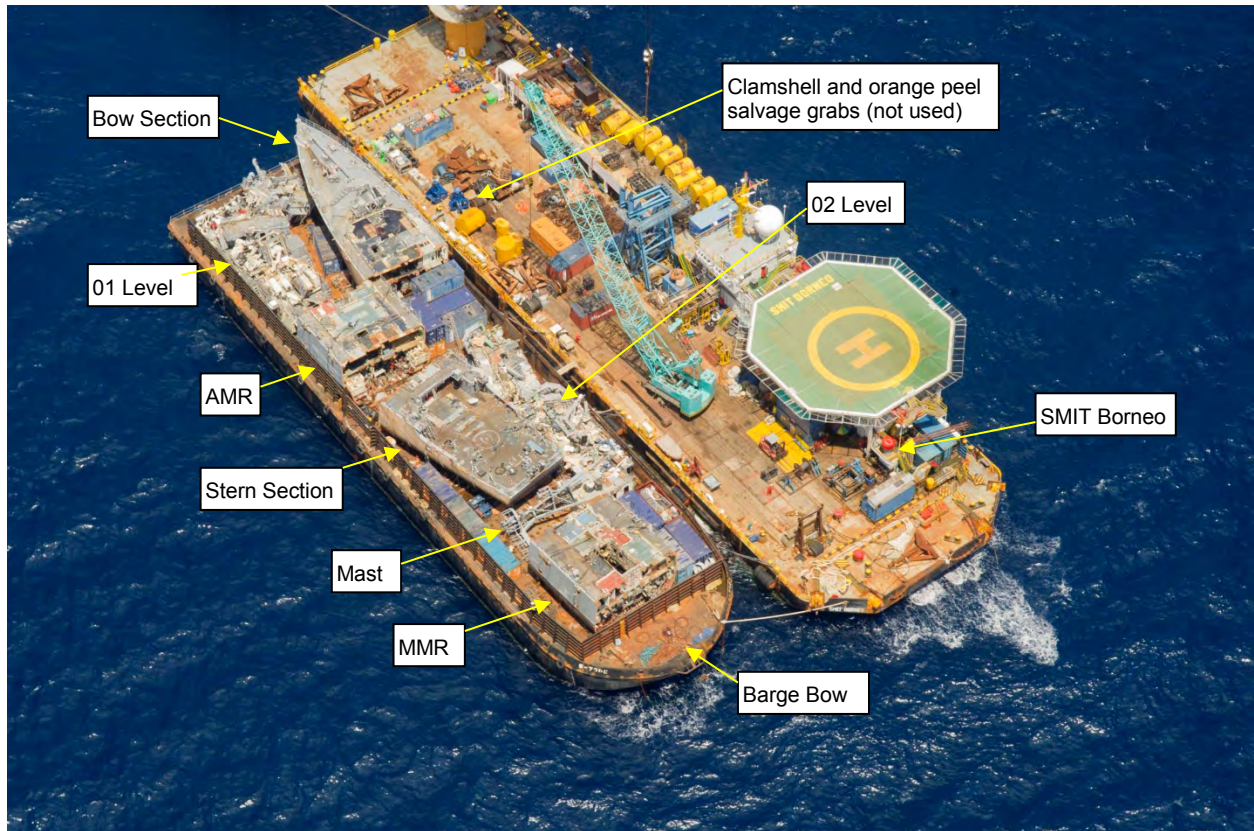
Figure 6-2. An aerial view of S-7000 barge alongside SMIT Borneo.

Note: The 02 Level was originally removed as one section, but was cut to make room on the barge for larger sections. 18 CONEX boxes, various debris and 2 OE-82 Antenna that were also on-loaded to the S-7000 barge.

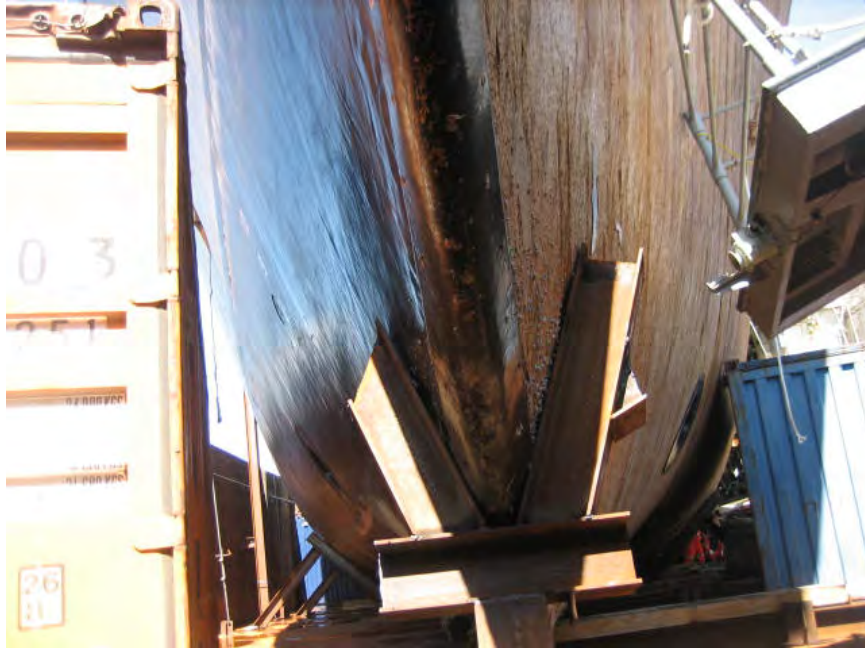
After all sections were on-loaded to the S-7000 barge, the Salvage Master inspected the pieces for stability and safety. I-beams were welded to the deck of the S-7000 barge to provide a cradle for the larger sections and to prevent movement during the transit.

Figure 6-3. Bow section cradle

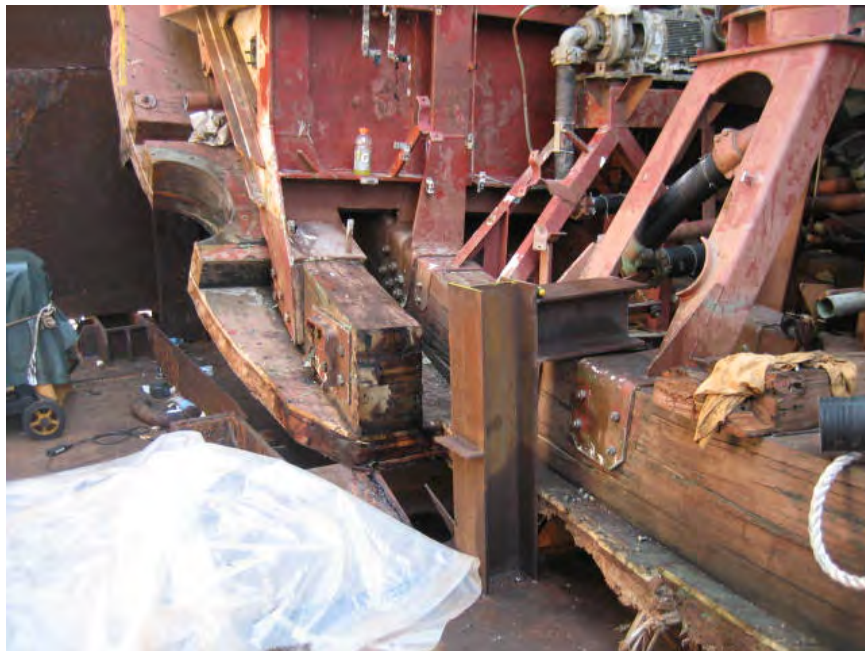
Figure 6-4. AMR Sea Fastening

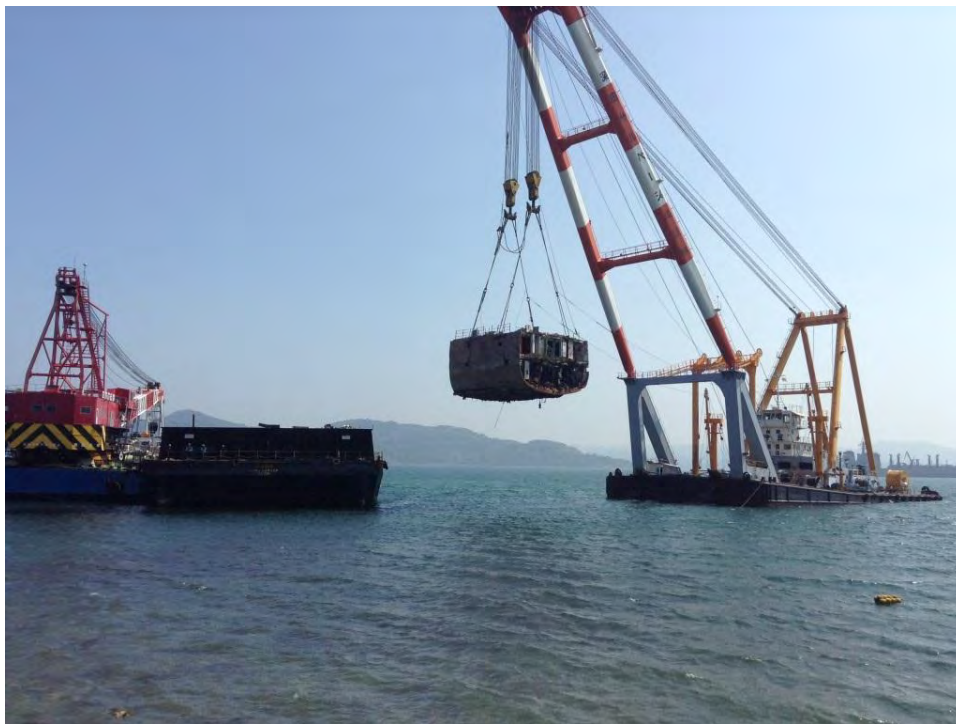
Figure 6-5. GUARDIAN sections being offloaded in Sasebo, Japan.

On 06 - 07 April, additional sea fastening was performed on the sections. LT David Armandt was on scene and inspected the additional sea fastening. At 2100 on 07 April, S-7000 barge cast off, at 2200 TRAJABADOR 1 cast off. At 2330, outside Subic Roads, TRAJABADOR 1 hooked the bridle chain, paid out 1000 ft of tow length and began transiting to Sasebo, Japan with a transit speed of 8 kts arriving on 15 April. The GUARDIAN carcass sections and loose debris were safely offload along with the remaining CONEX boxes on 25 April. S-7000 barge was released from Sakibe for return on 4/26. Sakibe area had been approved as the lay down area for dismantle and disposal efforts. Figure 6-5 shows the derrick barge conducting the offload in Sasebo, Japan on 25 April.

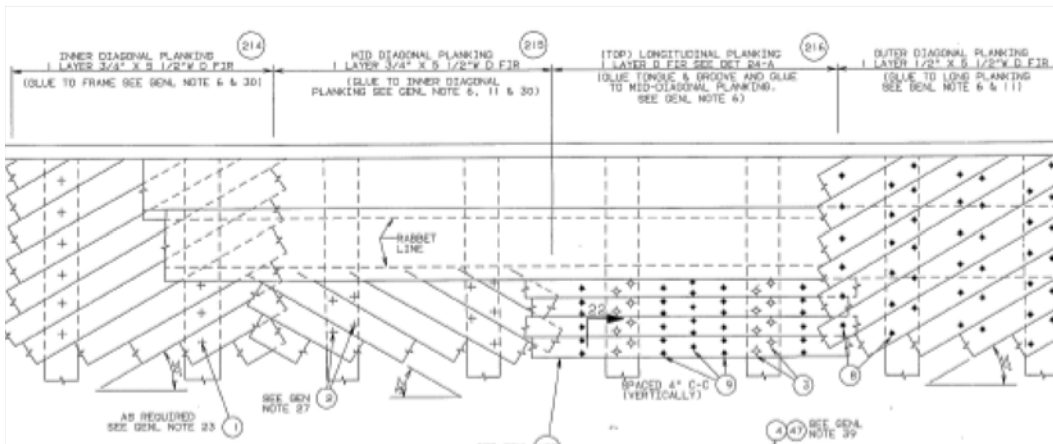
From NAVSEA Dwg 111-6134059, Detail 17-A

Inner diagonal planking: 0.75-inch @ 30-deg
 mid diagonal planking: 0.75-inch @ -30-deg
 long'l planking T&G: 2.5-inch horizontal
 outer diagonal planking: 0.5-inch @30-deg

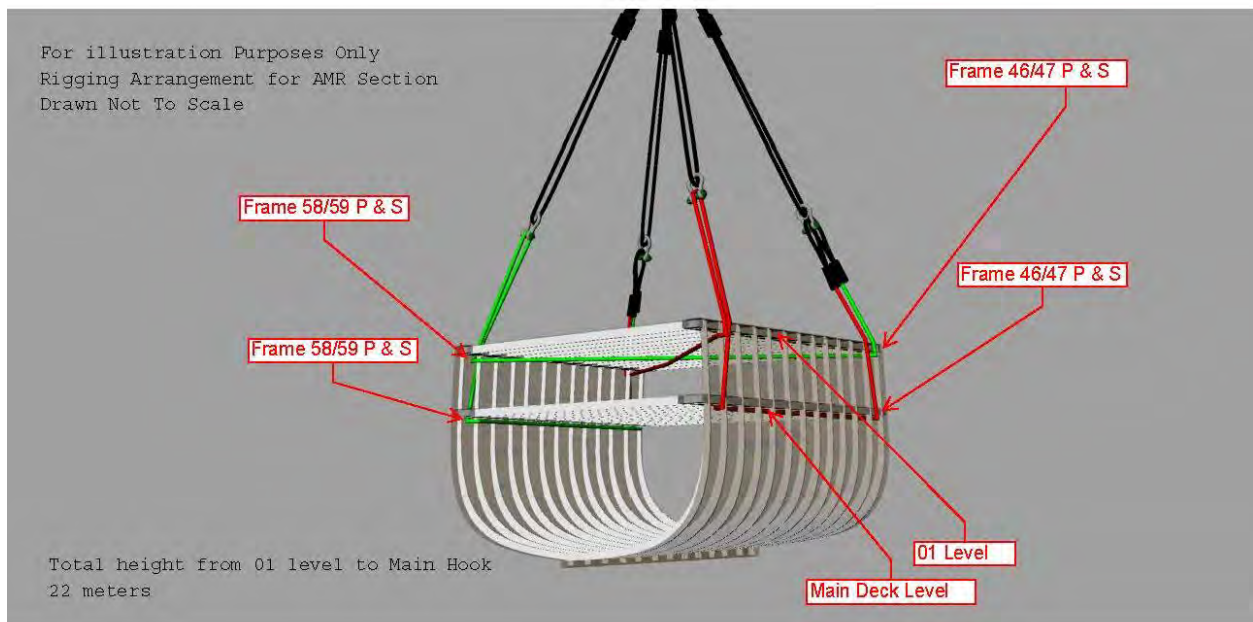
As equipment removal continued and the weather quieted down, the team realized the hull sections were likely to retain enough strength to allowing lifting SMIT proposed the lift sling concept. A drawing of that follows:

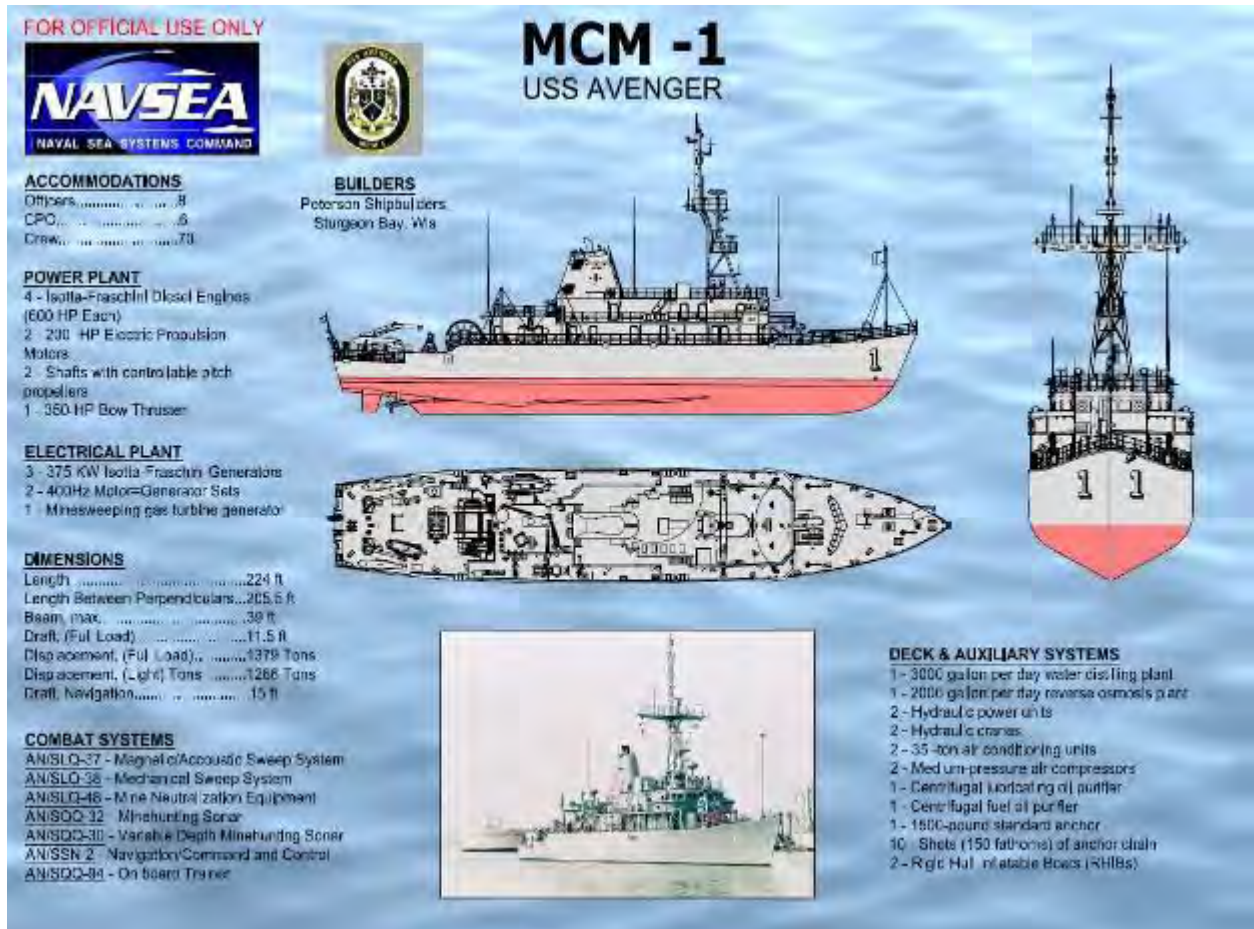
Fig. 1 (general specifications)

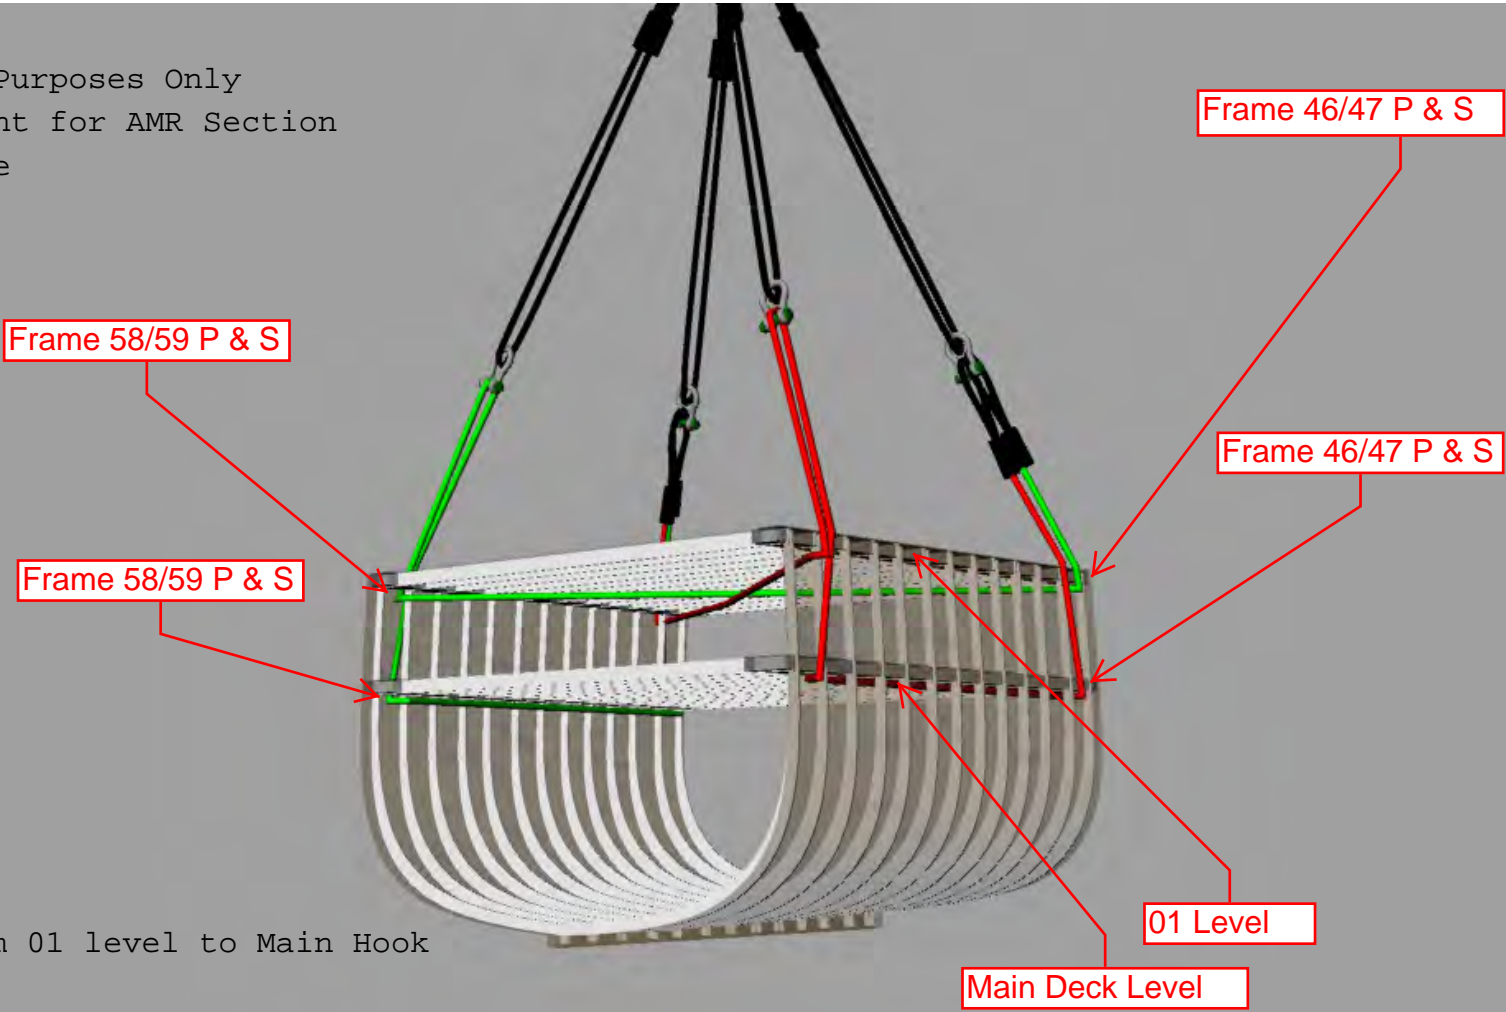
Total height from 01 level to Main Hook
22 meters
