NYC Department of Education
Building Condition Assessment Survey 2023 - 2024

Architectural Inspection

Asset: P.S. 1 - BROOKLYN, 309 47 STREET, New York, 11220

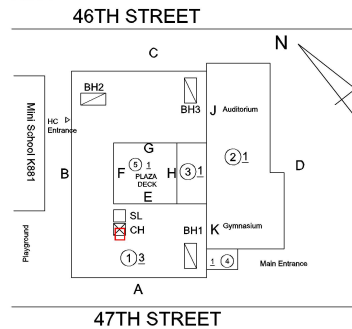
BRICK: MINOR CRACKS AND SPALLING
 K001

30
 S.F.
 RESTITCH
 PRIORITY 3
 LEVEL 2

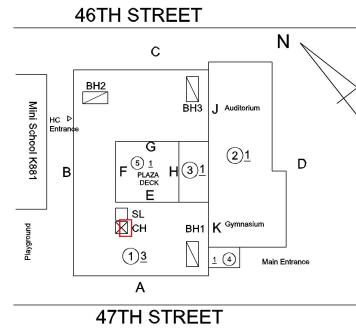
BRICK: DETERIORATED JOINTS
K001

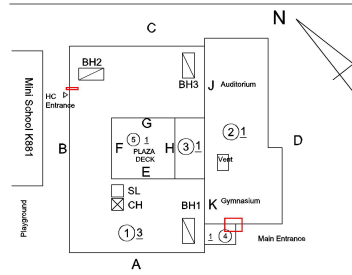
CAST STONE: CRACKED/BROKEN PIECES

REPLACE-IN-KIND

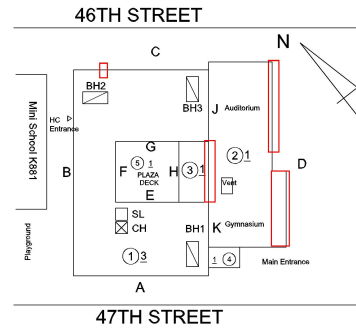
**CAST STONE: DETERIORATED TRANSVERSE JOINTS
K001**

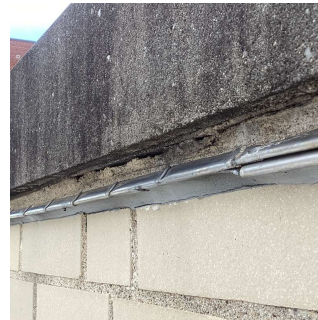
Roof 1

CAST STONE: DETERIORATED BED JOINT

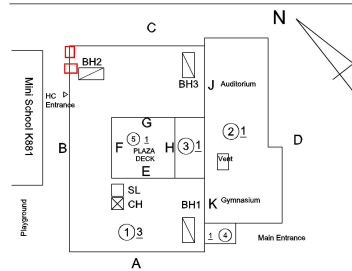
ROLL-UP DOOR: DETERIORATED DOOR AND FRAME - MAJOR DETERIORATION

REPLACE

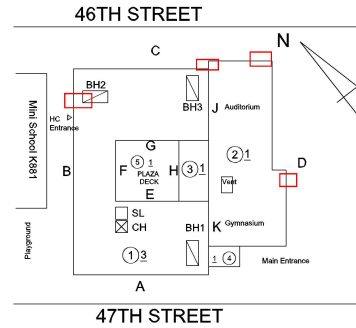
METAL: DETERIORATED DOOR AND FRAME - MAJOR DETERIORATION

REPLACE

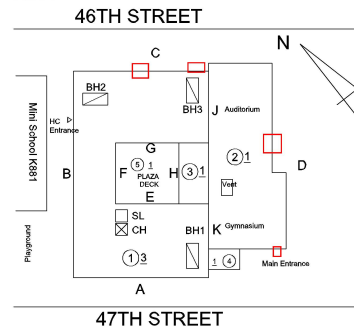
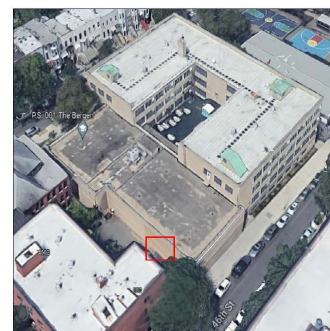
BRICK: MAJOR / THRU CRACKS
K001

30
S.F.
REMOVE AND REBUILD
PRIORITY 4
LEVEL 2

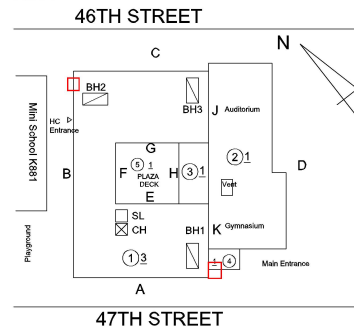
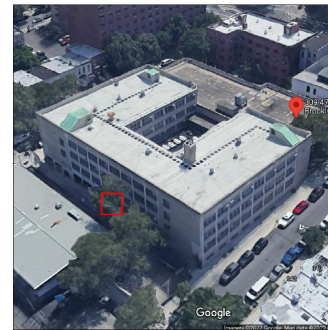
**CAST IN PLACE / PRE-CAST CONCRETE: MAJOR
CRACKS/SPALLING**

REPLACE

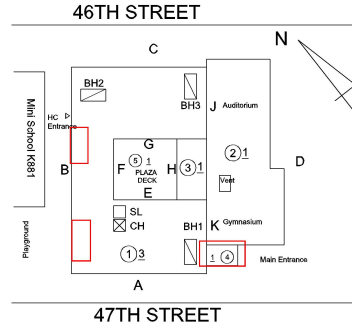
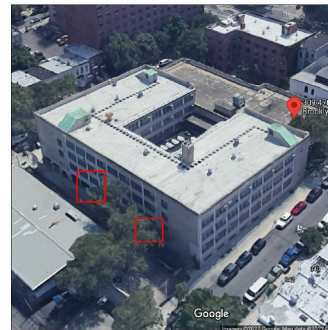
STUCCO/PLASTER: MAJOR CRACKS/SPALLING

REPLACE

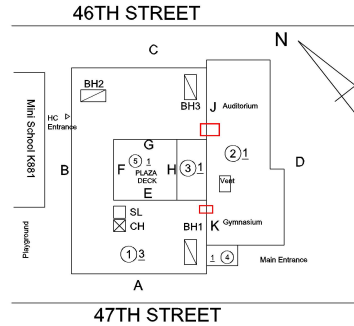
**BRICK: MAJOR DETERIORATION/CRACKS
K001**

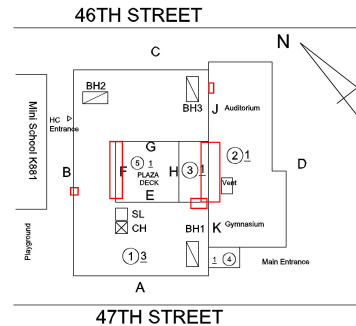
BRICK: DETERIORATED JOINTS

100
S.F.
REPOINT
PRIORITY 4
LEVEL 2

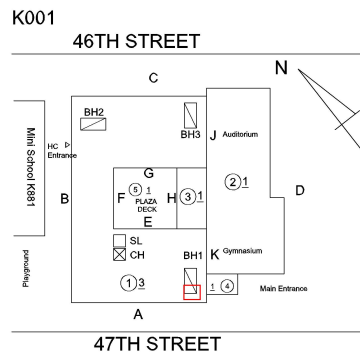
BULKHEAD/PENTHOUSE WALLS/EXTERIOR: MAJOR THRU CRACKS

K001
10
S.F.
REMOVE AND REBUILD

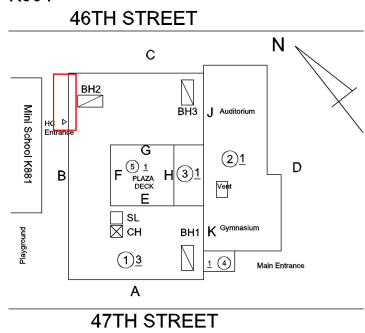
Violations	Facade C No violations recorded.
Deficiency	CONCRETE: CRACKS/SPALLING - MAJOR
Roof Plan reference	K001

<p align="center">46TH STREET</p> <p align="center">47TH STREET</p>
Deficiency Quantity	20
Quantity Uom	S.F.
Potential Action	REPLACE
Urgency of Action	PRIORITY 4
Purpose of Action	LEVEL 2
Deficiency Photo1

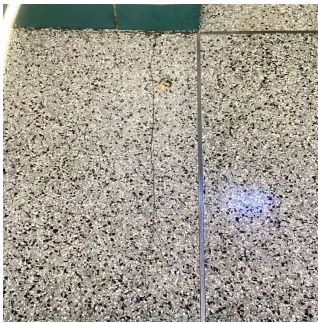
Violations	Room 135A No violations recorded.
Floor Finish	Inspected
Condition	2 - Between Good and Fair
Deficiency	TERRAZZO: CRACKS
Deficiency Location/Instance	Corridor near Courtyard Entrance
Deficiency Quantity	20
Quantity Uom	S.F.
Potential Action	REPLACE

Corridor near Courtyard Entrance No violations recorded.
Deficiency Deficiency Location/Instance Deficiency Quantity Quantity Uom Potential Action Urgency of Action Purpose of Action Deficiency Photo1 Violations	VINYL TILES: BROKEN/DETERIORATED/MISSING TILES Corridor near Room 232 10 S.F. REPLACE PRIORITY 3 LEVEL 2

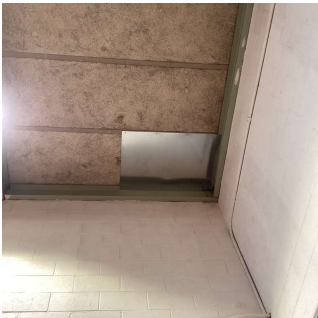
Question	Response
INTERIOR	
CLASSROOMS/CORRIDORS/ADMIN SPACES	Inspected
Specialties	Does not Exist
GYMNASIUM	Inspected
Instance on 1st Floor	Inspected
Ceiling	
Instance on 1st Floor	Inspected
Condition	2 - Between Good and Fair
Deficiency	TECTUM: DAMAGED/MISSING
Deficiency Location/Instance	Near Main Entrance, By Exit 12
Deficiency Quantity	80
Quantity Uom	S.F.
Potential Action	REPLACE
Urgency of Action	PRIORITY 3
Purpose of Action	LEVEL 2
Deficiency Photo1

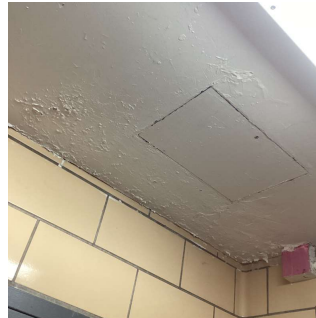
Violations	Stair B/Bulkhead No violations recorded.
KITCHEN	
Instance on Basement	Inspected
Ceiling	
Instance on Basement	Inspected
Condition	3 - Fair
Deficiency	PLASTER: CRACKS/SPALLING
Deficiency Location/Instance	Exit 8 - Vestibule
Deficiency Quantity	20
Quantity Uom	S.F.
Potential Action	REPLACE
Urgency of Action	PRIORITY 3

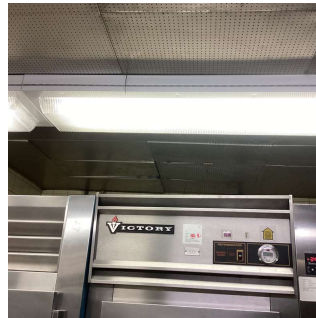
Near Fridges

METAL PAN: DAMAGED/MISSING

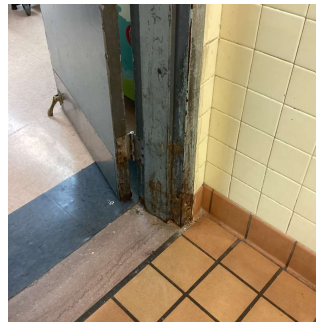
Servery

METAL: DETERIORATED DOOR AND FRAME

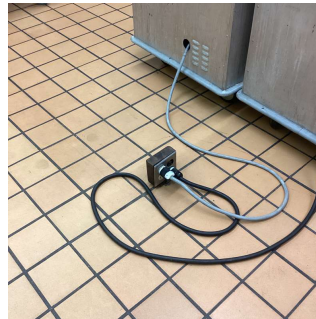
Instance on Basement	Inspected
Condition	3 - Fair
Deficiency	QUARRY TILE: TRIPPING HAZARD - ELECTRICAL OUTLET
Deficiency Location/Instance	Near Servery
Deficiency Quantity	10
Quantity Uom	S.F.
Potential Action	REMOVE
Urgency of Action	PRIORITY 5
Purpose of Action	LEVEL 6
Deficiency Photo1

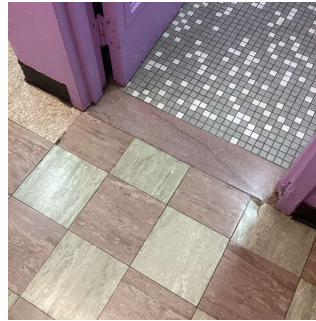
In Kitchen Locker Room

Deficiency	VINYL TILES: BROKEN/DETERIORATED/MISSING TILES
Deficiency Location/Instance	Kitchen Locker Room
Deficiency Quantity	10
Quantity Uom	S.F.
Potential Action	REPLACE
Urgency of Action	PRIORITY 3
Purpose of Action	LEVEL 2

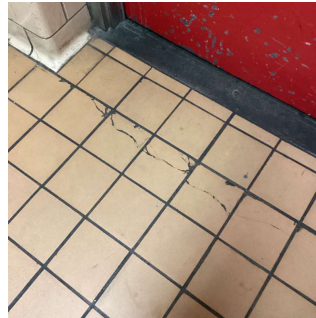
Exit 8 - Vestibule

QUARRY TILE: BROKEN/MISSING TILES

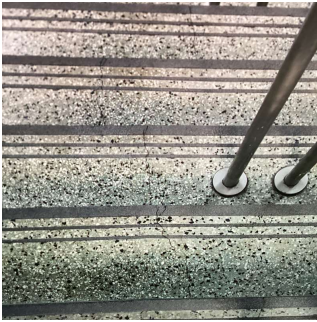
Question	Response
INTERIOR	
STAIRS/RAMPS: INTERIOR	
Ceiling	Inspected
Violations	No violations recorded.
Door(s)	Inspected
Condition	2 - Between Good and Fair
Deficiency	No deficiencies recorded
Partition	Does not Exist
Railings	Inspected
Condition	2 - Between Good and Fair
Deficiency	No deficiencies recorded
Stairs and Landings	Inspected
Condition	3 - Fair
Deficiency	TERRAZZO: CRACKS
Deficiency Location/Instance	Corridor near Gymnasium
Deficiency Quantity	70
Quantity Uom	S.F.
Potential Action	REPLACE
Urgency of Action	PRIORITY 3
Purpose of Action	LEVEL 2
Deficiency Photo1

Violations	Corridor near Gymnasium No violations recorded.
Deficiency	STONE: BROKEN/MISSING
Deficiency Location/Instance	Stairs A/1, B/Basement, 1, C/3, 12/1 and others
Deficiency Quantity	130
Quantity Uom	S.F.
Potential Action	REPLACE
Urgency of Action	PRIORITY 3
Purpose of Action	LEVEL 2
Deficiency Photo1

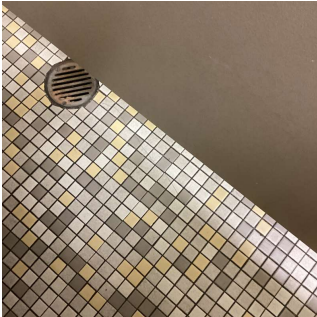
Question	Response
INTERIOR	
TOILET ROOMS - STAFF	
Floor Finish	
Deficiency Quantity	20
Quantity Uom	S.F.
Potential Action	REPLACE
Urgency of Action	PRIORITY 3
Purpose of Action	LEVEL 2
Deficiency Photo1

Room 7
Violations	No violations recorded.
Stalls	Inspected
Condition	5 - Poor
Deficiency	RUST - MAJOR
Deficiency Location/Instance	In Kitchen Locker Room
Deficiency Quantity	1
Quantity Uom	EACH
Potential Action	REPLACE
Urgency of Action	PRIORITY 3
Purpose of Action	LEVEL 2
Deficiency Photo1

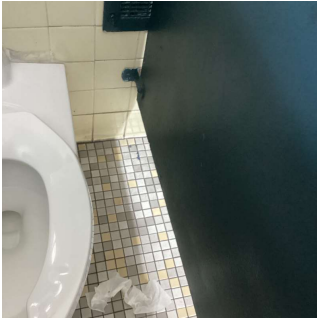
Question	Response
INTERIOR	
TOILET ROOMS - STUDENTS	
Floor Finish	Inspected
	Room 8
Violations	No violations recorded.
Stalls	Inspected
Condition	4 - Between Fair and Poor
Deficiency	RUST - MAJOR
Deficiency Location/Instance	Girls Toilet Room - 2nd Floor
Deficiency Quantity	3
Quantity Uom	EACH
Potential Action	REPLACE
Urgency of Action	PRIORITY 3
Purpose of Action	LEVEL 2
Deficiency Photo1

Violations	Girls Toilet Room - 2nd Floor No violations recorded.
Deficiency	BROKEN/MISSING
Deficiency Location/Instance	Room B05
Deficiency Quantity	1
Quantity Uom	EACH
Potential Action	REPLACE
Urgency of Action	PRIORITY 3
Purpose of Action	LEVEL 2
Deficiency Photo1

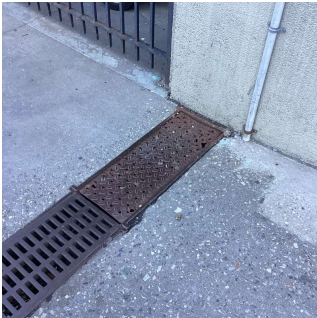
Question	Response
SITE	
Drainage System for Concrete	
Catch Basins/Manhole - Surrounded by concrete	
Deficiency Quantity	1
Quantity Uom	EACH
Potential Action	REPLACE
Urgency of Action	PRIORITY 3
Purpose of Action	LEVEL 2
Deficiency Photo1

Near Exit 17
Violations	No violations recorded.
Culverts - Concrete Covering	
	Does not Exist
Drainage System for Soil	
	Does not Exist
DRINKING FOUNTAINS	
Condition	Inspected
Deficiency	1 - Good
	No deficiencies recorded
FENCES	
Condition	Inspected
	4 - Between Fair and Poor
Deficiency	CHAIN LINK: RUST - MAJOR
Deficiency Location/Instance	Near Exit 12
Deficiency Quantity	300
Quantity Uom	S.F.
Potential Action	REPLACE
Urgency of Action	PRIORITY 3
Purpose of Action	LEVEL 2
Deficiency Photo1

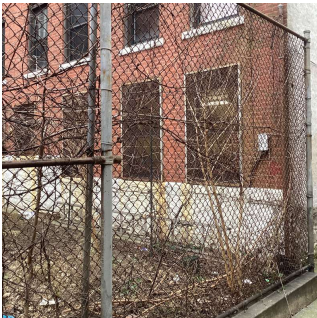
Near Exit 12
Violations	No violations recorded.
Deficiency	CHAIN LINK: DAMAGED POST/RAIL
Deficiency Location/Instance	46th Street, near Exit 12
Deficiency Quantity	30
Quantity Uom	L.F.
Potential Action	REPLACE

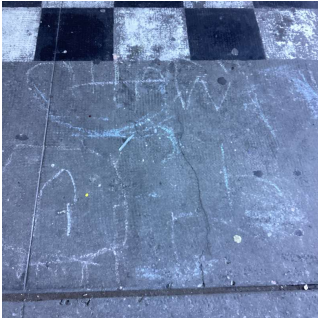
46th Street
Violations	No violations recorded.
IRRIGATION SYSTEM	
	Does not Exist
PAVING	
	Inspected
Student Non-Use	
	Does not Exist
Student Use	
Gravel Exists?	No
Asphalt	
	Inspected
Condition	1 - Good
Deficiency	No deficiencies recorded
Concrete	
	Inspected
Condition	3 - Fair
Deficiency	DAMAGED/DETERIORATED/MISSING SECTIONS
Deficiency Location/Instance	Near Exits 7, 8, 9
Deficiency Quantity	150
Quantity Uom	S.F.
Potential Action	REPLACE
Urgency of Action	PRIORITY 3
Purpose of Action	LEVEL 2
Deficiency Photo1

Near Exit 8
Violations	No violations recorded.
Pavers	
	Does not Exist
Site Sidewalks & Walkways	
	Inspected

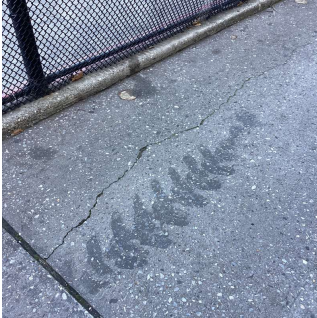
Question	Response
SITE	
PAVING	
Site Sidewalks & Walkways	
Asphalt	Inspected
Condition	1 - Good
Deficiency	No deficiencies recorded
Concrete	Inspected
Condition	3 - Fair
Deficiency	DAMAGED/DETERIORATED/MISSING SECTIONS
Deficiency Location/Instance	Near Mini Building, 47th Street
Deficiency Quantity	325
Quantity Uom	S.F.
Potential Action	REPLACE
Urgency of Action	PRIORITY 3
Purpose of Action	LEVEL 2
Deficiency Photo1

Near Mini Building
Violations	No violations recorded.
Pavers	Does not Exist
DOT Sidewalk	Inspected
Asphalt	Does not Exist
Concrete	Inspected
Condition	4 - Between Fair and Poor
Deficiency	HEAVING
Deficiency Location/Instance	46th Street
Deficiency Quantity	75
Quantity Uom	S.F.
Potential Action	REPLACE
Urgency of Action	PRIORITY 3
Purpose of Action	LEVEL 2
Deficiency Photo1

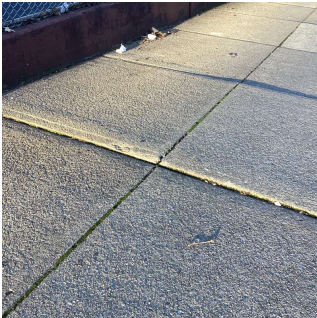
46th Street
Violations	No violations recorded.
Deficiency	DAMAGED/DETERIORATED/MISSING SECTIONS

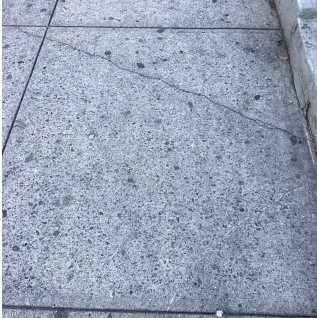
Question	Response
SITE	
PAVING	
DOT Sidewalk	
Concrete	
Deficiency Location/Instance	47th Street, 46th Street
Deficiency Quantity	725
Quantity Uom	S.F.
Potential Action	REPLACE
Urgency of Action	PRIORITY 3
Purpose of Action	LEVEL 2
Deficiency Photo1

Violations	47th Street No violations recorded.
Deficiency	DAMAGED CURBS
Deficiency Location/Instance	47th Street, 46th Street
Deficiency Quantity	170
Quantity Uom	L.F.
Potential Action	REPLACE
Urgency of Action	PRIORITY 3
Purpose of Action	LEVEL 2
Deficiency Photo1

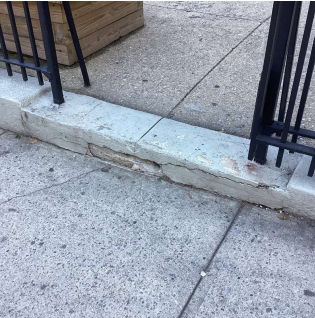
Question	Response
SITE	
RETAINING WALLS	
Deficiency Photo1 Violations

47th Street No violations recorded.
SEATING	Does not Exist
SITE WALLS (NOT RETAINING WALLS)	Does not Exist
STAIRS/RAMPS: EXTERIOR	Does not Exist
ARTWORK	Inspected
Instance Instance Photo	Exterior - Main Entrance - 11559
