NYC Department of Education
Building Condition Assessment Survey 2023 - 2024

Architectural Inspection

Asset: I.S. 2 - BROOKLYN, 655 PARKSIDE AVE, New York, 11226

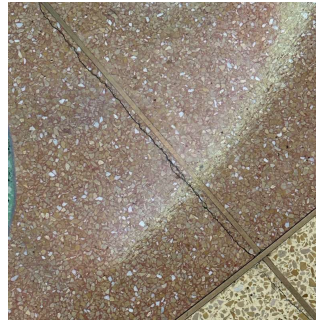
Corridor near Stair A/1

Floor Finish

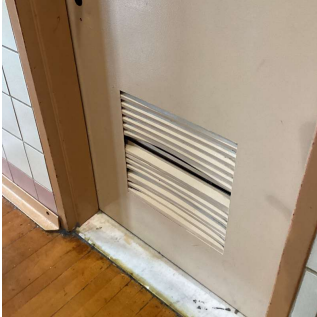
Question	Response
INTERIOR	
GYMNASIUM	
Door(s)	
Purpose of Action	LEVEL 2
Deficiency Photo1

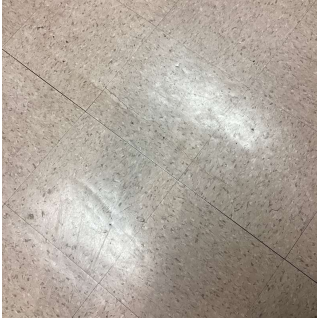
Office
Violations	No violations recorded.
Deficiency	WOOD: DAMAGED/DETERIORATED
Deficiency Location/Instance	Right Side, Left Side, Near Drinking Fountain
Deficiency Quantity	40
Quantity Uom	S.F.
Potential Action	REPLACE
Urgency of Action	PRIORITY 3
Purpose of Action	LEVEL 2

Right Side
Violations	No violations recorded.
Fixed Equipment	
Instance on 3rd Floor	Inspected
Condition	2 - Between Good and Fair
Deficiency	No deficiencies recorded
Floor Finish	
Instance on 3rd Floor	Inspected
Condition	2 - Between Good and Fair
Deficiency	VINYL TILES: DETERIORATED SUBSTRATE
Deficiency Location/Instance	Office
Deficiency Quantity	10
Quantity Uom	S.F.
Potential Action	REPLACE
Urgency of Action	PRIORITY 3
Purpose of Action	LEVEL 2
Deficiency Photo1

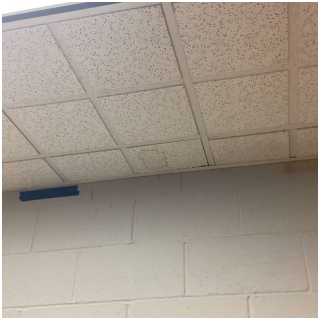
Question	Response
INTERIOR	
KITCHEN	Inspected
Walls	
Violations	Near Exit to Staff Cafeteria No violations recorded.
LIBRARY	Inspected
Instance on Room A225	Inspected
Built-in Furnishing	
Instance on Room A225	Inspected
Condition	2 - Between Good and Fair
Deficiency	No deficiencies recorded
Ceiling	
Instance on Room A225	Inspected
Condition	2 - Between Good and Fair
Deficiency	ACOUSTIC TILES: DAMAGED/MISSING
Deficiency Location/Instance	Room A225B
Deficiency Quantity	10
Quantity Uom	S.F.
Potential Action	REPLACE
Urgency of Action	PRIORITY 3
Purpose of Action	LEVEL 2
Deficiency Photo1

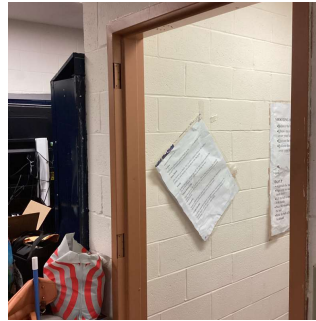
Entrance Vestibule

Door(s)

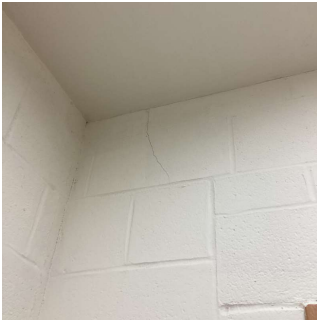
Question	Response
INTERIOR	
LOCKER ROOM	
Walls	
Deficiency Photo1

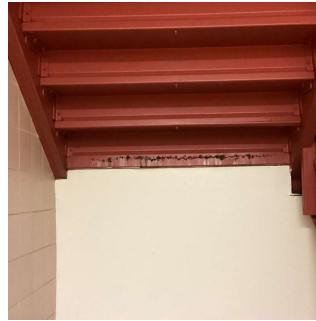
Stair Z/3

Stairs and Landings

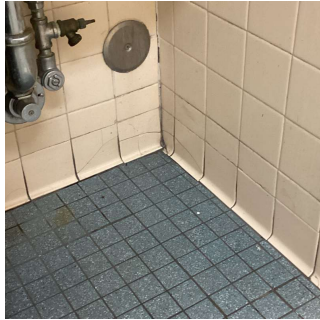
Question	Response
INTERIOR	
TOILET ROOMS - STUDENTS	
Floor Finish	Inspected
	Room C112A
Violations	No violations recorded.
Stalls	Inspected
Condition	2 - Between Good and Fair
Deficiency	No deficiencies recorded
Walls	Inspected
Condition	2 - Between Good and Fair
Deficiency	CERAMIC TILE: BROKEN/ MISSING
Deficiency Location/Instance	Room C110A, 2nd Floor Girls B Side, 3rd Floor Boys Near Gymnasium, 3rd Floor Girls A Side, 4th Floor Boys A Side, and others
Deficiency Quantity	120
Quantity Uom	S.F.
Potential Action	REPLACE
Urgency of Action	PRIORITY 3
Purpose of Action	LEVEL 2
Deficiency Photo1

Violations	4th Floor Boys A Side No violations recorded.
LIFE SAFETY	Inspected
F.D. HOLDING AREA	Does not Exist
STEEL STAIRS	Does not Exist
SITE	Inspected
CONTAINERIZATION	Inspected
Condition	3 - Fair
Deficiency	FENCING DAMAGED
Deficiency Location/Instance	Parkside Avenue
Deficiency Quantity	100
Quantity Uom	S.F.
Potential Action	REPAIR

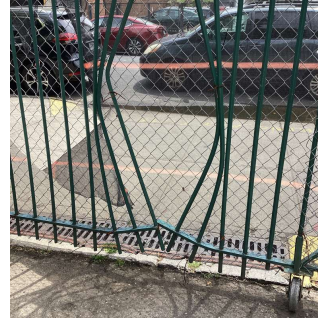
Parkside Avenue

FENCES

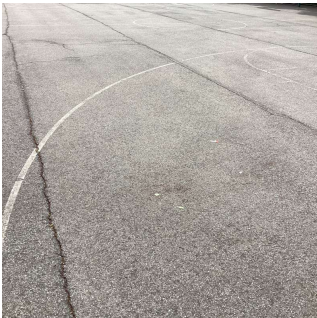
Violations	Parking Lot No violations recorded.
Concrete	Inspected
Condition	2 - Between Good and Fair
Deficiency	No deficiencies recorded
Pavers	Does not Exist
Student Use	Inspected
Gravel Exists?	No
Asphalt	Inspected
Condition	4 - Between Fair and Poor
Deficiency	CRACKS - MAJOR
Deficiency Location/Instance	West Schoolyard
Deficiency Quantity	1,400
Quantity Uom	S.F.
Potential Action	REPLACE
Urgency of Action	PRIORITY 3
Purpose of Action	LEVEL 2
Deficiency Photo1

Violations	West Schoolyard No violations recorded.
Concrete	Inspected
Condition	3 - Fair
Deficiency	DAMAGED/DETERIORATED/MISSING SECTIONS
Deficiency Location/Instance	West Schoolyard
Deficiency Quantity	50
Quantity Uom	S.F.
Potential Action	REPLACE
Urgency of Action	PRIORITY 3
Purpose of Action	LEVEL 2

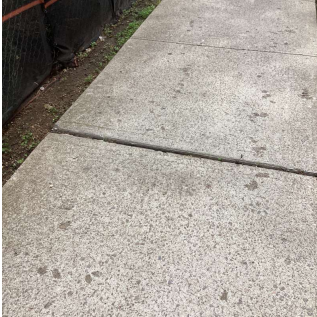
Question	Response
SITE	
PAVING	
Site Sidewalks & Walkways	
Concrete	
Deficiency Photo1

Violations	East Side of Building No violations recorded.
Pavers	Inspected
Condition	2 - Between Good and Fair
Deficiency	DAMAGED/MISSING
Deficiency Location/Instance	Parkside Avenue
Deficiency Quantity	10
Quantity Uom	S.F.
Potential Action	REPLACE
Urgency of Action	PRIORITY 3
Purpose of Action	LEVEL 2
Deficiency Photo1

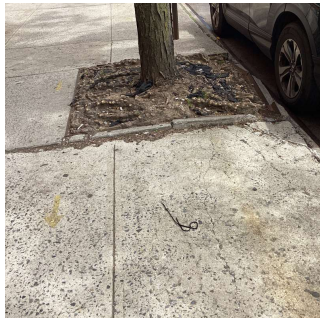
Violations	Parkside Avenue - Exit 2 No violations recorded.
DOT Sidewalk	Inspected
Asphalt	Does not Exist
Concrete	Inspected
Condition	4 - Between Fair and Poor
Deficiency	HEAVING
Deficiency Location/Instance	Parkside Avenue
Deficiency Quantity	650
Quantity Uom	S.F.
Potential Action	REPLACE
Urgency of Action	PRIORITY 5
Purpose of Action	LEVEL 6
Deficiency Photo1

Violations	Parkside Avenue No violations recorded.
Deficiency	DAMAGED CURBS
Deficiency Location/Instance	Parkside Avenue
Deficiency Quantity	10
Quantity Uom	L.F.
Potential Action	REPLACE
Urgency of Action	PRIORITY 3
Purpose of Action	LEVEL 2

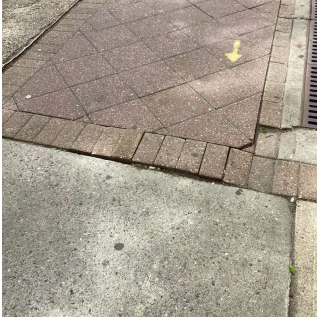
Question	Response
SITE	
PAVING	
DOT Sidewalk	
Pavers	
Deficiency Photo1

Violations	Parkside Avenue No violations recorded.
Deficiency	DAMAGED/MISSING
Deficiency Location/Instance	Nostrand Avenue, Parkside Avenue
Deficiency Quantity	85
Quantity Uom	S.F.
Potential Action	REPLACE
Urgency of Action	PRIORITY 3
Purpose of Action	LEVEL 2
Deficiency Photo1

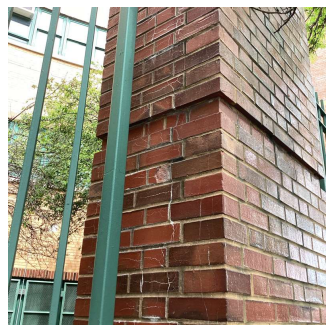
Question	Response
SITE	
SITE WALLS (NOT RETAINING WALLS)	
Deficiency Photo1 Violations

<p>Parkside Avenue No violations recorded.</p>
STAIRS/RAMPS: EXTERIOR	
	Inaccessible
ARTWORK	
Instance	Inspected
Instance Photo	Interior - Lobby - 21346
