NYC Department of Education
Building Condition Assessment Survey 2023 - 2024

Architectural Inspection

Asset: P.S. 6 - BROOKLYN, 43 SNYDER AVENUE, New York, 11226

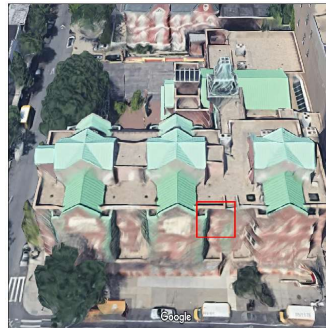
Elevation

Question	Response
EXTERIOR	
WINDOWS	
Replacement Quantity	7,000
Replacement Uom	S.F.
EXTERIOR GUARDS	Inaccessible
LINTELS	Inaccessible
WINDOWS	Inspected
Material Type(s)	Aluminum
Instance on Aluminum - Double Hung: All Facades	Inspected
Instance Condition	3 - Fair
Instance Quantity	6,900
Instance Quantity Uom	S.F.
Are these windows insulated	No
Installation Year	1993
Source of Installation	Custodial Staff
Deficiency	ALUMINUM - DOUBLE HUNG: AIR/WATER INFILTRATION, DETERIORATED JOINTS WITH DAMAGED CAULKING
Roof Plan reference

900
L.F.
MAINTENANCE
PRIORITY 3
LEVEL 2

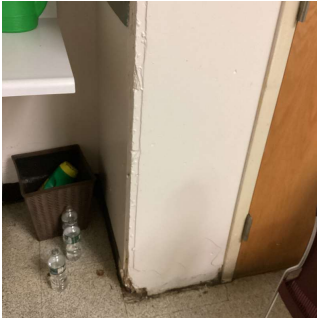
Question	Response
INTERIOR	
CAFETERIA	
Stage	
Instance on 1st Floor - Students	Does not Exist
Walls	
Instance on 1st Floor - Staff (600 SF)	Inspected
Condition	2 - Between Good and Fair
Deficiency	GYPSUM BOARD: DETERIORATED
Deficiency Location/Instance	Near Sink, Next to Main Entrance
Deficiency Quantity	20
Quantity Uom	S.F.
Potential Action	REPLACE
Urgency of Action	PRIORITY 3
Purpose of Action	LEVEL 2
Deficiency Photo1

Near Sink
Violations	No violations recorded.
Window Curtains/Shades/Blinds	
Instance on 1st Floor - Students	Does not Exist
Instance on 1st Floor - Staff (600 SF)	Does not Exist
CLASSROOMS/CORRIDORS/ADMIN SPACES	
Ceiling	Inspected
Condition	2 - Between Good and Fair
Deficiency	ACOUSTIC TILES: DAMAGED/MISSING - ACTIVE LEAK
Deficiency Location/Instance	Rooms 410, 419C, 420
Deficiency Quantity	100
Quantity Uom	S.F.
Potential Action	REPLACE
Urgency of Action	PRIORITY 5
Purpose of Action	LEVEL 2
Deficiency Photo1

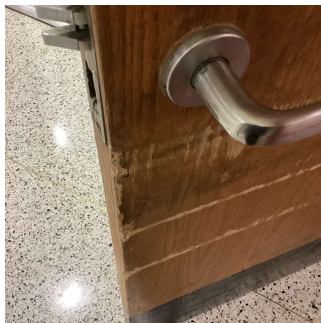
Question	Response
INTERIOR	
KITCHEN	
Door(s)	
Deficiency Photo1

Violations	Near Nurses Office No violations recorded.

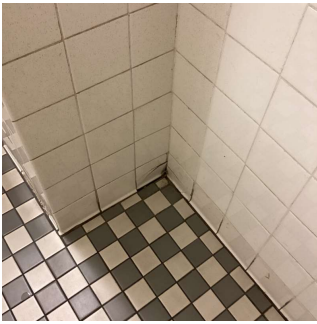
Question	Response
INTERIOR	
TOILET ROOMS - STAFF	
Floor Finish	
Deficiency Photo1	 
	Room 413
Violations	No violations recorded.
Stalls	Inspected
Condition	2 - Between Good and Fair
Deficiency	No deficiencies recorded
Walls	Inspected
Condition	2 - Between Good and Fair
Deficiency	CERAMIC TILE: BROKEN/ MISSING
Deficiency Location/Instance	Room 113
Deficiency Quantity	10
Quantity Uom	S.F.
Potential Action	REPLACE
Urgency of Action	PRIORITY 3
Purpose of Action	LEVEL 2
Deficiency Photo1

Room 113
Violations	No violations recorded.
TOILET ROOMS - STUDENTS	
	Inspected
Ceiling	Inspected
Condition	2 - Between Good and Fair
Deficiency	GYPSUM BOARD: DAMAGED/DETERIORATED
Deficiency Location/Instance	Rooms 415, 221, 220
Deficiency Quantity	30
Quantity Uom	S.F.
Potential Action	REPLACE
Urgency of Action	PRIORITY 3
Purpose of Action	LEVEL 2

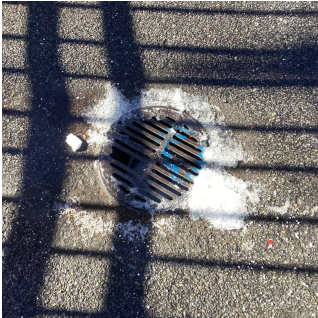
Question	Response
LIFE SAFETY	Inspected
F.D. HOLDING AREA	Does not Exist
STEEL STAIRS	Does not Exist
SITE	Inspected
CONTAINERIZATION	Does not Exist
Drainage System for Asphalt	Inspected
Catch Basins/Manhole - Surrounded by asphalt	Inspected
Condition	3 - Fair
Deficiency	DAMAGED COVER
Deficiency Location/Instance	Schoolyard
Deficiency Quantity	1
Quantity Uom	EACH
Potential Action	REPLACE
Urgency of Action	PRIORITY 3
Purpose of Action	LEVEL 2
Deficiency Photo1

Violations	Schoolyard No violations recorded.
Culverts - Asphalt Covering	Does not Exist
Drainage System for Concrete	Inspected
Catch Basins/Manhole - Surrounded by concrete	Inspected
Condition	2 - Between Good and Fair
Deficiency	No deficiencies recorded
Culverts - Concrete Covering	Does not Exist
Drainage System for Soil	Does not Exist
DRINKING FOUNTAINS	Does not Exist
FENCES	Inspected
Condition	2 - Between Good and Fair
Deficiency	No deficiencies recorded

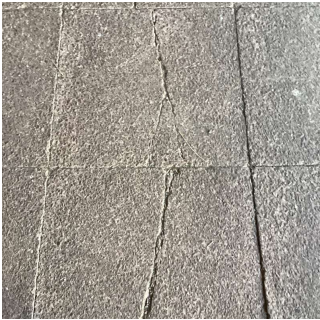
Violations	Schoolyard No violations recorded.
Concrete	Inspected
Condition	2 - Between Good and Fair
Deficiency	No deficiencies recorded
Pavers	Inspected
Condition	3 - Fair
Deficiency	DAMAGED/MISSING
Deficiency Location/Instance	Schoolyard
Deficiency Quantity	300
Quantity Uom	S.F.
Potential Action	REPLACE
Urgency of Action	PRIORITY 3
Purpose of Action	LEVEL 2
Deficiency Photo1

Violations	Schoolyard No violations recorded.
Site Sidewalks & Walkways	Inspected
Asphalt	Does not Exist
Concrete	Inspected
Condition	3 - Fair

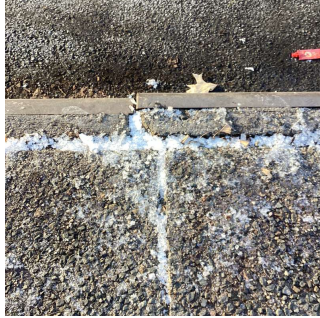
Question	Response
SITE	
PAVING	
DOT Sidewalk	
Concrete	
Urgency of Action	PRIORITY 3
Purpose of Action	LEVEL 2
Deficiency Photo1

Bedford Avenue
Violations	No violations recorded.
Deficiency	HEAVING
Deficiency Location/Instance	Bedford Avenue
Deficiency Quantity	150
Quantity Uom	S.F.
Potential Action	REPLACE
Urgency of Action	PRIORITY 3
Purpose of Action	LEVEL 2
Deficiency Photo1
