**NYC Department of Education**  
**Building Condition Assessment Survey 2023 - 2024**

Architectural Inspection

**Asset: P.S. 7 - BROOKLYN, 858 JAMAICA AVENUE, New York, 11208**

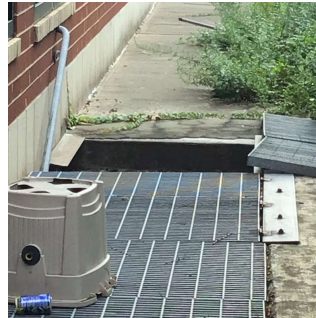
AW2

Question	Response
<b>Architectural</b>	
<b>EXTERIOR</b>	Inspected
<b>AREAWAY</b>	Inspected
Instance on AW1-AW2	Inspected
Instance Condition	3 - Fair
Instance Quantity	2
Instance Quantity Uom	EACH
Deficiency	AREAWAY GRATINGS: MAJOR RUSTING AND / OR BROKEN SUPPORTS
Roof Plan reference

Deficiency Quantity	20
Quantity Uom	L.F.
Potential Action	REPLACE

PRIORITY 4  
LEVEL 2

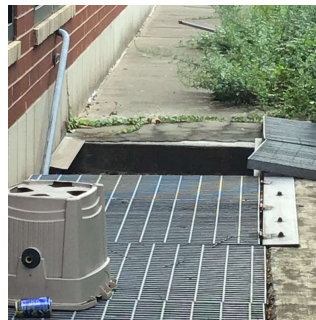
AW2

AREAWAY SLAB: CRACKS AND SPALLING

20  
S.F.  
REPLACE  
PRIORITY 4  
LEVEL 2

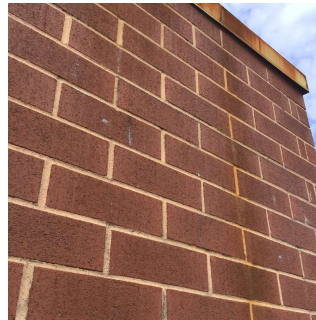
CH

BRICK: DETERIORATED JOINTS

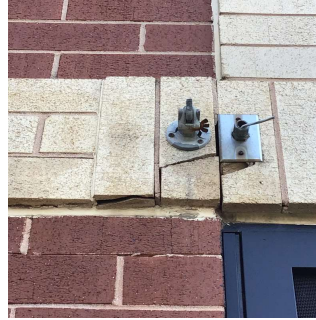
Facade F

BRICK: MAJOR / THRU CRACKS

S.F.  
REMOVE AND REBUILD  
PRIORITY 5  
LEVEL 6

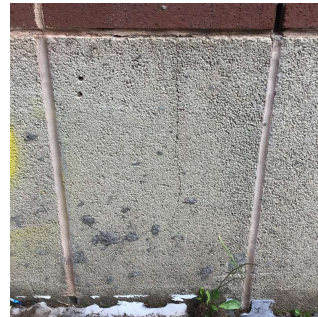
Facade C

**CONCRETE MASONRY UNIT: MINOR CRACKS AND SPALLING**

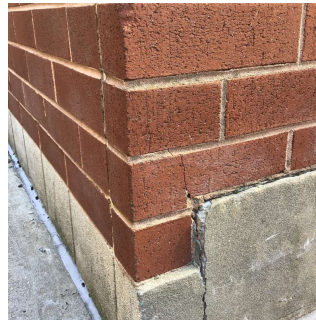
Facade C

BRICK: CRACKS/DISPLACED/SPALLED BRICK AT BUILDING CORNERS

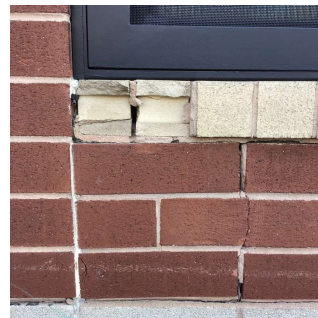
Facade F

BRICK: DETERIORATED MASONRY SILLS - MAJOR

REMOVE AND REPLACE

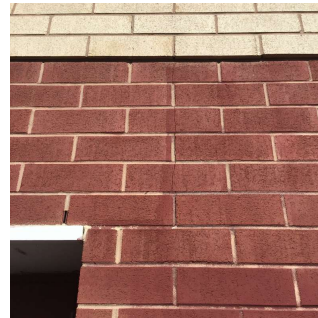
Facade E

BRICK: MINOR CRACKS AND SPALLING

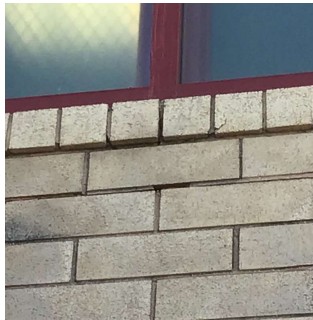
Facade F

CONCRETE MASONRY UNIT: MAJOR / THRU CRACKS

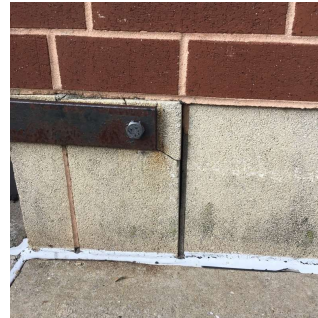
Facade B

**BRICK: DETERIORATED CONTROL/EXPANSION JOINTS**

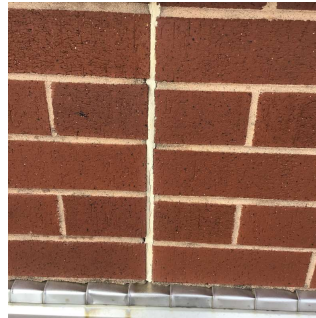
Roof 1

Deficiency	BRICK: MINOR CRACKS, SPALLING
------------	-------------------------------

Deficiency Quantity 10  
Quantity Uom S.F.  
Potential Action REPAIR  
Urgency of Action PRIORITY 3  
Purpose of Action LEVEL 2

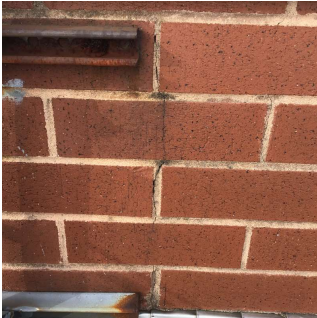
Violations	Roof 1 No violations recorded.
Deficiency	<b>BRICK: DETERIORATED JOINTS</b>
Roof Plan reference

Deficiency Quantity	40
Quantity Uom	S.F.
Potential Action	REPOINT
Urgency of Action	PRIORITY 3
Purpose of Action	LEVEL 2
Deficiency Photo1

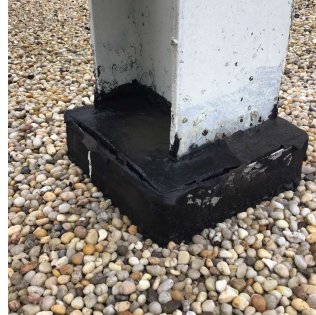
Roof 1

**BUILT-UP: ROOFING: DELAMINATION**

**REPLACE ROOFING WITHOUT MAJOR EQUIPMENT REMOVAL**

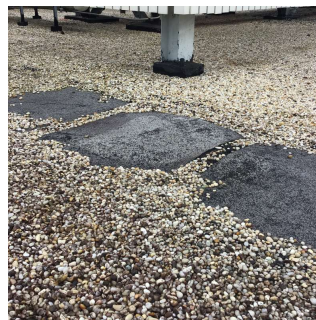
Roof 1

**BUILT-UP: FLASHING: CAP FLASHING DAMAGED**

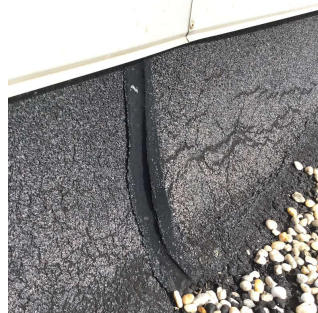
Roof 1

**BUILT-UP: ROOFING: LOSS OF GRAVEL**

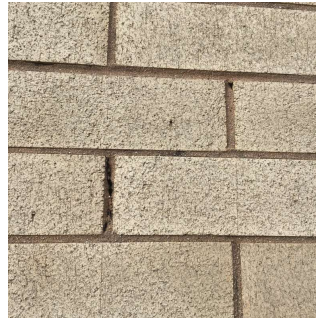
BH

**BULKHEAD/PENTHOUSE WALLS/INTERIOR: CMU  
CRACKS/SPALLING**

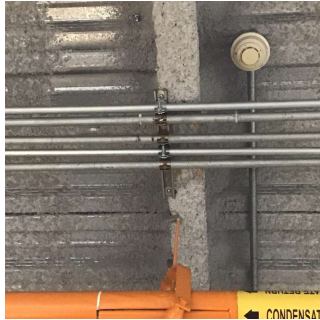
Question	Response
<b>EXTERIOR</b>	
<b>WINDOWS</b>	
<b>WINDOWS</b>	
Instance Quantity	7,800
Instance Quantity Uom	S.F.
Are these windows insulated	No
Installation Year	1999
Source of Installation	Custodial Staff
Deficiency	No deficiencies recorded
<b>INTERIOR</b>	Inspected
<b>POOLS</b>	Does not Exist
<b>STRUCTURAL</b>	Inspected
<b>COLUMNS/BEAMS/BEARING WALLS</b>	Inspected
Condition	3 - Fair
Deficiency	STEEL COLUMNS/BEAMS: DETERIORATED/MISSING SPRAY-ON FIREPROOFING
Deficiency Location/Instance	Room 307, Gymnasium Mechanical Equipment Room, Boiler Room
Deficiency Quantity	40
Quantity Uom	S.F.
Potential Action	REPLACE
Urgency of Action	PRIORITY 3
Purpose of Action	LEVEL 5
Deficiency Photo1

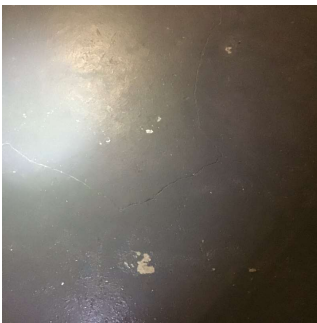
Room 307
Violations	No violations recorded.
<b>FLOOR STRUCTURE</b>	Inspected
Condition	3 - Fair
Deficiency	CONCRETE SLAB ON GRADE: THRU CRACKS
Deficiency Location/Instance	Basement - Boiler Room, Water Meter Room, Corridor
Deficiency Quantity	60

Quantity Uom	S.F.
Potential Action	REPAIR
Urgency of Action	PRIORITY 3
Purpose of Action	LEVEL 5

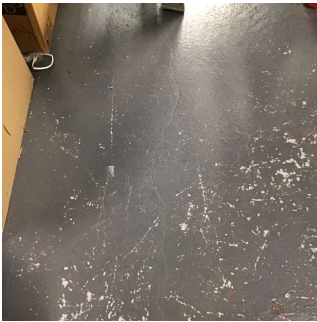
Violations	Basement - Boiler Room No violations recorded.
Deficiency	CONCRETE: CRACKS/SPALLED/REINFORCEMENT EXPOSED
Deficiency Location/Instance	Rooms 307, 340
Deficiency Quantity	40
Quantity Uom	S.F.
Potential Action	REPAIR
Urgency of Action	PRIORITY 3
Purpose of Action	LEVEL 5
Deficiency Photo1

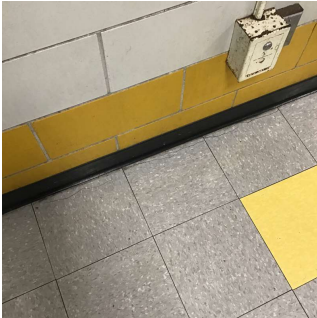
Question	Response
<b>INTERIOR</b>	
<b>CAFETERIA</b>	
<b>Fixed Equipment</b>	
Instance on 1st Floor	Does not Exist
<b>Floor Finish</b>	
Instance on 1st Floor	Inspected
Condition	2 - Between Good and Fair
Deficiency	VINYL TILES: BROKEN/DETERIORATED/MISSING TILES
Deficiency Location/Instance	Near Drinking Fountain
Deficiency Quantity	10
Quantity Uom	S.F.
Potential Action	REPLACE
Urgency of Action	PRIORITY 3
Purpose of Action	LEVEL 2
Deficiency Photo1

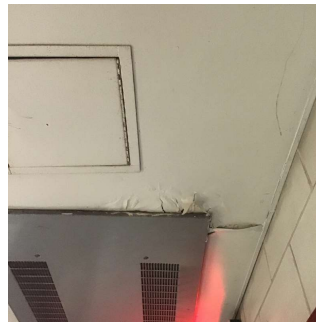
Main Entrance Vestibule

Deficiency	GYPSUM BOARD: DAMAGED/DETERIORATED
Deficiency Location/Instance	Main Entrance Vestibule, Exit 3 Vestibule
Deficiency Quantity	25
Quantity Uom	S.F.
Potential Action	REPLACE
Urgency of Action	PRIORITY 3
Purpose of Action	LEVEL 2

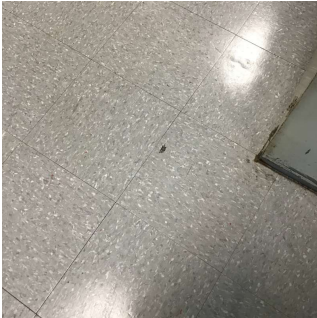
<b>Question</b>	<b>Response</b>
<b>INTERIOR</b>	
<b>CLASSROOMS/CORRIDORS/ADMIN SPACES</b>	
<b>Door(s)</b>	Inspected
	Room 329
Violations	No violations recorded.
<b>Floor Finish</b>	Inspected
Condition	2 - Between Good and Fair
Deficiency	VINYL TILES: BROKEN/DETERIORATED/MISSING TILES
Deficiency Location/Instance	Room 204, Corridor near Room 349
Deficiency Quantity	15
Quantity Uom	S.F.
Potential Action	REPLACE
Urgency of Action	PRIORITY 3
Purpose of Action	LEVEL 2
Deficiency Photo1

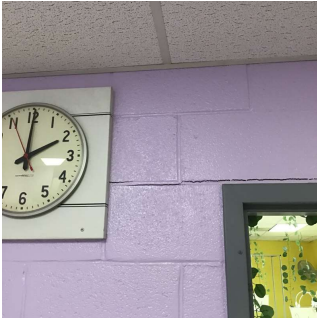
Room 329
Violations	No violations recorded.
<b>Walls</b>	Inspected
Condition	2 - Between Good and Fair
Deficiency	MASONRY: CRACKS/SPALLING
Deficiency Location/Instance	Rooms 118, 207
Deficiency Quantity	20
Quantity Uom	S.F.
Potential Action	REPLACE
Urgency of Action	PRIORITY 3
Purpose of Action	LEVEL 2
Deficiency Photo1

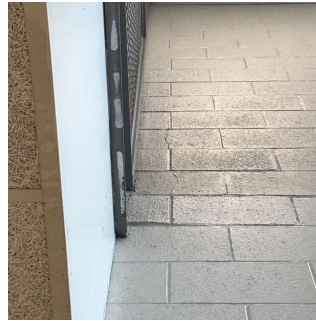
Question	Response
<b>INTERIOR</b>	
<b>STAIRS/RAMPS: INTERIOR</b>	
<b>Ceiling</b>	
Deficiency Photo1	 
	Stair C/2
Violations	No violations recorded.
<b>Door(s)</b>	Inspected
Condition	2 - Between Good and Fair
Deficiency	No deficiencies recorded
<b>Partition</b>	Does not Exist
<b>Railings</b>	Inspected
Condition	2 - Between Good and Fair
Deficiency	No deficiencies recorded
<b>Stairs and Landings</b>	Inspected
Condition	2 - Between Good and Fair
Deficiency	VINYL TILES: BROKEN/DETERIORATED/MISSING TILES
Deficiency Location/Instance	Stair B/3
Deficiency Quantity	10
Quantity Uom	S.F.
Potential Action	REPLACE
Urgency of Action	PRIORITY 3
Purpose of Action	LEVEL 2
Deficiency Photo1	 
	Stair B/3
Violations	No violations recorded.
<b>Walls</b>	Inspected
Condition	2 - Between Good and Fair
Deficiency	MASONRY: CRACKS/SPALLING
Deficiency Location/Instance	Stairs B/3, C/2
Deficiency Quantity	20
Quantity Uom	S.F.
Potential Action	REPLACE

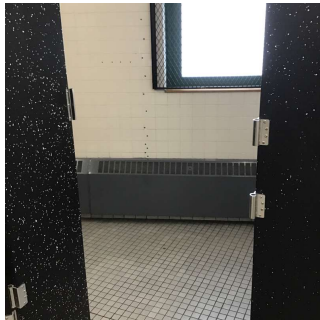
Room 313
Violations	No violations recorded.
<b>Walls</b>	Inspected
Condition	2 - Between Good and Fair
Deficiency	CERAMIC TILE: BROKEN/ MISSING
Deficiency Location/Instance	Rooms 213, 219, In Room 143/149

Question	Response
<b>INTERIOR</b>	
<b>TOILET ROOMS - STUDENTS</b>	
<b>Door(s)</b>	Inspected
	In Room 264
Violations	No violations recorded.
<b>Floor Finish</b>	Inspected
Condition	2 - Between Good and Fair
Deficiency	CERAMIC TILE: BROKEN/MISSING TILES
Deficiency Location/Instance	Room 219
Deficiency Quantity	10
Quantity Uom	S.F.
Potential Action	REPLACE
Urgency of Action	PRIORITY 3
Purpose of Action	LEVEL 2
Deficiency Photo1	 
	Room 219
Violations	No violations recorded.
<b>Stalls</b>	Inspected
Condition	2 - Between Good and Fair
Deficiency	BROKEN/MISSING
Deficiency Location/Instance	Room 313
Deficiency Quantity	1
Quantity Uom	EACH
Potential Action	REPLACE
Urgency of Action	PRIORITY 3
Purpose of Action	LEVEL 2
Deficiency Photo1

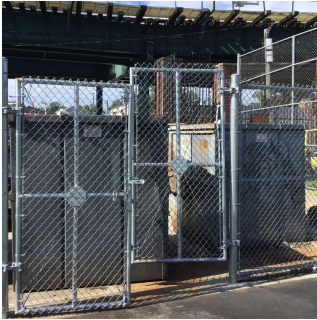
Question	Response
<b>SITE</b>	
<b>CONTAINERIZATION</b>	
Deficiency Photo1

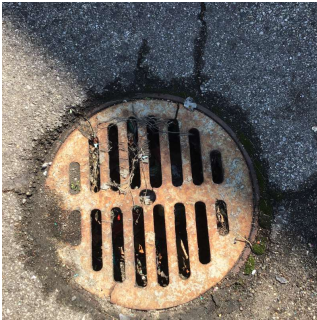
Violations	Crescent Street Schoolyard No violations recorded.
<b>Drainage System for Asphalt</b>	Inspected
<b>Catch Basins/Manhole - Surrounded by asphalt</b>	Inspected
Condition	3 - Fair
Deficiency	DAMAGED COVER
Deficiency Location/Instance	Inner Schoolyard
Deficiency Quantity	1
Quantity Uom	EACH
Potential Action	REPLACE
Urgency of Action	PRIORITY 3
Purpose of Action	LEVEL 2
Deficiency Photo1

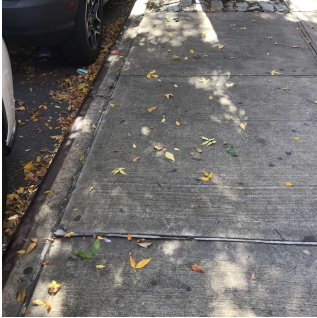
Question	Response
<b>SITE</b>	
<b>PAVING</b>	
<b>DOT Sidewalk</b>	
<b>Concrete</b>	
Condition	3 - Fair
Deficiency	HEAVING
Deficiency Location/Instance	Hemlock Street
Deficiency Quantity	50
Quantity Uom	S.F.
Potential Action	REPLACE
Urgency of Action	PRIORITY 3
Purpose of Action	LEVEL 2
Deficiency Photo1

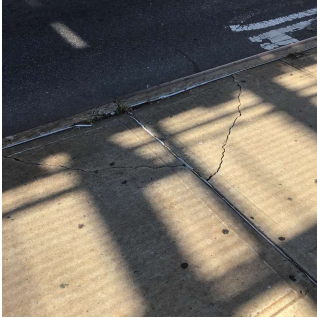
Violations	Hemlock Street No violations recorded.
Deficiency	DAMAGED/DETERIORATED/MISSING SECTIONS
Deficiency Location/Instance	Crescent Street, Jamaica Avenue, Hemlock Street
Deficiency Quantity	200
Quantity Uom	S.F.
Potential Action	REPLACE
Urgency of Action	PRIORITY 3
Purpose of Action	LEVEL 2
Deficiency Photo1

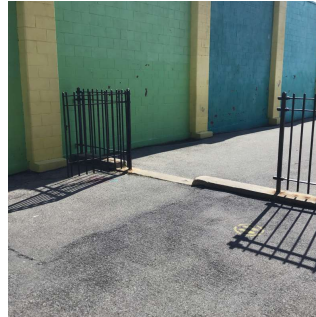
Violations	Crescent Street No violations recorded.
<b>Pavers</b>	Does not Exist
<b>PLAYGROUNDS</b>	Inspected
Instance on Schoolyard	Inspected
<b>Benches</b>	
Instance on Schoolyard	Does not Exist
<b>Fence</b>	
Instance on Schoolyard	Inspected
Condition	2 - Between Good and Fair
Deficiency	WROUGHT IRON: MISSING SECTIONS

Deficiency Location/Instance	Gate to Schoolyard
Deficiency Quantity	40
Quantity Uom	S.F.
Potential Action	REPLACE
Urgency of Action	PRIORITY 3
Purpose of Action	LEVEL 2
Deficiency Photo1
