NYC Department of Education
Building Condition Assessment Survey 2023 - 2024

Architectural Inspection

Asset: P.S. 11 - BROOKLYN, 419 WAVERLY AVENUE, New York, 11238

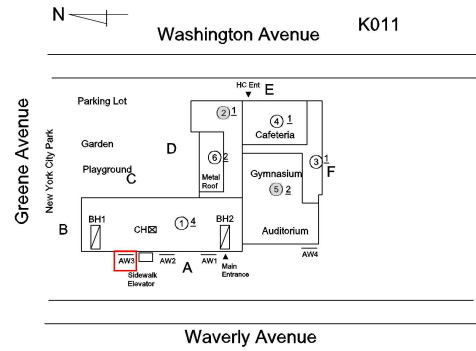
Question	Response
Architectural	
EXTERIOR	Inspected
AREAWAY	Inspected
Instance on AW1 - AW4	Inspected
Instance Condition	3 - Fair
Instance Quantity	4
Instance Quantity Uom	EACH
Deficiency	AREAWAY DRAINS: DETERIORATED

1
EACH
REPLACE
PRIORITY 4
LEVEL 2

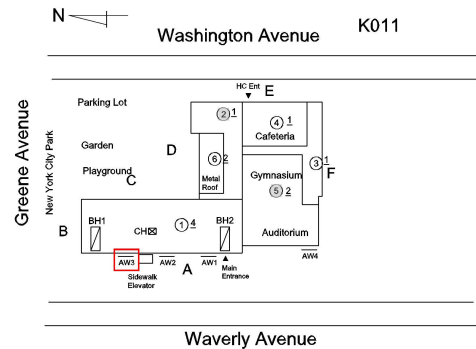
AREAWAY SLAB: CRACKS AND SPALLING

10
S.F.
REPAIR
PRIORITY 3
LEVEL 2

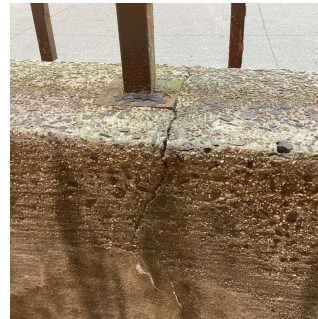
AW2

AREAWAY WALLS: CRACKS AND SPALLING

REPAIR

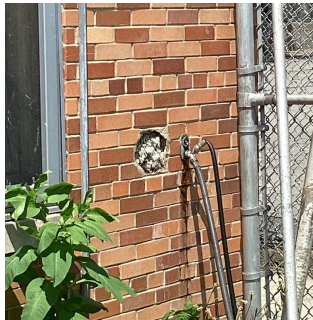
Facade C

BRICK: MAJOR / THRU CRACKS

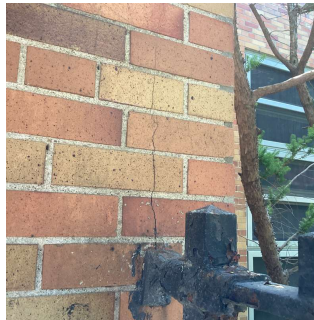
Facade A

BRICK: MINOR CRACKS AND SPALLING

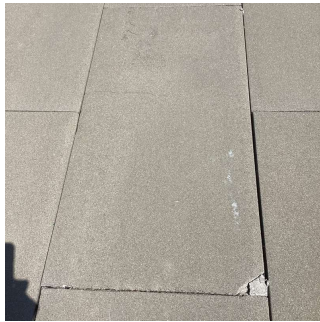
Roof 1
Violations	No violations recorded.
Instance on Modified Bitumen: Roof 4, 5	Inspected
Instance Condition	1 - Good

Roof 1
Instance Quantity	20,000
Instance Quantity Uom	S.F.
Does the roof have major mechanical equipment sitting on Dunnage Steel less than 18" above the Roofing?	No
Does this roof instance have a Sustainable Roof System?	No
Do solar panels exist on these roofs?	No
Is/Are the roof(s) suitable for Solar Panel installation?	Yes
Installation Year	2022
Source of Installation	Custodial Staff
Deficiency	IRMA: ROOFING: DETERIORATED PAVERS WITH INTEGRAL INSULATION
Roof Plan reference

<p align="center">Washington Avenue K011</p> <p align="center">Greene Avenue</p> <p align="center">Waverly Avenue</p>
Deficiency Quantity	200
Quantity Uom	S.F.
Potential Action	REPLACE
Urgency of Action	PRIORITY 4
Purpose of Action	LEVEL 2
Deficiency Photo1

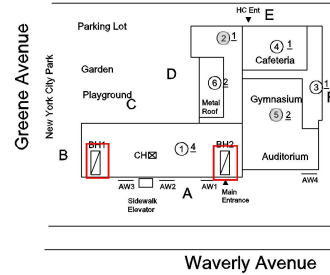
BH2
No violations recorded.

Do solar panels exist on these roofs?	No
Is/Are the roof(s) suitable for Solar Panel installation?	No
Installation Year	2022
Source of Installation	Custodial Staff
Deficiency	No deficiencies recorded
ROOFING DRAINS	Inspected
Condition	1 - Good
Deficiency	No deficiencies recorded
Specialties	Inspected
BULKHEAD/PENTHOUSE	Inspected
Condition	3 - Fair
Deficiency	BULKHEAD/PENTHOUSE WALLS/INTERIOR: CMU CRACKS/SPALLING

20
S.F.
REPLACE
PRIORITY 3
LEVEL 2

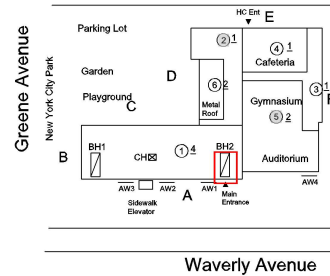
BULKHEAD/PENTHOUSE ROOF: DETERIORATED

20
S.F.
REPLACE
PRIORITY 4
LEVEL 2

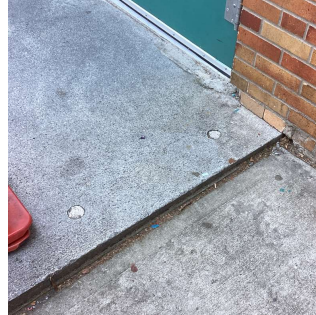
Facade B - Exit 8

MISSING RAILING

20
 L.F.
 REPLACE

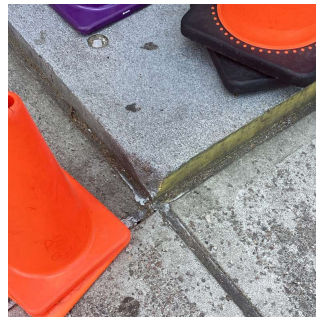
Facade B - Exit 8

STONE: CRACKS/SPALLING - MINOR

10
 S.F.
 REPAIR
 PRIORITY 3
 LEVEL 2

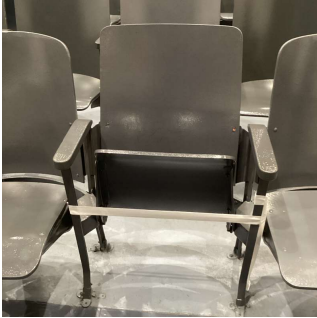
Question	Response
INTERIOR	
AUDITORIUM	
Door(s)	
Instance on Ground Floor (402 Seats)	Inspected
Condition	2 - Between Good and Fair
Deficiency	No deficiencies recorded
Fixed H/C Lift	
Instance on Ground Floor (402 Seats)	Does not Exist
Fixed Seating	
Instance on Ground Floor (402 Seats)	Inspected
Condition	3 - Fair
Deficiency	DAMAGED/BROKEN/INOPERABLE
Deficiency Location/Instance	Seat A/111
Deficiency Quantity	1
Quantity Uom	EACH
Potential Action	REPLACE
Urgency of Action	PRIORITY 5
Purpose of Action	LEVEL 6
Deficiency Photo1

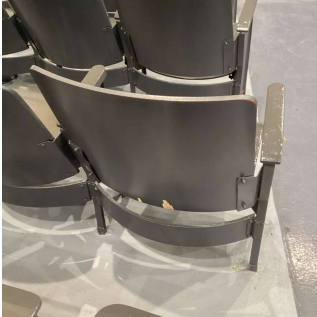
Violations	Seat F/2 No violations recorded.
Floor Finish	
Instance on Ground Floor (402 Seats)	Inspected

Violations	Seat A/111 No violations recorded.
Deficiency	DAMAGED/BROKEN/INOPERABLE
Deficiency Location/Instance	Seats A/113, D/7, E/3, 9, F/2 and others
Deficiency Quantity	21
Quantity Uom	EACH
Potential Action	REPLACE
Urgency of Action	PRIORITY 3
Purpose of Action	LEVEL 2
Deficiency Photo1

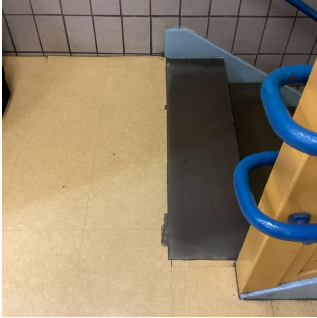
Violations	Stair A/Ground Floor No violations recorded.
Deficiency	STONE: BROKEN/MISSING
Deficiency Location/Instance	Stairs A/Ground Floor, 1, 2, B/3
Deficiency Quantity	40
Quantity Uom	S.F.
Potential Action	REPLACE

Violations	Exit 1 - Vestibule No violations recorded.
Stairs and Landings	Inspected
Condition	3 - Fair
Deficiency	VINYL TILES: BROKEN/DETERIORATED/MISSING TILES
Deficiency Location/Instance	Stairs A/Ground Floor, 3, Bulkhead, B/3
Deficiency Quantity	40
Quantity Uom	S.F.
Potential Action	REPLACE
Urgency of Action	PRIORITY 3
Purpose of Action	LEVEL 2
Deficiency Photo1

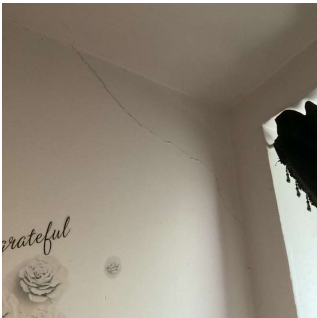
Violations	In Kitchen Locker Room No violations recorded.
TOILET ROOMS - STUDENTS	
Ceiling	
Condition	Inspected
Deficiency	1 - Good
Deficiency	No deficiencies recorded
Door(s)	
Condition	Inspected
Deficiency	1 - Good
Deficiency	No deficiencies recorded
Floor Finish	
Deficiency	Inspected

Violations	In Kitchen Storage Room No violations recorded.
Stalls	Inspected
Condition	2 - Between Good and Fair
Deficiency	No deficiencies recorded
Walls	Inspected
Condition	2 - Between Good and Fair
Deficiency	PLASTER: CRACKS/SPALLING
Deficiency Location/Instance	In Kitchen Locker Room
Deficiency Quantity	10
Quantity Uom	S.F.
Potential Action	REPLACE
Urgency of Action	PRIORITY 3
Purpose of Action	LEVEL 2
Deficiency Photo1

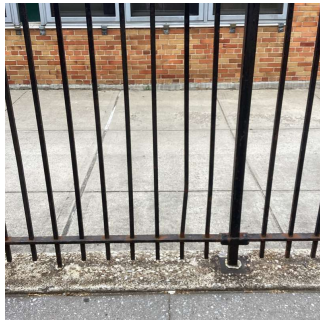
Washington Avenue
Violations	No violations recorded.
Deficiency	CHAIN LINK: DAMAGED POST/RAIL

Deficiency	WROUGHT IRON: DAMAGED/DETERIORATED
Deficiency Location/Instance	Washington Avenue, Waverly Avenue
Deficiency Quantity	400
Quantity Uom	S.F.
Potential Action	REPLACE
Urgency of Action	PRIORITY 3
Purpose of Action	LEVEL 2
Deficiency Photo1

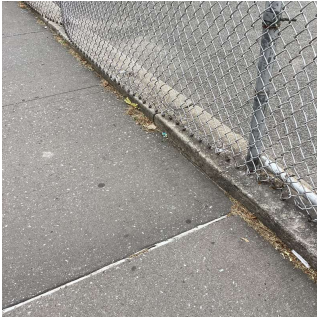
Question	Response
SITE	
FENCES	
Deficiency Location/Instance	Washington Avenue, near Exit 3
Deficiency Quantity	50
Quantity Uom	L.F.
Potential Action	REPLACE
Urgency of Action	PRIORITY 3
Purpose of Action	LEVEL 2
Deficiency Photo1

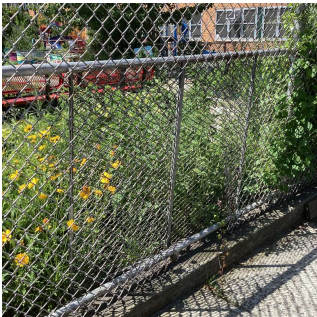
Violations	Washington Avenue No violations recorded.
Deficiency	CHAIN LINK: DAMAGED/DETERIORATED
Deficiency Location/Instance	Near Garden, Schoolyard
Deficiency Quantity	150
Quantity Uom	S.F.
Potential Action	REPLACE
Urgency of Action	PRIORITY 3
Purpose of Action	LEVEL 2
Deficiency Photo1

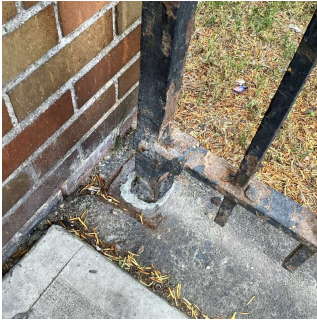
Violations	Near Garden No violations recorded.
Deficiency	WROUGHT IRON: RUST - MAJOR
Deficiency Location/Instance	Waverly Avenue
Deficiency Quantity	40
Quantity Uom	S.F.
Potential Action	REPLACE
Urgency of Action	PRIORITY 3
Purpose of Action	LEVEL 2

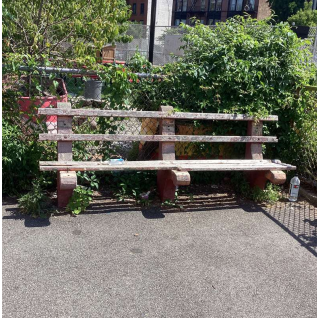
Question	Response
SITE	
PLAYGROUNDS	
Benches	
Deficiency Location/Instance	Near Garden
Deficiency Quantity	2
Quantity Uom	EACH
Potential Action	REPLACE
Urgency of Action	PRIORITY 3
Purpose of Action	LEVEL 2
Deficiency Photo1

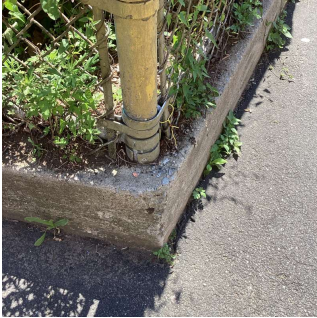
Near Exit 7
Violations	No violations recorded.
Deficiency	CHAIN LINK: DAMAGED POST/RAIL
Deficiency Location/Instance	Near Garden
Deficiency Quantity	10
Quantity Uom	L.F.
Potential Action	REPLACE
Urgency of Action	PRIORITY 3
Purpose of Action	LEVEL 2

Near Garden
Violations	No violations recorded.
Fence	
Instance on Schoolyard	Inspected
Condition	2 - Between Good and Fair
Deficiency	CONCRETE CURB: DAMAGED/DETERIORATED
Deficiency Location/Instance	Near Exit 7
Deficiency Quantity	10
Quantity Uom	S.F.
Potential Action	REPLACE
Urgency of Action	PRIORITY 3
Purpose of Action	LEVEL 2
Deficiency Photo1

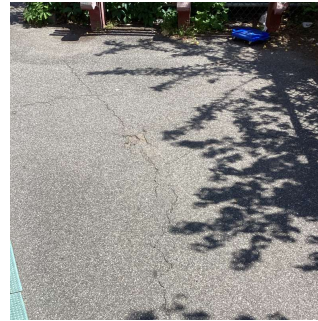
Near Safety Surface

Violations	Near Main Entrance No violations recorded.
Deficiency	ASPHALT: CRACKS - MAJOR
Deficiency Location/Instance	Near Safety Surface, by Exits 7, 15, close to Entrance
Deficiency Quantity	180
Quantity Uom	S.F.
Potential Action	REPLACE
Urgency of Action	PRIORITY 3
Purpose of Action	LEVEL 2

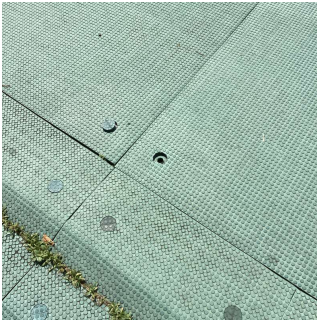
Question	Response
SITE	
PLAYGROUNDS	
Safety Surfacing	
Deficiency Photo1

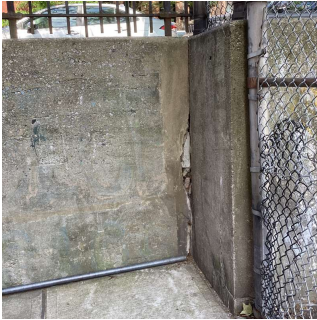
Violations	Near Exit 15 No violations recorded.
Unpaved Area	
Instance on Schoolyard	Inspected
Condition	2 - Between Good and Fair
Deficiency	No deficiencies recorded
PLAYING SURFACE	Does not Exist
RETAINING WALLS	
Are there any Retaining Walls 6' OR higher facing public street/sidewalk?	Inspected Yes
Condition	2 - Between Good and Fair
Deficiency	CAST IN PLACE CONCRETE: CRACKS/SPALLING - MAJOR
Deficiency Location/Instance	Waverly Avenue
Deficiency Quantity	20
Quantity Uom	S.F.
Potential Action	REPLACE
Urgency of Action	PRIORITY 3
Purpose of Action	LEVEL 2
Deficiency Photo1

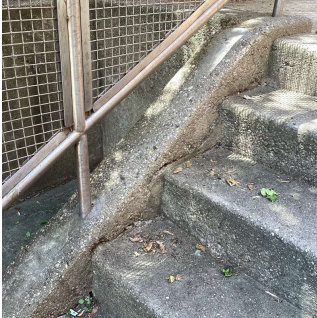
Near Exit 2
Violations	No violations recorded.
Stairs/ramps	Inspected
Condition	2 - Between Good and Fair
Deficiency	No deficiencies recorded
ARTWORK	Does not Exist

Condition	2 - Between Good and Fair
Deficiency	CAST IN PLACE CONCRETE: CRACKS/SPALLING - MAJOR

Question	Response
SITE	
STAIRS/RAMPS: EXTERIOR	
Site Cheek/flank Walls	
Deficiency Location/Instance	Near Exit 2
Deficiency Quantity	20
Quantity Uom	S.F.
Potential Action	REPLACE
Urgency of Action	PRIORITY 3
Purpose of Action	LEVEL 2
Deficiency Photo1
