NYC Department of Education
Building Condition Assessment Survey 2023 - 2024

Architectural Inspection

Asset: P.S. 16 - BROOKLYN, 157 WILSON STREET, New York, 11211

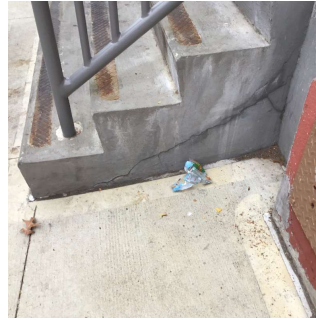
Exit 3
 No violations recorded.

Deficiency Quantity	10
Quantity Uom	S.F.
Potential Action	REPAIR
Urgency of Action	PRIORITY 3
Purpose of Action	LEVEL 2
Deficiency Photo1
